Museum Archive Dehumidification in Hot & Humid Climates

B. K. Browning, PE Principal Engineer KWR Services Austin, Texas

ABSTRACT

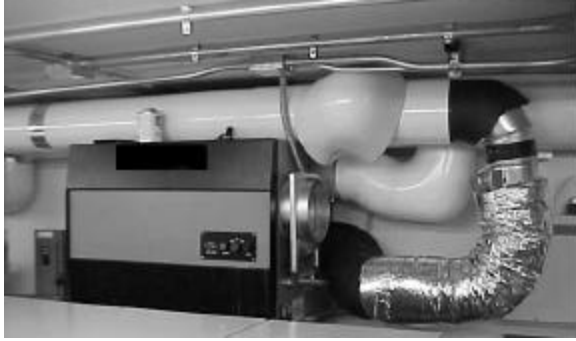
Figure 2 – Dehumidifier DH-3 during regeneration control damper installation.

Plans were made to install control dampers in the regeneration air exhaust of each dehumidifier. The control dampers were to be wired in parallel with the command for that particular dehumidifier so the damper would remain closed unless that dehumidifier was commanded on. The inaccessible air filters were to be replaced with a single filter in the common regeneration inlet duct. Since the space conditions were being maintained by the portable dehumidifiers, these changes were to be made as time and budget allowed. Due to continuing personnel turnover and budget constraints, these have not been completed. Figure 2 shows dehumidifier DH-3 during control damper installation.

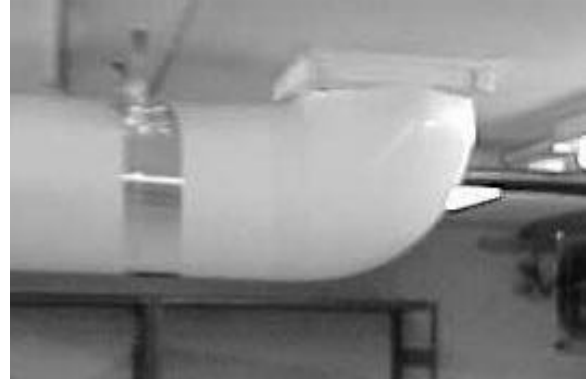
Figure 4 – Visible picture of regeneration air inlet from inside archive. Water damaged materials were found on shelves in background. This is the same duct as Figure 3.

During dehumidifier installation in 1995, the regeneration air ducts were tapped into existing exhaust fan ducts that ran from the archive to the roof. Figure 4 is the view of the regeneration air inlet from inside the archive. Figure 5 is the view of inside the duct from the roof. These existing ducts were completely un-insulated. The ends of the existing duct that were exposed inside the archive would be at 50 F or 60 F at all times. The new regeneration air

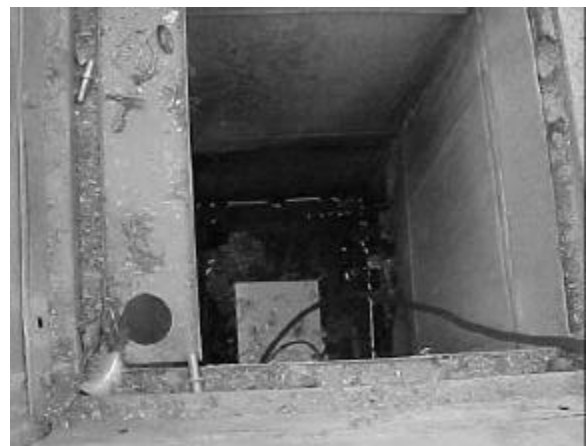
Figure 5 – Picture of regeneration exhaust viewed from roof. Water level is visible inside duct. Hose at lower right is pressure measurement reference.

Based on these estimates, the regeneration ducts were sealed at the roof to prevent the entry of wet outside air. The seal was made with duct board and mastic until a permanent solution was implemented. Within a day the electrical conduit to the roof mounted condensers had filled with water and were leaking into the archive. Pressure measurements with respect to the outside indicated the archive was depressurized by 12 Pascal (0.048 IWC)! When the regeneration ducts were sealed the electrical conduits were the next best path for outside air to try to 'fill' the depressurization. Since there are no exhaust fans shown on the drawings or exhaust grills found in the archives, the depressurization was not expected. The conduits were replaced and sealed closed with silicon caulk to stop the water leakage.

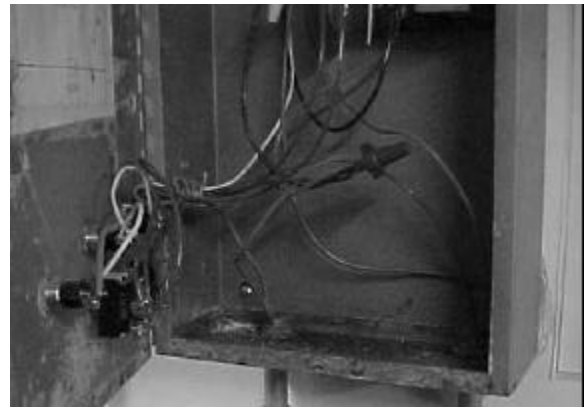
Figure 7 – Control box corrosion indicating it had been filled with water to top of door flange.

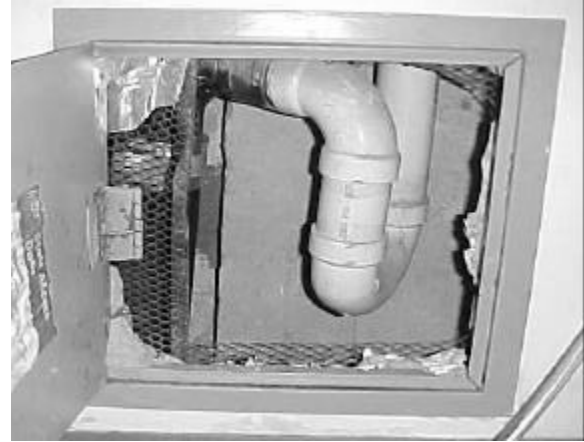
Figure 8 – Plumbing access panel that allows exhaust fan to depressurize archive.

An exhaust fan was found that appears to draw air from a plumbing chase adjacent to the 50 F room (shown between UC-2 and UC-4 in Figure 1). This plumbing chase has a 24 inch square access panel that connects the chase to the 50 degree room. The access panel was also allowing the exhaust fan to depressurize the archive spaces. Figure 8 shows a picture of the access panel. The access panel was sealed with duct board.

After the plumbing access panel was sealed, the archive was measured to remain between + 2Pa and - 2 Pa. It was not determined if the pressure variations were due to mechanical equipment interactions or other sources such as wind, stack effect, or instrument drift. Water was no longer being drawn into the archive and the investigation was stopped.
