## **Experience on Commissioning of Heating/Cooling System and Thermal/Air Quality Environment**

### **Summary**

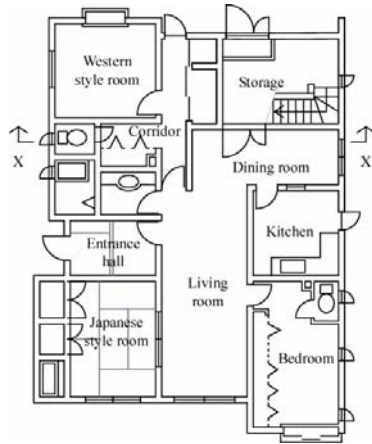
Figure 1 First floor plan

The residential house thus designed (**Fig. 1**) is a highly insulated and airtight steel frame house with an attic space<sup>3</sup>. The resident is an elderly lady, and she spent most of her time in the bedroom.

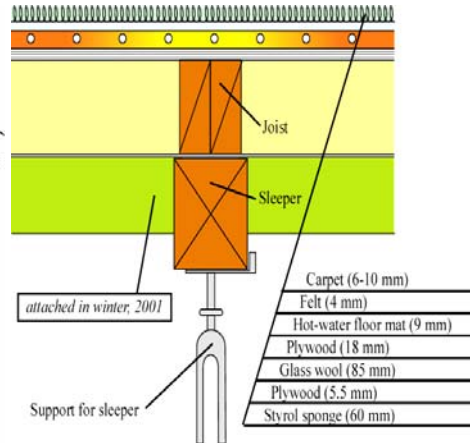
Figure 2 Floor section

1) thermal insulation: The insulation thickness of the external wall and the floor are 100 mm (GW 10 K) and 145 mm (85 mm GW and 60 mm styrol-sponge), respectively. **Figure 2** shows the structure of the floor. Low-E pair glasses, whose overall heat transfer coefficient is  $2.7 \text{ W/m}^2\text{K}$ , glaze all windows and the solar transmittance is 0.74. The outer windows on the south and west sides are installed with outside blinds.

temperatures of the header and hot water pipes were high and the insulation to the pipes for floor heating was insufficient. Also, a part of the floor insulation (styrol-sponge 60 mm) was not attached as specified in the design document. Therefore, the heat loss through the floor and the downward heat flux from the floor heating panel were estimated to be much larger than expected.

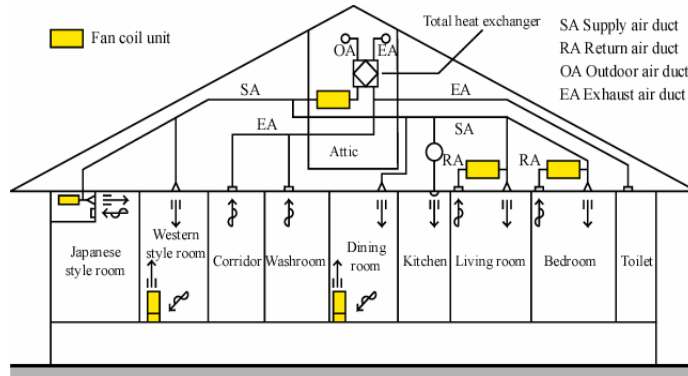
Figure 3 Duct system

3) ventilation plan and centralized HVAC system: A centralized air conditioning system, which supplies and exhausts the minimum necessary air volume ( $200 \text{ m}^3/\text{h}$  in total) through a total heat-exchanger, is adopted so that increase in energy consumption can be minimized whilst preventing degradation of the air quality due

to lack of fresh air (**Fig.3**). All rooms are supplied with fresh air, and the supplied air is exhausted through the washroom and corridor. The doors between the bedroom and living room, living room and corridor have undercuts.

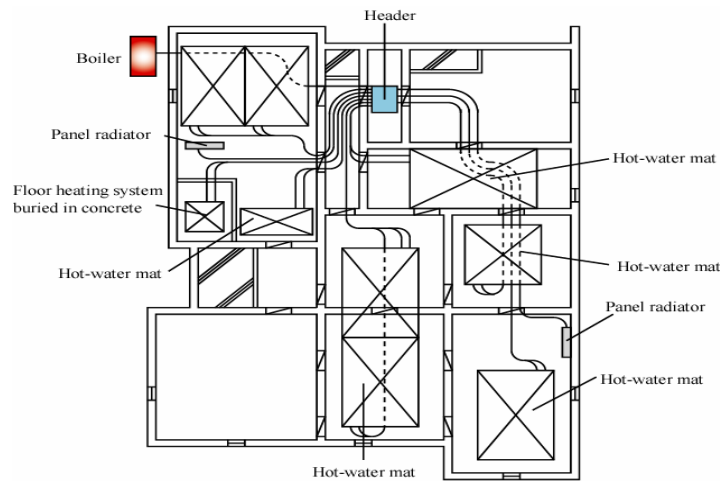
Figure 4 Heating panel and piping network for hot water floor heating

4) floor heating: All rooms except for the Japanese-style room are installed with the hot water floor heating system including a bathroom. **Figure 4** schematically shows the heating panels and piping network for floor heating. Hot water is produced by a gas-boiler and flows to the header located in the crawl space beneath

the closet-corridor. The header controls the water flow rate.

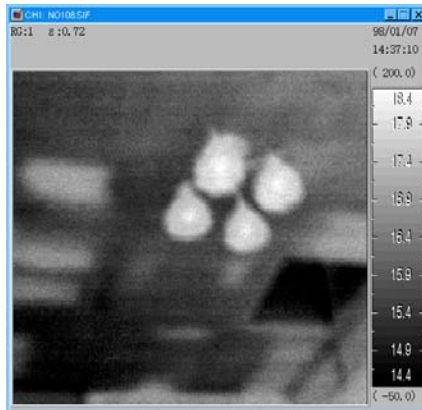
3) results: A part of the roof insulation was separated and pending. Out of the floor insulation, visual inspection through the floor trapdoor in the kitchen revealed that a 60 mm thick styrol-sponge was not attached as specified by the design document. As a result of the surface temperature measurement by a thermo-camera (**Fig.5**), the separation of the insulation from the ceiling panel was found, which resulted from the air gap between the ceiling and the insulation due to the braces.

Figure 5 insulation defect at ceiling of living room

4) unresolved issues: Regarding the hidden areas such as the inside of the walls or the areas difficult to see such as crawl space, it is quite difficult to judge whether the building elements are insulated exactly following the design documents. In that sense, an infrared thermo-camera is very effective. Even though, other methods should be developed for the location such as crawl space, and also simple measuring method of the overall heat transfer coefficient<sup>5)</sup> is highly required.

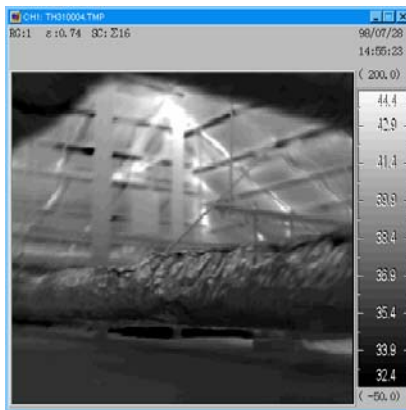
**Figure 6** shows the measured temperature distribution in the duct space of the attic. The temperature of the upper part of the column and the metal hangers are higher than 40°C.

Figure 6 Heat bridge in duct room

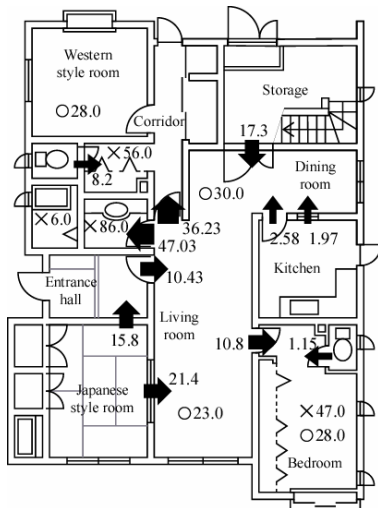
3) results: Measured supply and exhaust air flow rates, airflow between the rooms during winter are shown in **Fig.7**. All the doors and windows were closed during the measurement. The cold air enters from the storage room to the dining room and from the porch to the living room. **Figure 8** shows the temperature distribution around the lower part of the door between the storage and dining rooms, seen from the dining room. Low temperature air can be seen entering the dining room. During winter, the airflow rate from the porch to the living room, the airflow rate entering the living room, which comes through the small openings between storage and dining rooms and flows through the curtain, are quite large (**Fig. 7**). The incoming air flows towards the exhausted outlets in the washroom and the corridor, through the undercuts of the doors between the living room and washroom and between the living room and corridor. In such a case, the heat exchange efficiency of the total heat exchanger decreases, since the exhaust air from the living room with low temperature cannot exchange heat with the outdoor air. Furthermore, the indoor air cannot be exchanged with fresh outdoor air. Airflow rate, the location of the inlet and outlet and the width of the small openings should be examined.

Figure 7 Airflow from inlet and outlet, between rooms

4) problems: Measurement of airflow rates through the small openings such as door undercut is quite difficult. Appropriate and simple measuring method and the method of data analysis are required. On the other hand, since cold outdoor air inflow and indoor air temperature distribution can easily be identified by a thermo-camera, an evaluation method of ventilation efficiency could be developed by making use of the thermo-camera.

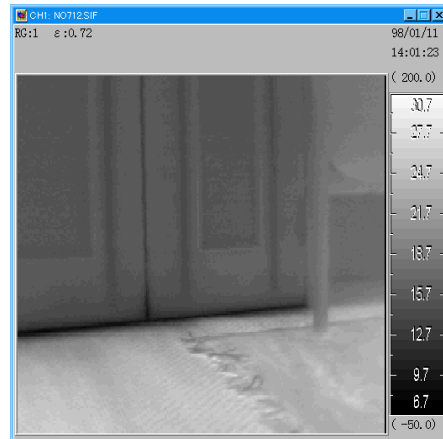
Figure 8 Door between storage and dining rooms (seen from dining room)

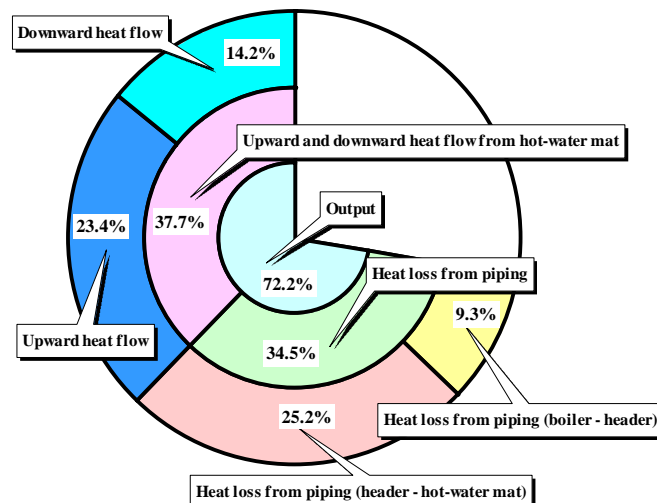
**Figure 9** shows the efficiency of the boiler, heat loss through the piping and the calculated heat flux emitted upward and downward (partly estimated). The heat loss from the piping is significant.

Figure 9 Efficiencies of floor heating system and heat source

4) problems: A simpler method should be developed for measuring hot water temperature and upward and downward heat flow rate, since the measurements are difficult and time consuming. Also, the performance of the floor heating system might be specified as a catalogue value. The floor heating was measured in detail because there was not good agreement between the measured and calculated heat balance of the whole house. Even a very simple calculation of heat balance provides a lot of information. This can be used effectively for commissioning.
