SHORELINE ASSESSMENT OF JEFFERSON COUNTY, TEXAS

A Thesis

August 2003

Major Subject: Ocean Engineering

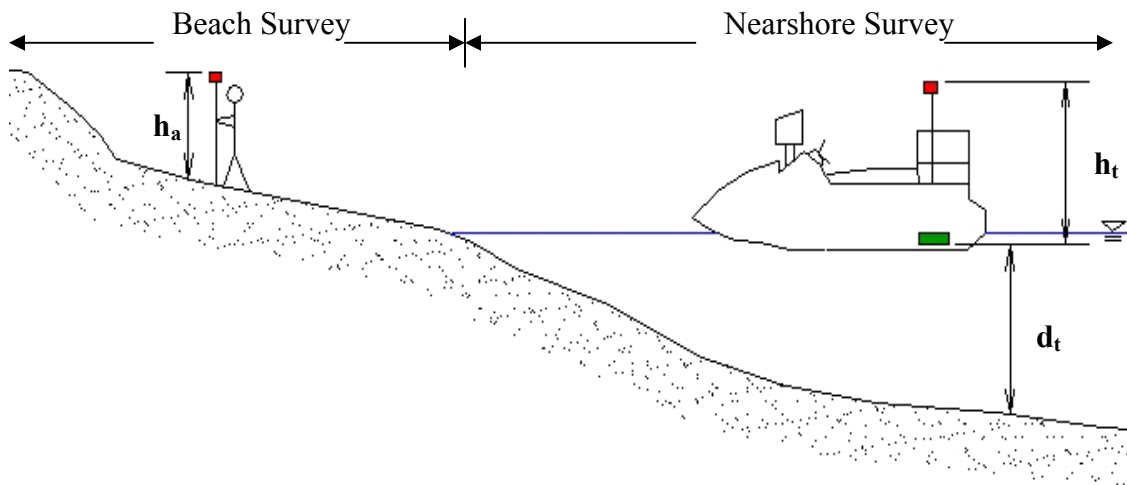
Fig. 2. Survey system (Wamsley, 1999).

The survey on the beach utilizes Real-Time Kinematic Differential Global Positioning System (RTK-DGPS) equipment carried by the surveyor in a backpack. For our purposes, the beach survey includes measurements from a surf zone wading depth to the wetlands area just landward of the overwash fans. The nearshore bathymetry is monitored by mounting the RTK-DGPS equipment on a personal watercraft and integrating it with an echo sounder. Using navigation software, repeatable beach survey lines are traversed in the nearshore zone. The hydrographic survey includes measurements from the point where the wading survey ends to approximately 600 meters offshore. The two surveys are combined to provide a complete profile from the depth of closure to the start of the wetlands behind the dune field. Figure 2 is a schematic of the profiling system.

When using GPS technology, the location of the base station and the height of the GPS antennas are known, as well as the distance from the base station. Therefore the topography of profiles are calculated based on that information. For the beach surveys, the antenna height, h_a , is subtracted from the antenna location to get the X, Y, and Z coordinates of the beach topography. The nearshore bathymetry is obtained by reducing the measured antenna elevation by the height of the antenna above the echo sounder transducer and measured depth below the transducer, h_t+d_t .

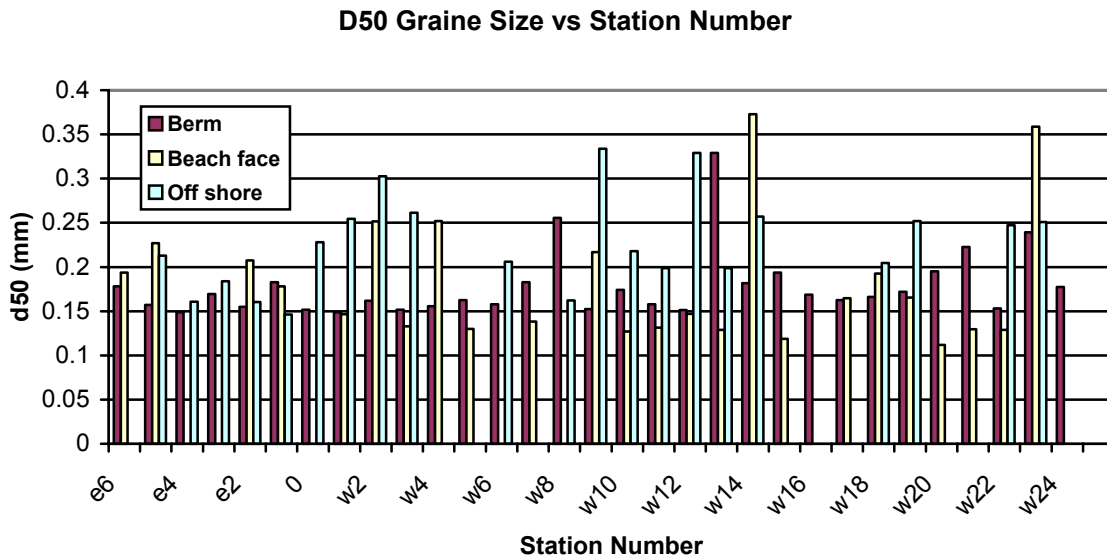
Fig. 3. Sorted RSA results from east to west (Howard, 1999).

In the spring of 1999 Steven Howard completed the report entitled “Impact of Shoreline Changed Proposed Texas Highway 87 Reconstruction”. In this study Howard defines a research project that is responsible for collecting a comprehensive set of base line data including sediment samples over the damaged section of SH87. He accomplishes this task by achieving the following tasks. The first phase of the project was to acquire data to determine the storm surge and wave set up in the Gulf of Mexico. The next step was to obtain 76 core samples that were then taken to the University of Florida to be run through a rapid sand analyzer. The figure 3 shows the grain size distribution as resulting from the RSA. The samples were taken at every 800m from east to west along the beach on the berm, beach face, and off shore. Line zero is located in 5.6km from the Clam Lake Road.

Howard was able to determine that the beach was made of fine sands and silts. From this information he determined that quarterly surveys were to be taken along shore position, and cross-shore profiles to the depth of closure, which is around 600 meters off shore.

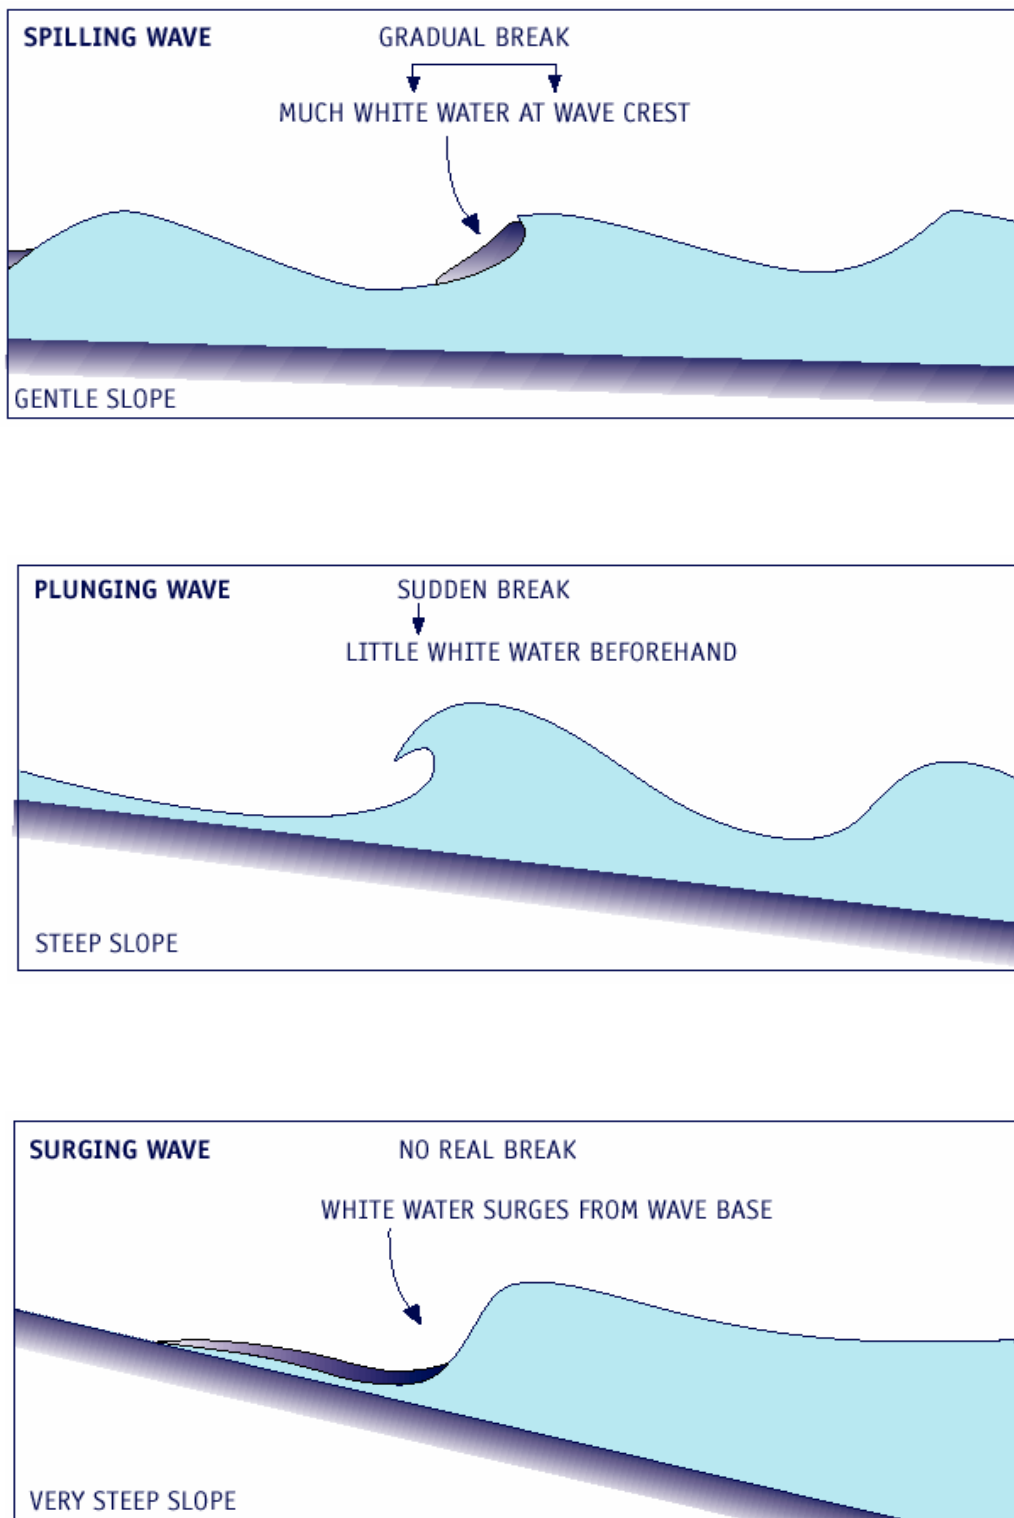
Fig. 4. Three types of breaking waves
(www.env.qld.gov.au/environment/science/coasts/bp1111.pdf).

There are three types of breaking waves also known as breakers (Figure 4). They are the spilling breakers where each wave gradually peaks until the crest becomes unstable and cascades down known as white water. Plunging breakers occurs when the shore ward face of the wave becomes vertical, curls over, and plunges forward and downward as intact mass of water. Finally Surging breakers peak up as if to plunge, but then the face of the wave surges up the beach face so that the crest collapses and disappears (Komar, 1998).

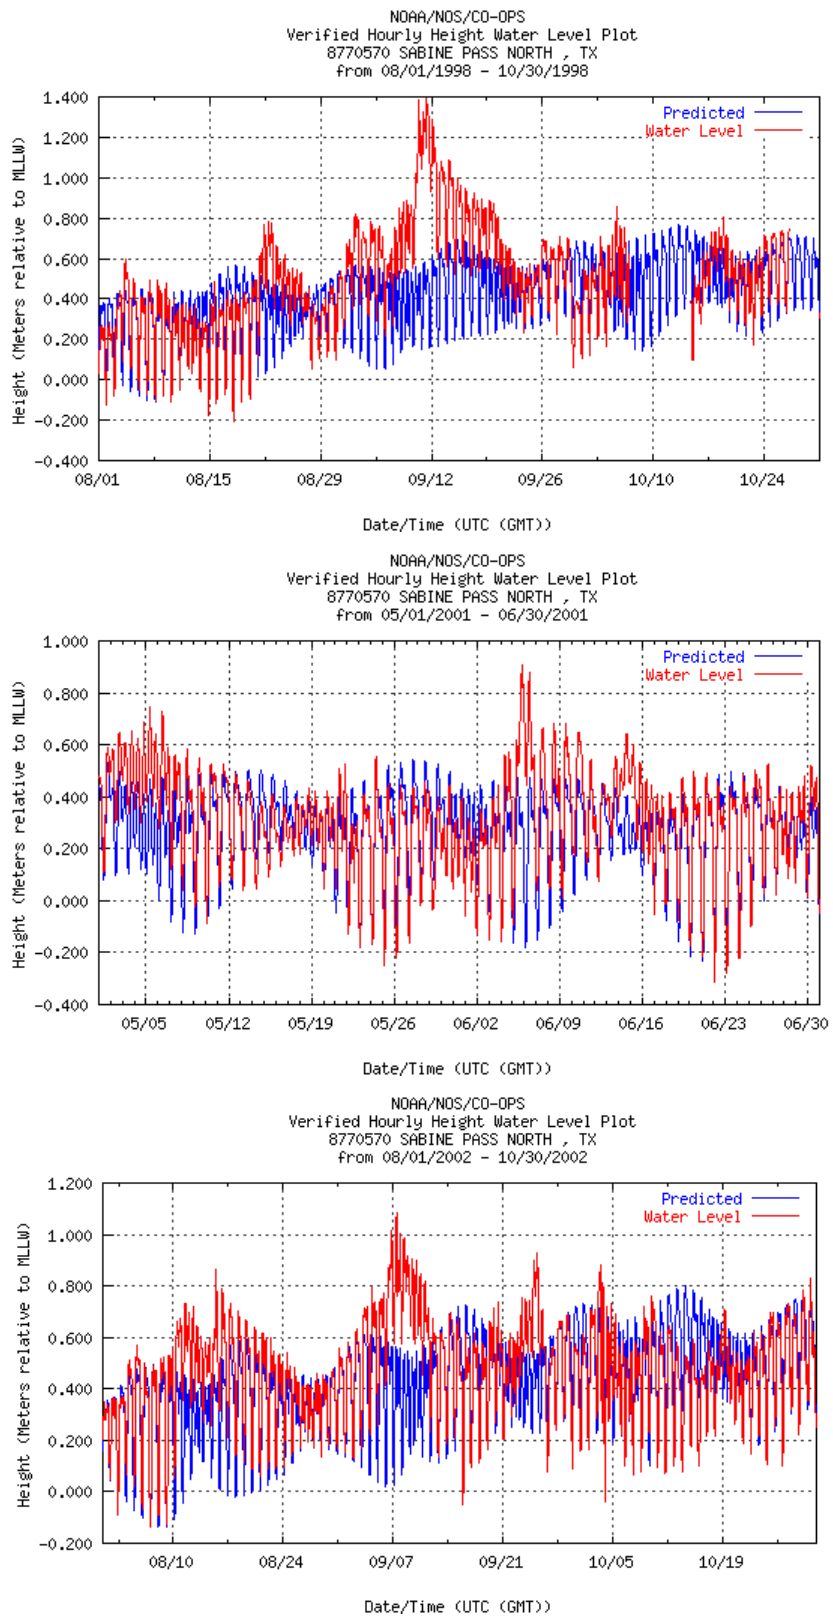
Fig. 6. Historic tide data of Sabine Pass north.

The water level data has been fit to Weibull and Gumble distributions using 95% confidence limits. Calculations were done with the use of the USACE's Automated Coastal Engineering System (ACES) program. The Weibull distribution with $k=2.00$ was used for design purpose due to its highest correlation coefficient. The correlation coefficient is simply a measure of how well the data set fit the intended distribution. A perfect fit would require a coefficient equal to one. Table 6 presents the 95% confidence limit results for the Weibull Distribution.

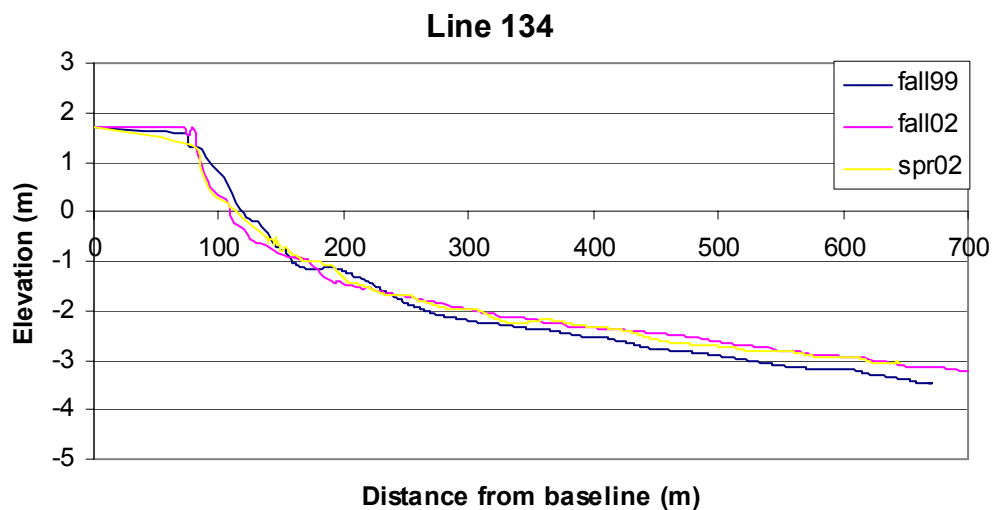
Fig. 7. Comparison of three profiles at line 134.

Data gathered from beach profile surveys enabled the calculation of sediment erosion rate and direction. All data in this study were collected and analyzed by Texas A&M University from the Summer of 1999 to the Fall of 2002. Eight beach profile surveys were done in the Jefferson county area. In the first survey, there were 156 lines every 200 meters along the entire survey area but survey lines were established again every 400 meters since the fall of 1999 so just even line profile data are listed in Appendix A and B. Figure 7 shows comparison of on and offshore profile for three surveys. In case of the data of on and offshore profile, there are three surveys. A full presentation of all of the data is listed in Appendix B. A brief presentation of the data is given below.

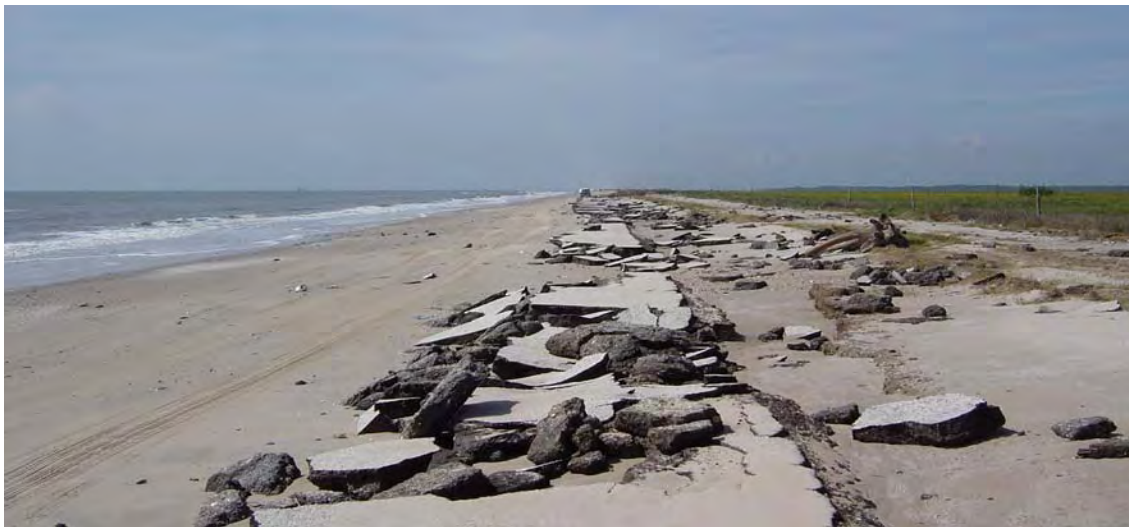
Fig. 8. Near CATT where road is destroyed, picture taken October 5, 2002.

The survey location is divided into three areas according to the erosion rate. The west section of the survey area is roughly line 1 through 30 where erosion rates are relatively low. The profile line starting at line one contains larger dunes, then they taper out around line eight. On these dunes there is tall grass which inhibits the sand from being washed away from storm surge, or the every day occurrence of wind. At line eight this small dune system completely tapers out to around line 22 where there is less vegetation in that area. Line 22 is located in front of the survey monument CATT. Figure 8 shows near CATT

area. At line 22 there are small dunes, but there are also trees, and shrubs on the beach which help the sand from eroding at a quicker rate.

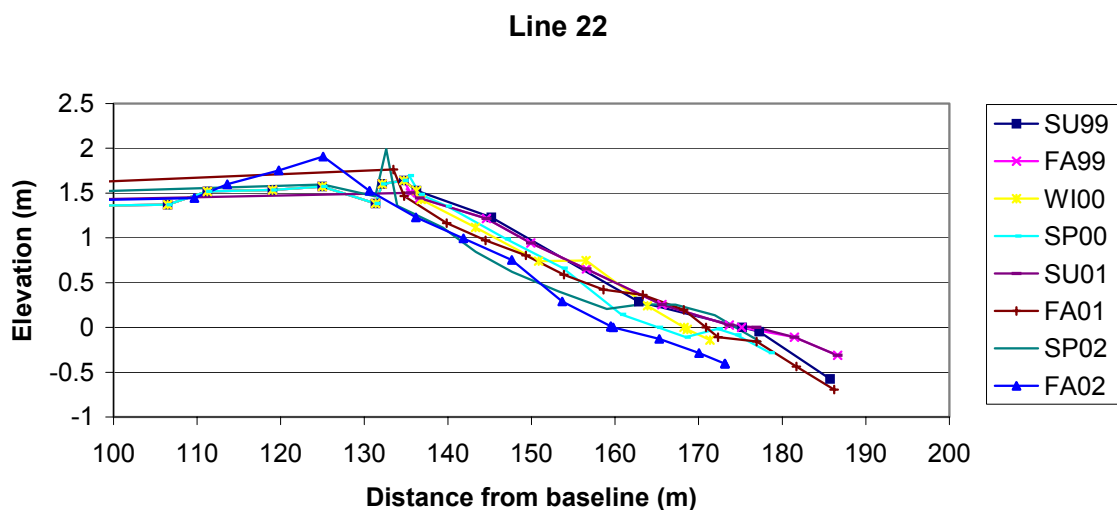
Fig. 9. Line 22 onshore data.

When looking at the overall data at line 22 that is presented in figure 9, it is clear that the formation of a small berm has migrated there over the seasons and rate of erosion averaged about 4m/yr. The small berms could have been created either from storm surge or the natural movement of the sand through the season. Then at line 30 the dunes and vegetation disappears as the rate of erosion increases.

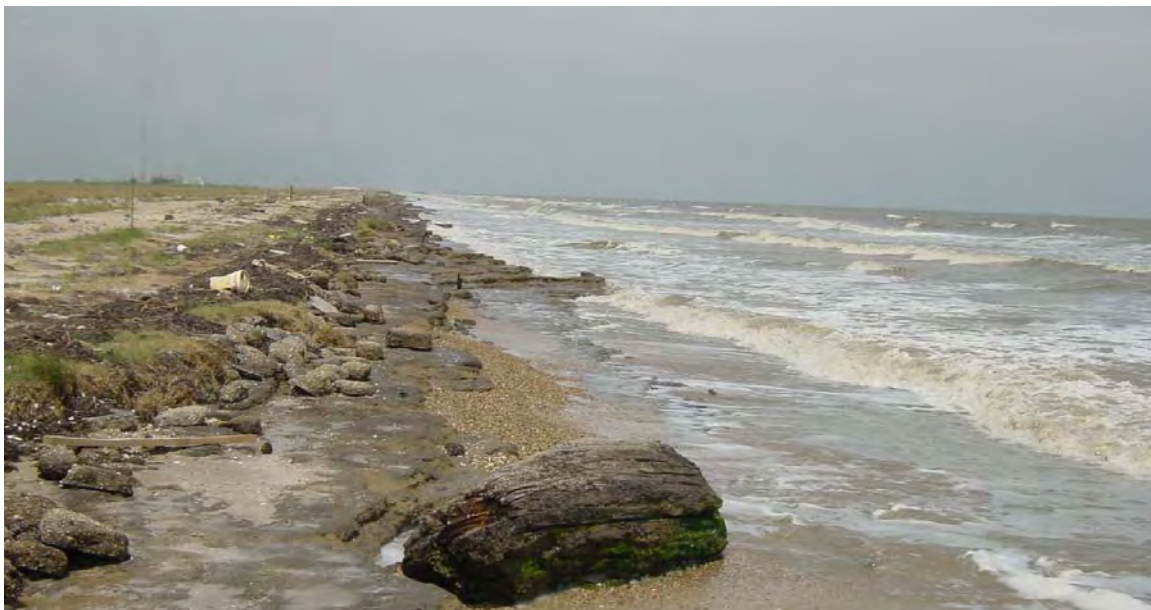
Fig. 10. Near VASTAR where the beach no longer exists, picture taken May 24, 2002.

The midsection of survey area from line 30 through 130 includes the beach segment where Highway 87 has been destroyed by erosion. In the middle section where the most continuous erosion occurs there is very little vegetation to be found on the beach. This beach segment is characterized by a narrow, relatively steep beach and washover terrace composed of sand and shell and underlain by mud. The crest of the washover terrace or edge of the destroyed road is the shoreline feature for this beach segment. There are no dunes to prevent the pasture or wetlands from flooding during heavy weather. The only change in topography was created by farmers fixing their fences and scraping a dirt road in January of 2002. From line 90 eastward, there is more mud to be found than sand (physically observed).

Figure 11 shows line 114 onshore profile with roughly 25 meters of erosion over a four-year period. Line 114 is located near the survey monument VASTAR (Figure 10). It is the most eroded region in the survey area.

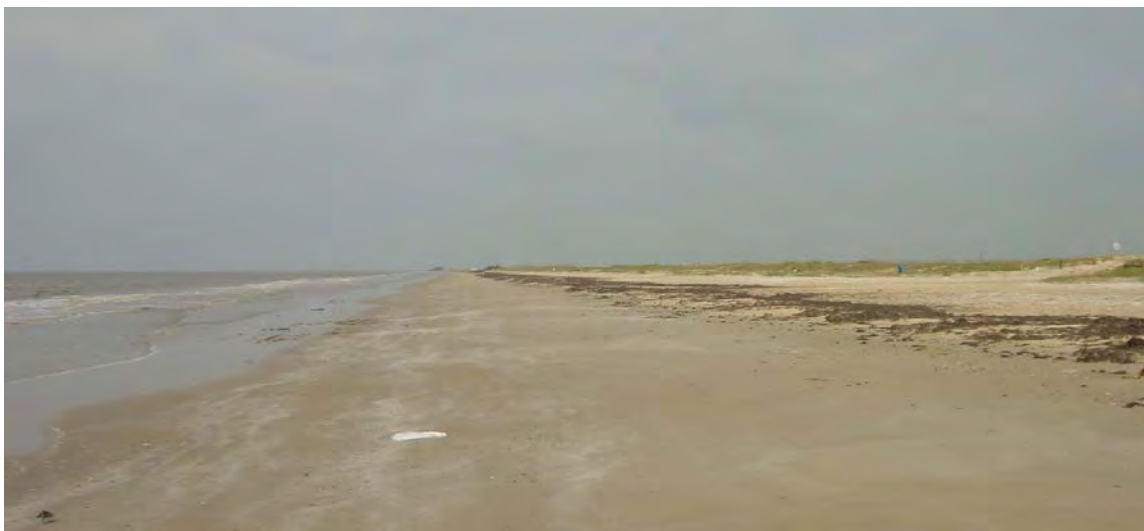
Fig. 12. Near CLAM where the beach is wide, picture taken May 24, 2002.

The east section of survey area consists of lines 130 to lines 156, which includes the survey monument CLAM. Figure 12 views near CLAM. The beach of this segment is relatively wide, exhibits low vegetated dunes, and is composed of sand over mud.

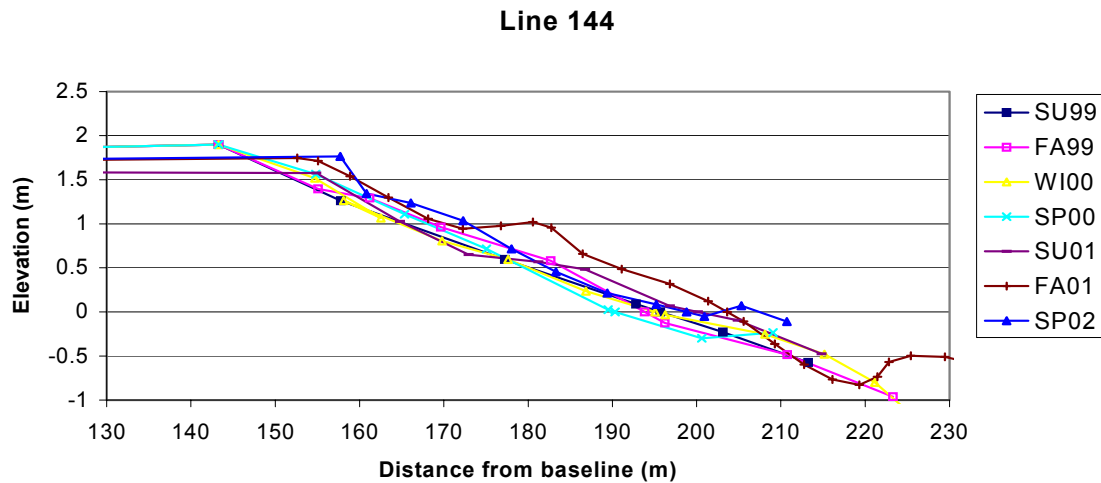
Fig. 13. Line 144 onshore data.

and healthier. This coincides with the dunes in this area, as they also start to increase as well as the vegetation on the dunes. There are also shrubs in this area where inhibit the movement of sand during heavy weather. Figure 13 shows line 144 onshore profile with wide and gentle slope beach.

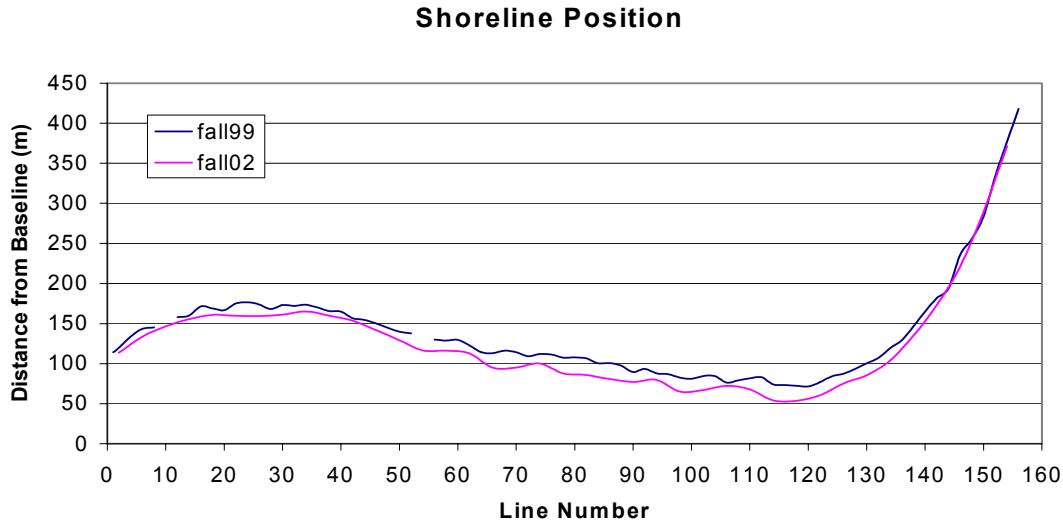
Fig. 14. Change in shoreline comparing the Fall99 and Fall02.

The shoreline is defined as mean sea level (MSL), which corresponds to an orthometric height of zero using the NAVD 88 datum. Using the measured profiles, a zero elevation was interpolated using an Excel spreadsheet at each transect creating a continuous MSL contour.

Figure 14 shows the change of shoreline position. Comparing the shoreline position shows how much erosion occurred over four years. But since the shoreline is not a uniform line we can use the change in position of the zero elevations from the summer of 1999 to the fall 2002 to determine the total amount of erosion that has occurred over the last four years.

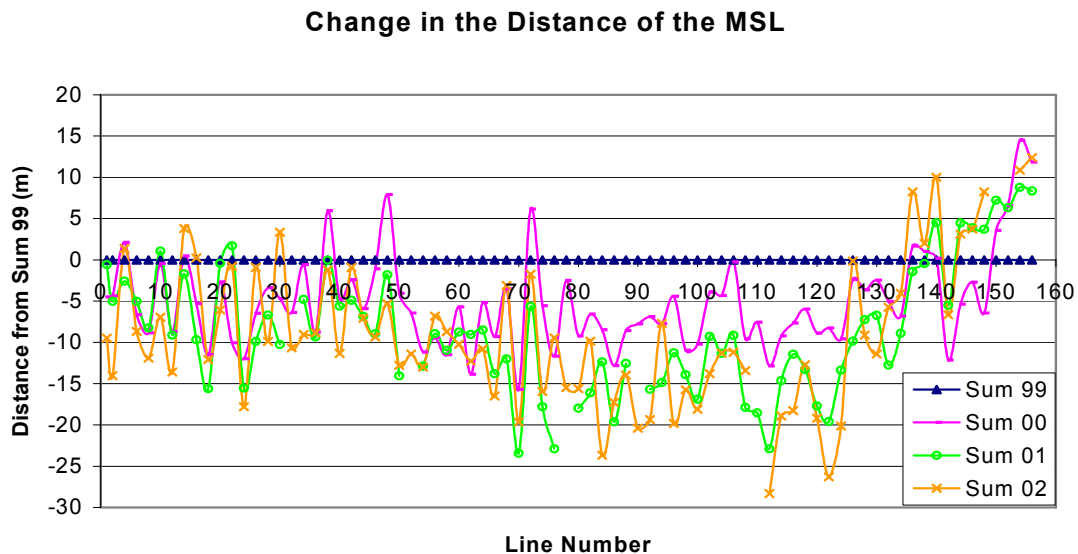
Fig. 15. Graph of the erosion rate based on the distance of the MSL.

The figure 15 shows the middle region of the survey area has the highest amount of sediment transported away from the site. This supports the hypothesis that maximum beach recession is occurring at the central survey area.

The maximum erosion occurred at line 112 with roughly 28 meters of loss over a four-year period. Whereas line 156 shows more than 10 meters of accretion over a four-year

The highest rates of recession are in the central region from line 30 through 130 including VASTAR. The maximum erosion occurred at line 112 with roughly 28 meters of loss over a four-year period. The nodal point where the sand transport is divergent is assumed to occur at line 114. The midsection conversely has no dunes, and there is no vegetation on the sand area to prevent the sand from being removed into the overwash area. During storm event, the sand on the beach face is washed up and over the berm because of storm surge. These storms cause the dune to roll back on itself as the clay is exposed. Without a protective layer of sand to absorb wave energy, the substrate is eroded. Beach survey data and wave data confirm that the greatest shoreline recession coincides with the highest waves.

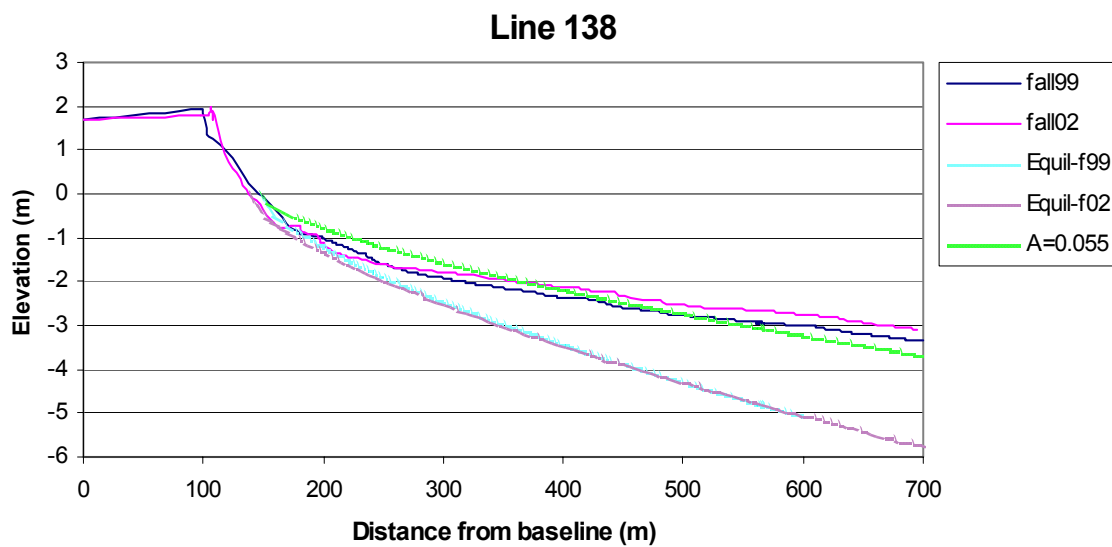
Fig 16. Equilibrium beach profile at line 138.

$$A_N = \frac{\sum_1^I h_i y_i^{2/3}}{\sum_1^I y_i^{4/3}}$$

in which I is the total number of depths available. Applying above equation to the available data for profile 138 results in an $A = 0.055 \text{ m}^{2/3}$ which is significantly smaller than A value estimated from table 11. That means there exist different grain size or different material on the seabed such as mud, clay or fine sand beyond the 1 meter depth. This characteristic of profile exists in the entire survey area.
