TR- 300
2007

Geographical Information System Coverage For Characterization of the Pecos River Basin

Watershed Protection Plan Development for the Pecos River

Task 1.1 Geographical Information System Coverage For Characterization of the Pecos River Basin

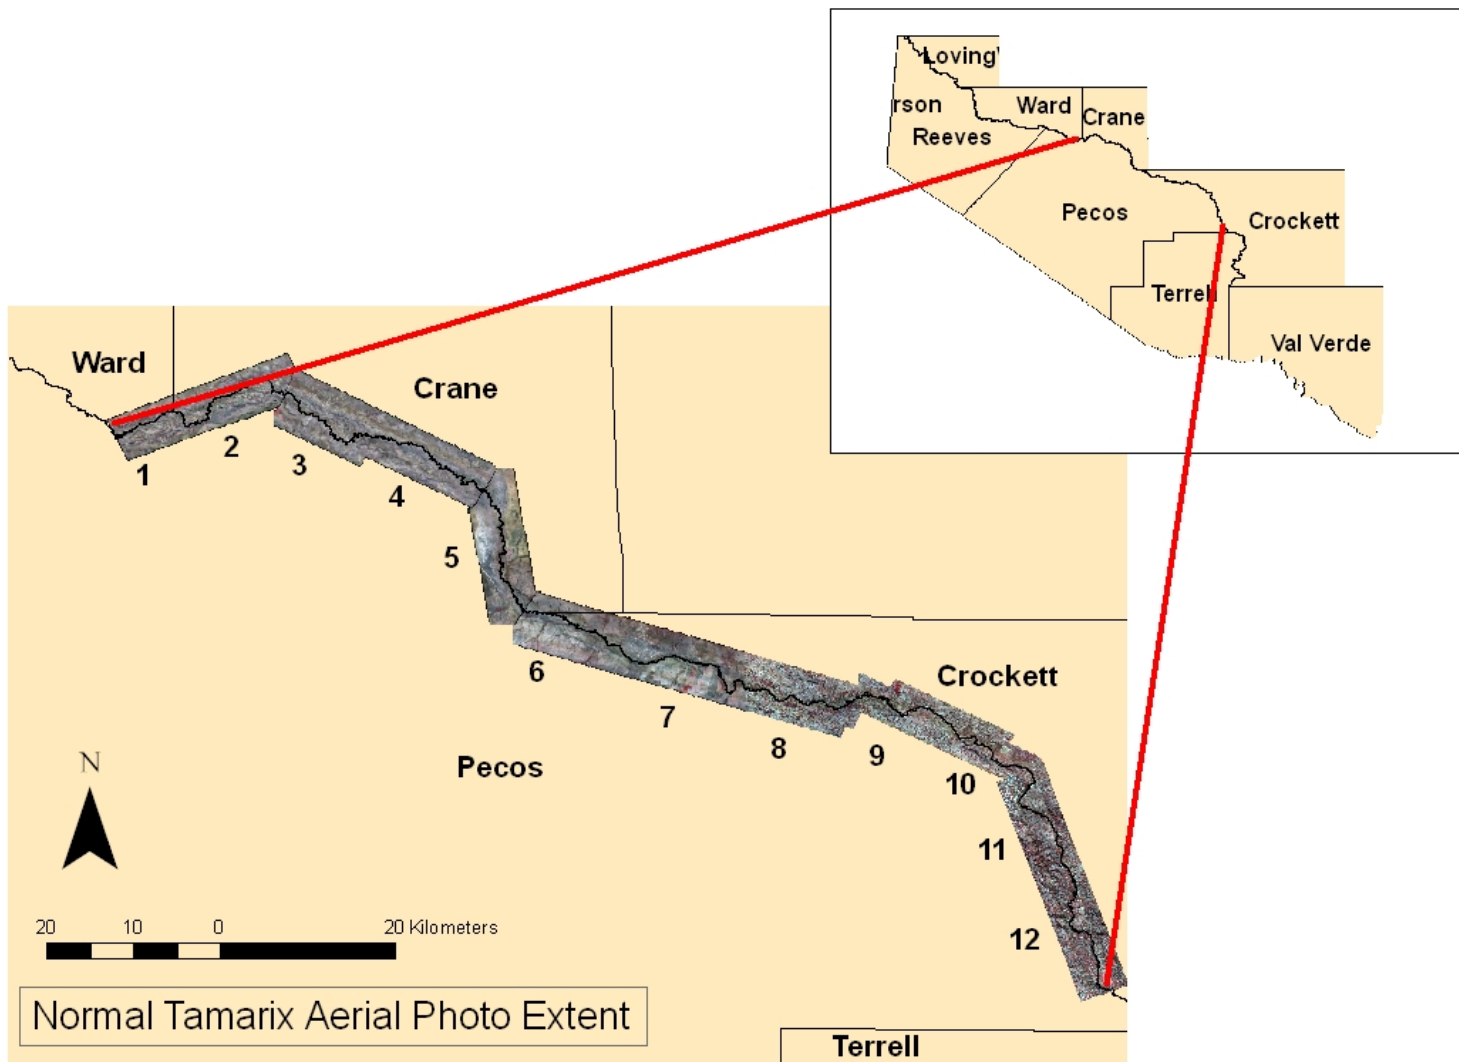
Figure B1 Overview of aerial photo coverage for Normal Tamarisk

(2) Pecos aerial*- Large scale map of all aerial coverage.

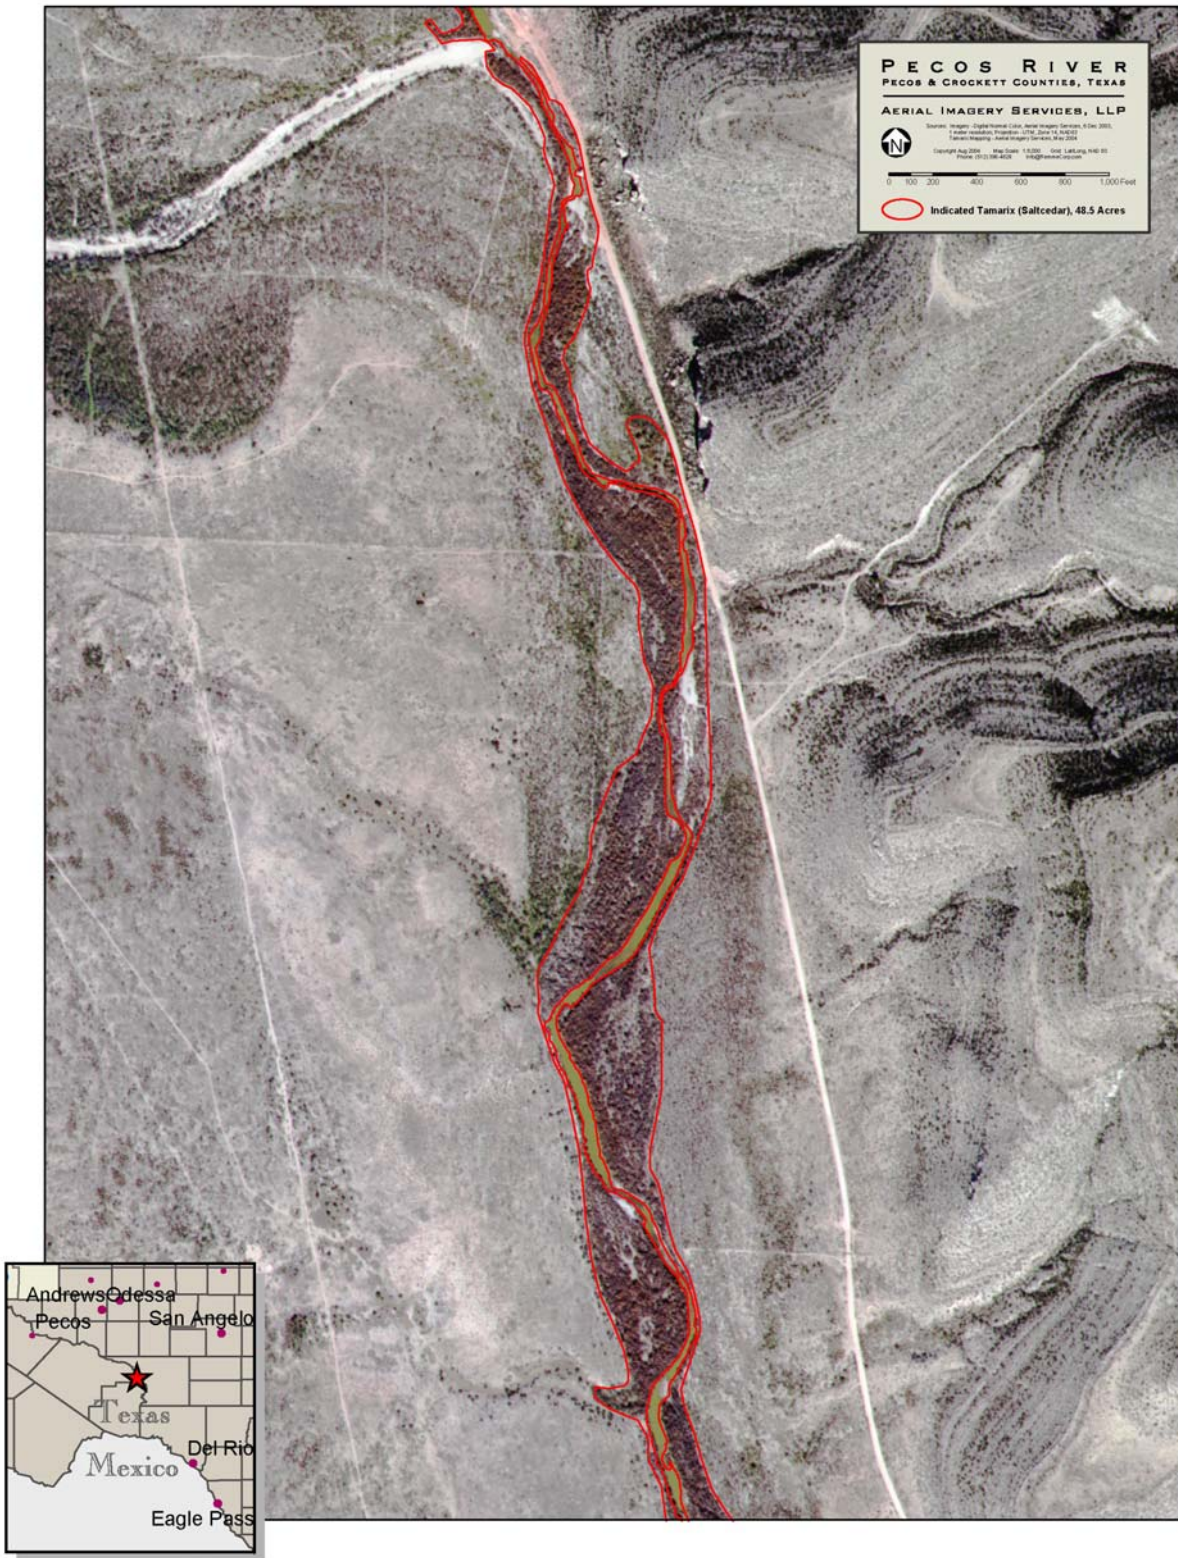
Figure E1. Example Tamarisk Delineation Map on the Pecos River.

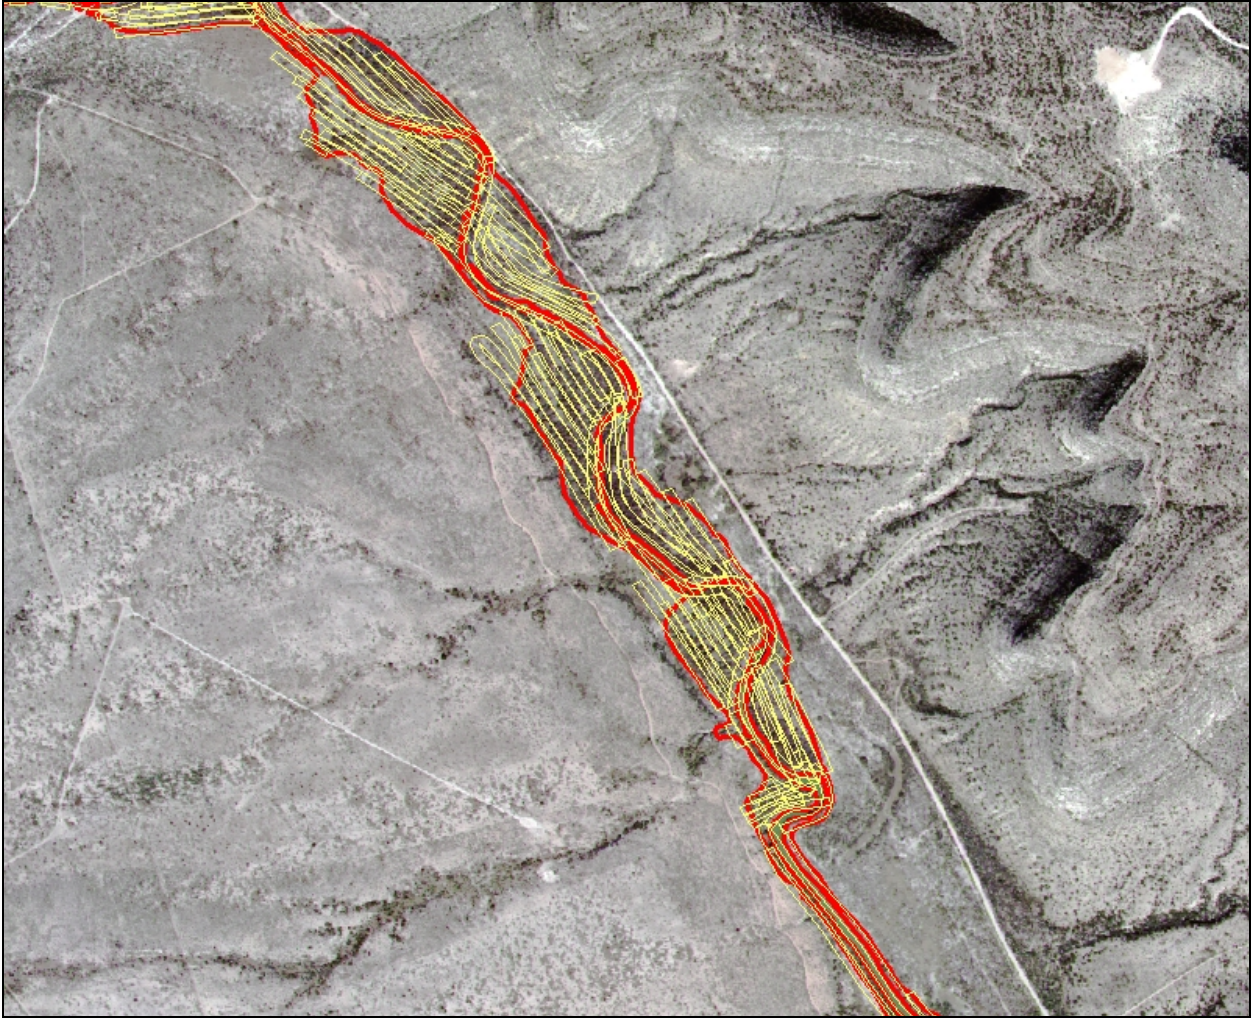
Figure E2. Example of Tamarisk delineation (in red) and GIS spray files of area sprayed (yellow) overlaid on aerial imagery.

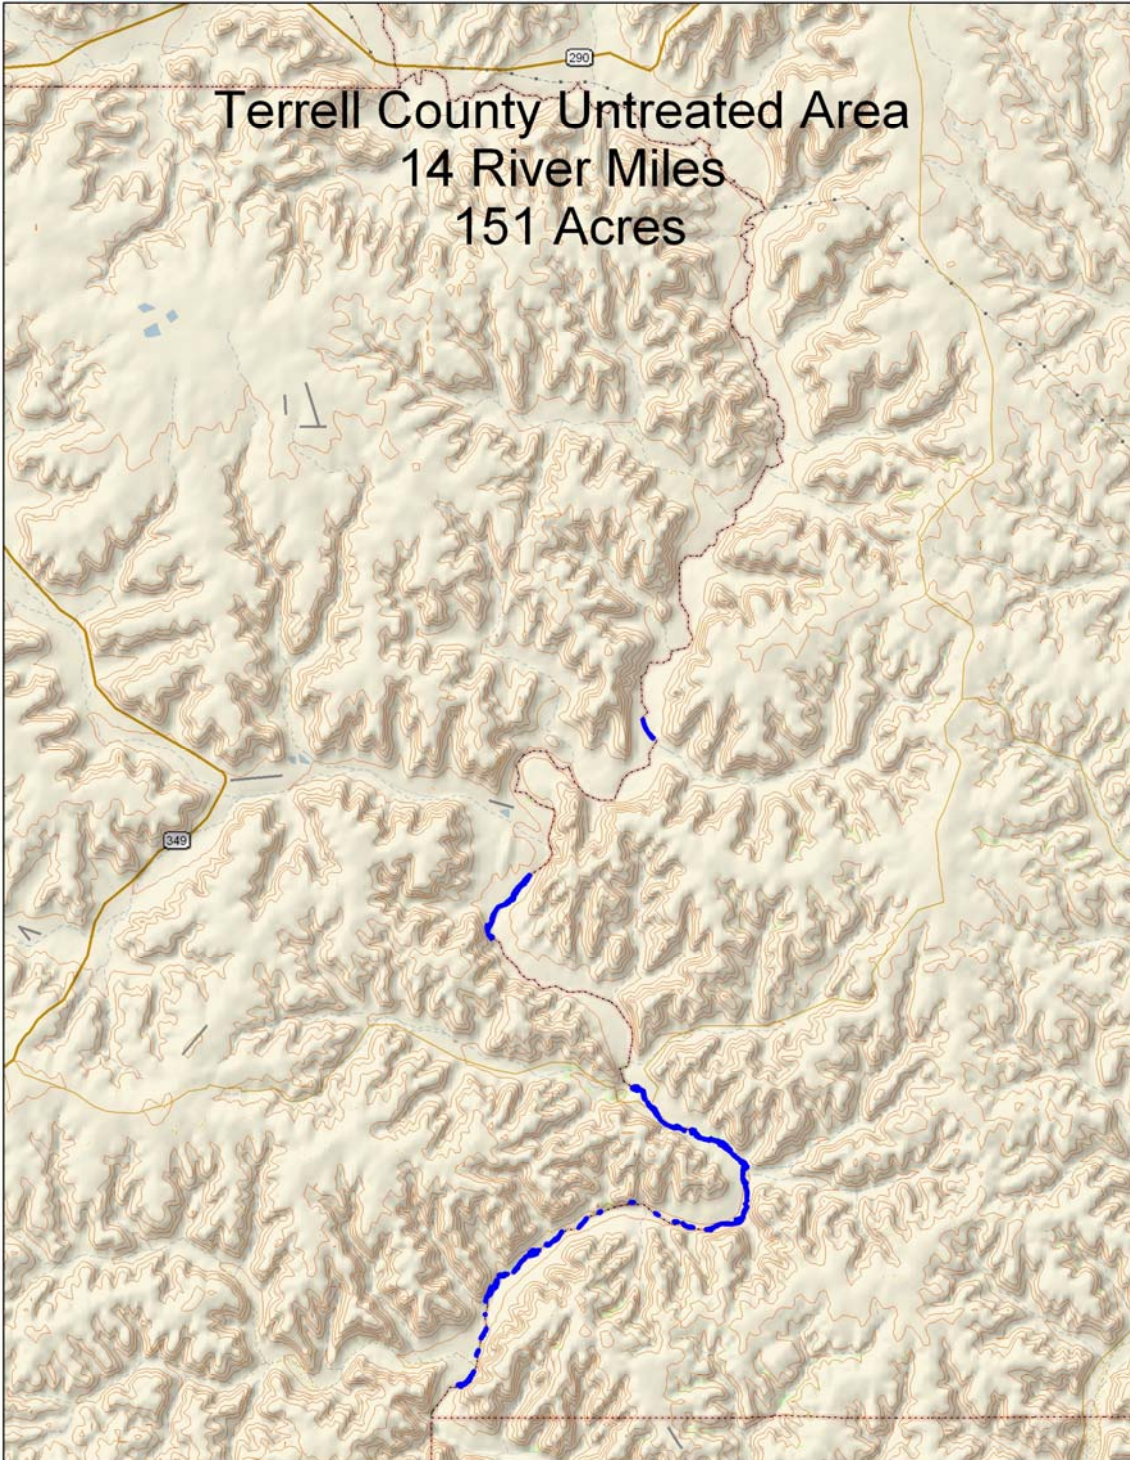
Figure E8. Untreated saltcedar located in Terrell County along the Pecos River.

The final estimates for Terrell County and Val Verde counties are suspect. For different reasons, the model performs poorly in each. In Terrell County, two large areas, originally classified as Unknown, strongly affect the results. In this particular case, the second model was judged to be the best of the three models and the aggregated county estimate (Table 3) uses its result. In Val Verde County the mapped acreage is quite small. The ratios calculated in the first half of the model are also quite small, resulting in an extreme new estimate. None of the models produced results for Val Verde County that were acceptable.
