Continuous Commissioning[®] of A Medical Research Facility

ABSTRACT

This paper presents a case study for Continuous Commissioning[®] (CC[®])¹ of a 520,000 square foot medical research facility. All of the primary energy using systems in the building were investigated to determine their existing condition and operation. Using these findings, the needed CC[®] measures were developed. Some of the CC[®] measures include repairing the heat exchangers, valves, and dampers that are not working. Also, reset schedules for air handling unit supply temperature and static pressure were created. Chilled and hot water loop ΔP setpoints were fine-tuned. Economizer operation and air-to-air heat exchanger operation were also optimized. The airflow stations in many of the terminal boxes were found to be in need of cleaning and addition of filters. From January 2004 through March 2006 the CC[®] engineers implemented the CC[®] measures with the assistance of facility staff. Cumulative CC[®] savings from April 2004 to July 2006 was over \$1,900,000 and the building experienced significant comfort improvements.

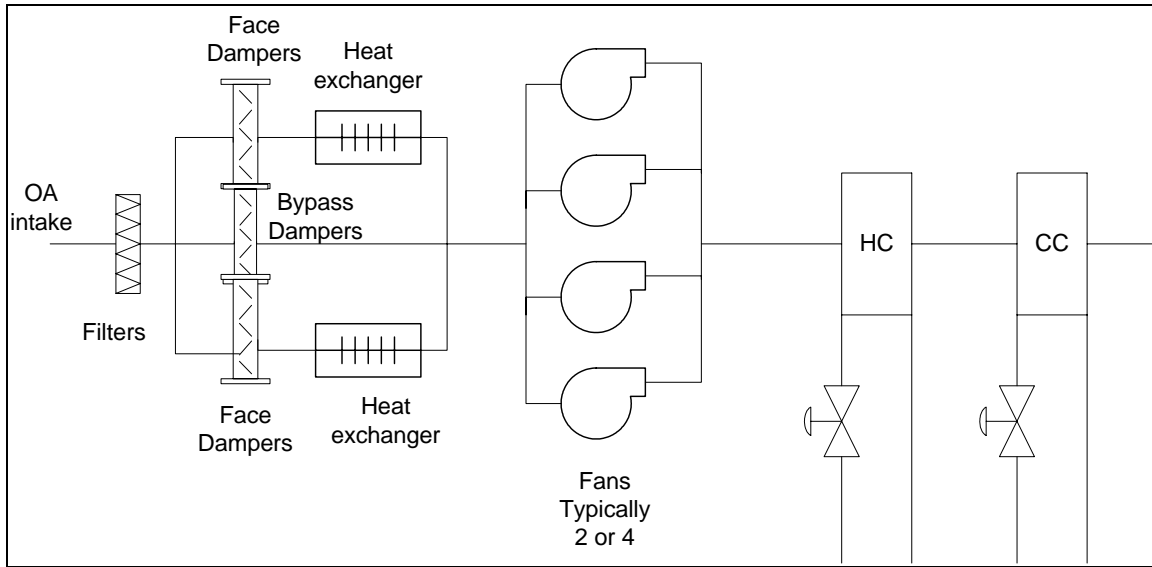
Figure 1. Schematic of a typical AHU

The nine AHUs that serve areas with labs operate the same but are of different sizes. They all are single duct systems with multiple supply and exhaust fans that are equipped with variable frequency drives (VFDs). Due to possible contaminates from the lab areas, only outside air is used in the AHUs. Figure 1 is a schematic typical of AHUs 1-9. Outside air enters through air to air heat exchangers. Incoming outside air can go directly into the AHU through a bypass or go across the heat exchanger. A set of dampers with pneumatic actuators controls how much air goes to the bypass and heat exchangers. In the heat exchanger, energy is transferred between the outside air and the leaving exhaust air. After passing through the fans, the air goes through hot water heating coils, a steam humidifier, and chilled water cooling coils. All valves and dampers on the AHUs are pneumatic.

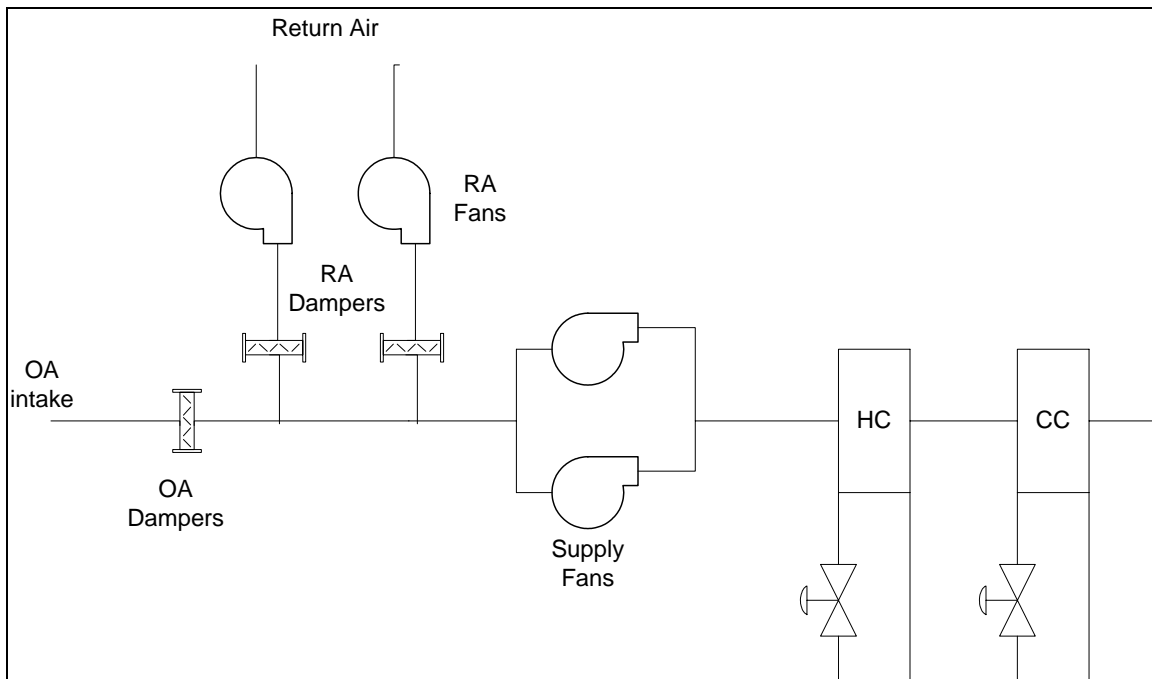
Figure 2. Schematic of AHU 10.

AHU 10 only serves office and meeting areas so it is able to use return air. It is also single duct with VFDs on both the supply and return fans. Instead of a heat exchanger, this unit has economizer dampers

that control the amount of return and outside air taken into the AHU. Figure 2 is a schematic of AHU 10.

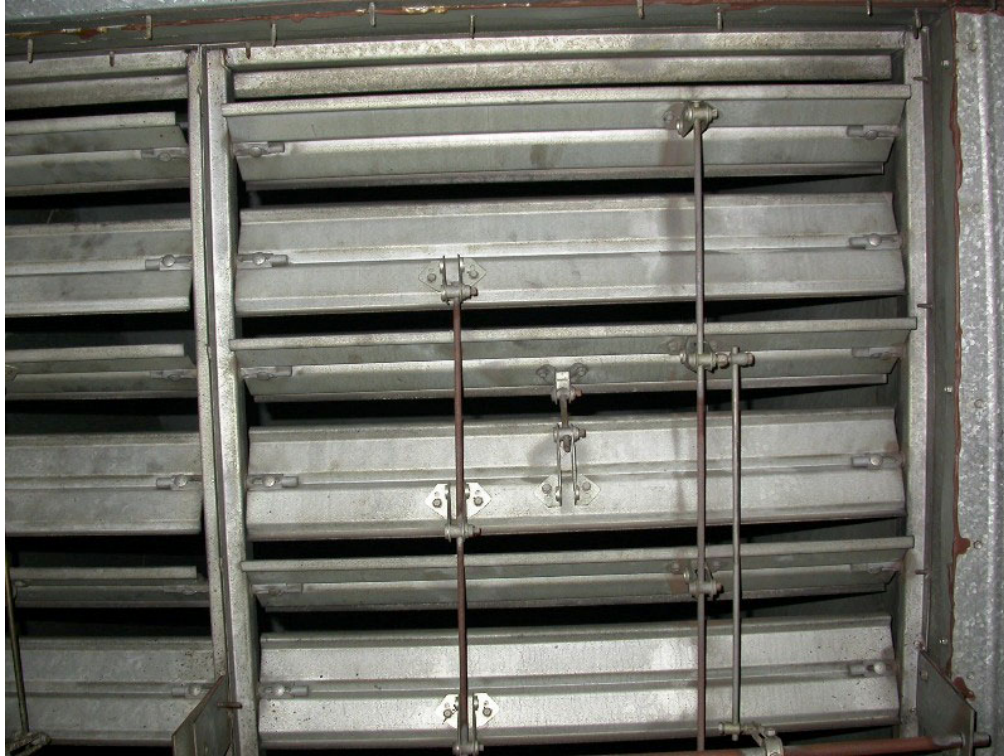
Figure 5. Heat Exchanger Dampers in Original Condition (Fully Open).

The AHUs that use 100% outside air (AHUs 1-9) have air-to-air heat exchangers on them to recover some of the energy from the exhaust air. Entering outside air will either be routed directly into the AHU or through the heat exchanger depending on what is needed to maintain the temperature setpoint. Pneumatic actuators move the dampers open and closed to direct the airflow. When we first inspected these dampers, none of them were working. They were stuck in random positions and could not move. Figure 5 shows that the face dampers were only about 30% open when they were commanded to 100%. The dampers cannot open fully and the horizontal driving rod is warped from the strain put on it. The heat exchangers are an important part of the AHU system and when they do not work it increases the load on the cooling and heating system. In the summer of 2002, the building lost control of space conditions even though all three chillers were operating at full load.

The dampers for the heat exchangers were not working when the project began. They were all stuck in various stages of open and closed. The building maintenance personnel attempted to make them operational as originally intended. Some of the actuators were replaced or the pneumatic controls were adjusted. The dampers were lubricated and realigned in an attempt to make them move in the correct sequence. The operation of the dampers was much improved but they were never able to fully open and close. It was determined that a new mode of operation would be needed to get the largest possible benefit from the heat exchangers. The new method called for the dampers going to the heat exchanger to be disconnected from the driving shaft and left open permanently. With only the bypass dampers being driven, it was possible to align them so they could open and close completely. Now, the full effect of the heat exchangers can be used by closing the bypass dampers. When bypass is needed, the bypass dampers will open. Air will still go through the heat exchangers but some of the effect of the bypass will still be achieved. By fixing the face dampers fully open all the time, some energy is lost during mild seasons when the economizer (bypass dampers) should be in full operation. However, we also determined that the pressure drop through the bypass dampers was also higher than the pressure drop through the heat exchangers. Therefore, the loss of “free cooling” is just about offset by the increased fan power in full bypass mode. The poor heat exchanger design precluded any opportunity for the heat exchangers to work as designed, so the decision was to fix the dampers in the heat exchange mode.

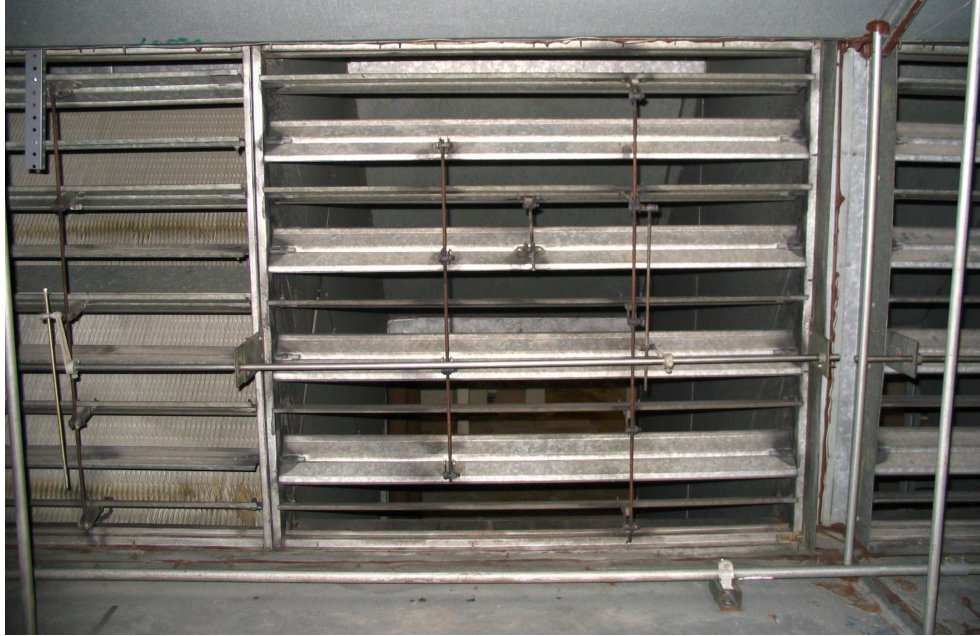
Figure 6. Heat Exchanger Dampers in New Configuration.

Figure 6 is a picture of the dampers in their new configuration. The damper on the left side is a face damper. It is being held open by a bracket from the top and the driving rod has been disconnected. The damper in the middle is a bypass damper in the open position. There is no bracket holding it open and the driving rod is still connected.

The position of the bypass and heat exchange dampers was originally modulated to maintain a setpoint at the heat exchanger discharge. There were two setpoints for the discharge, one for summer mode and one for winter mode. A switchover setpoint was used to determine at what outside air temperature it changed between summer and winter modes. New programming was added to change the control of the dampers in the winter mode. The winter setpoint is now 1°F above the supply temperature setpoint and measured at the discharge of the unit. This allows the heat exchanger to take advantage of the new supply temperature reset schedule. The summer mode still controls to a constant setpoint of 73°F measured at the heat exchanger discharge. The switchover setpoint is 55°F.

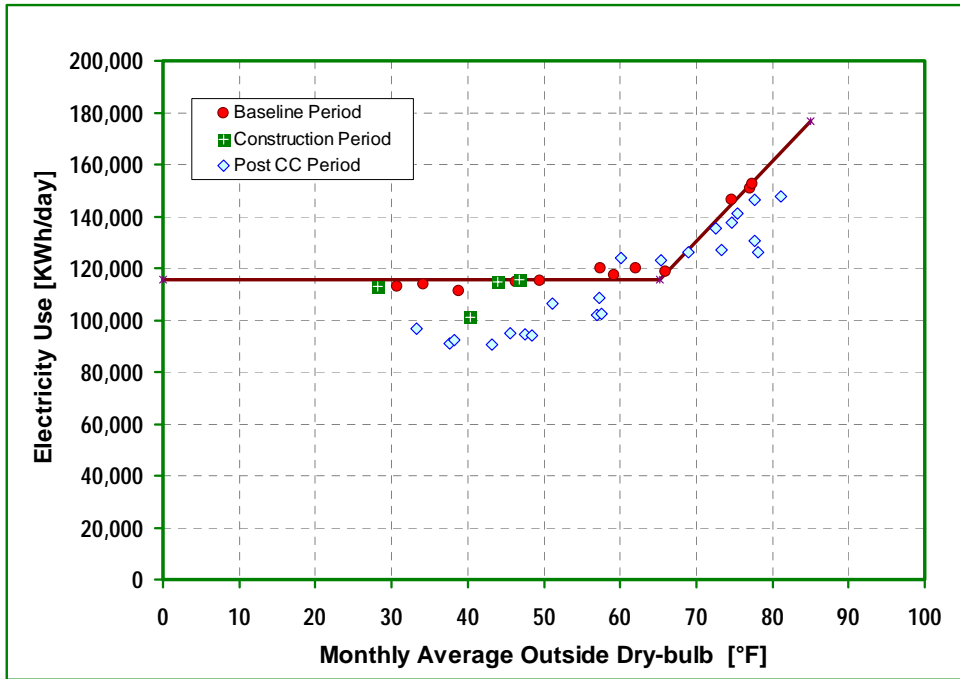
Figure 7. Pre-CC Electricity Use and Measured Electricity Use After CC.

Savings were determined by analyzing data from the time some major CC® work had been completed (April 2004) until July 2006. The baseline model and outside air temperatures were used to predict what the electricity and gas usage would have been without CC®. Utility data from that same time period was compared to the baseline prediction to determine the energy savings. Figures 7 and 8 show the baselines for electricity and gas respectively as a function of outside air dry-bulb temperature along with data points taken before and after CC®. The total accumulated electricity saved between April 2004 and July 2006 is 11,212,000 kWh. Total gas savings for the same time period is 741,000 therms.

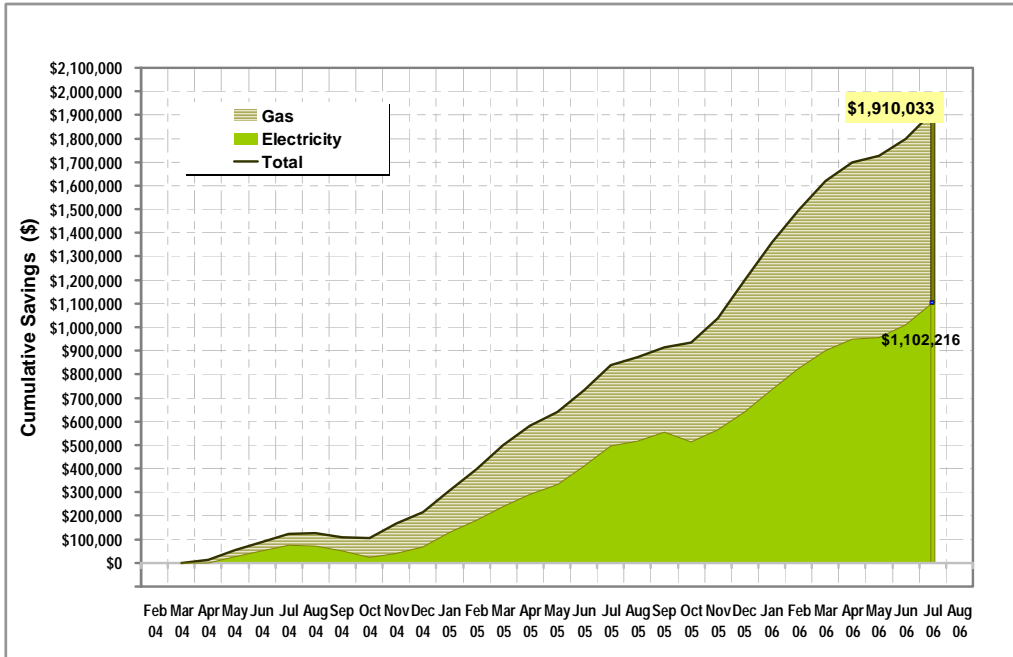
Figure 9. Cumulative Savings for the Facility Using Actual Utility Rates.

The cumulative savings from CC® calculated from the actual utility costs is given in Figure 9. The total accumulated savings amounts to \$1,910,000.

When the project began, utility rates were \$0.087/kWh for electricity and \$0.62/therm for gas. Since that time, rates have increased and the facility is currently paying \$0.1193/kWh and \$1.1654/therm. Savings estimates were made using two methods, the first was to assume the rates remained the same as original, and the second was using actual rates. Using the original utility rates, the total savings in this period amounts to \$1,434,000. Of that total, electricity savings amount to \$975,000 and gas savings are \$459,000.
