A Study on the Effects of Unwanted Air Infiltration on Thermal Comfort at an Airport Terminal

Bill Lander
Research Associate II

Guanghua Wei, PE
Research Engineer
Energy Systems Laboratory
Texas A&M University
College Station, Texas 77843, USA

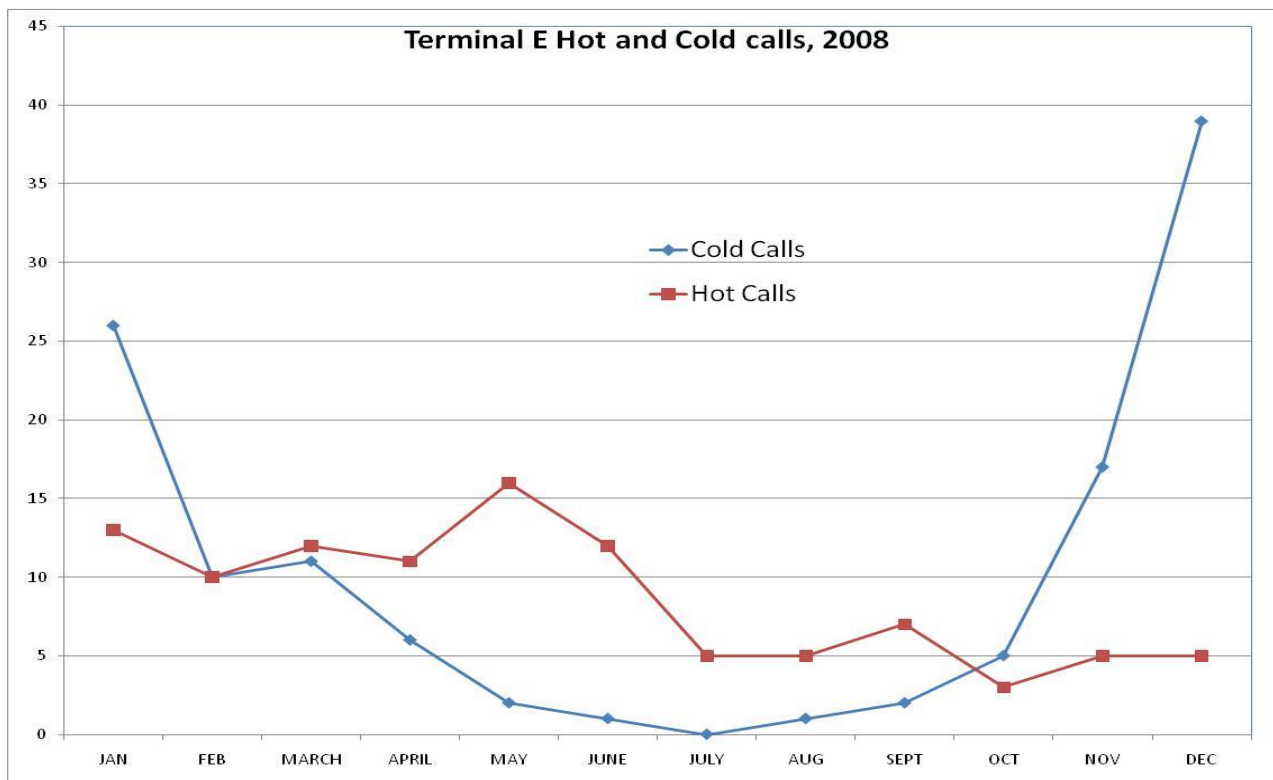
Figure 1 Terminal E Hot and Cold Calls

DFW terminal management reported that the areas around the security checkpoints had the highest occurrences of hot and cold calls to the maintenance department. The maintenance department captures the call in a work order data base and has an HVAC technician address the complaint. The process to address the complaint depends on the technician that is given the work order and their experience level in dealing with the complaints. ESL requested a data dump of the work orders related to either hot or cold complaints to attempt to identify the root cause of the complaints. ESL reviewed and compiled the data to remove any unrelated information and categorized the complaints into figures 1 and 2 below. The data shows that a large majority of complaints occur at or around the TSA checkpoints where passengers are waiting in line, or employees are stationary. The chart also shows a high number of calls at the center of the building's C-shape and where entryways line-up with the checkpoints and gate doors on the opposite side of the building. ESL performed another walkthrough of the area with high complaints and noticed a large amount of air movement during those times of high passenger traffic and gate doors being opened. The gate doors are typically open for one-half hour before the aircraft departure time to allow boarding.

Further analysis of the hot and cold call data was performed along with wind speed and direction data from NOAA. When the data from hot and cold complaints was compared to the wind data, it became very evident that weather conditions were having a dramatic effect on indoor thermal comfort.

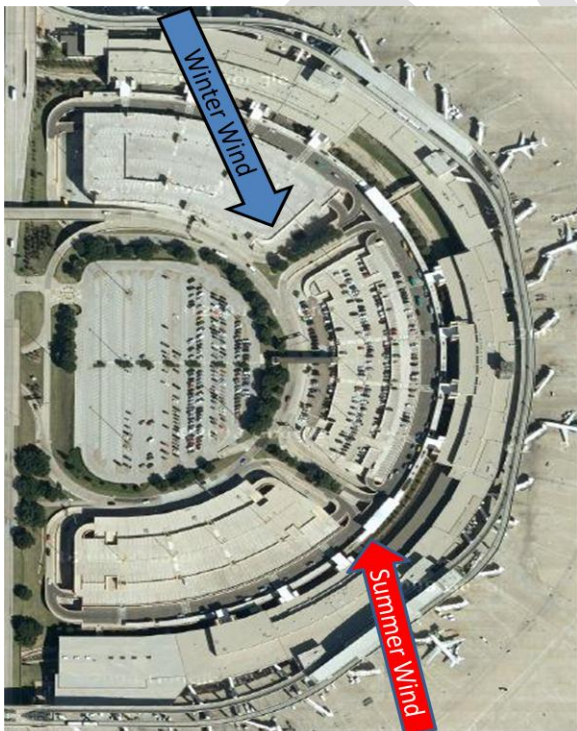
Figure 3 Seasonal Prevailing Wind

Before the effort to increase building static pressure by increasing the amount of outdoor air being drawn in by the HVAC systems, section C of the terminal building had a positive static pressure reading. After opening the outside air dampers completely, the static pressure relative to outside in section C decreased. Although there was a drop in static pressure in section C, the doors leading to the outside at the Southwest side of the building had a pronounced movement of air flowing out of the door when opened, indicating a positive static pressure. Table 1 shows a difference in static pressure for section C from positive to negative on different days when building pressure readings were taken. This difference in pressure was significant enough and led the team to investigate for possible air infiltration points and to compare weather conditions on the specific days when the readings were taken. Weather data for the days reading were taken were reviewed and it was revealed that when the wind was out of the South-Southeast, the static pressure in section C of the terminal was positive and when the wind was more out of the northerly direction the static pressure was lower or negative with respect to the outside pressure.

It is known that wind forces act on buildings creating positive pressure on the windward side and a negative pressure on the leeward side. Eighteen months of weather data from the NOAA archive was analyzed for wind prevailing direction at DFW airport. Figure 3 shows the general wind direction during the summer and winter months. Spring and autumn seasons in the Dallas area tend to be short, and the wind direction for spring is similar to that of summer and likewise for winter and fall. During the smoke test, it was noticed that certain areas within the terminal had air movements much higher than others. The areas with the higher air motion were much narrower than the open waiting and seating spaces near or around gate doors. Air movement velocities of 350 to 450 feet per minute were

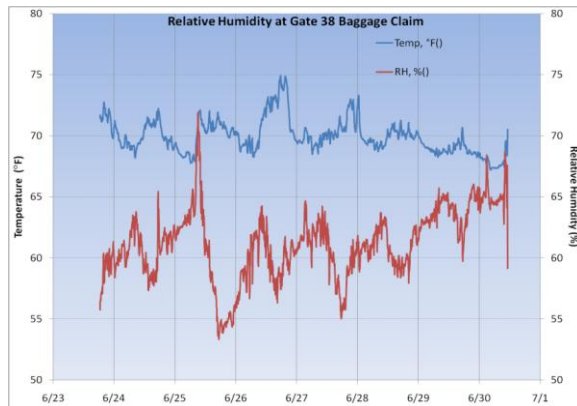
clues to air infiltration were observed. Several HVAC diffuser vents had drops of condensation on the outside, and in a few cases the humidity has been so high that ceiling tiles were sagging, and air currents could be felt on the skin. Smoke tests conducted around baggage claim areas 37 & 38 confirmed that air infiltration was taking place and at rate large enough to give a false sense of positive building pressure at entry way doors nearby. A logger was installed to measure temperature and humidity and the output is shown in fig. 5.

Figure 4 Baggage Claim Area Humidity

Areas in the vicinity of the terminal's ten baggage claim carousels were examined and several
