Texas Loan STAR Monitoring & Analysis Program
Improving the Performance of Retrofits by Providing Operator Feedback from Measured Data
Aamer Athar, Mustafa Abbas, Venugopal Challa, Jeff Haberl, David Claridge

Energy Systems Laboratory
Mechanical Engineering Department
Texas A&M University
College Station, Texas

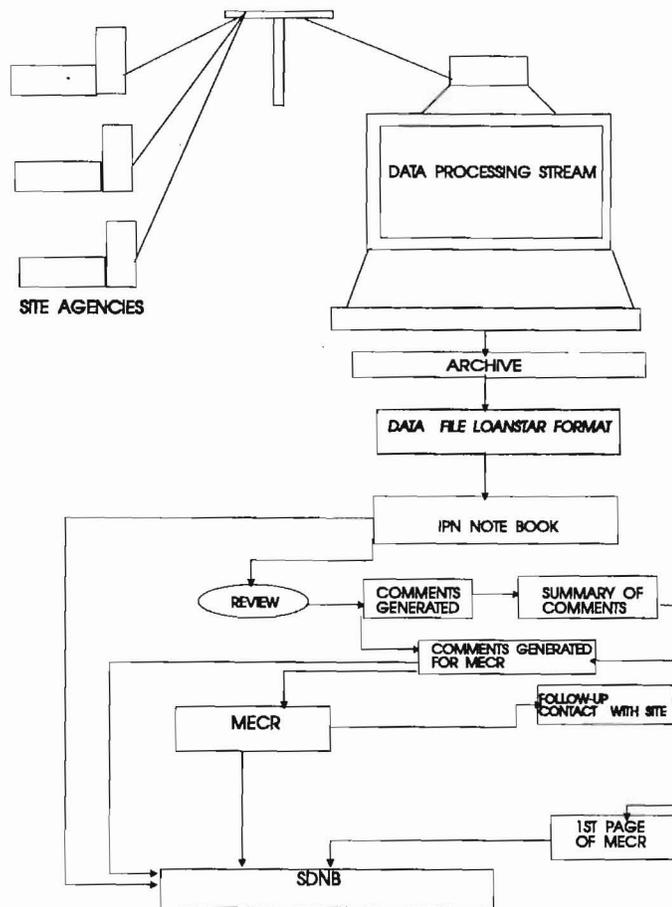
Figure 1: Data handling procedure for the LoanSTAR Program. Illustration of the process from retrieving the data from micro-processor based data recorder to the storage of the feedback from the buildings operators into the Site Description Notebooks.

Anomalous behavior in the data is usually identified by the MAP staff and when such behavior is observed, comments about the behavior are included in the MECR, followed by a phone call to the site contact person to discuss the behavior observed (Figure 1). If a problem is determined, steps are taken by the MAP staff and the facilities personnel to diagnose the problem, quantify the cost of the problem, identify and implement a solution. If it is determined that the retrofit measure(s) is (are) not working properly, the design engineer or contractor is contacted to help resolve the problem. If the building systems are not operating properly, the facilities staff will normally change procedures or make repairs as needed.

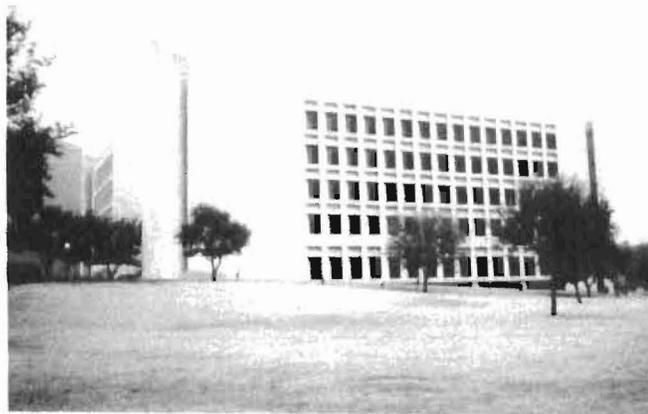
Figure 2: Example Building - Perry Castaneda Library. One of the biggest building on the U.T. Austin Campus, covering an area of about 484,000 square feet. The library is an open-stack library, with most of the floors occupied by book shelves and study tables.

The Perry Castaneda Library (PCL) is a six story structure built in 1977, with a gross area of approximately 484,000 square feet (Figure 2). The exterior walls consist of limestone panels and concrete block. The windows consist of 1/4 inch, single-pane tinted glass and cover approximately 12% of the exterior wall area. It is used as an open-stack library, with most of the floor area occupied by book shelves and study tables. The building was retrofit in November 1991 with variable air volume AHUs and variable speed pumping. Under the new system it is conditioned by four groups of air conditioning equipment consisting of eight variable volume single duct AHUs (75 hp each), twelve variable volume dual duct AHUs (two 100 hp and ten 75 hp), four variable volume hot deck AHUs (one 50 hp and three 40 hp), twelve variable frequency drive return AHUs (25 hp each) and one variable volume chilled water pump (60 hp).

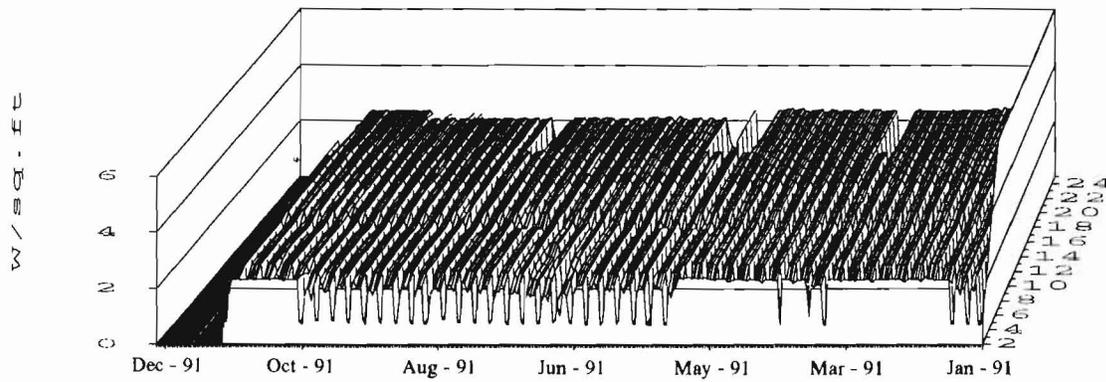
Figure 3: Hourly whole-building electricity consumption per square foot for the Perry-Castaneda Library from January 1991 through December 1991.

Chilled water and steam are supplied by the main physical plant, located on campus. Steam at 165 psi from the campus loop enters the building and is immediately reduced to 10 psi. Part of this low pressure steam is used to heat domestic water. The remainder is piped to reheat coils in the single duct units and to the dual-ducts units. The electricity consumption per square foot from January 1991 to Dec. 1991 is shown in Figure 3 as a three-dimensional plot, where the x-axis represents the day of the year and the y-axis (into the page) represents the hour of the day. energy use is measured as the height above the x-y plane.

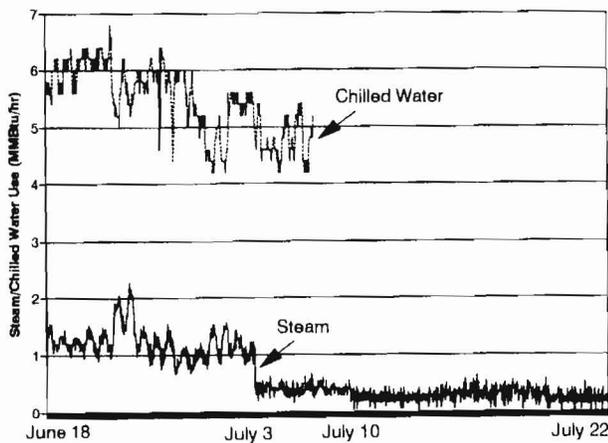
Steam & CHW Consumption at PCL June 18 - July 22 1991

Figure 4: Steam consumption from June 18 - July 22, 1991 and chilled water consumption from June 18 - July 7, 1991 at the Perry Castaneda Library. Chilled water data for the period July 8, 1991 through July 22, 1991 experienced hardware problems.

July 3, 1991. The result was a sharp decline in the usage of steam from 1.5 million Btu/hr to about 0.5 million Btu/hr as shown in the Figure 4. A second visit was made on July 10, 1991 accompanied by the facility and the design engineer. After a consensus was reached, the remaining valves were also shut off. An additional drop in chilled water consumption for the 8 single duct air handling units occurred and was confirmed through monitored data. Figures 4 and 5 show the drop in steam and chilled water use when plotted against time and outdoor dry bulb temperature. The closure of these valves resulted in savings of approximately \$7,000 per month. These savings may not have been achieved without the monitoring and close attention to detail.

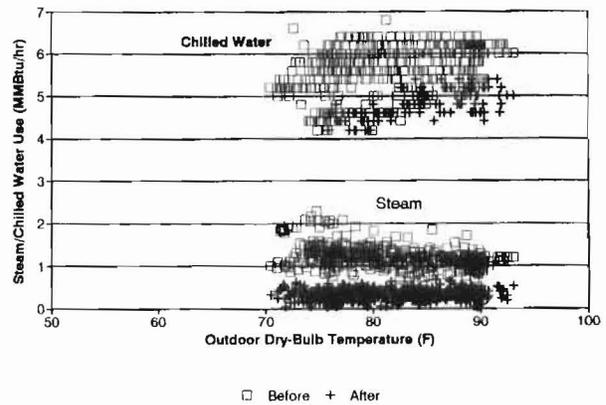
Steam & CHW Use vs Outdoor DB Temp. at PCL June 18 - July 22, 1991

Figure 5: Steam consumption from June 18 - July 22, 1991 and chilled water consumption from June 18 - July 7, 1991 at the Perry Castaneda Library plotted against outdoor dry-bulb temperature for Austin, Texas.

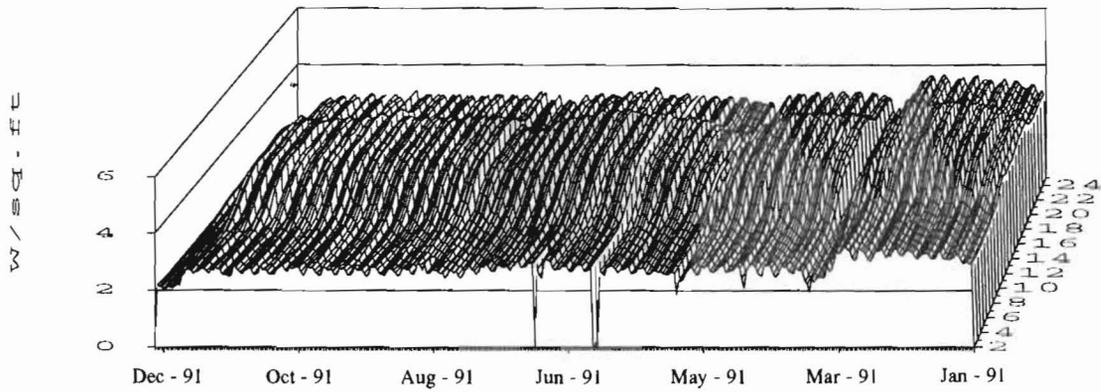
Figure 7: Hourly whole-building electricity consumption per square foot for the Zachry Engineering Center from January 1991 through December 1991.

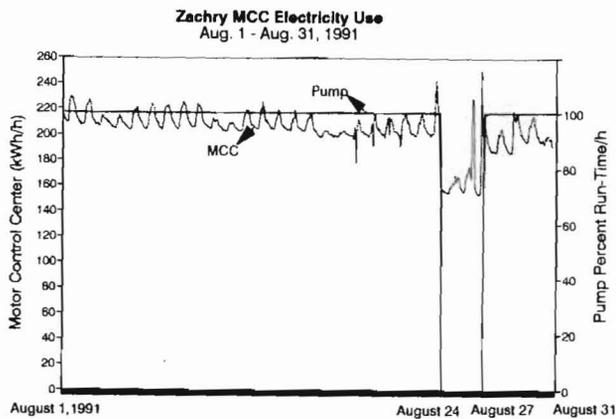
Figure 8: Electricity consumption for the Motor Control Center and percent run-time of the hot water Pump at the Zachry Engineering Center (TAMU) from August 1 to August 31, 1991.

In the ZEC it was observed that a 20 hp hot water pump was running continuously during the summer, when there was little demand for hot water. The building operator, when interviewed, was under the impression that all the pumps in the building were shut-off and also confirmed that there was no need to run the pump in the summer months. So, it was recommended that the pump should be turned-off. The pump was turned-off on August 24, 1991 and remained off for about four days. Then it was started again on August 27, 1991 because of hot water requirements in one of the laboratories. The drop in MCC electrical consumption can be seen in Figure 8. The potential savings from this recommended action are approximately \$2,700 per year. Even though this matter is still under investigation, it is clear that without monitoring this problem would have gone unnoticed.

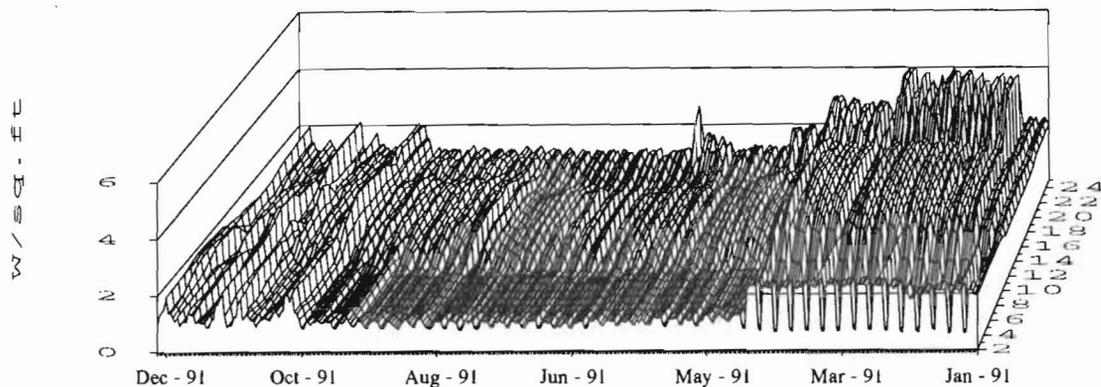
Figure 10: Hourly whole-building electricity consumption per square foot for the Nursing building from January 1991 through December 1991. The large evening-time spikes in electricity use during Jan.-Mar. 1991 are due to tennis court lights, which were later removed by rewiring the data logger.

(Figure 9). The building has steel frame, reinforced concrete floors and exterior walls of precast concrete panels. The windows consist of single-pane clear glass and cover approximately 30% of the exterior wall area. The building houses nursing classrooms and lecture halls, workshops, lounges and faculty offices. Chilled water and steam are supplied by the main physical plant, located on the UT campus. The building HVAC system consists of two variable volume, dual-duct AHUs (100 hp each). The building also has a 30 hp chilled water pump supplying chilled water to the air handling units. The HVAC system operates 24 hours per day. The electricity consumption per square foot from January 1991 to December 1991 is shown in Figure 10. General Schematics of the AHU at the Nursing Building is shown in Figure 11.

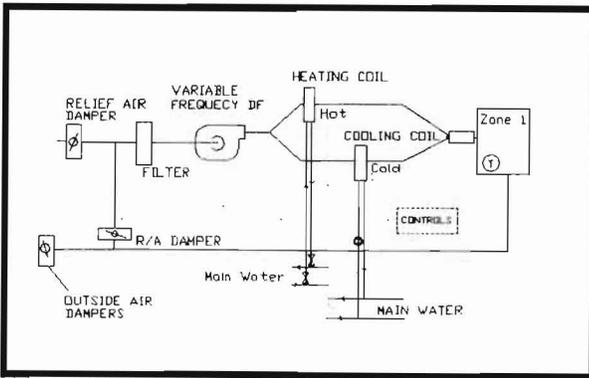
Figure 11: Nursing Building AHU Schematics. The variable frequency drive is controlled by either cold or hot duct static pressure sensors. The lower of the two controls the speed. Two-way chilled water valves controls the supply of chilled water to the AHU.

The site contact at U.T. Austin was informed immediately of this increase. After further investigation it was found that the variable frequency drives for the two air handling units were controlled by either the cold duct static pressure or the hot duct static pressure (i.e., the lower of the two). The steam pressure on the steam coils supplying steam to the hot deck coils is kept at approximately 5 psi. When the temperature dropped below 55° F, the building operator decided to operate the vent (economizer) cycle, which was added as a part of the retrofit. When there was a call for heat, the cold side of the mixing boxes closed which raised the cold duct static pressure. When the hot side of the mixing boxes opened (as the building needed more heat) it lowered the static pressure of the hot duct thus controlling the variable frequency drives, and forced the motors to run at very high speed. When the operator noticed this, the vent cycle was immediately closed because the required hot deck temperature could not be maintained and cold air was being delivered to the zones. The air handling units continued to run at very high speeds thus consuming more electricity as the temperature dropped. This phenomenon can be seen in Figure 13, where electricity consumption of the air handling units is plotted against out-door dry bulb temperature. One of the possible reasons for this increase is a lack of heating capacity. This matter is still under investigation.

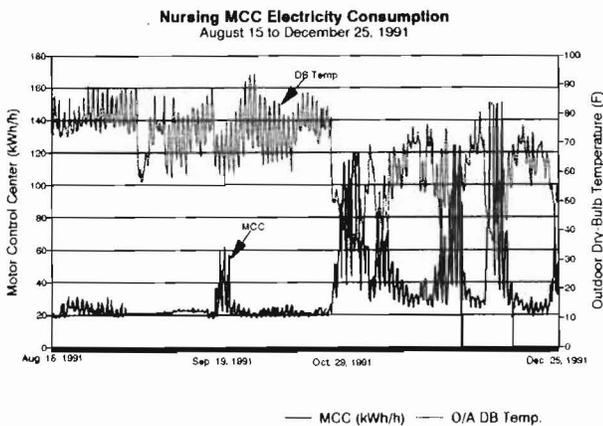
Figure 12: Electricity consumption by Motor Control Center at the Nursing building and outdoor dry-bulb temperature for Austin, Texas from August 1, to December 25, 1991.

As shown in Figure 12 electricity consumption by the two air handlers was steady at about 20 to 25 kWh/hr after the April 1991 retrofit. A sharp increase in the electricity consumption was first noted on September 19, 1991 and again on October 29, 1991. The 120 kW (350%) increase corresponded to outside air temperature falling below 55° F. The coincidence in the electricity consumption with dropping temperature can be seen in Figure 12.

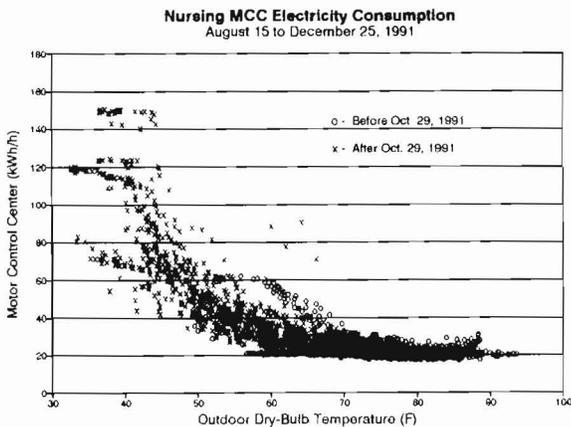
Figure 13: Electricity consumption by the Motor Control Center at the Nursing building plotted against outdoor dry-bulb temperature for Austin, Texas from August 15 to December 25, 1991.
