**INFLUENCE OF CULTURE, FAITH, ENVIRONMENT, AND BUILDING
TECHNOLOGY ON THE BUILT FORM: THE CASE OF NINETEENTH
CENTURY CATHOLIC CHURCHES IN GALVESTON, TEXAS**

A Dissertation

Major Subject: Architecture

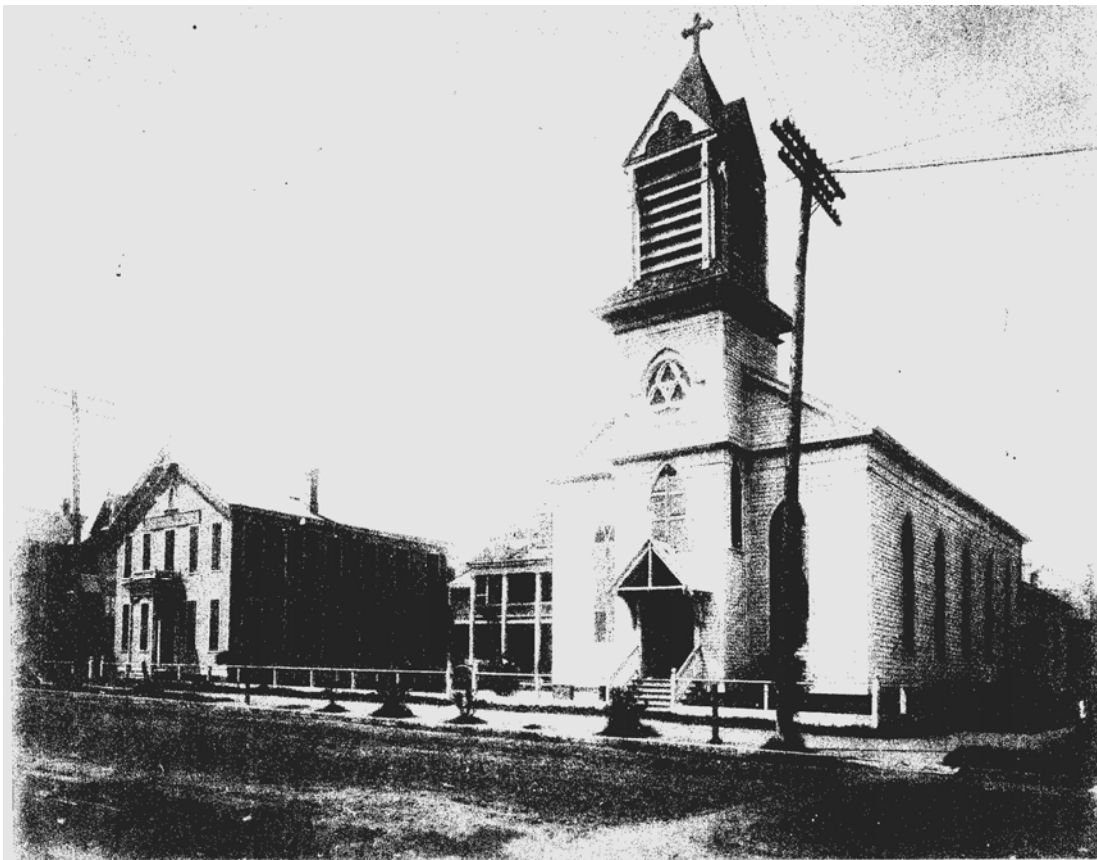
Figure 6: St. Joseph's Church, circa 1904-1905; Catholic Guide Book.
Source: Courtesy; Rosenberg Library, Galveston, Texas.

Architectural Style (see figure 6, p. 80)

- Plants for shading. This condition is not met. Pictures (figure 6, p. 80; additional photos available at the Galveston and Texas History Center, Rosenberg Library, Galveston) show no trees present at the church perimeter. Characteristic of a barrier sand island's climate and geology the presence of large trees would be an anomaly. It is likely that such shading was not present on the site at the time St. Joseph's was constructed. Forty years after the church was built, sufficient time for trees to establish themselves, a 1900 Storm damage photograph, available at (<http://www.gthcenter.org/exhibits/storms/index.html>) reveals no trees proximate to the building.

- Proper drainage conditions to eliminate or minimize standing water. Since Galveston's initial elevation was approximately nine feet above MSL at its highest point, drainage was a likely concern. Numerous buildings were built on elevated foundations to avoid potential and periodic flooding that occurred. Figure 6 (p 80), shows the presence of a street curb and gutter at the corner of Avenue K and Twenty-Second Street. This is evidence of an attempt to promote positive drainage away from the site. Consequently, this measure is considered met.

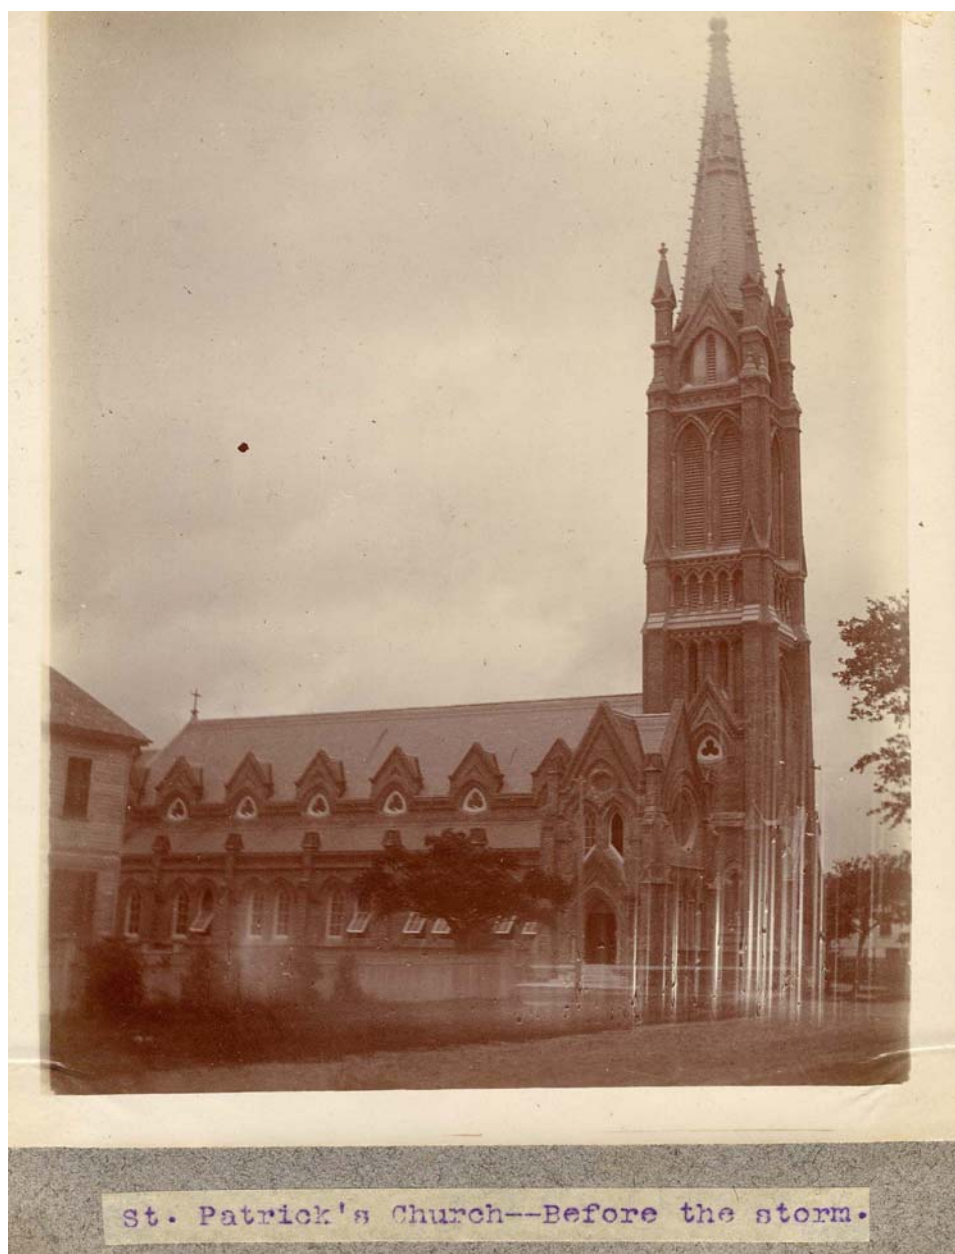
Figure 8: St Patrick's Church, before the 1900 Storm.
Source: Courtesy of the Catholic Archives of Texas, Austin.

Architectural Style (see figure 8, p. 98)

Hierarchy of Space: Galveston Daily News articles of November 20, 1877 and March 17, 1898 (Lauve, 2000) describe the church as containing a nave, side aisles, and chancel (sanctuary). A photograph (#G-8426, Rosenberg Library, Galveston) taken on St. Patrick's day 1887, and one appearing as Figure 8 (p. 98) indicate the presence of the front entrance and a narthex located at the base of the bell tower. This is confirmed by a church floor plan drawn by Clayton, dated 2-14-98 (Almond, 1988)—the 98 being 1898—that shows a circular baptismal font located in the front corner of the right transept. All of the desired space elements were present in the church—entrance,

- Cross-ventilation through operable windows on the windward and leeward building elevations. The church orientation places 12 windows on the south (windward) and 12 on the north (leeward) building façades. In addition, Figure 8 (p. 98) shows these windows to be open (window sash tilting out at bottom). Therefore, this design condition is met.

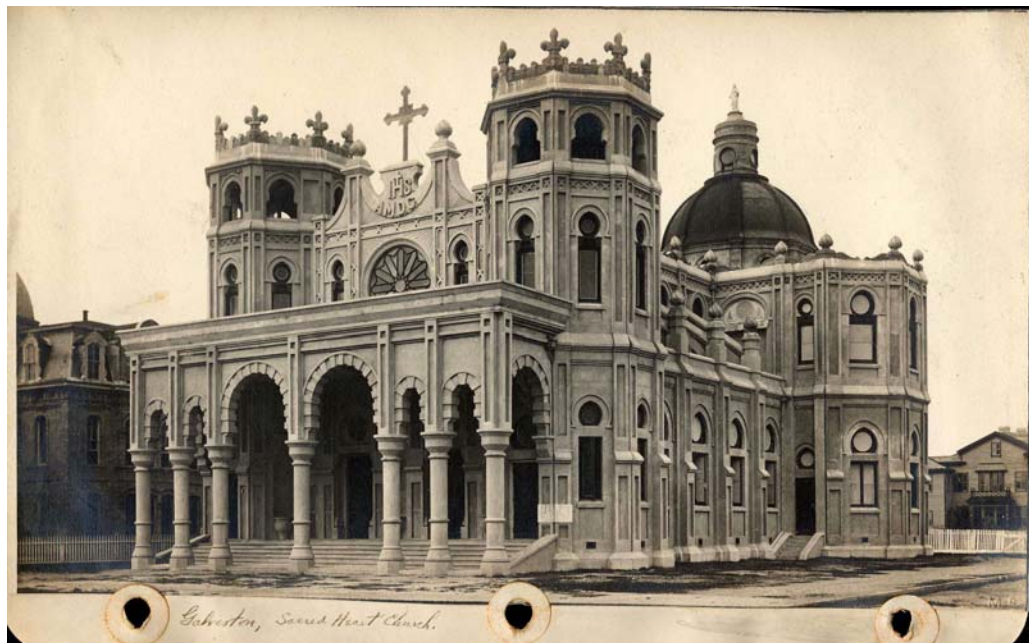
Figure 12: Sacred Heart-II, after the 1900 Storm.

Architectural Style (see figure 12, p. 136)
