THE *A.J. GODDARD*:
RECONSTRUCTION AND MATERIAL CULTURE OF A
KLONDIKE GOLD RUSH STERNWHEELER

A Thesis

Submitted to the Office of Graduate Studies of
Texas A&M University
in partial fulfillment of the requirements for the degree of

The *A.J. Goddard*, a steamboat built for the Klondike Gold Rush of 1897-1898, wrecked in 1901 on Lake Laberge, Yukon Territory, where it lay undisturbed until its rediscovery in 2008 by the Yukon River Survey Project, directed by John Pollack. The complete and undisturbed nature of the wreck site, which is the only known site from this period to show such remarkable preservation, provides an unparalleled opportunity for studying the construction features of one of the Klondike steamboats and its associated material culture.

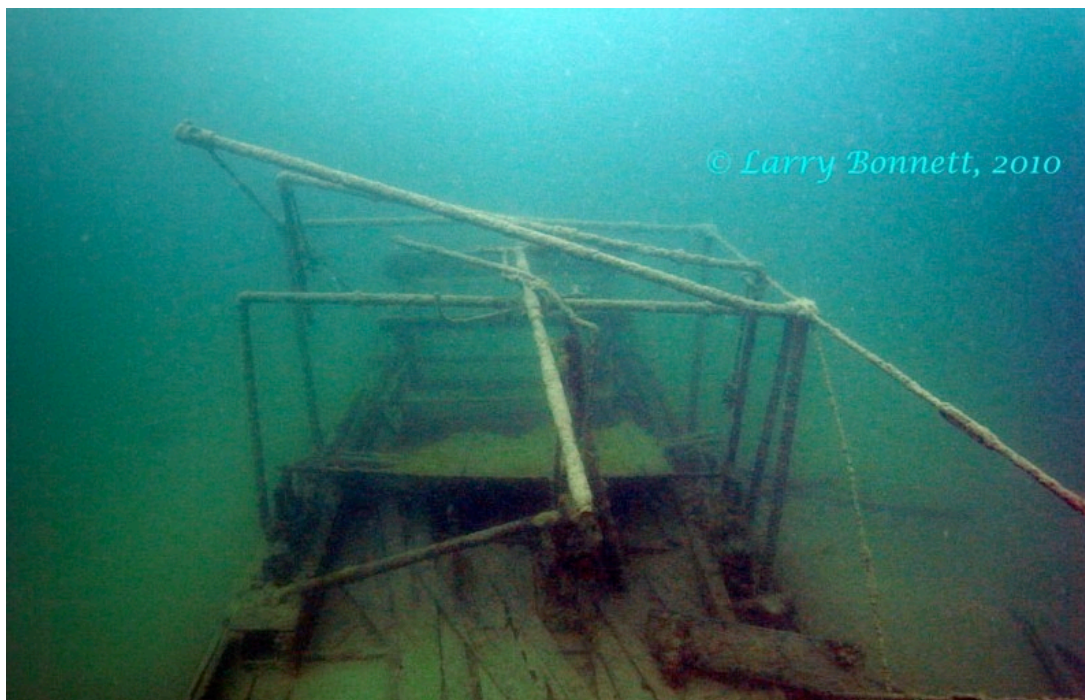
FIGURE 3.6. Damage to the hogging system in the stern (Photo by Larry Bonnett).

45-foot long (15 m) dead tree, called a dead-head, became stuck or anchored upright in the approximate location of the *A.J. Goddard* for two years approximately 20 years ago (Jenine Caruthers 2010, pers. comm. per Doug Davidge). The ice that annually forms on the surface of the Lake surrounded the top of the dead tree at the surface, and any movement by the ice would exert more pressure upon the tree and thus upon the hogging system that it may have been stuck in. If the heavy root mass of the dead tree was indeed trapped in the hogging system, wind and wave driven movement of the ice would have caused great pressure on the tree, bending the hogging system and steam pipes until the tree could break free. The ice would need to move only approximately two ft. (0.61 m) to cause the damage seen on the wreck.

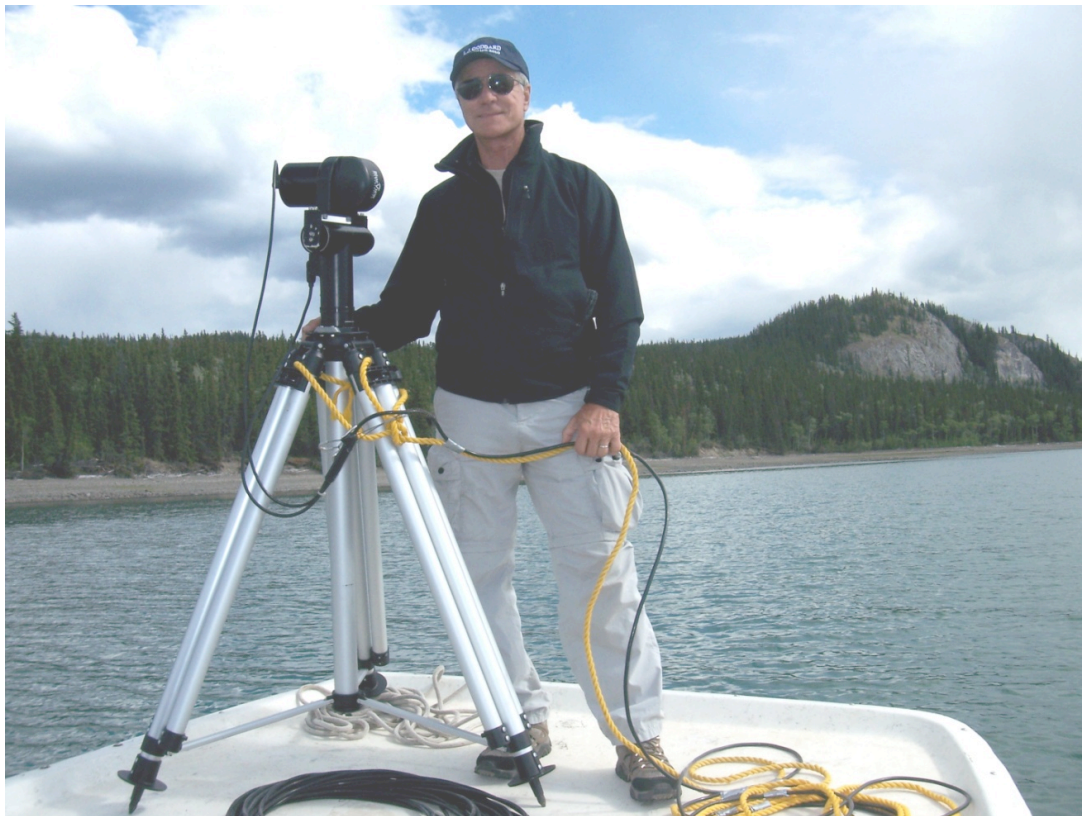
FIGURE 4.6. OceanGate Citizen Scientist Wayne Loeber with the BV-5000 (Photo by Mark Thomas).

Through the donated assistance of BlueView Technologies, which develops underwater acoustic measurement and imaging systems, and OceanGate, a company dedicated to assisting scientific research by pairing researchers with interested volunteers who contribute necessary resources, the 2010 field team had access to the BlueView BV-5000, a high-resolution profiling sonar that is capable of creating a 3D point cloud in minutes. The highly portable unit is capable of capturing both sector and spherical scan data. (Figure 4.6).

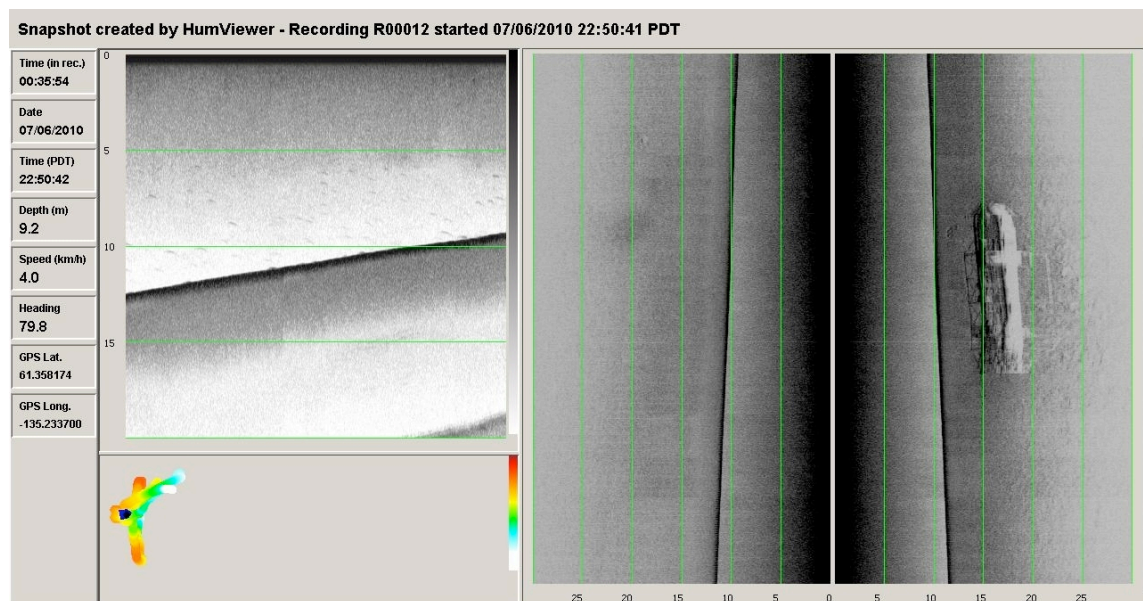
FIGURE 4.8. Humminbird sonar image (Courtesy of Douglas Davidge).

On 7 June, a Humminbird 1197c SI sidescan sonar unit was also used to scan the wreck site and surrounding area (Figure 4.8). The stack was not located at this time.

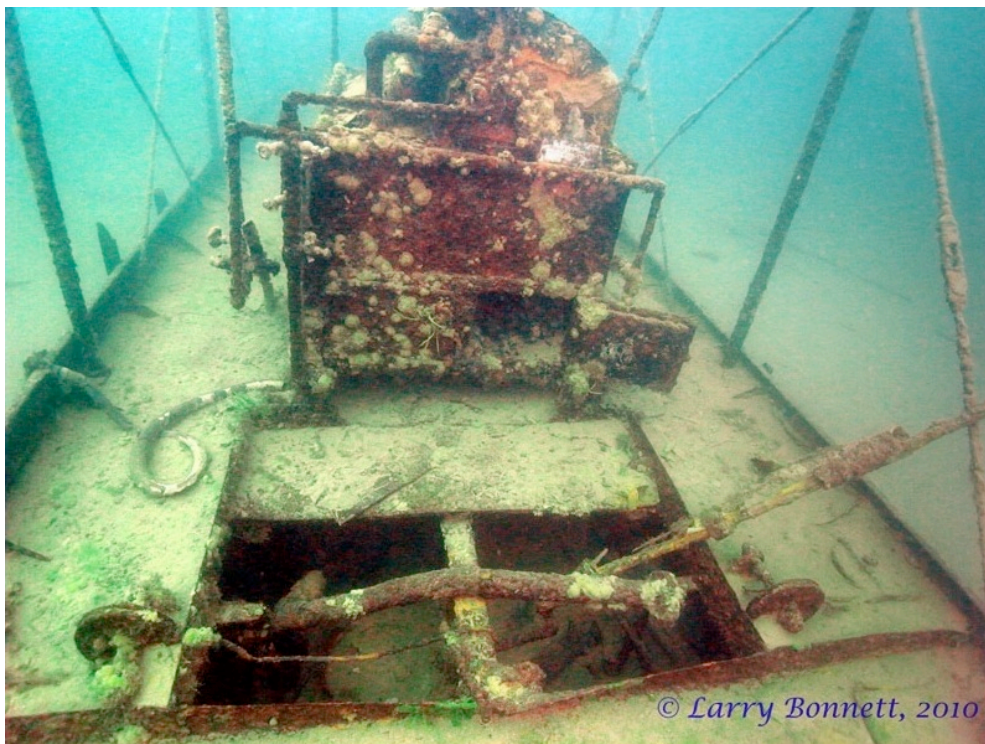
FIGURE 5.9. Boiler and largest set of hatches (Photo by Larry Bonnett).

the boiler (Figure 5.9). He was provided a small measure of protection from the spray on Lake Laberge by the bow rail that was installed sometime after the *A.J. Goddard* began working the river. It should be noted that the date July 1898 on the boiler name plate may indicate that the boiler itself was added after the *A.J. Goddard* had been operating the Yukon for some time (perhaps replacing an older boiler) due to the fact that the vessel made its first trip in beginning of June. Alternately, this may have a been marketing gimmick intended to make the boiler appear very new.

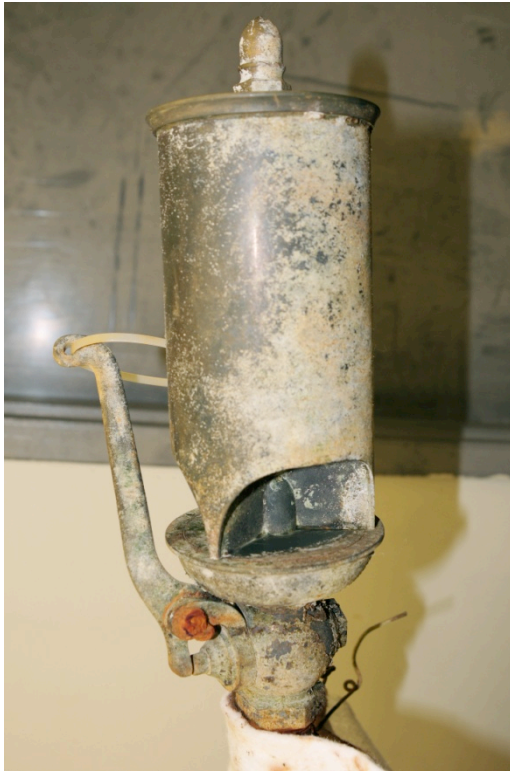
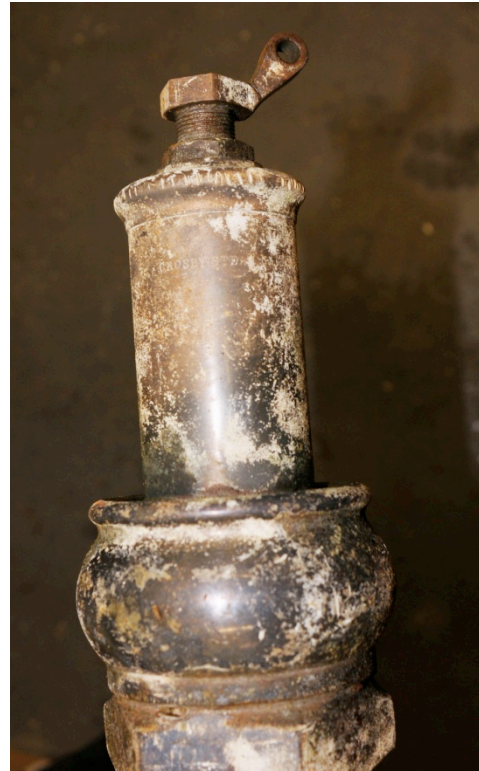
The steam whistle and the safety valve were made by the Crosby Steam Gage and Valve Co. of Boston, Massachusetts (Figures 5.10 and 5.11). Both elements have the name of the company stamped into the brass in very small letters that wrap around the curved surface of the whistle and valve. The steam whistle features elaborate castings and several separate parts. At this phase of conservation, it is not possible to search all of its components for marks. One mark was found, however, stamped on the bowl. Less than a ¼ in. in height, it reads CROSBY STEAM GAGE & VALVE CO BOSTON US PATENT JAN 30 1877. On the angled surface at the bottom of the whistle, where it inserts into the iron steam pipe, are the stamped numbers “4344”. The safety valve exhibits another stamp on the main curved surface of the whistle cylinder that reads CROSBY STEAM GAGE & VALVE CO BOSTON USA PATENT JAN 25 1878 and MARCH 20_ _ . The final markings after 20 are impossible to read due to damage or an incomplete stamp impression.

FIGURE 5.10. Steam whistle.
(Yukon Government).

FIGURE 5.11. Safety valve.
(Yukon Government).

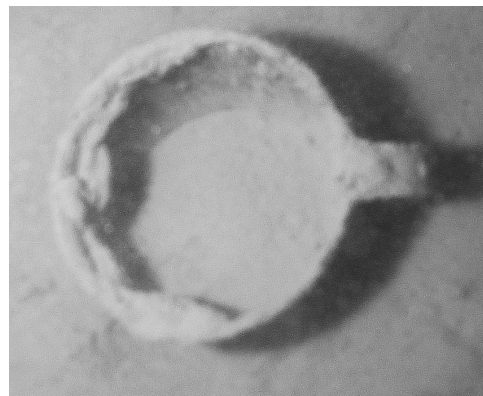
JiUt-5:91

Flat metal object, possibly a stove plate
intended to fit between two burners.
