**INVESTIGATING THE EFFECTS OF CORROSION ON THE FATIGUE
LIFE OF WELDED STEEL ATTACHMENTS**

A Thesis

May 2012

Major Subject: Civil Engineering

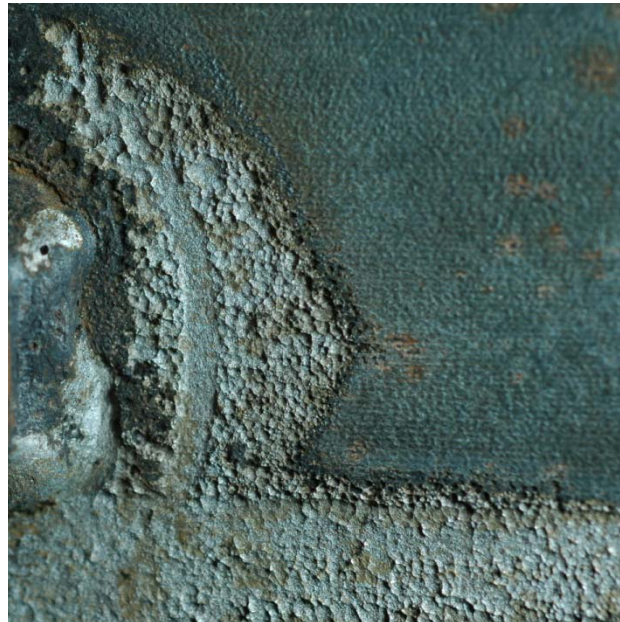
Figure 2. Surface Corrosion Around Weld

During the welding process the mill scale's integrity is compromised, due to the high heat, after which it can easily flake off. As the corrosion mechanism continues, the affected area will grow outward from the weld. Over time as the corrosion spreads, it reduces the material thickness as the rust scale flakes away (Culp & Tinklenberg, 1980). Figure 2 shows the process of corrosion as it spreads from the toe of a weld. The small crater-like areas seen are individual corrosion cells where the 'pit' of the crater is the local anode.

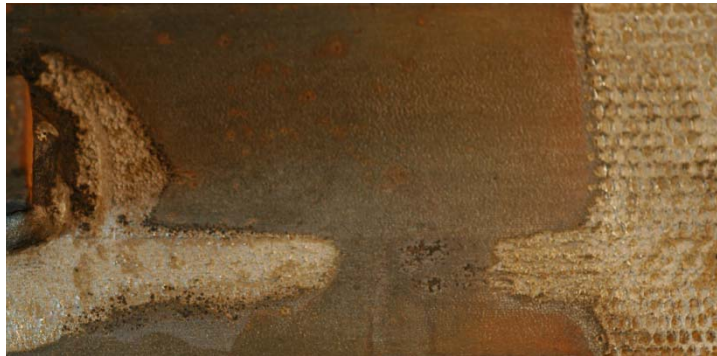
Figure 3. Initial Corrosion of Mill Scale

Figure 3 shows the effects of corrosion on an unpainted mill scale surface after 15 corrosion cycles of 7 days each in a 3.5% NaCl solution. The areas of bare steel are where the corrosion process has begun. On the left is a stiffener plate and its weld toe. The weld toe was the first area to corrode and then began to progress outward. At the same time, small surface imperfections in the mill scale, which occurred during the rolling process, begin to corrode. On the far right is the grip section of the specimen. The tensile grips use a cross hatch pattern to grip the steel which causes breaks in the mill scale. Figure 4 is a more advanced case of corrosion of mill scale than that of Figure 3.

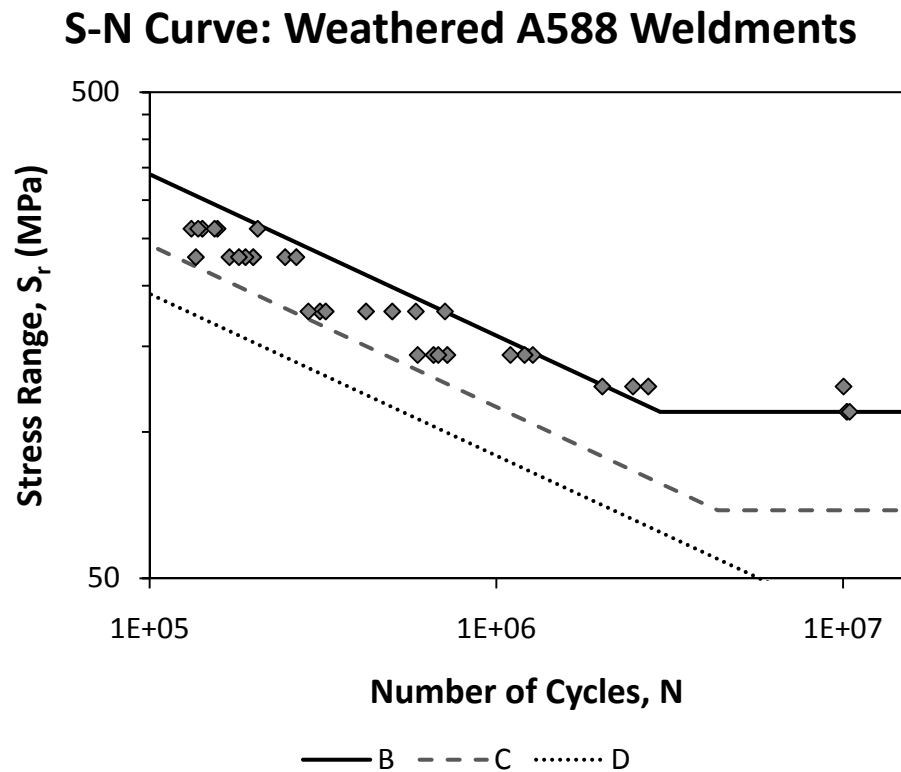
Figure 5. Weathered A588 Weldments

The specimens were weathered outdoors in University Park, Maryland. Due to University Park's proximity to a large metropolitan area, the specimens were exposed to an above average amount of automobile exhaust. Although the specimens were not subjected to direct salt contamination or prolonged wet/dry cycles, rust pitting still occurred. These specimens were tested after three and eight years of weathering and it was found that they had a reduced fatigue life when compared to the control specimens.

The resulting data can be seen in Figure 5 (Albrecht & Friedland, 1980; Albrecht & Cheng, 1983).

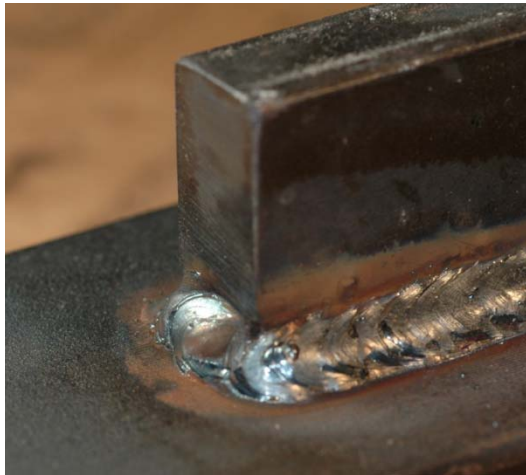
Figure 8. Typical Weld Toe

The specimens consisted of a 51mm x 3mm x 381mm (2" x 1/8" x 15") long main plate, to which one 25.5mm x 13mm x 127mm (1" x 1/2" x 5") longitudinal stiffener was welded to each side with a 5mm (3/16") weld. Since the tensile strength has no relation to the fatigue life, all specimens were created from ASTM A36 bar stock (Fisher, Frank, Hirt, & McNamee, 1970; Fisher, Albrecht, & Yen, 1974). The welds were made using a MIG welder with AWS 5.18 ER70S-6 wire. All specimens were fabricated on the same day by one professional welder to ensure consistency. A typical weld toe where fatigue cracks are expected to propagate from can be seen in Figure 8. The dimensions and configuration of the specimens can be seen in Figure 9.

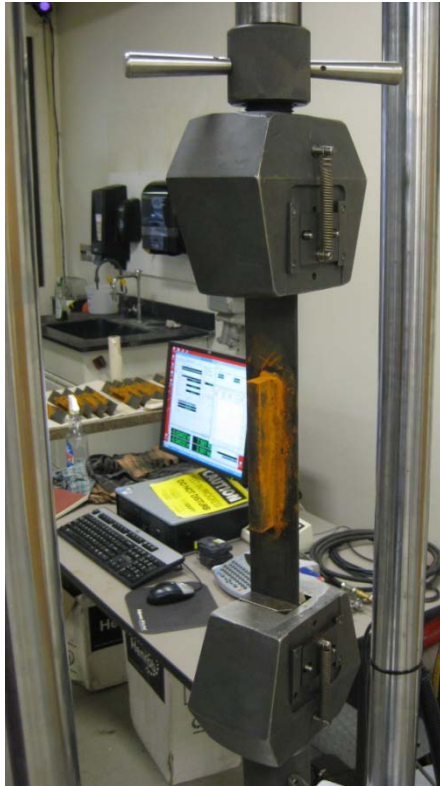
Figure 10. Specimen in Test Frame

date, and any errors encountered (such as the displacement/force interlocks being tripped). Figure 10 shows a specimen in the MTS load frame during testing.

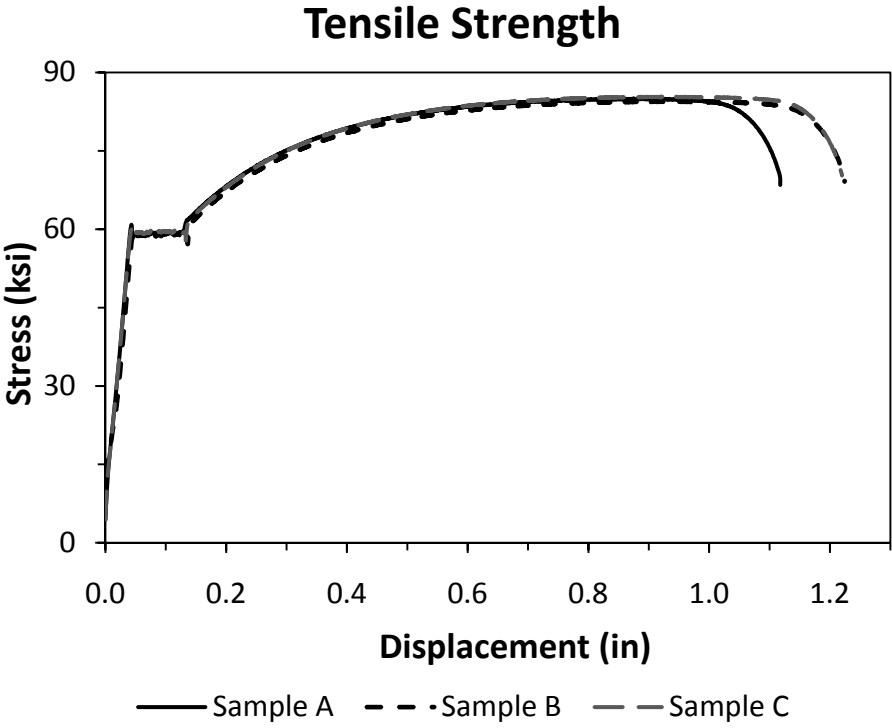
Figure 11. Tensile Test Results

Due to the number of specimens involved, three 6m (20') sections of bar stock were used for the base metal. From each of the three sections, material was tested in tension to determine the individual yield and ultimate strengths, as well as having its chemistry content analyzed. The results are shown in Figure 11 and Table 1, respectively.

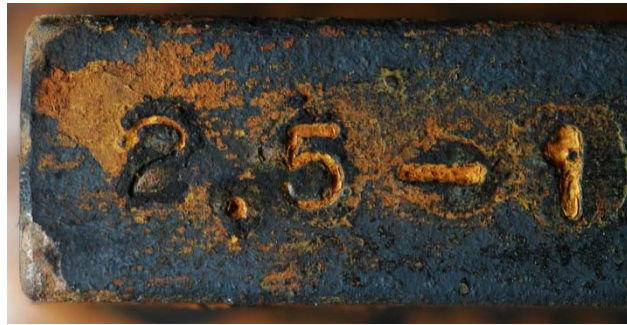
Figure 14. Stamped Specimen

To ensure that accurate records were kept, all corrosion-fatigue specimens were marked on the face of the longitudinal stiffener with steel stamps. A diagram of these marking is shown in Figure 13. The first numbers (2.5-1) denote the percentage of average control fatigue life per test interval and the individual specimen number, which ranged from 1-4. The middle number identifies the time interval of exposure to the corrosive environment, whether it is seven days, or in this example, three and a half. The final letter identifies the main base plate metal, A, B, or C. A picture of one end of a specimen can be seen in Figure 14.

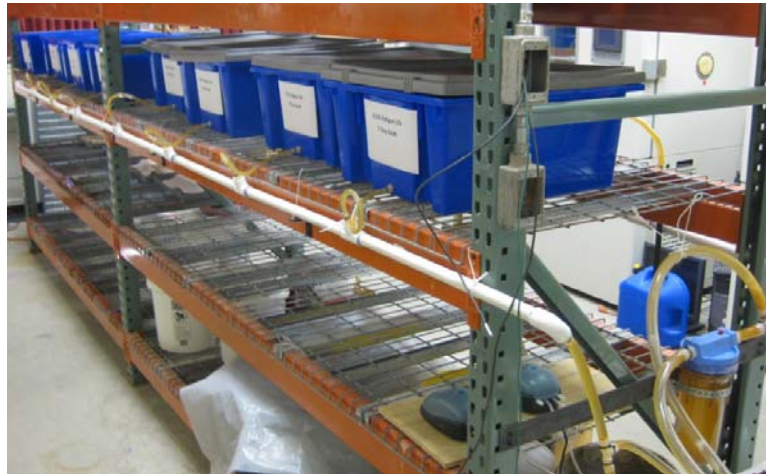
Figure 15. Front of Corrosion Containers

This corrosion bath system ensured that all specimens were subjected to identical environmental conditions. The front of the corrosion bath system can be seen in Figure 15, where the water flows into the bottom of each container. Figure 16 shows the rear of the containers, where the water exits thru the two ports located near the top.

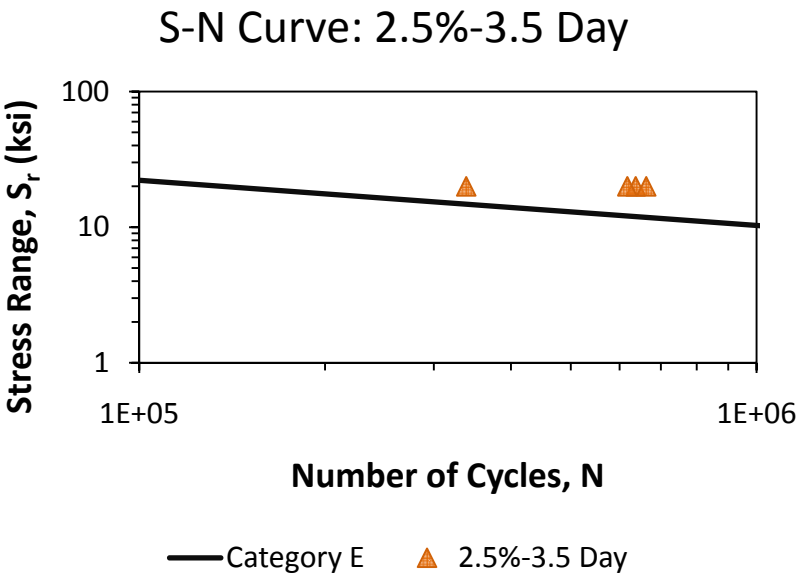
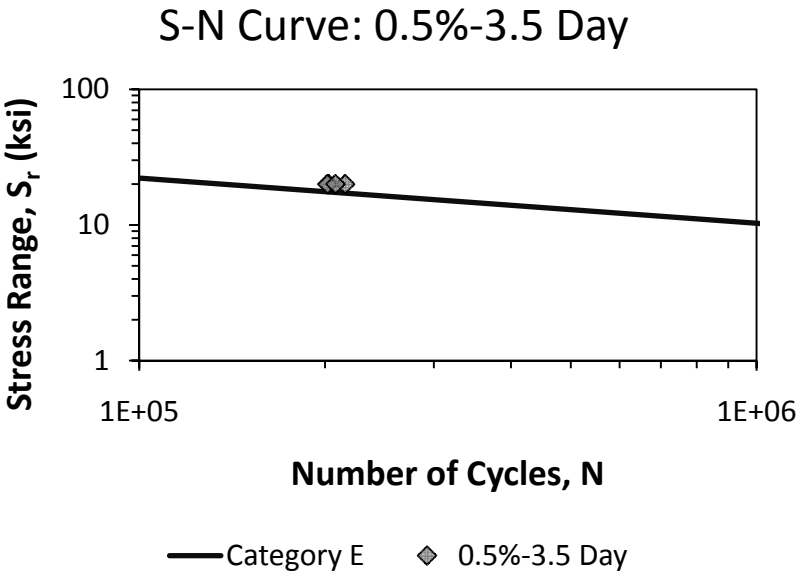
Specimens	Total Cycles
5 - 1	344,401
5 - 2	256,249
5 - 3	476,219
5 - 4	1,325,020
Average :	600,000
2.5 - 1	338,490
2.5 - 2	637,072
2.5 - 3	662,612
2.5 - 4	617,362
Average :	564,000
1 - 1	444,973
1 - 2	449,427
1 - 3	398,991
1 - 4	397,405
Average :	423,000
0.5 - 1	202,684
0.5 - 2	215,595
0.5 - 3	201,714
0.5 - 4	207,978
Average :	207,000

As seen in Table 5, the fatigue lives of the corrosion-fatigue specimens in groups ‘1%-3.5 Day’ and ‘0.5%-3.5 Day’ showed a decreased fatigue life. This is likely due to the extent of corrosion damage and the resulting cross section loss. The results are discussed later in more detail.

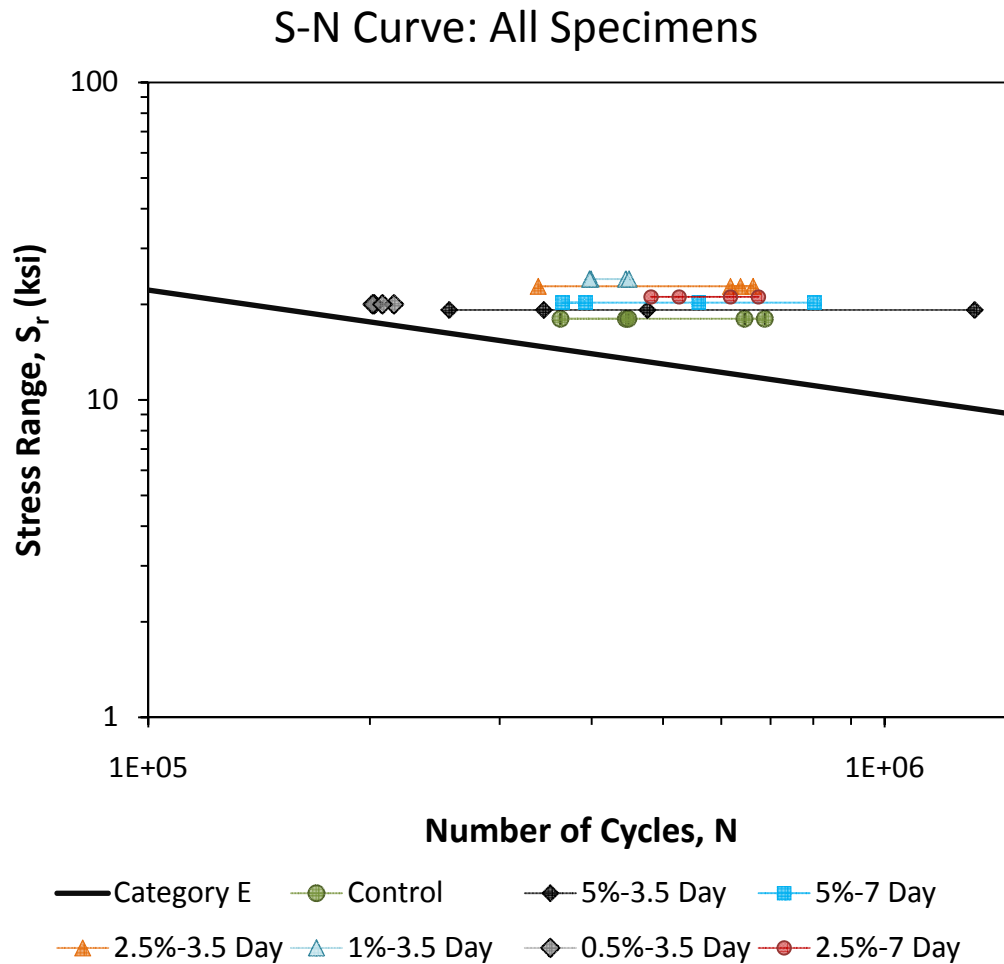
Figure 23. S-N Curve for All Corrosion-Fatigue Specimens

Figure 23 shows the fatigue lives of all the previously mentioned corrosion-fatigue specimen groups with a slight vertical exaggeration for increased clarity.

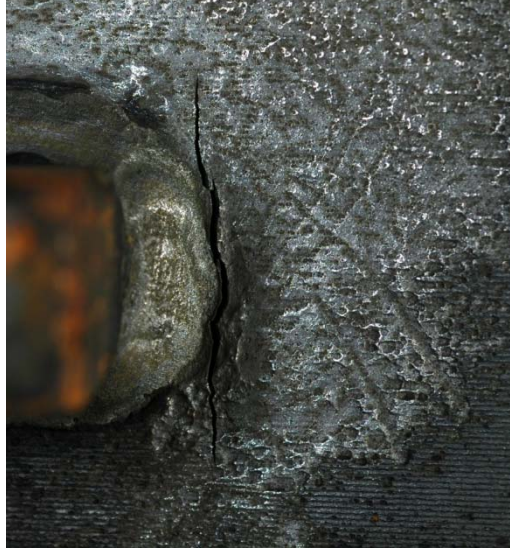
Figure 24. Thru Crack in Specimen 2.5-1 '3.5 Day' (front)

Below, in Figure 24 and Figure 25 a thru crack can be seen in the end of specimen '2.5-1' of the '3.5 Day' exposure group, which would ultimately lead to failure. It is evident that the fatigue crack initiated at the toe of the weld on one side and propagated until it reached a critical length. Around the edges of the following figures, the remaining mill scale can be seen. This is because the corrosion process began at the area near the weld and progressed outward in a radial fashion.

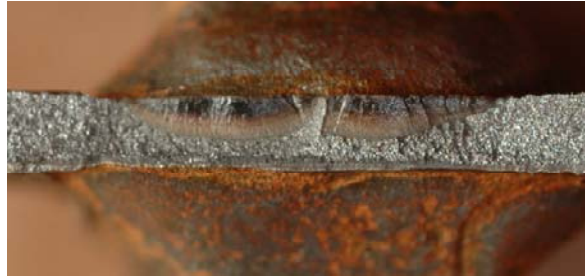
Figure 27. Fracture Surface of Specimen 5-3 '3.5 Day' at 'Remaining'

While the specimens can only fail at one end of the welded stiffener, it is very likely that the remaining weld toe also experienced fatigue crack growth. To investigate, the remaining weld toe is cut down to size and the base plate is notched along the same plane as the leading edge of the weld toe. Liquid nitrogen is then used to lower the sample below its brittle transition temperature, making it easier to fracture the steel along the failure plane of the crack and the notch. The results of using this technique can be seen below in Figure 27.

From Figure 26, Figure 27 and Figure 36, it is evident that the assumption of the crack shape being semi-elliptical is accurate.

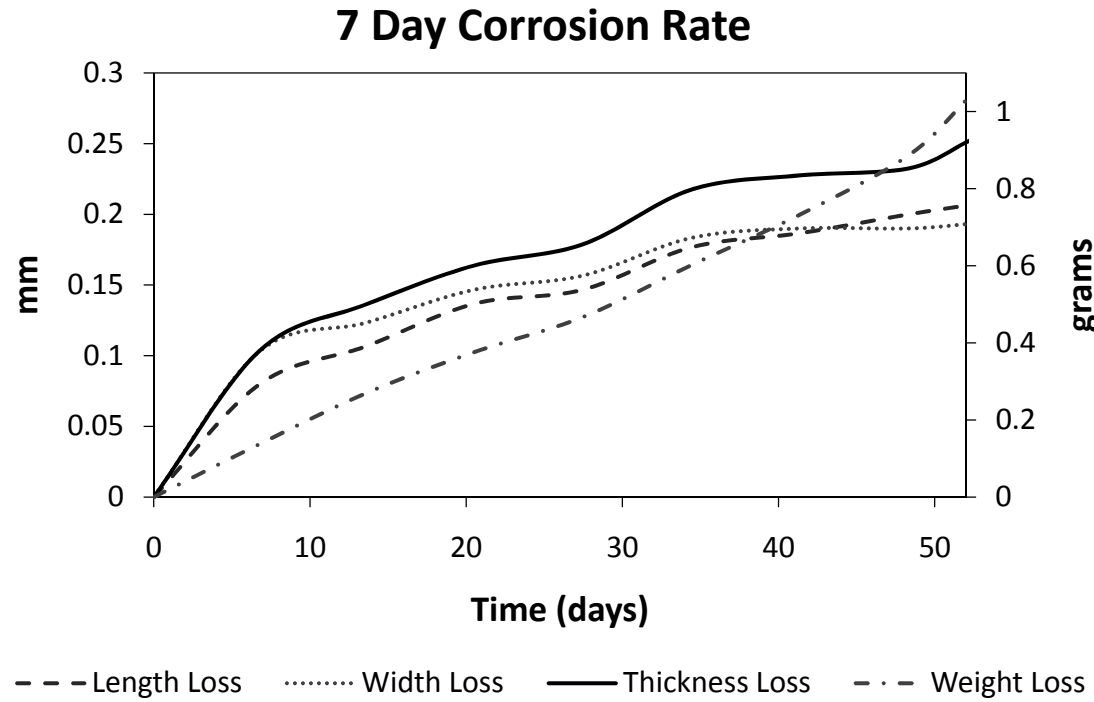
Figure 28. 7 Day Corrosion Rate

In addition to the measurements taken at the weld toe of each specimen, two coupons from a leftover section base metal 'A' were used to approximate the corrosion rate. The mill scale on each was removed to approximate the conditions around the weld toe where the mill scale was damaged during the welding process, as well as to provide a uniform surface for precise and consistent measurements. Each coupon was then carefully measured and weighed. After their respective exposure periods, each coupon was removed, cleaned with a nylon brush and fine steel wool, and measured. The results can be seen in Figure 28 and Figure 29.

These coupon results can only serve as a reference for the corrosion rates experienced by the corrosion-fatigue test specimens. Since the corrosion coupons were not loaded and were smaller than the corrosion-fatigue specimens, there will inherently be some variation in the coupon corrosion rates as compared to that of the corrosion-fatigue specimens.

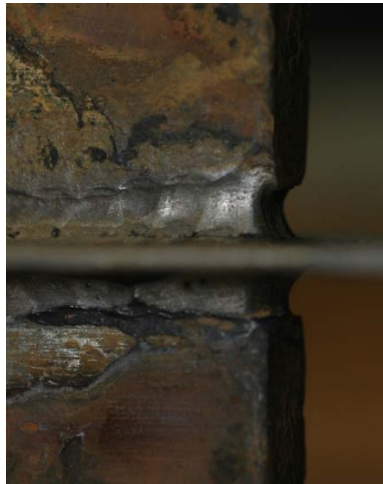
Figure 30. Corrosion Damage at Stiffener Termination

Although the extent of corrosion damage on each corrosion-fatigue specimen varied, Figure 30 shows how aggressive the corrosion process was as the silhouette of the remaining portion of weld toe can be seen. Figure 31 shows that the corrosion process has nearly eaten through to the root of the weld. In fact, the stiffener shown in

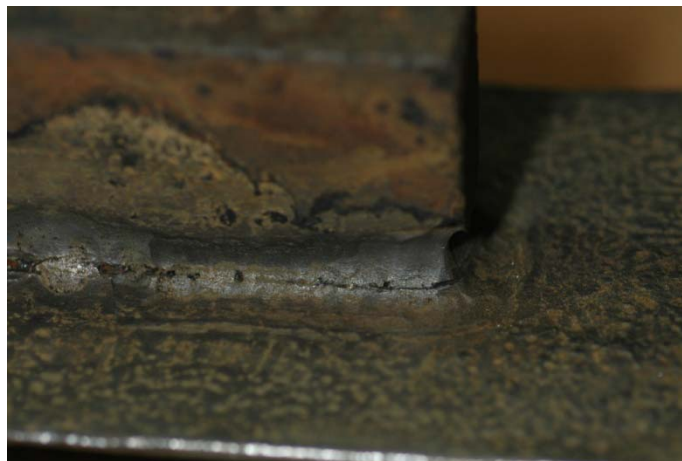
Figure 31. Corrosion Damage at Root of Weld

Figure 31 fell off when liquid nitrogen was used to fracture the remaining weld toe of the corrosion-fatigue specimen, as previously discussed; the result can be seen in Figure 32.

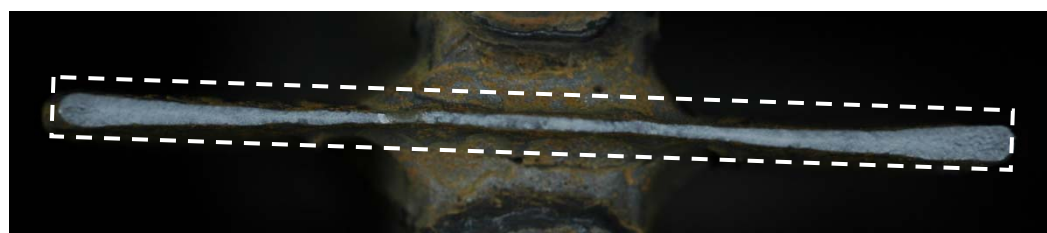
Figure 34. Reduced Cross Section

specimens were measured to determine the approximate amount of cross sectional area lost, and thickness lost at the center of the base plate. All losses are given as percentages of original dimensions. Figure 34 shows the reduced cross section of the base plate due to the corrosion process; the white dotted line represents the original section outline.

These results coincide with the findings of Albrecht et al. (1980; 1983) that weathering prior to fatigue cycling can reduce the fatigue life. By pre-corroding the specimens prior to any fatigue loading, the location of the most severe stress concentrations transition from being in the weld region to the most severe case of rust pitting. This is true for both weathering and non-weathering steels alike. For non-weathering steel, the net area is also reduced locally (Ref. Table 7 & Table 9) which causes a reduction in fatigue life.

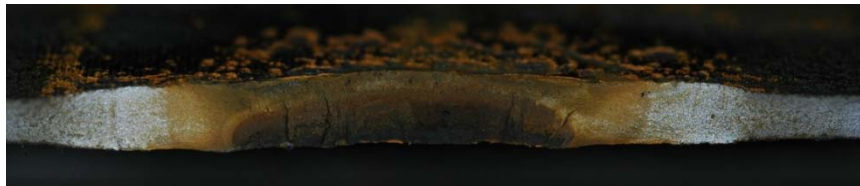
Figure 36. Elliptical Crack Growth

Although the idealized crack begins as a semi-ellipse, the ratio of the depth component (a) to the width component ($2c$) does not remain constant, due to the localized stress at the crack tip in the minor axis direction being larger than the localized stress in the major axis direction (Hertzberg, 1996). Smith and Smith (1983) observed that regardless of the initial ratio of the semi-elliptical depth to width, during stable growth the ratio converged to a shape “slightly shallower than semi-circular.” Due to the complexity required to accurately model the entire life cycle, only the initial stage of crack propagation will be analyzed so we can neglect the differential growth rates of the
