Evaluation of Electrostatic Particle Ionization and BioCurtain Technologies to Reduce Dust, Odor and other Pollutants from Broiler Houses

Final Report

November 2011

Texas Water Resources Institute Technical Report No. 415
Texas A&M University System
College Station, Texas 77843-2118

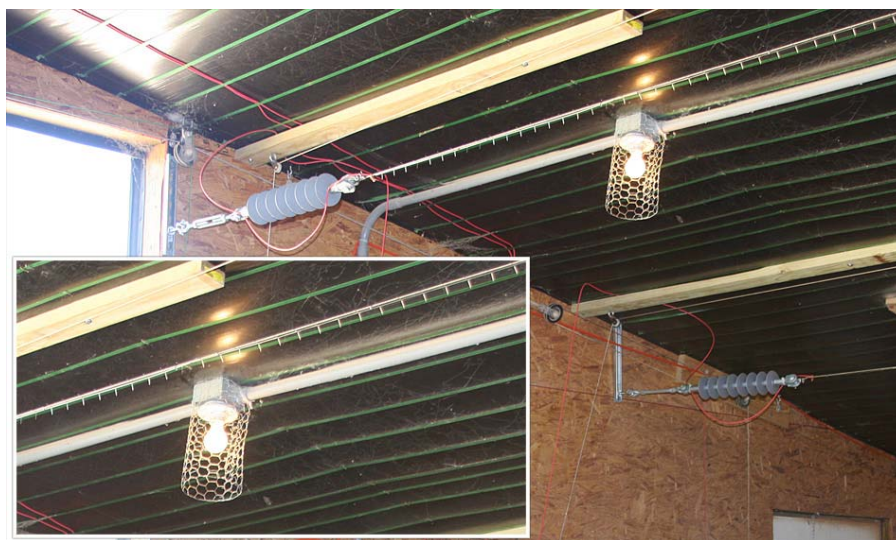
Figure 1. Corona lines running from power source.

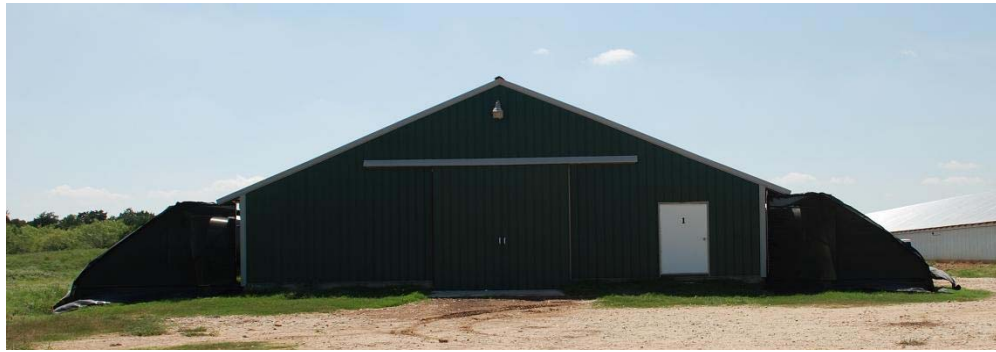
Figure 2. BioCurtain installations on poultry house

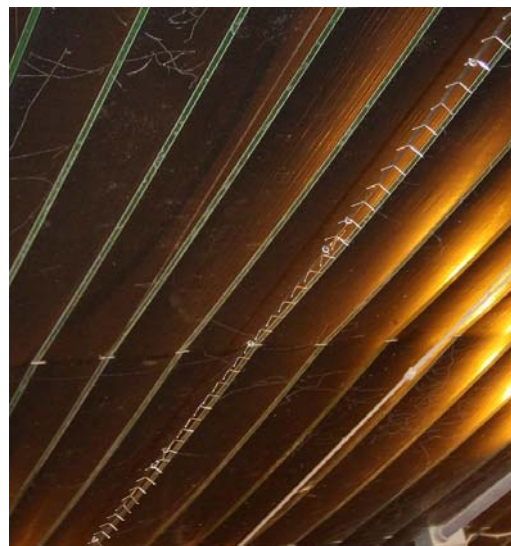
- Look for broken ceiling insulators. The ceiling insulators keep the corona line from short-circuiting and do the lifting and lowering of the corona line. If they are broken, the chances of problems arising increase. Most ceiling insulators hold the corona line up, but some hold the corona line to the side or down, away from grounded objects. Replace broken insulators as soon as possible.
- Keep the corona points pointing toward the floor. Pressure washing between flocks occasionally causes the corona points to become tangled and point in odd directions. The EPI system works best when the corona points are pointing toward the floor as seen in Figure 3.

Figure 3. Corona lines for EPI system near roof of poultry house.

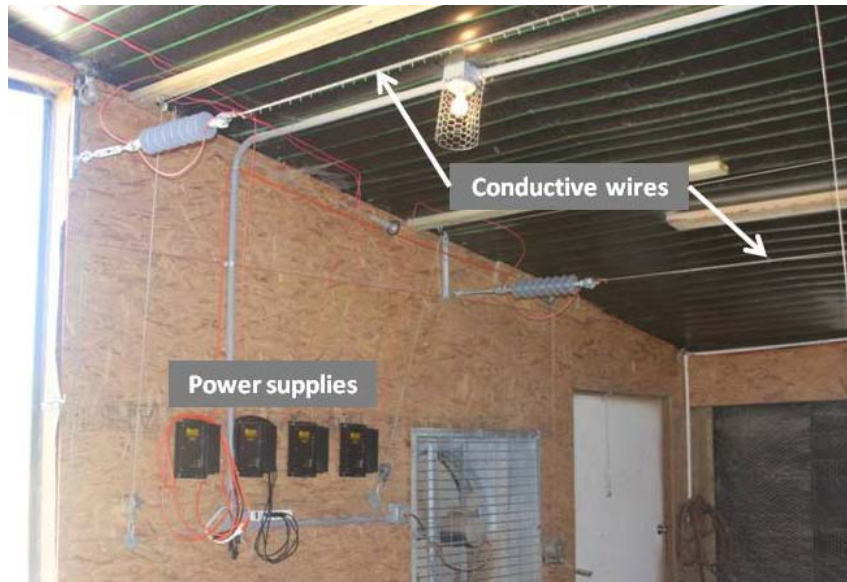
The EPI™ system (Baugmgartner Environics Inc., Olivia, MN) installed inside the treatment house consisted of four rows of inline, negative ionization units (consisting of conductive wires with discharge electrodes) that are suspended 30 cm from the ceiling and ran along the entire length of the house (Figure 2). Each of these ionization units was attached to a high voltage power supply to generate -30kV DC (at a low current level of up to 2 mA) to ensure safety. The high-voltage negative corona discharge occurs at the stainless-steel electrodes located at 2.54 cm intervals and is pointed toward the litter as shown in Figure 3. The negative corona imparts negative charge to the airborne particles as they flow through the charging field causing them to be attracted to grounded surfaces such as floor, walls, ceilings, and other surfaces in the building.

Figure 2. The ionization units hanging from the ceiling of the broiler treatment house and connected to the power supplies.

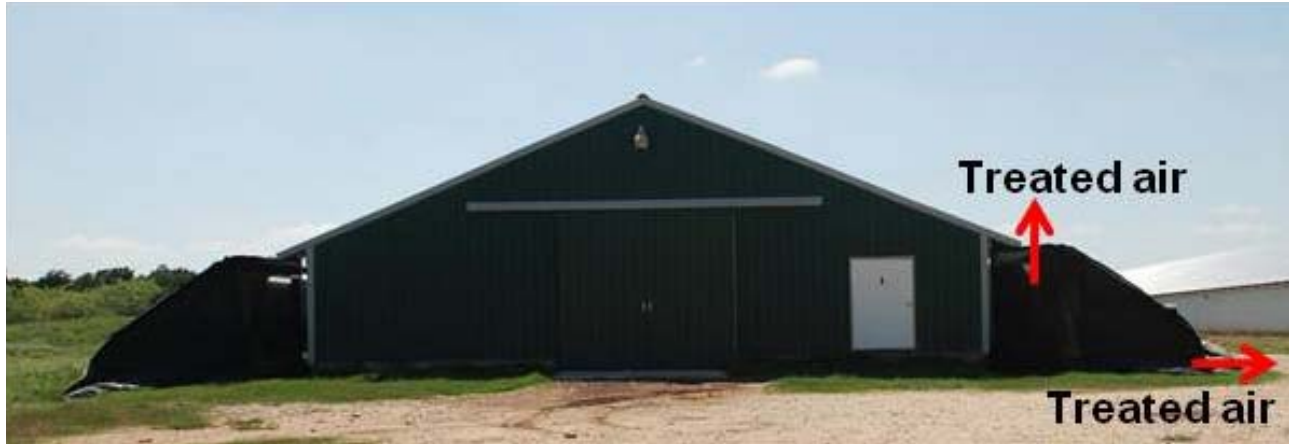
The BioCurtain™ system (Baugmgartner Environics Inc., Olivia, MN) is comprised of a metal frame structure, covered with a woven geotextile fabric used to enclose a group of ventilation fans. It was installed about four fan diameters away from the exhaust fans covering the entire exhaust area on both sides of the building (Figure 4). Each curtain was 12.2 m long and 5.5 m wide.

Figure 4. Biocurtain covering the entire exhaust area on both sides of the treatment house. Treated air leaves vertically and through the opening near the bottom corner of the structure.

The BioCurtain™ functions by altering the aerodynamics of the air being exhausted from the barns by directing it toward the geotextile fabric and down into the bottom corner of the structure, where dust settles out of the air stream. The treated air is then exhausted out vertically and through the opening near the bottom corner of the structure (Figure 4). An EPI™ system was also installed inside the BioCurtain™ (Figure 5) enclosure to enhance the collection of suspended particles before the treated air leaves the structure.

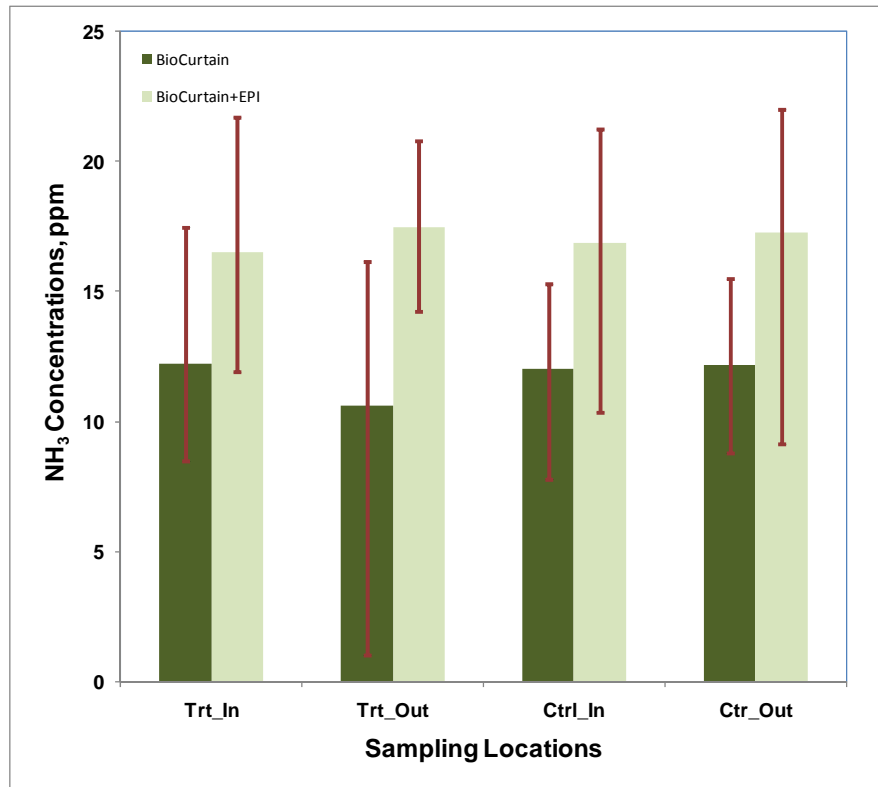
Figure 9. Comparison of the NH₃ concentrations measured in December 2010 when only the BioCurtain™ was in operation and when both the BioCurtain™ and EPI™ are active. The error bars represent the minimum and maximum values. Trt=treatment, Ctrl=control, In=upstream of the exhaust fans, Out=downstream of the exhaust fans.

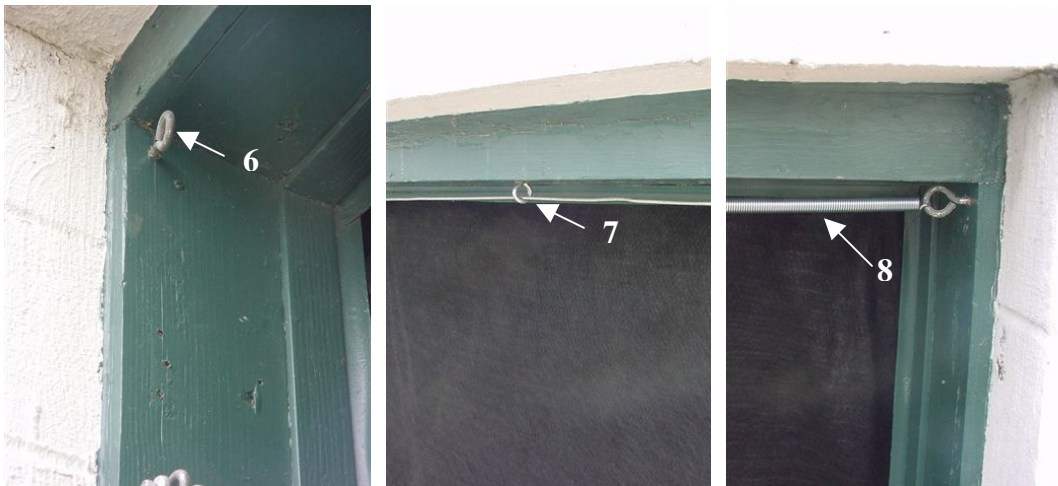
Attach ground-exciter anchors, springs, and ceiling brackets, and ratchets

- 6) Ground-exciter anchors should be attached as close to the ceiling as possible on each end of the barn.
- 7) Attach a ceiling bracket approximately every 9 meters to the ceiling, in line with the anchors.
- 8) Attach a spring to each ground-exciter anchor, on the far end of the building.

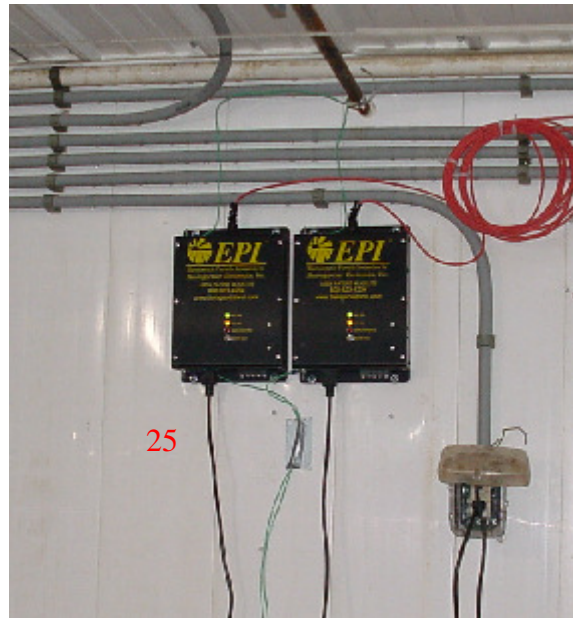
Attach high-voltage wire to each corona point line to each power supply

- 25) Install the power supplies in a hallway or office, out of the animal production area, if possible. Use the tabs provided on each power supply to fasten the power supply to the wall.
- 26) Install the Power Supplies in a cool place, when possible. It is best to be below 70 degrees F (21 degrees C) and space the power supply approximately 1 inch (2 cm) off the wall and at least 4 inches (10 cm) between power supplies to allow free air movement.

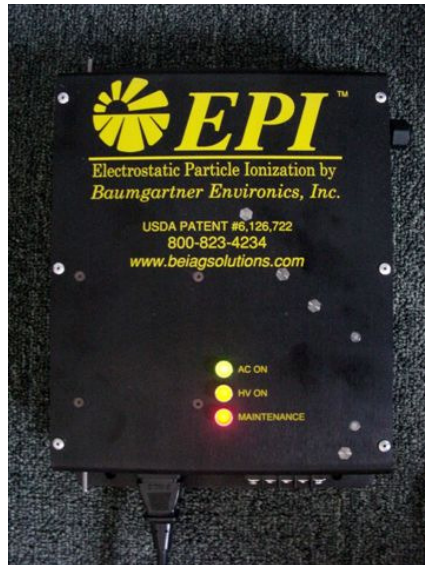
The power supply is designed to shut down if a short-circuit condition occurs. A short-circuit condition may be caused by any contact of a grounded object with the corona point line. The power supply can tell you when a short-circuit occurs: the green "AC" light remains on, the yellow "HV" light will turn off and the red "maintenance light" will turn on. (The green, yellow, and red lights are located on the face of the power supply.)

In the event of a short-circuit, the power supply will attempt to power-up again in approximately 45 to 55 seconds. If the short-circuit is still present, it will not power-up. The green light will remain on, the yellow light will stay off, and the red light will stay on. The power supply will continue to try to power-up every 45 to 55 seconds. The power supply is configured this way to ensure continuously safe operation of the EPI system.

Upon eliminating the short-circuit from the corona line, the power supply will power up. The power supply will return to normal operation: the green light is on, the yellow light is on, and the red light is off.

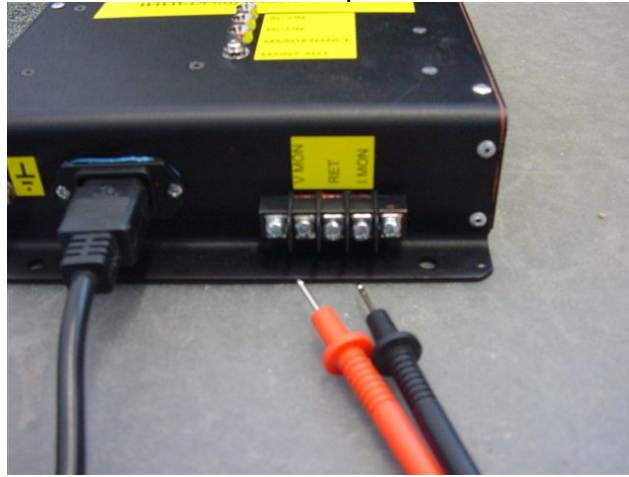
- Locate the "V MON; RET; and I MON" ports on the bottom of the power supply.

- To read the high voltage output: Touch the black probe to the "V MON" port and the red probe to the "RET" port. The number displayed on the voltage meter is 1/10,000 of the actual output voltage. In picture 3, the reading is -3.01 volts, which equals an output of -30,100 volts. $-3.01(10,000) = -30,100$

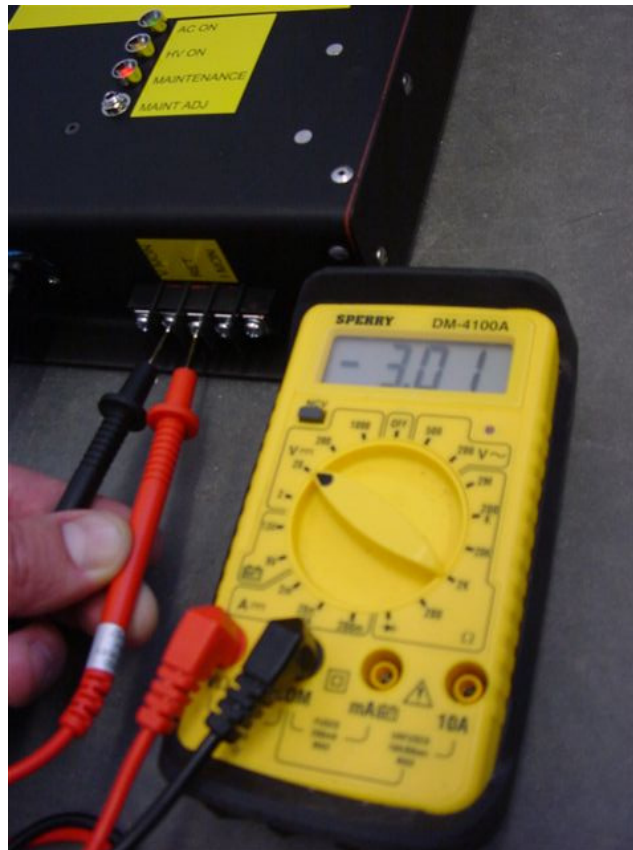
- To read the amperage output: Press the black probe to the "I MON" port and the red probe to the "RET" port. The number displayed on the voltage meter is: - 0.08 volts, or 0.08 mA. One volt equals one milliamp or 1 Volt = 1mA. 0.08(1) = 0.08.

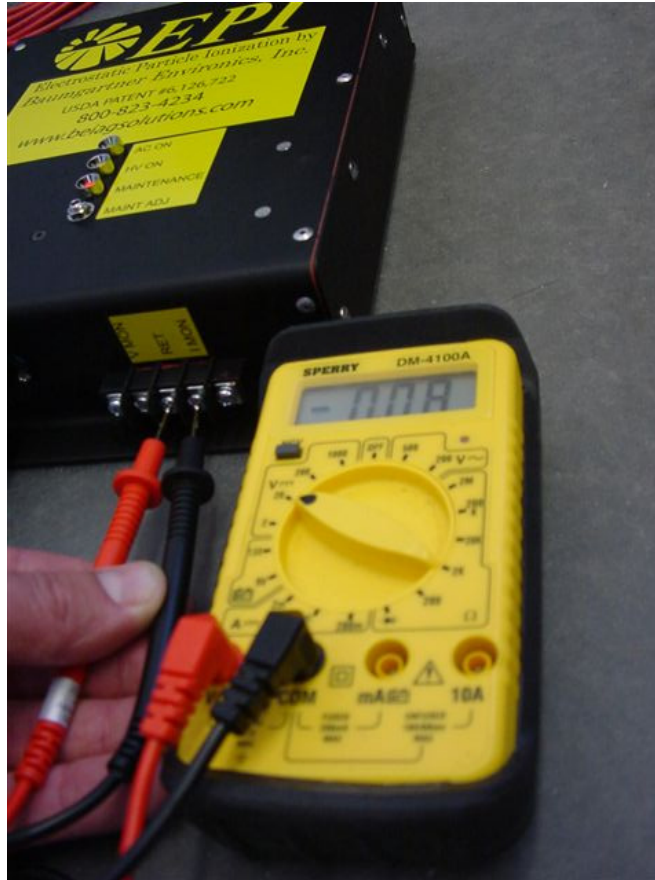
Notes: 1 mA = 1/1000 Amp

Ohms Law: volts(amps)=watts 30,100(0.00008)= 2.408 watts

- 38) To read the amperage output: Press the black-probe to the "I MON" port and the red-probe to the "RET" port. The number displayed on the voltage meter is: -0.08 volts, or 0.08 mA. One volt equals one milliamp or $1 \text{ Volt} = 1 \text{ mA}$. $0.08(1) = 0.08$

- Notes:
 - $1 \text{ mA} = 1/1000 \text{ Amp}$
 - Ohms Law: volts(amps)=watts $30,100(0.00008) = 2.408 \text{ watts}$
- 39) Adjust amperage to maximum by tightening the ratchet and moving the corona point closer to the ceiling.

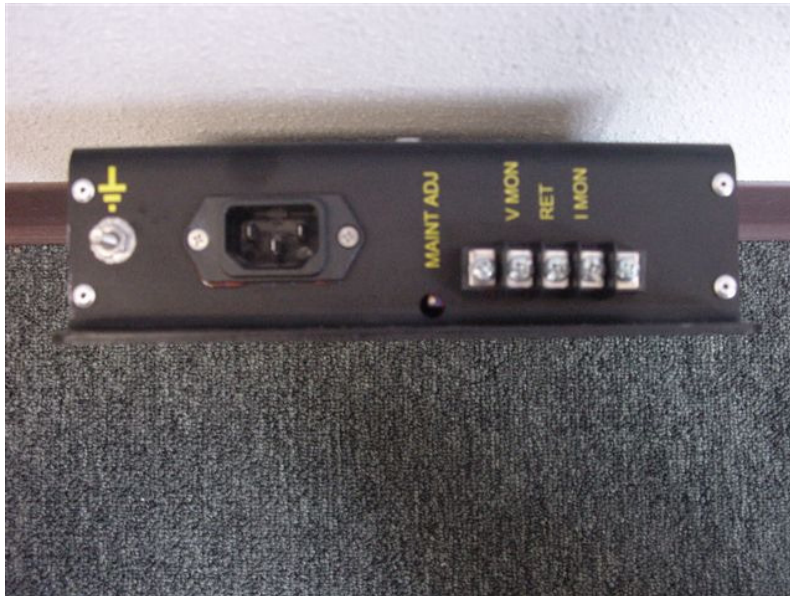
To set the red light, locate the tiny screw on the bottom of the power supply. It is accessible through a small circular hole in the aluminum case. Turning the screw clockwise raises the setting and turning the screw counter-clockwise lowers the setting. (The screw cannot be over-tightened and the screw cannot be over-loosened. In other words, it spins in place if adjusted over or under range.)

For example: If the amperage (current) reading of the power supply is 1.99 mA, turning the maintenance adjust screw clockwise until the red light turns on, means that the red light is now set to turn on anytime the amperage output reading is at or below 1.99 mA. If the screw is now turned 360° counterclockwise, the red light will be set to turn on when the amperage output drops to 1.90 mA or below. Each 360° turn of the screw adjusts the setting 0.09 mA. The total adjustable range is 1.62 mA, with an 18-turn pot. It takes 18-360° turns to move from the lowest setting to the highest and vice-versa.

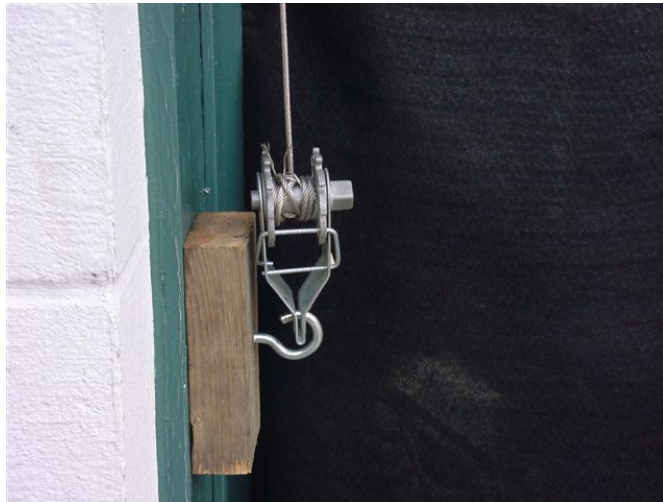
Wrapping cable onto the ratchet moves the corona line up. Un-wrapping cable from the ratchet allows the corona line to move down.

As dust builds up on surfaces in the barn, each corona line may need to be adjusted closer to the ceiling based on the amperage reading from the power supplies. Using a wrench, turn the ratchet one click at a time until the amperage level has been increased to the desired level (~2mA). [See section: *When to Adjust the Corona Lines*]

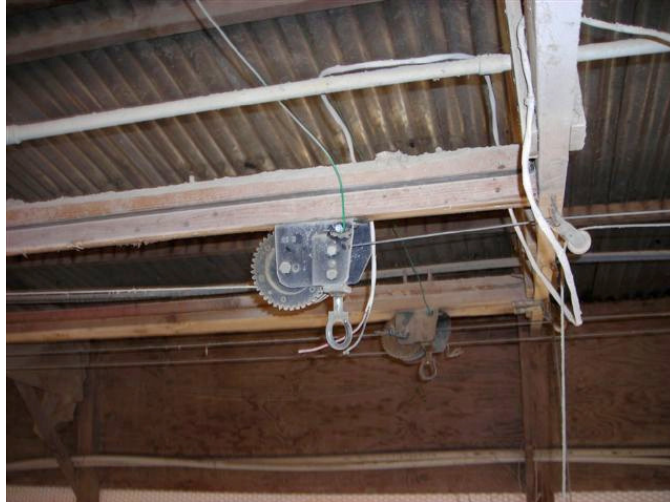
- Ground wires are connected to the ratchets, feeder lines, and water lines. All these ground connections are important to the operation of the EPI system. The ground wire attached to the ratchets must be connected to the power supplies. The feeder lines and water lines are grounded via a connection from the center lifting cranks to the upper ground line of the EPI system. These grounds are important for keeping the feeder lines and water lines free of static charges.
