EXPERIMENTAL STUDY OF MULTIPHASE PUMP WEAR

A Thesis

DANIEL D'ANDREA STECK

August 2014

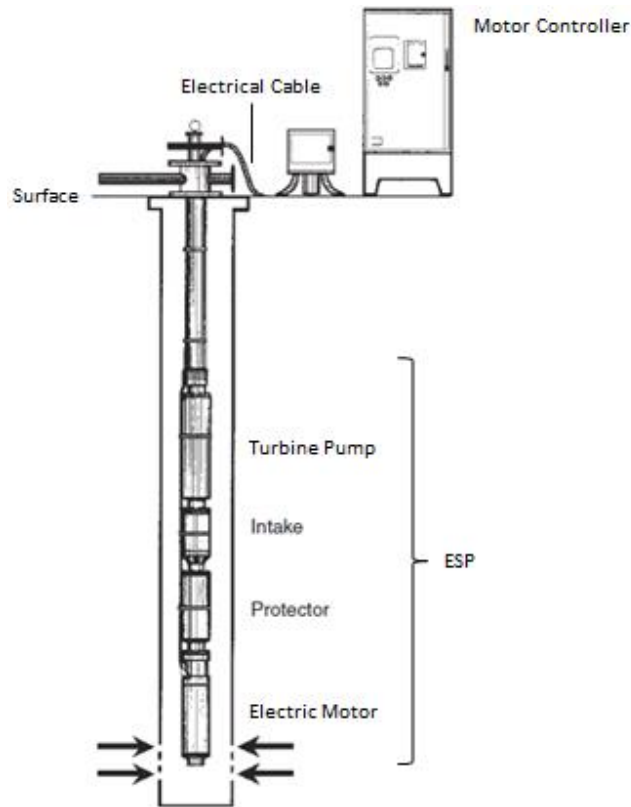
**Figure 2. Oil well schematic (not drawn to scale) [2]**

ESPs are commonly used in the oil and gas industry to pump crude oil from underground formations [2]. An oil well equipped with an ESP is depicted in Figure 2. An electrical cable extends from the motor controller to the electric motor. Oil enters the well below the electric motor, flows over the motor and protector and into the turbine pump's intake. The turbine pump pressurizes the fluid enough to push it to the surface which can be up to 10,000 ft above [6]. Often times, natural gas will come up with the crude oil [2]. The percentage of gas volume flow rate to total volume flow rate, at the pump inlet, is referred to as Gas Volume Fraction (GVF) [7]. It is possible that in addition to crude oil and natural gas, a small concentration of solid particles could reach the turbine pump [2]. This situation leads to liquid-gas-particulate wear within the turbine pump.

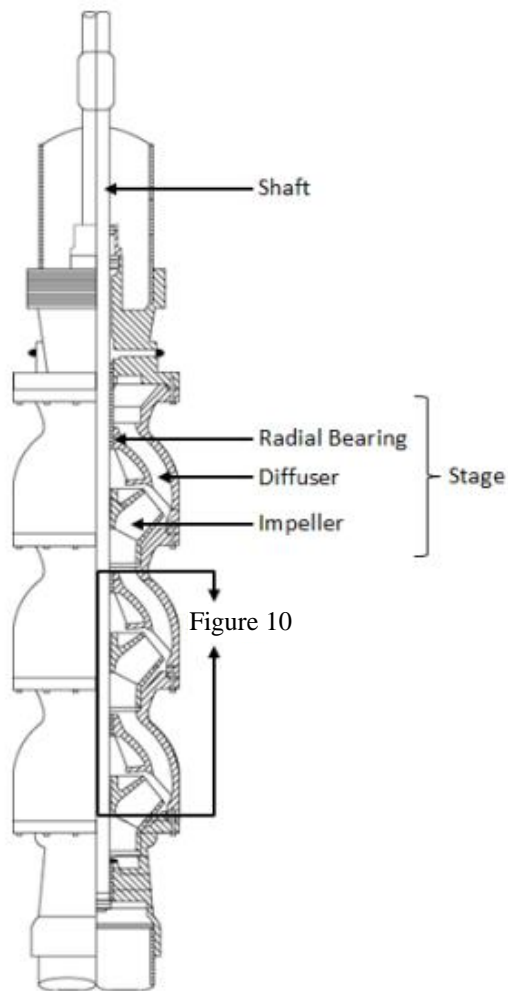
**Figure 3. Three stage turbine pump [8]**

Figure 3 depicts some of the key components within a turbine pump. The depicted turbine pump has three stages, with each stage consisting of an impeller and a diffuser. Each impeller is rotated by the shaft and imparts energy to the fluid. The diffusers consist of stationary channels that direct the fluid to the next impeller and decrease the fluid velocity. The radial bearings support the rotating shaft.

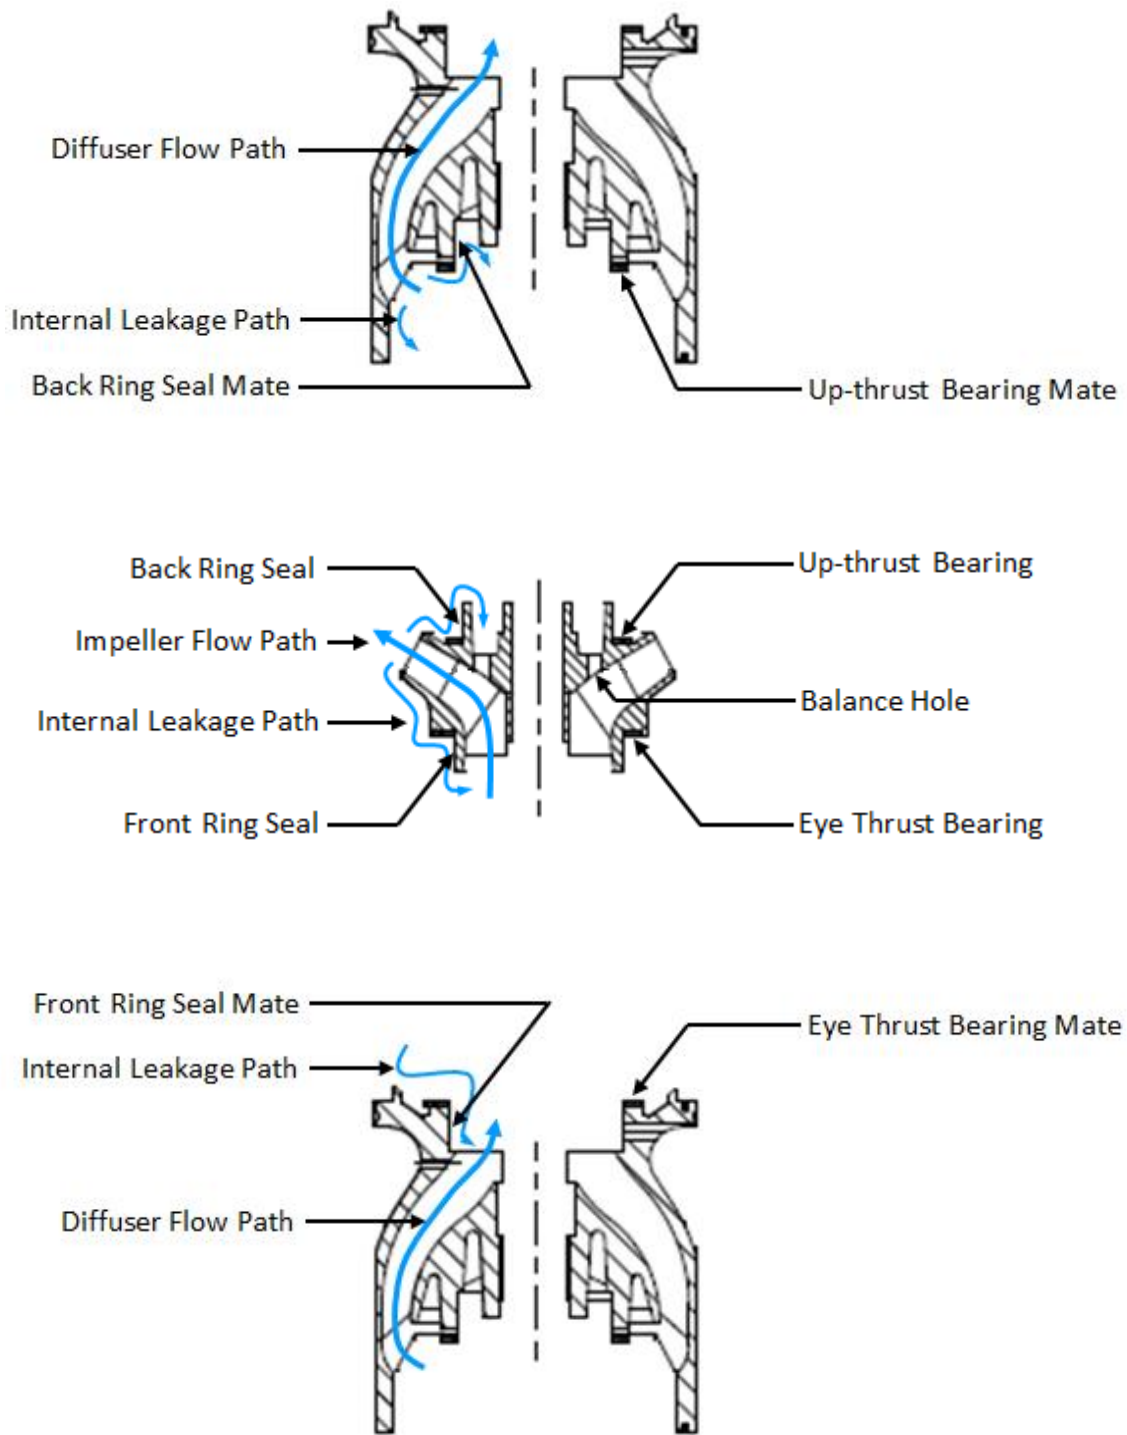
**Figure 4. Mixed flow impeller (center) and two diffusers (upper and lower)**

Figure 4 depicts one mixed flow impeller and two adjoining diffusers from the turbine pump depicted in Figure 3. The impeller and diffuser flow paths are identified by the thick blue lines. The arrows point from inlet to outlet. The internal leakage flow paths are identified by the thin blue lines. The arrows show the direction of fluid leakage. Fluid leaks through clearances from the high pressure impeller outlet to the low pressure impeller inlet because of the pressure differential. Ring seals at the front and back of the impeller are used to minimize the leakage. The ring seal surfaces on the impeller mate with ring seal surfaces on the adjoining diffusers. The narrow ring seal gaps restrict the leakage flow. The ring seals also act as radial bearings. Under most conditions, the impeller experiences downward thrust because the outlet pressure is significantly higher than the inlet pressure. This downward thrust is minimized by allowing inlet pressure fluid into a cavity above the impeller through balance holes. The remaining downward thrust is transferred to the lower diffuser through the eye thrust bearing. At high flow rates and during pump startup, the change in momentum flux can dominate the pressure forces and produce an upward thrust. This thrust is transferred to the upper diffuser by the up-thrust bearing.

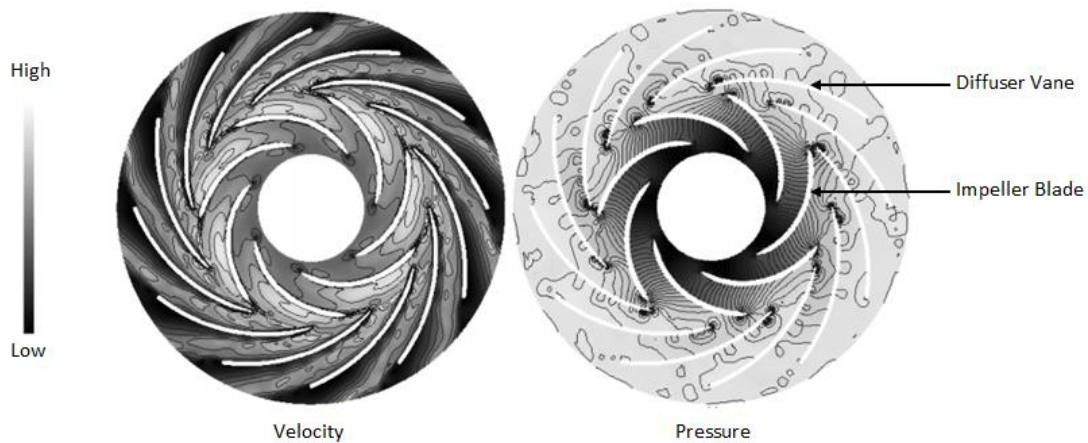
**Figure 5. Velocity field (left) and pressure field (right) in a radial flow pump [11]**

The purpose of each impeller and diffuser is to increase the fluid pressure. The impeller rotates and imparts energy to the fluid in the form of flow, kinetic, internal, and potential energies [9]. These forms of energy manifest themselves as rises in pressure, velocity, temperature, and elevation, respectively. The diffuser decreases the fluid velocity in order to convert excess kinetic energy into flow energy, i.e. to further increase the fluid pressure. The impeller contributes most of the overall pressure rise [10]. The rise in temperature and elevation are generally small. The velocity field and pressure field within a radial flow pump stage are illustrated in Figure 5. The general flow field trends are general to all pumps, including turbine pumps. The pump's inlet is at the center of the annulus and the pump's exit is at the periphery. The velocity field shows that the fluid is accelerated by the impeller and decelerated by the diffuser. This results in the highest velocities at the boundary between the impeller blades and diffuser vanes. The pressure field shows that the fluid is steadily pressurized from inlet to outlet.

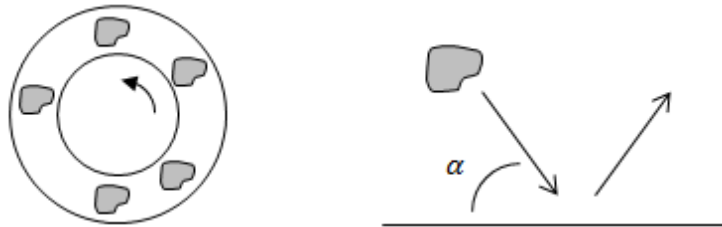
**Figure 6. Abrasive (left) and erosive (right) wear**

Liquid-particulate pump wear has been extensively studied [12]. The primary mechanisms of liquid-particulate pump wear are abrasion and erosion [13]. The two mechanisms of wear are depicted in Figure 6. Abrasive wear occurs when particles are trapped between two surfaces that move relative to one another and erosive wear occurs when particles impact a surface. Abrasive and erosive wear increase as particle size, concentration, angularity, relative velocity, and hardness increase and as the surface hardness decreases (for metallic surfaces). Erosive wear also increases as particle density and impingement angle  $\alpha$  increase.

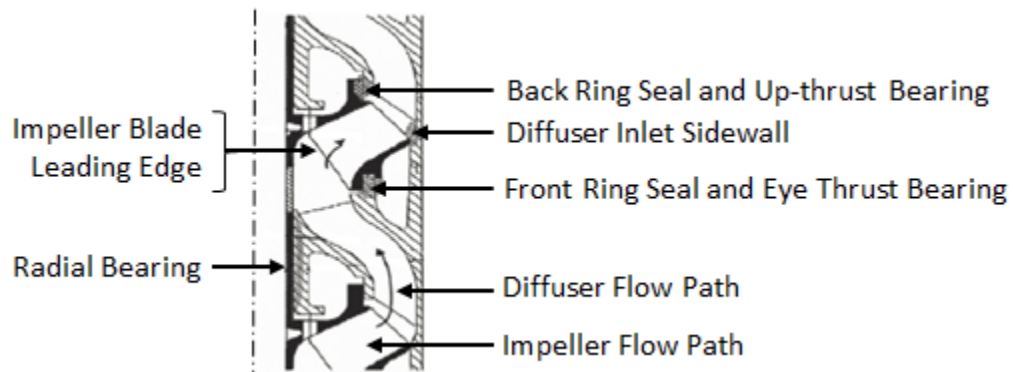
**Figure 10. Detail schematic identified in Figure 3 showing areas of significant liquid-particulate erosion in turbine pumps [2]**

Figure 10 shows a detailed depiction of the region identified in Figure 3 on page 4. The impellers are depicted with a black cross section and the diffusers are depicted with a hatched cross section. Turbine pumps are known to experience significant liquid-particulate wear on the areas depicted in Figure 10 [2]. Abrasive wear is the major cause of radial bearing, thrust bearing, and ring seal wear. Erosive wear is the major cause of impeller and diffuser flow path wear. The highest degree of erosive wear generally occurs at the impeller blade leading edge and the diffuser inlet sidewall because large angle impingement occurs at these locations.

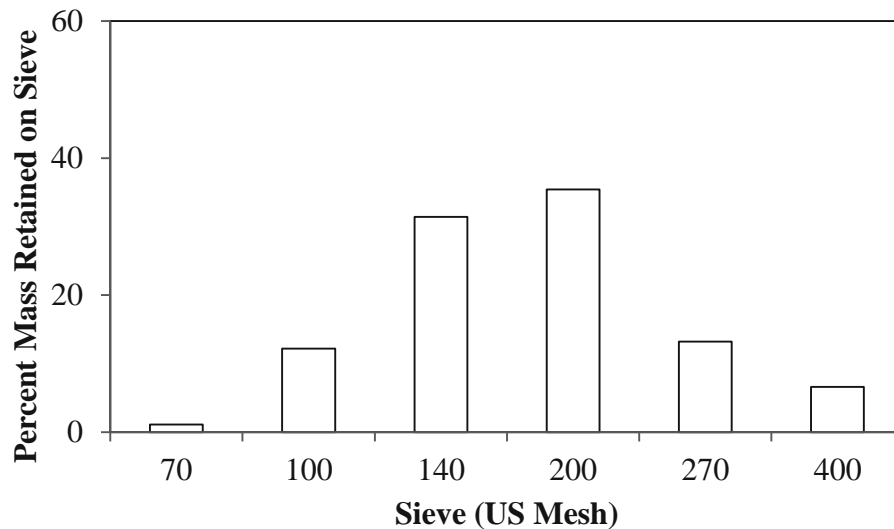
**Figure 12. Sand sieve analysis**

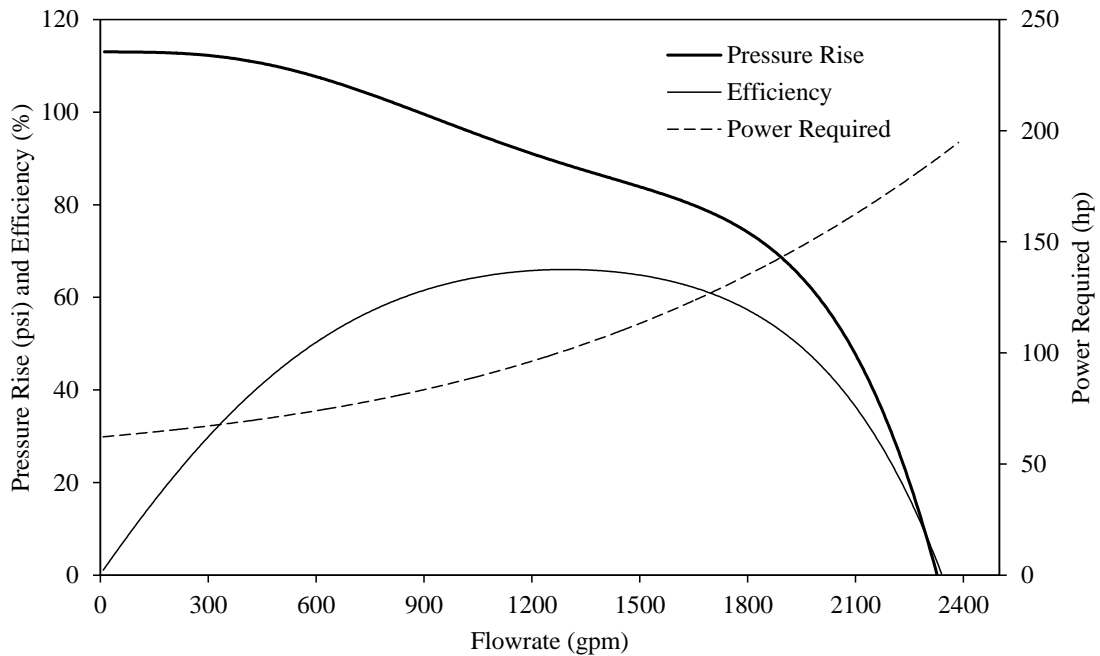
**Figure 16. G400 single stage 0% GVF performance curves [26]**

Figure 16 displays the manufacturer provided performance curves for each stage of the G400 at 0% GVF. Accordingly, a new G400 stage has a Best Efficiency Point (BEP) at 1,440 gpm and 90 psi. The pump also has a dimensionless specific speed,  $N_s$ , of 0.9 at its BEP. Figure 17 displays the required inlet pressure to arrest cavitation for 0% GVF. The inlet pressure curve was determined using Net Positive Suction Head Required ( $NPSH_R$ ) data provided by the manufacturer. Higher GVFs significantly reduce cavitation effects [25]. An inlet pressure of 40 psig is sufficient to minimize cavitation effects provided that 0% GVF flow rates do not exceed 1,300 gpm and temperatures do not exceed 120°F.

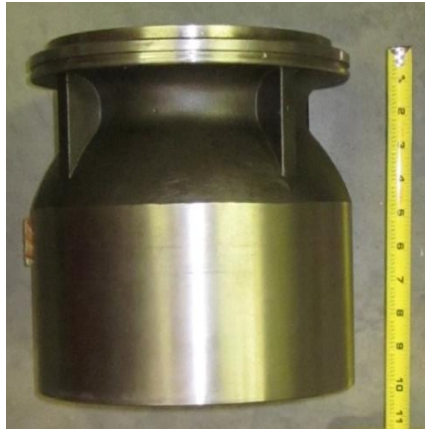
**Figure 20. G400 diffuser overall view**

Figure 3 on page 4 illustrates the construction of each G400 pump. Figure 4 on page 6 details the other G400 components not listed in Figure 3. Figure 18 and Figure 19 show these components on an actual G400 impeller. Figure 20 through Figure 22 show these components on an actual G400 diffuser. Each radial bearing consists of two parts, an outer bushing and an inner shaft sleeve. Figure 22 shows the outer bushing and Figure 23 shows the inner shaft sleeve. The gap between these parts is referred to as the radial bearing clearance.

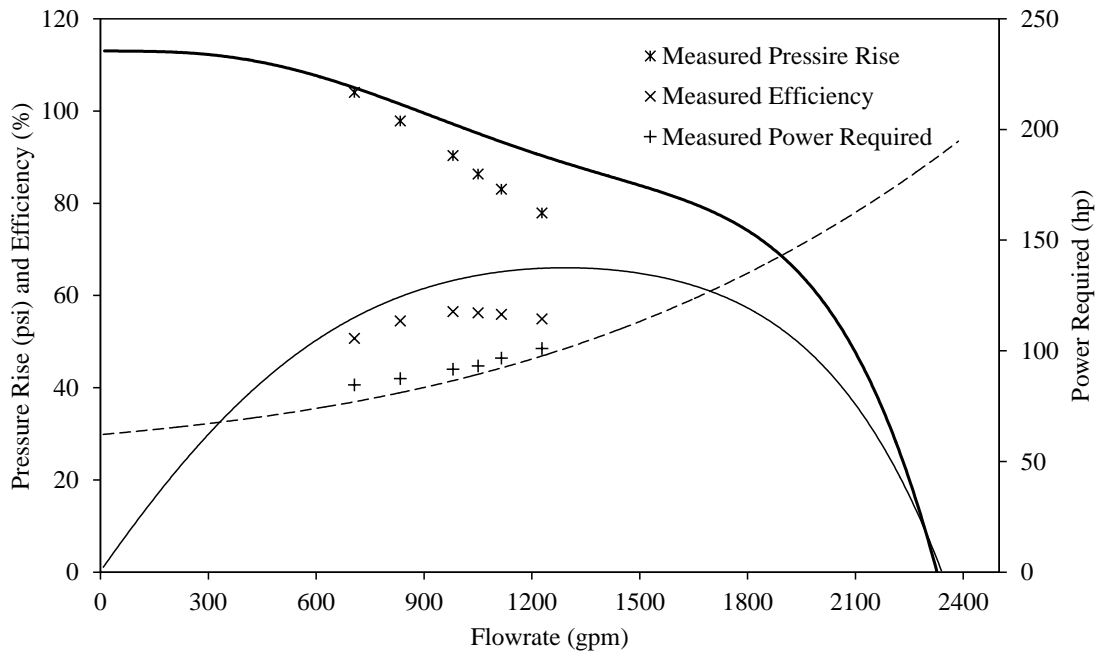
**Figure 24. G400 single stage 0% GVF measured performance curves before WS testing**

The G400 pump used for WS testing, referred to as the WS G400, had been previously used at a Shell Oil Company testing facility and consisted of two stages. The G400 pump used for WAS testing, referred to as the WAS G400, was new and consisted of three stages. Before wear testing was conducted, 0% GVF performance curves were obtained for both G400 pumps. Figure 24 shows the performance curves for the WS G400 and Figure 25 shows the performance curves for the WAS G400. The WS G400 shows more deviation from the manufacturer provided curves than the WAS G400. This is due to the fact that the WS G400 was previously used. The WS G400 deviation displays classic impeller wear [28].

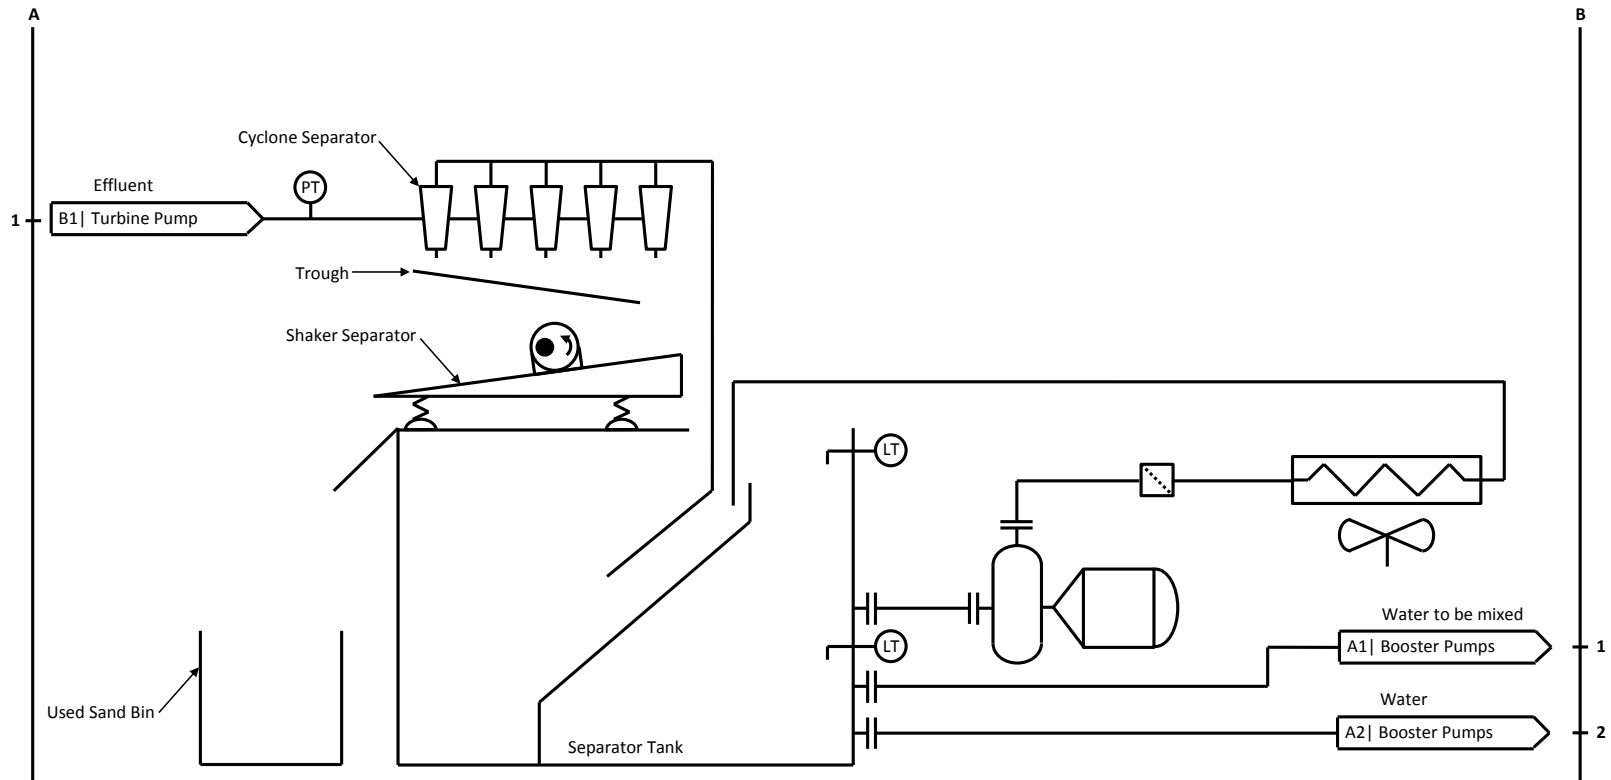
**Figure 26. Separator Tank P&ID**

The left hand side of the separator tank is separated from the right side to allow any sand that may have gotten into the left side of the tank to settle to the bottom. The clean water from the top of the tank spills over into the right side of the tank to replenish it. This cycle repeats continuously during the turbine pump testing. As the water is cycled, the internal energy of the water is constantly increased. A cooling loop illustrated in Figure 26, is used to constantly remove internal energy from the water and maintain a specific water temperature.

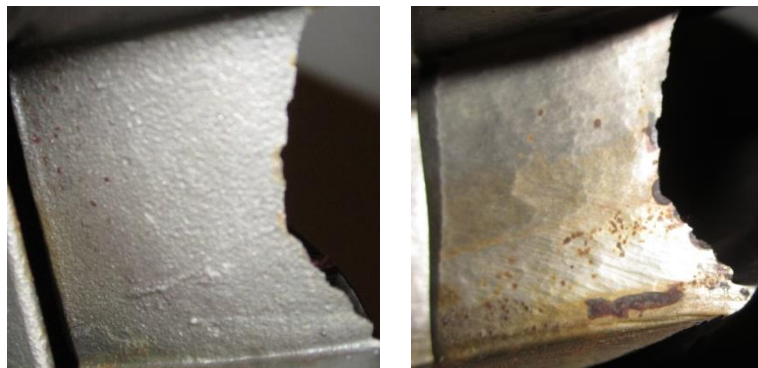
**Figure 29. Suction side (left) and pressure side (right) of WAS tested impeller split blade outer member**

Figure 29 illustrates a general wear trend pertinent to impeller blades and diffuser vanes, jointly referred to as flow elements. The left image shows the suction side of a flow element after being tested and the right image shows the pressure side of the same element. The suction side of the flow element experienced minimal wear. This is evidenced by its original cast appearance. However, the pressure side experienced significant wear. This is evidenced by its grooved appearance. The general trend is that the pressure side of flow elements experiences the most wear. This trend is not caused by the pressure difference between the sides. This is evidenced by the fact that at any given length along the suction side of the element, which corresponds to a different pressure, the wear does not noticeably change. Rather, the trend is caused by flow path geometry that causes particles escaping fluid pathlines (viewed in an inertial reference frame) to impact the pressure side of the elements and not the suction side of the elements.

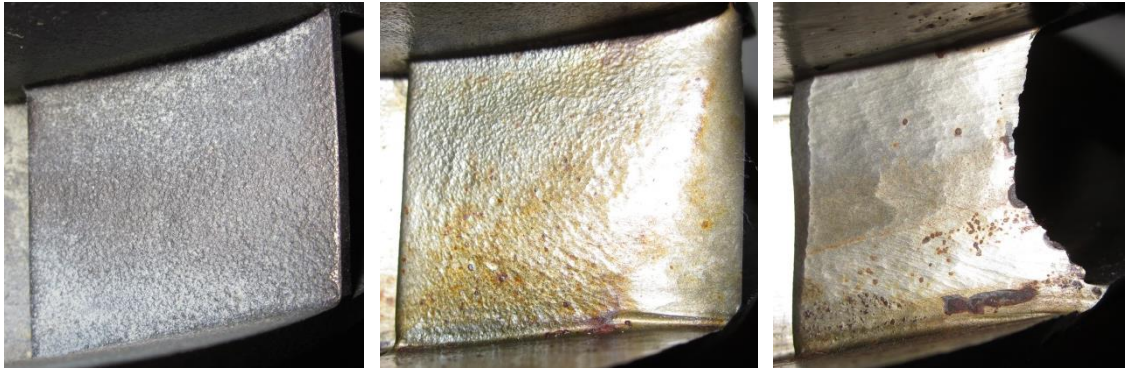
**Figure 30. Untested (left), WS tested (middle), and WAS tested (right) second stage split blade outer member**

The trailing edges of the split blade outer members for the WS G400 experienced significantly less wear than the WAS G400. The WS trailing edges were noticeably worn, but they kept their general geometric shape. The WAS trailing edges were worn through the thickness of the blade and appear feathered as seen in Figure 30 and Figure 32. Figure 31 shows that the hub sidewall for the WS G400 experienced significantly less wear than the WAS G400. The shroud sidewalls experienced similar wear. Figure 33 shows a meridonal section of a G400 stage. A meridonal section is obtained by taking an axial cross section of a stage and then translating flow element geometry to the cross section. The meridonal section view provides a convenient way to visualize three dimensional pump flow. Figure 34 maps the unique WAS trailing edge and hub sidewall wear to the meridonal section. Figure 34 also maps a predominantly air region to the meridonal section based on liquid-gas pump mechanics presented in the Introduction. Figure 34 suggests that predominantly air regions increase wear. This suggestion is substantiated by the fact that air is significantly less viscous than water and lower fluid

viscosity allows particles to more easily escape from fluid pathlines. This phenomenon was documented in the Liquid-Particulate Pump Design subsection presented in the Introduction.

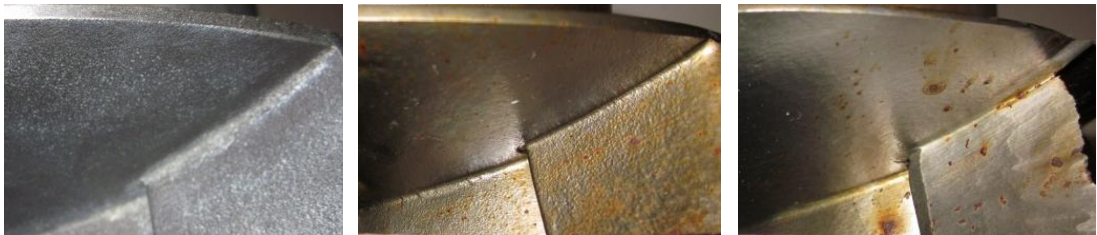
**Figure 31. Untested (left), WS tested (middle), and WAS tested (right) second stage hub sidewall**

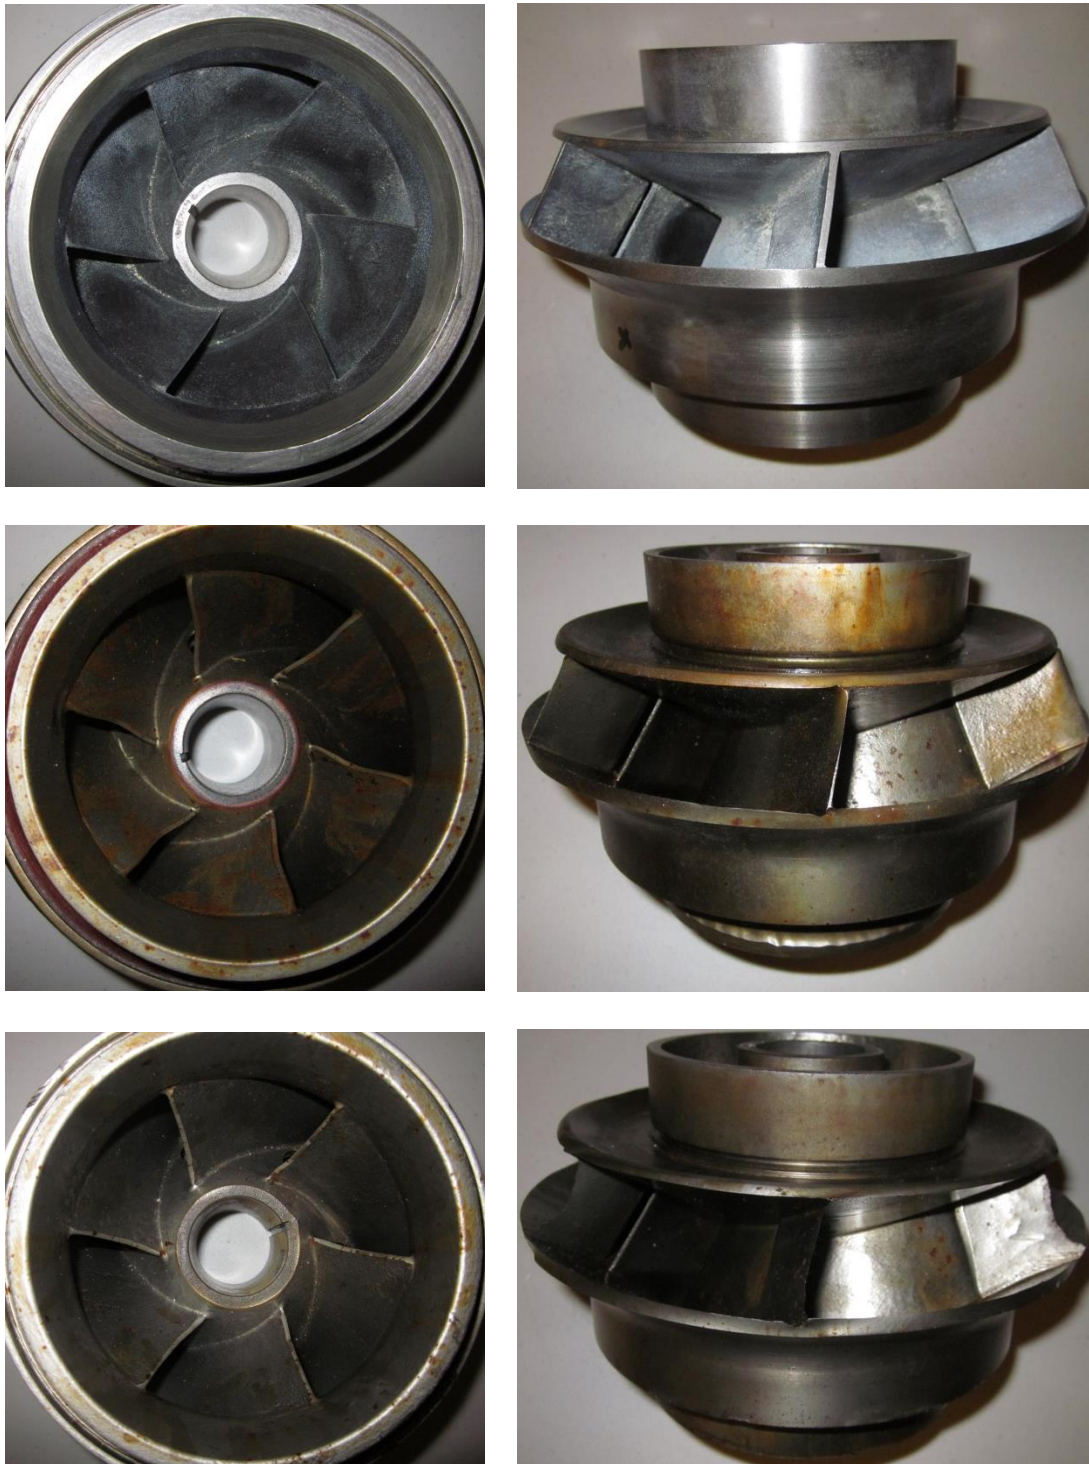
**Figure 32. Untested (top), WS tested (middle), and WAS tested (bottom) second stage impeller. Inlet views are displayed on left and outlet views are displayed on right.**

Figure 32 shows the G400 second stage impeller before and after the WS and WAS wear tests. The pressure side of the blades experienced a majority of the wear. The leading edges of the split blade inner members for the WS G400 experienced slightly different wear patterns than the WAS G400. The WS leading edges show preferential wear near the mid-span. The WAS leading edges show more uniform wear along the span. The cause of this phenomenon is unknown. Figure 30 shows a close-up view of a split blade outer member before and after WS and WAS wear tests. The leading edge of the split blade outer members for the WS G400 experienced significantly less wear than the WAS G400. Although the leading edges of the inner members were worn similarly, the leading edges of the outer members were worn differently. This difference in leading edge wear behavior is likely due to fluid incidence angle considerations because the larger the discrepancy between fluid incidence angle and blade entrance angle, the greater the wear will be. The inner member and outer member of the G400 split blade both have their own member entrance angle which is analogous to the blade entrance angle for a continuous blade. There was likely a significant discrepancy between inner member entrance angle and fluid incidence angle for both the WS and WAS tests. While there was likely good agreement between outer member entrance angle and fluid incidence angle for the WS test, there was likely a significant discrepancy between outer member entrance angle and fluid incidence angle for the WAS test. It is believed that good agreement between outer member entrance angle and fluid incidence angle for the WS test was produced by uniform flow, with minimal

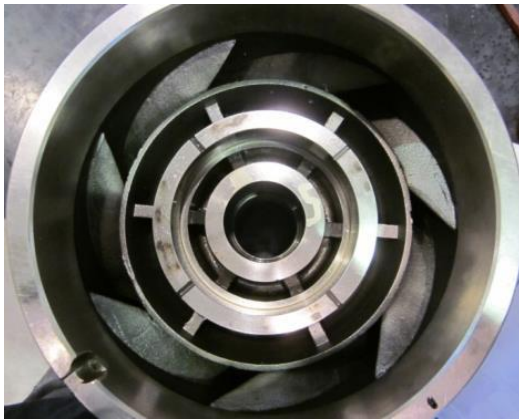
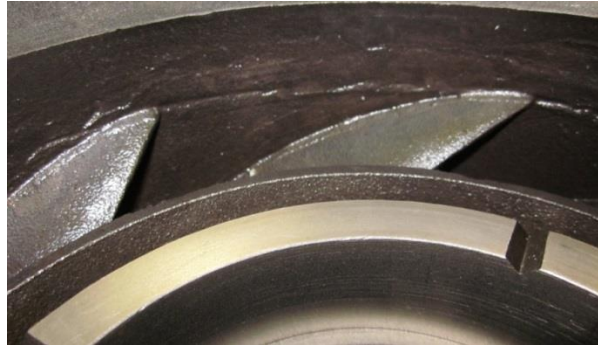
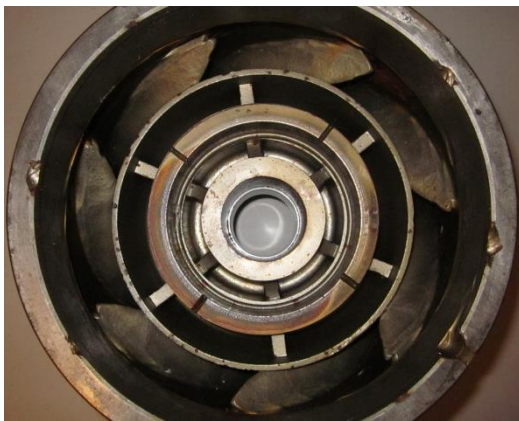
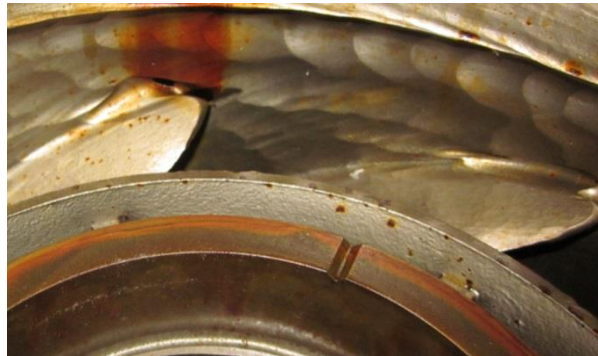
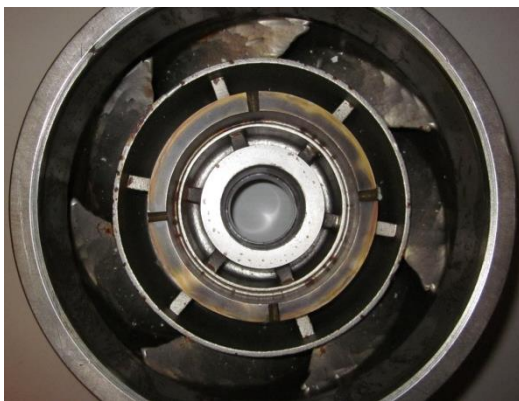
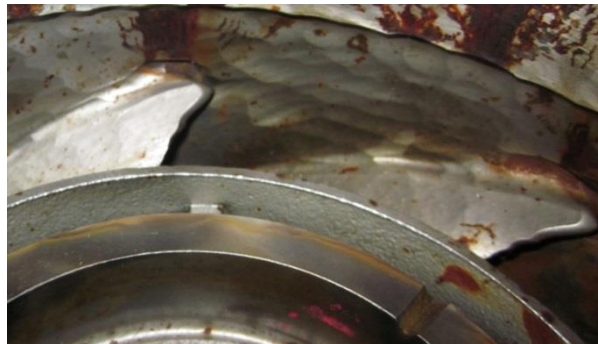
**Figure 35. Untested (top), WS tested (middle), and WAS tested (bottom) second stage diffuser. Inlet views are displayed on left and a close-up inlet view of two diffuser vanes are displayed on right.**

Figure 35 shows the G400 stage diffuser before and after WS and WAS wear tests. In general, the pressure sides of the vanes experienced more wear than the suction sides. However, the suction side of the diffuser vane leading edges did experience significant wear as can be seen in Figure 35. This is simply due to a poor mismatch between diffuser vane entrance angle and fluid incidence angle. This mismatch is caused by poor interaction between the impeller and diffuser. This poor interaction could be explained by the fact that the split blade impeller was designed to be used directly in place of existing impellers and the interaction between the split blade impeller and the existing diffusers may not be rigorously checked by the manufacturer [22]. The leading edges of the diffuser vanes for the WS G400 experienced significantly different wear patterns than the WAS G400. Although the leading edges for both diffuser vanes experienced preferential wear nearest the diffuser sidewall, different wear patterns along the span of the leading edge and extending along the length of the diffuser vanes were present as can be seen in Figure 35. The WS diffuser vanes showed uniform wear near the leading edges. The WAS diffuser vanes showed nonuniform wear near the leading edges. The WS leading edges are less jagged than the WAS leading edges. The WS diffuser vanes near the leading edges also have fewer gouges than the WAS diffuser. The nonuniform wear in the WAS diffuser was likely caused by recirculation zones, predominantly liquid regions, and predominantly gas regions present in the WAS diffuser that were not present in the WS diffuser.

The WS tested and WAS tested diffuser inlet sidewall were severely scalloped as can be seen in Figure 35. The diffuser inlet sidewalls experienced severe wear because fluid pathlines change direction abruptly at the diffuser entrance as seen in Figure 36 and allow particles to impinge on the diffuser sidewall. The intersection of the diffuser vane leading edge and diffuser sidewall experienced the most wear. The WS tested diffuser developed four holes through the sidewall thickness at the aforementioned intersection point. Two such holes are visible in Figure 37. The WAS tested diffuser developed two holes through the sidewall thickness at the intersection point. Although the amount of wear that took place on the WS tested and WAS tested diffusers was similar, more wear appeared to have taken place on the WS tested diffuser than on the WAS tested diffuser. However, the amount of wear seen on the diffusers cannot be entirely related to the presence or absence of air. A more likely explanation for the similarities and differences in wear is related to the distribution of air within the WAS tested G400 and the amount of energy supplied to the particles by the impellers. The similarities between the wear can be attributed to the presence of a predominantly air region at the location depicted in Figure 36 and the presence of a predominantly water region near the diffuser sidewall during the WAS test. This situation would allow the diffuser sidewall to experience similar wear during the WS testing and the WAS testing because the fluid near the diffuser sidewall would have a similar viscosity for both tests. The differences between the wear can be attributed to the amount of energy supplied to the particles by the impellers. For the WS test, the impeller split blade outer members kept their general geometry and constantly supplied a large amount of energy to the particles. For the

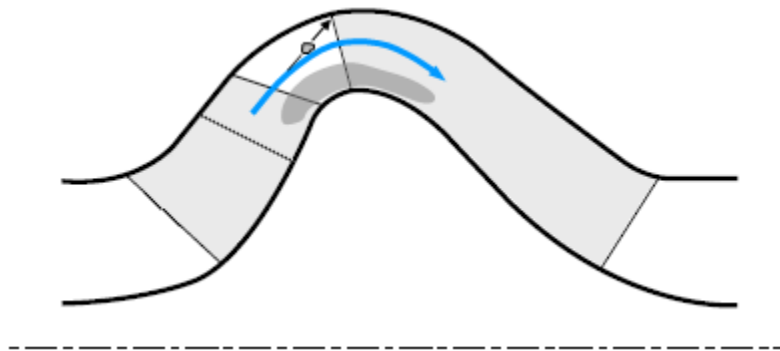
**Figure 36. G400 stage meridional section illustrating a particle escaping a fluid pathline and impacting the diffuser inlet sidewall. A predominantly air region developed within a WAS tested diffuser is also illustrated.**

WAS test, the impeller split blade outer members were worn through their thickness and accordingly supplied less energy to the particles as the test progressed. The above explanation suggests that both diffusers were being worn at the same rate at the beginning of the testing; however, as the testing progressed, the WAS tested diffuser began to wear slower than the WS tested diffuser.

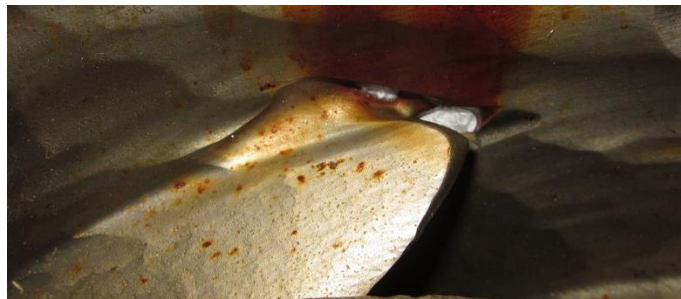
**Figure 37. Close-up view of the middle right image in Figure 35. A white cloth was placed behind the diffuser to clearly show two through thickness holes developed at the diffuser vane leading edge and sidewall intersection point.**

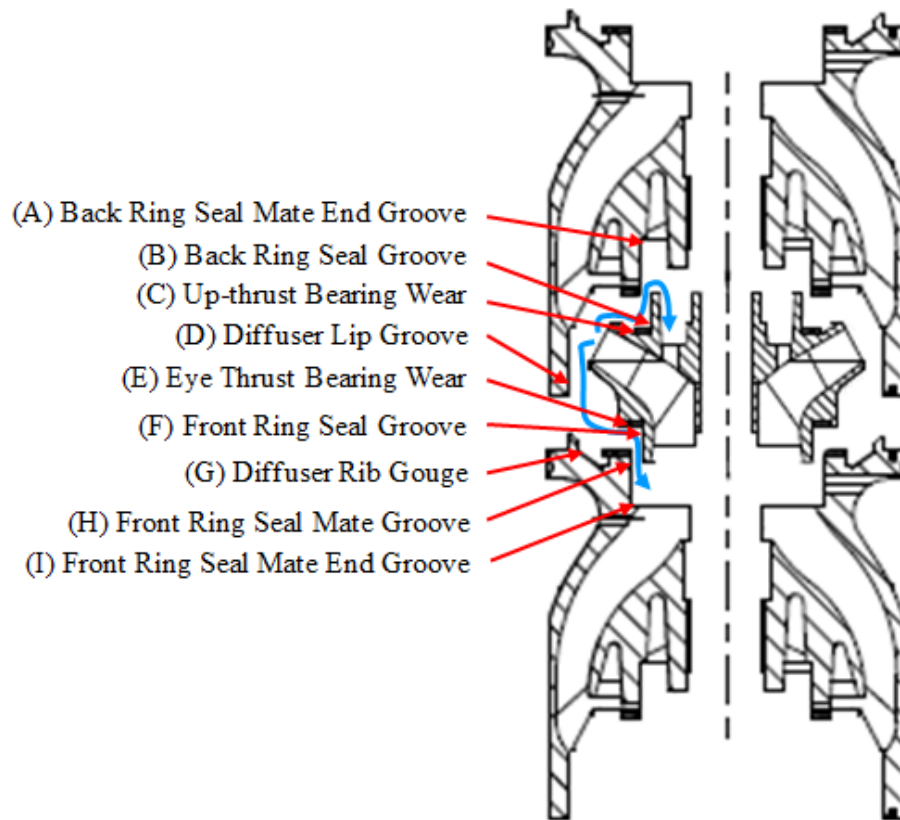
**Figure 38. Internal leakage wear points**

Figure 38 identifies points within the WS tested and WAS tested pumps that experienced significant internal leakage wear. Similar internal leakage wear took place for both tests. Deep groves and gouges occurred where internal leakage flow was required to change direction, i.e. at the locations identified in Figure 38. Figure 39 through Figure 42 depict the wear points on the WAS tested G400. The WS tested wear points look similar. Most of the composite thrust bearings were entirely worn away during the tests. The tested pumps were installed in such a way that the thrust bearings would not counteract the thrust generated by the pump, per the manufacturer's instructions. Any thrust generated by the pump was instead taken by the motor's thrust bearings throughout the entire test. The pump would be installed in an oil well in such a way that the thrust bearings would counteract the thrust generated by the pump. Any thrust generated by the pump would initially be taken by the thrust bearings, but would be transferred to the motor as the thrust bearings wore away. This suggests that turbine pump thrust bearing wear could be the root cause of some premature motor failures which one study, summarized in Figure 1 on page 2, found to account for 61% of ESP failures. The small diffuser ribs, seen in Figure 42, were gouged on one side by the internal leakage flow that moved in a downward spiral around the impeller and preferentially wore one side of each rib. Figure 43 shows a radial bearing shaft sleeve before and after erosion. The shaft sleeve is noticeably scratched in the circumferential direction. This wear pattern is common to WS tested and WAS tested shaft sleeves.

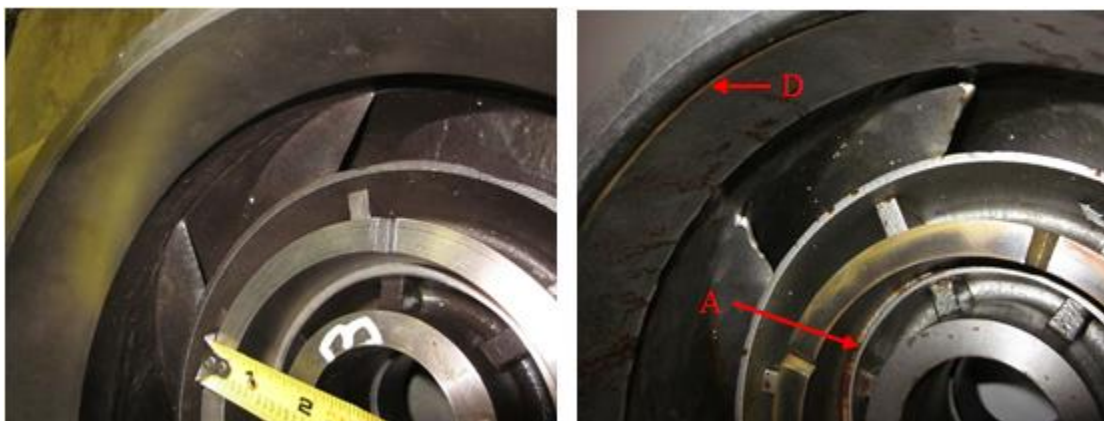
**Figure 39. Untested (left) and WAS tested (right) second stage diffuser inlet. The right image shows the back ring seal mate end groove (A) and diffuser lip groove (D).**

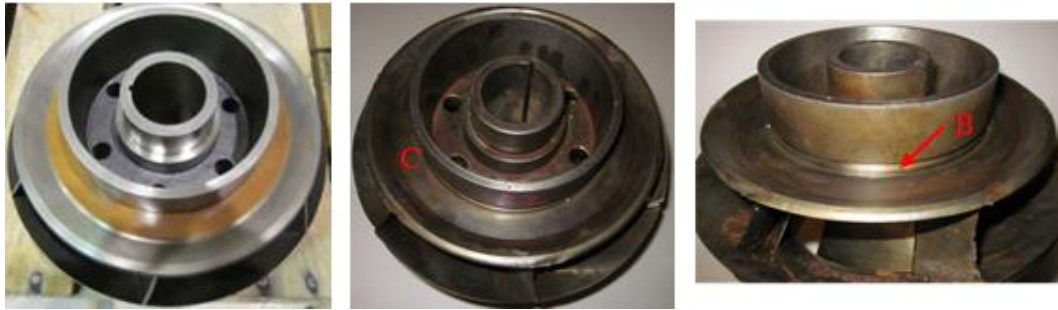
**Figure 40. Untested (left) and WAS tested (middle and right) second stage impeller outlet. The right image shows the back ring seal groove (B). The middle image shows the worn away up-thrust bearing (C).**

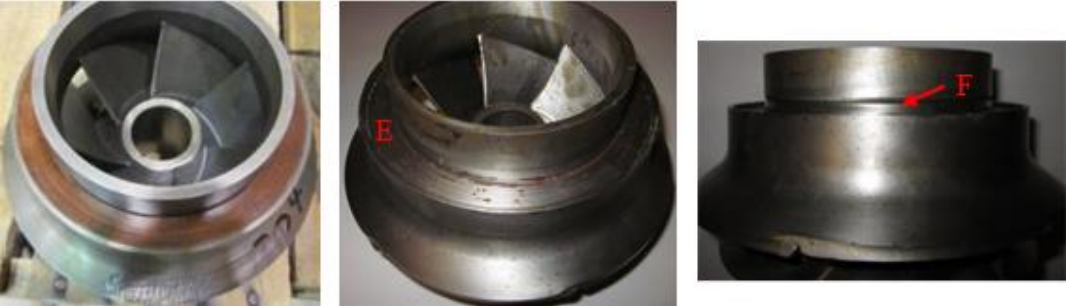
**Figure 41. Untested (left) and WAS tested (middle and right) second stage impeller inlet. The middle image shows the worn away eye thrust bearing (E). The right image shows the front ring seal groove (F).**

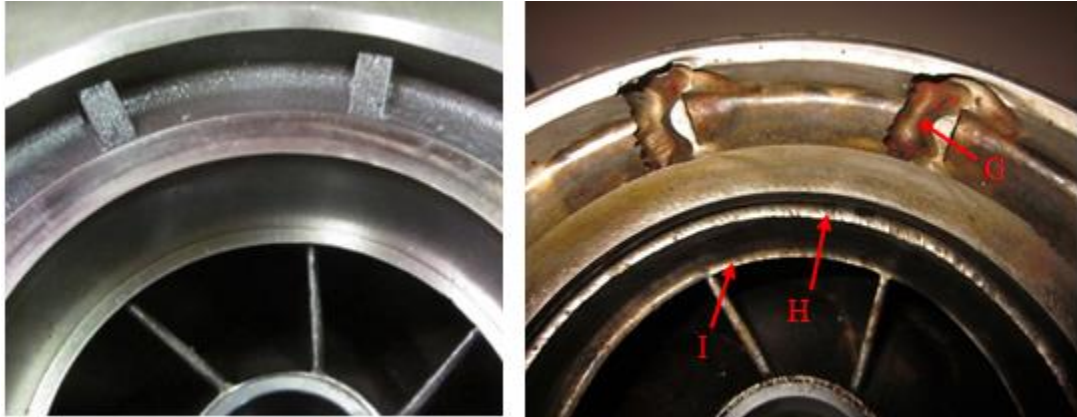
**Figure 42. Untested (left) and WAS tested (right) second stage diffuser outlet. The right image shows the diffuser rib gouges (G), the front ring seal mate groove (H), and the front ring seal mate end groove (I).**

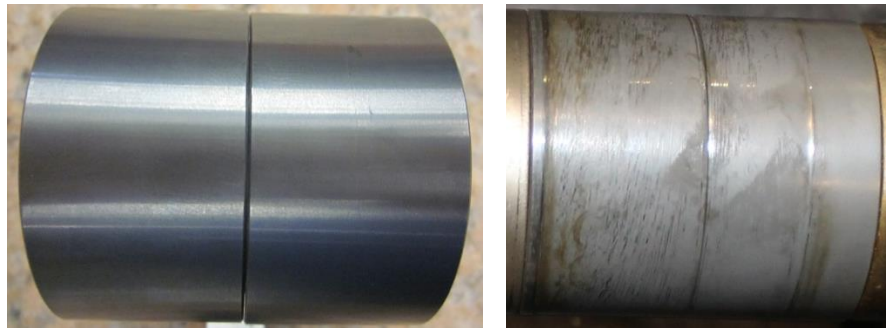
**Figure 43. Untested (left) and WS tested (right) radial bearing shaft sleeve**

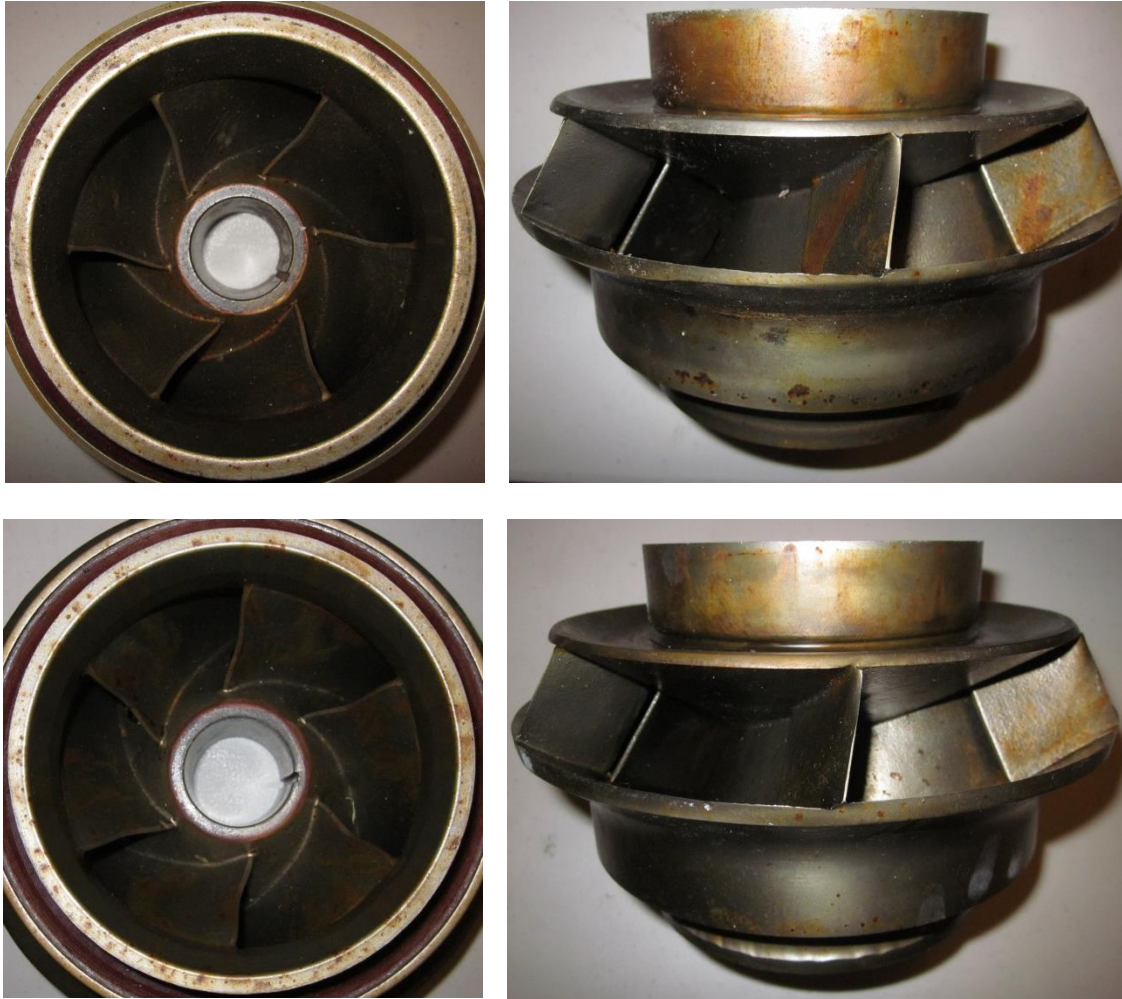
**Figure 44. WS tested first stage (top) and second stage (bottom) impeller. Inlet views are displayed on left and outlet views are displayed on right.**

Figure 44 shows the WS tested G400 first and second stage impellers. Both stages displayed similar wear, the details of which have already been discussed in the Second Stage Visual Results subsection.
