EXPERIMENTAL STUDY OF MULTIPHASE PUMP WEAR

A Thesis

DANIEL D'ANDREA STECK

August 2014

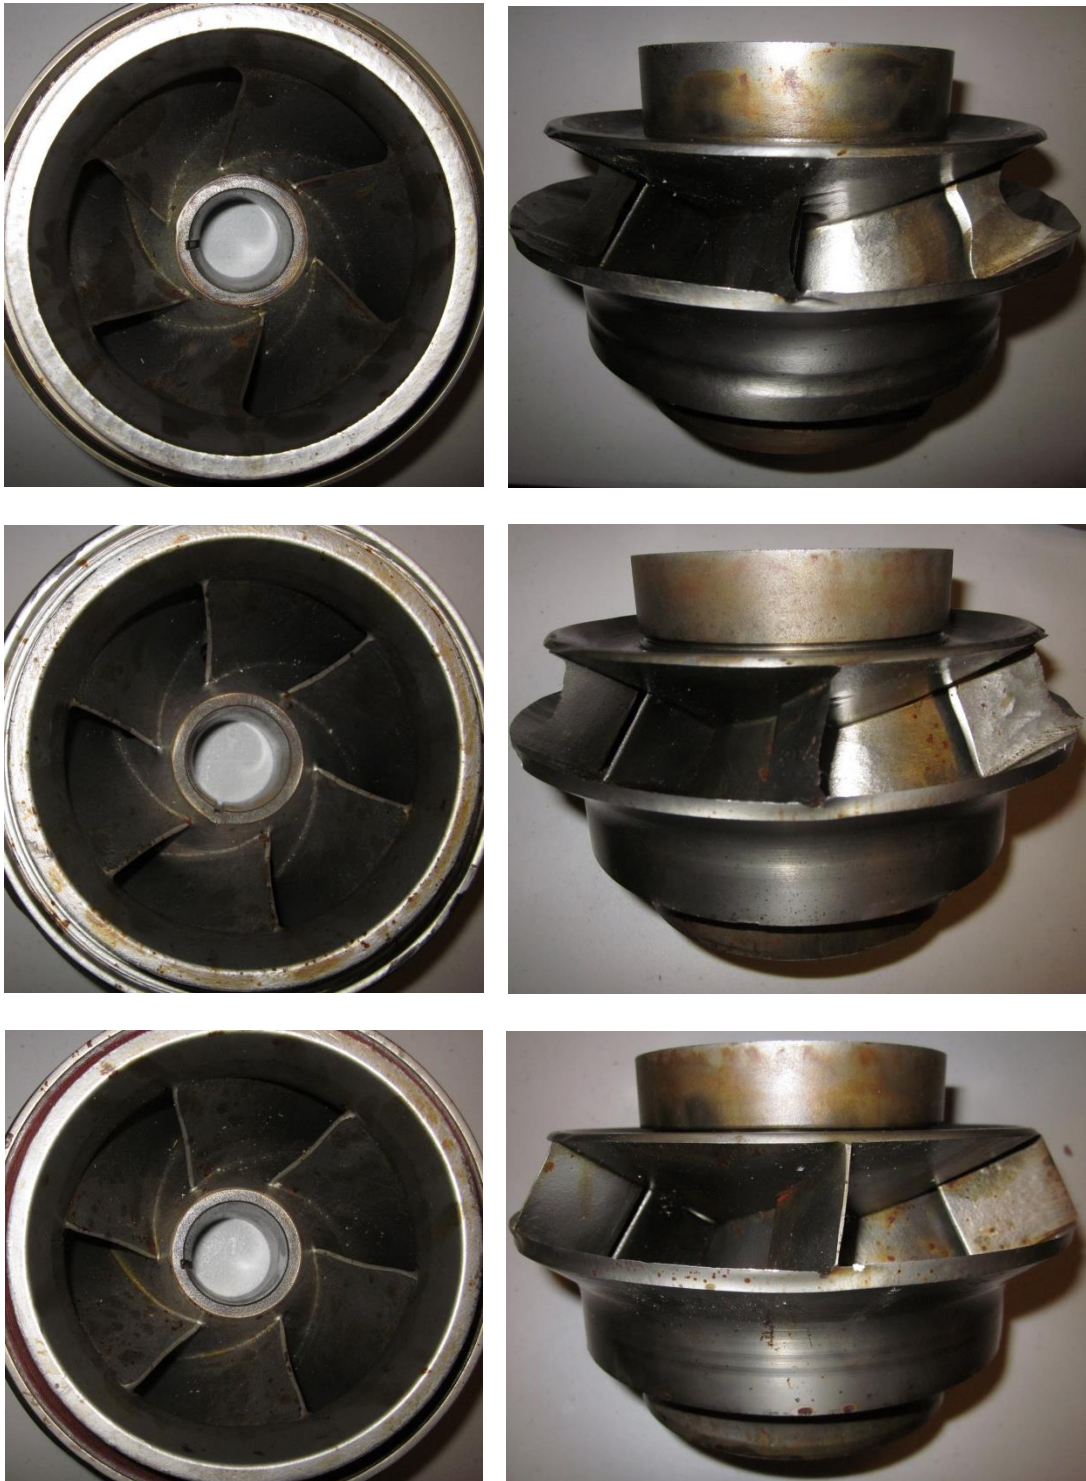
**Figure 45. WAS tested first stage (top), second stage (middle), and third stage (bottom) impeller. Inlet views are displayed on left and outlet views are displayed on right.**

Figure 45 shows the WAS tested G400 first, second, and third stage impellers. The three stages displayed different wear. It is likely that each stage wore differently because each stage had a different inlet pressure and therefore a different inlet GVF. The stage inlet GVF decreased through the pump. The leading edges of the split blade inner members experienced different wear patterns. The first stage leading edges experienced preferential wear near the shroud sidewall. The second stage leading edges showed relatively uniform wear along the span. The third stage leading edges showed preferential wear at the mid-span. The reason for these different wear patterns is unknown, but it is likely that the cause is due to the distribution of air at the inlet of each impeller. The leading edges of the split blade outer members also experienced different wear patterns. The first stage leading edges showed extremely preferential wear near the hub sidewall. The third stage leading edges showed minimal wear similar to that of the split blade outer member leading edges for the WS tests. The second stage leading edges showed moderately preferential wear near the hub sidewall. These observations support the placement of the predominantly air region in Figure 34.

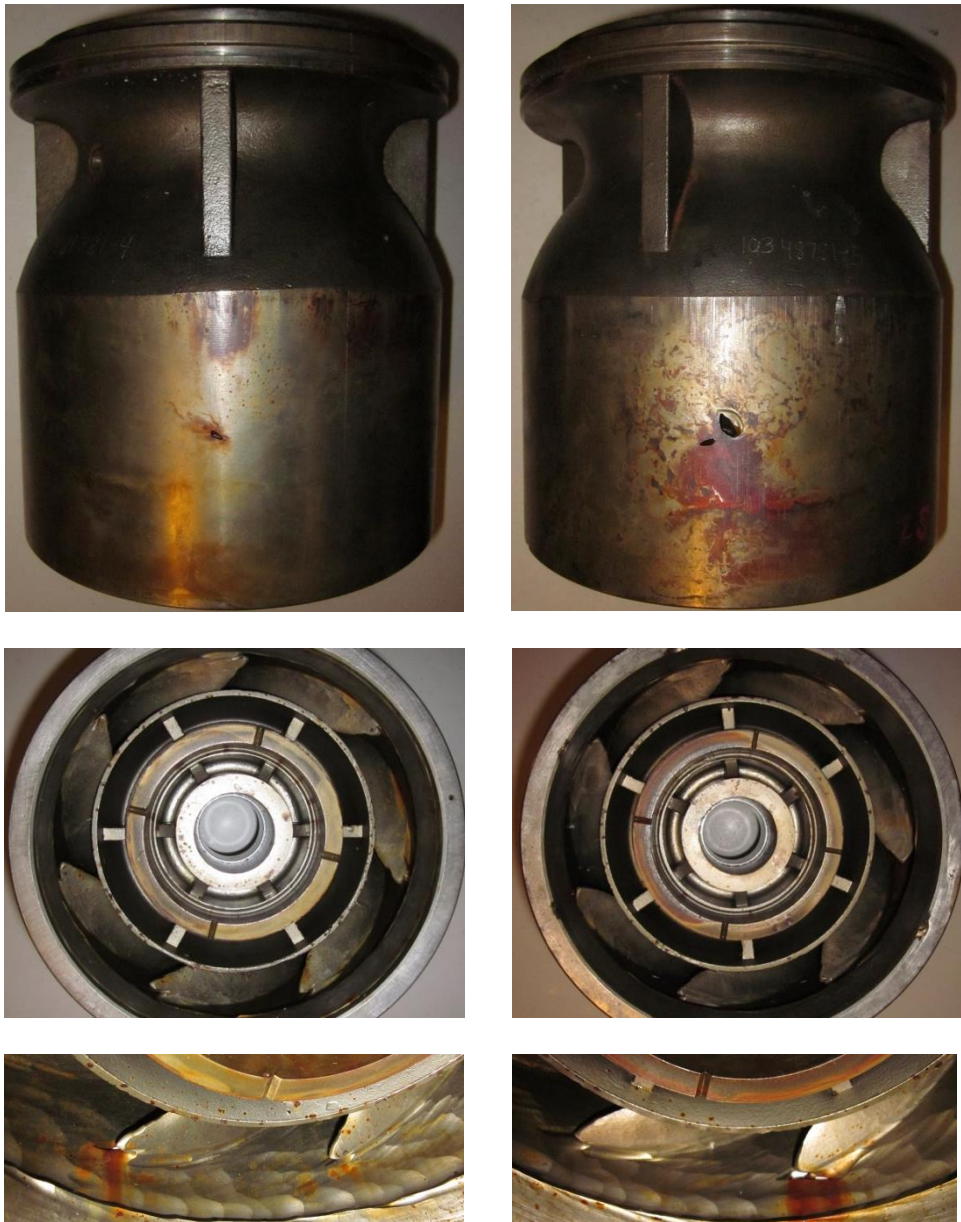
**Figure 46. WS tested first stage (left) and second stage (right) diffuser. Side views are displayed at top, inlet views are displayed in middle and a close-up inlet view of two diffuser vanes is displayed on bottom.**

Figure 46 shows the WS tested G400 first and second stage diffusers. The second stage shows more diffuser sidewall wear than the first stage. The second stage developed four through thickness holes in the diffuser sidewall while the first stage developed only one. It is believed that the second stage sidewall wore more than the first stage sidewall because the concentration of solid particles along the sidewall increases through the pump, i.e. the rotating pump flow causes solid particles to migrate radially outward through the pump.

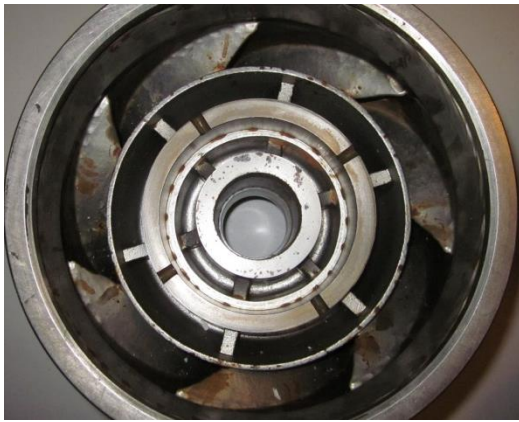
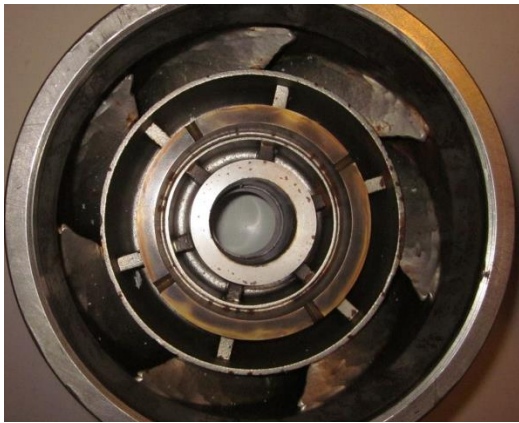
**Figure 47. WAS tested first stage (top), second stage (middle), and third stage (bottom) diffuser. Inlet views are displayed on left and a close-up inlet view of two diffuser vanes are displayed on right.**

Figure 47 shows the WAS tested G400 first, second, and third stages. The diffuser sidewall wear increased through the pump. The third stage developed five through thickness holes in the diffuser sidewall while the second stage developed two and the first stage developed none. It is believed that the increase in diffuser sidewall wear through the pump was primarily caused by the amount of impeller split blade outer member trailing edge wear as discussed in the Second Stage Diffuser Flow Path Wear subsection.

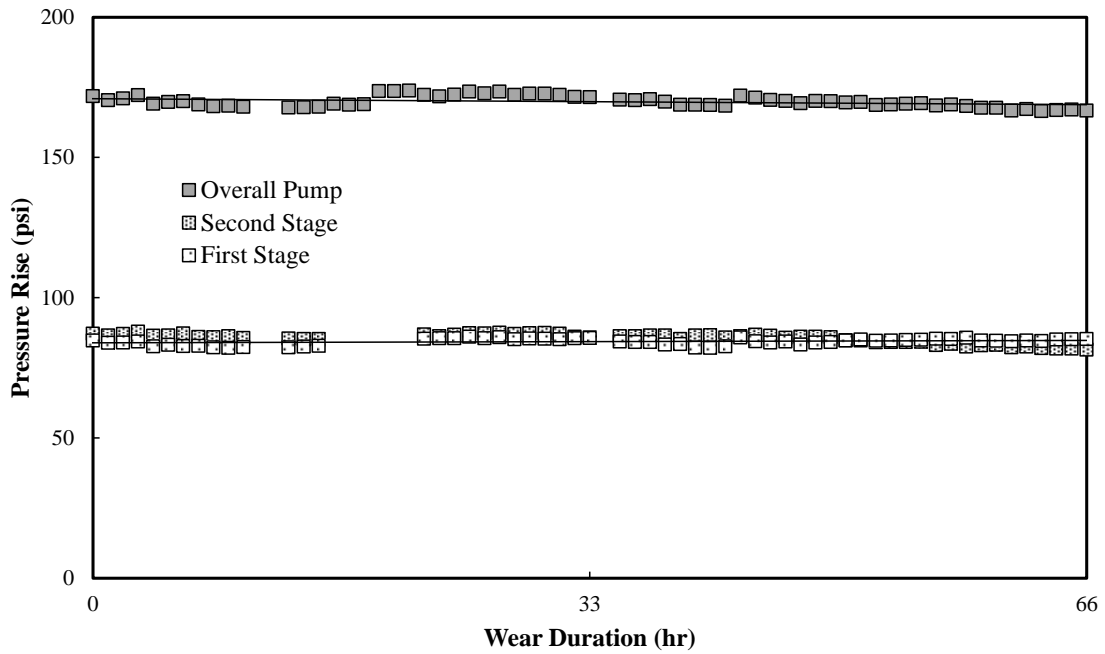
**Figure 48. Pressure degradation during Water-Sand, WS, wear (data obtained at 0% GVF)**

Figure 48 shows the pressure rise produced by the WS G400 stages during the test. The two WS G400 stages began the test producing similar pressure rises, as expected for 0% GVF flow. The first stage showed a slight pressure increase during the test. The second stage showed a slight pressure degradation. This phenomenon will be further discussed in the 12% GVF Per Stage Pressure Rise subsection.

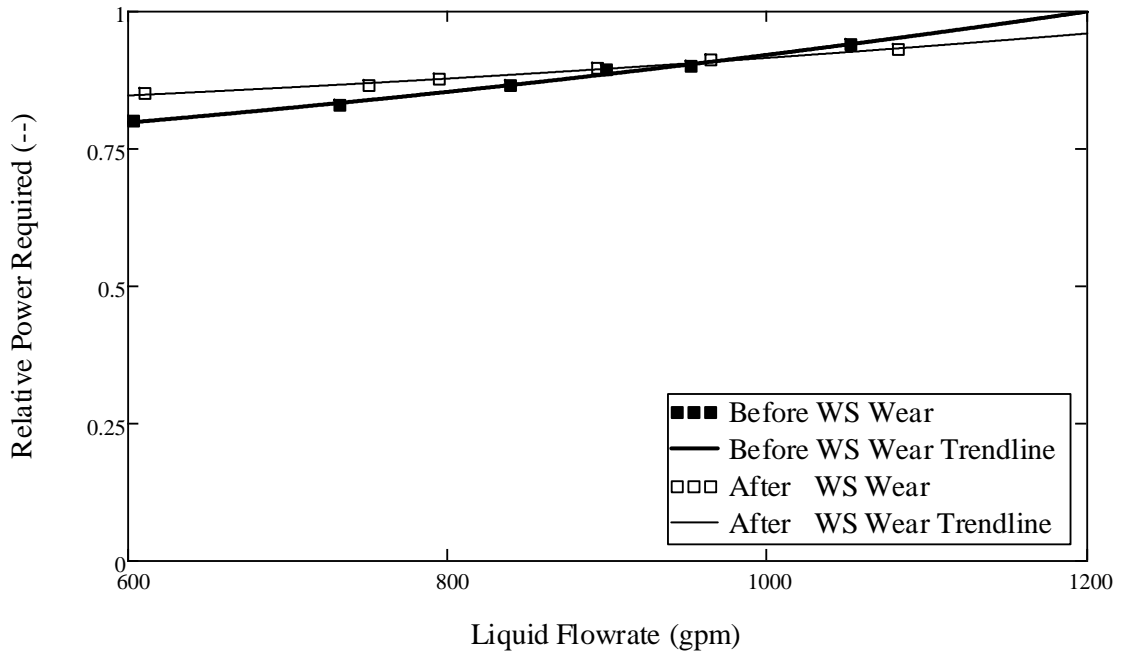
**Figure 50. WS wear test pump power requirement increase (data obtained at 12% GVF)**

Figure 50 through Figure 55 show power required, efficiency, and pressure rise curves at 12% GVF for each wear test. Performance data for the overall pumps are presented. Although the second stage is of primary interest, power required and efficiency data were only obtainable for the entire pump. Although pressure rise data for the full pump are presented in Figure 54 and Figure 55, the pressure rise for the second stage are more significant and are presented in Figure 56 and Figure 57. Each figure shows how a performance curve changed after the wear test. All performance data is relative to the initial data obtained for each pump because one pump was used while the other was new. Table 9 summarizes the changes in power required, efficiency, and pressure rise. The summary values were obtained by finding the area between the before wear and after wear curves. The WS wear test slightly increased the power required, but the WAS wear test drastically decreased the power requirement. The slight increase in power required during the WS test was likely due to ring seal wear that increased internal leakage. The increase in internal leakage caused the WS tested pump to require more power to maintain the same test condition liquid flow rate. The drastic decrease in power required during the WAS test was caused by the split blade outer members wearing away. The split blade outer member through thickness wear reduced the amount of energy the impellers could impart to the fluid. The WS wear test and WAS wear test produced similar efficiency degradations. This similar efficiency degradation between the WS and WAS test was likely caused by the similar ring seal and radial bearing wear between the two tests. The WAS wear test caused more pressure

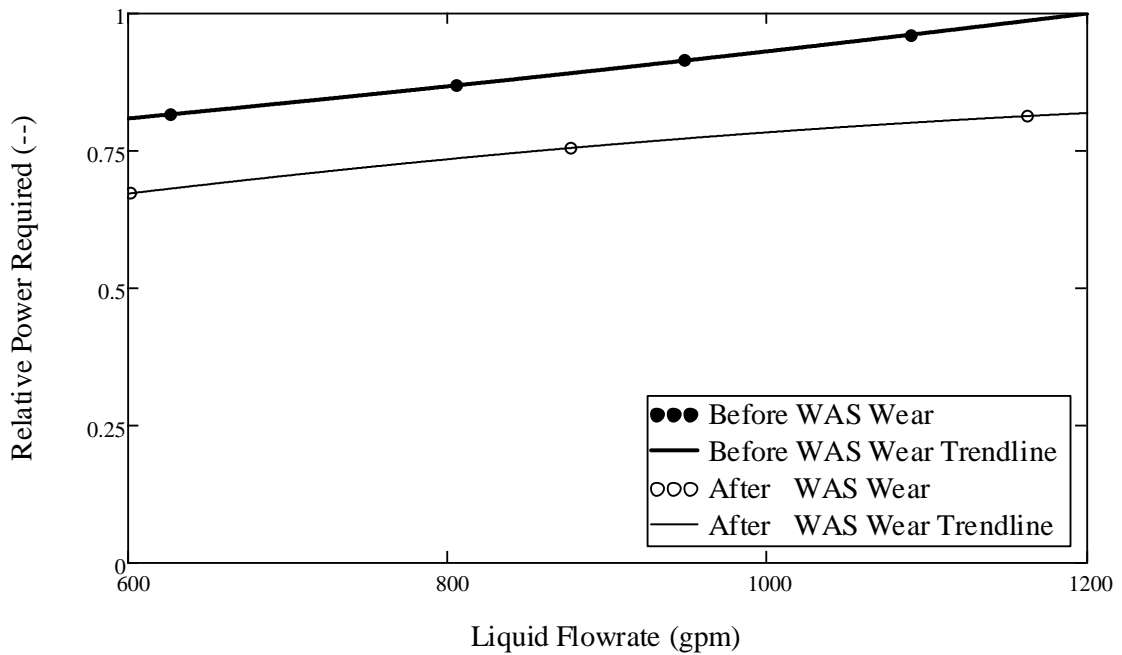
**Figure 51. WAS wear test pump power requirement decrease (data obtained at 12% GVF)**

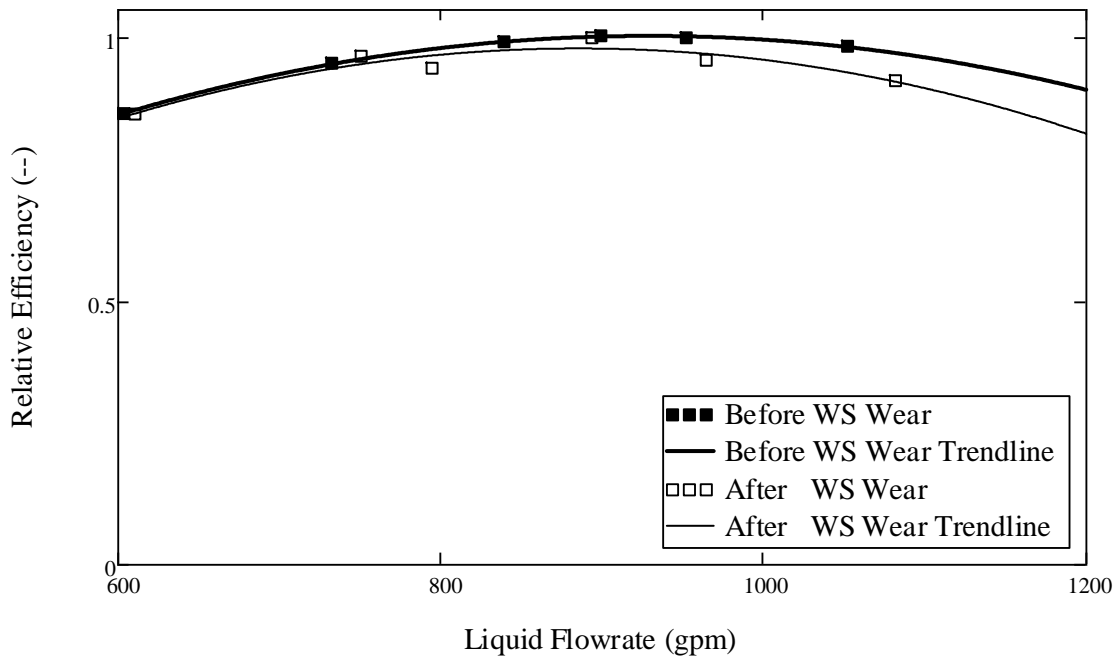
**Figure 52. Pump efficiency degradation after Water-Sand, WS, wear (data obtained at 12% GVF)**

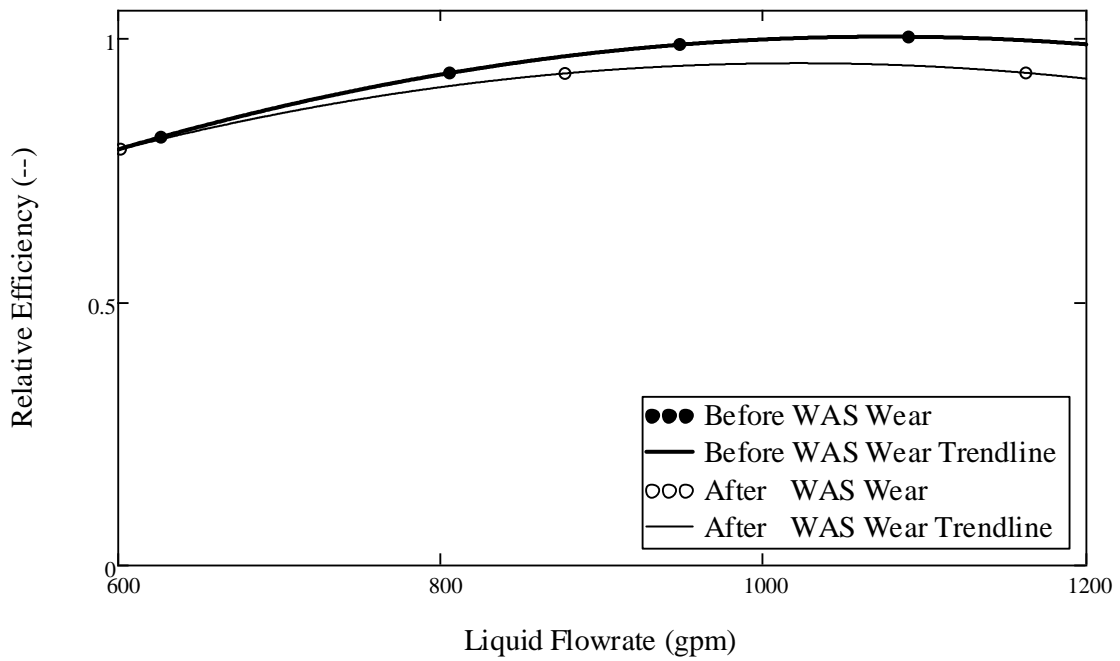
**Figure 53. Pump efficiency degradation after Water-Air-Sand, WAS, wear (data obtained at 12% GVF)**

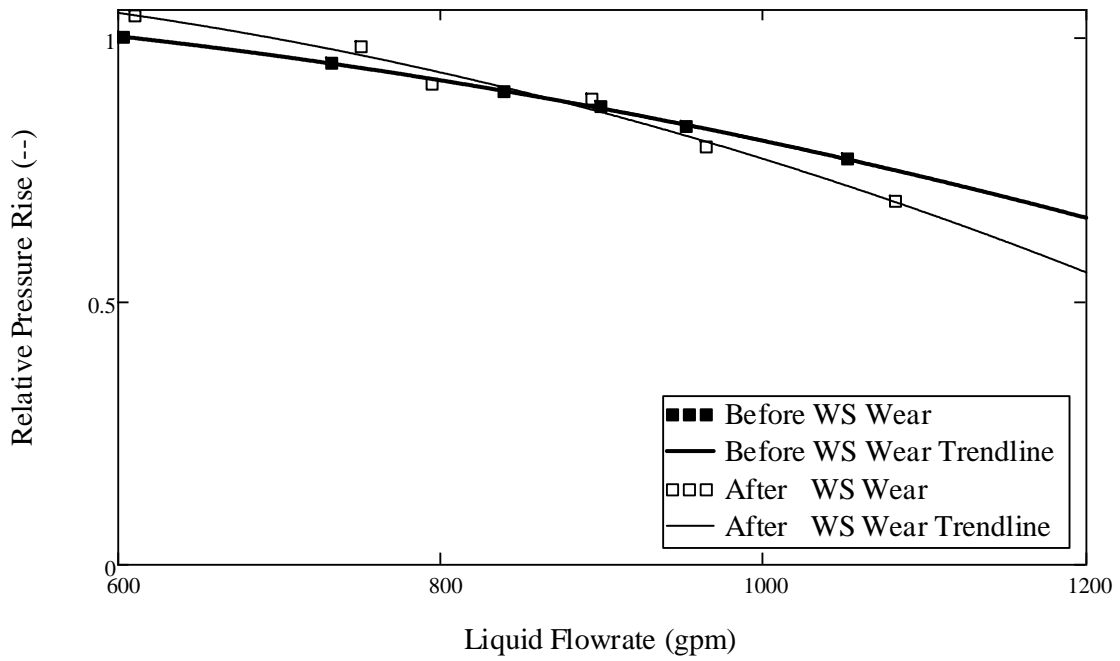
**Figure 54. Pump pressure degradation after Water-Sand, WS, wear (data obtained at 12% GVF)**

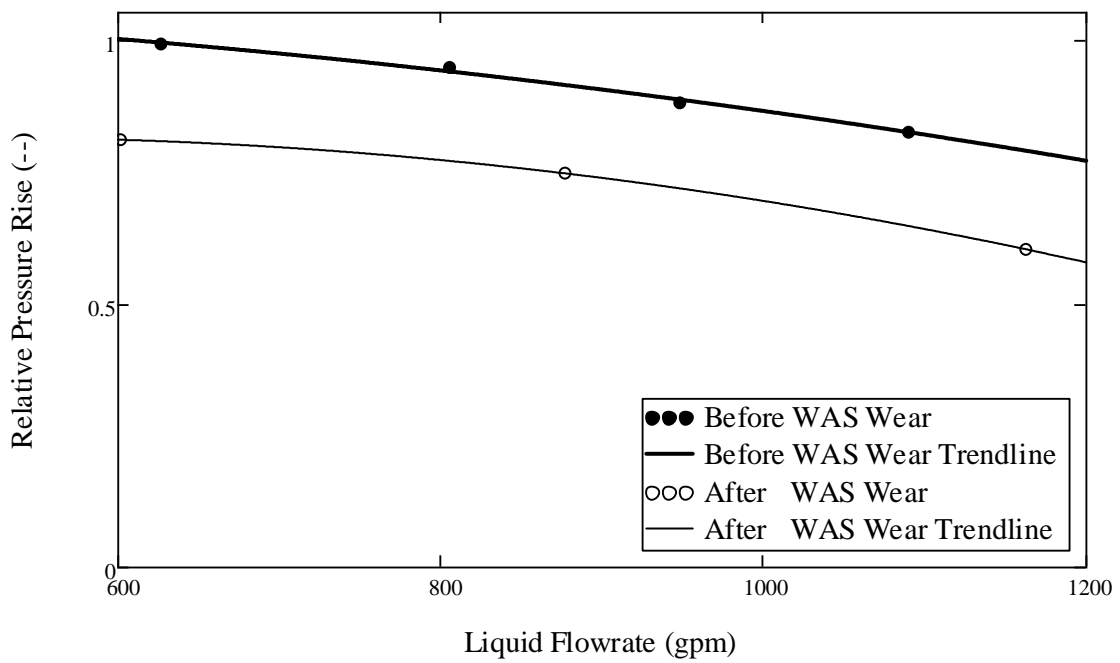
**Figure 55. Pump pressure degradation after Water-Air-Sand, WAS, wear (data obtained at 12% GVF)**

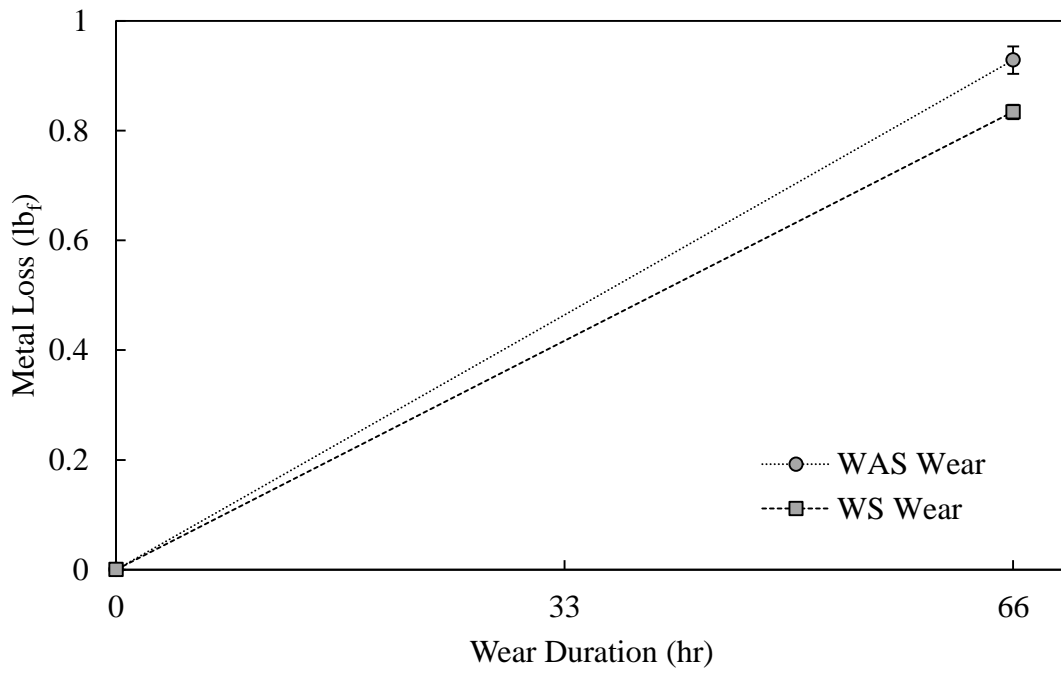
**Figure 63. Second stage impeller metal loss**

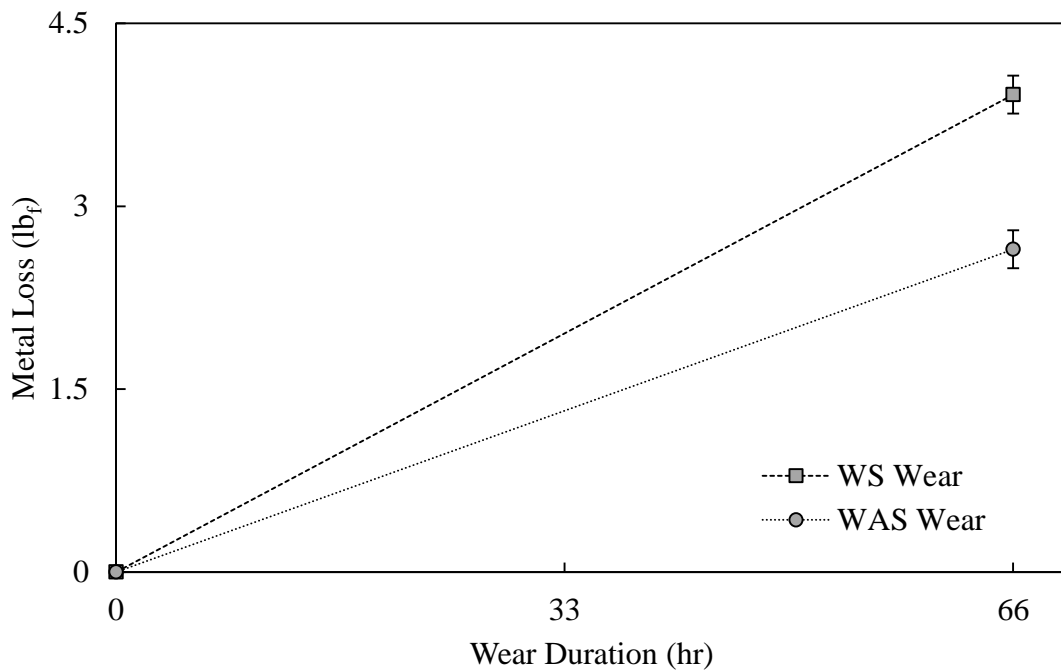
**Figure 64. Second stage diffuser metal loss**

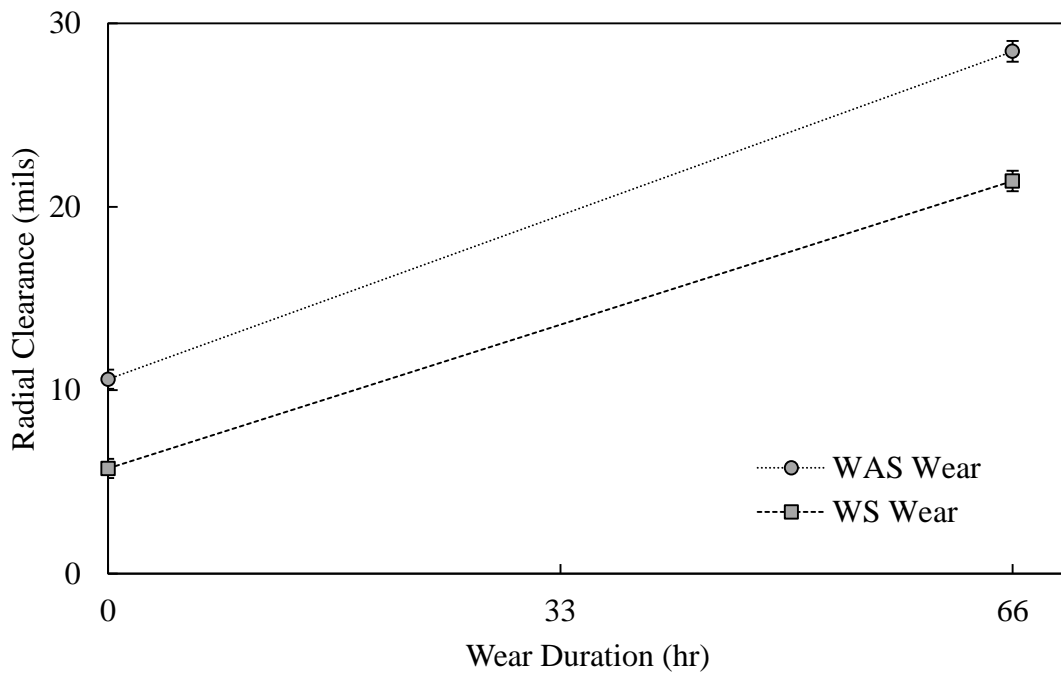
**Figure 65. Second stage front ring seal clearance growth**

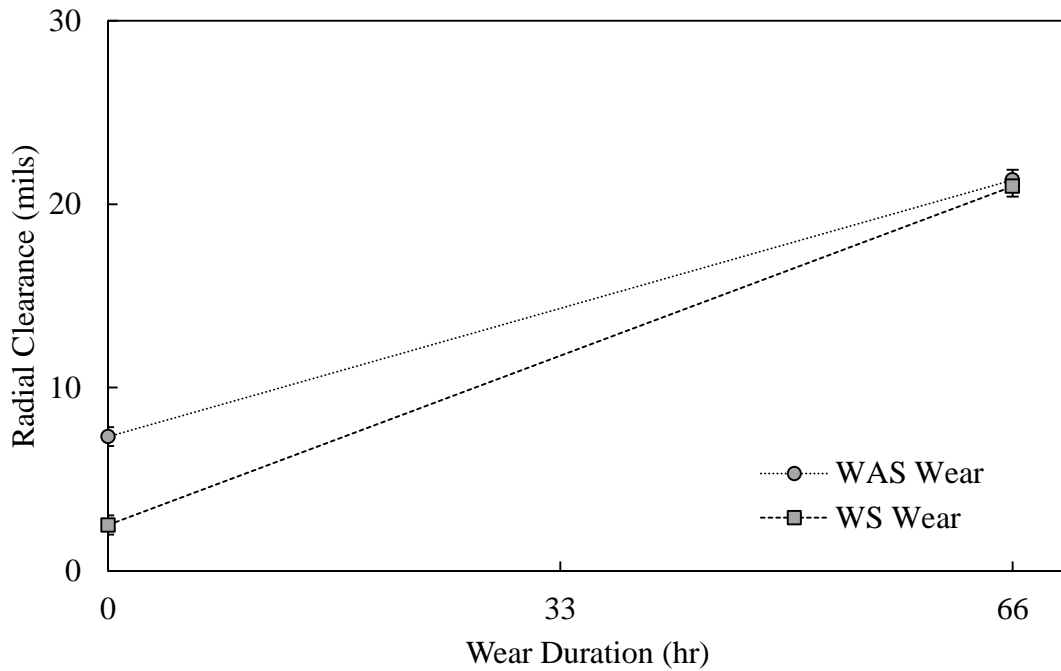
**Figure 66. Second stage back ring seal clearance growth**

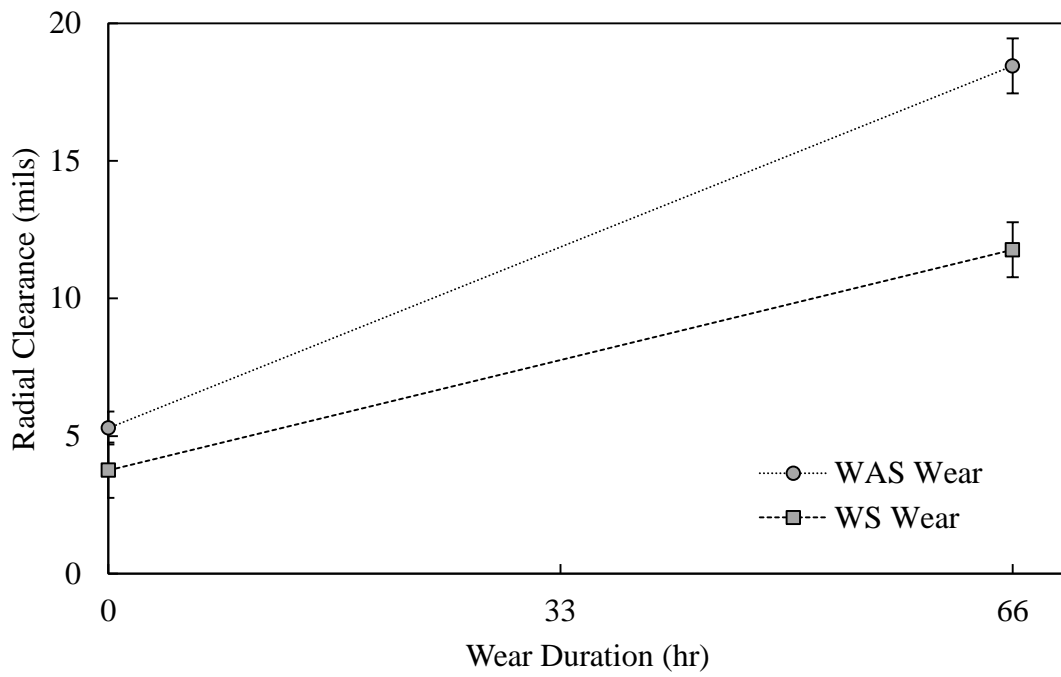
**Figure 67. Second stage radial bearing clearance growth**
