ELECTRICAL CHARACTERIZATION OF ARCING FAULT BEHAVIOR
ON 120/208V SECONDARY NETWORKS

A Dissertation

DOCTOR OF PHILOSOPHY

Major Subject: Electrical Engineering

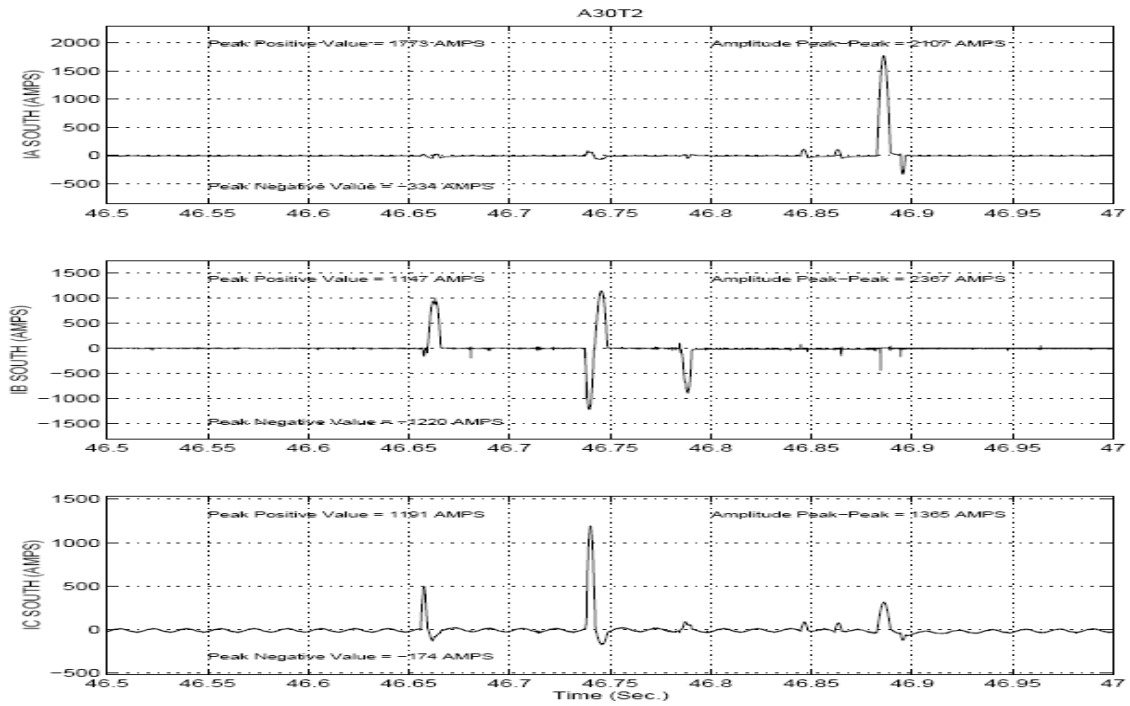
Figure 5: Arcing waveforms from 3rd Avenue Yard tests, Location "A"

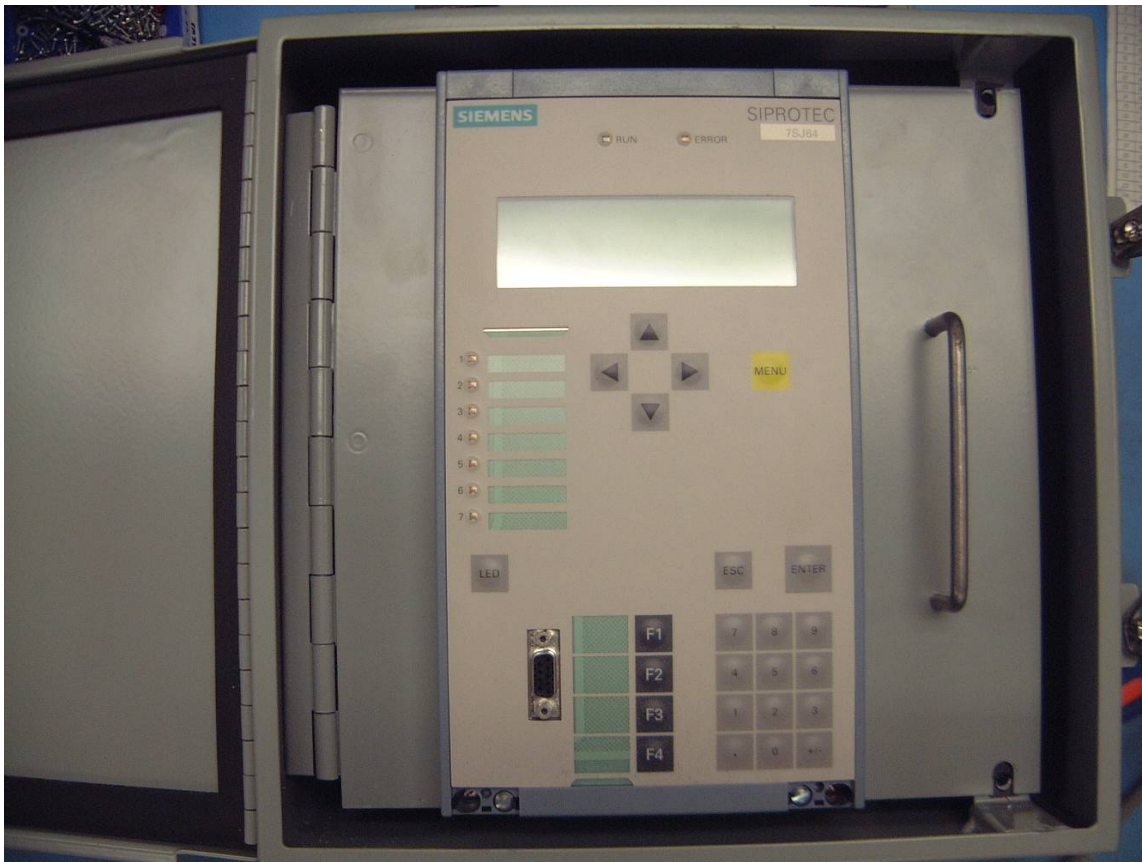
Figure 7: Installed enclosure containing Siemens 7SJ64 relay

Following the recommendation of the 3rd Avenue Yard test final report, ConEdison began an internal project to explore the possibility of using a broad deployment of relays to detect the electrical signatures produced by arcing faults. In 2005 ConEdison installed 50 Siemens model 7SJ64 relays in selected transformer vaults on the Fashion network. The Fashion network is a relatively small secondary network, and 50 monitored points represented a substantial percentage of the network’s 114 network transformers. Figure 7 shows an enclosure containing one of the 7SJ64 relays,

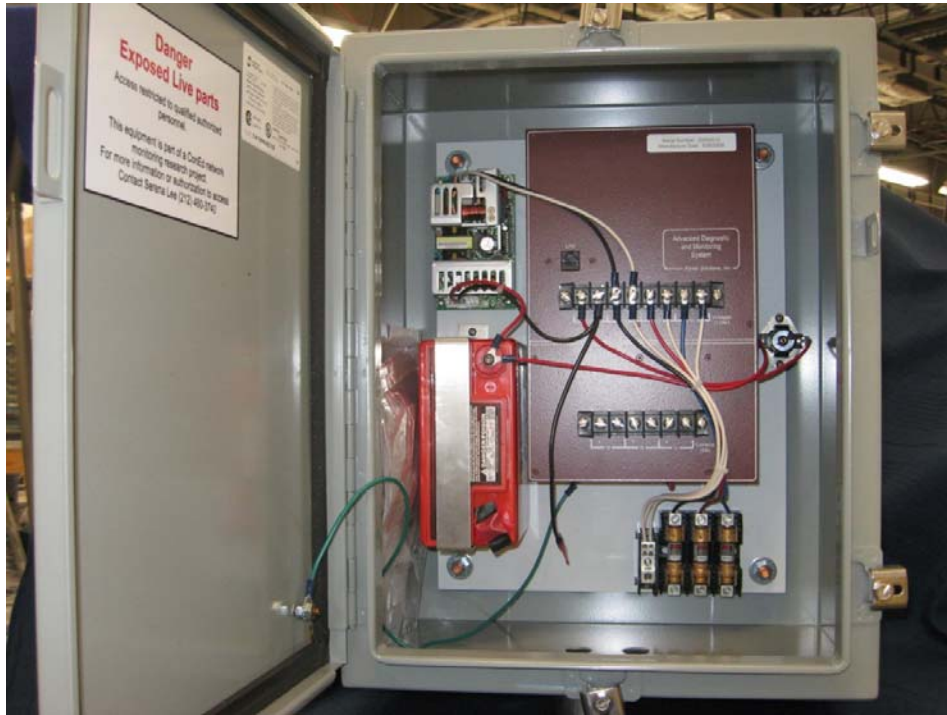
Figure 15: NEMA enclosure with DCD installed

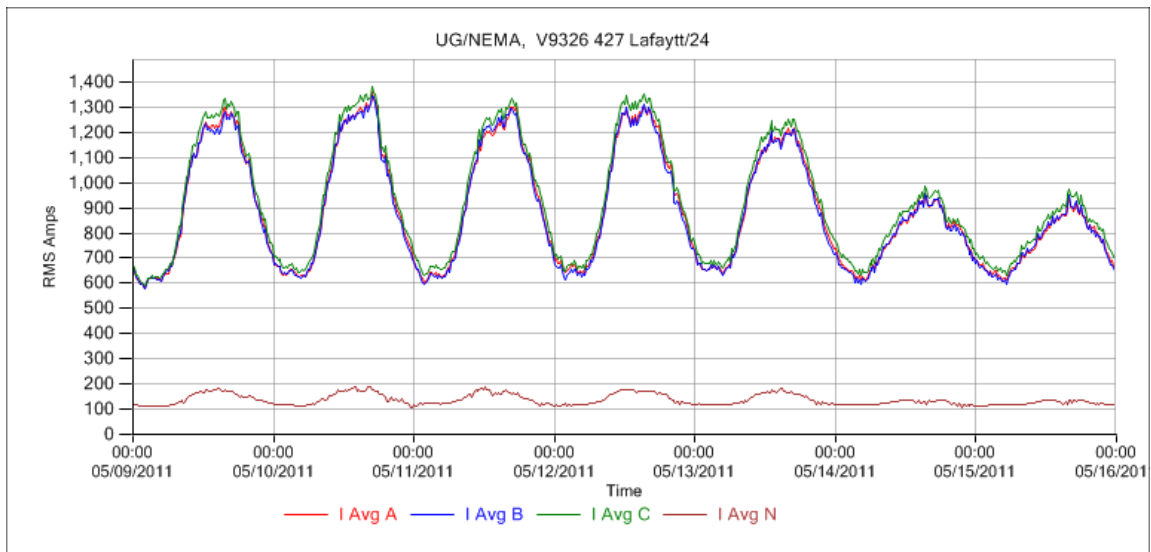
Figure 19: Average RMS currents (15 minute interval) over one week period, V9326

Figure 19 shows the average RMS currents measured at V9326 over a one week period. These graphs are derived from the interval data stored by each DCD as discussed in Section 4.4.1. Each day begins with a relatively low load in the night, rising sharply in the morning, and peaking in the early afternoon before returning to nighttime levels. The two days with significantly lower peaks represent a weekend period, while the five days with highest peaks represent weekdays. Figure 20 shows the average 120Hz components of current measured at 15 minute intervals during this same time period. While the same diurnal cycle can be seen, the absolute current level is much lower, with an absolute peak of 3.5 amperes, compared to a total-load peak of over 1,300 amperes. Finally, Figure 21 shows the maximum value of 120Hz current recorded at each 15 minute interval over the same one week period of time. In this graph, clear peaks indicate transient activity. Another important feature of this graph can be observed in a transition of “steady state” maximum values during the day on May 12. This transition was caused by a load shift within the network, which is typical in the event of a primary feeder being removed from service, or restoration of a primary feeder which had previously been out of service.

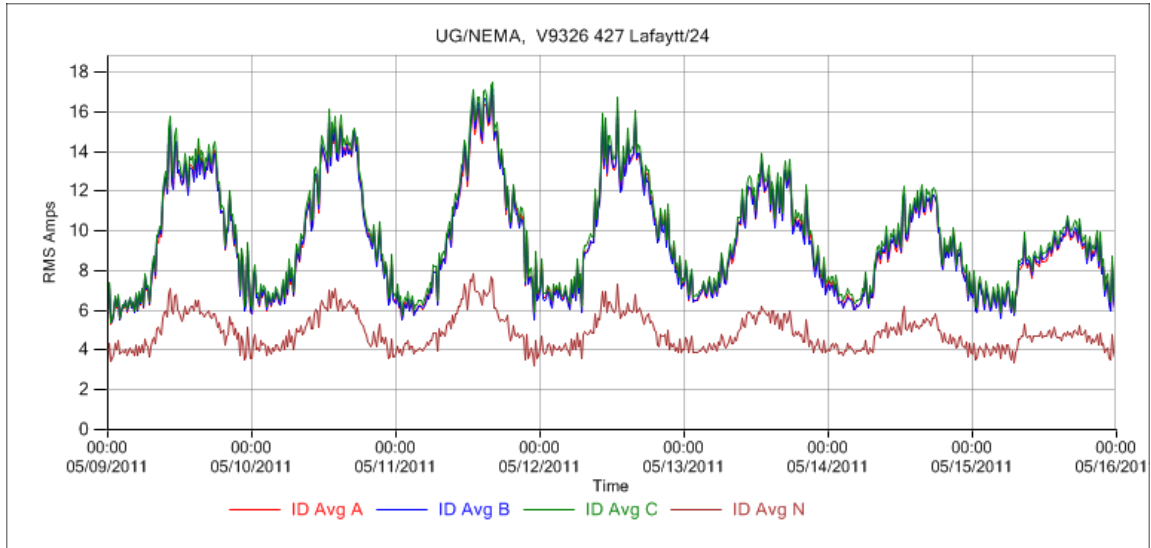
Figure 22: Average RMS "differenced" current (15 minute interval) over one week period, V9326

The third parameter used for triggering is the RMS of a cycle-to-cycle “simple” difference, where each cycle is subtracted from the previous cycle on a point-by-point basis. This parameter is a measure of cycle-to-cycle variability typically produced by transient events. Figure 22 shows the average value of this parameter as measured during each 15 minute interval over the same one week period used in the examples of harmonic current. Figure 23 shows the maximum value of this parameter as measured over the same time intervals and time period. As shown in Figure 22, there is a more or less constant level of average transient activity loosely correlated to system load. When viewing the maximum transient observed in a given interval, as in Figure 23, clear “spikes” corresponding to major transient events are visible. In particular, the neutral current clearly shows activity indicative of single-phase transient events.

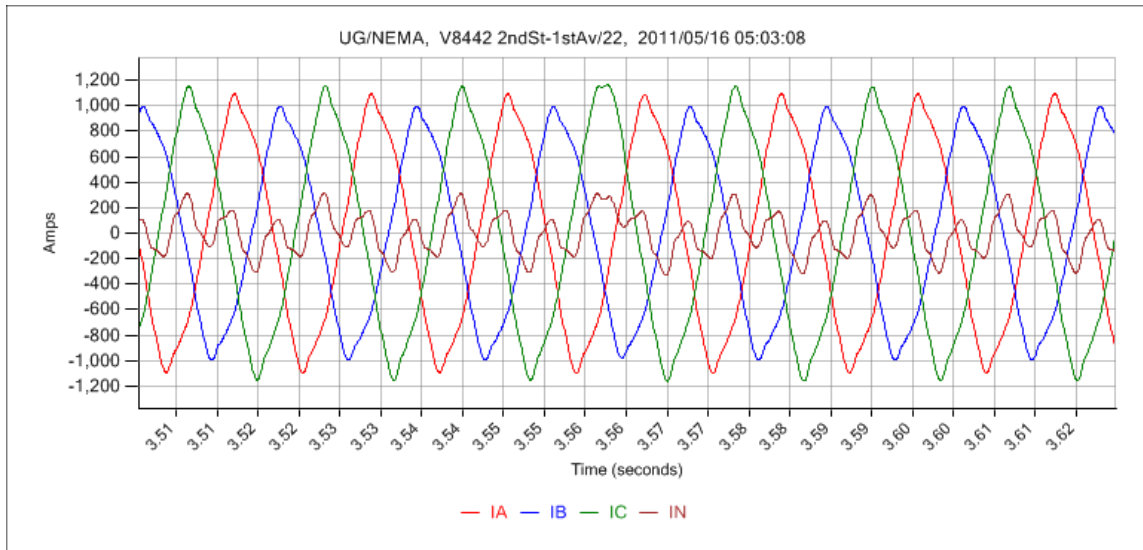
Figure 38: Half-cycle arc burst, unprocessed current waveforms

Figure 38 shows a portion of the same data zoomed to show the faulted section of the waveform recording in greater detail. The fault is visible upon close inspection as a slightly distorted peak on Phase C between 3.560 and 3.565 seconds. While this current peak is clearly different from those around it, a detailed analysis of differences in characteristics between the peaks is not readily accessible. By contrast, Figure 39 shows the same period of data after processing through the phasor differencing algorithms. In this graph, the nature of the transient condition can be clearly identified and studied.

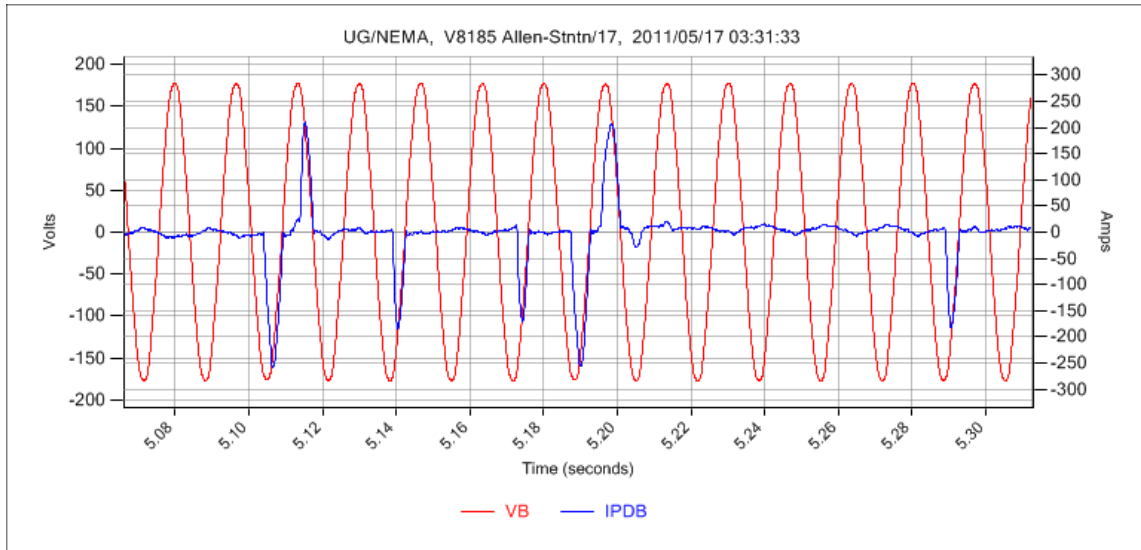
Figure 42: Multi-cycle single-phase arc burst, voltage and differenced current waveforms

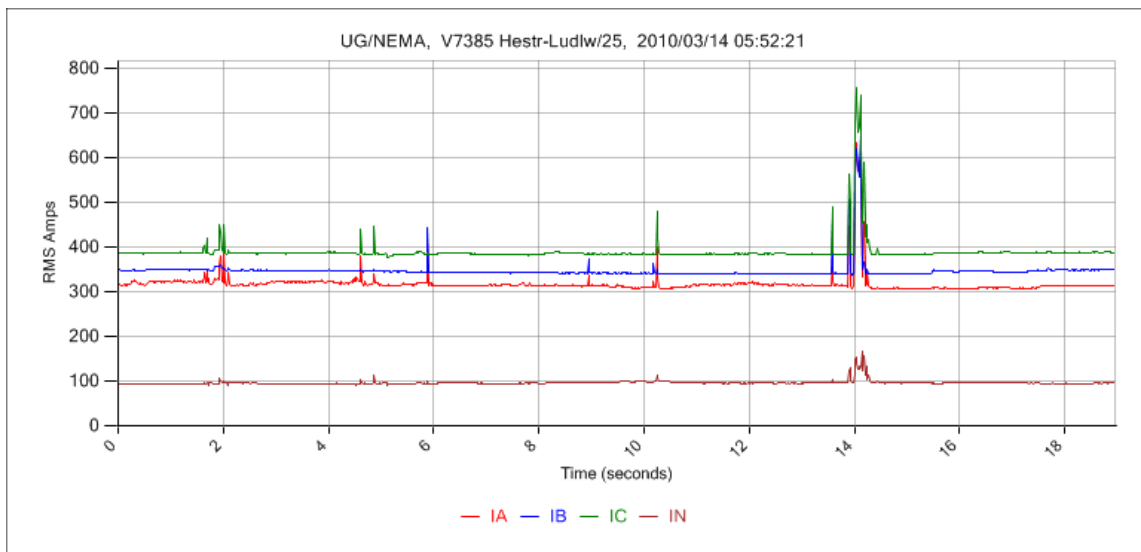
Figure 103: Additional arcing, observed 28 hours after initial burst

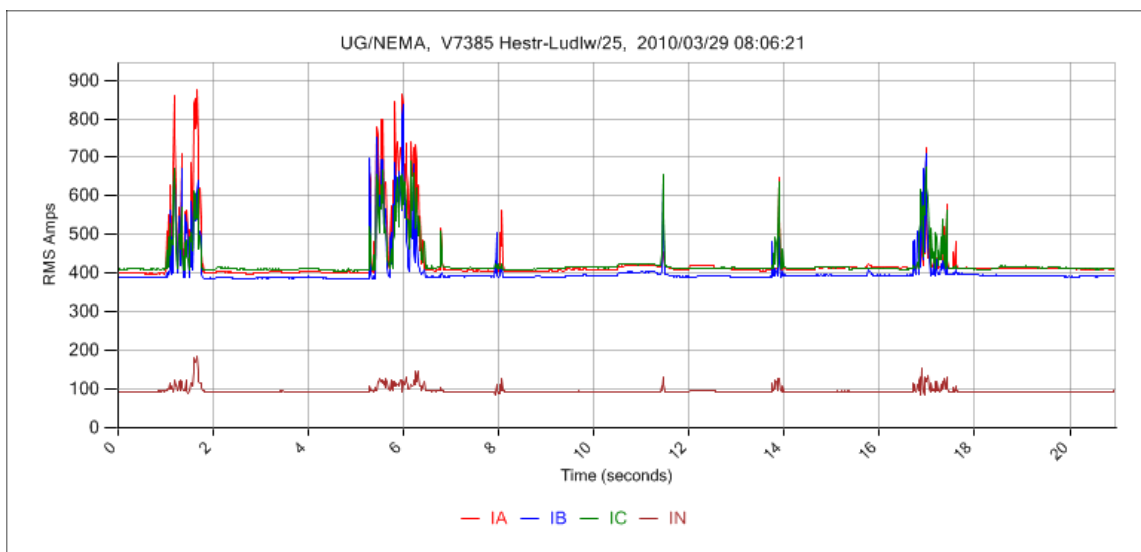
Figure 104: Additional arcing, observed 16 days after initial burst.
