45TH **TURBOMACHINERY** & 32ND **PUMP SYMPOSIA**
HOUSTON, TEXAS | SEPTEMBER 12 – 15, 2016
GEORGE R. BROWN CONVENTION CENTER

Improving Reliability and Reducing Steam Leakage in General Purpose Steam Turbines with Floating Brush Seals

Abstract

This case study examines four different applications where brush seals were introduced into the gland boxes of process steam turbines where conventional carbon rings and mechanical seals were previously applied. The resulting observations and data are presented to highlight the impacts to gland box reliability, steam losses, and bearing life.

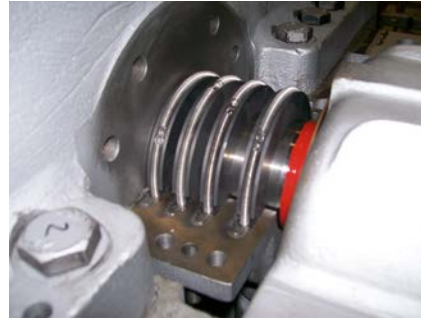
- Conventional: Carbon Rings
 - Conventional practice
 - 4 to 5 rings typical
 - Tight clearance
 - Easy to install
 - Wear easily
- Upgrade: Mechanical Seals
 - Low leakage
 - Alignment sensitive
 - Sensitive to “wet” steam

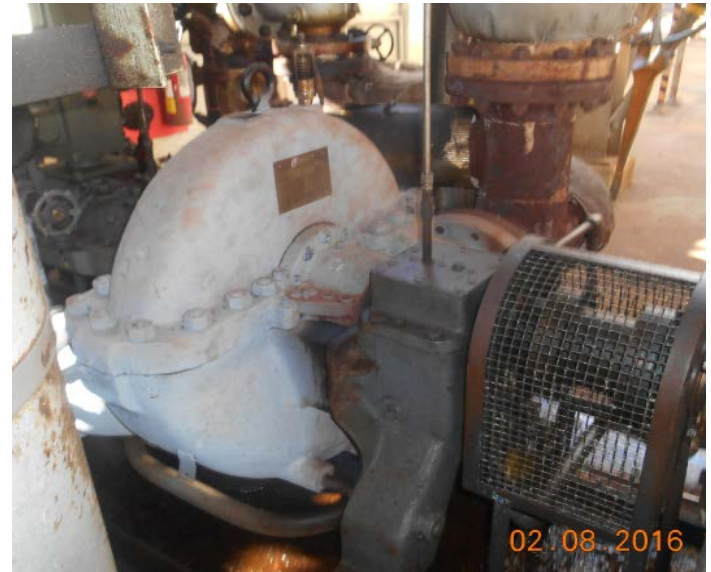
Case I: Refinery in Pascagoula

- (2) 825HP steam turbines; parallel operation; 24/7 operation
- (6) ring gland box
- Unit 1B – carbon rings; installed January 2011
- Unit 1C – floating brush seal upgrade; installed August 2015
- Exhaust Back Pressure: 150 psig
- Wet steam

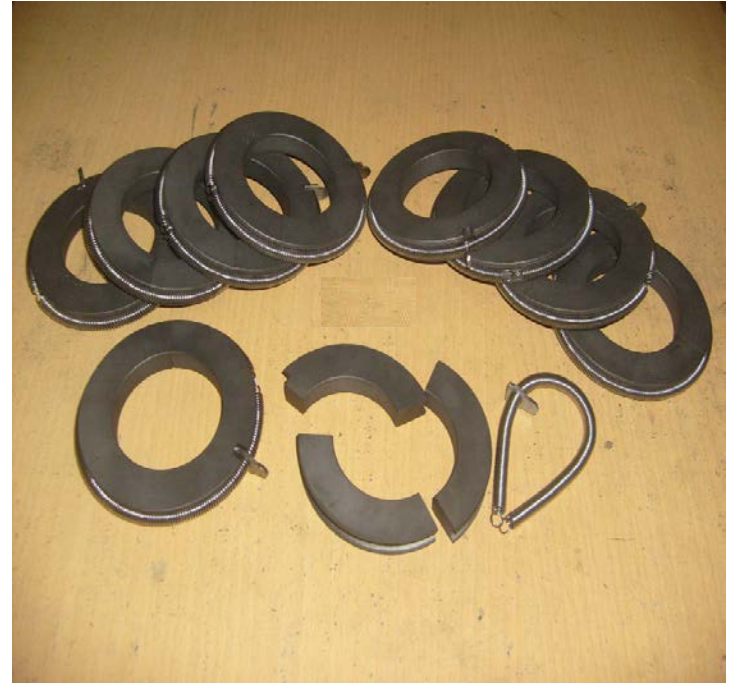
Case I: Problem Statement

- Excessive Steam Leakage
 - Gland boxes
 - Carbon ring wear
- Steam Cross-over to Bearing
 - High Oil Temperatures
 - Oil Contamination
- Environmental and Safety Hazard
 - Visible steam cloud

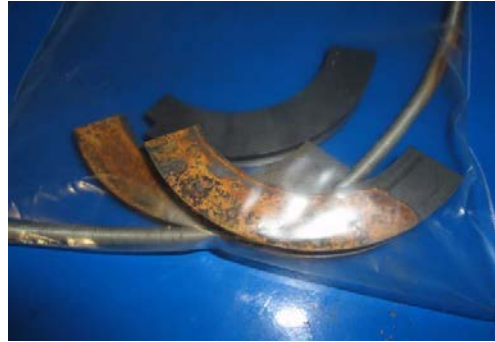
Rust and Debris Contaminants

- Carbon ring wear
- Steam contamination from rust and hard particles
- Wet steam application accelerated carbon ring wear

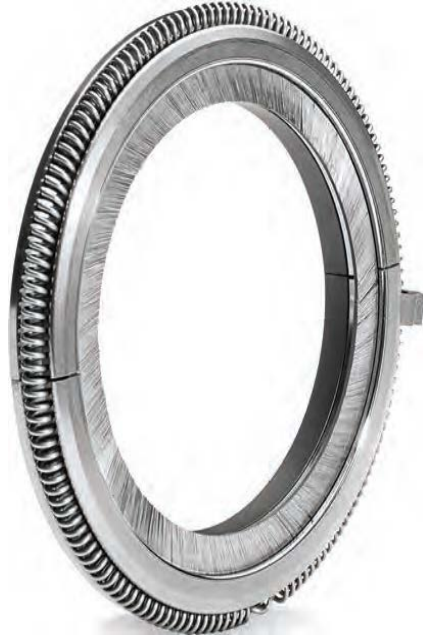
Floating Brush Seal (FBS)

- Densely packed bristles are applied to a carbon ring
- Floating brush seals installed in gland boxes
- Drop-in replacement
- Contacting bristles filter steam contaminants
- Bristles protect downstream carbon rings

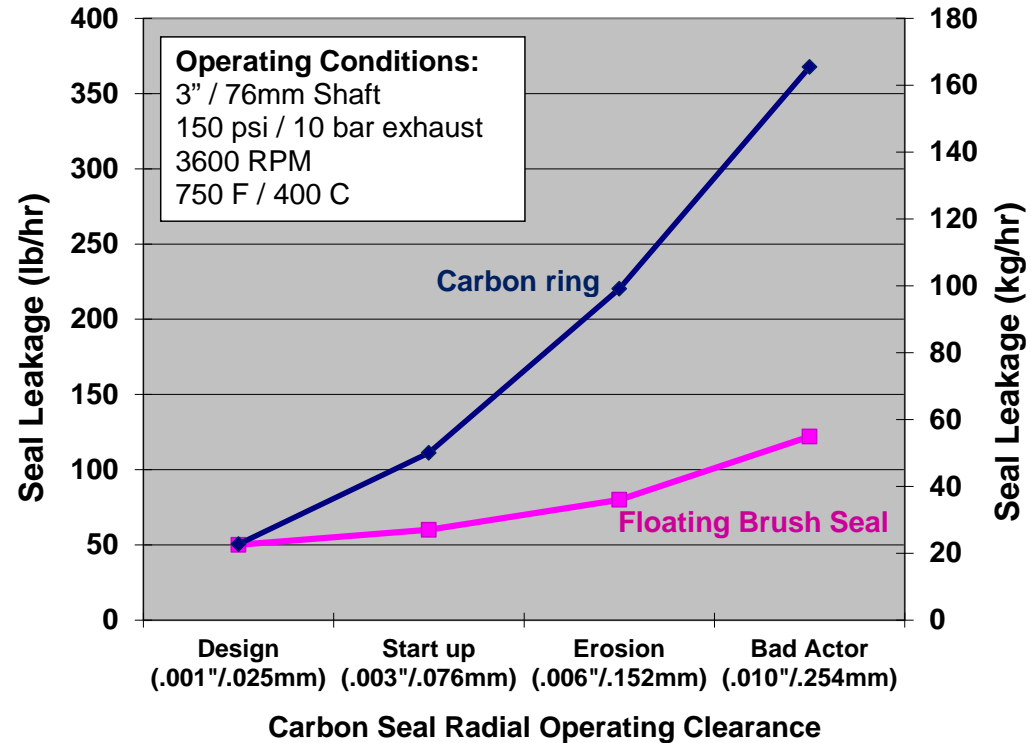
Evaluation of FBS performance

- Rig test comparison
- Carbon clearances based on customer interviews
- Bristle wear rate based on past steam turbine experience
- Brush seal provides a tighter clearance and lower leakage rate

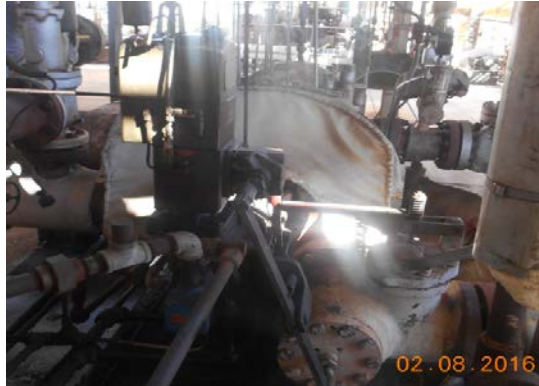
Unit 1B – Carbon Rings

- Two identical units selected
- Turbines lacked instrumentation to measure leakage
- Surface temperatures measured on gland boxes and bearing casings

- Temperature gun used
- FBS upgrade showed 20°F drop
- Higher surface temperature on FBS gland boxes supports lower steam flow to pull heat from gland casing.
- Unable to quantify leakage rate.
