IMPROVING THE RELIABILITY OF A HIGH SPEED REFRIGERATION COMPRESSOR

Ray D. Kelm

Malcolm E. Leader

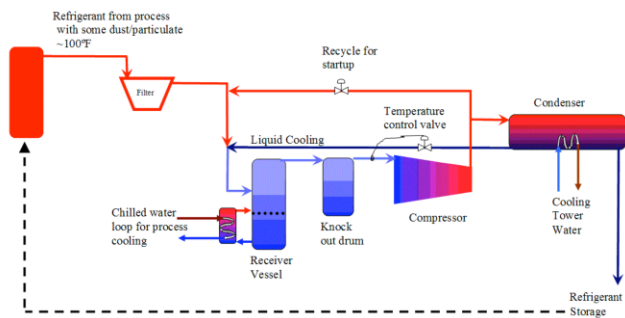
A general process flow diagram is drawn in Figure 2. The refrigerant is cooled with liquid that is recycled from the condenser, and blended in the receiver vessel with gas evaporated from a reboiler. The reboiler provides chilled water to the process and produces vapor to feed the compressor. A knock out drum is installed directly upstream of the compressor to prevent liquid from entering the compressor suction.

Figure 2. Refrigerant Process Flow Diagram.

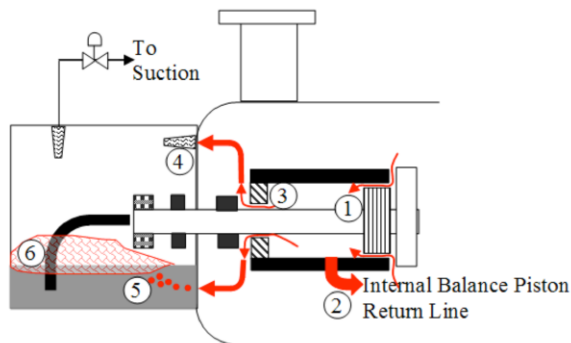
The oil system on a pressurized oil sump refrigeration compressor of this type is shown in Figure 3. A shaft driven oil pump located inside the sump provides pressurized oil to the added secondary cooler and oil filters. The filtered oil then flows to the bearings on both ends of the compressor.

- 1 – Excessive Balance Piston Leakage
- 2 – Restrictive Balance Piston Return Line
- 3 – Excessive Process Seal Leakage Into Oil Sump
- 4 – Plugged Screen
- 5 – Hot Gas Blowing Through Oil Return Port
- 6 – Foam Developed In Oil Sump

Figure 3. Cause of Oil Foaming Problem.

Once the compressor was operating, there were varying degrees of foaming that existed at all times. However, as the balance piston chamber pressure would increase, the level of foaming would always increase as well. If the balance piston seal is damaged and excessive flow passes into the balance piston chamber, this area begins to pressurize as the flow increases. This machine was provided with several internal balance piston return tubes that were also found to foul and plug after short-term operation. When that would happen, the flow across the internal process seal would increase even more forcing balance piston seal leakage past the internal process seal and into the oil reservoir on the nondrive end of the compressor.

The design of the oil system flow causes the gas flow past the process seal on the outboard end to flow back into the oil sump, then through the vent return line that attaches to the top of the oil sump. This connection into the sump was provided with a coalescing screen. The purpose of the screen is believed to be to prevent oil foam during startup from migrating backward to the passage between the process seal and the outboard bearing.

The oil foaming during normal operation was reduced by replacing the screen on the gas return line back to the oil sump with a new screen. The original screen included an external screen with some packing material that resembled steel wool. After the new replacement screen plugged reasonably quickly due to the particulate in the gas stream, a screen with larger mesh and no packing was installed. This modification reduced the foaming to acceptable levels.

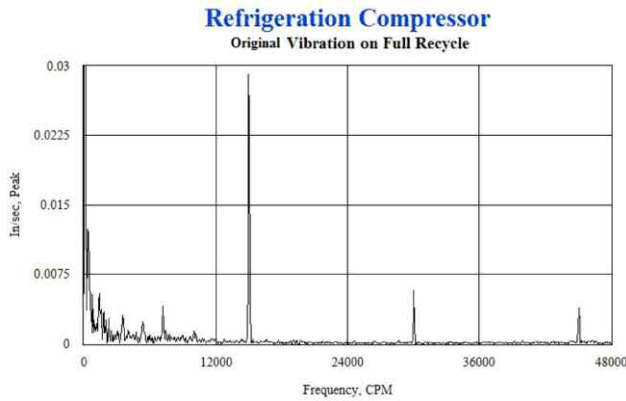
The casing to rotor weight ratio was large with a rotor weight of about 100 pounds and a casing weight over 4000 pounds. With such a heavy casing, large amplitude casing vibration was not expected. The vibration immediately after a startup following an overhaul with the compressor operating on full recycle is shown in Figure 4. The overall vibration was about 0.05 in/sec peak, with a 1× rpm amplitude of about 0.027 in/sec peak. Two× and 3× rpm harmonics were also present.

Figure 4. Measured Case Vibration on Compressor Before Modifications.

Casing amplitudes of 1× rpm vibration in the heavily fouled condition were observed to be as high as 0.2 in/sec peak. The vibration data also indicated there were high vibration amplitudes near 2 Hz caused by surging.

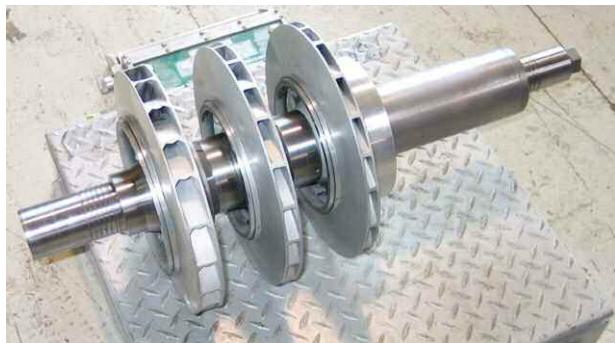
The history of the compressor suggested that it was very sensitive to imbalance. Not all of the changes made in the past were fully documented, but it appeared that at least one bearing design change had been previously implemented. No other analysis models were available so the spare rotor was carefully measured and all parts weighed. The compressor rotor, Figure 5, is driven at 15,200 rpm by an induction motor through a speed increaser. The flexible coupling between the pinion and the compressor is a hybrid design with one flexing element and a long quill shaft. Thus, to fully define the compressor dynamics a combined model of the pinion, coupling and compressor was constructed as seen in Figure 6. A closeup view of the flexible diaphragm portion of the coupling can be seen in Figure 7.

Figure 5. Photograph of Unmodified Compressor Rotor. (Courtesy of Vibration Institute)

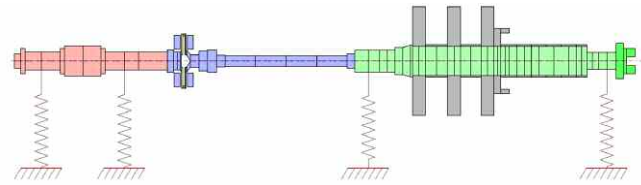
Figure 6. Finite Element Model of Pinion, Coupling, and Compressor Rotor.

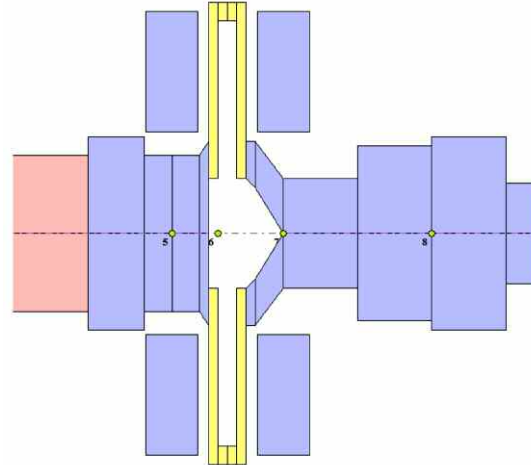
Figure 7. Enlarged View of Flexible Coupling.

The coupling ends are rigidly connected to both the pinion and compressor shafts. The flexible diaphragm section of the coupling accommodates misalignment along with the inherent flexibility of the long thin quill shaft. In the finite element model, the diaphragm sections have their elastic and shear moduli adjusted to reflect the actual lateral and torsional stiffnesses.

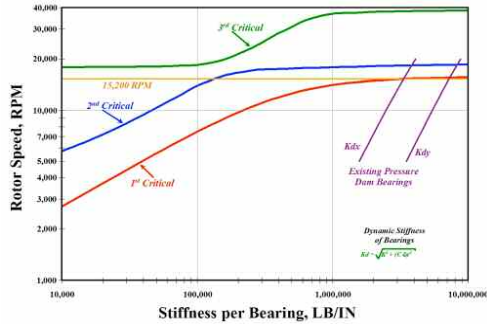
An undamped critical speed analysis indicated that there could be a direct interference of operating speed and the first critical speed. The undamped critical speed map, Figure 8, shows that the bearings are very stiff compared to the rotor in this application since they intersect the first critical speed curve in its asymptotic section.

Figure 8. Undamped Critical Speed Map of Unmodified Rotor and Original Bearings.

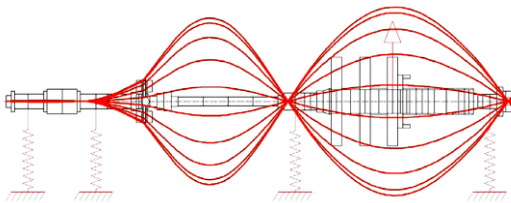
The undamped first critical speed mode shape, shown in Figure 9, indicates that the quill shaft portion of the coupling is a strong influence. The pinion is not significantly involved in the dynamics as it is isolated by the flexible membrane. It is important to note that the maximum deflection at this resonance is very close to the balance piston location in the compressor.

Figure 9. Undamped Critical Speed Mode Shape of Unmodified Compressor Train.

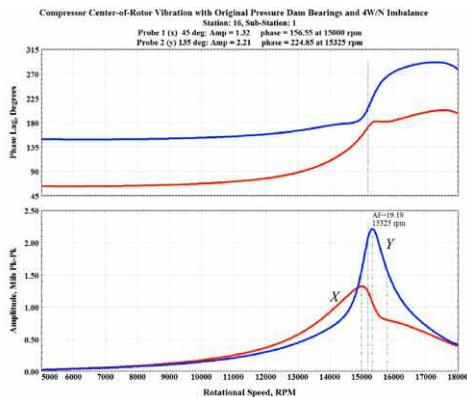
Figure 10 is the damped unbalance response synchronous amplitude and phase predicted for the center of the compressor rotor for a 4W/N imbalance placed at that same location. This confirmed that the compressor was operating directly on resonance in its current condition.

Figure 10. Predicted Unbalance Response at Compressor Rotor Center with Original Bearings.

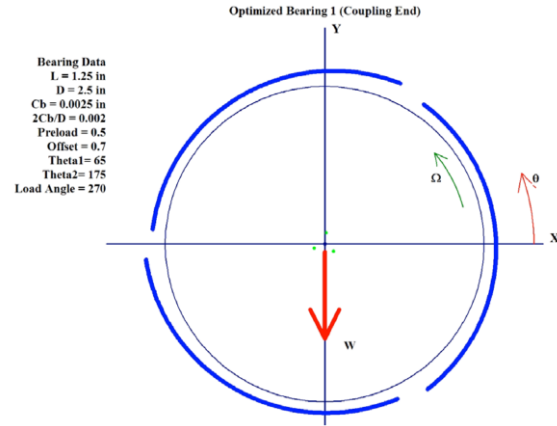
With the direct interference and the high amplification factor, it became evident that the bearings needed to be softened. Many different bearing types were considered including a squeeze film damper arrangement. Only thin liner types of bearings were applicable due to space limitations. After many iterations, the best bearing was found to be a three-lobe design as shown in Figure 11.

Figure 11. Optimized Three-Lobe Bearing for Refrigeration Compressor.

Based on an optimization routine, the coupling end bearing was axially shortened to produce the lowest stiffness and most effective damping. In addition, clearance, preload, offset, and lobe orientation were all varied to optimize the bearing design. Tables 4 and 5 list the final three-lobe bearing characteristics and dynamic stiffnesses. The calculated dynamic stiffnesses are much softer than the original bearing dynamic stiffnesses, particularly on the coupling end where the difference exceeds 5-to-1. While the drop in calculated damping may seem to be detrimental, the dramatic stiffness decrease actually allows the available bearing damping to be much more effective in attenuating critical speed vibration amplitude.

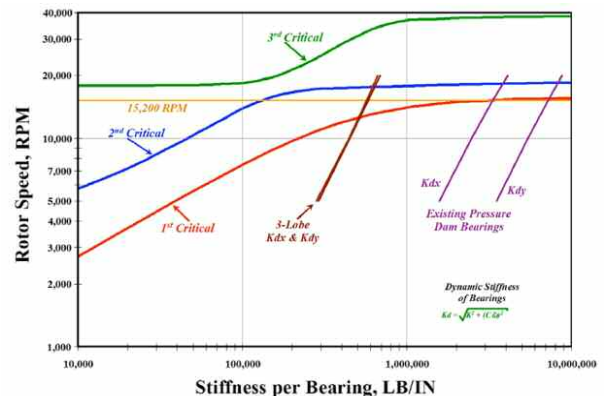
With the drop in bearing stiffnesses it was hoped that this would solve the compressor's problem with critical speed interference. The undamped critical speed map, Figure 12, gave hope that this would happen. From this, the operating speed would appear to lie safely between the first and second critical speeds.

Figure 12. Undamped Critical Speed Map of Unmodified Rotor and Three-Lobe Bearings.

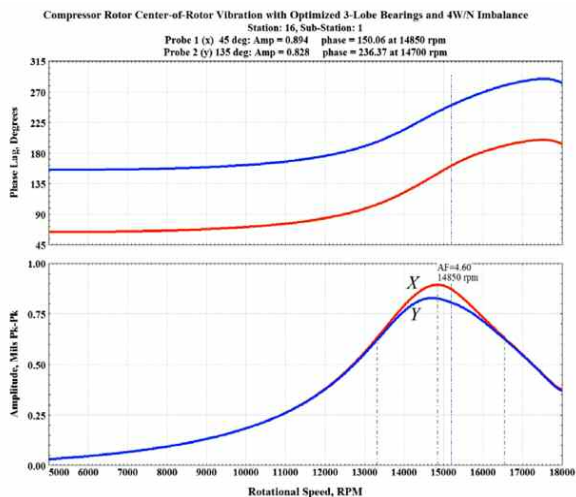
When the damped unbalance response was calculated, it was surprising to find that the resonance was still very near operating speed. The maximum center span amplitude had dropped from 2.2 mils to 0.9 mils and the amplification factor had dropped from 19.9 to 4.6 but the critical speed interference remained, as seen in Figure 13. The reason for this is that the more active bearing damping may be increasing the dynamic stiffness more effectively than before.

Figure 13. Predicted Unbalance Response at Compressor Rotor Center with Three-Lobe Bearings Only.

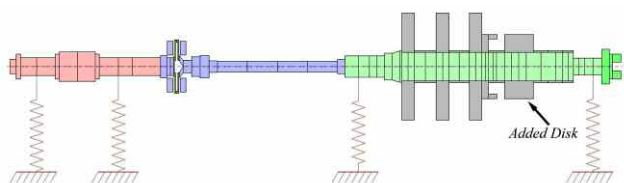
At this point rotor modifications were considered. Both shaft diameter changes and bearing span changes were not possible due to space limitations. The idea of adding mass to the rotor became the focus of the study. One idea was to make new wheels out of steel instead of aluminum but this was an expensive and long delivery route. Since there was axial room on the rotor, a dummy wheel was added next to the balance piston location as indicated in the new rotordynamics model, Figure 14. A photograph of the modified rotor, Figure 15, also features coated impellers. In the picture, a 12-inch scale rests on the impellers to help visualize the size of the rotor. This new disk added 34 pounds to the rotor's original 102 pounds or a 33 percent increase near the middle of the rotor. This was determined to be very effective in lowering the first critical speed frequency.

Figure 14. Finite Element Model of Compressor Train with Added Disk.

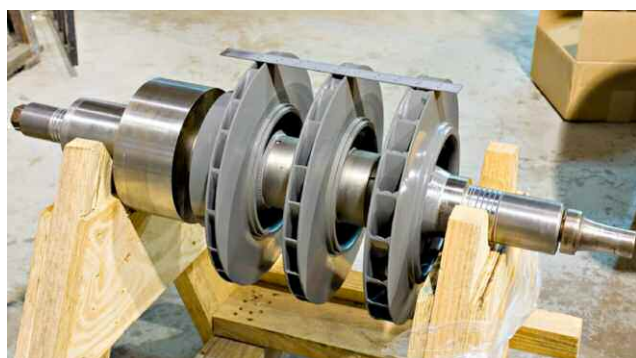
Figure 15. Photograph of Modified Compressor Rotor.

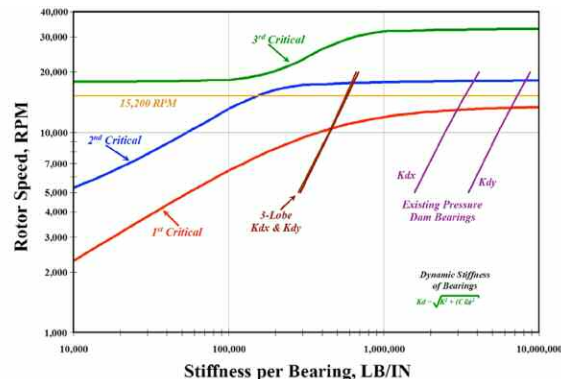
With the new added disk the undamped critical speed map, Figure 16, showed that the first critical speed frequency had been significantly reduced so that even the original bearings would probably not have had a direct interference even if they were still too stiff.

Figure 16. Undamped Critical Speed Map of Modified Rotor and Both Bearing Types.

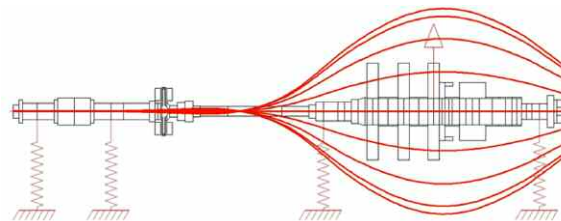
The calculated first critical speed mode shape with the additional disk and the optimized bearings is plotted in Figure 17. While the amplitude is still a maximum in the rotor center, the contribution of the quill shaft to this mode has been reduced. In addition the relative amplitude at the bearings has been increased. This allows the bearing damping to be more effective than when there are nodal points near the bearing centers.

Figure 17. Undamped Critical Speed Mode Shape of Modified Compressor Train.

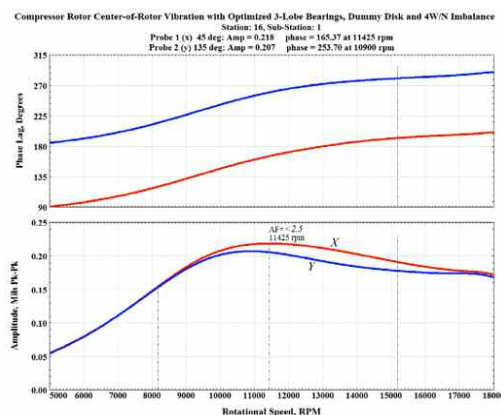
The redesigned rotor and bearing combination unbalance response, Figure 18, is predicting a very well controlled rotor. The maximum predicted amplitude is less than 12 percent of the original and the amplification factor is less than 1.0 with an operating speed amplitude of less than 0.2 mils peak-to-peak for a 4W/N imbalance. It should be noted that with the increased rotor weight, the applied 4W/N imbalance also increased and the bearing coefficients were recalculated for the new journal loads.

Figure 18. Predicted Unbalance Response at Compressor Rotor Center with Three-Lobe Bearings and Added Disk.

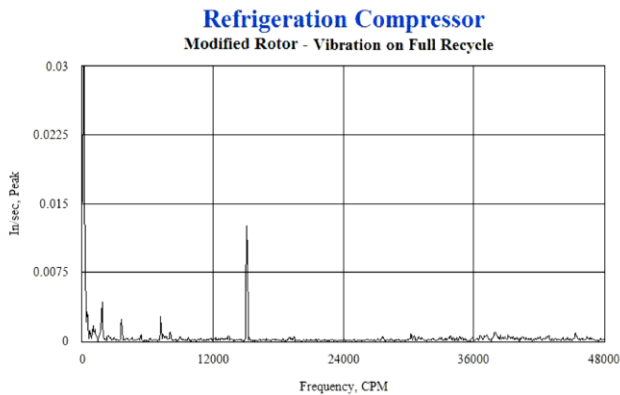
New three-lobe bearings were manufactured and the dummy wheel was built and mounted during a compressor rebuild. When this modified machine was operated, there was a 56 percent reduction in 1x casing vibration velocity. The casing velocity spectrum at the same point is compared in Figure 4, the original configuration, and Figure 19, which is after the rotor and bearing modifications.

Figure 19. Measured Case Vibration on Compressor with Modified Rotor and Three-Lobe Bearings.

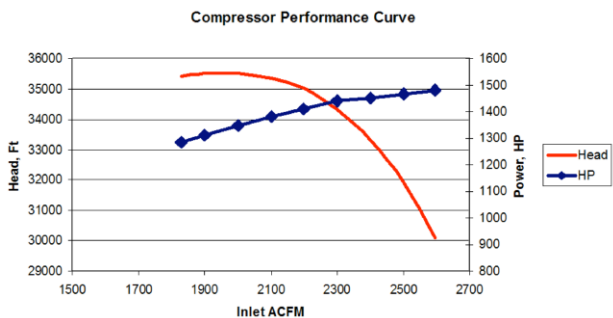
Subsequently, continuous surging of the machine along with material buildup on the impellers eventually caused the balance piston pressure to increase and caused a shutdown. The new three-lobe bearings were found to be damaged, just like the pressure dam bearings. To address this problem new three-lobe bearing liners were manufactured of unbabbitted bronze. This material is about 10 times stronger than Babbitt. This configuration was found to be able to run, without damage to the bearings or seals, for several months at a time until the impellers become choked with buildup. A process team is currently addressing this problem. The surging will continue until the rotor is modified or a recirculation system is implemented to increase the flow through the compressor. Figure 20 indicates the current compressor performance curves.

Figure 20. Compressor Performance Curve.

The typical performance curve with the IGVs fully open is shown in Figure 20. The minimum flow to prevent surge is slightly over 1800 ACFM with the guide vanes fully open. Once a dependable flow rate could be determined from the process, the actual flow compared to the published performance curve is plotted in Figure 23. Thus, the actual flow is less than about 50 percent of the minimum flow to prevent surge.

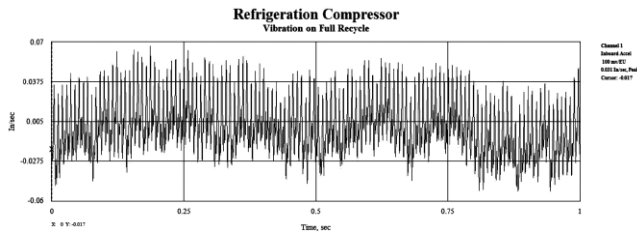
Figure 21. Compressor Vibration on Full Recycle.

Figure 21 shows a typical casing vibration response time waveform when the compressor was on full recycle. A total peak amplitude of less than 0.1 in/sec was measured. Once the recycle valve was closed, Figure 22, which is normal operation, the casing response would shift with significant vibration near 2 Hz. At times, the casing response near 2 Hz was observed to reach as high as 0.4 in/sec peak.

After the compressor was well loaded, field testing indicated it was continuously surging. This was identified by reviewing the casing vibration data as well as visual observations during operation. The typical casing vibration response with and without surge is shown in Figures 21 and 22.

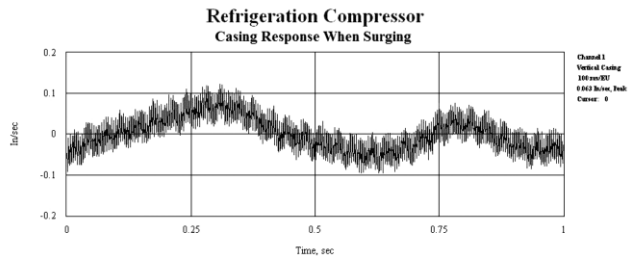
Figure 22. Compressor Vibration During Surging.

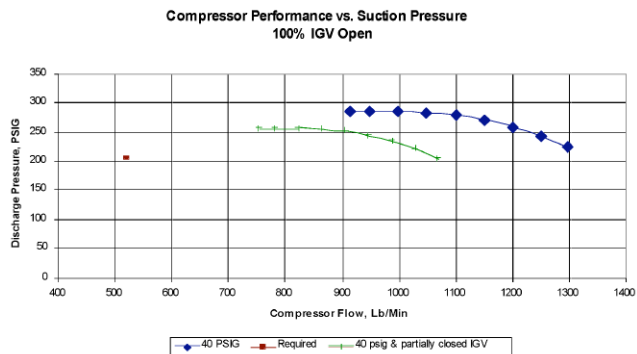
Figure 23. Compressor Performance Versus Suction Pressure and Operating Point.
