46<sup>TH</sup> TURBOMACHINERY & 33<sup>RD</sup> PUMP SYMPOSIA  
HOUSTON, TEXAS | DECEMBER 11-14, 2017  
GEORGE R. BROWN CONVENTION CENTER

## Effect of Gas Presence on Erosive Wear of Split-Vane Electrical Submersible Pump

Texas A&M University, College Station, TX

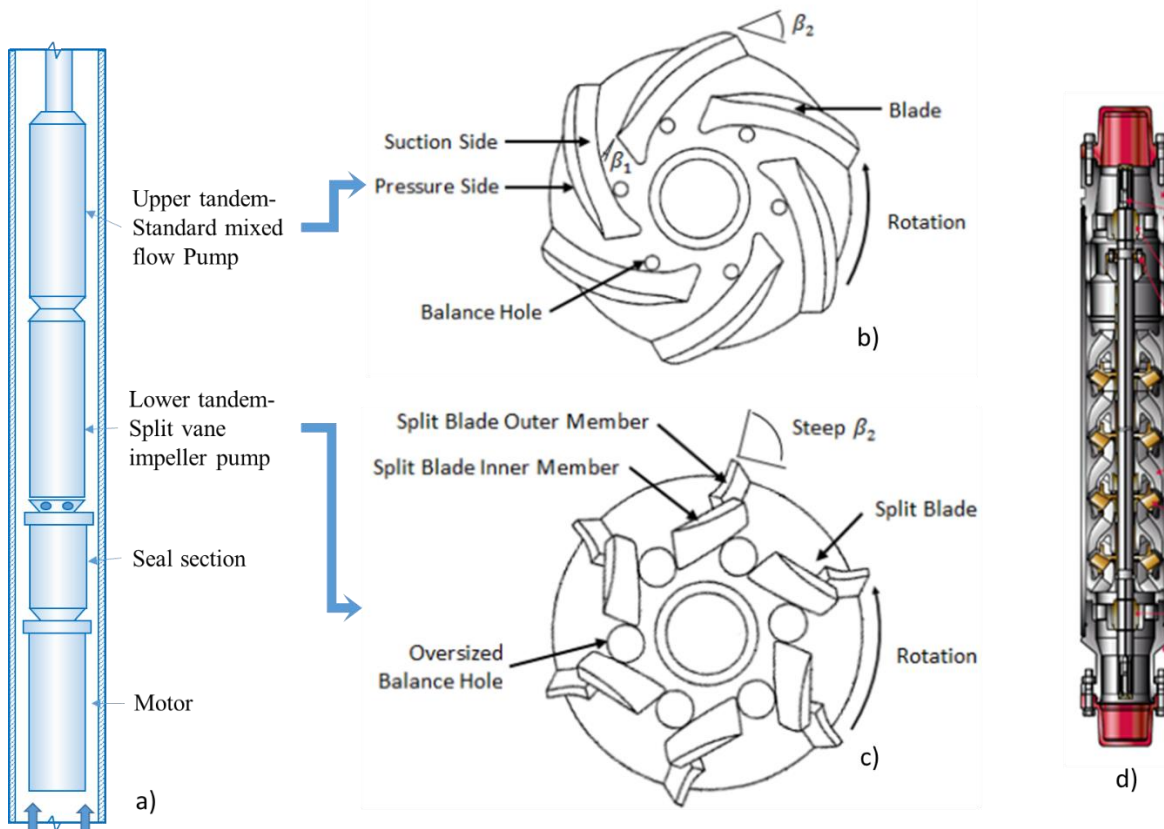
Figure 1: a) Typical configuration of downhole ESP system with gas handling stages b) Mixed flow impeller c) Split vane impeller (gas handler) d) Typical ESP pump section

An electrical submersible pumping (ESP) system is shown in Fig. 1 a). Pump section is configured into different tandems, with each tandem encasing multiple pump stages depending on head requirement. Usually, the upper tandem is equipped with standard mixed flow impeller pump stages as shown in figure 1 b) while lower tandem is equipped with gas handling stages with uniquely designed impellers used to homogenize the flow by inducing turbulent mixing to enable better gas handling. Impellers as shown in the figure 1c) have split vanes and oversized balance holes to alter the pressure distribution and induce turbulence to break up the gas bubbles and vanes with steep exit angle to increase the total head. However, reliability of such an impeller while subjected to frac sand in gassy wells is still unknown.

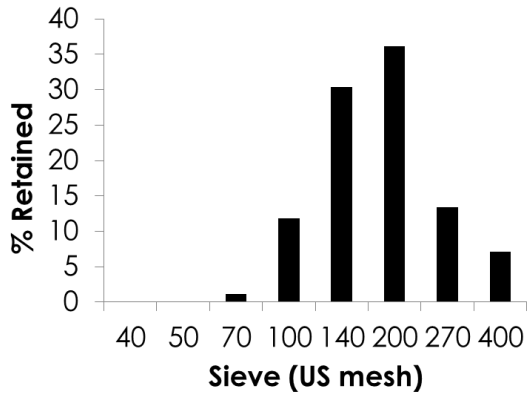
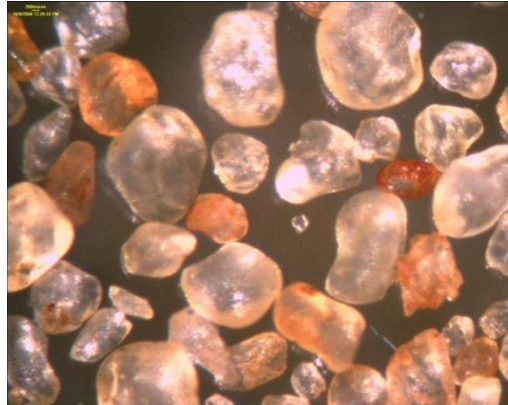
Figure 2: a) Sand sieve analysis b) Microscopic photograph

For a new pump, radial clearance of the front and back seals varies from 8 to 12 mils and the average radial clearance between bearing and journal is 6 mils. The impeller and diffuser are made of Ni-Resist 1b cast iron, and the bearings are made of cemented carbide. The sand is made of highly abrasive frac particles, which are comparable to the particles in oil well. Figure 2 a) shows the sand size distribution obtained by a sieve analysis. Figure 2 b) shows a microscopic photograph of a sand sample. The average size of the sand is smaller than the smallest radial clearance in the stage. The purpose of this study is to determine how the presence of 140 mesh hydraulic fracturing sand affects the pump over a period of time in the presence of different gas fractions.

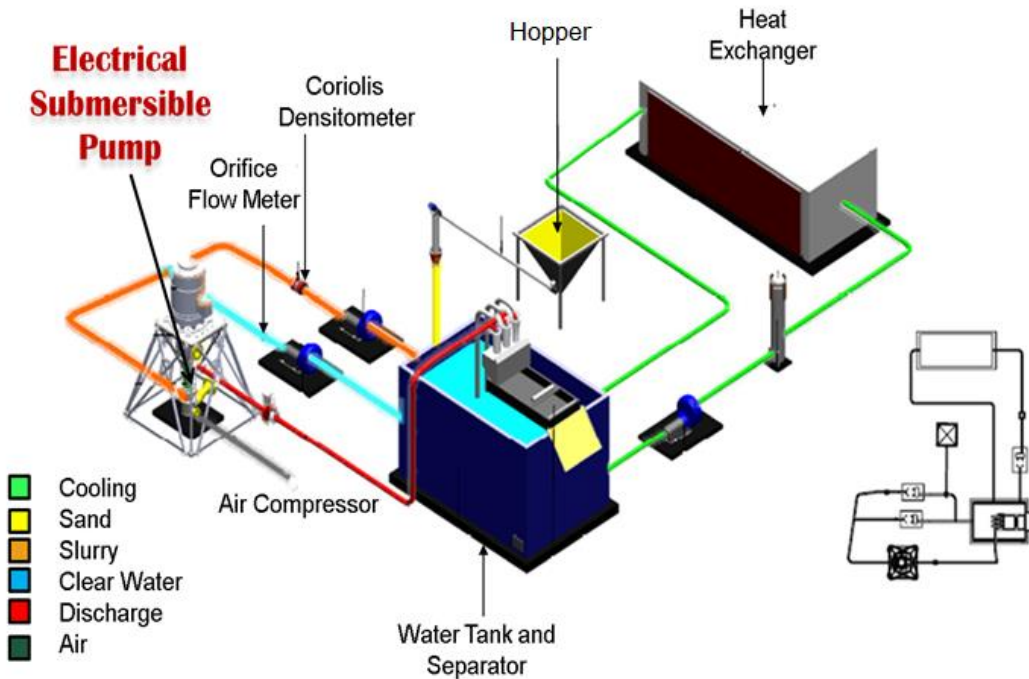
Figure 3: Experimental Setup Diagram

A facility to perform erosion studies was designed and constructed for this project. **Error! Reference source not found.** shows a schematic of the facility. Sand is loaded into a hopper from which a variable speed auger is used to convey sand into a stand pipe feeding a small centrifugal pump. This pump provides about 5% of the water required by the ESP but has all of the sand passing through it. This is done so that the Coriolis flow meter can accurately measure the amount of sand and water passing through this pump. This information is used to adjust the speed of the auger to maintain an overall ESP sand load of 2 grams/liter. The other 95% of the water passes through a separate pump and the flow rate is metered using an orifice flow meter. The water source is from the clean water side of a hydro cyclone separator system which removes the sand as it exits the ESP.

The two supply pumps' flows are combined and provide an inlet pressure of 40 psig to the ESP which exceeds the minimum required to prevent cavitation in the ESP. The flow passes through the ESP, through a choke, and into the separator system. Here, the sand is removed and discarded. The sand passes through the pump only one time allowing a constant input parameter.

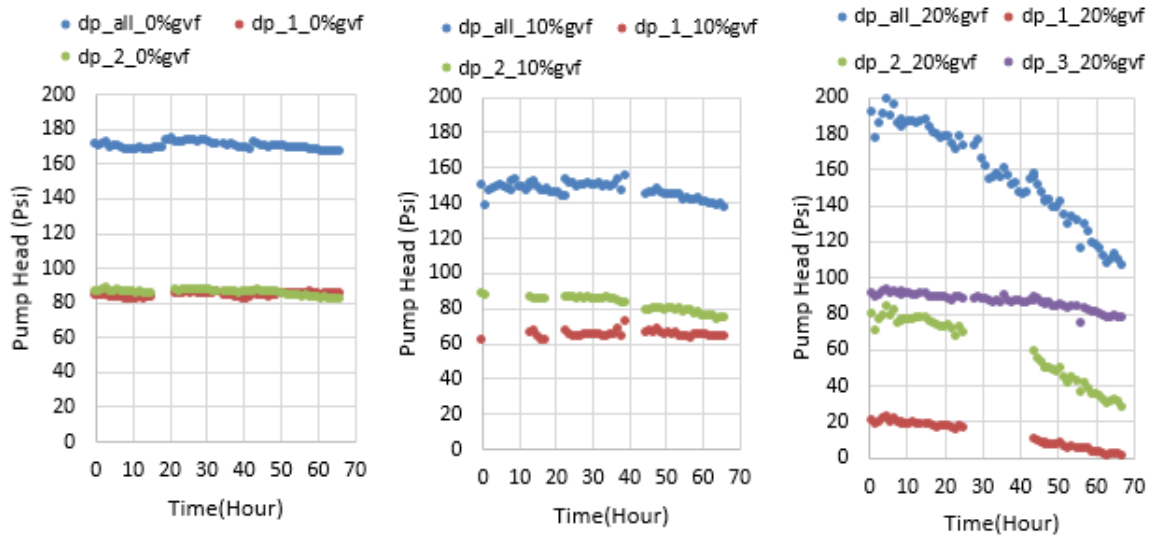
Figure 4: Pump head change for each stage during the test

Figure 4 above shows the changes of the pressure difference during the 66 hours erosion tests at their working conditions. Gas presence in the fluid has significant effects upon the pump erosion which is reflected in the head degradation of the pump with time.

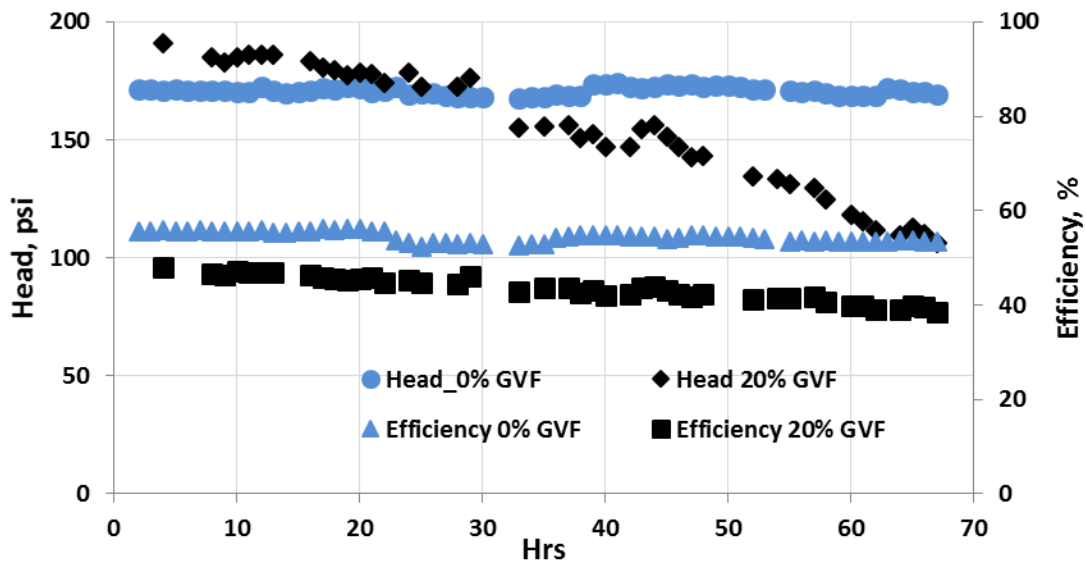
Figure 6: Pump performance with time for 0% and 20% GVF

Typically, head change is mainly caused by pump geometry change due to erosion, inlet GVF and inlet pressure. Thus the head change cannot be evaluated merely based on erosion without considering the working condition difference (inlet GVF and pressure). Moreover, regarding the different stage number in these 3 tests, and different erosion on each stage, it will be more convincing to compare the “change” on each single stage than on the overall pump.

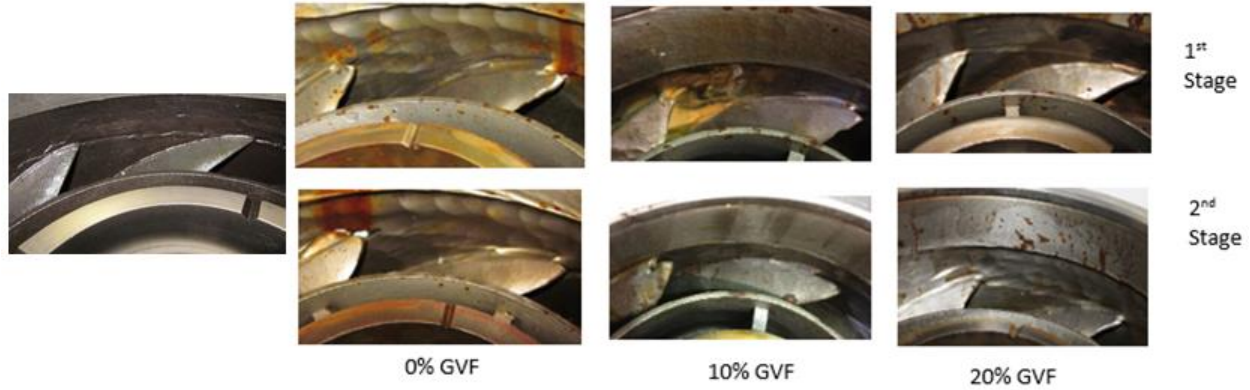
Figure 8: Wear at diffuser inlet

Inlet sidewalls and blades of all diffusers experienced severe wear because fluid pathlines change direction abruptly at the diffuser entrance as shown in Figure 8. This results in particles impinging on the diffuser sidewall. The intersection of the diffuser vane leading edge and diffuser sidewall experienced the most wear. At this location the erosion created a hole in the diffuser housing. Figure 8 shows the erosion at the diffuser inlet. It can be deduced that area loss on the outer impeller blades reduced the impact of the sand on the vanes and sidewall of diffuser. Erosion on the diffuser might reduce the efficiency of the pump, but since the diffuser does not create the head and the volume loss is not big enough to change the flow patterns, it is a secondary factor that affects the performance of the pump.

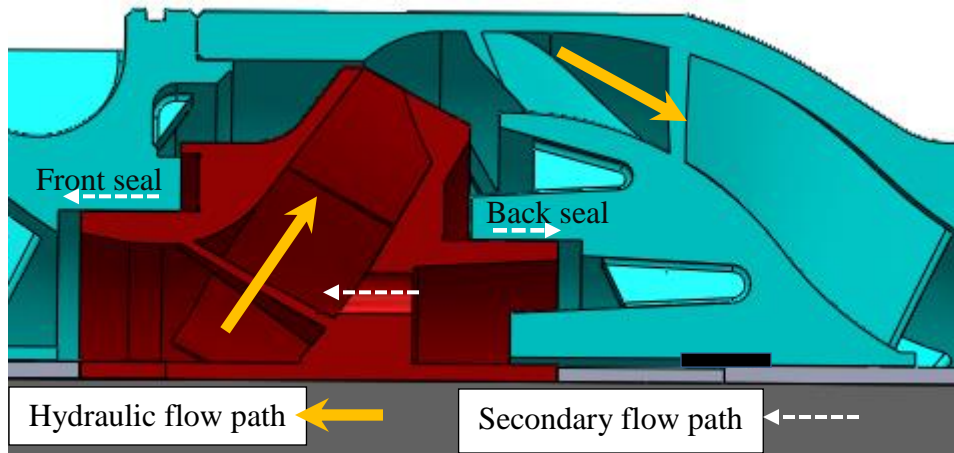
Figure 9: Flow path in mixed flow pump

In this section, the erosion caused by internal leakage is discussed. Figure 9 introduces the location and the trace of this erosion

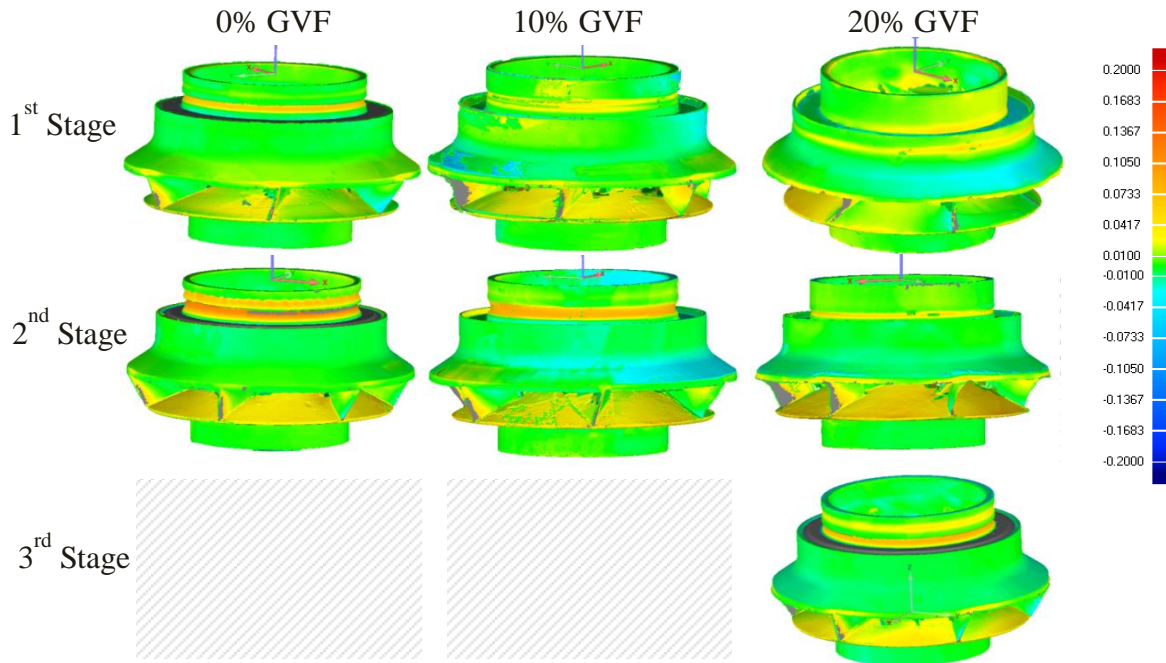
Figure 10: 3D scanned images of eroded impellers

Compared with wear of the main flow which is caused by impingement of the particles, the wear of the front and back seal channels may be mainly influenced by three-body abrasion. Figure 10 shows 3D scans of impellers tested at different GVFs. The wear at the front seal stage surfaces was significant compared to back seal surfaces due to higher pressure drop and possibly higher sand concentration. Also, the wear on a stage seal surfaces was reduced with increase in GVF due to reduced pressure drop. For 20% GVF testing, the 1<sup>st</sup> stage impeller seal had insignificant wear compared to 3<sup>rd</sup> stage seal. Highest wear was observed in the stage tested at 0% GVF. Hence with 0% GVF the pump is erode most in the secondary flow paths while increasing GVF shifts this to the primary flow path, changing the area of dominant wear and pump failure. Total mass loss is shown in table 2.

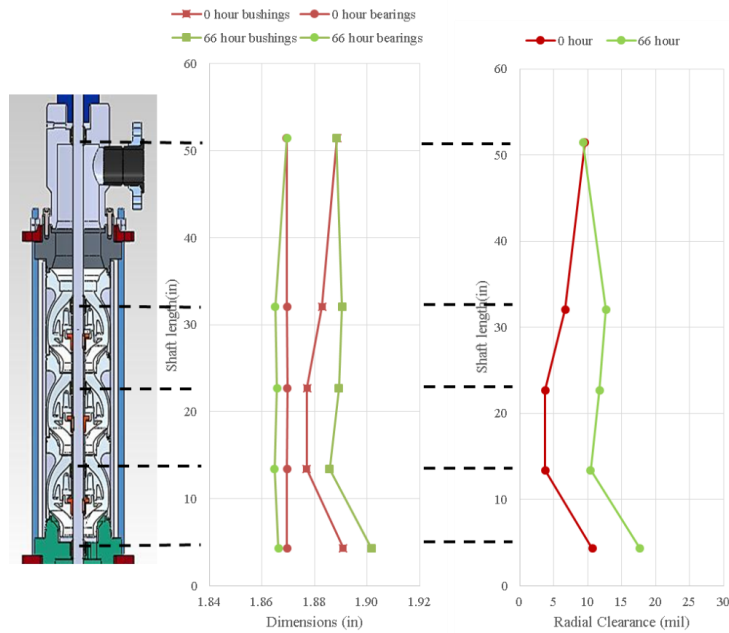
Figure 11: Comparison of radial clearance in the 0% GVF erosion test

**Wear Comparison:** The bearing outside diameters and bushing inside diameters were measured at 0 hour and 66 hours of erosion respectively in each experiment. The comparisons of bearing radial clearance are shown in the Figure 11, Figure 12, and Figure 13. Please note that the top and bottom bearings in the test with 10% GVF were reused from the test with 0% GVF. Following observations are made for the bearing wear.

- The radial clearance of bearings increased significantly after 66 hours of erosion.
- The erosion of the bearings becomes severe along the shaft from top to the bottom.
- Generally, the erosion rate increases with increases in GVF.

In general, the erosion is maximum for the inlet bearing and decreased in the direction of flow. However, for 20% GVF the inlet bearing wear is slightly less than to two subsequent bearings. This may be due to the severe decrease in head generated by the first stage which reduces the loading on the bearing.

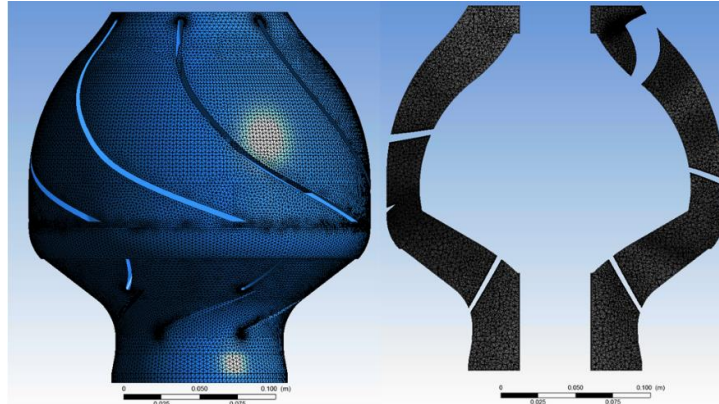
Unstructured mesh in the main flow path

**Model and Mesh:** Computational Fluid Dynamic Modeling can be utilized to evaluate the failure modes occurring due to sand presence. It can provide important information regarding design of the pump being affected due to the flow behavior in presence of sand. CFD simulation was utilized to obtain detailed flow data to evaluate the effect of sand presence on pump erosion. Hydraulic path of the pump was meshed using Star-CCM+ for unstructured mesh generation and ANSYS Fluent 17.1 for simulation.

The mesh independence was tested with the main flow path for one set of impeller and diffuser. The simulation’s environment is based on the 2nd stage in the 0% GVF test. This simulation setting is 3D transient realizable k- ε model with standard wall function, with a mass-flow inlet and a pressure outlet. The outlet is kept at 216.1209 psig while the inlet has the incoming mass flow of water at the rate of 67.18282 kg/s. After the impeller’s rotation exceed 10 rounds at a 3600rpm, the flow becoming fully developed turbulence and the inlet pressure become stable. Three sets of unstructured mesh are tested in this part. The original one has over 2 million tetrahedral cells in impeller and over 1 million tetrahedral cells in diffuser. The 2nd mesh increases cell number by 30% and the 3rd mesh increases cell number by 50%. The result is shown in Table 2. The pressure difference due to mesh size is less than 0.2%, thus the original mesh is suitable for this simulation.

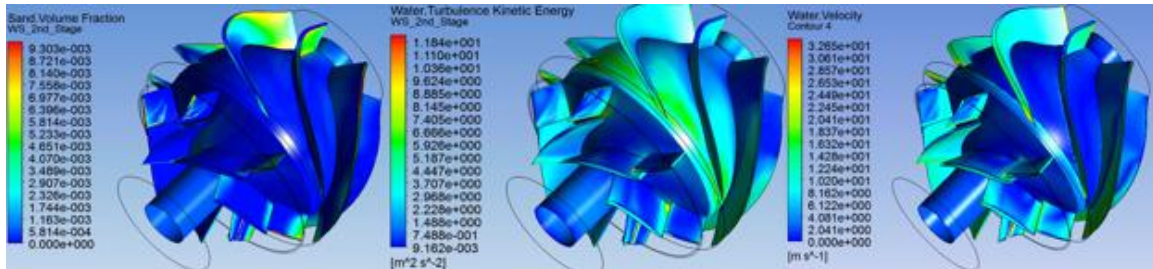
Figure 17: Distribution of (a) Sand Volume Fraction and (b) water turbulence kinetic energy (c) Water Velocity on stage vanes and hub at the 2nd stage for 0% GVF Eulerian simulation

**Erosion Prediction:** Erosion modeling was performed using ANSYS Fluent Euler-Granular model. A set of equations are obtained by deriving conservation equations for each phase. Flow behavior was evaluated using sand volume fraction, water velocity and turbulent kinetic energy distribution. Split vane pump is preliminarily used to handle fluid with high gas void fraction by inducing turbulence in the flow. However, the presence of abrasives may have an adverse effect on erosive characteristics of this kind of pump. Figure 17 shows increased turbulence levels due to special design of an impeller, sand volume fraction and water velocity near the stage wall.

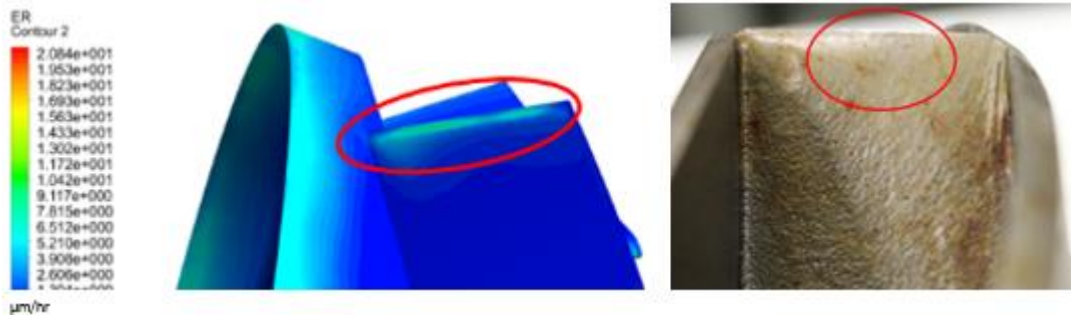
Figure 18: Erosion prediction on pressure side of outer blade

Erosion model developed by Pirouzpanah which is based on parameters discussed above is used for the prediction. Higher erosion rates were observed across areas such as pressure side of the back vane (Figure 18), intersection between front vane trailing edge and back vane leading edge (Figure 19) and the diffuser inlet section (Figure 20). Qualitative prediction of CFD results agree well with eroded location. Features such as steeper blade exit angle and split vanes are the design features to induce the turbulence, however, induced turbulence also caused the higher erosion rates as predicted by model.

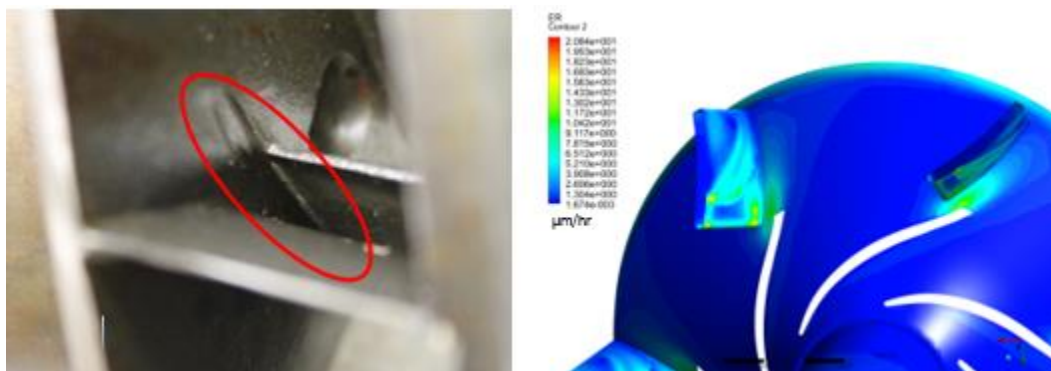
Figure 19: Erosion prediction at split area of impeller blade

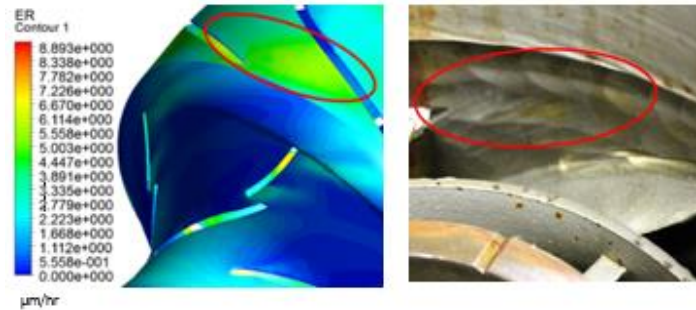
Figure 20: Erosion prediction at inlet shroud area of diffuser.
