IMPROVING ROADWAY DIAGNOSTICS USING NETWORK-LEVEL DATA

A Dissertation

CHARLES FELDER GURGANUS

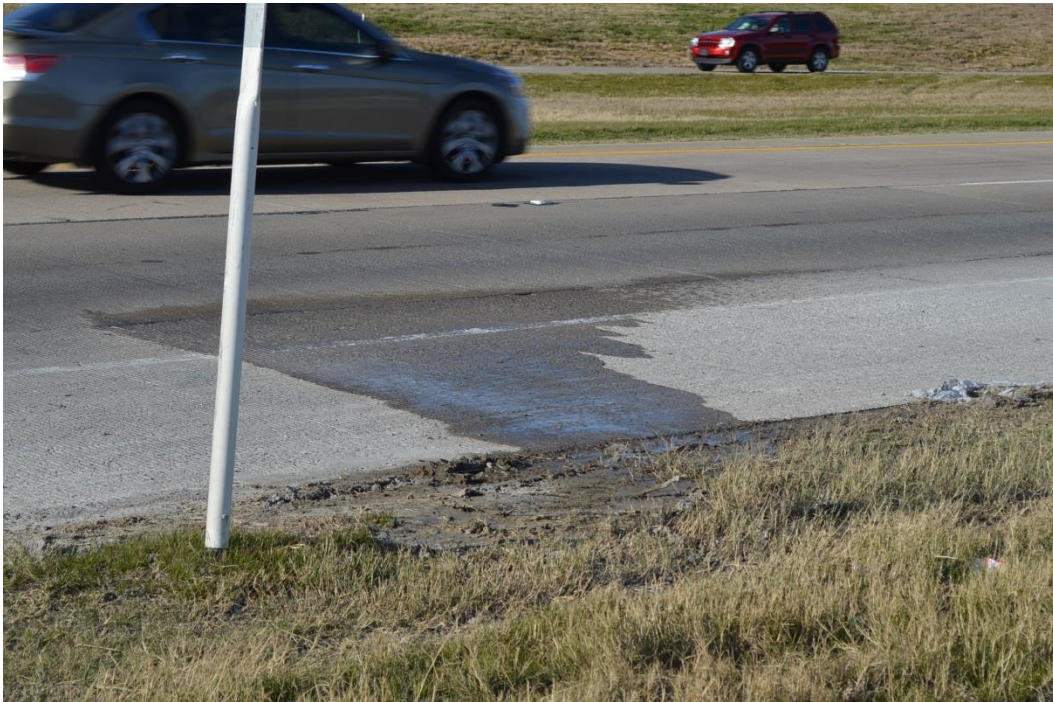
Fig. 1. Water pumping through a pavement structure due to inadequate surface drainage and pavement distress

For highway pavements, extensive damage can be caused by both surface and subsurface water entering lower, unbound layers more quickly than it can exit (Winterkorn and Fang 1975). When water becomes entrapped within the pavement structure, the strength of unbound layers and subgrade soils is greatly reduced. Loading a pavement with wet sublayers results in a loss of support (Huang 2004). The need to properly drain pavements using pavement geometry and roadside geometry to ensure the expected design life has been advocated for many years (Cedergren 1987; Birgisson and Ruth 2002). Though the problem has been noted for years, it continues to plague SHAs. Fig. 1 is a photo of water being pumped out of concrete pavement by passing traffic, taken by the researcher in 2016. This water was initially surface water that was not adequately drained away from the roadway.

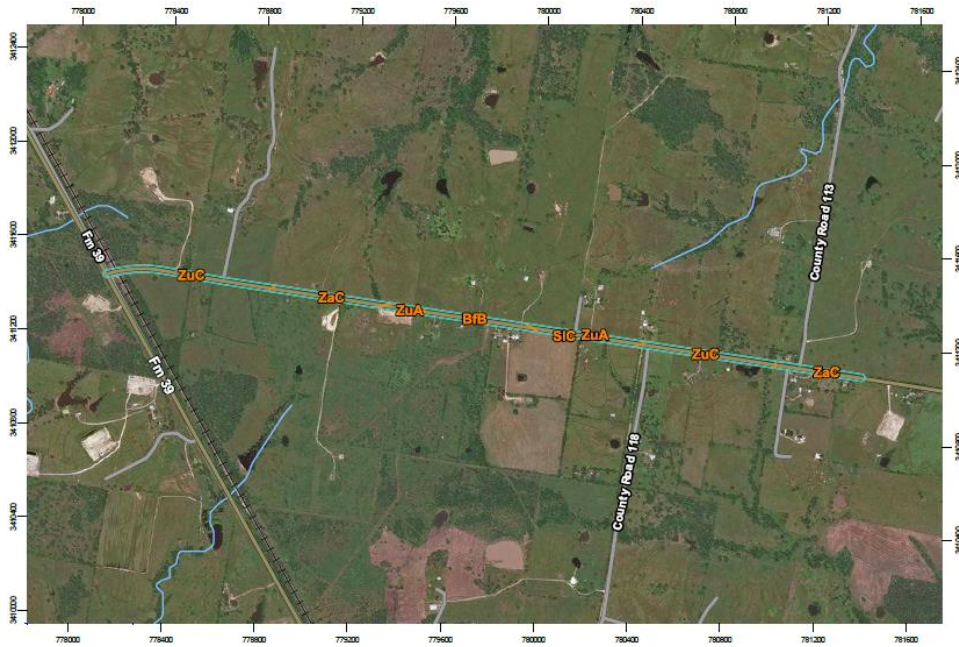
Fig. 3. Example of soil map for FM 1696

The AASTHO system uses seven groups, listed as A-1 through A-7. With regard to subgrade quality, soils classified as A-1 through A-3 are typically considered excellent to good, while soils classified as A-4 through A-7 are fair to poor (Budhu 2015). Fig. 3 is an example of a 3.22 km (2 mi) soil map of FM 1696 showing the soil labels at different locations along the roadway. Table 3 has the AASHTO soil classification at different depths for the same portion of the FM 1696 project as the soil map in Fig. 3. Table 3 also has the percent of the area of interest (AOI) of each soil type within this portion of the project that was used to develop a weighted classification for each 3.22 km (2 mi) section of a project.

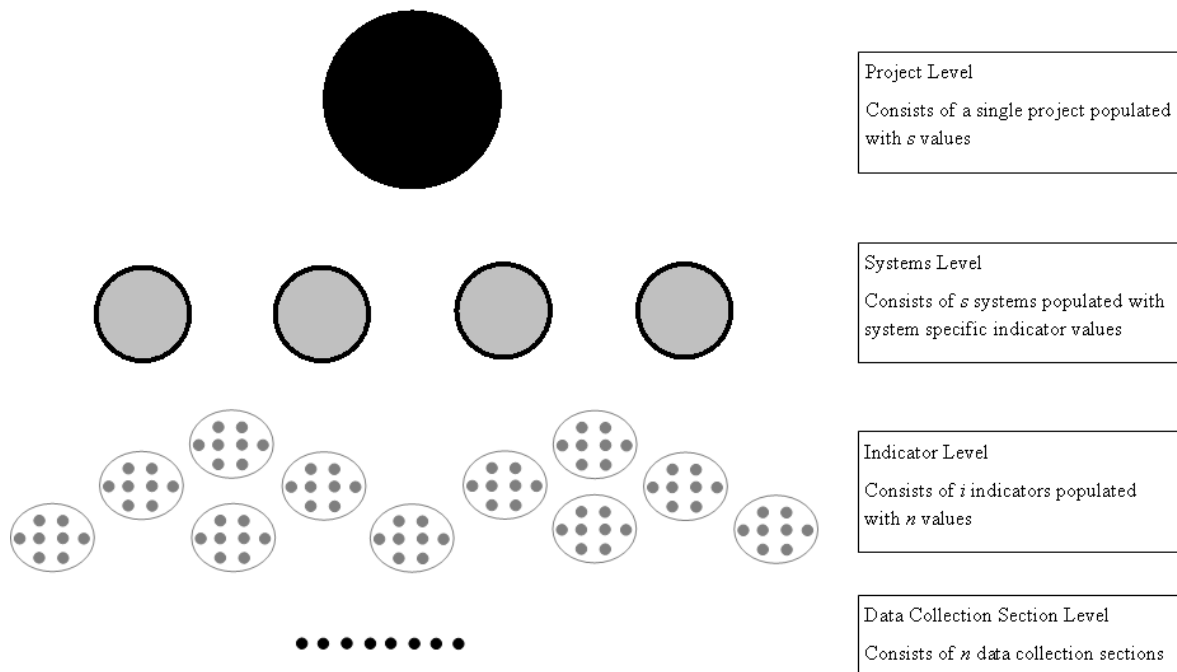
Fig. 4. Conceptual representation of a roadway project as a network

Conceptually, the network looks like Fig. 4 for a project with eight data collection sections.

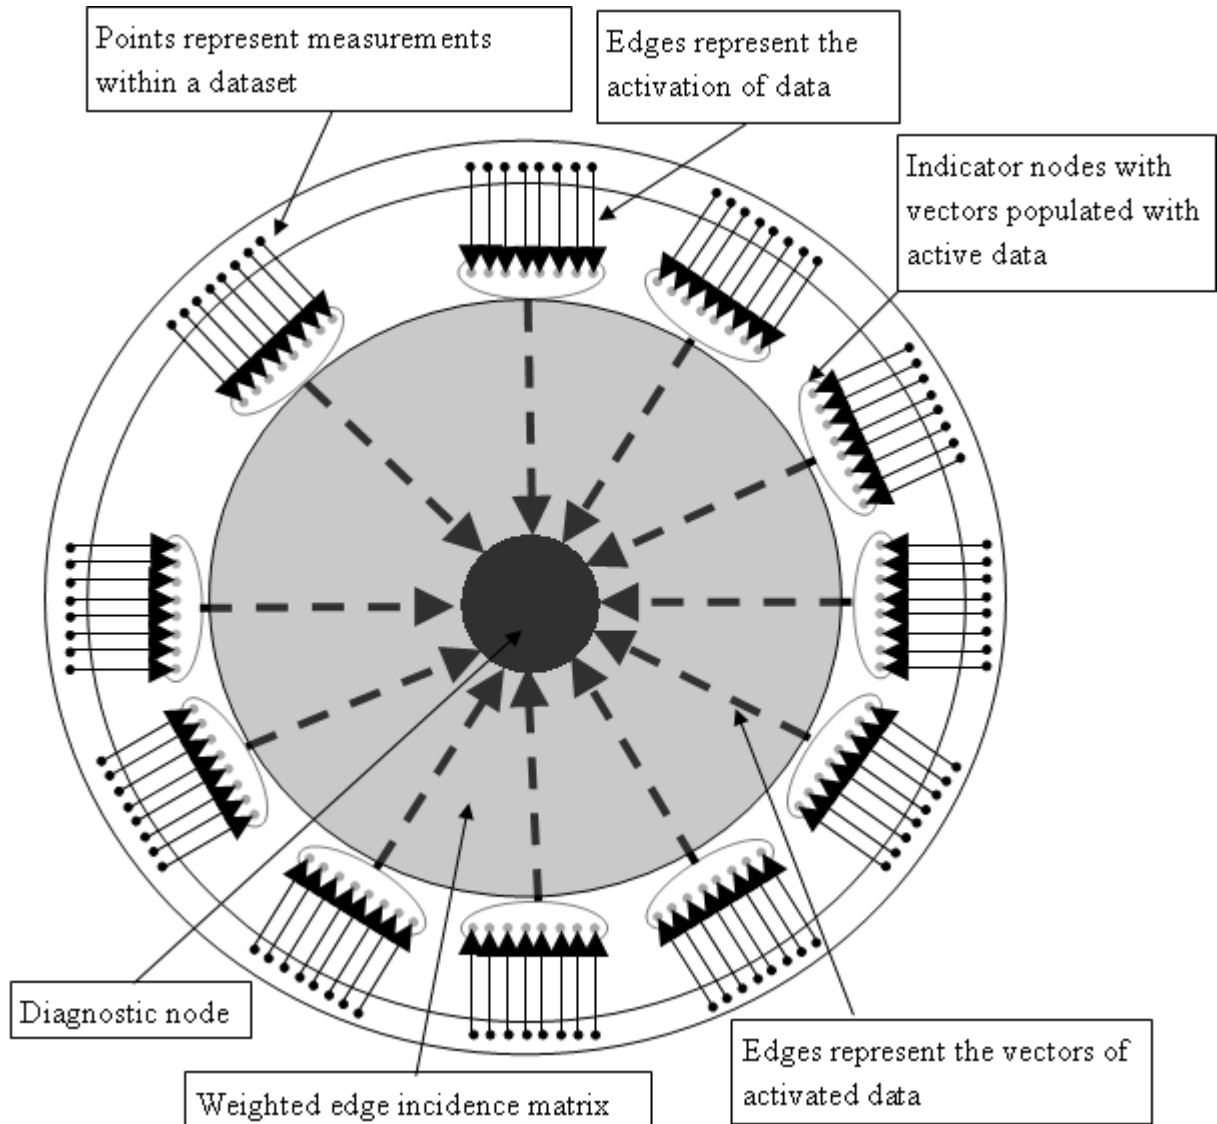
Fig. 5. Project representation as a weighted directed acyclic graph (DAG)

weighted edge incidence matrix provide the diagnostics for the project as a whole and ultimately for various project systems and all of the indicators.

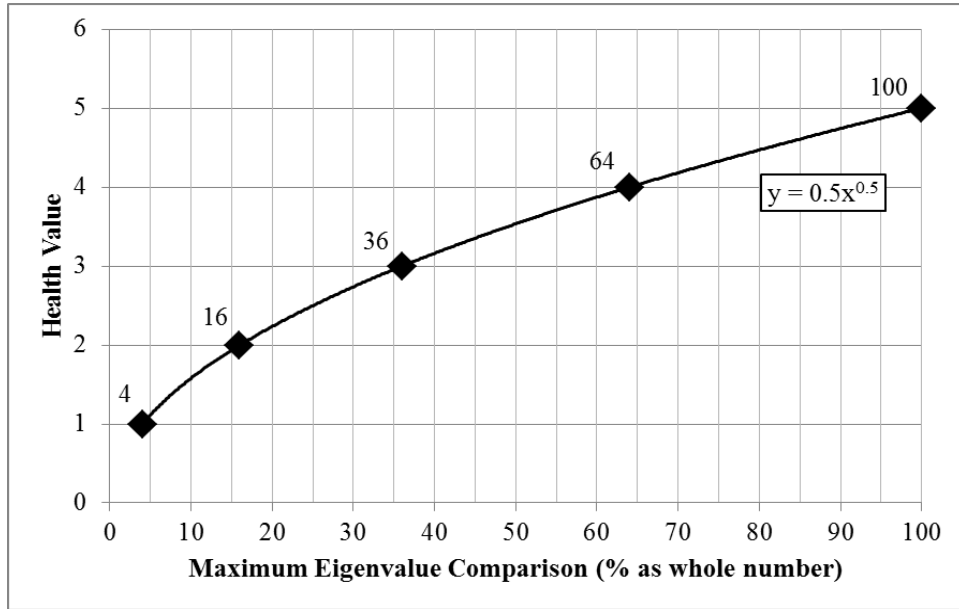
Fig. 6. Health curve

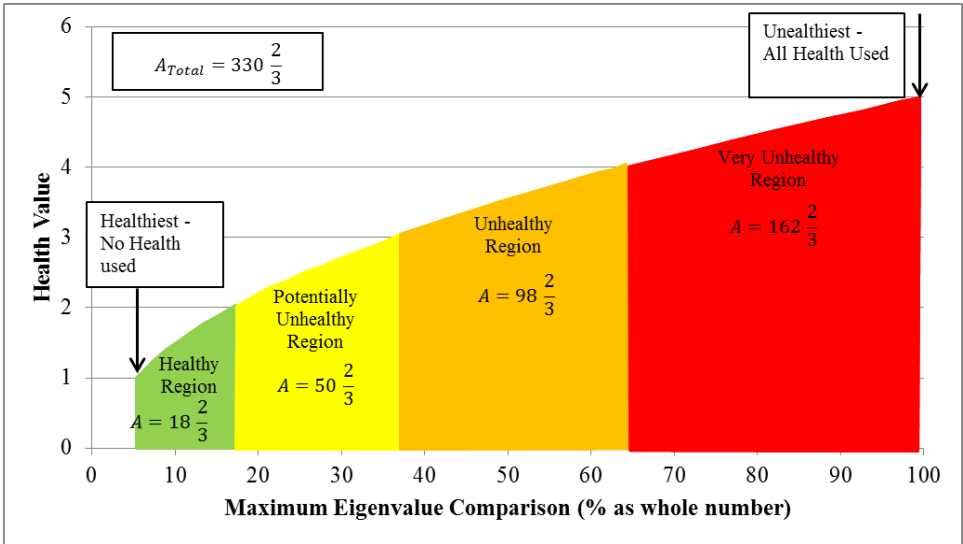
Fig. 7. Integrated health curve with health regions

produced Fig. 7, color coded based on health regions that are used to qualitatively describe the health. The color coding and overall appearance of Fig. 7 provided the foundation for the visual aid created within the diagnostic method. Table 5 contains the values associated with the integrated health curve as well as showing the region boundaries in terms of both area and indicator value.

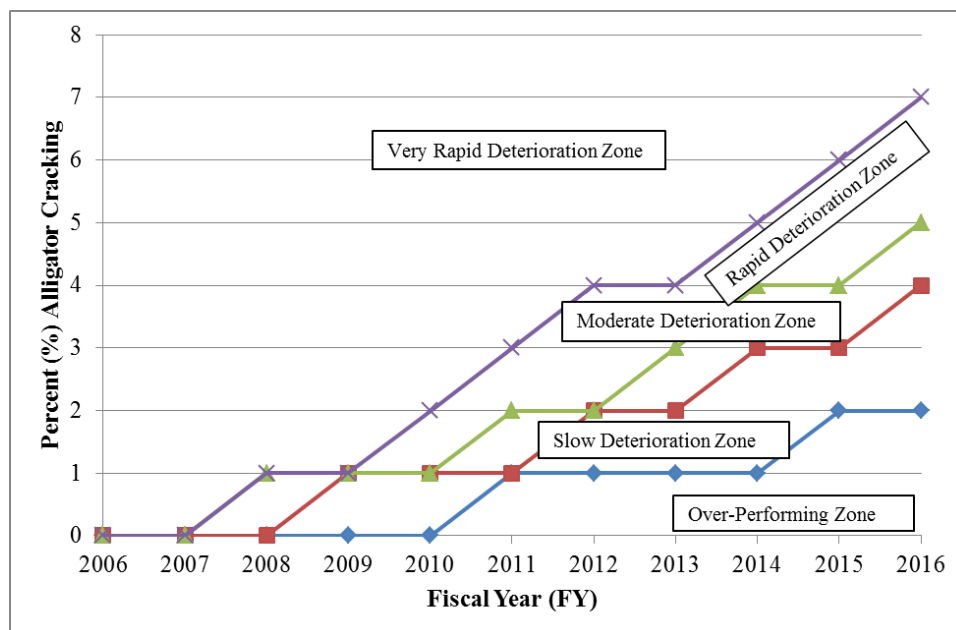
Fig. 9. FM 1696 project alligator cracking control chart

Fig. 9 shows an example control chart for the FM 1696 project.

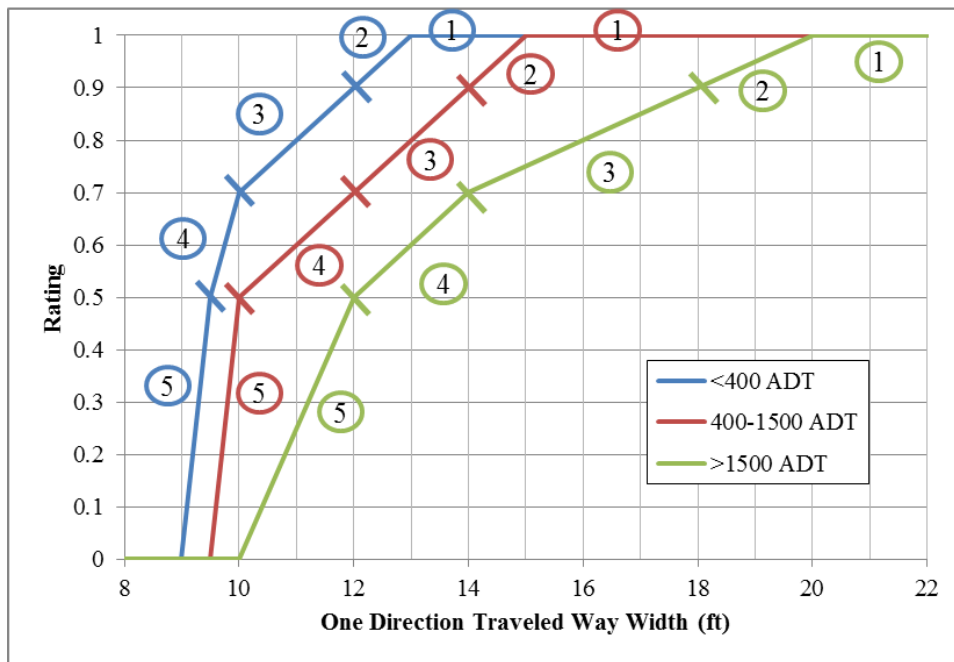
Fig. 10. Traveled-way width data activation curves

While 4R design standards represent the ideal, 3R standards provide guidance on what is acceptable for the existing system. For activation purposes, the ideal represents a perfect indexed value. The traveled way width data was activated for inclusion in the weighted edge incidence matrix using the curves in Fig. 10.

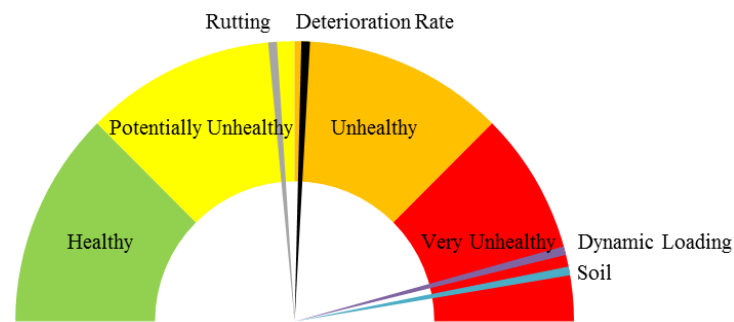
Fig. 15. FM 1696 structural system diagnosis

Fig. 15 shows the FM 1696 structural system diagnostic plot. Fig. 14 intimated from a diagnostic standpoint that the structural system was the unhealthiest system, almost falling within the very unhealthy band. Fig. 15 provides insight as to why the structural system is unhealthy, driven predominantly by the very unhealthy behavior of the dynamic loading indicator and the soil indicator. On the other hand, the rutting indicator presents as potentially unhealthy, but the healthiest of all structural indicators. The deterioration rate falls within the unhealthy band, but the relative distance between deterioration rate and dynamic loading load was large. Fig. 15 allows the decision maker to visually see that dynamic loading and soil conditions must be addressed within the planned project.

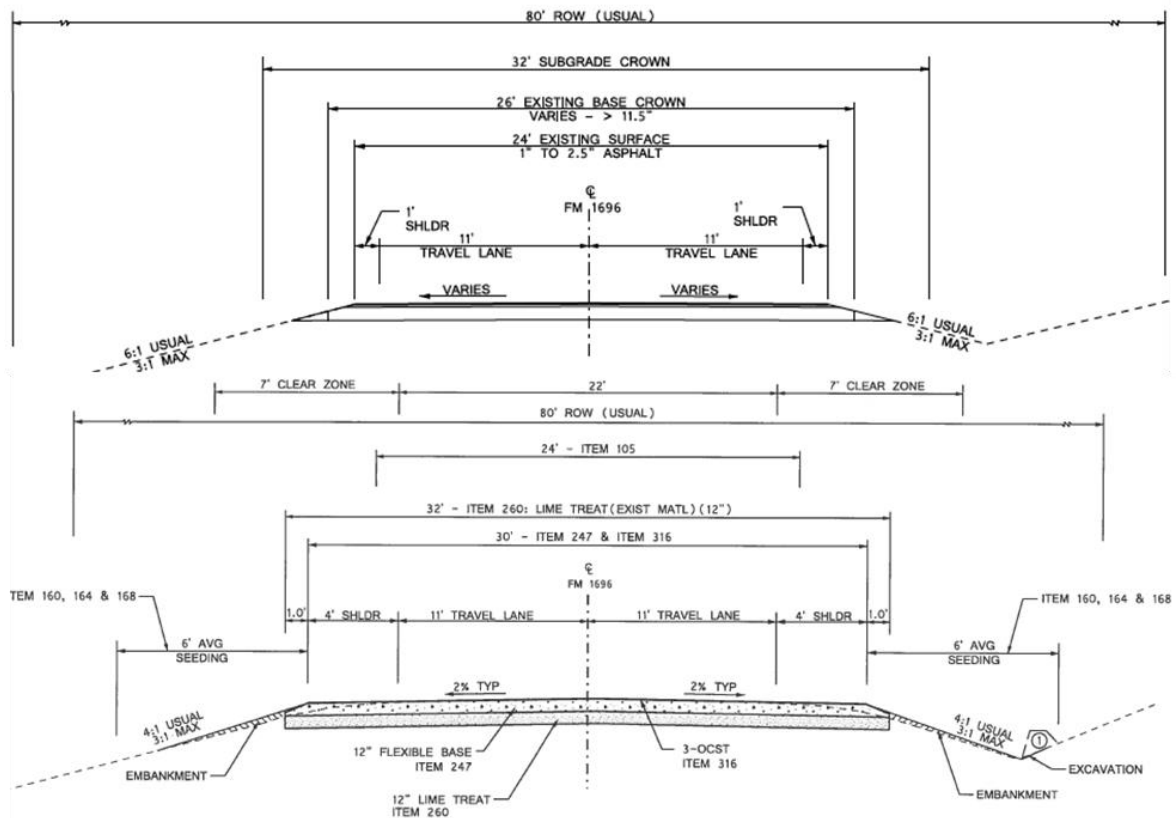
Fig. 19. FM 1696 existing and proposed typical section

shows that FM 1696 currently has a 7.32 m (24 ft.) paved surface over a 9.75 m (32 ft.) subgrade crown. The proposed section widens the paved surface to 9.14 m (30 ft.) over a 9.75 m (32 ft.) lime treated subgrade in the clay areas. The usual front slope increases from 6(H):1(V) in the existing section to 4(H):1(V) in the proposed section. Each of these elements agrees with the diagnostic information produced using the new diagnostic method. Widening the paved surface and treating the subgrade addresses the very unhealthy indicators, dynamical loading and soil. It also likely addresses roughest year and roughness change indicators that have a current health close to the very unhealthy line.

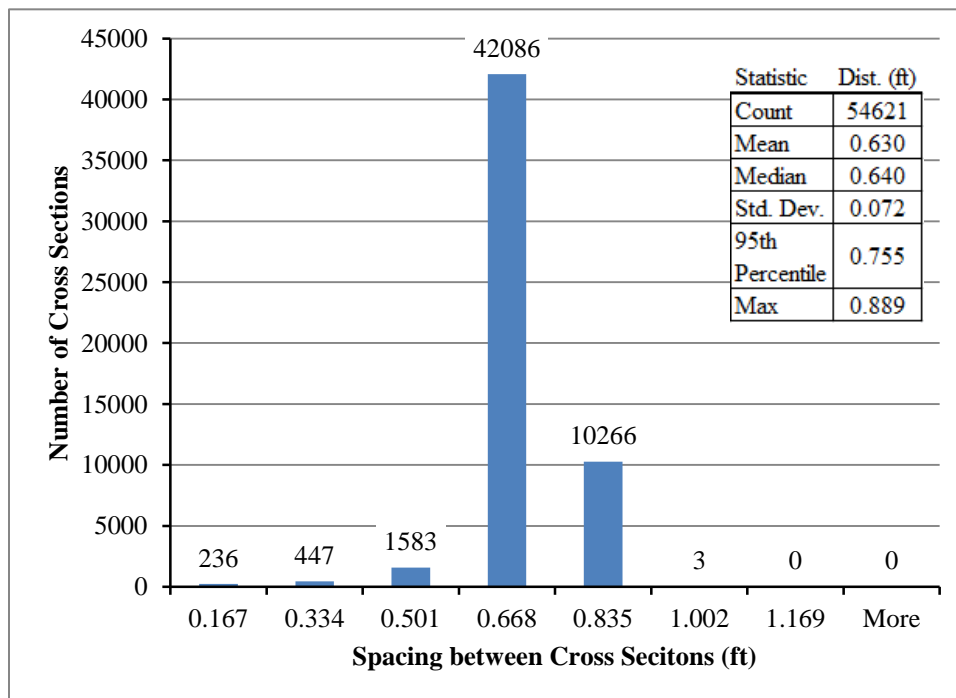
Fig. 34. Transverse cross section spacing over multiple miles traveling at approximately 43 mph (English Units)

Longitudinal spacing represents the spacing between cross section measurements and must be accounted for during data reduction. Using mobile LiDAR, transverse cross sections are taken on small intervals, typically less than 30 cm (1 ft.). Fig. 34 displays transverse cross section spacing for a 10.5 km (6.5 mi.) section of rural highway. On this roadway, 54,621 transverse strings of data were created. The average spacing between these strings is 19.2 cm (less than 8 in.) apart. Data were collected on this roadway section at an average vehicle speed of 69 kph (42.9 mph).

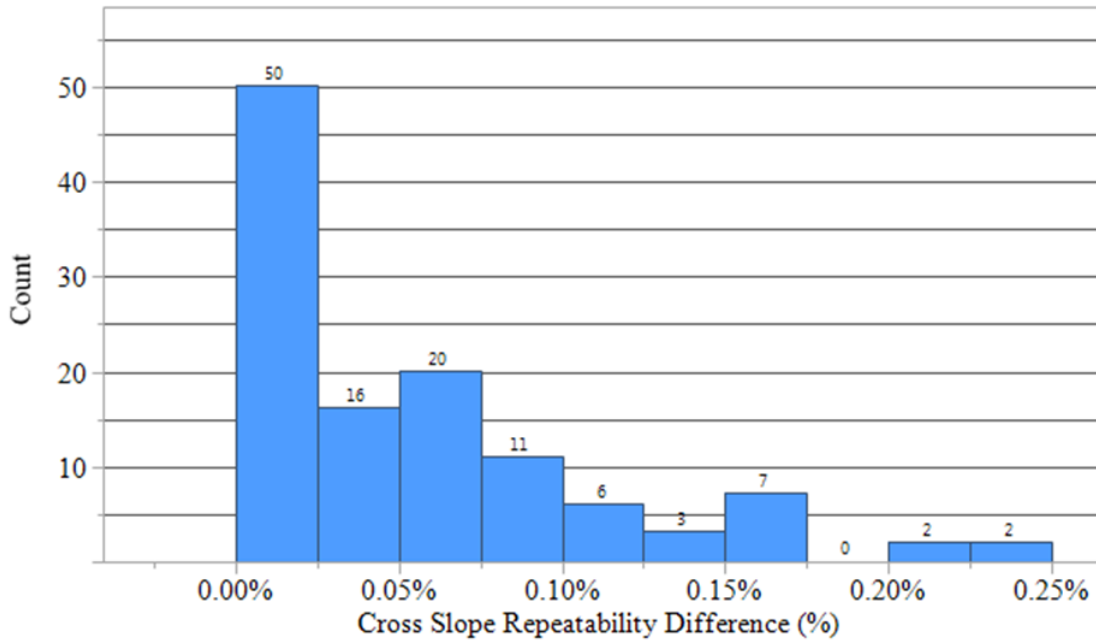
Fig. 37. Histogram of cross slope repeatability between MLS runs

The multiple runs associated with this accuracy analysis allows for a comparison of the repeatability of the cross slope measurement. Fig. 37 shows that 83% of cross sections have cross slope repeatability within 0.10% and 91% within 0.15%.

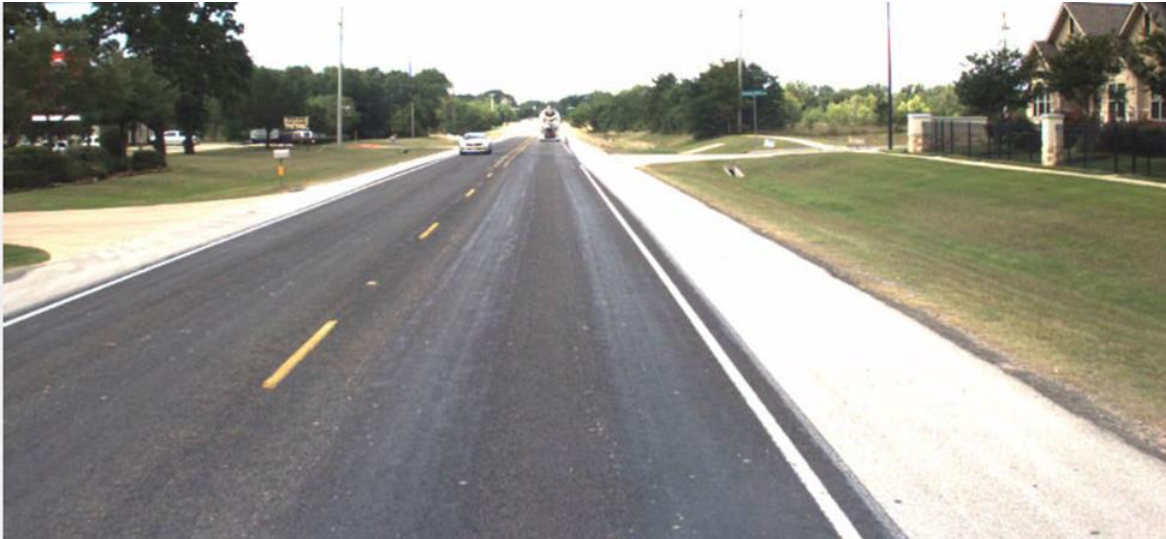
Fig. 38. SH 30 on the day of MLS data collection

Along the right roadside, a finished mowed surface creates a ditch or roadside surface between one inch and three inches higher than the actual ground surface. Vegetation also affects the measured slopes of the roadside. For rural areas, vegetation is expected to be higher. Ideally, data collection will occur immediately following the TXDOT mowing cycle. Under Item 730 in TxDOT's Standard Specifications, roadside mowers should be set to between 12.7 cm (5 in.) and 17.78 cm (7 in.) (Texas Department of Transportation (TxDOT) 2014d).

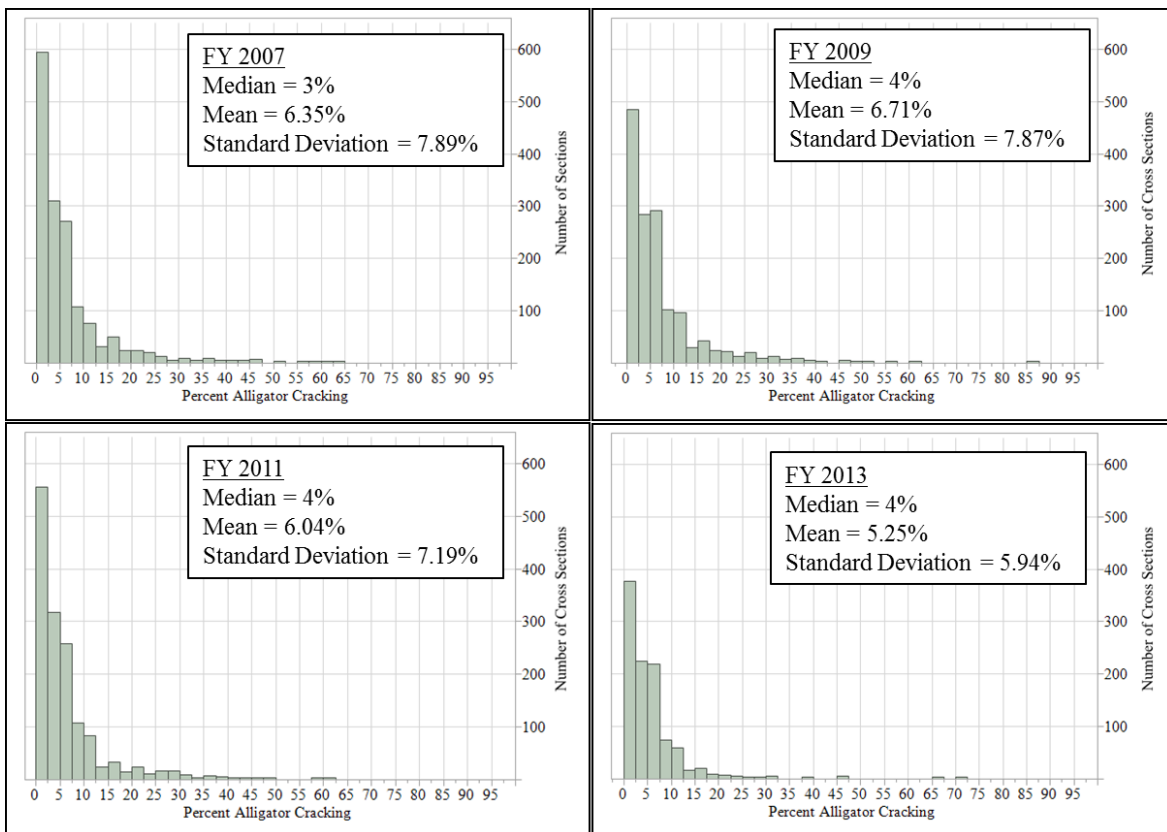
Fig. 42. Percent alligator cracking histograms for Austin District pavement sections in FY 2007, 2009, 2011, and 2013

Pavement distress data does not follow a normal distribution. Fig. 42 shows histograms for percent alligator cracking from the TxDOT Austin District across four fiscal years. The data is highly right skewed with standard deviations higher than the mean value.
