## ASIA TURBOMACHINERY & PUMP SYMPOSIUM

# Unexpected Vibration on a Centrifugal Compressor Caused by Vibration Probe Support

Yves Bidaut

MAN Energy Solutions Schweiz AG

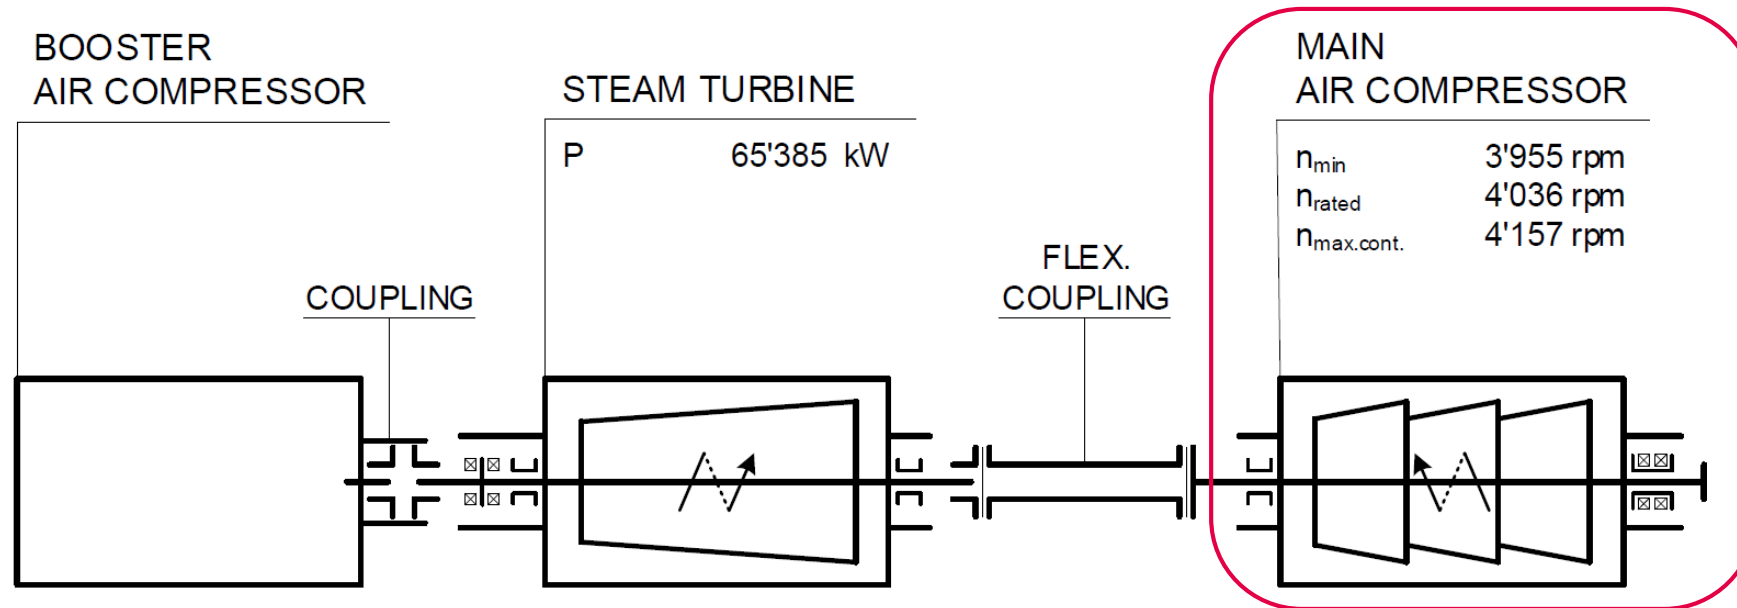
# Background – Train Arrangement, Compressor

Main Air Compressor	
	3 stages, in-line
	Internal coolers between St. 1 - 2 and St. 2 - 3
	Tilting Pad Journal Bearing

Feature Main Air Compressor	SI Unit	
Suction Pressure	bara	0.9
Discharge Pressure	bara	5.6
Suction Temperature	°C	28
Discharge Temperature	°C	90
Mass Flow	kg/s	160
Gas (MW)	- (g/mol)	Air (29)

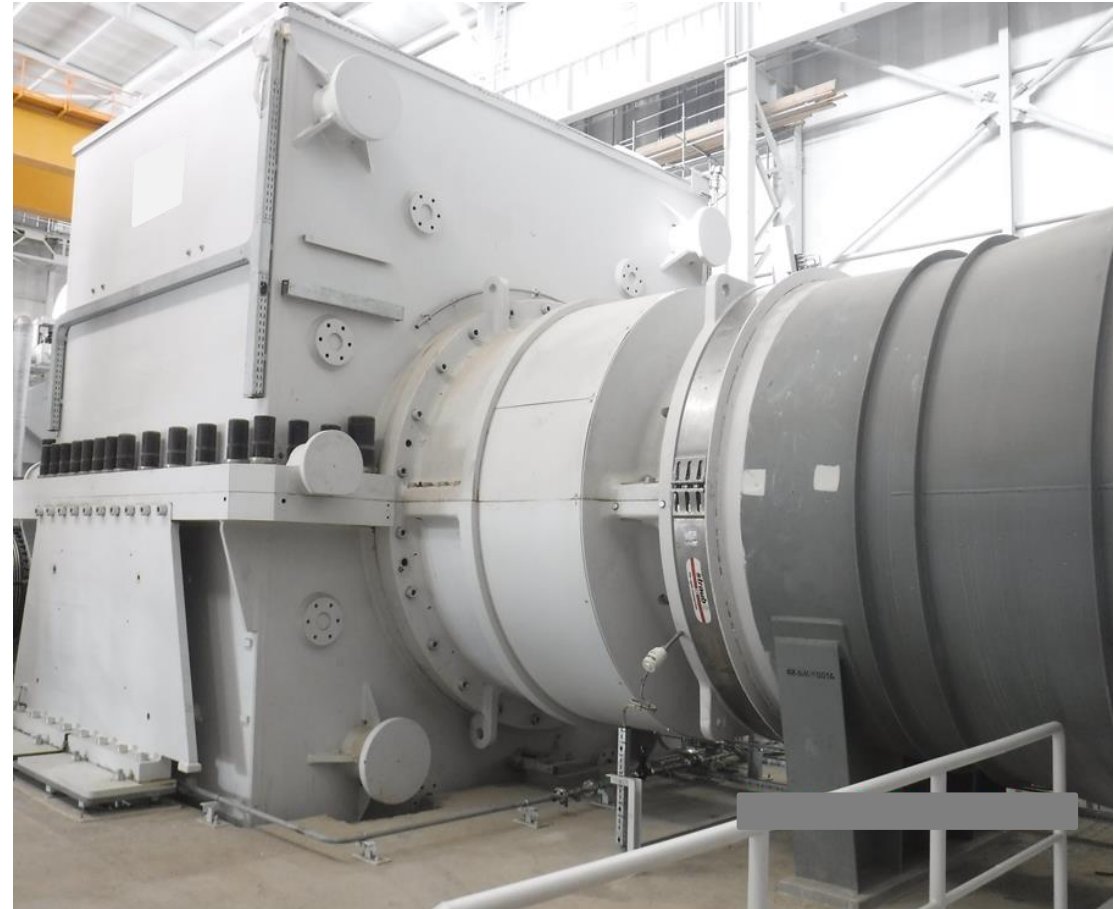
# Description

- Standard Compressor, designed for a wide speed range. Same machines (100% repeat) already in operation w/o any issue.
- Machine delivered on site w/o test
- During commissioning:
  - increased radial vibrations appeared at Non-Drive End probe
    - Vibrations below trip limit
    - Vibrations increased with opening IGV
    - Because of unexpected vibrations
      - Origine of phenomenon investigated.

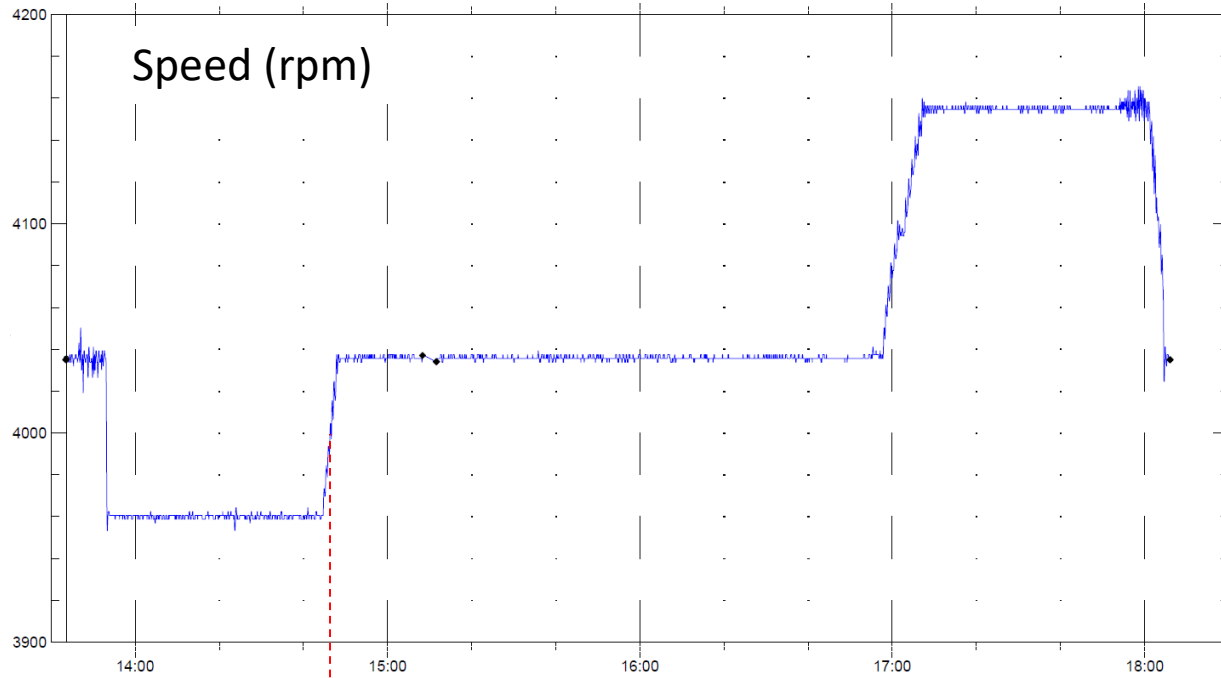
# RCA – Further Investigations – Test 1

Test	IGV	Speed	Discharge Pressure	ASU
1	35%	3'960 rpm	≈ 2.9 bara	100% → 90%
		4'036 rpm	2.9 → 4.7 bara	100% → 65%
		4'155 rpm	≈ 3.1 bara	100% → 80%

## Vibrations NDE:

- Sudden increase @ ≈ 4'000 rpm
- Then slight decrease with increased pressure
- More sensitive to speed than to pressure

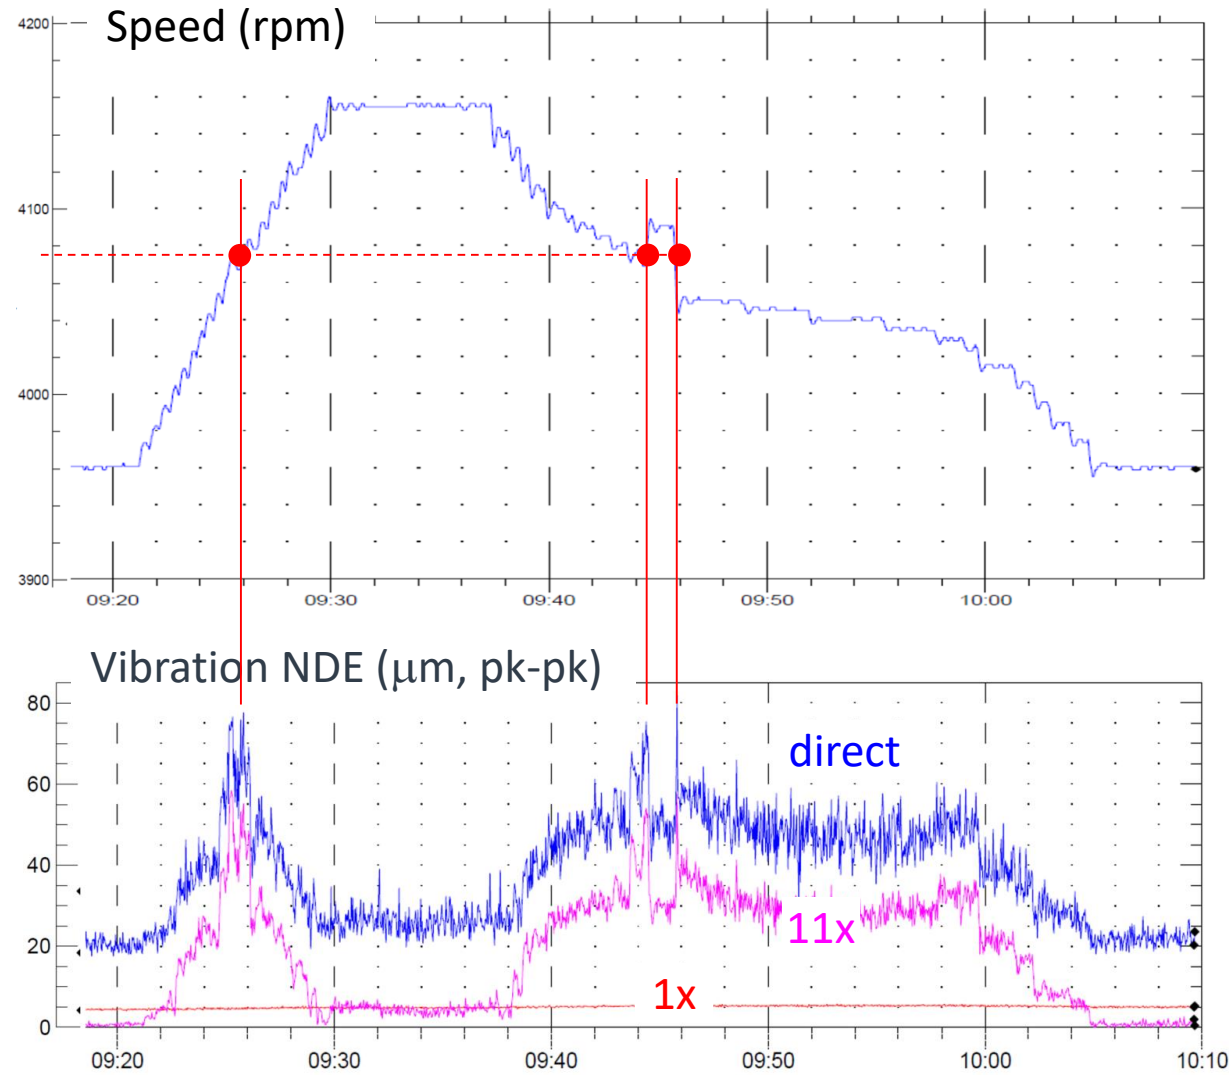
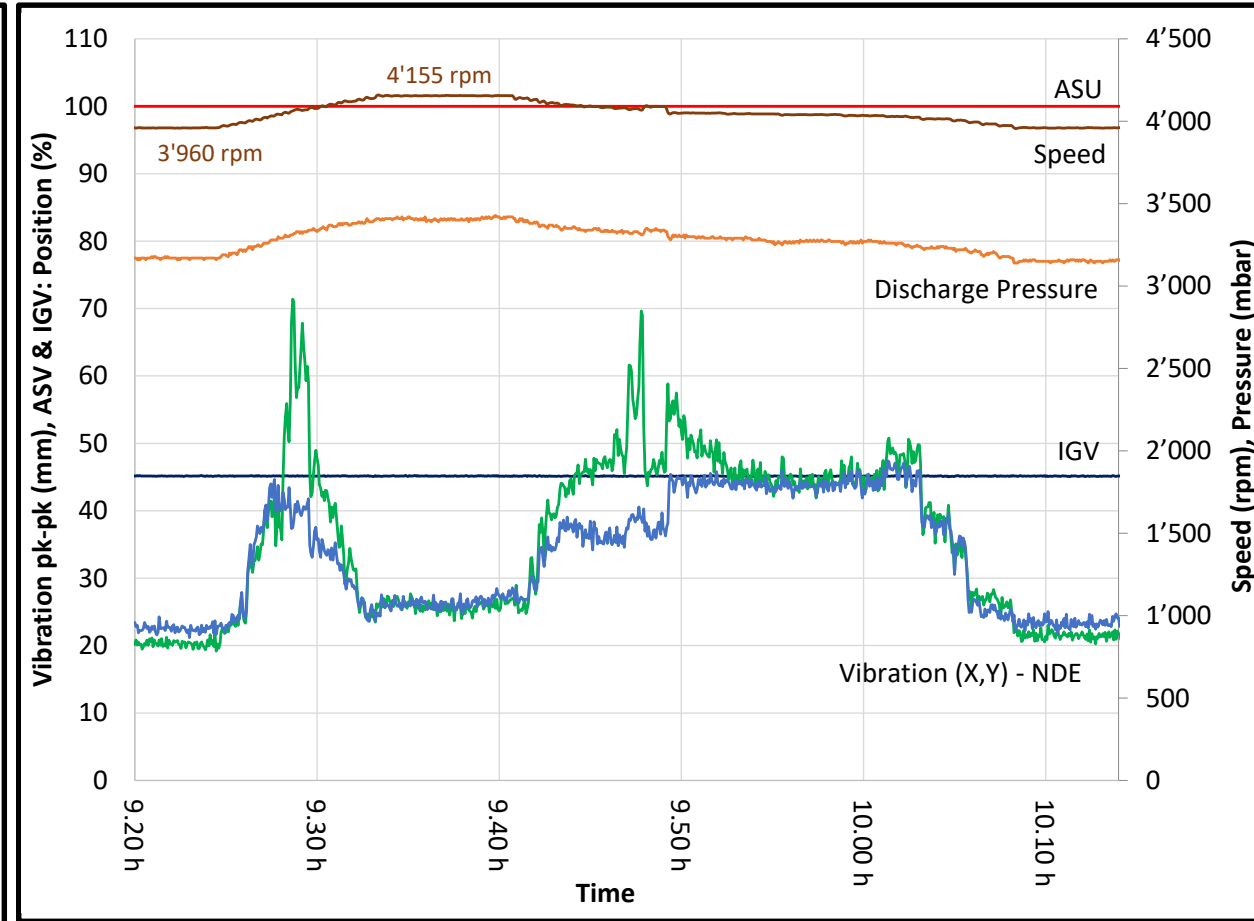
# RCA – Further Investigations – Test 4

Test	IGV	Speed	Discharge Pressure	ASU
4	45%	3'960 → 4'155 rpm	3.2 - 3.4 bara	100%

## Vibrations NDE:

- Clear dependence on speed
- Max amplitude (80  $\mu\text{m}$ ) reached @  $\approx$  4'070 rpm

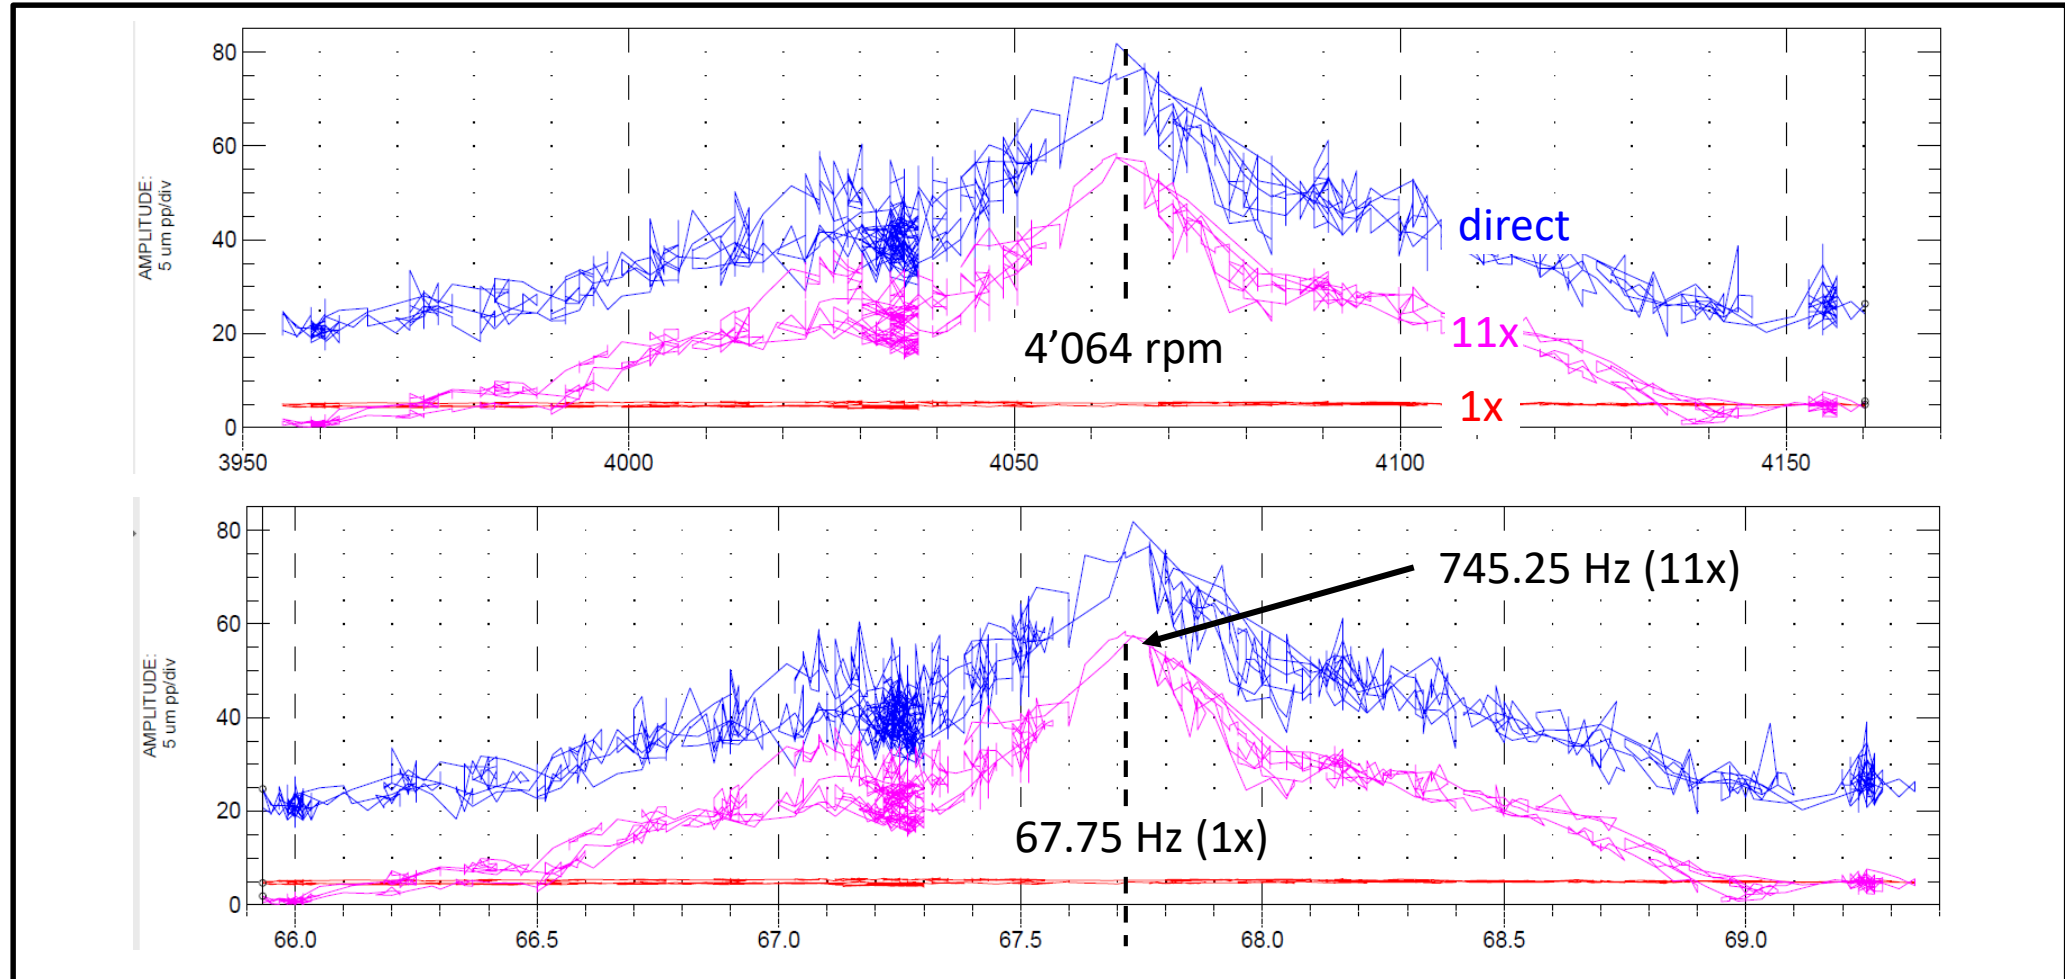
# RCA – Further Investigations – Test 4

Test	IGV	Speed	Discharge Pressure	ASU
4	45%	3'960 → 4'155 rpm	3.2 - 3.4 bara	100%

- Clear resonance @ 4'064 rpm and 11x harmonic
- Resonance frequency: 745 Hz

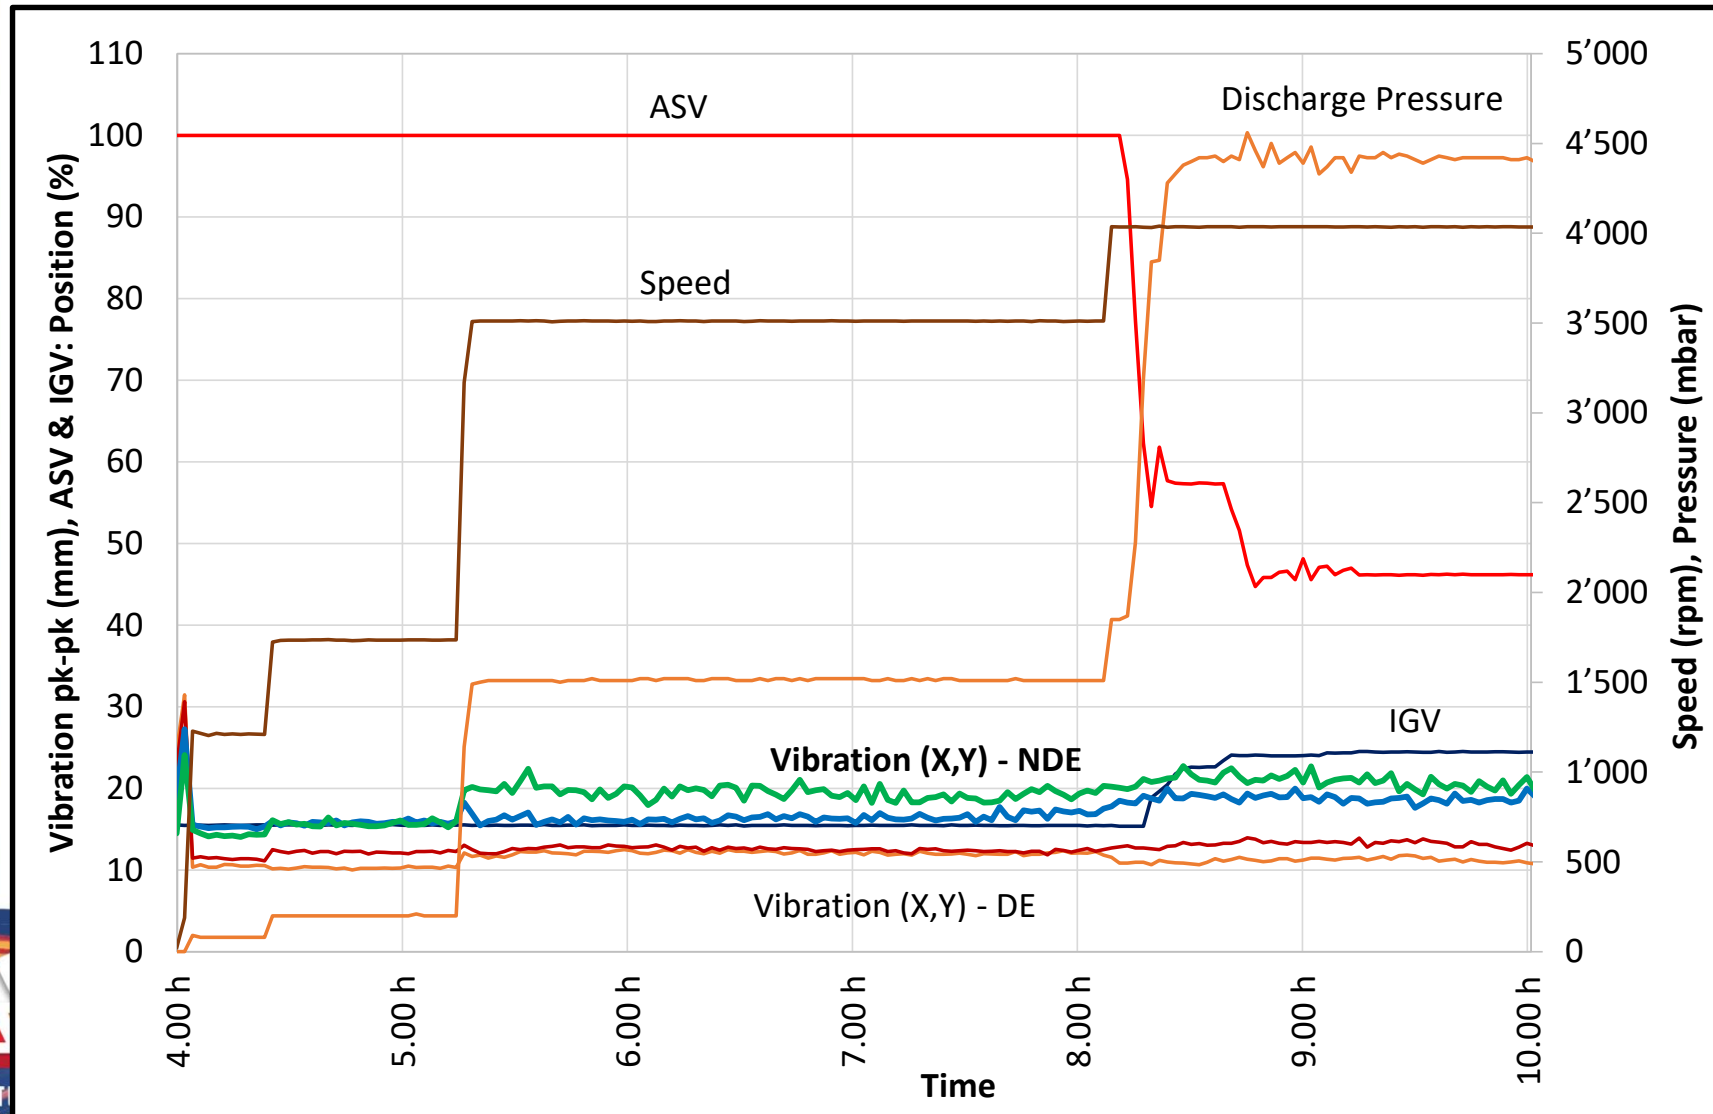
# Measurements after Modification

- All vibrations low and stable
