**DEVELOP STATEWIDE RECOMMENDATIONS FOR APPLICATION OF PCC
JOINT REFLECTIVE CRACKING REHABILITATION STRATEGIES**

A Thesis

Major Subject: Civil Engineering

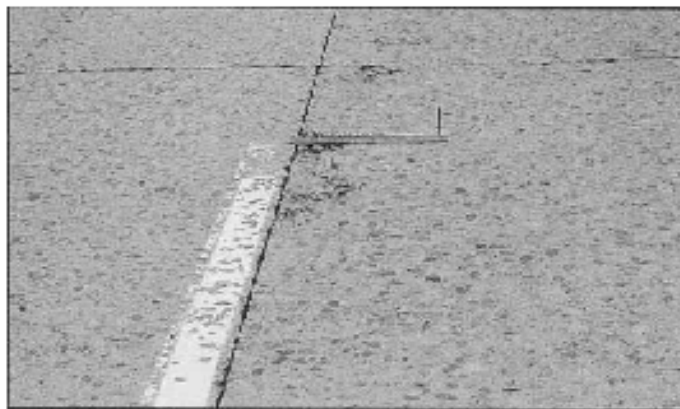
Spalling of cracks and joints is the cracking, breaking or chipping of the slab edges within 2 ft (0.6m) of the joint or crack (Huang et. al 2004). Joint spalling is a construction related distress in the rigid pavement that mainly affects the structural integrity of the concrete slab. The horizontal delaminations in the concrete slab result from early shrinkage of the concrete spread out under various conditions and give rise to spalls. Spalling does not extend vertically through out the entire slab thickness but extends to intersect the joint at an angle.

The primary factors causing the occurrence of spalling include early age characteristic of concrete mixtures, early sawing, improper load transfer at the joints, incompressible material in joints or cracks, alkali-aggregate reaction, D cracking and honey combing in the concrete at joints. Spalling mainly affects the smoothness and ride quality of the pavement. Partial depth and Full depth repairs are used to address spalling, depending upon the level of severity. Figure 2.1 (LTPP Distress Identification Manual, FHWA 2003) shows typical spalling failure in rigid pavements.

FIG. 2.1. Spalling Distress (LTPP Distress Identification Manual, FHWA 2003)

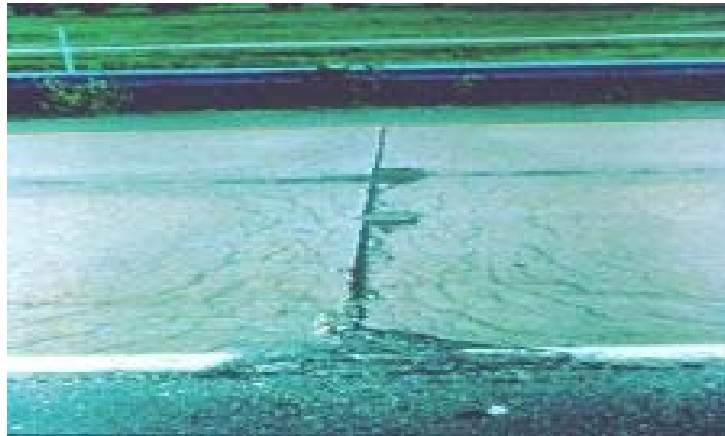
“D” cracking is the deterioration of the pavement due to freeze-thaw action in coarse aggregates. It is a material-related distress seen in the concrete pavements. “D” cracking appears as a series of closely spaced, crescent-shaped, hairline cracks that appear at the concrete surface adjacent to and roughly parallel to joints and cracks – and along the slab edge (Huang et al 2004).

The main factors that cause the development of “D” cracking include size of coarse aggregate, properties of coarse aggregates, availability of the moisture and occurrence of freeze-thaw cycles. “D” cracking significantly reduces the structural integrity of the pavements. Slab reduction techniques with overlays are used to eliminate “D” cracking in the concrete pavement. Figure 2.2 (<http://www.fhwa.dot.gov/pavement/full2.htm>) shows typical “D” cracking in concrete pavements.

FIG. 2.2. High Severity “D” Cracking (FHWA, 2002)

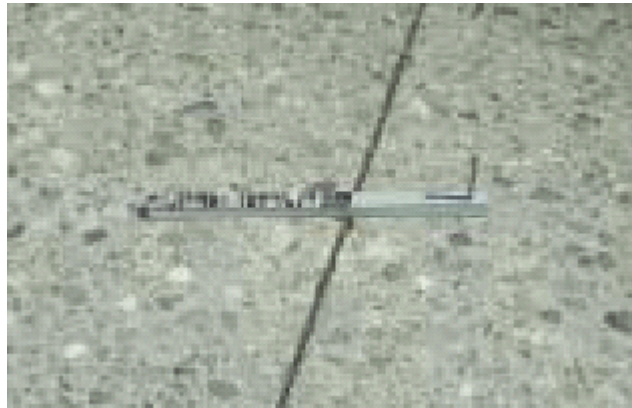
Joint seal damage is the loss of adhesion between the seal material and the joint faces, removal or displacement of sealer material. It is a material related distress in the concrete pavements. Sealers are used to fill in the space between the joints so that no debris or dust gets accumulated in the pavement surface. Under the influence of weathering and solar radiation, loss of bond occurs between the sealant and joints and the sealer material gets extruded from the pavement surface. The factors that cause joint seal damage may be the use of inappropriate sealant, improper installation of sealant or aging of the sealant. The treatment for joint seal damage is to remove the existing joint sealant, thoroughly clean the joint surface and reseal the joint with proper sealant. Figure 2.3 shows typical joint seal damage in concrete pavements.

FIG. 2.3. Joint Seal Damage (LTPP Distress Identification Manual, FHWA 2003)

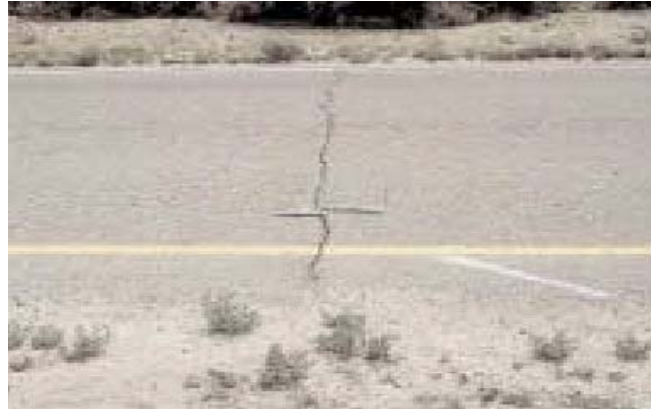
Transverse cracks are randomly oriented cracks that mainly occur at the pavement sections away from joint locations. The cracks are perpendicular to the central line of the pavement. Transverse cracking is the main structural distress occurring in the concrete pavements. The greatest stresses due to wheel loads occur at the outer slab edges, midway between the transverse joints, transverse cracking generally occurs at the mid slab portion of the concrete slab.

Mid slab cracking in concrete pavements occurs due to the fatigue damage under the influence of repeated wheel loading and hence is not much related to the type of coarse aggregate. The various factors that influence transverse fatigue cracking include the magnitude and number of wheel loads, thickness of the concrete slab, stiffness and uniformity of the base, degree of friction between the slab and the base and the degree of load transfer across the joints. There should be adequate reinforcement so that the width of the transverse crack is tightly held and there is proper load transfer across the crack. Figure 2.4 shows typical transverse cracking in concrete pavements.

FIG. 2.4. Transverse Cracking (LTPP Distress Identification Manual, FHWA 2003)

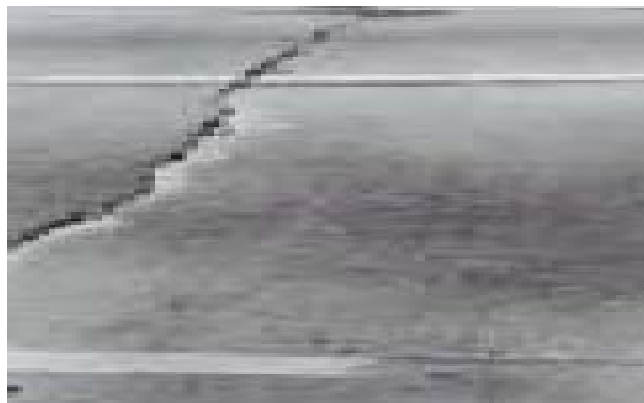
Faulting is a discontinuity in the pavement surface across the two adjacent slabs. It occurs at the joints or cracks of the abutting slabs. Faulting is environmental related distress. It is partly caused by the pumping of loose infiltrated materials under the application of heavy wheel loads at the approach slabs and partly due to the loss of support beneath the leave sides of the joints or cracks. The other factors include pumping and curling and warping stresses developed in the pavements and loss of load transfer across the joints. Figure 2.5 shows typical faulting in concrete pavements.

FIG. 2.5. Faulting Distress (LTPP Distress Identification Manual, FHWA 2003)

Faulting significantly reduces the ride quality of concrete pavements. Dowel bar retrofitting is used to repair moderate severity faulting areas. Slab reduction technique and overlay are used to repair high severity faulting areas.

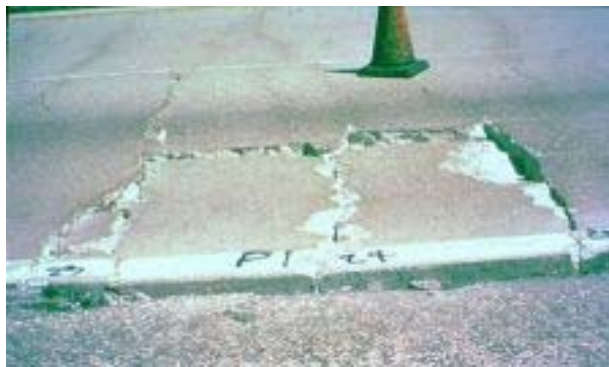
Punchouts are localized areas of failures in pavements caused by insufficient structural strength. Edge punchouts are major structural distress of continuously reinforced concrete (CRC) pavements and are characterized by a loss of aggregate interlock at one or two closely spaced, cracks, usually less than 2 ft (1.2 m) apart (Huang et al 2004). Punchouts are mainly caused by shrinkage and close transverse cracking and crack spalling.

The other factors that cause the development of punchouts are number and magnitude of wheel loads, thickness of slabs, stiffness of base, drainage conditions and erosion of support along the slab edge. Also consideration should be given to the aggregate properties such as shape, gradation and wear-out that will govern the aggregate interlock and the crack pattern formation. For low severity punchouts, the affected area is first removed and then patched. For high severity punchouts, slab reduction techniques with overlays are used. Figure 2.6 (<http://www.fhwa.dot.gov/pavement/full2.htm>) shows typical punchout formation in concrete pavements.

FIG. 2.6. High Severity Punchout (FHWA, 2002)

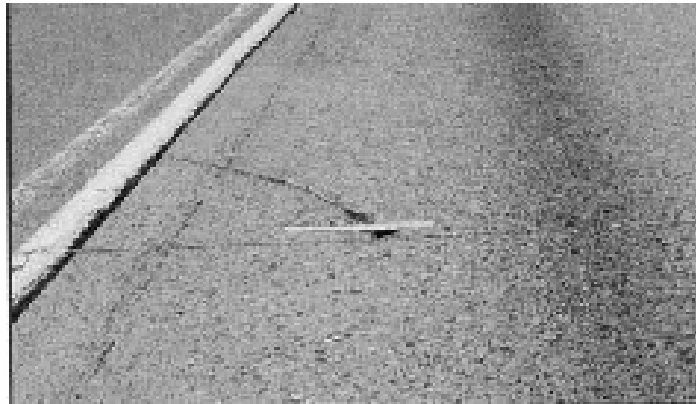
Corner break is a traffic load induced distress in the rigid pavement. It is the major structural distress in the concrete pavement. Corner break is a random diagonal crack that occurs at the intersection of the transverse and longitudinal joints. It is a vertical crack that propagates through the entire thickness of the slab. Corner breaks in concrete slab are mainly due to fatigue damage caused by the application of heavy wheel load repetitions

The other factors include the frequency and magnitude of the traffic load, thickness of the concrete slab, stiffness of the concrete slab and base, degree of load transfer at the joints, amount of steel reinforcement, coefficient of thermal expansion of aggregate and curling and warping stresses in the slab. Low severity corner breaks are not a serious concern and hence do not require any treatments. Crack sealing and full-depth patching is performed to repair high severity corner breaks. Slab reduction techniques and overlays are used to repair the pavements that have numerous corner breaks. Figure 2.8 (TM 5-826-6/AFR 93-5, USACE, 1989) shows typical corner break occurrence in the concrete pavements.

FIG. 2.8. Corner Break (TM 5-826-6/AFR 93-5, USACE 1989)

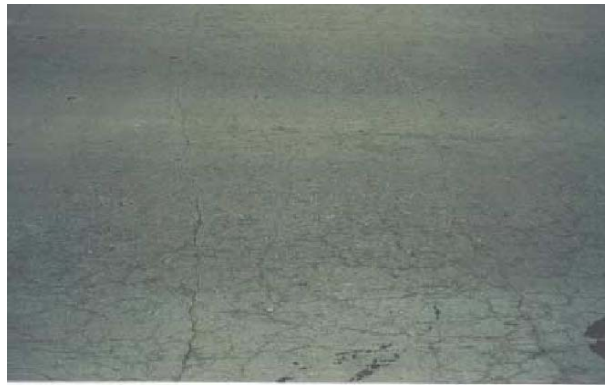
Alkali Silica Reactivity (A.S.R) is a formation of gel like substance on the surface of concrete pavements. It is a material related distress occurring in the pavement. Fine, closely spaced longitudinal cracks are seen at transverse joints and cracks, joint widths and compressed joint sealant. Reactive aggregates contain silica that chemically reacts with alkalies present in the Portland cement in presence of water to form a gel-like

substance. This gel-like substance then absorbs water and swells causing expansion and cracking of the concrete pavements. The other factors responsible for A.S.R include the portion of the reactive aggregates in the mix, alkali content of the cement availability of free water and the particle size of aggregates in the mix. Shoving occurs due to the expansion of concrete pavement with reactive aggregates. Advanced stage of alkali silica reactivity causes blowup distresses in the concrete pavement. Slab reduction techniques and overlay are treatments generally used for repairing this distress. Figure 2.9 (Visual Distress Survey Manual, SDDOT 2003) shows typical A.S.R in the concrete pavements.

FIG. 2.9. Alkali Silica Reactivity (Visual Distress Survey Manual, SDDOT 2003)

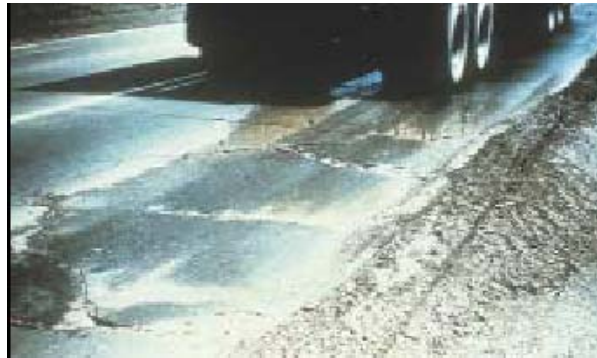
Pumping is the ejection of water, fines or silt through joints or cracks, caused by the deflection of slab under moving loads (Huang et al 2004). It is a traffic load induced distress in the pavement. As the slab gets deflected, water and fines are pumped vertically upwards through the longitudinal and transverse cracks and joints in the slab. This movement occurs in an opposite direction to the movement of the traffic. Under the influence of heavy wheel loads, the material is forced backwards under the approach corner and then finally it comes upwards through the cracks and joints.

The factors that cause pumping are the poor load transfer across the joints and cracks, erodible base materials, presence of excess water in pavement, warping and curling stresses in the pavements and heavy wheel loads. The treatment for pumping is to install the edge drains to remove the water and fines from the pavement subgrade and seal the cracks and joints. Figure 2.10 shows typical pumping in the concrete pavements.

FIG. 2.10. Pumping Distress (LTPP Distress Identification Manual, FHWA 2003)

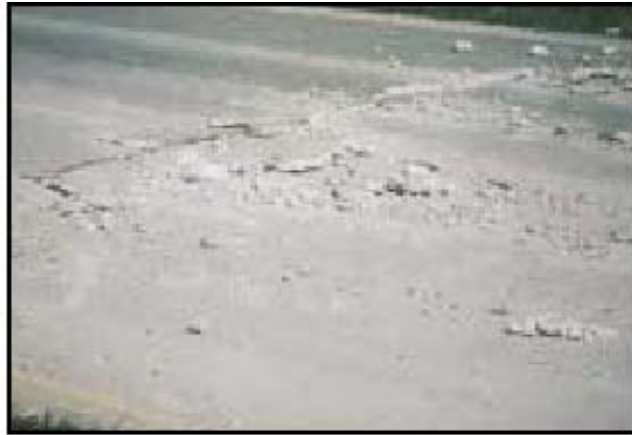
Blowup is a shattering of concrete pavement slab at joints or working cracks. It is an environmental related distress seen in the concrete pavements. They generally occur in hot weather climates at transverse cracks. Loss of sealant materials from joints causes infiltration of incompressible materials in the joints. During the hot weather period compressive stresses are induced in the slab. Blowups are thus induced due to these horizontal compressive forces. A shattering blowup will crumble the concrete on each sides of the crack. A buckling blowup will raise the pavement elevation by few inches on both sides of the crack.

blowups. In addition, poor joint sealant conditions and erodible base materials are some of the other factors that can cause blowups in the pavements. The treatment for blowups involves the removal of the affected area and then patching with suitable patch material. Figure 2.11 shows typical blowup in concrete pavements.

FIG. 2.11. Blowup Distress (LTPP Distress Identification Manual, FHWA 2003)

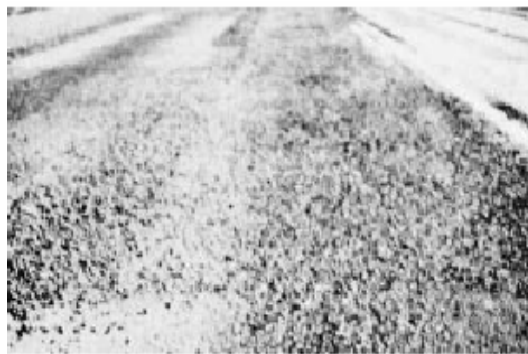
Ravelling is the progressive disintegration of a HMA layer from the surface downward as a result of the dislodgement of aggregate particles (Roberts et al 1996). Loss of bond between the aggregates and asphalt binder occurs either due to hardening of asphalt, localized areas of segregation in concrete mix or due to low in-place density of the mix. The loss of bond causes separation of asphalt and aggregate that ultimately causes raveling and weathering. Raveling can also be caused by inadequate compaction, construction in colder climates or overheating the mix. Raveling is generally recorded as the square meter of the affected area. However, there are no distress models or techniques available for modeling raveling distress. Raveling and weathering have potential for hydroplaning thereby creating safety hazards for the pavement. Figure 2.14 shows typical raveling in the asphalt pavements.

FIG. 2.14. Raveling (Iowa Design Guide, APAI 2003)

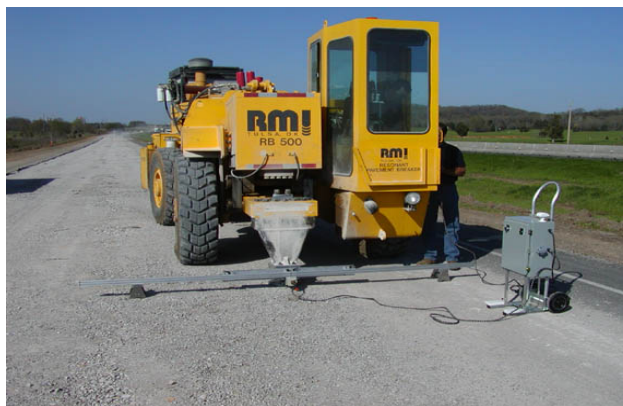
Rubblization involves breaking the existing pavement into pieces having a nominal maximum size of 75 mm or less and above 200 mm or less below any reinforcement before placing a new HMA overlay. This is primarily done to retard the reflective cracking by the total destruction of the concrete slab action. The work further includes the filling of granular material in the depression created by rubblization, compaction and seating (rolling) of the rubblized material, and removal of the waste material. Rubblization is a recycling technique. Several types of distress in concrete pavement require rubblization. The types of distress in concrete pavement that justify the rubblization technique when classified as low, medium or high severity distresses are durability "D" cracking, ASR, spalling and reflection cracking. Figure 2.15 describes typical resonant machine breaker.

FIG. 2.15. Resonant Machine Breaker (RMI 2002)

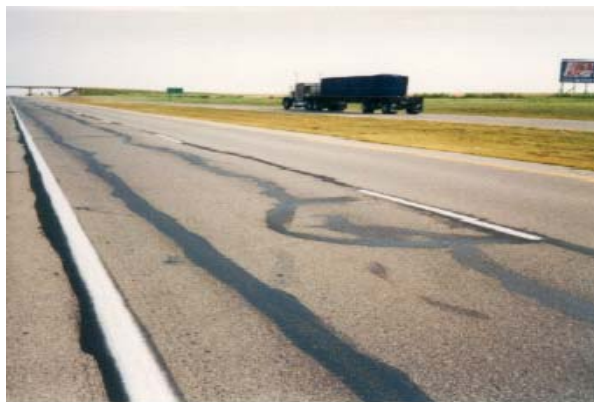
These distresses cause the concrete pavement to deteriorate and lose its structural integrity. Pavements that are in good condition but have reached the end of structural life are also good candidates for rubblization. Figure 2.16 describes a typical asphalt overlay over rubblized surface. The recognized design procedure for asphalt overlay design of rubblized concrete is AASHTO overlay design of fractured slabs (“Guide” 1994).

FIG. 2.16. Asphalt Overlay over Rubblized Surface (ACPA 1998)

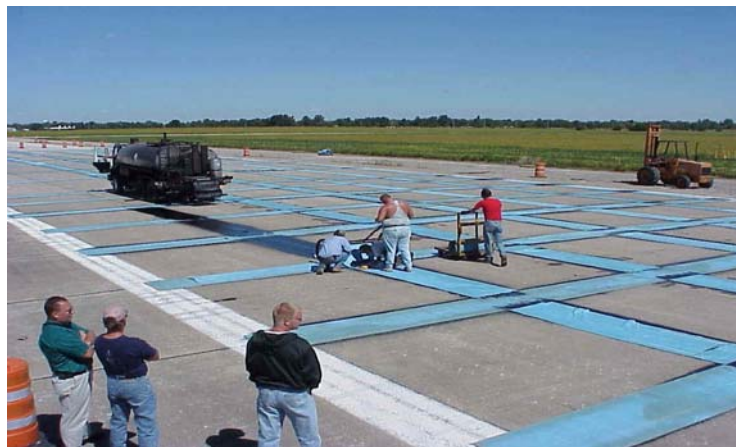
PavePrep® is a stress relief, geo-composite interlayer mainly used to retard the reflective cracking in the new asphalt overlays on the older paved surfaces. It consists of high-density mastic laminated between a lightweight non-woven polyester geo-textile and woven polyester geo-textile. It is placed in strips over cracked or spalled concrete sections in pavements. It retards the stresses occurring due to thermal expansion and contraction and hence reduces the tendency of crack reflection through overlay. *PavePrep*® also acts as a moisture barrier that can cause structural decay of the underlying pavement. Figure 2.18 shows a typical layout of *PavePrep*® application.

FIG. 2.18. Typical Layout of *PavePrep*® Surface (*PavePrep*® Inc 2002)

PavePrep® mainly finds its application in concrete pavements that exhibit low severity joint deterioration, longitudinal cracking and transverse cracking distress. It can also be used to protect expansion joints in concrete pavements from freeze thaw action.

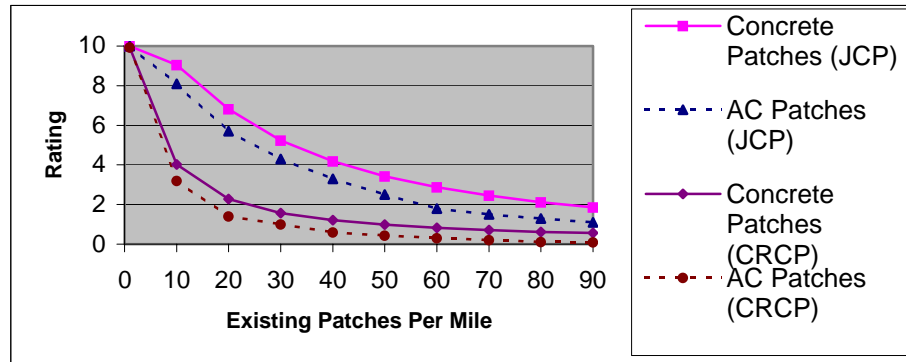
FIG. C.1. Rating Curve for Patches (Zollinger et al. 2001)

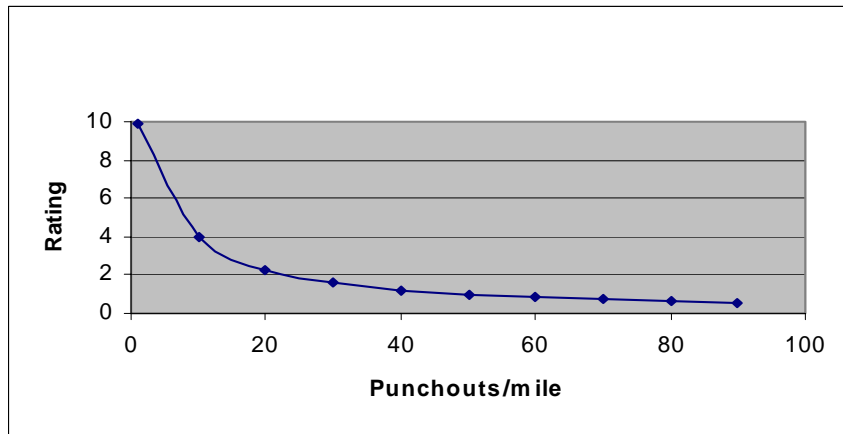
FIG. C.2. Rating Curve for Punchouts for CRCP (Zollinger et al. 2001)

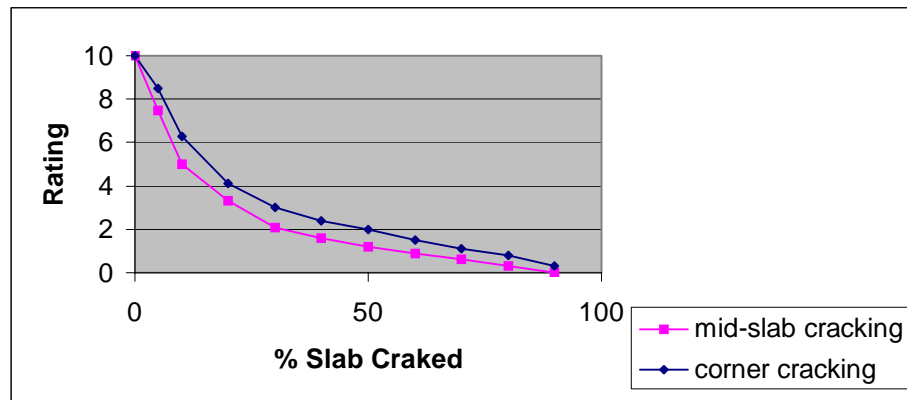
FIG. C.3. Rating Curve for Slab Cracking for JCP (Zollinger et al. 2001)

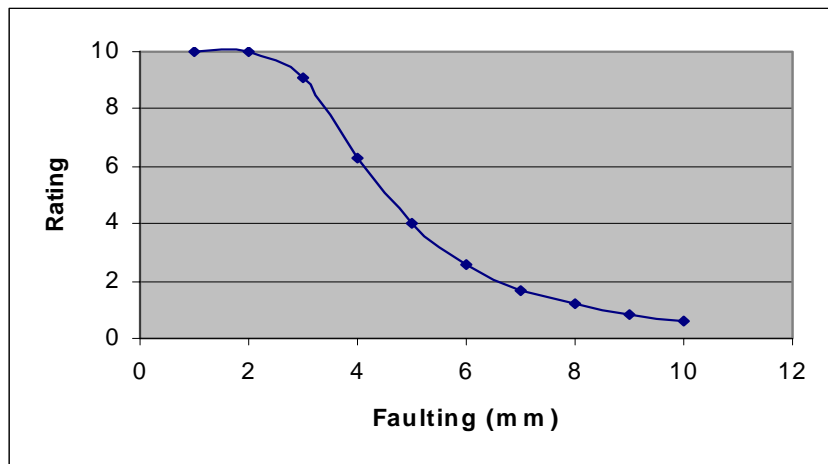
FIG. D.1. Rating Curve for Faulting for JCP (Zollinger et al. 2001)

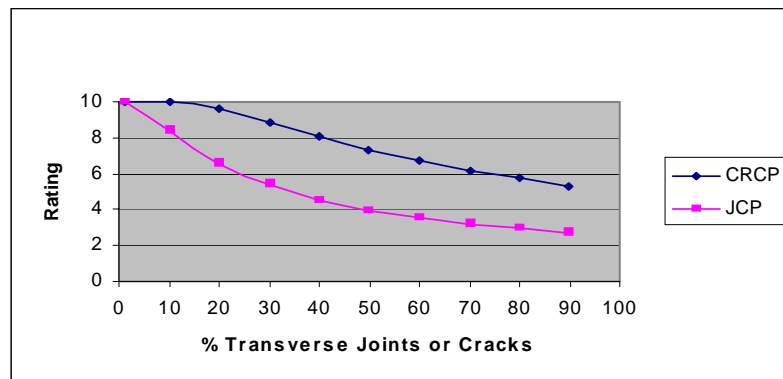
FIG. D.2 Rating Curve for Spalling (Zollinger et al. 2001)

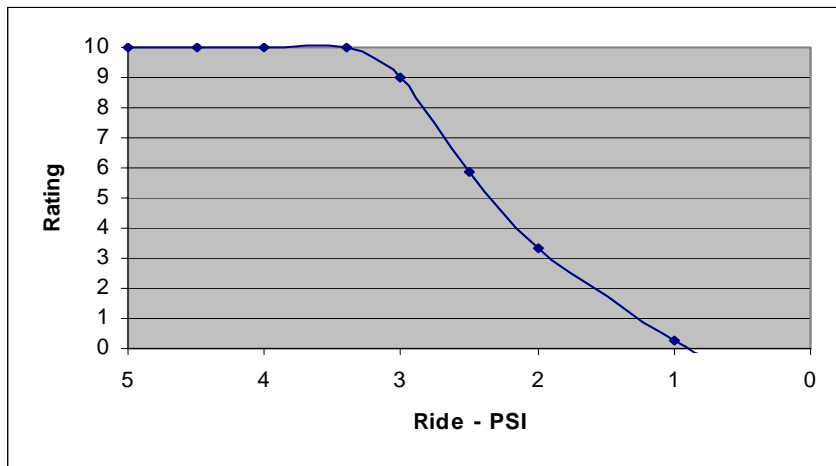
FIG. D.3. Rating Curve for Ride for JCP and CRCP (Zollinger et al. 2001)

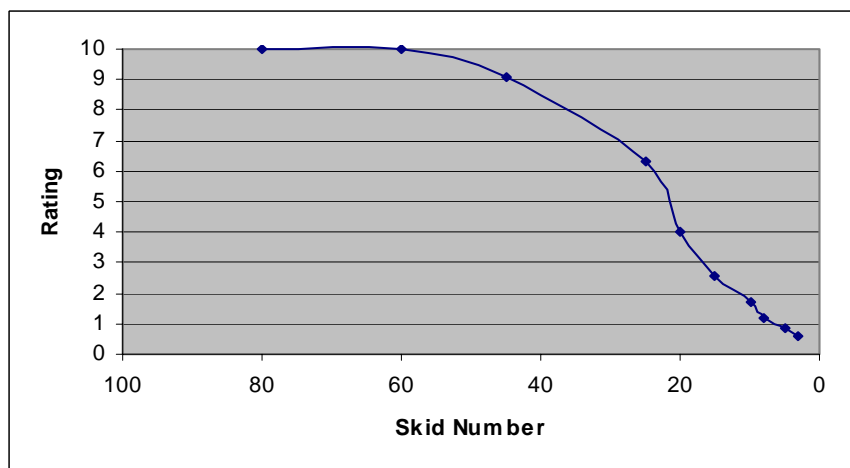
FIG. D.4. Rating Curve for Skid for JCP and CRCP (Zollinger et al. 2001)

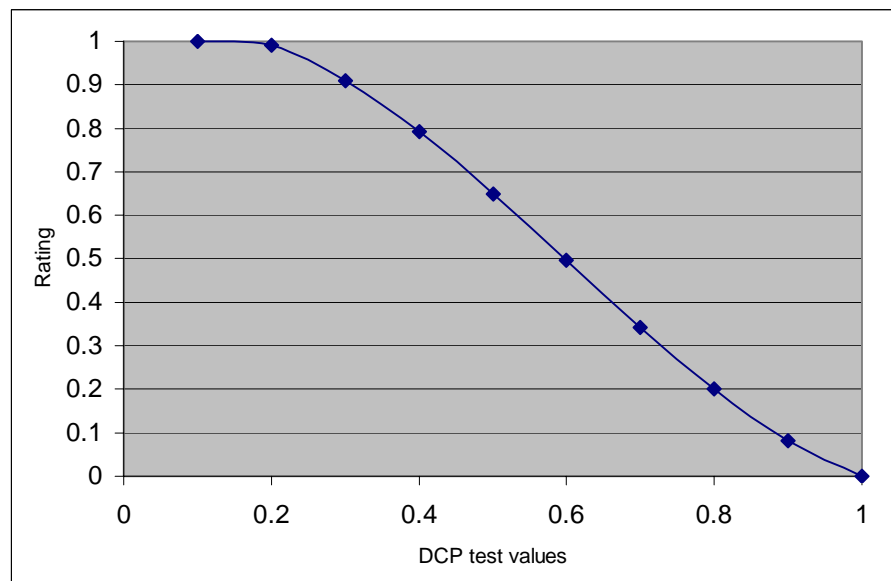
FIG. D.6. Rating Curve for DCP test values

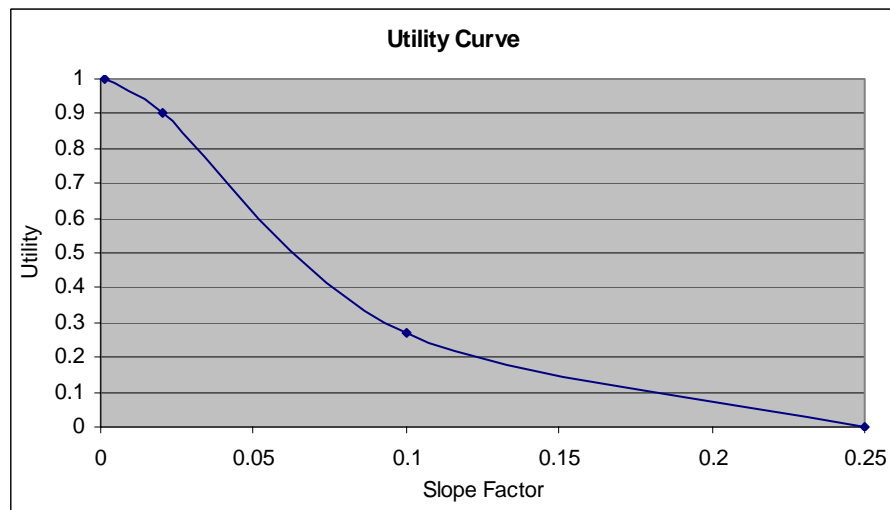
FIG. D.8. Rating Curve for Slope Factor

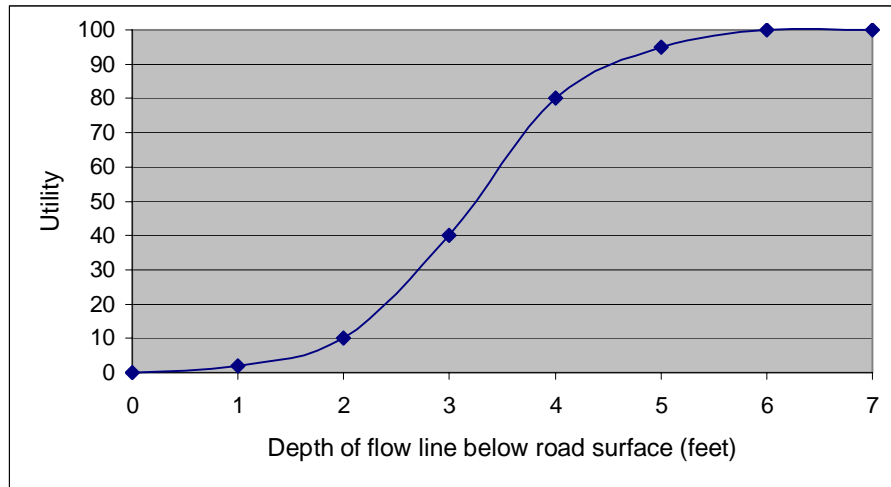
FIG. D.9. Rating Curve for Flow Line Depth

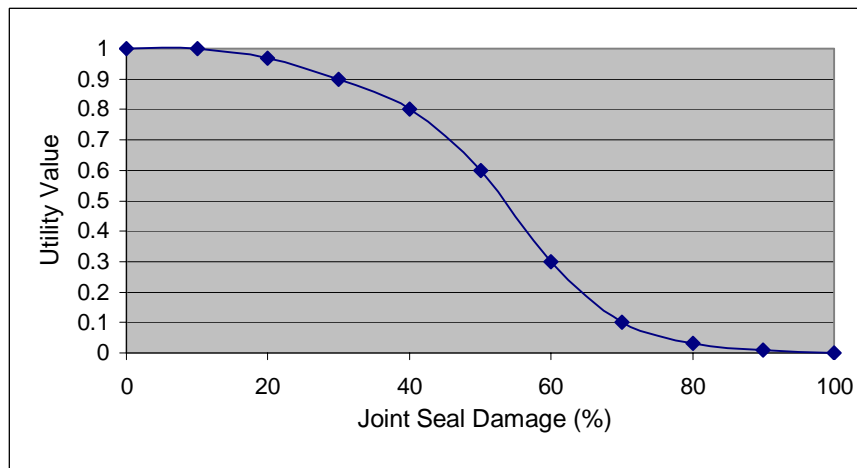
Figure D.10. Rating Curve for Joint Seal Damage
