**THE ACROPOLIS AT BABYLON:
A RECONSTRUCTION DURING THE LATE 6TH CENTURY B.C.**

A Thesis

December 2012

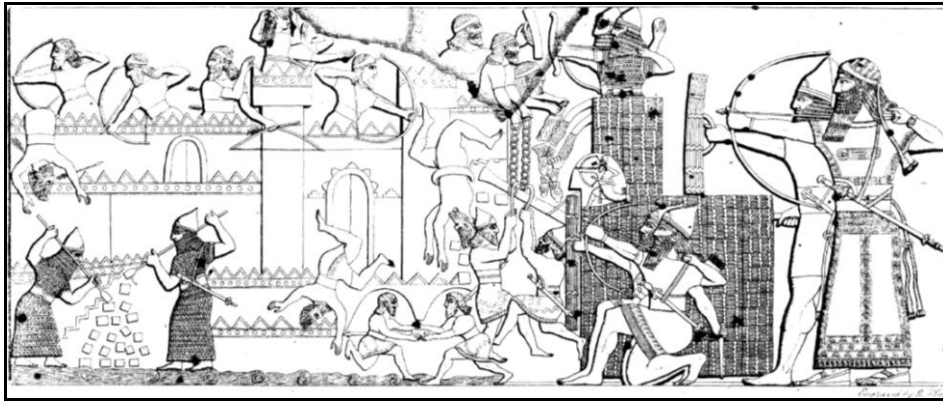
Fig. 3: Assyrian iconography displaying architectural elements (Layard 1853: Pl. 19).

The most useful data for reconstruction comes from iconography. Although little survives in Babylonia, much iconography has been recovered from murals found in Assyrian palaces (Fig. 3). These images depict Assyrian defenses and other Mesopotamian cities that they conquered. The Assyrian and Babylonian cultures mirrored each other in many ways including their architecture. While highly stylized and somewhat generic, these murals give indication of elements such as decoration and the placement of triangular defensive crenellations. Portrayed scenes of large defensive walls, upper blockhouses, and arched gateways display how Babylon likely appeared.

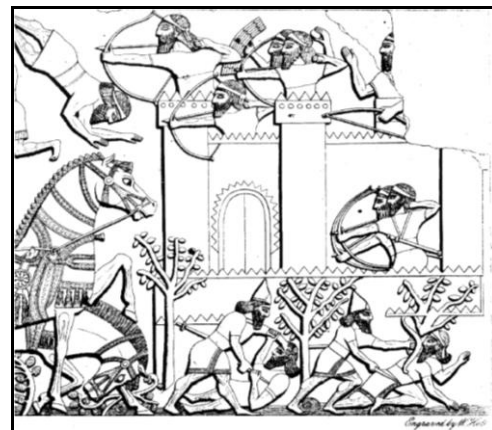
Fig. 6: Circular loopholes on defensive gatehouse. Cropped from Layard (1853: Pl. 13, 30).

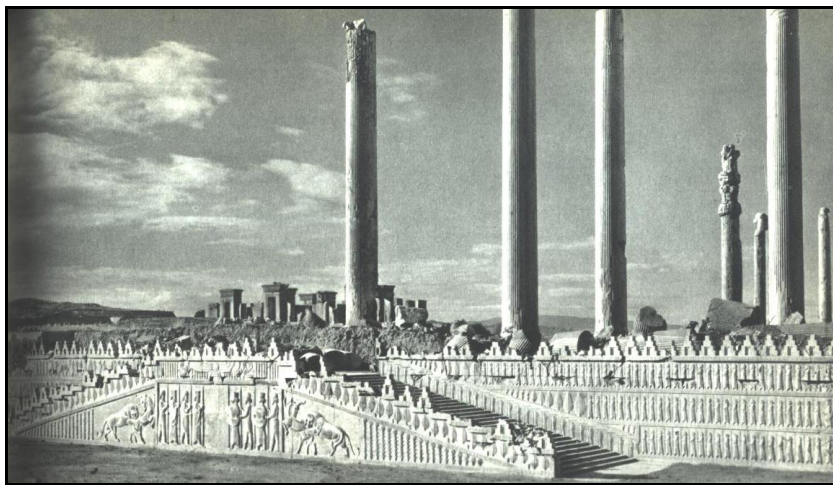
Fig. 7: Stone merlons at Persepolis (Parrot 1961: 195, Fig. 243). Surviving examples of stone merlons found in Assyrian and Persian sites help provide a basis for reconstruction.

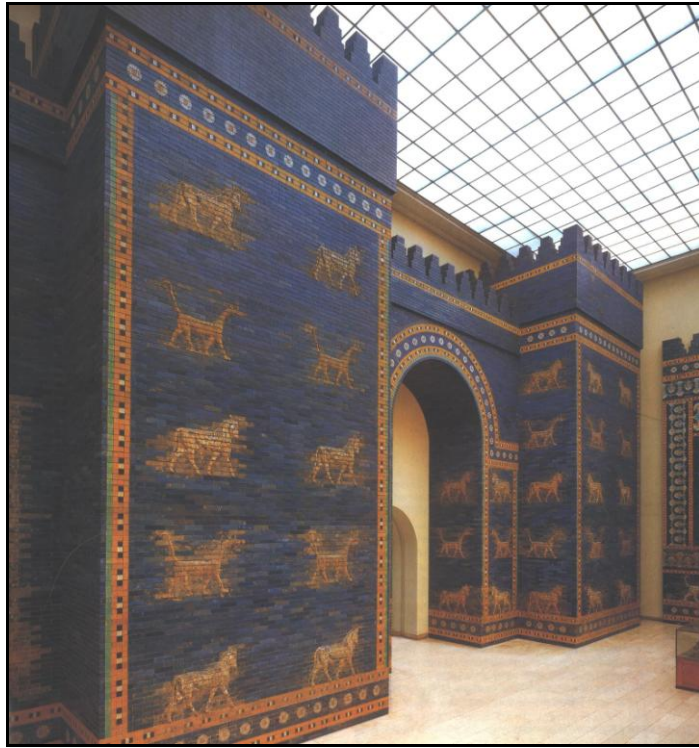
Fig. 8: Reconstruction of Ishtar Gate (Marzahn 1992: 23, Fig. 9). This image portrays the parapets that this thesis utilized in the digital reconstructions. Photograph by Jurgen Liepe, Vorderasiatisches Museum, G. Gerster, H. Schmid.

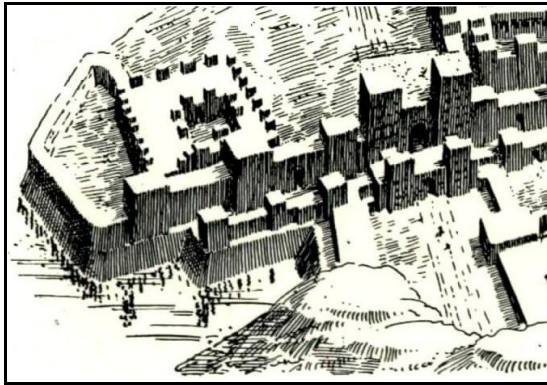
Fig. 26: Early sketch of Persian wall.
Cropped from Koldewey (1914: 66, Fig. 43).

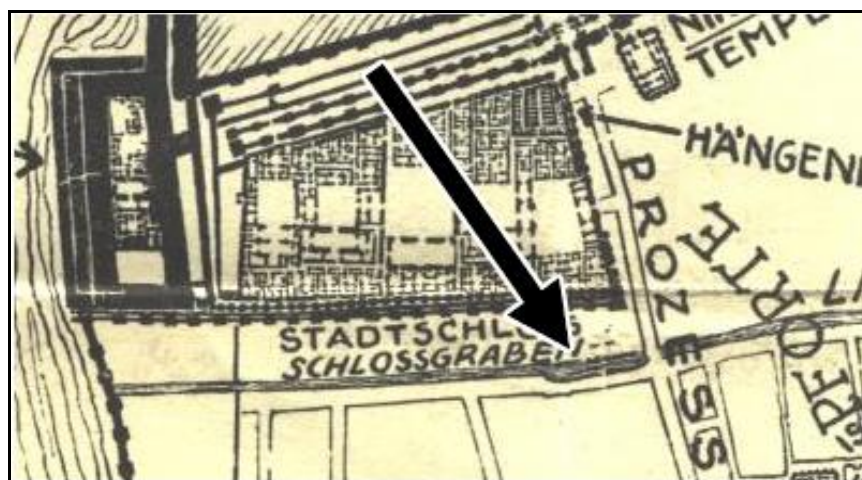
Fig. 30: Parthian canal incorrectly displayed in Neo-Babylonian era map. Map cropped and modified from Unger (1931: Pl. 57).

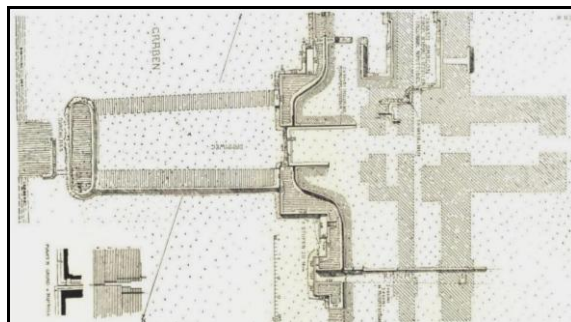
Fig. 34: Moat bridge at the Zababa Gate in southeastern Babylon (Unger 1931: Pl. 10, Fig. 19). This cropped image details the appearance of Babylon's lesser bridges in relation to the city's northern approach, which required a more substantial bridge.

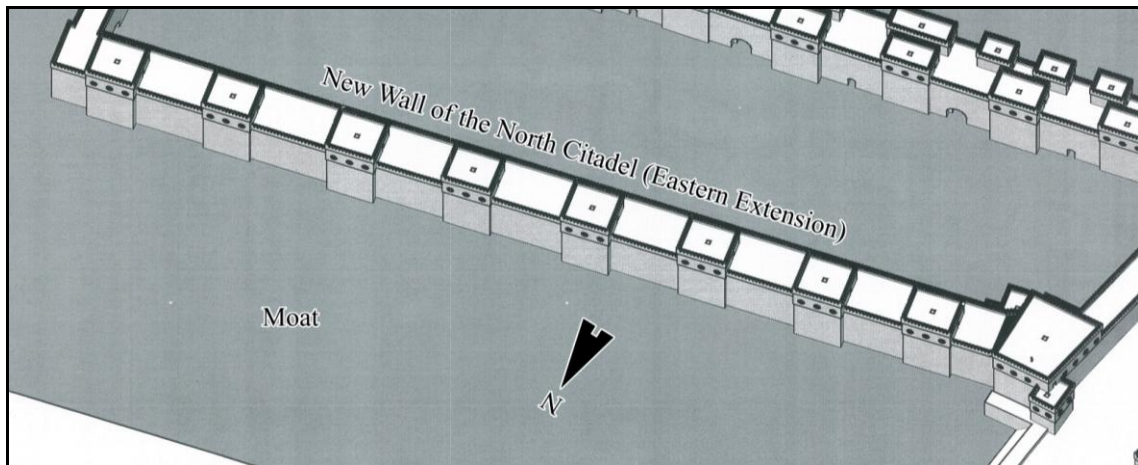
Fig. 43: Reconstruction of the New Wall of the North Citadel (Eastern Extension).

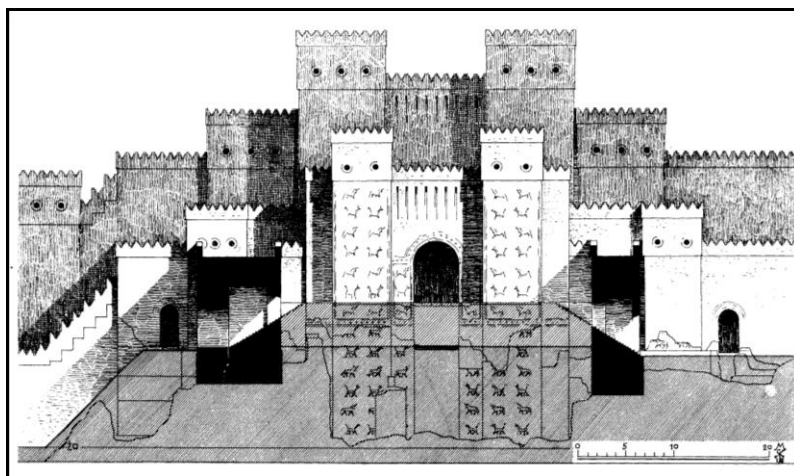
Fig. 56: Ishtar Gate above and below. From Koldewey (1918: Pl. 19). This image portrays the subterranean portions of the Ishtar Gate, a substructure that supports the newer gate portrayed in this thesis reconstruction.

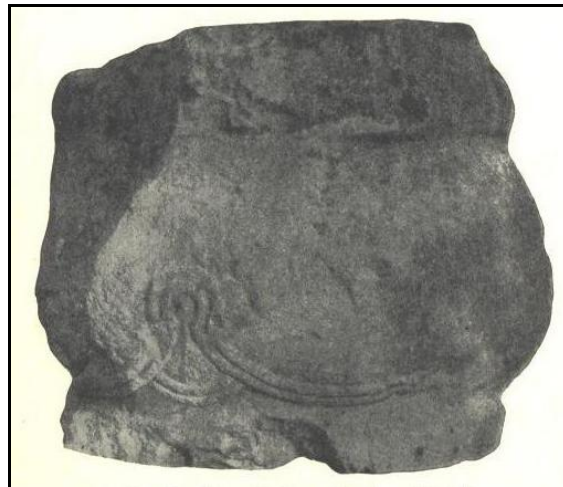
Fig. 76: Column base. From Koldewey (1914: 89, Fig. 58). Structural features are necessary to examine when analysing possible changes within the Southern Palace.

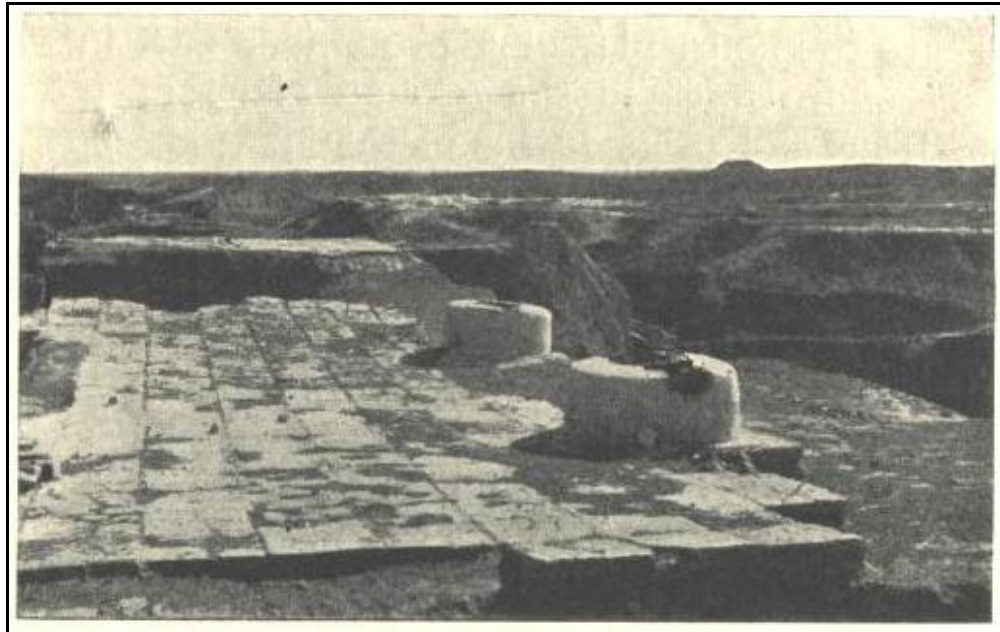
Fig. 99: Persian style column bases in court 36. From Koldewey (1914: 109, Fig. 66). This image was used to create the column bases in the digital reconstruction of the modified courtyard.
