EVALUATION OF BONE FIXATION IMPLANTS

A Thesis

This research investigates the effects of the human body on the mechanical, chemical, and morphological properties of the surface of internal fixation devices. Stainless steel and titanium devices that had failed were provided from the Shandong Provincial Hospital in China, along with controls: implants that had never been used. Comparative study was conducted by evaluating properties of these implants before and after implanting.

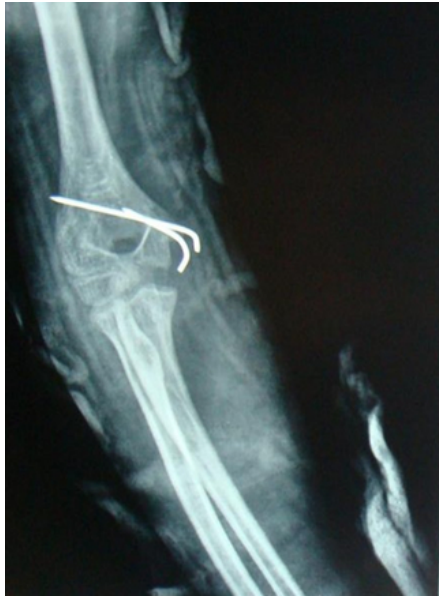
Figure 1. Internal fixation of a fractured elbow using wires [2].

Some common devices used in internal fixation are wires, plates, nails, screws, rods, and pins [1]. Wires are generally used for small fractures or in conjunction with other internal fixation methods. An example of wire internal fixation is shown in Figure 1.

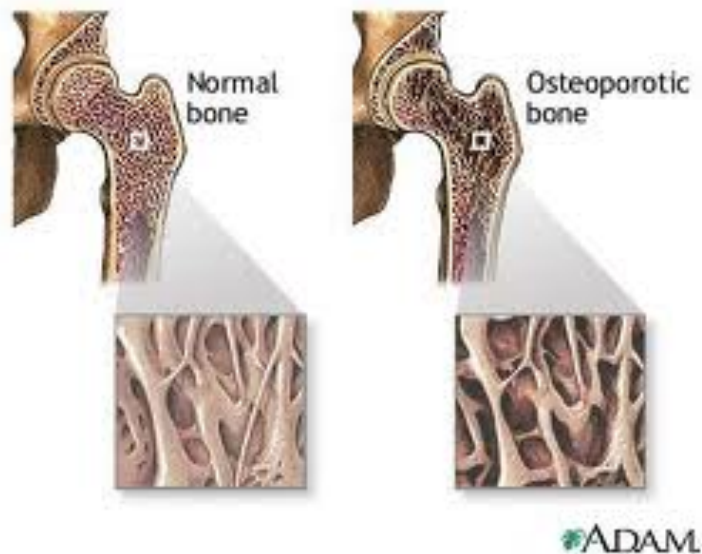
Figure 3. Normal bone versus osteoporotic bone shows the change in structure and density [14].

A patient may have physiological or pathological conditions that affect the healing of the bone fixation. Osteoporosis is the most common condition that affects bones. Osteoporosis causes a decrease in bone density and mass, as seen in Figure 3 [13].

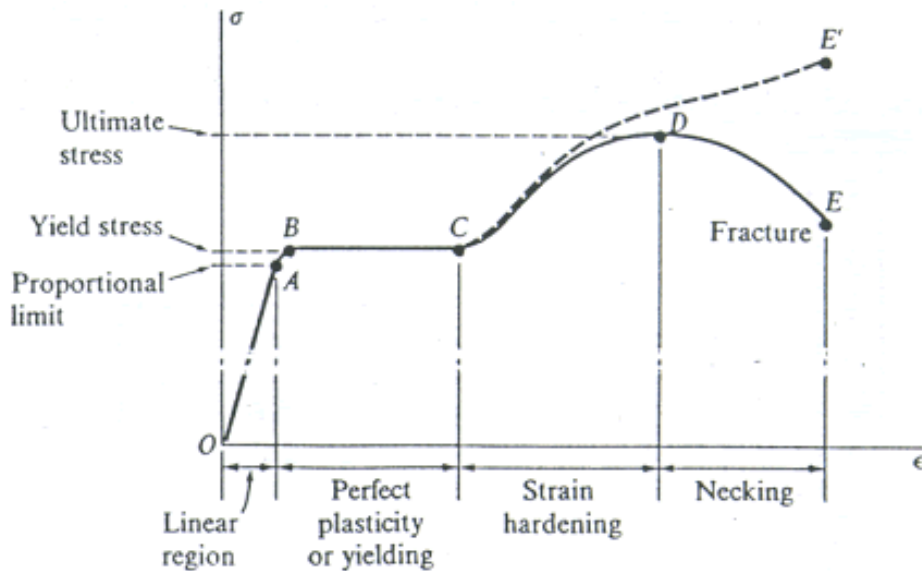
Figure 4. The stress strain curve shows extensive deformation once the yield stress (or strength) has been reached. The material is AISI 4140 alloy steel [18].

The yield strength of a material is the point at which the material begins to undergo plastic deformation. Before this strength is reached, the material is governed by elastic deformation. After the material has exceeded its yield strength, the elastic deformation can be recovered while the plastic deformation cannot [18]. A typical stress strain relationship is shown in Figure 4.

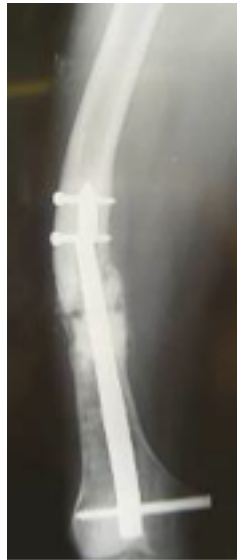
Figure 5. An x-ray image of a femoral fixation shows that intramedullary nail has failed. The screw was placed close to the fracture and bend in the bone.

Incorrect placement of the implant can cause fracture when the geometrical stress risers in the implant align with the high stress areas of the fracture. Figure 5 shows a femoral intramedullary nail fixation where the proximal interlocking screw was placed in proximity to the fracture site, and directly on top of an area of bone deformation.

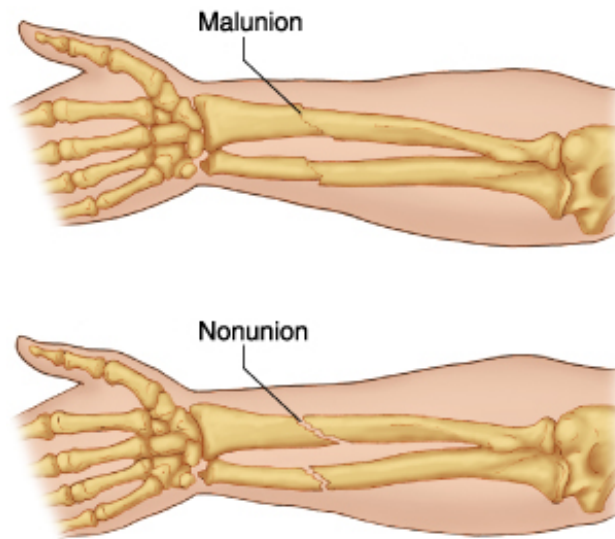
Figure 6. Malunion is a misalignment while nonunion occurs when the bone does not heal [33].

When the bone does not connect after ample amount of time post fixation, a malunion has occurred. Malunion has also been discussed for improper placement, as the bone is not properly aligned [31]. Nonunion occurs when the bone does not connect completely or at all [32]. Figure 6 shows an example of malunion and nonunion.

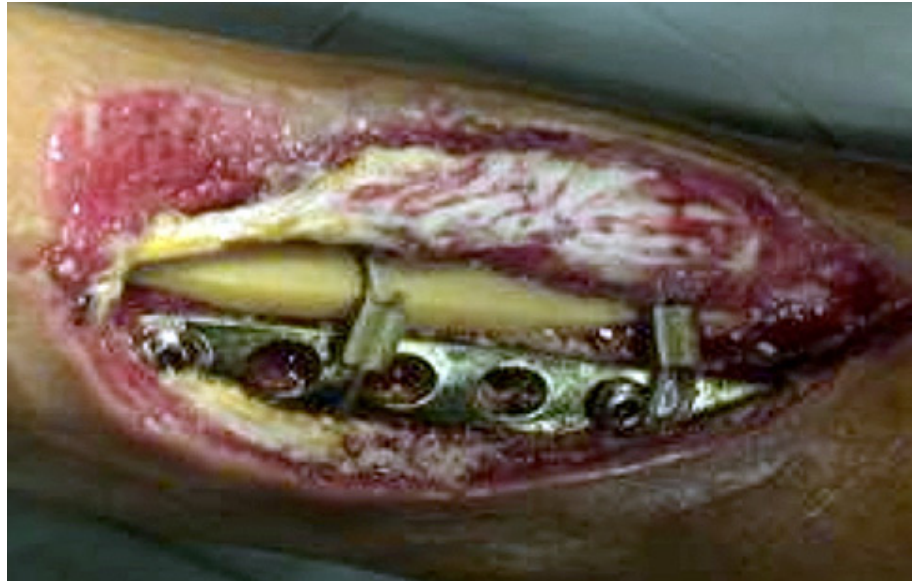
Figure 7. An infected internal fixation. Plates and cables are attached to a dead tibia with infected tissue surrounding [36].

Infection occurs when there is an imbalance of the body's defense system and infectious bacteria. The body's defense mechanisms are weakened by the trauma of the initial fracture, the surgical operation and fixation, and also by the addition of a foreign object into the body [34]. Infection is linked to nonunion and mal-union, and the implant is almost always removed in this case [35]. Figure 7 shows an example of an infected internal fixation.

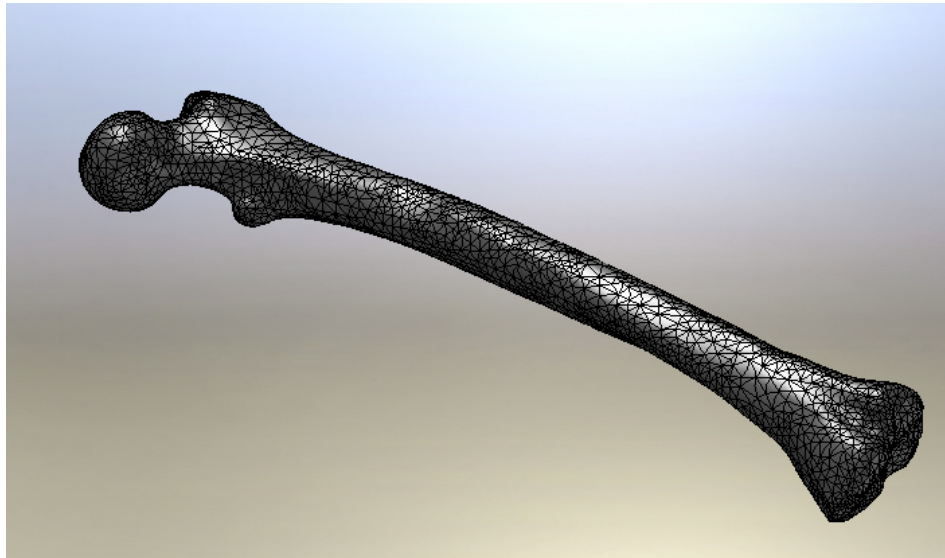
Figure 8. The Solidworks femur model was created from the bone scan of a real human femur.

These properties were used with a solid model of a femur generated by Redding Engineering LLC from a bone scan. For stress analysis, models in Solidworks require both dimensions and material properties. The properties were added to the model in Solidworks. The model used in this simulation appears in Figure 8.

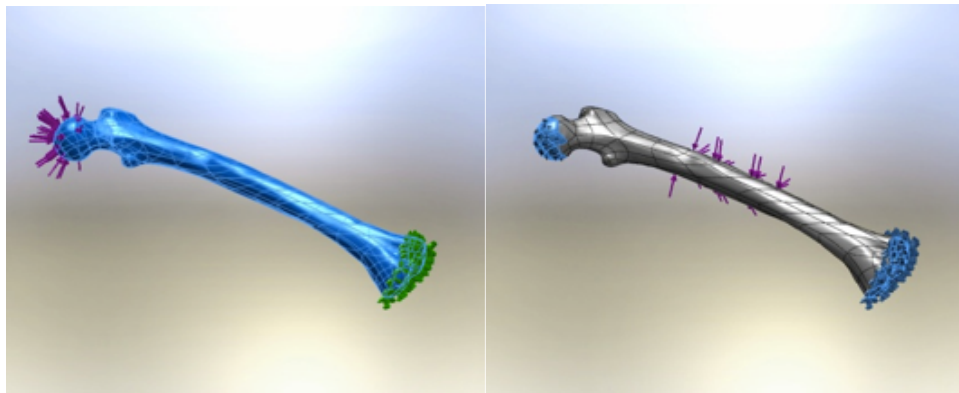
Figure 9. The Solidworks stress analysis required both fixtures and forces for each simulation: walking (left) and car accident (right).

Two test conditions were chosen: one for a femur under normal stresses during walking, and one for a traumatic car accident. The initial conditions required that fixtures and forces be applied to the model. The test conditions are shown in Figure 9.

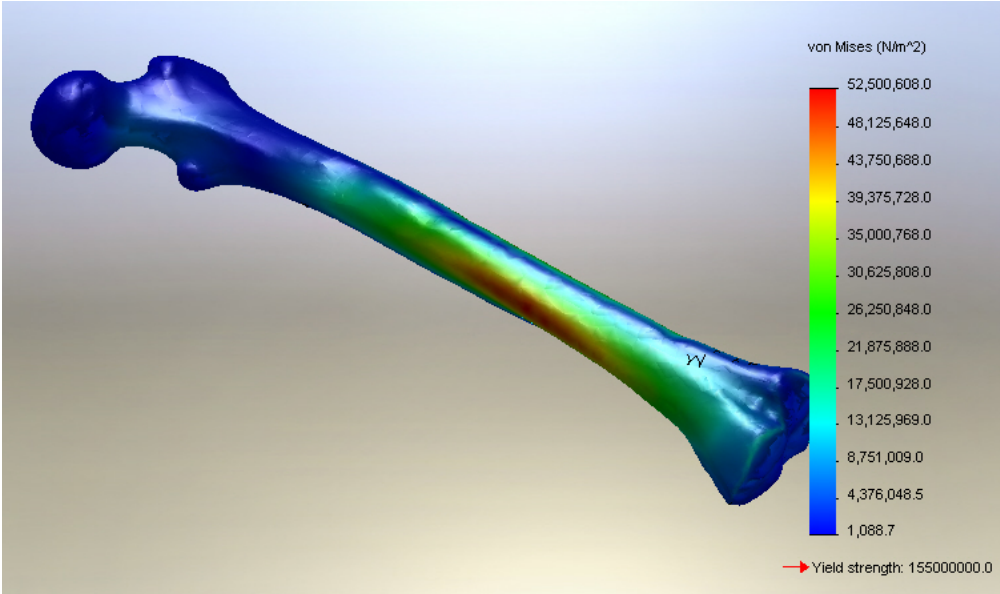
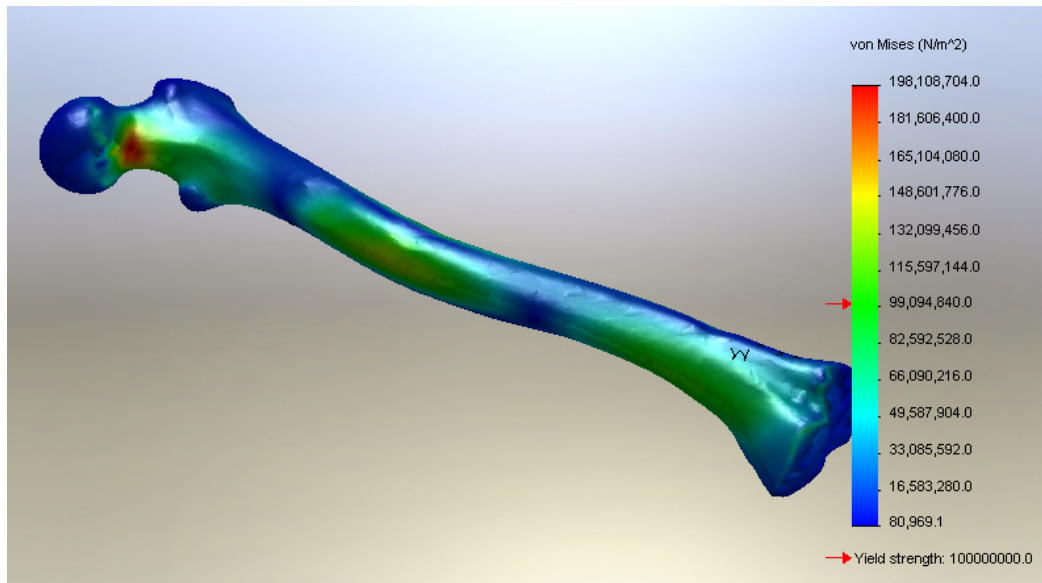
Figure 32: von Mises stress plot of the femur

The results for the stress, strain, and displacement distributions were simulated, and the results are shown in Figure 10, Figure 11, and Figure 12.

stresses at the neck. This agrees with the hip fracture/accident correlation. For the car accident case, the yield stress is exceeded as seen on the scale bar. The highest experienced stress was 198.1 MPa. Since stress and strain are related due to the elastic assumption, the distribution was identical with different values on the scale bar. The walking case showed the highest strain on the shaft, and the car accident case showed the highest strain at the neck. The highest strain for the walking case was 0.00139 (unit less) and the highest strain for the car accident was 0.00789 (unit less).

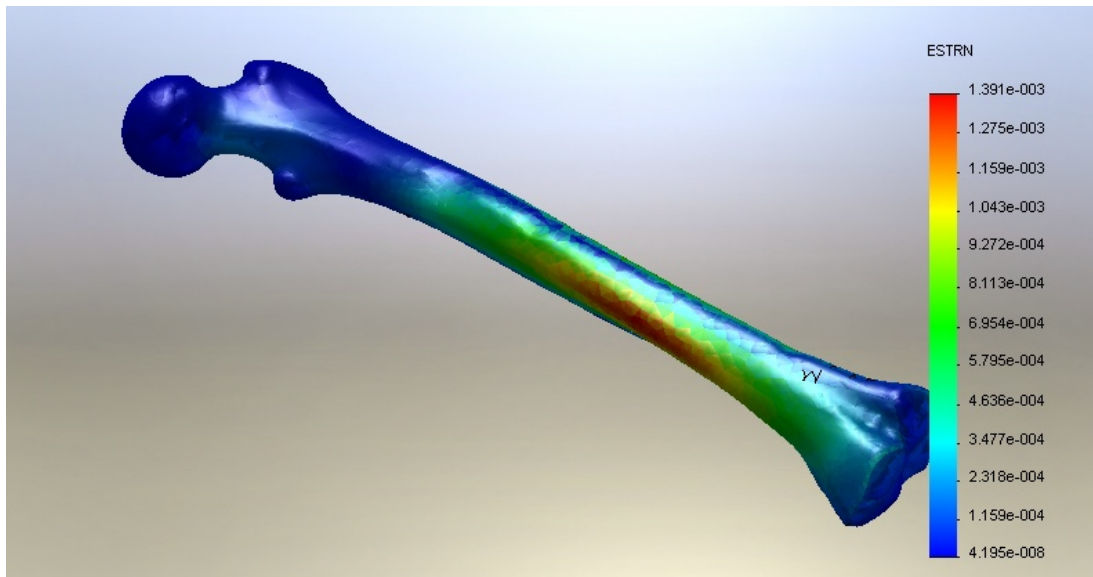
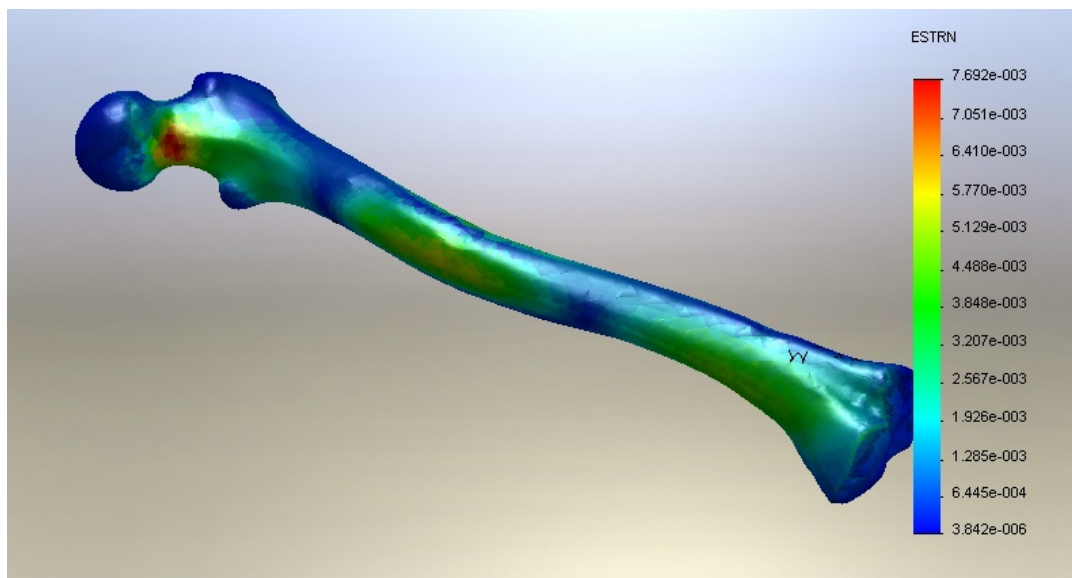
Figure 11. The strain analysis showed essentially the same distribution as the stress analysis.

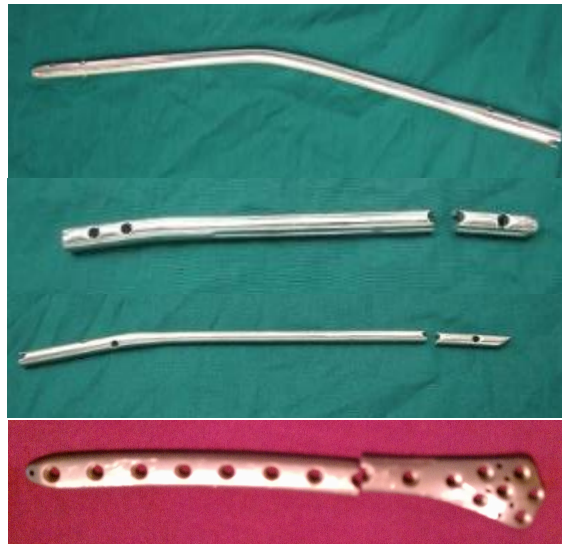
Figure 13. The tested samples supplied by the Shandon Hospital in order from top to bottom: long femoral nail, short femoral nail, tibial nail, femoral plate.

Four sets of implants were tested, and a set comprises an implanted sample and its control. Of the four sets, three were stainless steel 316L and one was unalloyed titanium grade 2. All of the stainless steel implants were intramedullary nails while the titanium implant was a femoral plate. Two of the stainless steel implants were designed for the femur and the other was designed for the tibia. Pictures of the implants are shown in Figure 13.

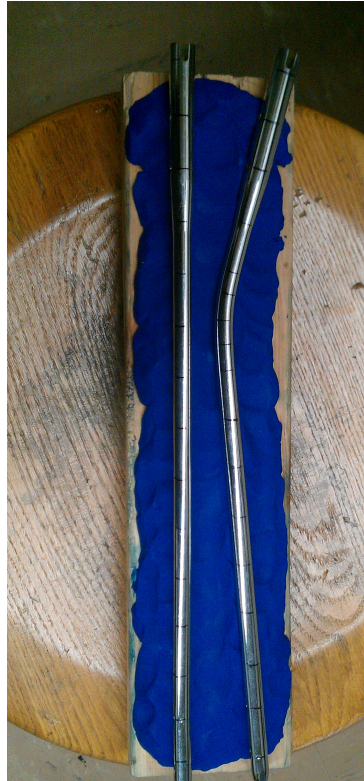
Figure 14. The implant samples were placed in a bed of clay for testing.

required to press the samples into the clay. The long femoral nails are shown in the bed of clay in Figure 14.

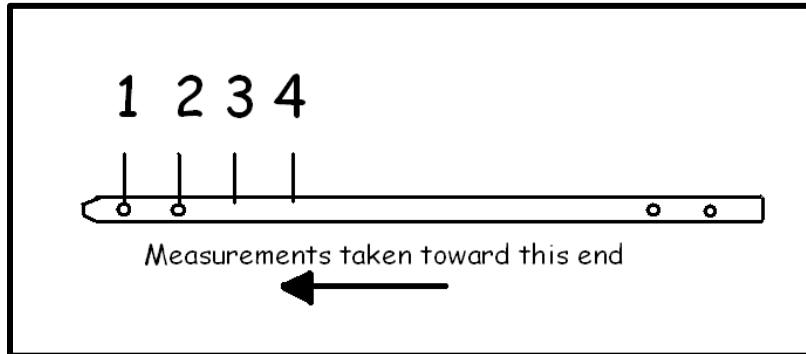
Figure 15. This illustration demonstrates the pattern for taking measurements for the experiments. For example, measurements taken at the first inch marking were taken to the left of the hole as shown in this picture.

information is included merely for consistency of measurement. A diagram is shown in Figure 15 to illustrate the measurement designations.

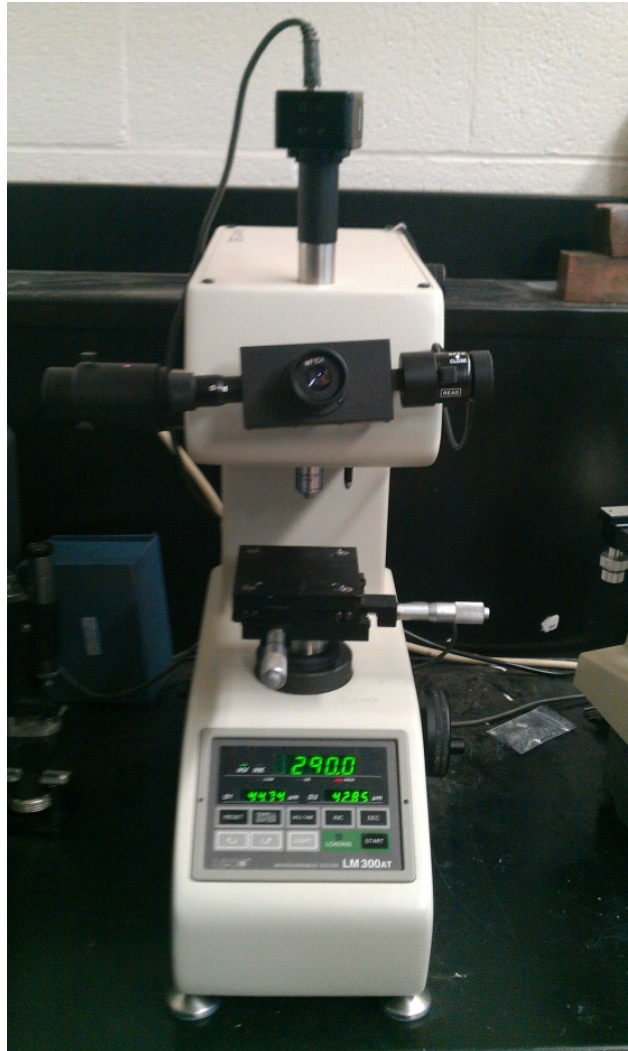
Figure 16. The LM 300 series Vicker's microhardness indenter was used to test the materials' hardness.

The machine used in the experiment was the LM 300 series Vicker's Microhardness Indenter, shown in Figure 16. A Vicker's Diamond indentation tip was attached to the indenter. This method was chosen over Knoop because of the low profile indent, which was needed to pack indents close to each other on a single axial ridge of the implant.

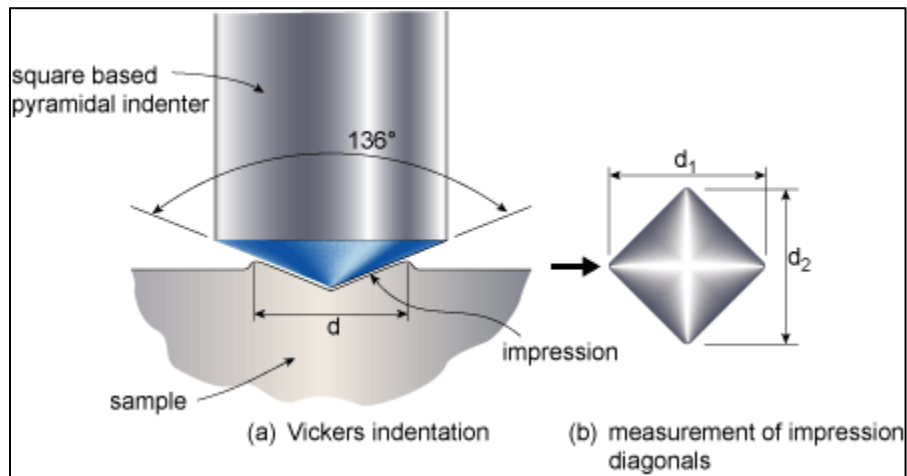
Figure 17. The Vicker's method leaves a diamond shaped indent, which is geometrically similar regardless of size.

The indenter measures the hardness by creating a diamond shaped indent that is the same shape no matter the size. The area of the indent is calculated by measuring the diagonals. Figure 17 shows a schematic of the indentation process and the resulting indent.

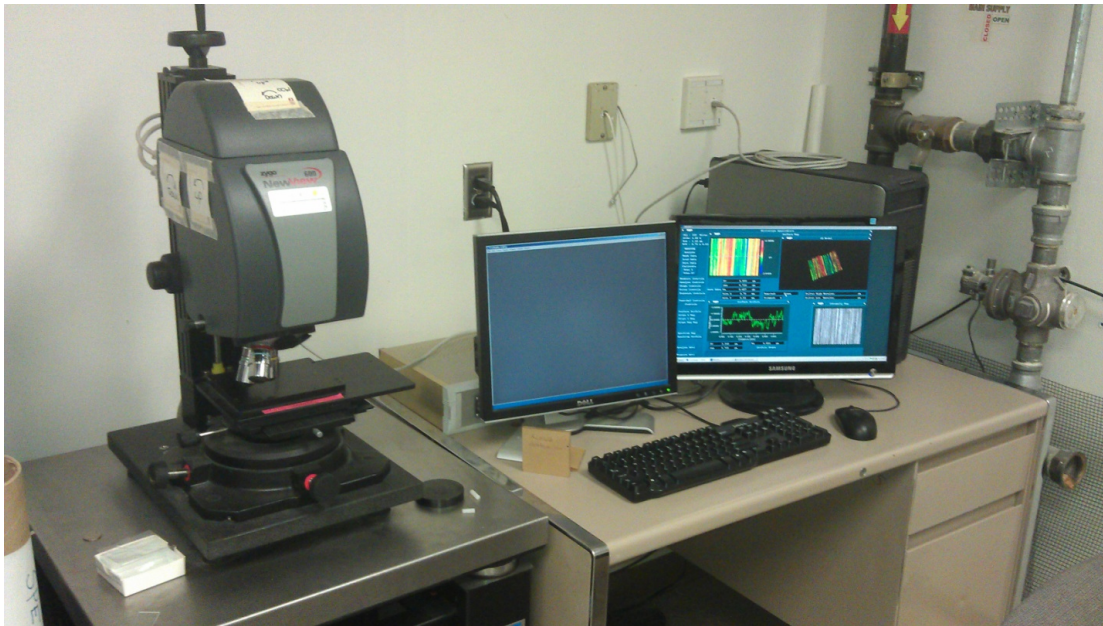
Figure 18. The test setup for roughness measurement includes the Zygo optical profiler, a vibration isolation table, and a computer with software for analysis.

To calculate the roughness parameters, the surface was analyzed using a Zygo 3D Optical Surface Profiler. The Zygo machine uses interferometry to profile the surface. A 10x objective was used for viewing the surface, and a 15 second scan elapsed during the interferometry process. Figure 18 shows the Zygo machine and the test setup.

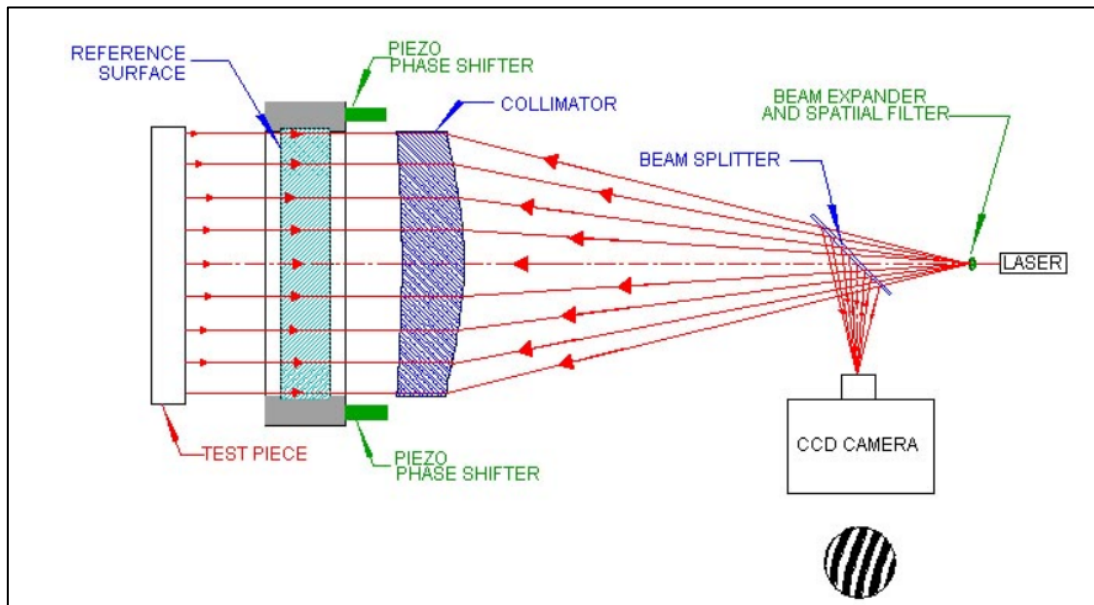
Figure 19. The interferometry process is illustrated.

Interferometry uses the diffraction pattern of light to map the surface that the light has reflected from. A beam splitter creates two beams of light, the original and the incident. The original beam passes through the beam splitter to a CCD camera, while the incident beam expands and passes through a collimator. The incident beam exits the collimator with parallel rays, and passes through a piezo phase shifter. After this the incident beam reflects from the test piece and returns through the piezo phase shifter and the collimator. The two beams are imposed on each other in the CCD camera, and the out of phase beams create a diffraction pattern. From this diffraction pattern, the topography of the surface can be extracted since beams that travelled a farther distance will be out of phase with beams that travelled a shorter distance. Figure 19 illustrates this process.

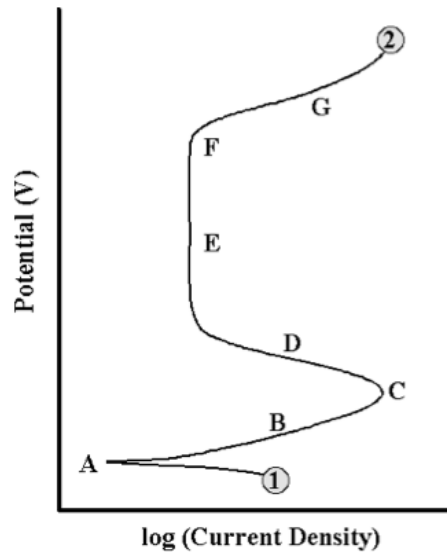
Figure 21. Theoretical anodic polarization scan of stainless steel [52].

The rest potential is the potential at which the anodic and cathodic reactions happen at the same rate, thus there is no current flow. The curve above the rest potential is the anodic polarization curve. This curve is shown in Figure 21.

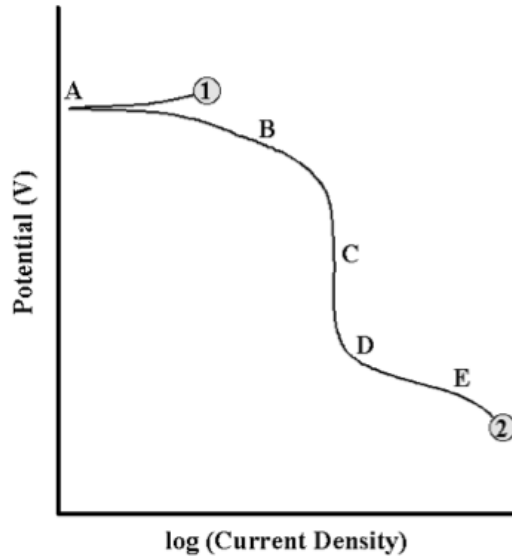
Figure 22. Theoretical cathodic polarization scan of stainless steel [52].

The cathodic polarization curve is under the rest potential, and the theoretical curve is shown below in Figure 22.

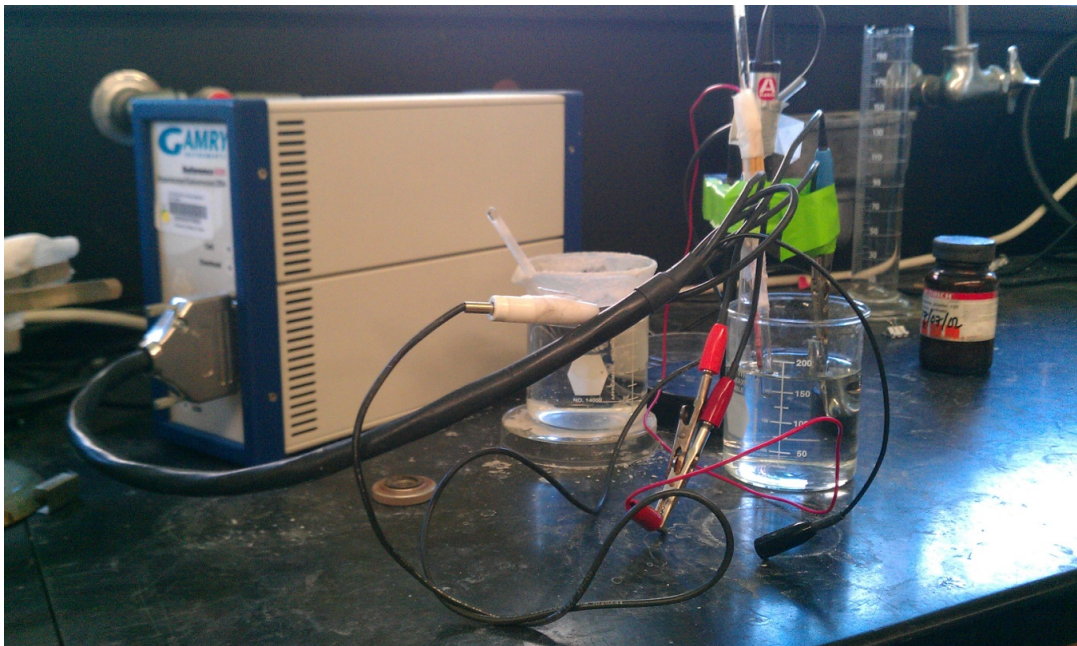
Figure 23. This figure shows the potentiodynamic polarization setup with the Gamry Reference 600 Potentiostat

Electrode (SCE) probe was used for a reference point. The approximate range of potential for stainless steel was determined from literature to be -1.2V to 0.4V. A solution of 2% NaCl in de-ionized water was used as the electrolyte. Figure 23 shows the test setup.

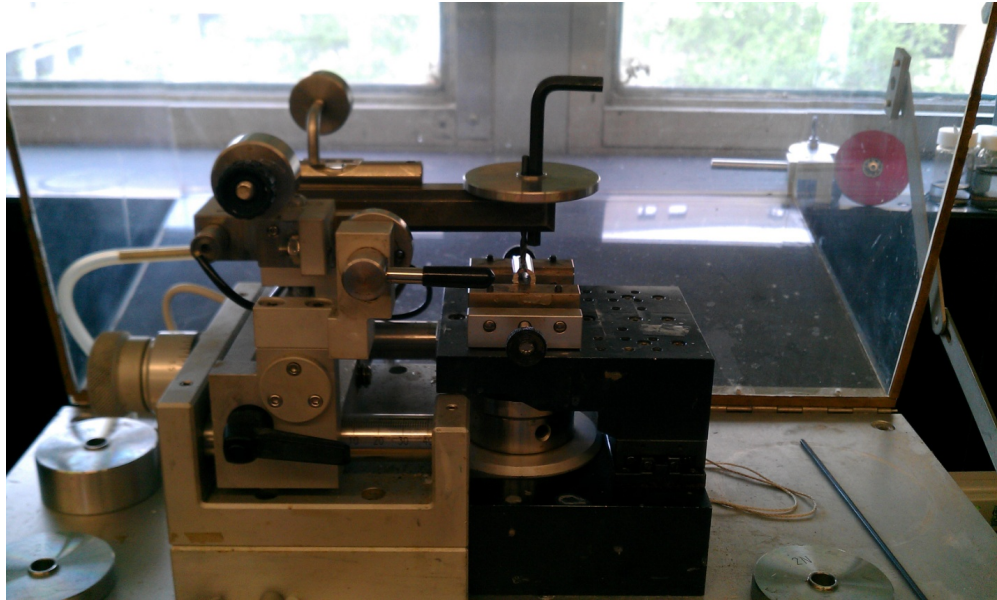
Figure 24. The tribometer doubled as a scratch tester when a drill bit was used in place of a ball bearing.

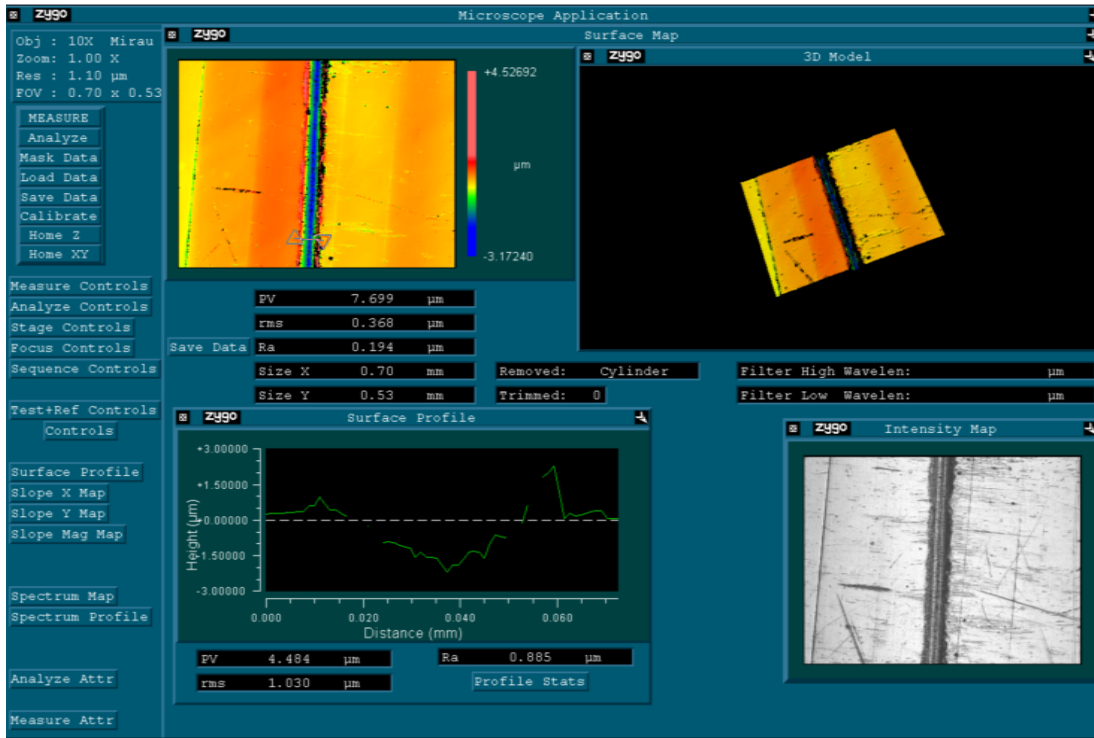
Figure 25. The Zygo interface during surface analysis of a scratch created with the tribometer.

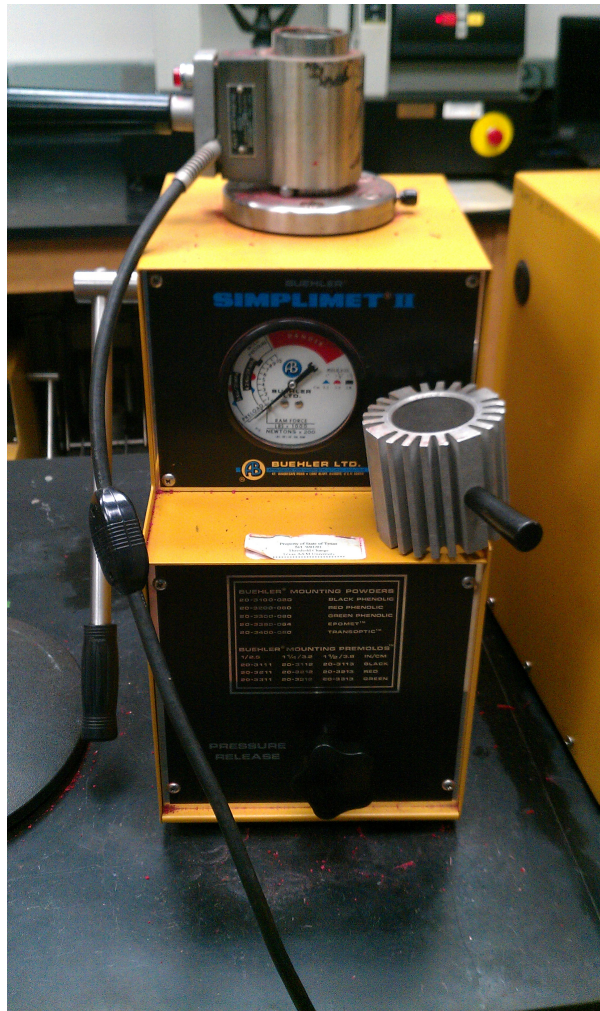
Figure 27. The Simplimet mounting press machine comes equipped with a pressure gauge, a heating cylinder, and cooling fins.

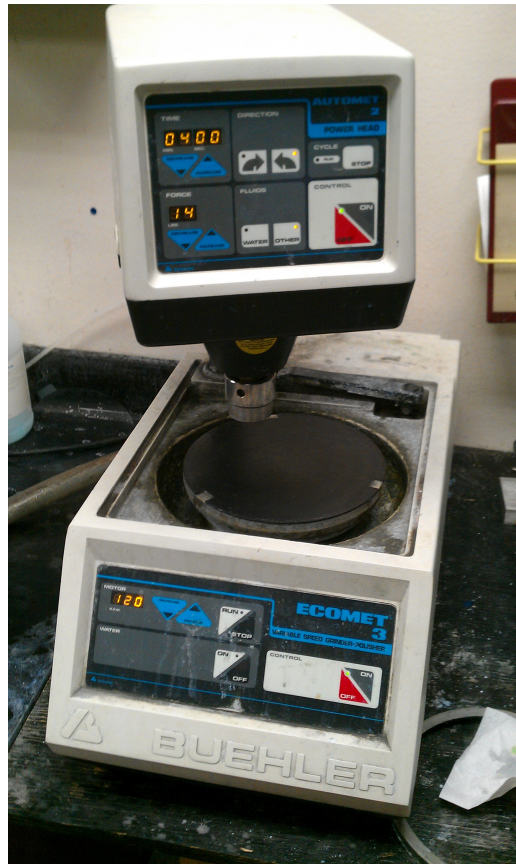
Figure 28. The Automet 2 polishing head mounts on the Ecomet 3 polishing table. Each machine is equipped with controls that are integrated with the other.

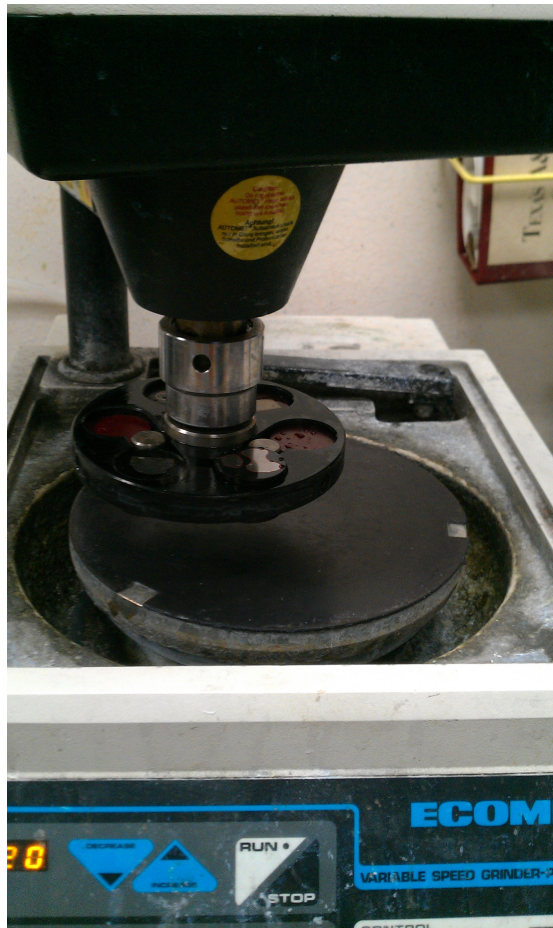
Figure 29. The samples were placed in a fixture, which attached to the rotating polishing head.

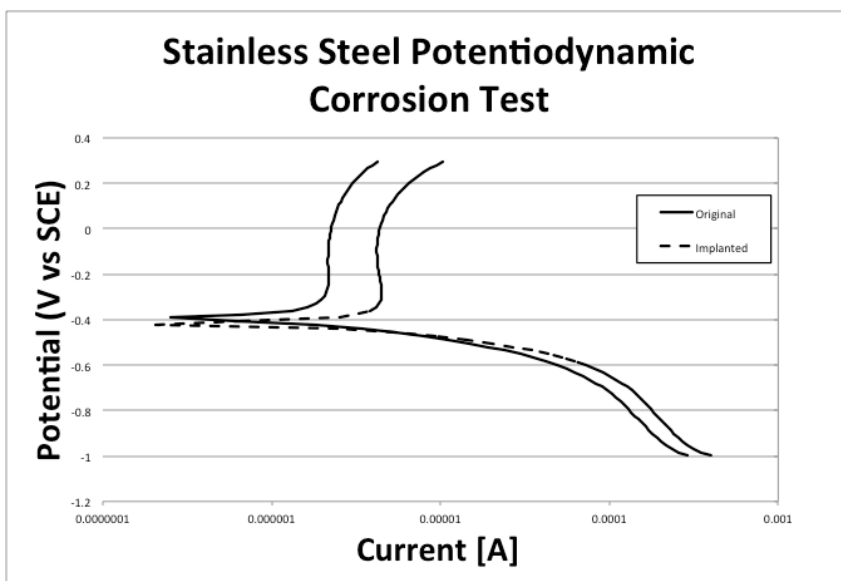
Figure 30. Potentiodynamic polarization curves for stainless steel long femoral intramedullary nails.

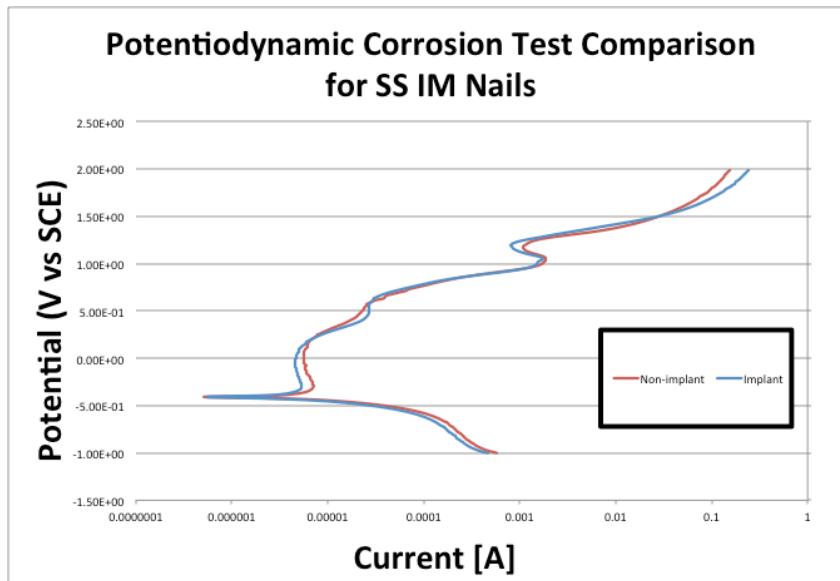
Figure 31. Potentiodynamic polarization curves for stainless steel tibial intramedullary nails.

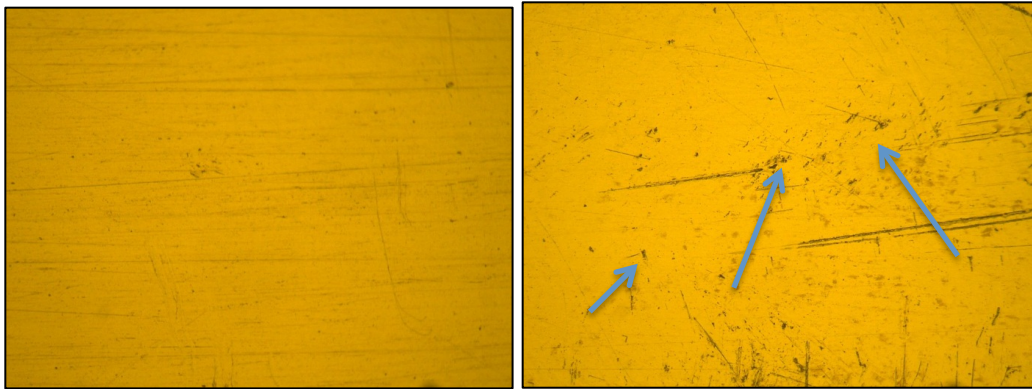
Figure 32. A typical view of the surfaces is shown for the stainless steel long femoral intramedullary nails, non-implanted (left) and implanted (right). Arrows indicate pitting.

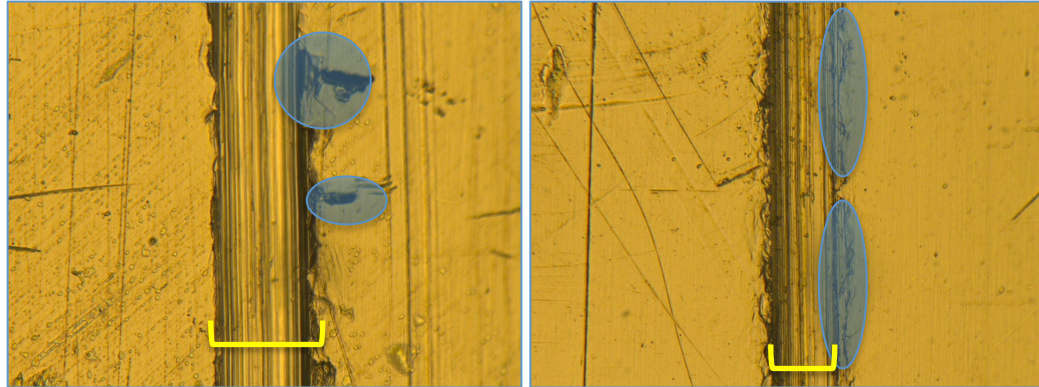
Figure 34. The images from the scratch tests are compared for the stainless steel long femoral intramedullary nail case, non-implanted (left) and implanted (right).

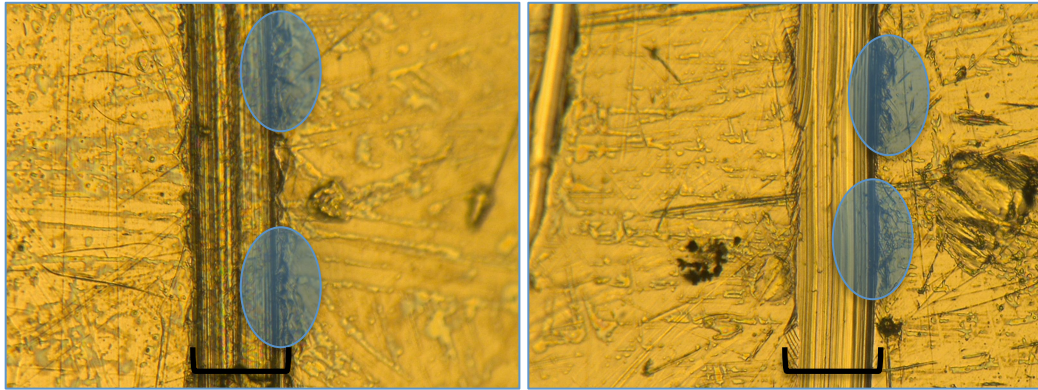
Figure 35. The images from the scratch tests are compared for the stainless steel tibial intramedullary nail case, non-implanted (left) and implanted (right).

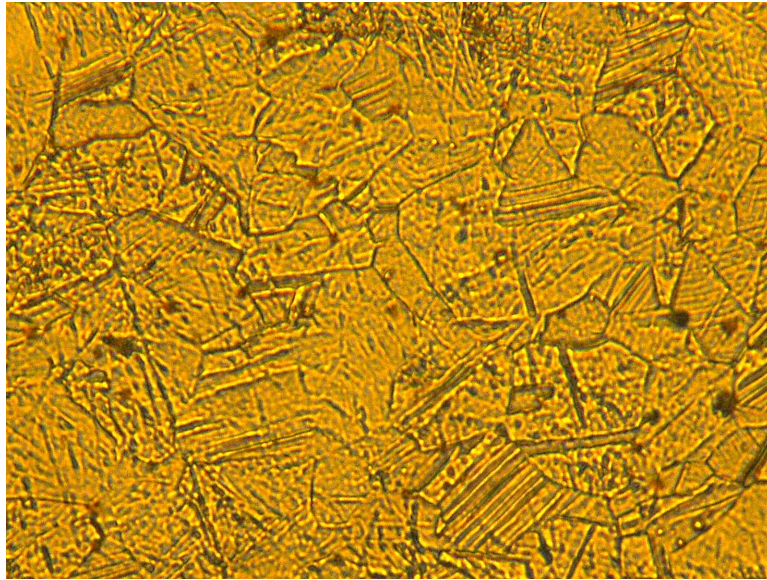
Figure 36. Microstructure of the non-implanted stainless steel long femoral nail (2000X magnification).

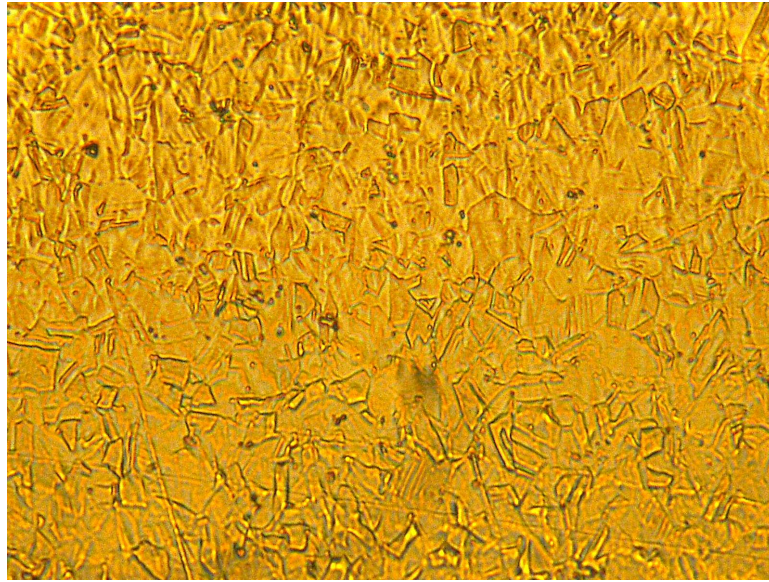
Figure 37. Microstructure of the implanted stainless steel long femoral nail (2000X magnification).

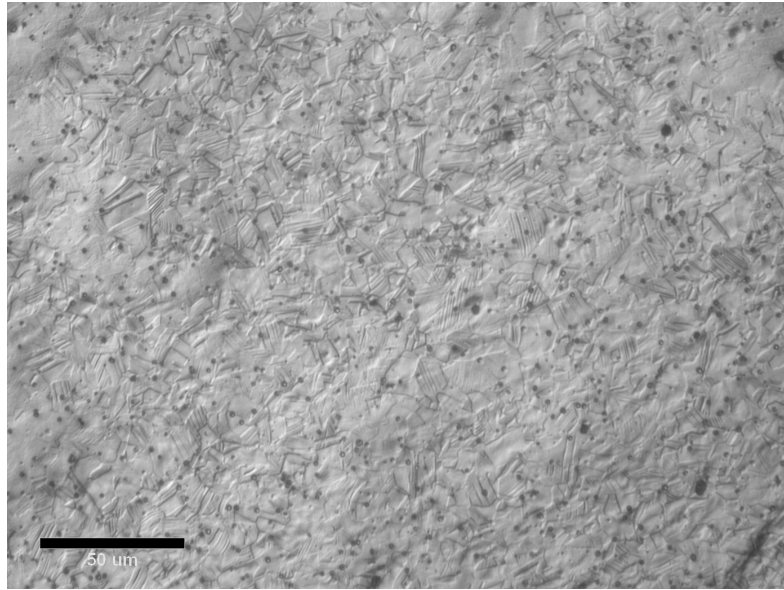
Figure 38. DIC image of the microstructure of the non-implanted stainless steel tibial nail (20X, 0.5 NA objective).

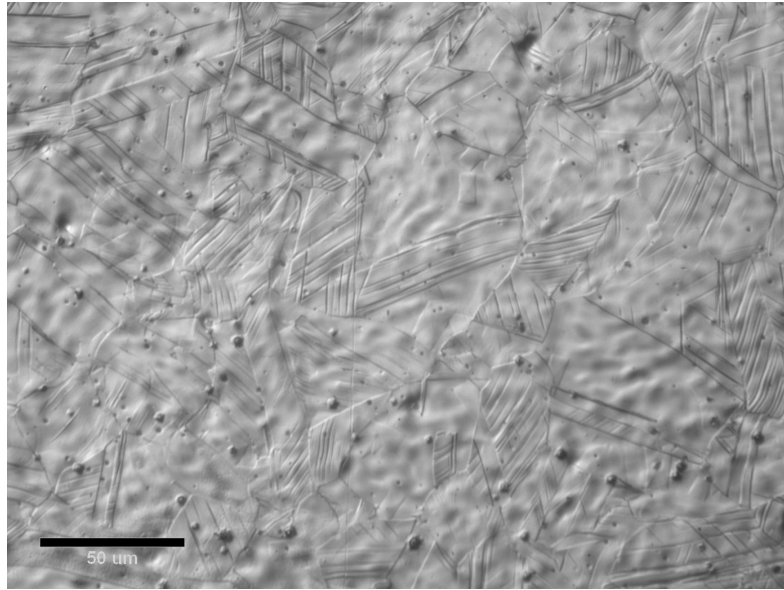
Figure 39. DIC image of the microstructure of the implanted stainless steel tibial nail (20X, 0.5 NA objective).

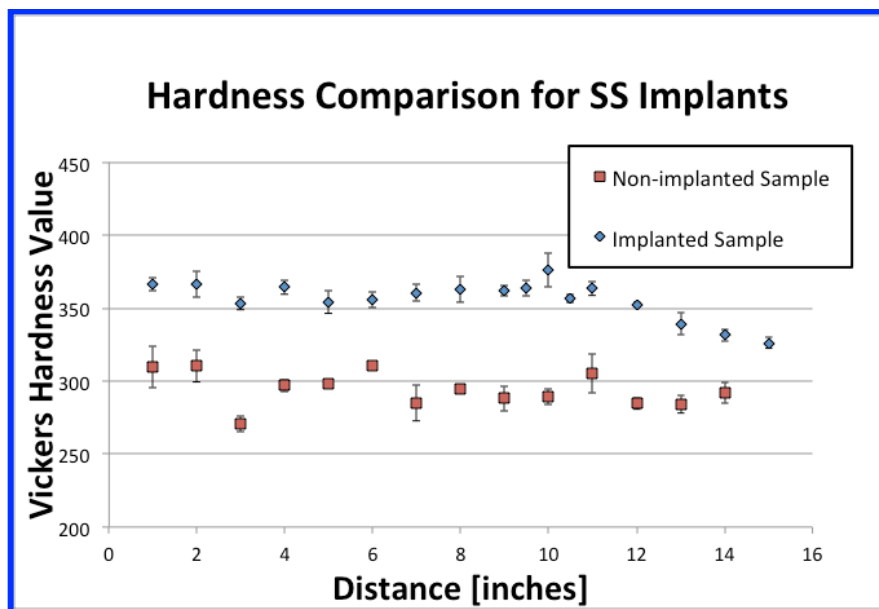
Figure 40. The hardness data for the long femoral nails shows that the surface of the implanted sample was harder on average.

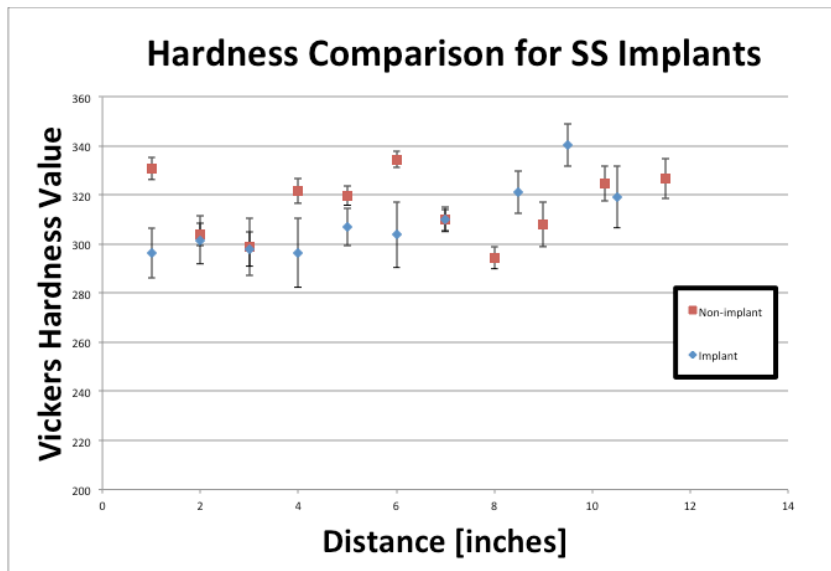
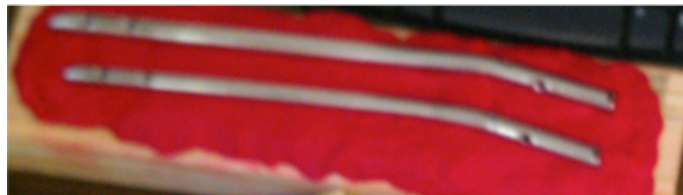
Figure 42. The hardness data for the tibial nails is inconclusive in interpreting a significant difference.

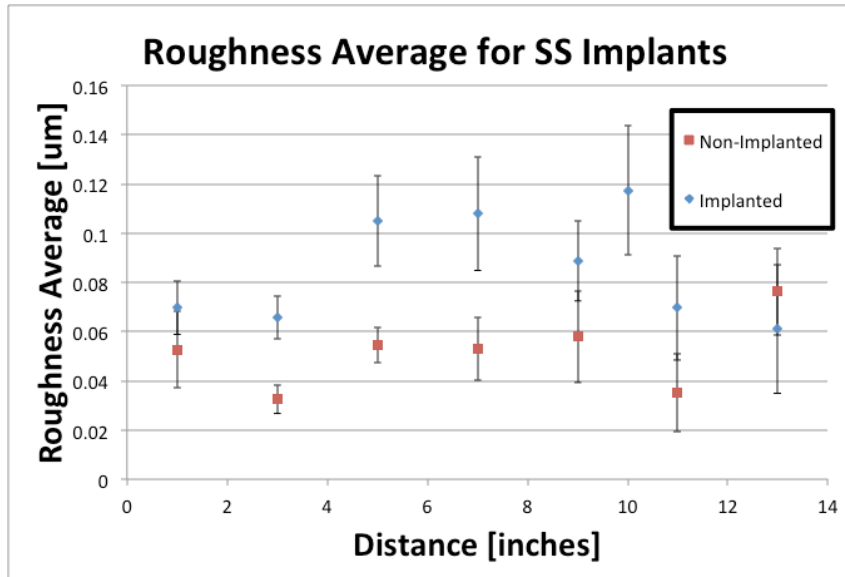
Figure 43. The roughness average data for the long femoral nails shows that the surface of the implanted sample was rougher on average.

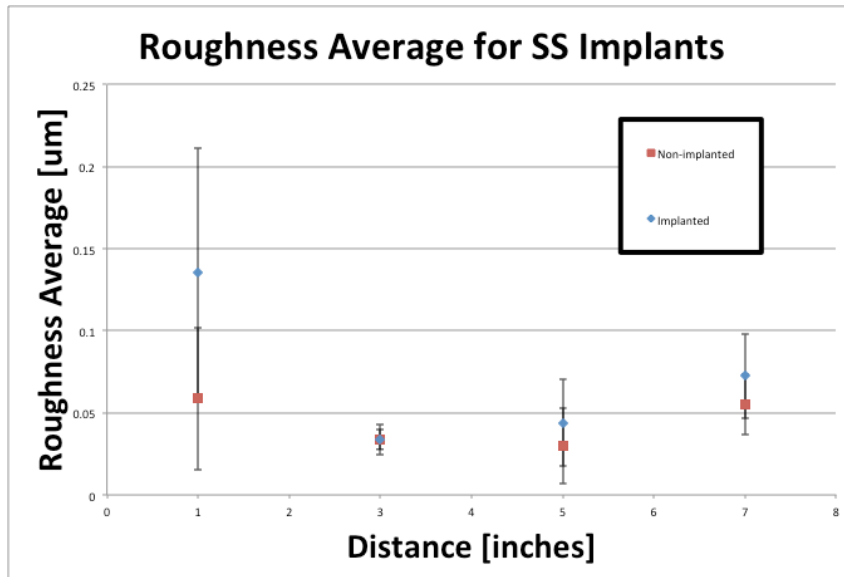
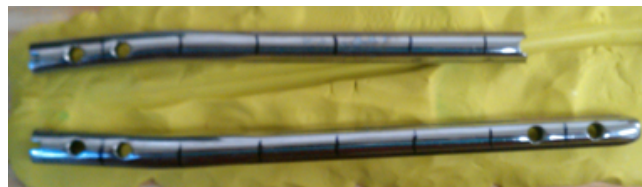
Figure 44. The roughness average data for the short femoral nails shows no conclusive evidence for a difference, but it appears that the implanted sample is rougher on average.
