EVALUATION OF BONE FIXATION IMPLANTS

A Thesis

This research investigates the effects of the human body on the mechanical, chemical, and morphological properties of the surface of internal fixation devices. Stainless steel and titanium devices that had failed were provided from the Shandong Provincial Hospital in China, along with controls: implants that had never been used. Comparative study was conducted by evaluating properties of these implants before and after implanting.

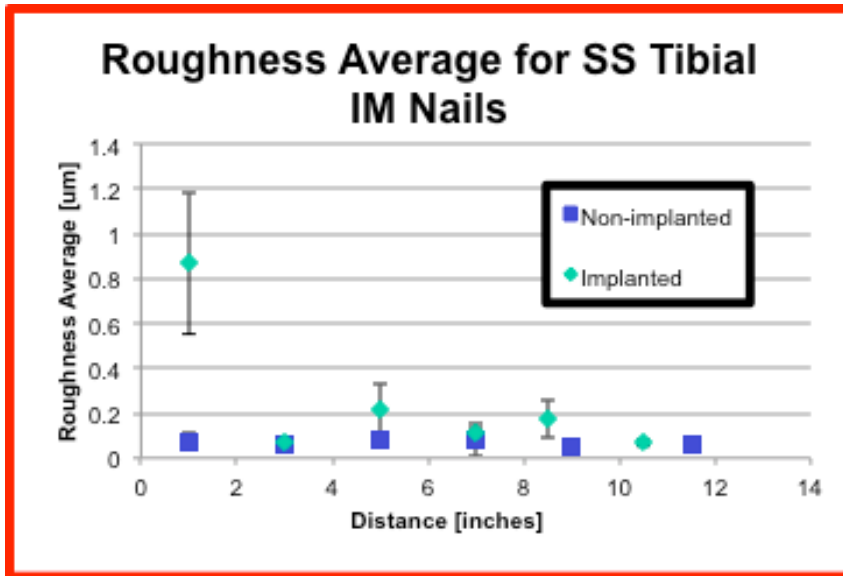
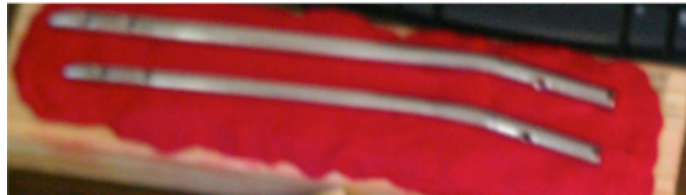
Figure 45. The roughness average data for the tibial nails shows that the surface of the implanted sample was rougher on average.

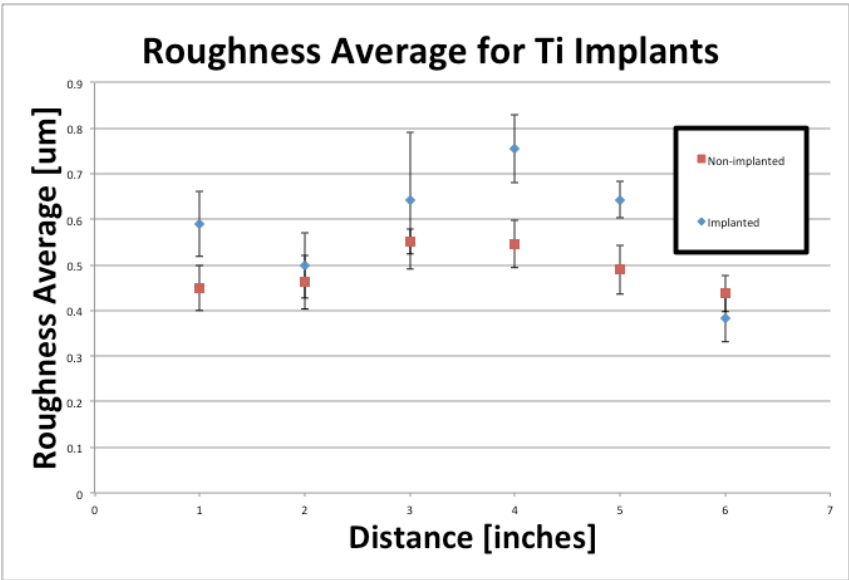
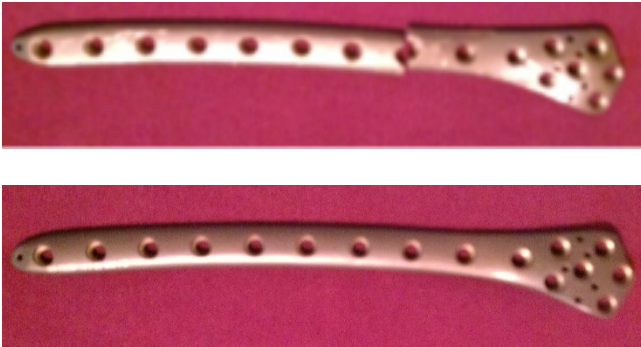
Figure 46. The roughness average data for the femoral plates shows that the surface of the implanted sample was rougher on average.

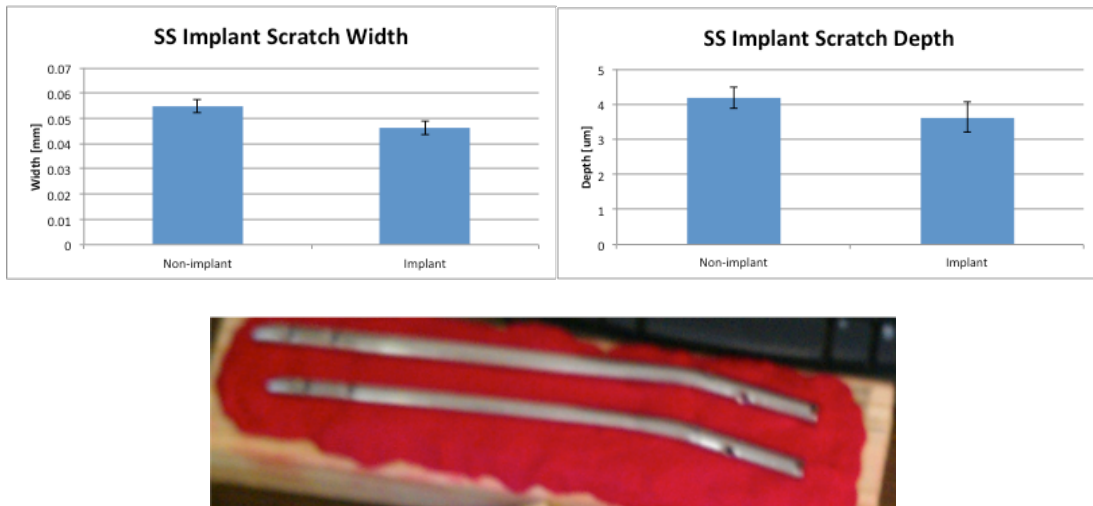
Figure 48. The scratch width and depth were smaller for the implanted tibial nail.

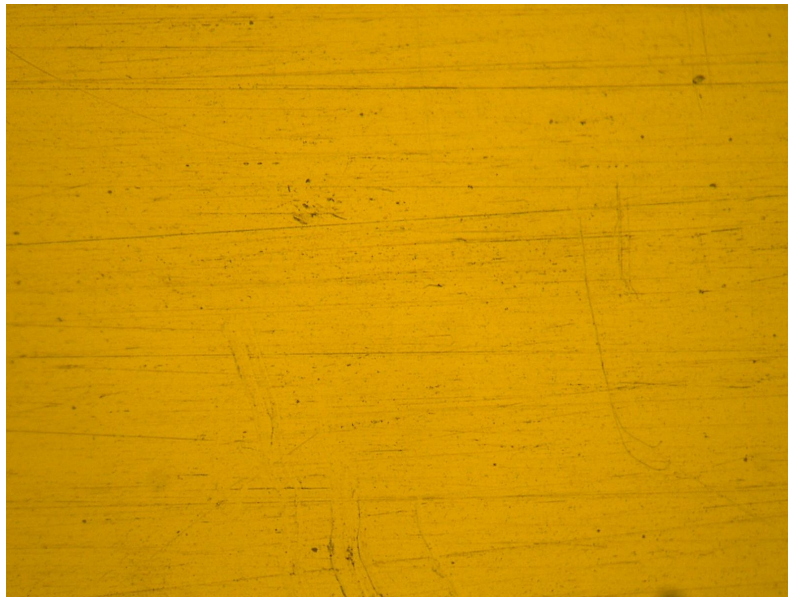
Figure 49. The non-implanted stainless steel appears to be polished although having several scratches.

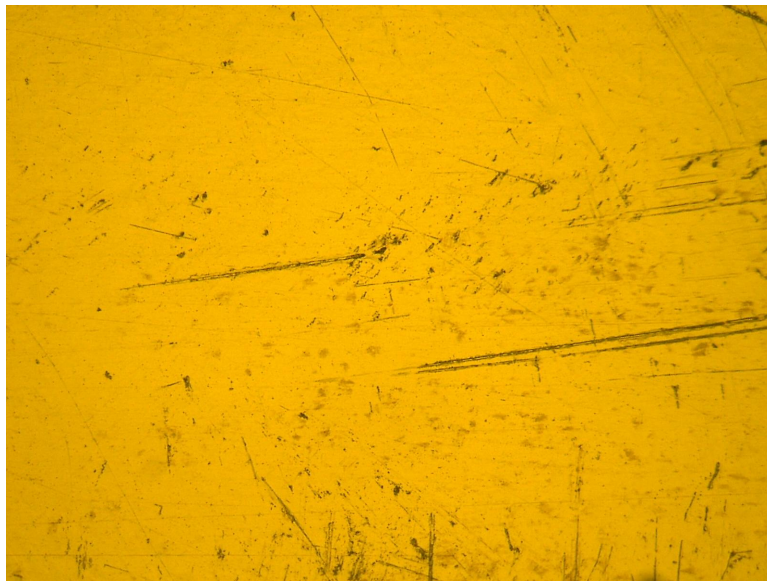
Figure 50. The implanted sample shows increased roughness due to localized pitting.

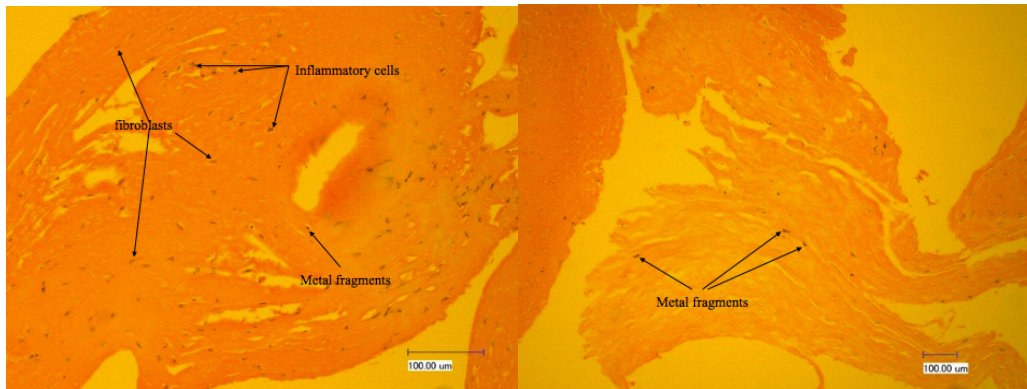
Figure 51. Tissue samples proximal to the bone implant show the presence of metal fragments, fibroblasts, and inflammatory cells.

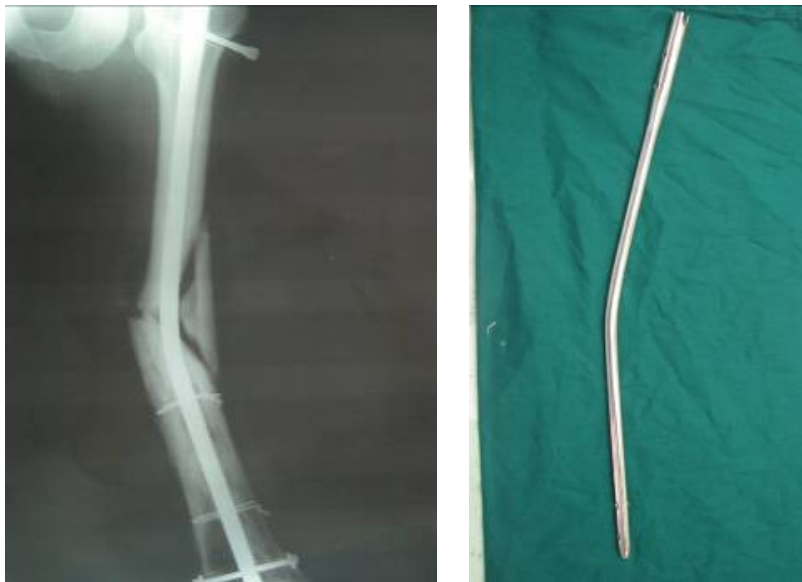
Figure 52. The x-ray and regular image show the bend in the long femoral intramedullary nail.

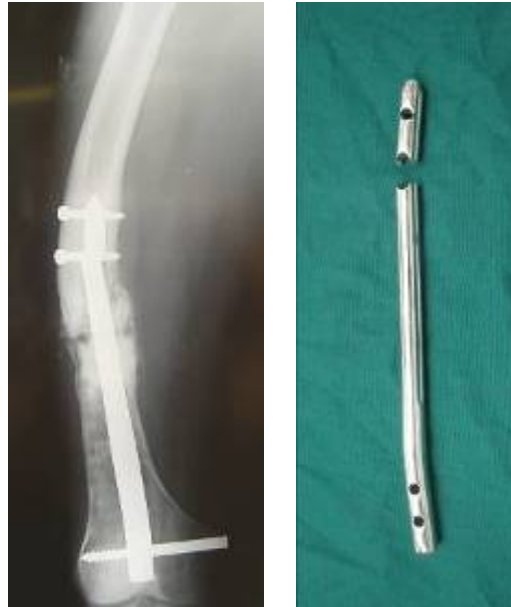
Figure 53. The x-ray and regular image show the bend in the short femoral intramedullary nail.

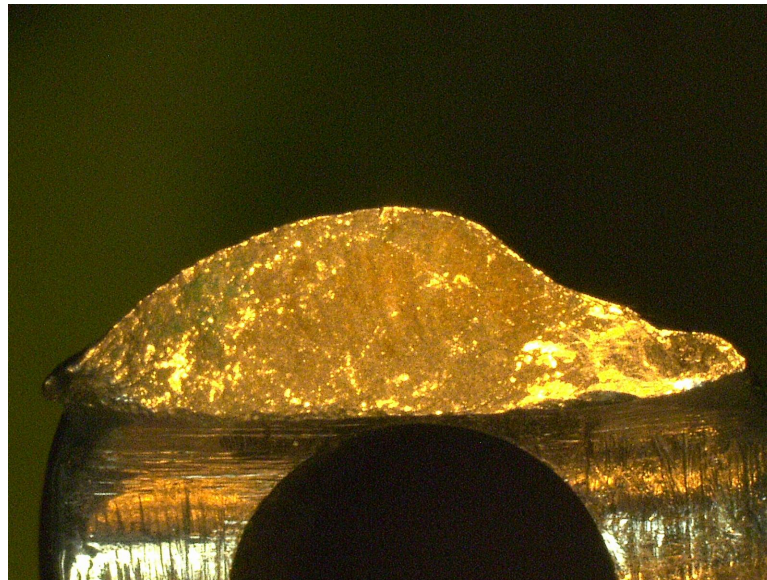
Figure 54. The fractography shows a brittle fracture.

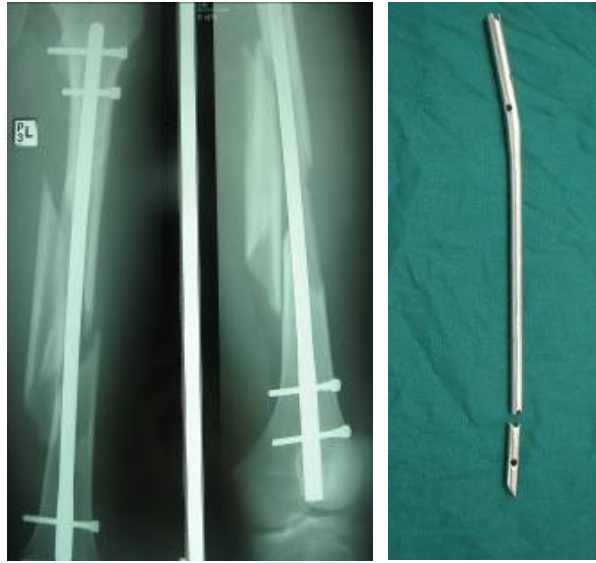
Figure 55. The x-ray and regular image show the bend in the tibial intramedullary nail.
