Evaluation of BMPs to Reduce NPS Pollution at the Farm Level

**Arroyo Colorado Agricultural Nonpoint Source Assessment
FY 06 CWA 319(h)
TSSWCB Agreement No. 06-10-07-05
Task 7 Report**

**Texas Water Resources Institute Technical Report No. 423
May 2012**

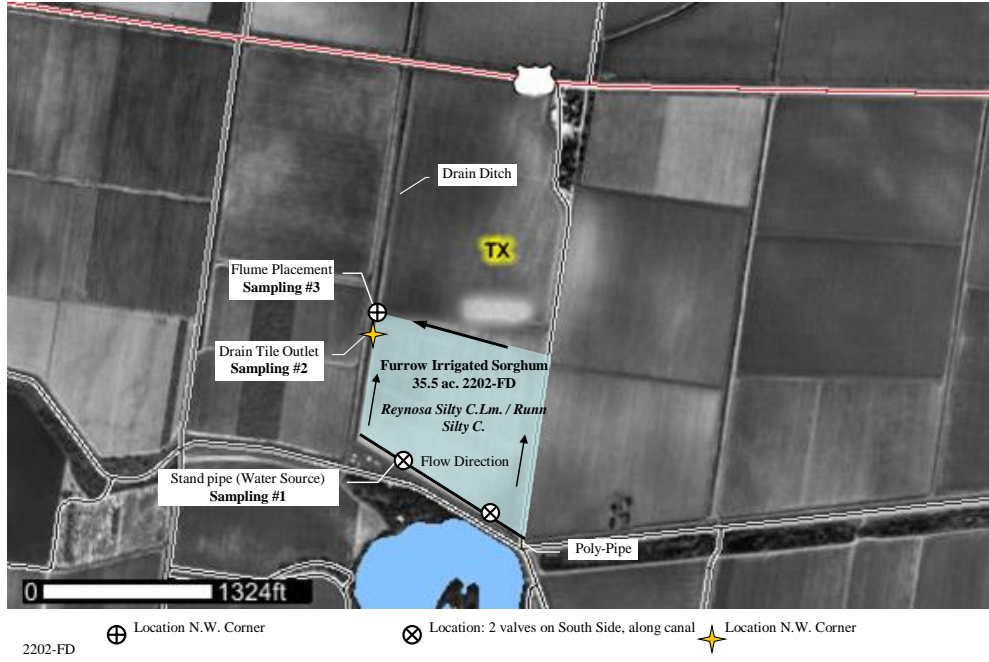
Figure 5. Site FD selected for the Agricultural Nonpoint Source Assessment Project.

- d. **Site FD** (site with no drain tiles): The previous crop was harvested and disked in mid-March. A pre-irrigation occurred afterwards to ensure a good germination of sorghum when it was planted. After planting, a 2-inch PVC access tube was installed to a depth of

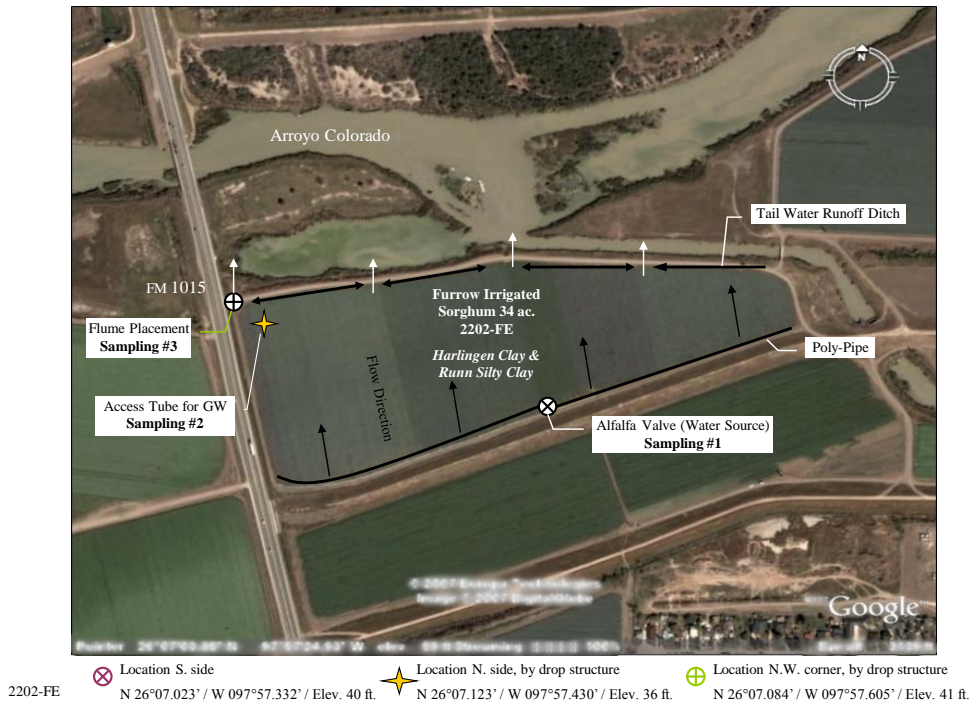
Figure 6. Sites FE selected for the Agricultural Nonpoint Source Assessment Project.

- 10 feet to collect groundwater samples. Watermark sensors were installed on one location at 6 and 12 inches deep to monitor soil moisture along the season.
- e. **Site FE** (site with drain tiles). Sorghum was planted and Watermark sensors were installed on one location at 6 and 12 inches deep to monitor soil moisture along the season.
 - f. **Site FF** (site with drain tiles): The outlet was under water most of the time.
 - g. AgriLife Research installed signs at all of the participating producer sites (in English and Spanish) to notify the producers to contact AgriLife Research before irrigating (Figure 8).

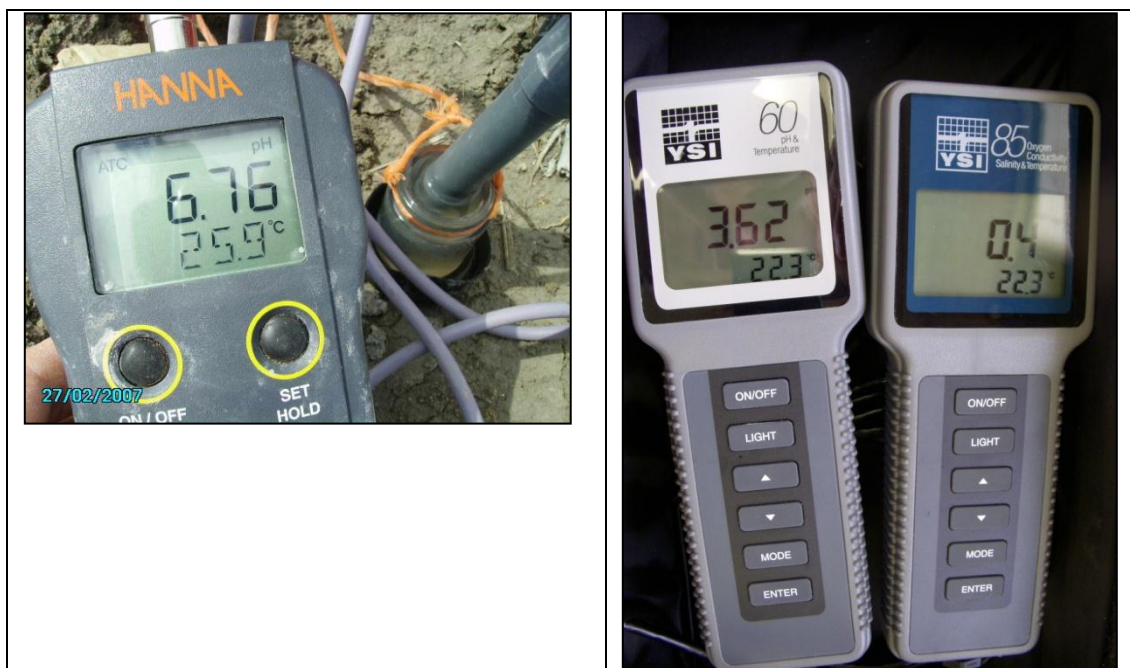
Figure 9. Left: Apparatus used to measure electrical conductivity of the water table. Right: apparatus used to monitor pH and BOD.

A water sample was collected in a clean LDPE bottle and rinsed to measure temperature, conductivity, DO, and salinity on the field. Field parameters were measured in-situ using a portable hand-held YSI 85 meter for temperature, conductivity, DO, and salinity; and a YSI 60 meter for pH (Figure 9). Duplicate field measurements were taken and recorded. This is done to monitor potential water and meter variability. Additionally, water samples were collected immediately after recording those measurements and shipped to TAMU-K for analysis of total phosphorus, dissolved orthophosphate phosphorus, total Kjeldahl nitrogen, dissolved ammonia, dissolved nitrite plus nitrate, TSS and BOD5 (Table 4).

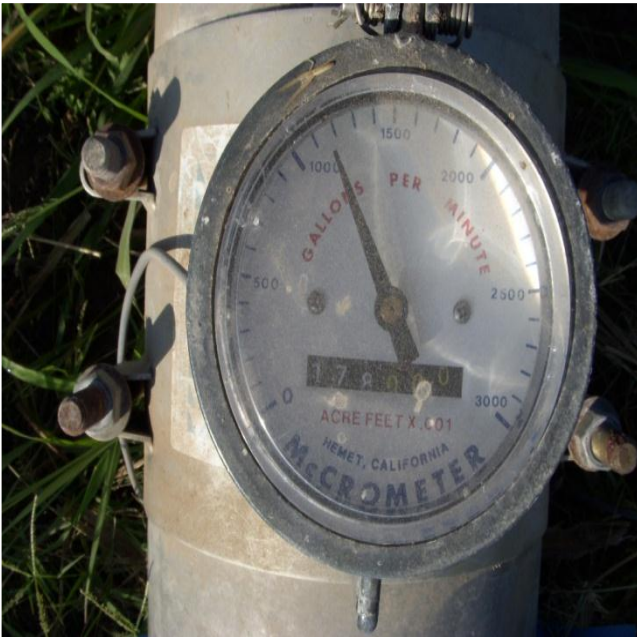
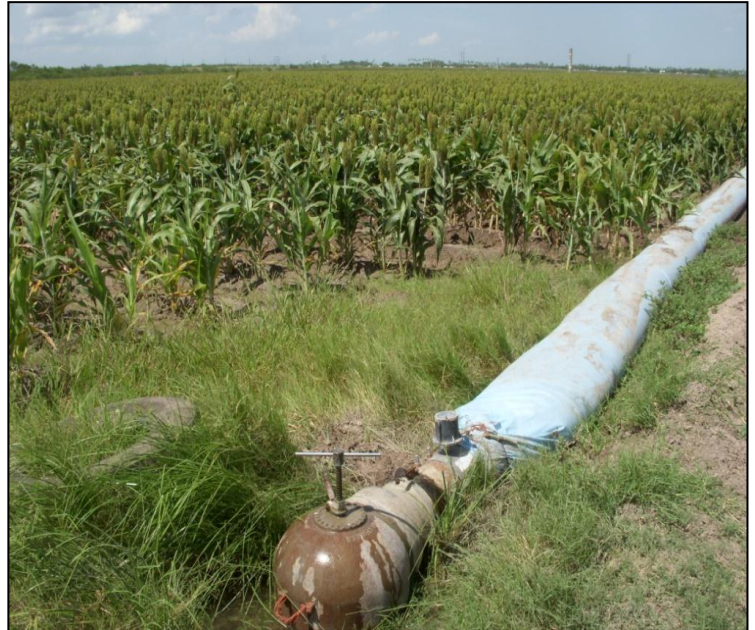
Figure 10. Propeller flow meters used to measure irrigation depth.

The volume of water used during each irrigation event was measured using propeller flow meters (McCrometer) such as the ones shown in Figure 10. The volumes were then converted to irrigation depth. The quality of irrigation water was measured directly from the irrigation pipe (Figure 11). In case the farmer was applying fertilizer with the irrigation water, the sample was taken before it was mixed with fertilizer.

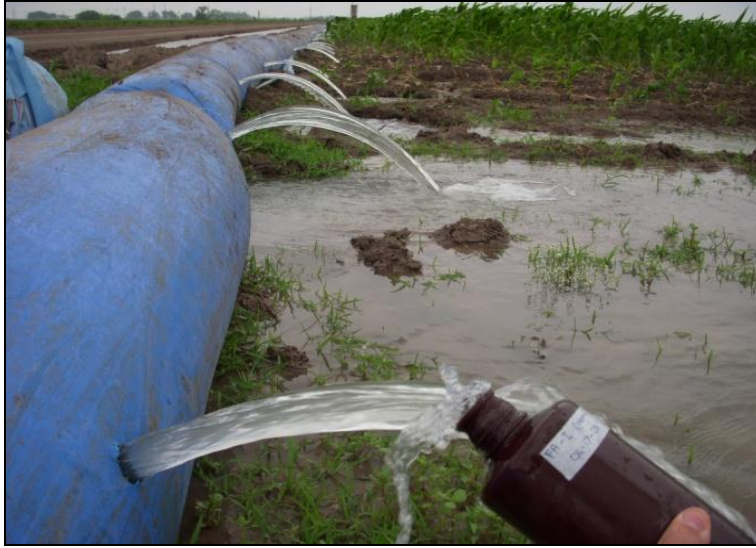
Figure 11. Collection of a water sample from irrigation.

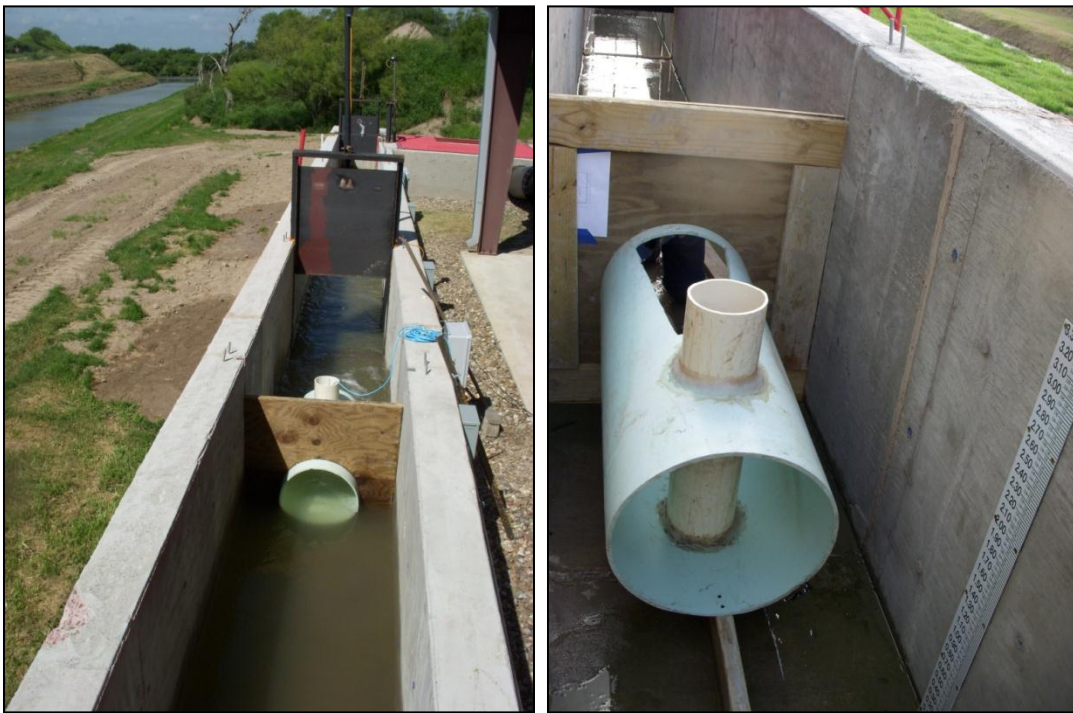
Figure 13. Calibration of the circular flow meter in the Harlingen Irrigation District.

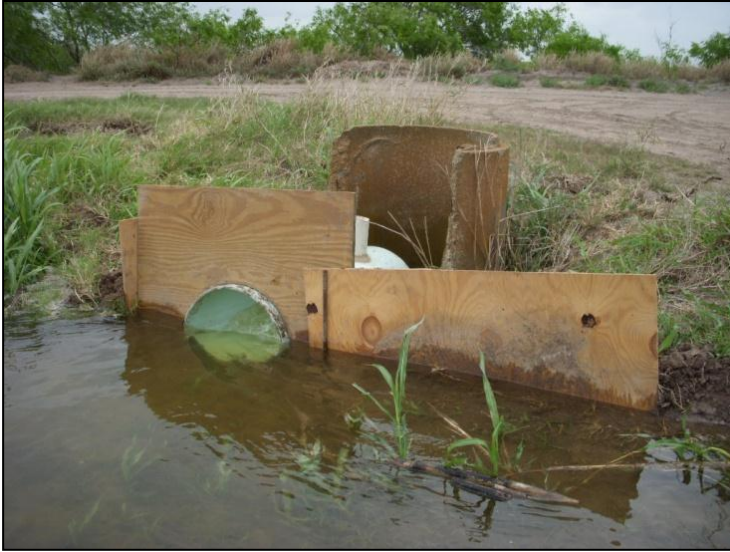
Measurement of Tail Water (Run-off) with a Flume

3rd Step: Field application & results: 2 samples/event, 2 irrigation events/year

Runoff was collected at the end of the surface drain before flow reached the Arroyo Colorado. A PVC mobile circular flume placed at the drainage ditch was used to measure runoff flow-rate using a data logger and a pressure transducer. This flume presented a discharge-head relationship for critical flow conditions by reducing the flow cross section (Hager 1988; Samani et al. 1991). Samani et al. 1991 described the construction and testing of these devices for different nominal sizes with different column pipes of external diameters. The flume measured water depth passing through and the water depth readings were recorded and directly related with the runoff flow rate. Two water samples were collected per irrigation event: a first sample collected during the early stage of the runoff event and a second sample at the peak runoff flow. Only the peak runoff was reported in this study. Peak runoff was taken from the drainage stream ditch where furrow discharge was in excess of irrigation water. See Figure 12 for schematic of the flume that was used to measure irrigation return flows. To assure that the circular flume measured accurately and with less than 10% error, the flow meter was calibrated in the Harlingen Irrigation District (Figure 13). The runoff depth was recorded with a data logger that was installed on the flume (Figure 14). The runoff volume was calculated from the hydrograph. Two water samples were collected per irrigation event: the first sample collected during the early stage of the runoff event and the second sample at the peak runoff flow (Figure 13). This is done because of the variability in runoff due to changing soil moisture conditions.

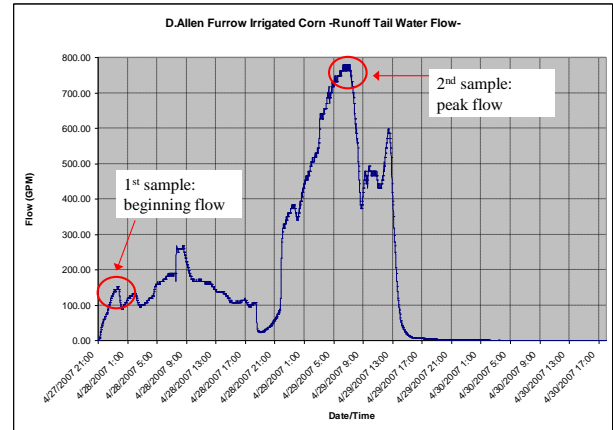
Figure 14. Left: Circular flume measuring runoff with a data logger. Right: Hydrograph obtained during the irrigation event.

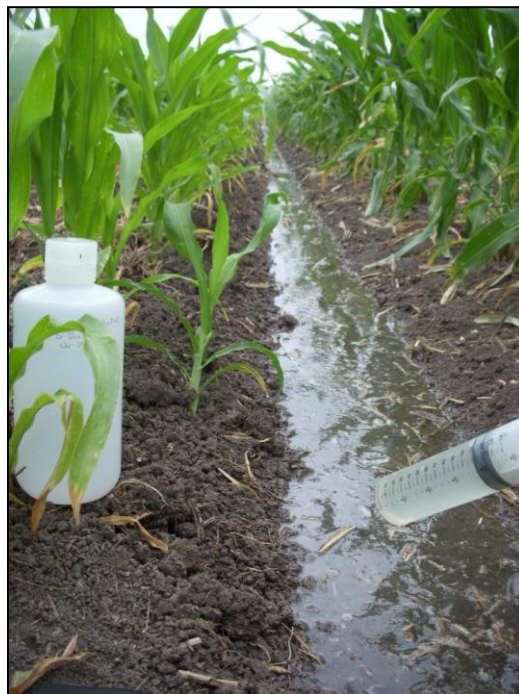
Figure 15. Collecting a water sample from initial runoff with a syringe at the end of the furrow.

Water samples were collected during initial runoff from one furrow. It was generally the faster row to reach the lower end of the field first (Figure 15). The peak runoff was taken from the earthen ditch that collected the runoff from all the rows that were being irrigated at the approximate time when the peak runoff was achieved (Figure 16).

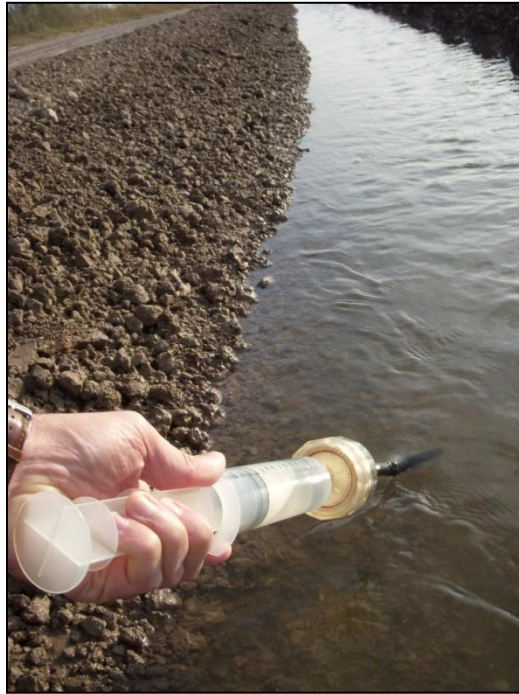
Figure 16. Collecting a water sample to determine peak runoff.

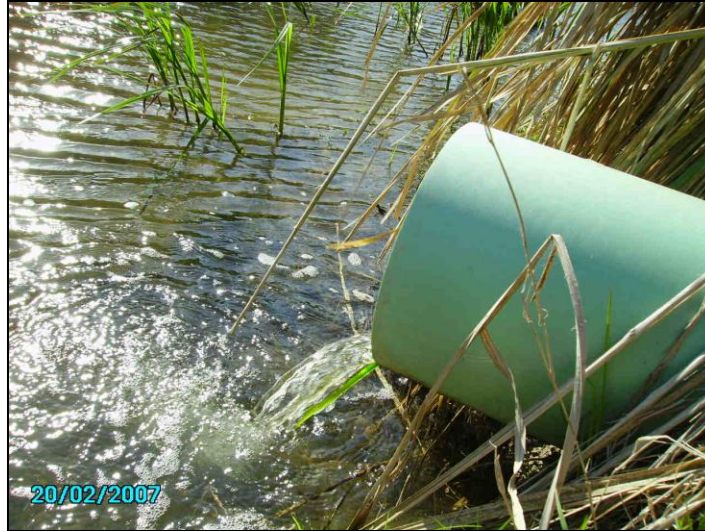
Figure 17. Outlet that received the water drain from the field during the irrigation event.

Field sites with tile drains installed were sampled during selected irrigation events at the main outlet of the tile drains (Figure 17). In the fields that did not have tile drains, groundwater samples were collected from a 2-inch well that was dug in the field to a depth of 6 feet. The well was cased with a perforated PVC access tube. The groundwater sampling and monitoring method was done using the method described by Harter (2003). The installation of the piezometer to monitor the shallow ground is shown in Figure 18. Shallow groundwater was sampled from the project fields with no tile drains using EPA standard methods (Figure 19).

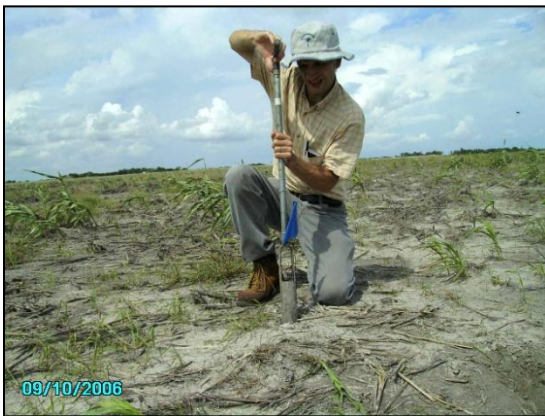
Figure 18. Left: Installing a piezometer to obtain groundwater samples. Right: Probe to measure the depth of the water table.

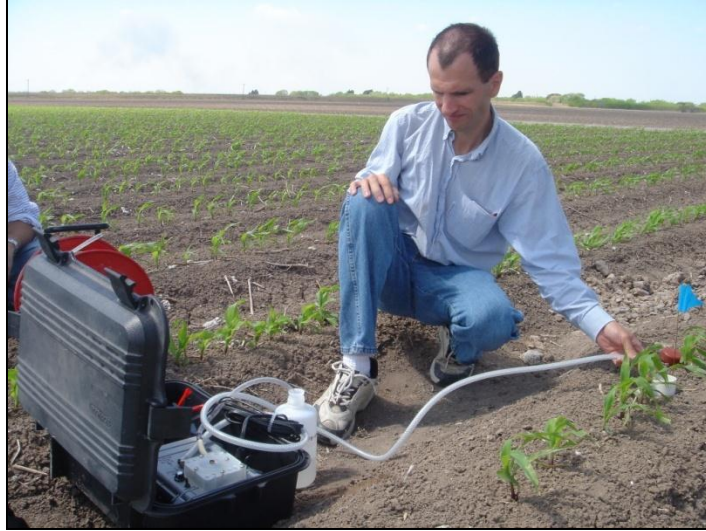
Figure 19. Collecting a groundwater sample with a variable flow pump from a 2-inch well.

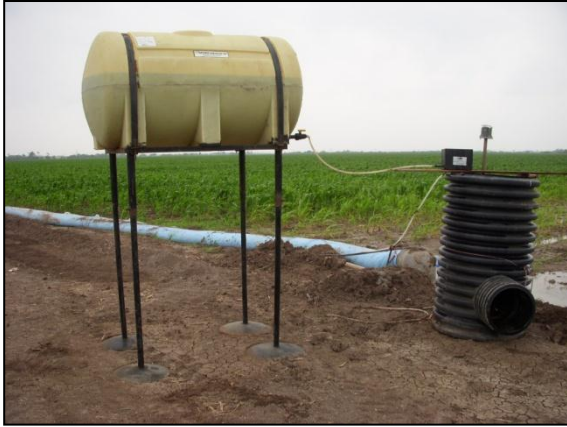
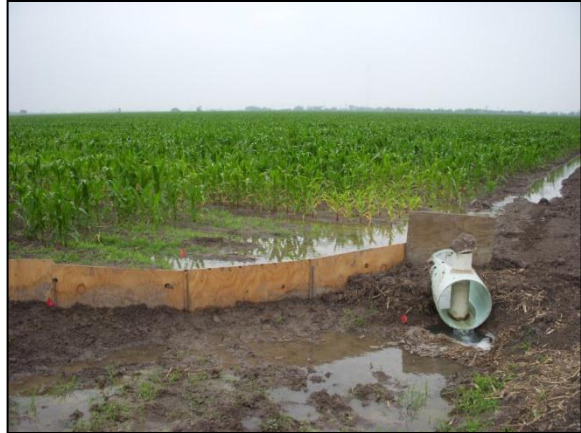
Figure 20. Site FA fertigrating during the first irrigation. Right: Shows the flume to measure runoff volume at the corner of the field.

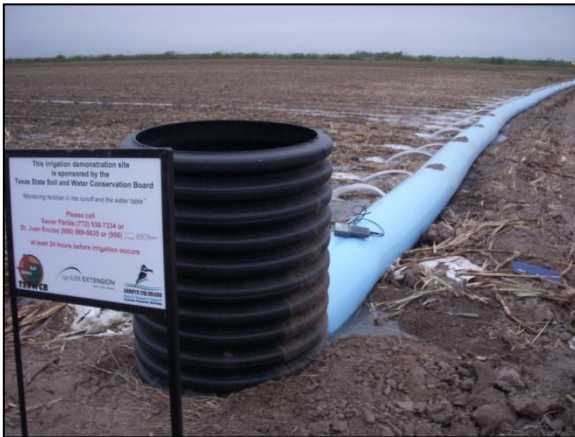
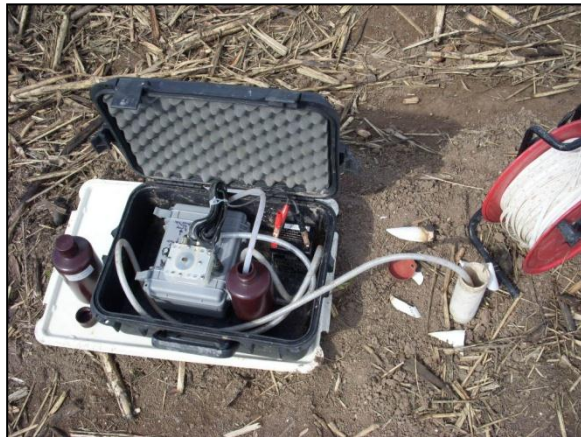
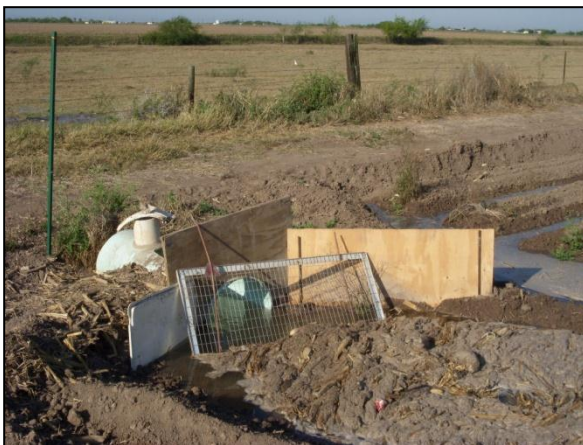
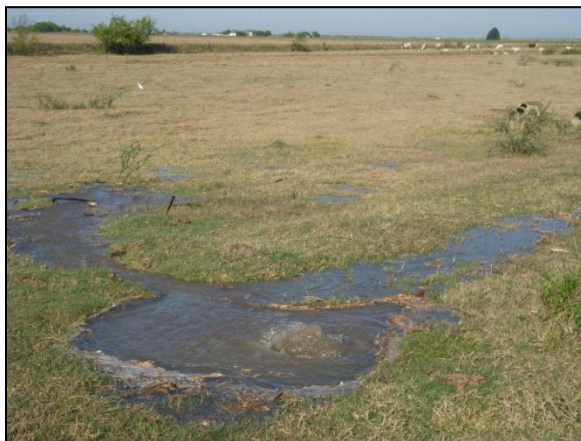
Figure 21. Upper Left: Site FB Irrigating with poly-pipe; Upper Right: Showing how water is pumped from the groundwater to collect samples for analysis. Lower Left: The lower left picture shows the installation of a flume to measure runoff volume. Lower Right: The lower right shows a vegetation strip where runoff is discharged.

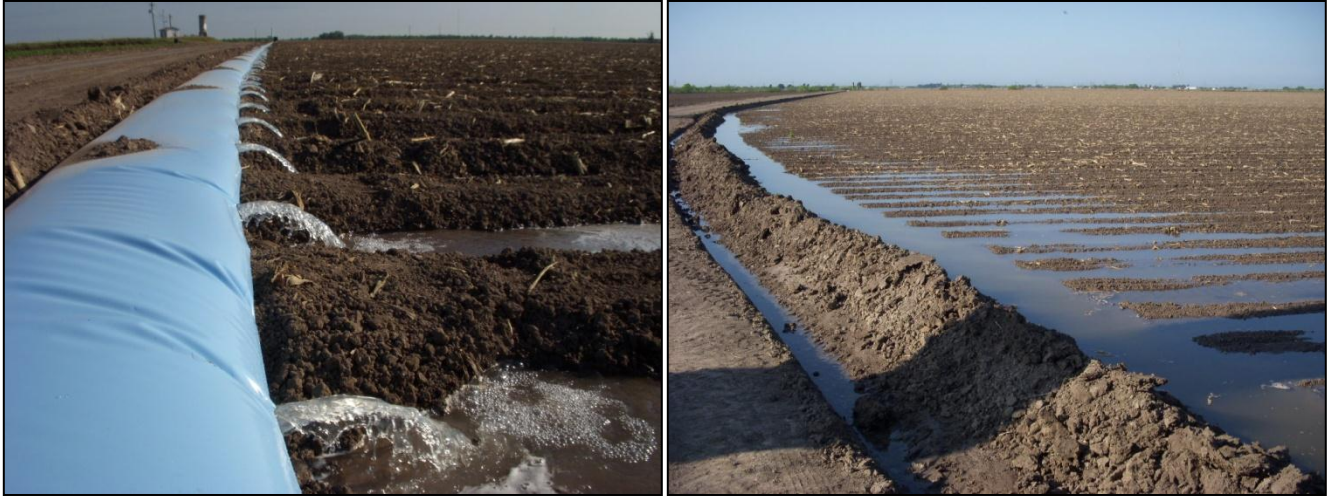
Figure 22. Upper Left: Site FC irrigation with poly-pipe; Upper Right: Showing the downstream end of the field where runoff was collected.

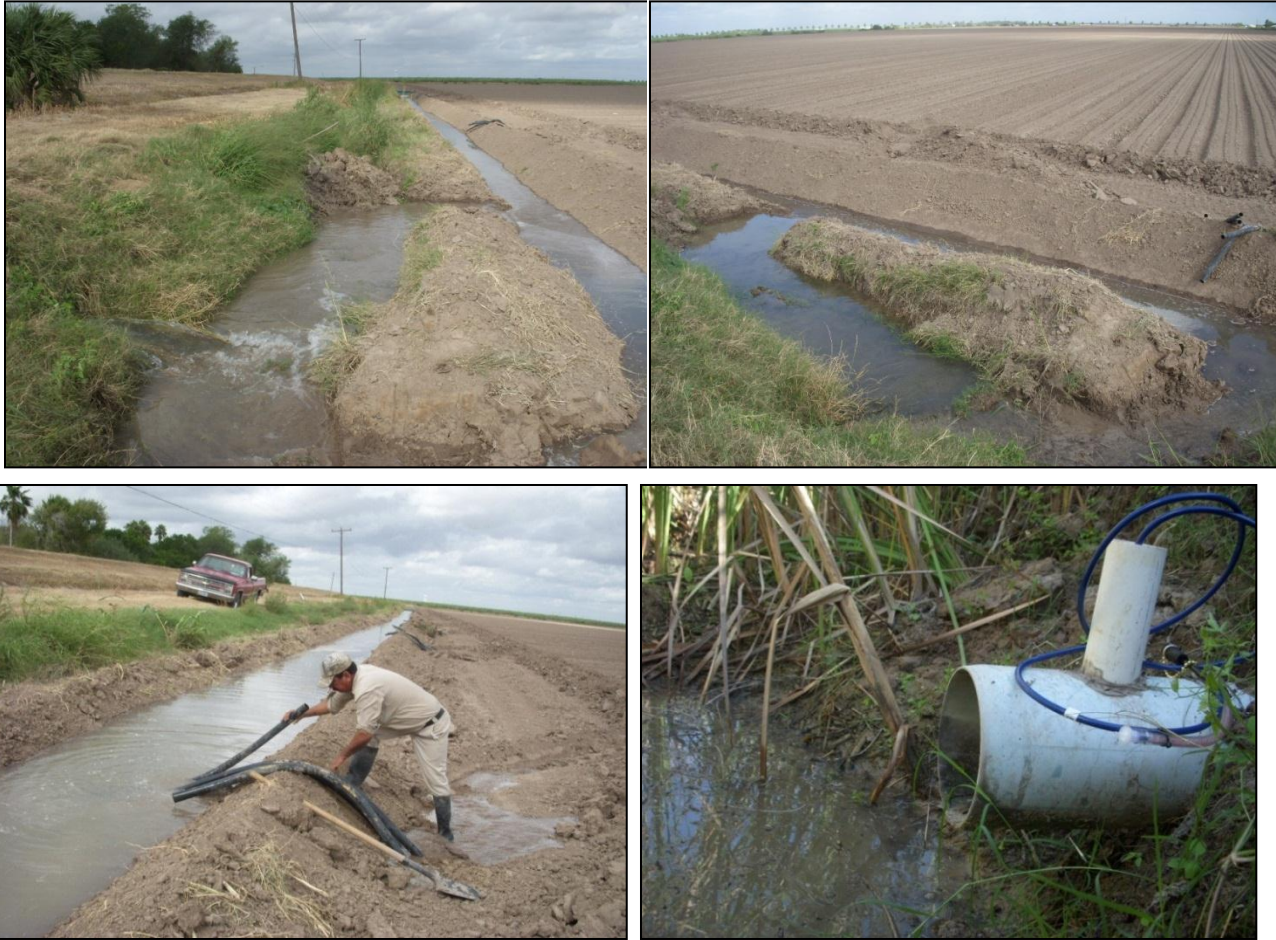
Figure 23. Upper Left and Right: Site FD Irrigation with earth ditches and siphon tubes. Bottom Left: The bottom left shows an irrigation starting a siphon tube; Bottom Right: The right picture shows a pressure transducer used to measure drainage water from an outlet of a drain tile.

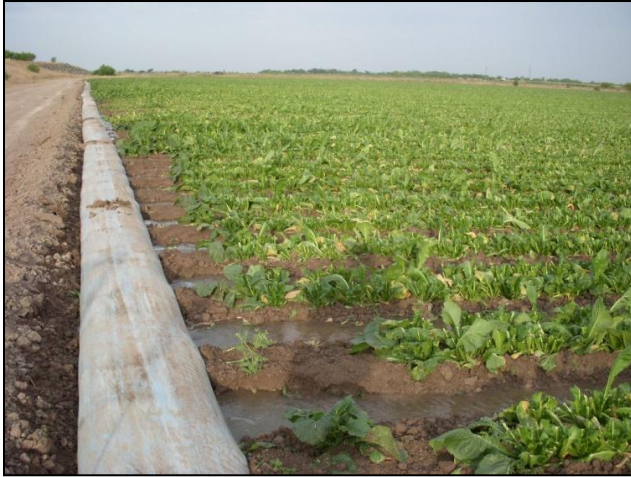
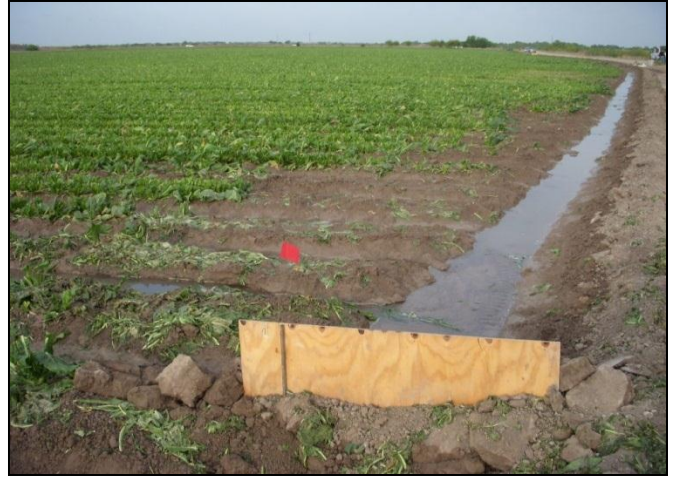
Figure 24. Site FE irrigated with poly-pipe and right picture showing the runoff from the field.

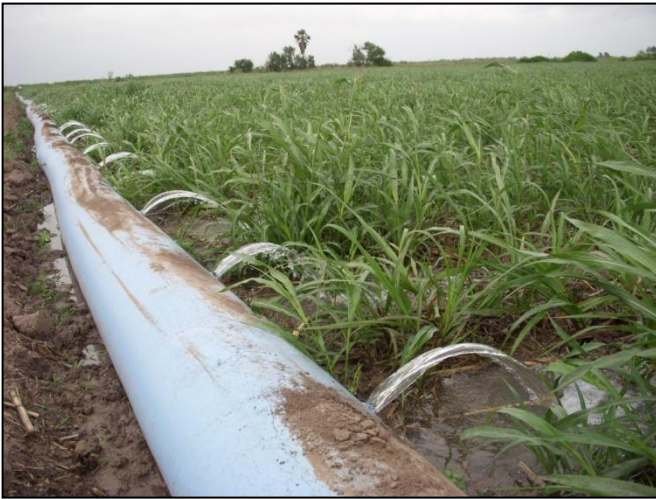
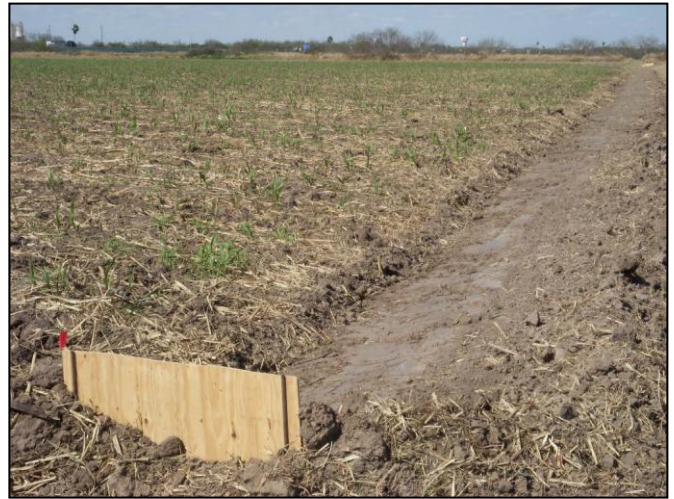
Figure 25. Site FF irrigated with poly-pipe and right picture showing the place where runoff was going to be measured.
