COMPARISON TEST FOR INFECTION CONTROL BARRIERS FOR
CONSTRUCTION IN HEALTHCARE

A Thesis

Major Subject: Construction Management

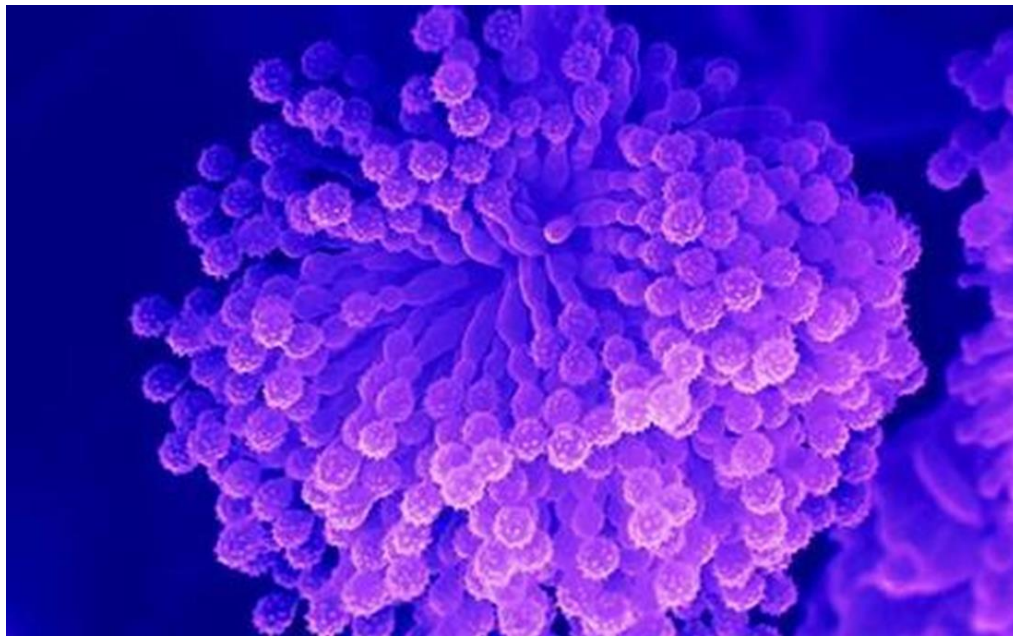
Figure 1 is a photograph of the *Aspergillus* spores that are released into the atmosphere. The picture in the Melbourne, Victoria, Australia newspaper, *The Age* relates to an upgrade of the Alfred Hospital, which is noted as the busiest trauma hospital in Australia.

Figure 1 *Aspergillus* spore (after Nader, 2006)

During construction activity, dust containing *Aspergillus* spores may be dispersed when floors, walls, and ceilings are penetrated and become airborne. These spores are very small, about two to three microns, which allow them to stay suspended in the air for a long period of time and increases their chance of being inhaled (Malik et al., 2008).

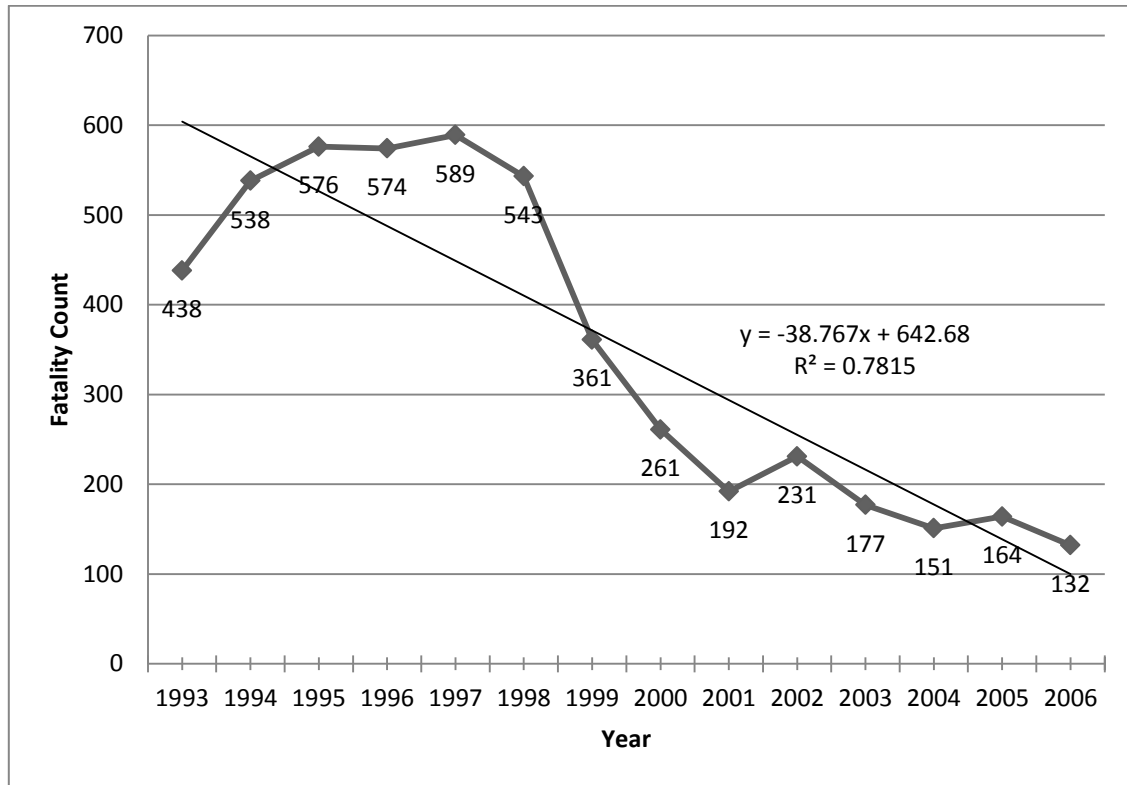
Figure 2 Aspergillosis fatalities - 1993 - 2006 in the USA

the CDC data for fatality counts for Aspergillosis in the USA for the period 1993 to 2006. Fatalities recorded by the Center for Disease Control show a consistent decline in deaths related to aspergillosis from 1993 to 2006 (CDC, 2009).

Figure 2 has a linear trend-line plotted using standard statistical techniques. The trend-line suggests a reduction in the death toll with year will continue. This pattern will need to be reviewed in a few years to determine if a population cohort exists that cannot be protected from Aspergillosis. This trend-line appears to indicate that aspergillosis is becoming less prevalent in the healthcare industry.

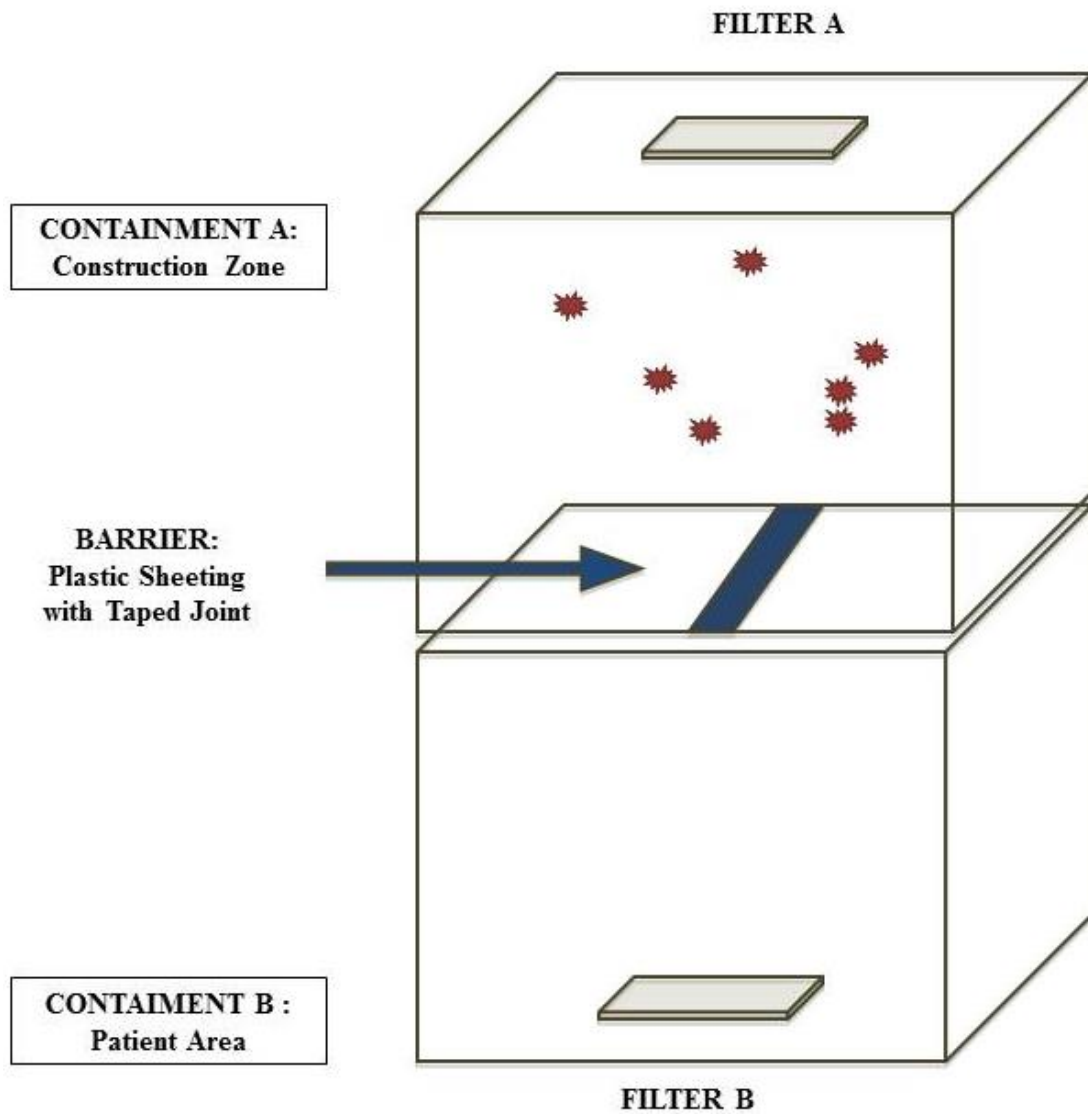
Figure 3 Containment vessel design

Figure 3 shows a sketch of the theoretical basis for the containment vessel. The vessel is constructed of plywood and timber glue.

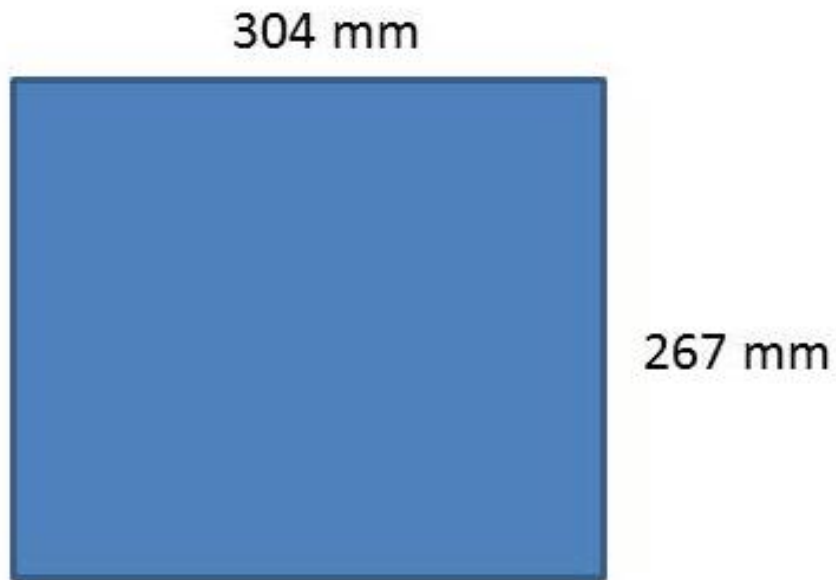
Figure 4 End piece dimensions in millimetres

Two identical, separate box containments were constructed for this experiment, Containment A and Containment B. Both boxes were built using 19 mm oak plywood, each with five enclosed sides and one open face. A flange was attached to the open face of each box to extend the edges by three inches. To begin, all dimensions were determined for Containments A and B. The containment vessel has two end pieces, with dimensions shown in Figure 4.

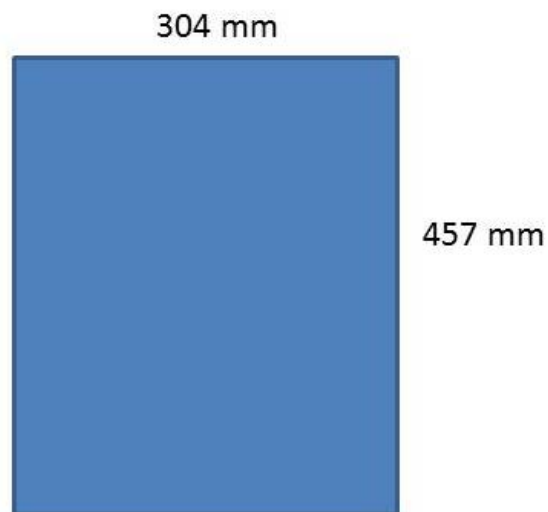
Figure 5 Side plate Type A – dimensions in millimetres

There are four side plates of the type A as shown in Figure 5.

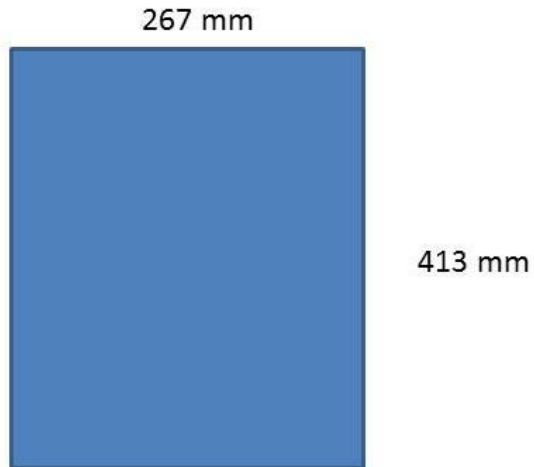
Figure 6 Side plate Type B - dimensions in millimetres

Figure 6 shows the dimensions of the side plate type B.

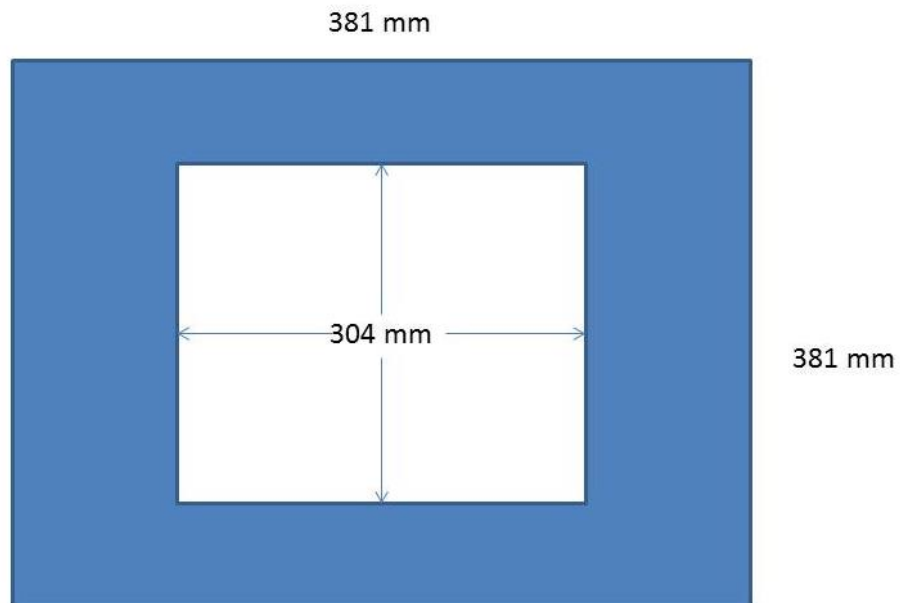
Figure 7 Flange plate - dimensions in millimetres

Figure 7 shows the flange plate, used to provide the edge for the barrier.

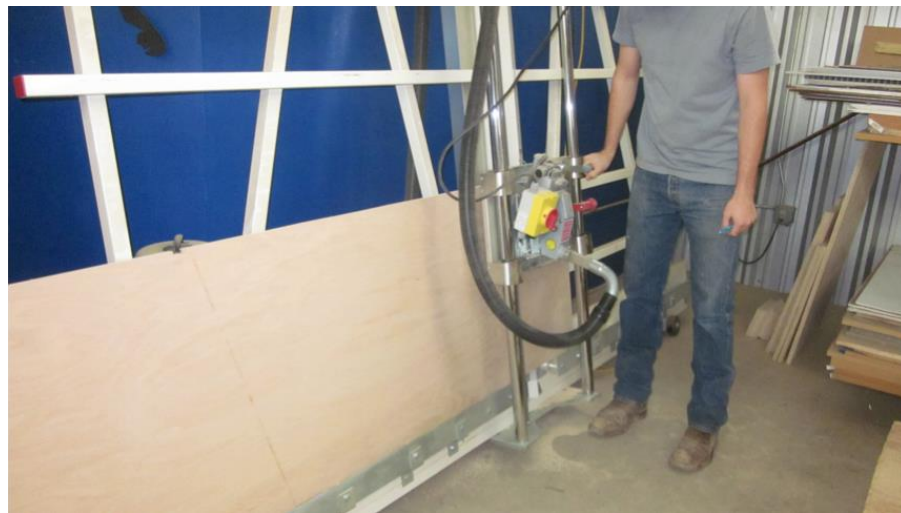
Figure 8 Panel saw cutting plywood

Plywood sheeting was cut first using a panel saw and then trimmed with a table saw. Pieces were all cut to size using the table saw. The flange pieces required an inside dimension to be cut out of the exterior dimension, posing a challenge to the construction. As a solution, Mr. Gary BS (2012) used a CNC Router to make these cuts. A CNC router is a computer-controlled device that shapes material from AutoCAD files designed and entered into the router system. After measuring, marking, and cutting appropriately, each box was assembled. This required placing wood glue along joints, then tightly securing each piece together using a nail gun. The end pieces were first connected to the bottom piece, following the side connections and the top piece. The flanges were connected to the boxes last. To seal the wood and any fibers that may conflict with the test, the insides of the boxes were coated with clear finish shellac. This process took place at the TAMU Architecture Ranch and the TAMU Woodshop, where all materials and tools were available and used to construct the containment.

Figure 8 and Figure 9 show the cutting of the plywood pieces from sheets.

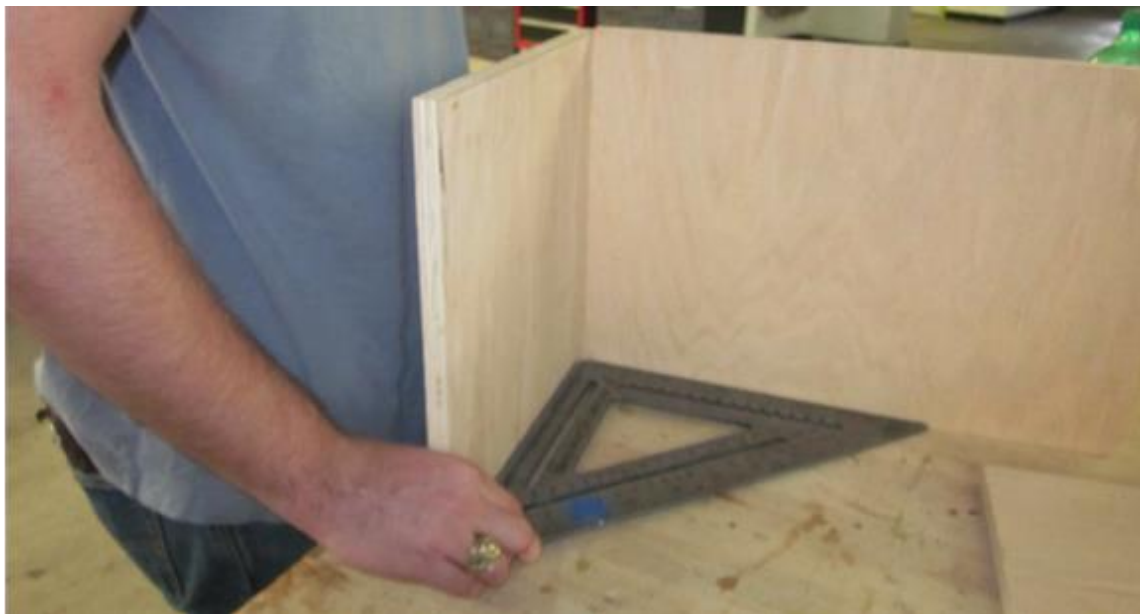
Figure 10 Squaring the plywood box

Figure 10 shows the geometric methods used in the box construction.

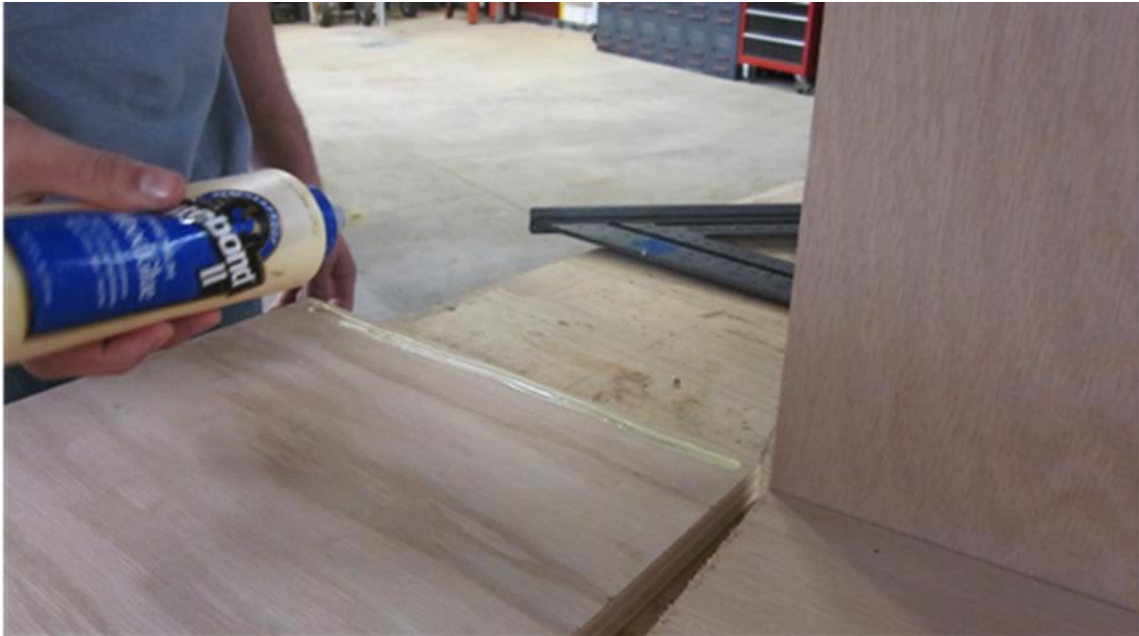
Figure 11 Gluing the edges of the box

Figure 11 shows the non-watertight all-purpose wood glue use to join the sides.

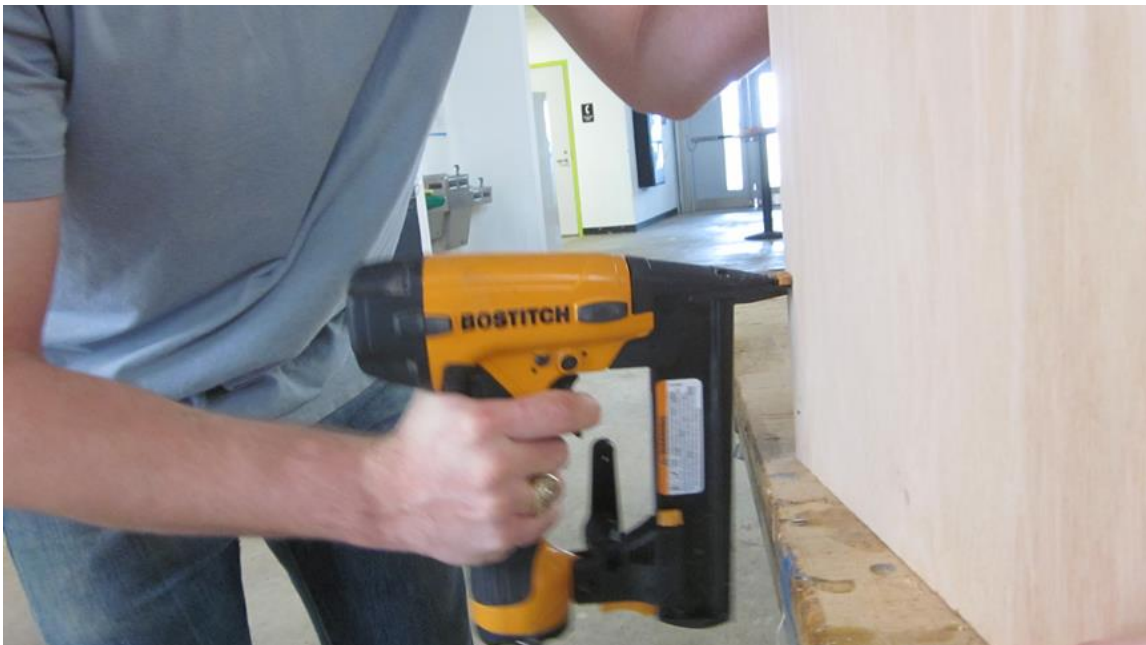
Figure 12 Nail gun used to hold boxes until glue dries

Figure 12 shows the boxes being tacked with nails to give the glue time to set.

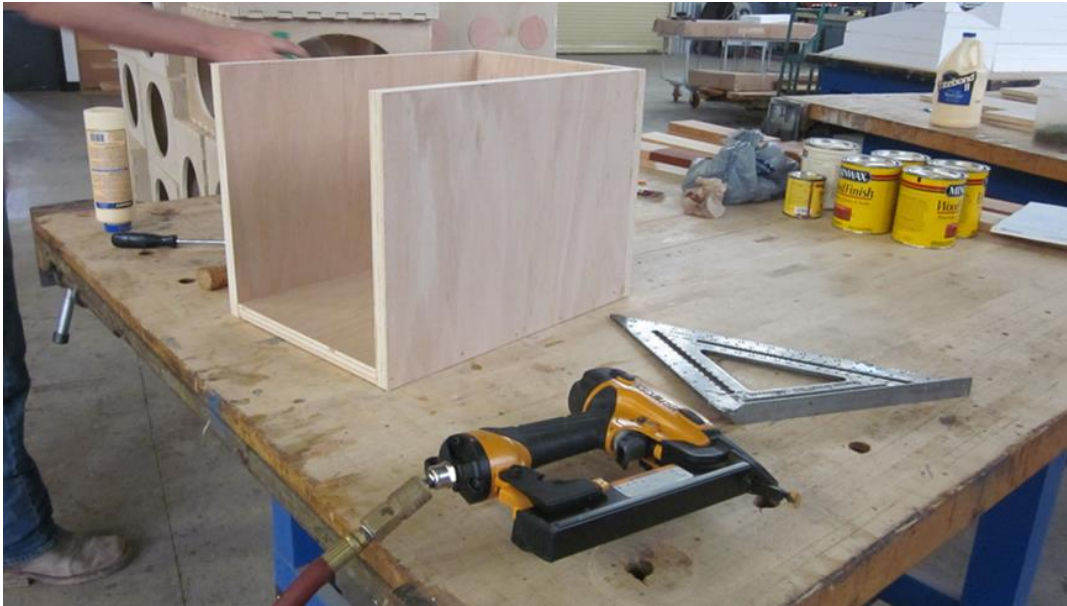
Figure 13 A partially assembled box in this case Containment A

Figure 13 shows a partially assembled box.

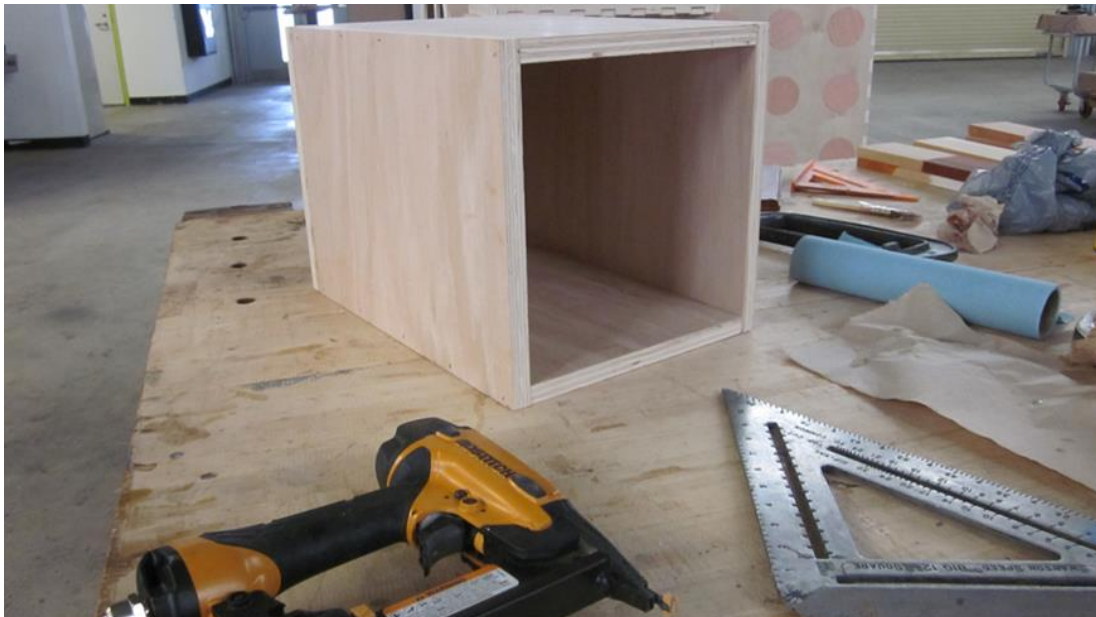
Figure 14 Containment A without flange piece

Figure 14 shows Containment Vessel A prior to the placement of the flanges.

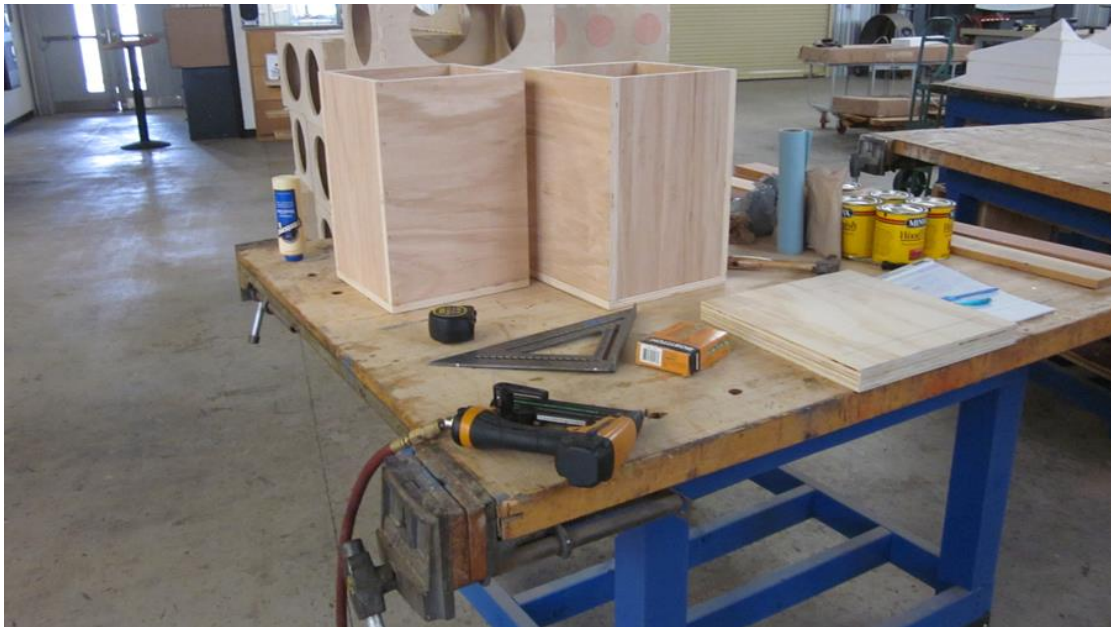
Figure 15 Containment A and Containment B without flange pieces

Figure 15 shows the two containment vessels, prior to the flange placement.

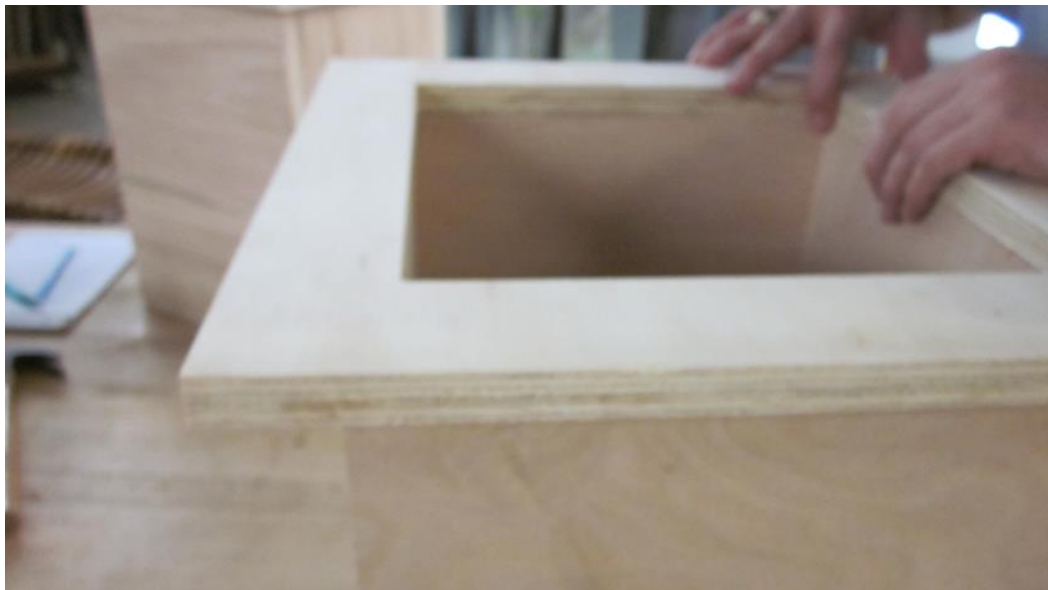
Figure 16 Flange pieces being attached to containments

Figure 16 shows the flange pieces being attached to the boxes.

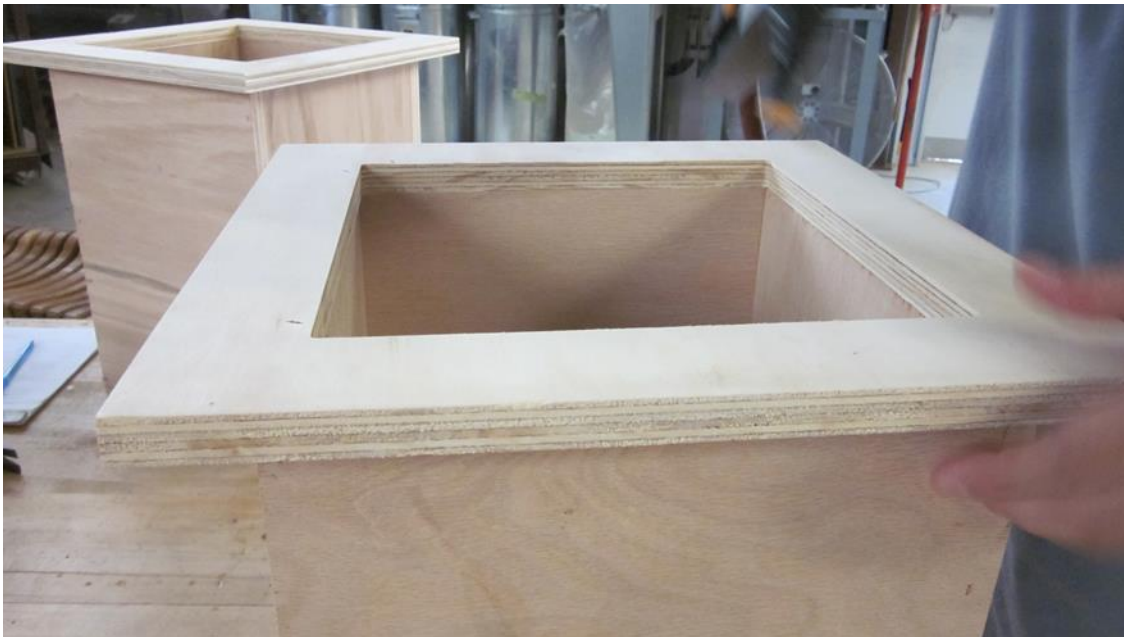
Figure 17 Flange pieces attached to Containments A and B

Figure 17 shows the completed containment vessels.

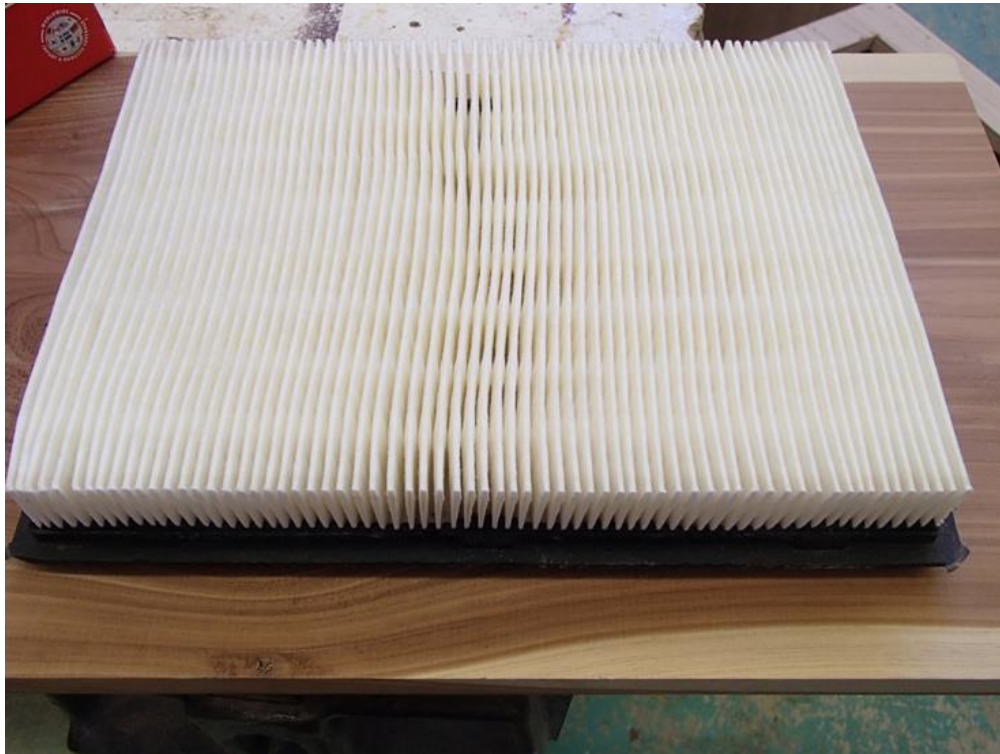
Figure 18 MicroGard MGA7635 Air Filter

To do this, a MicroGard MGA7635 air filter is inserted into the top of Containment A, as shown on Figure 18. Haberl (2013) suggested the use of the automotive air filters. A filter was selected that would lay flat on the base of the lower containment vessel to maximize the chances of trapping any particulate matter that passes the barrier.

This filter is lined with a rubber gasket to provide a tight seal for eliminating leakage of air. The dimensions of the filter, 248 mm by 178 mm, were cut out of the top of Containment A. The filter could then be tightly fit into the top of the Containment. Using an air pressure-regulating valve, air could then be pushed through the filter into the containment and into the barrier to mimic airflow of a construction zone.

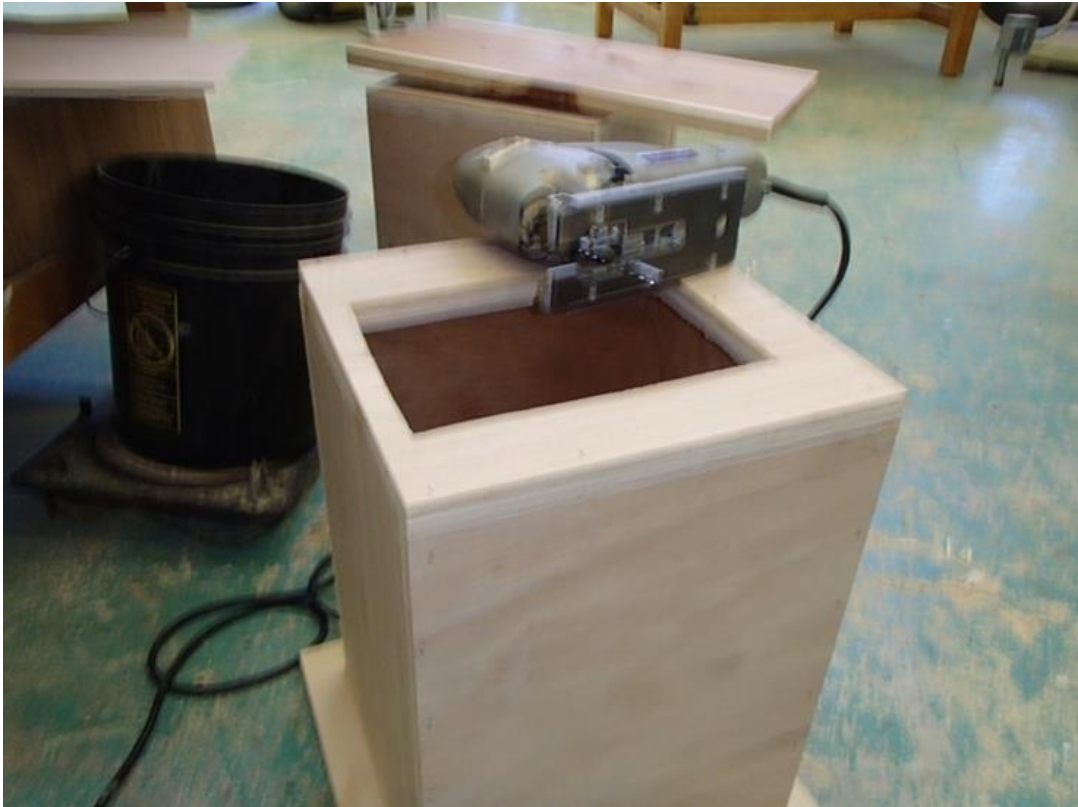
Figure 19 Filter space being cut into the containment vessel

Figure 19 shows the filter space being cut into the containment vessel. The cut is designed to leave the gasket outside the cut area to provide a tight seal.

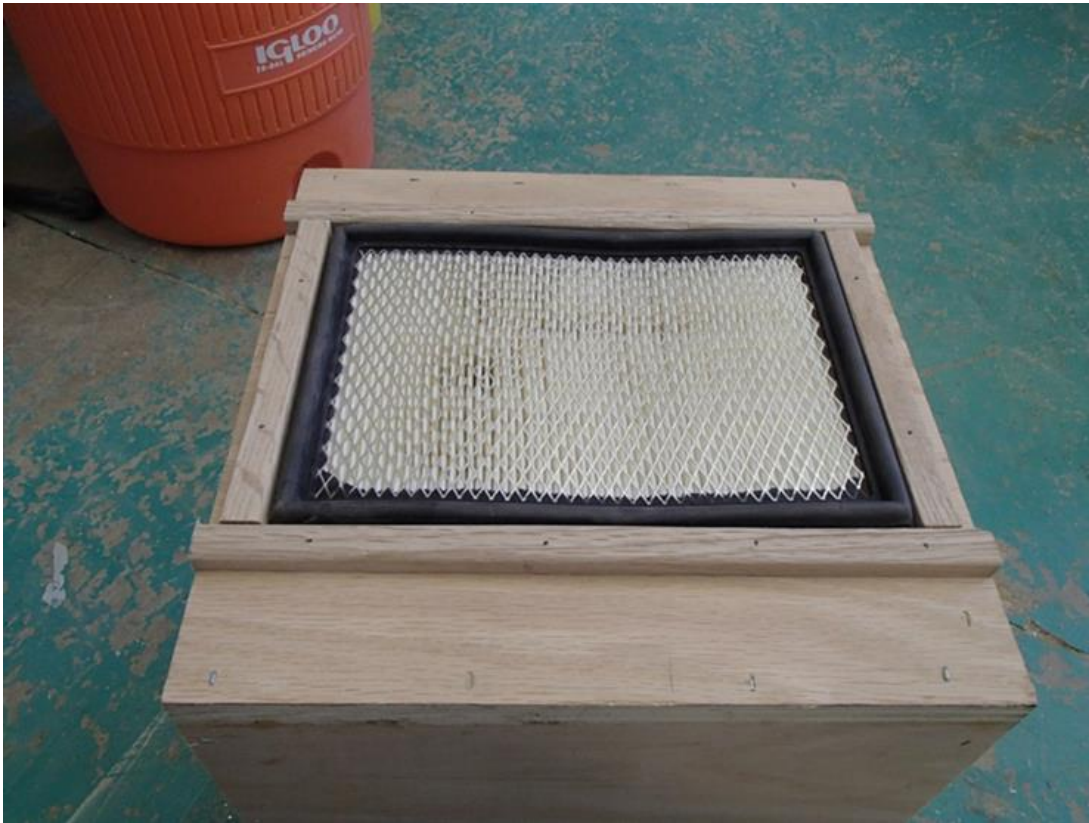
Figure 20 Filter fitted into place in containment vessel

Figure 20 shows the air filter in place in one of the containment vessels.

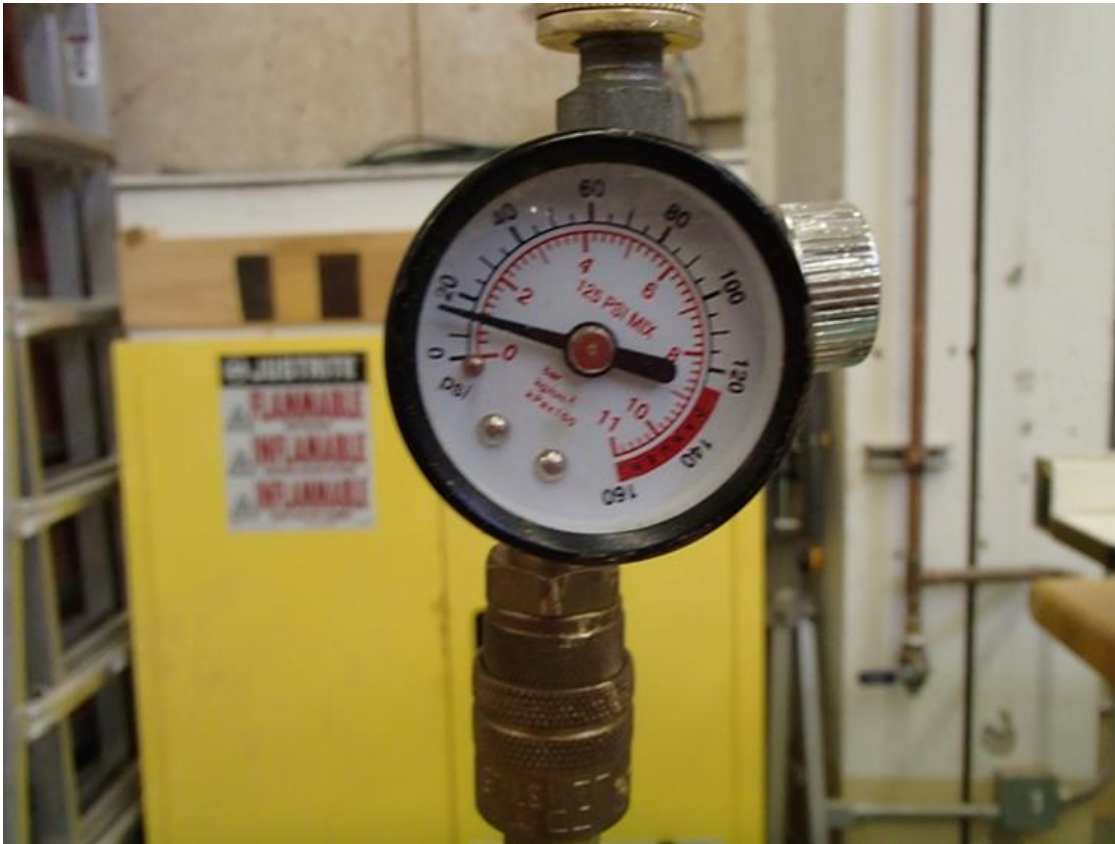
Figure 21 Pressure gauge

The conceptual idea for the containment vessel is to introduce an overpressure of 105 kilopascals into the upper vessel and measure the materials that pass through the barrier and fall onto the lower filter. The arrangement is a vertical arrangement so that a particle that passes through the barrier will likely fall onto the base, which is filtered.

Figure 21 shows the pressure gauge used to measure the overpressure of the incoming air system.

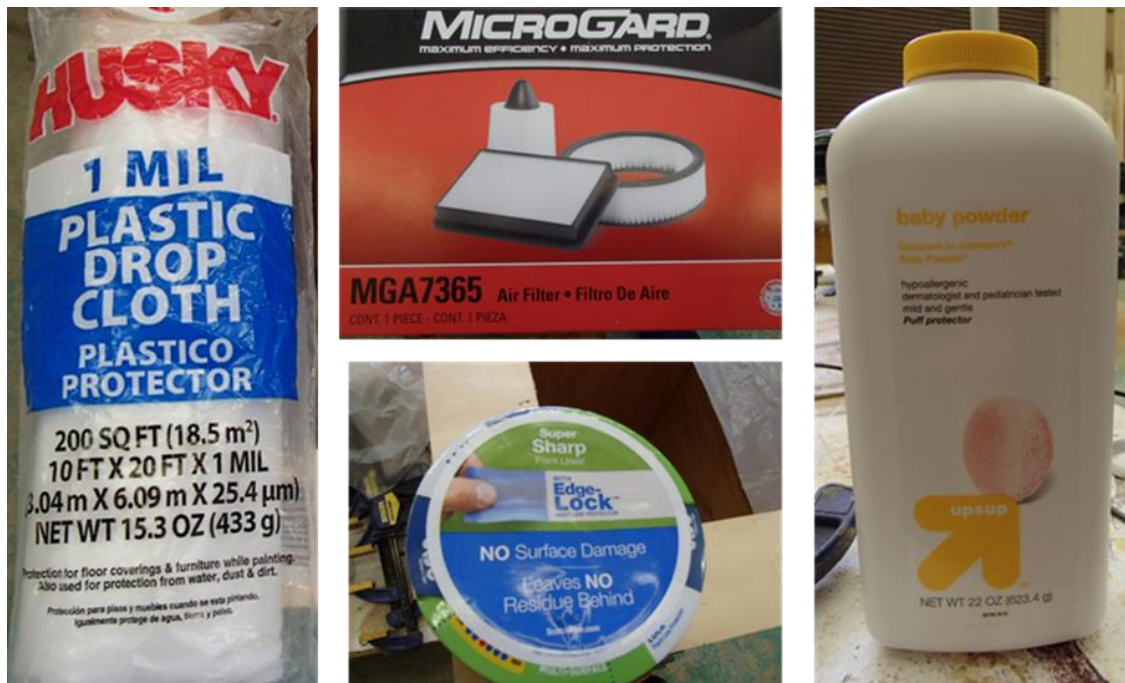
Figure 22 Materials used in experimental work

1. Dust source a commonly available baby powder manufactured from corn starch provided the substitute for common dust particles
2. Plastic sheeting a plastic sheeting with a thickness of 25.4 microns or in English units one thousand of an inch is a very thin plastic
3. Painters tape which has a low bond strength and likely to be the worst tape used on a construction site for a permanent seal
4. HEPA Filter a commercially available filter with the lowest cost was selected used for automotive purposes usually, but suggested by Haberl (2013)

Figure 22 shows the commonly available commercial materials used in the experimental work.

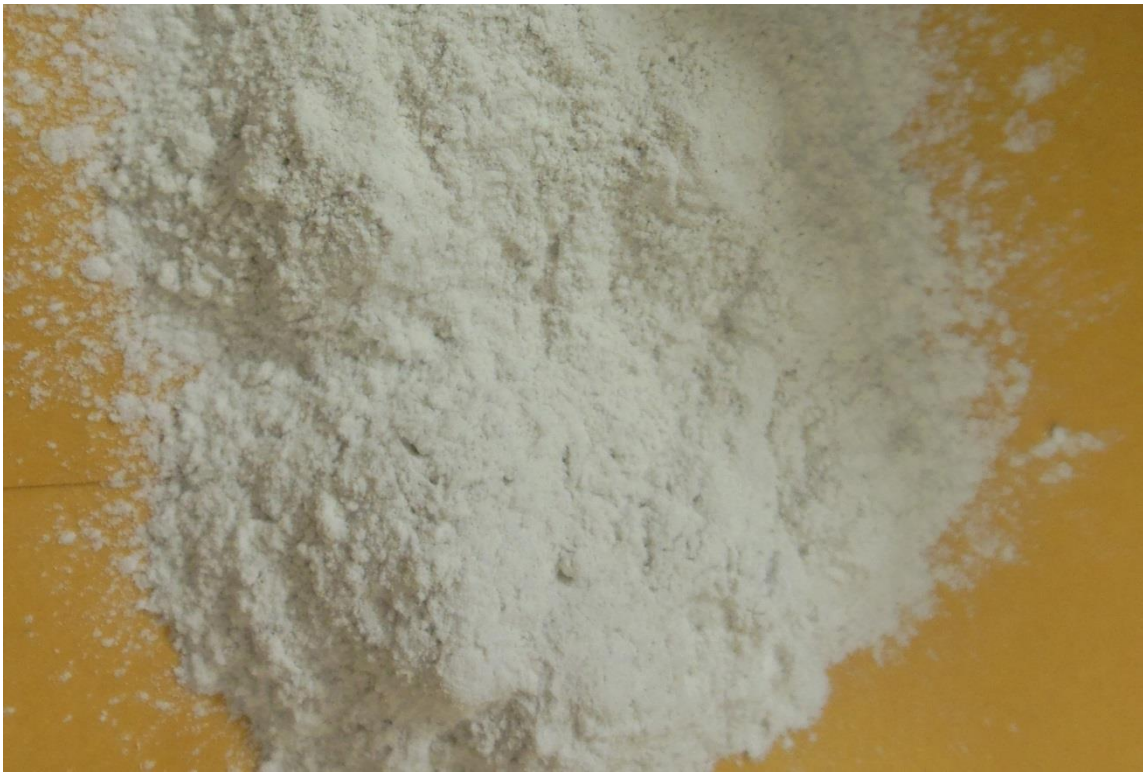
Figure 23 Cornstarch

Aspergillus spores have a size of two to three microns, and attach to dust particles as large as 25 microns (Malik et al., 2008; Wald et al., 1997). This experiment uses a commercially available cornstarch to model these dust particles.

Figure 23 shows a sample of a cornstarch powder taken from the sample used in this experimental work.

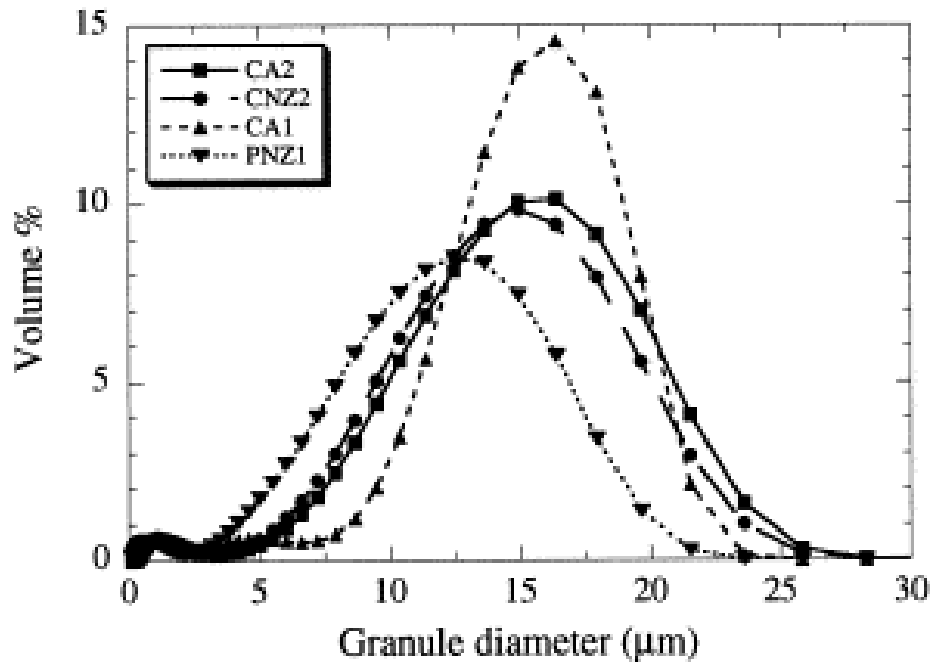
Figure 24 Cornstarch size distribution after (Paterson et al., 2001)

Cornstarch has a grain size distribution in the range of 1 to 27 microns from recent work completed by Paterson, Hardacre, Li, & Rao (2001) on cornstarch from Australian and New Zealand. Figure 24 shows the distribution of diameters measured by these researchers.

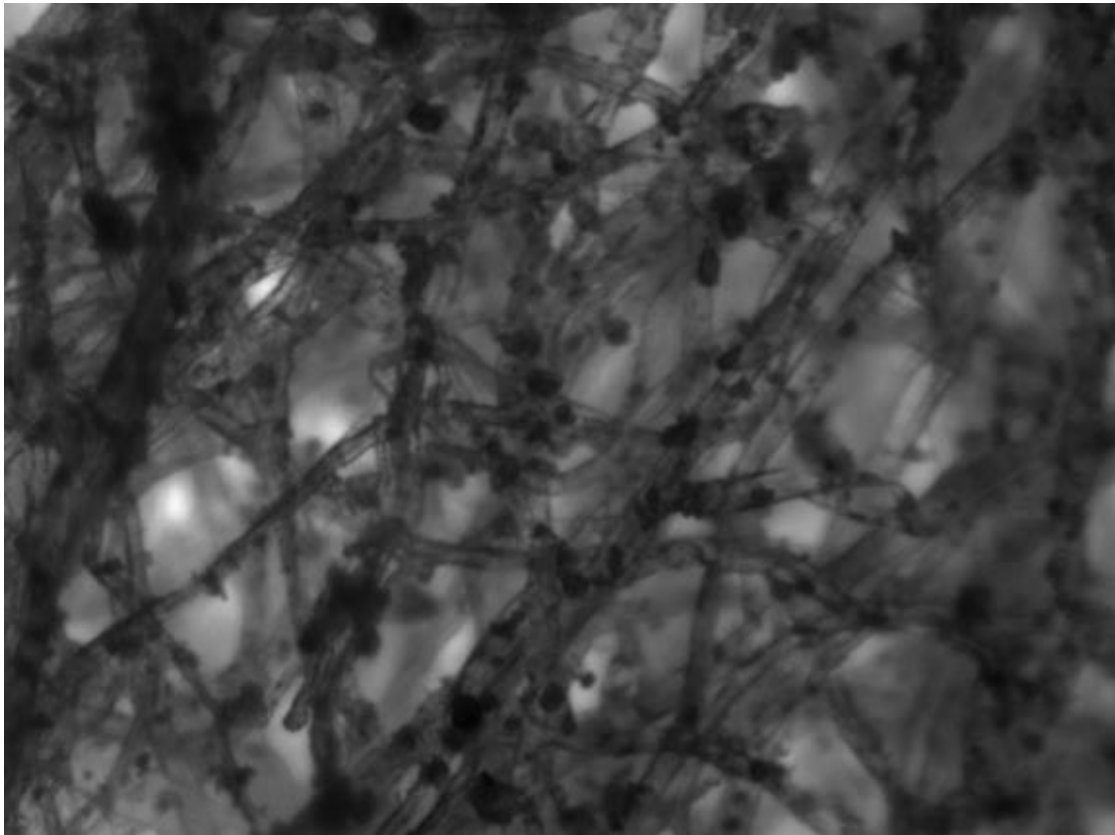
Figure 25 Picture of filter contaminated with cornstarch

Vitha (2013) noted the diameter at about 12 micrometres as shown on picture of a filter contaminated deliberately by Vitha with the powder. Approximately 20.4 grams of powder will be released into Containment A prior to applying air pressure. The mass fills a small sample container typically used in a soils laboratory. The powder represents contaminated dust released by construction activity.

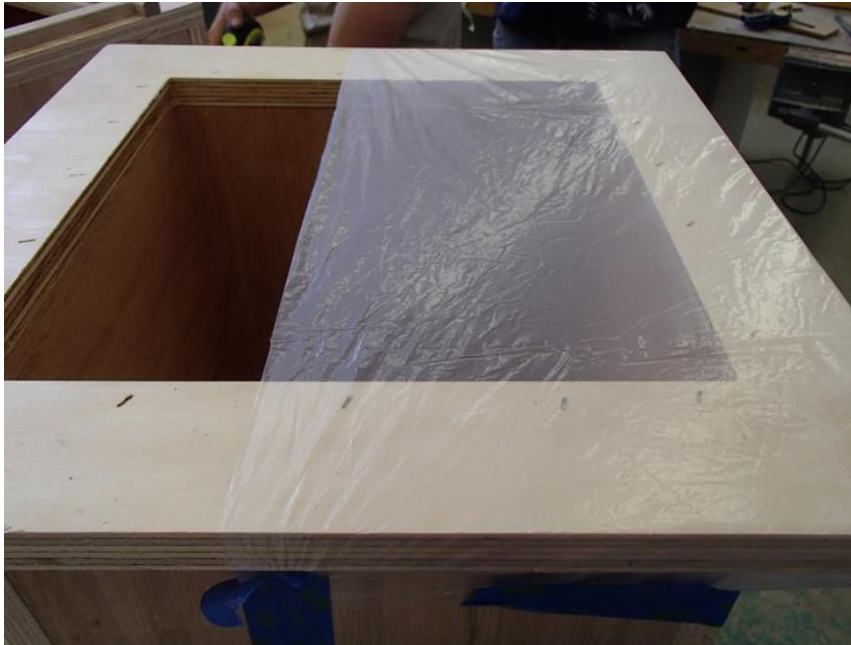
Figure 26 Placement of first plastic sheet

The first step in the preparation of the containment vessels is to clean the vessels to remove as much dust and other particulate matter as possible. The second step is to place and fix a sheet of plastic to the flange of the lower containment vessel; B. Figure 26 shows this step and the placement of the tape to seal the joints.

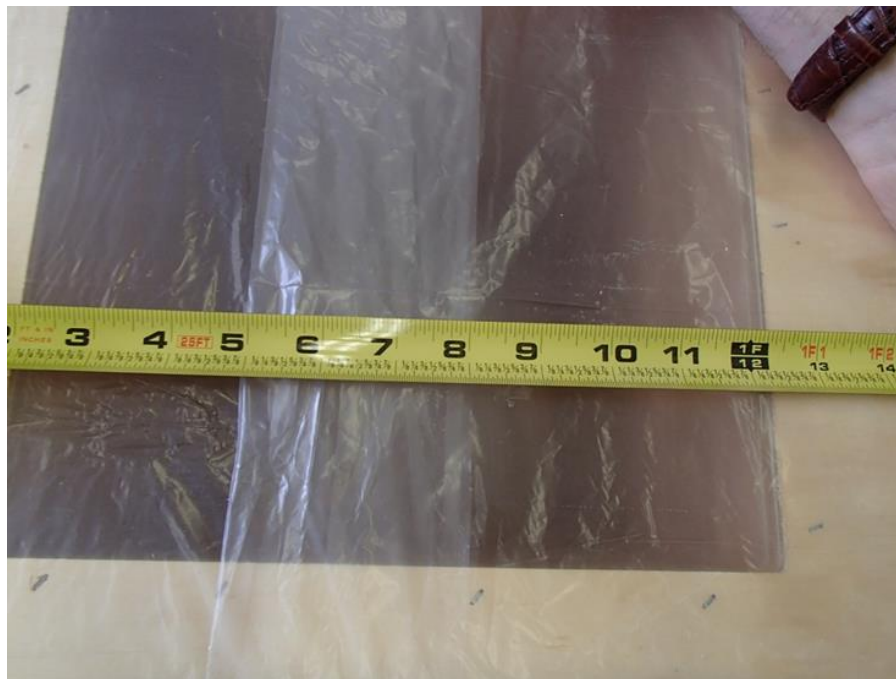
Figure 27 Placement of second plastic sheet and overlap measured

Figure 27 shows the placement of the second plastic strip.

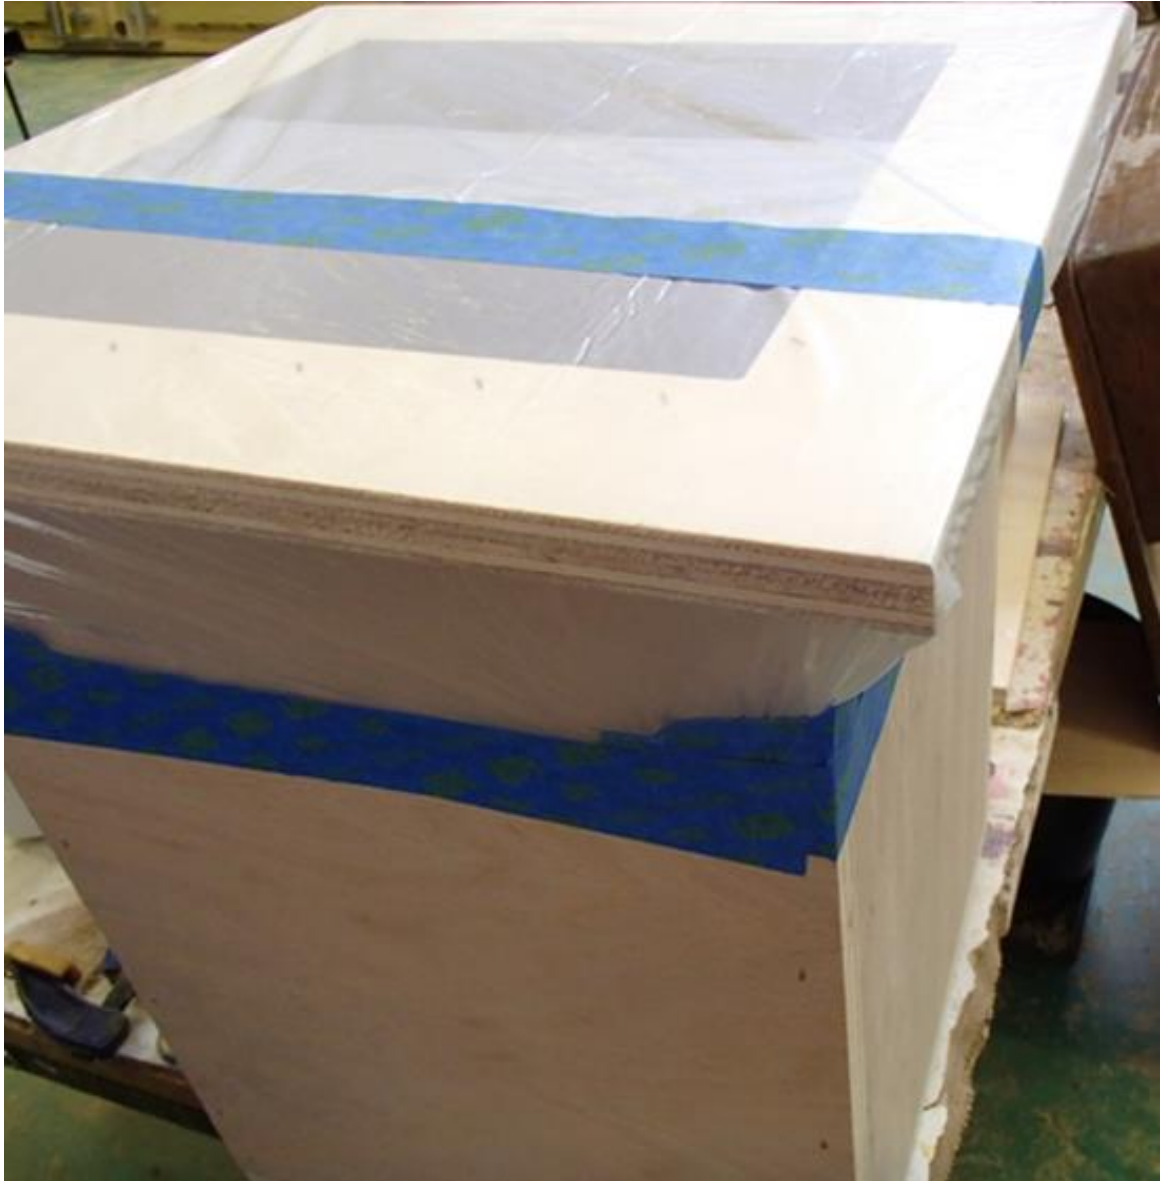
Figure 28 Taped and sealed plastic sheeting – 75 mm overlap

Figure 28 shows the third step being the placement of the second strip and the taping of the joints.

The picture clearly shows the difficult problem of ensuring a tight joint with painters tape. The joint exhibits curling of the plastic and tape.

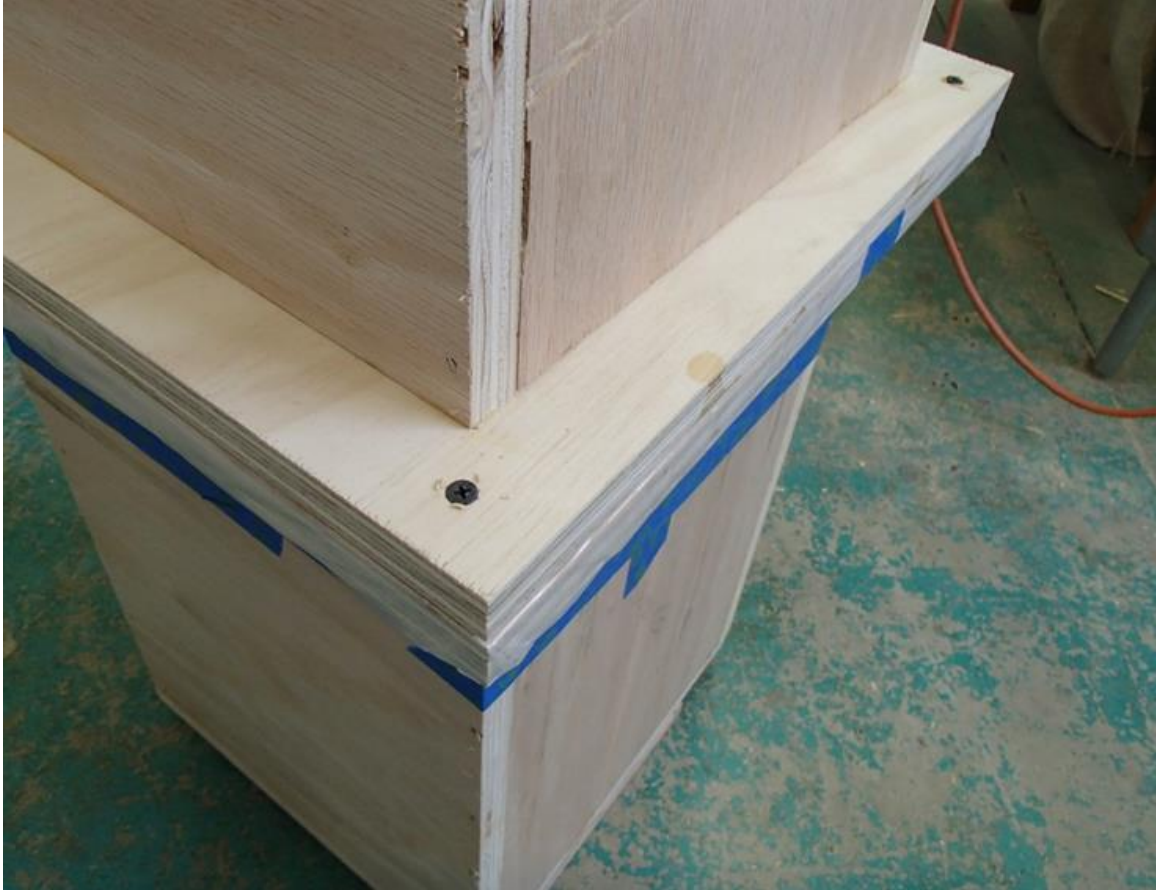
Figure 29 Flanges secured with screws

The fourth stage is sealing the top containment vessel to the bottom containment vessel. Figure 29 shows the screwed system used to ensure a tight seal.
