COMPARISON TEST FOR INFECTION CONTROL BARRIERS FOR
CONSTRUCTION IN HEALTHCARE

A Thesis

Major Subject: Construction Management

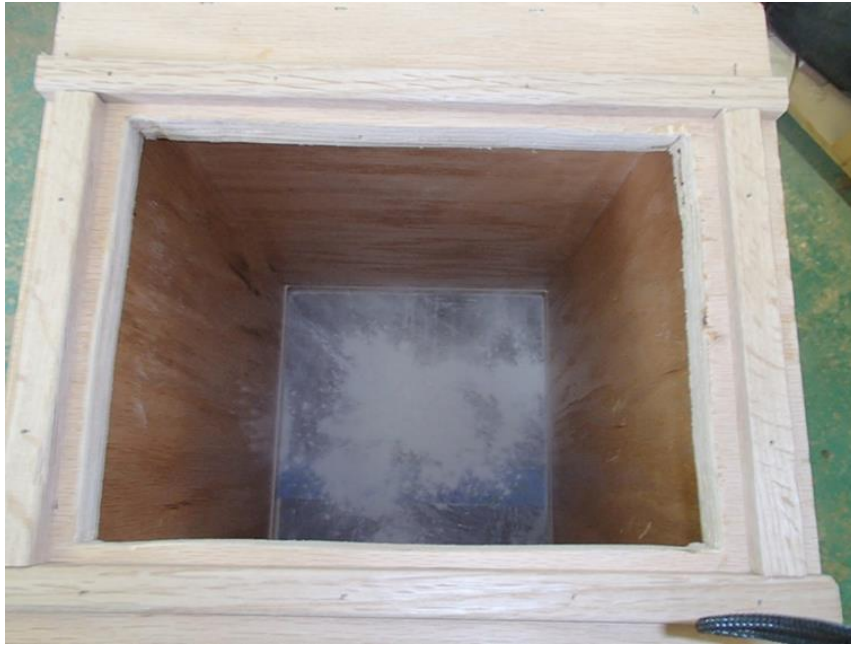
Figure 30 Powder in Containment A

No seal is going to be perfect given the limited resources of the experimental team. The clear purpose is to develop a repeatable test that determines if transmission is occurring and approximately at what rate. Figure 30 shows the 20.4 grams of powder placed in containment vessel A. It is placed directly onto the plastic sheeting in an approximately random fashion. Clearly, the method of placement has favoured the centre of the sheeting and the blue strip is visibly offset to one side.

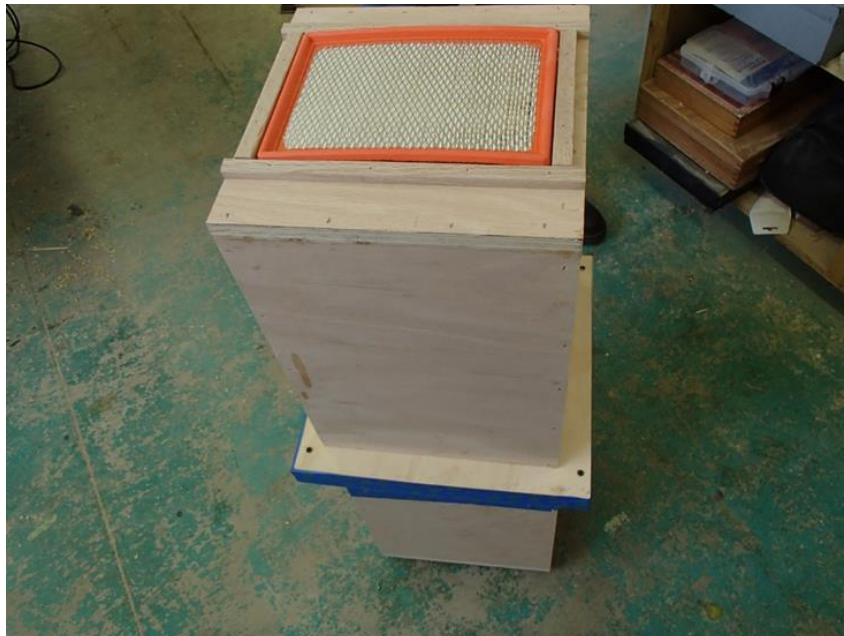
Figure 31 Containment sealed, all filters in place

Figure 31 shows the seals in place after the powder added to A.

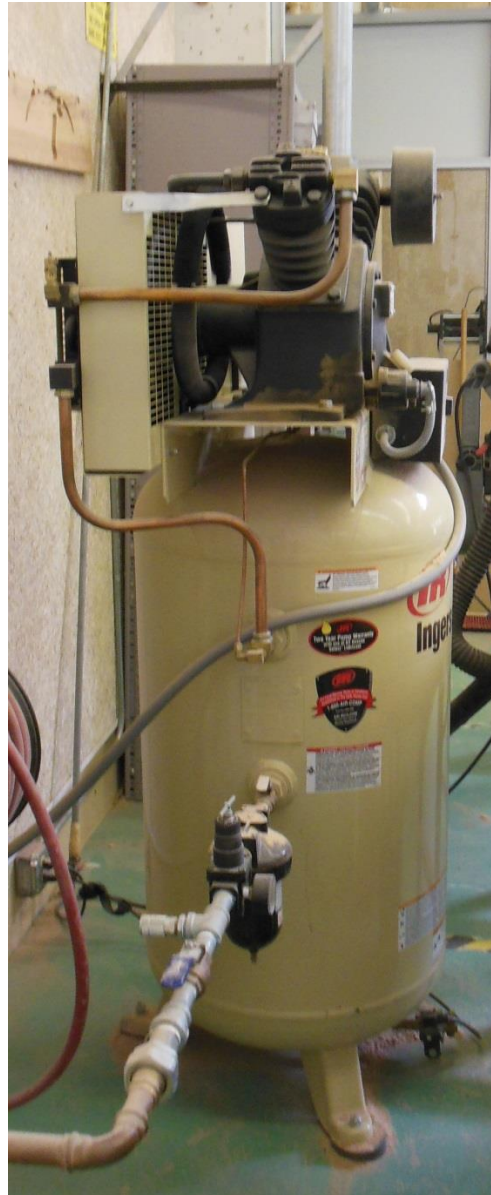
Figure 32 Air delivery system

The next step is the placement of the air supply system. An Ingersoll – Rand system is used to supply filtered air to the test area, as shown in Figure 32.

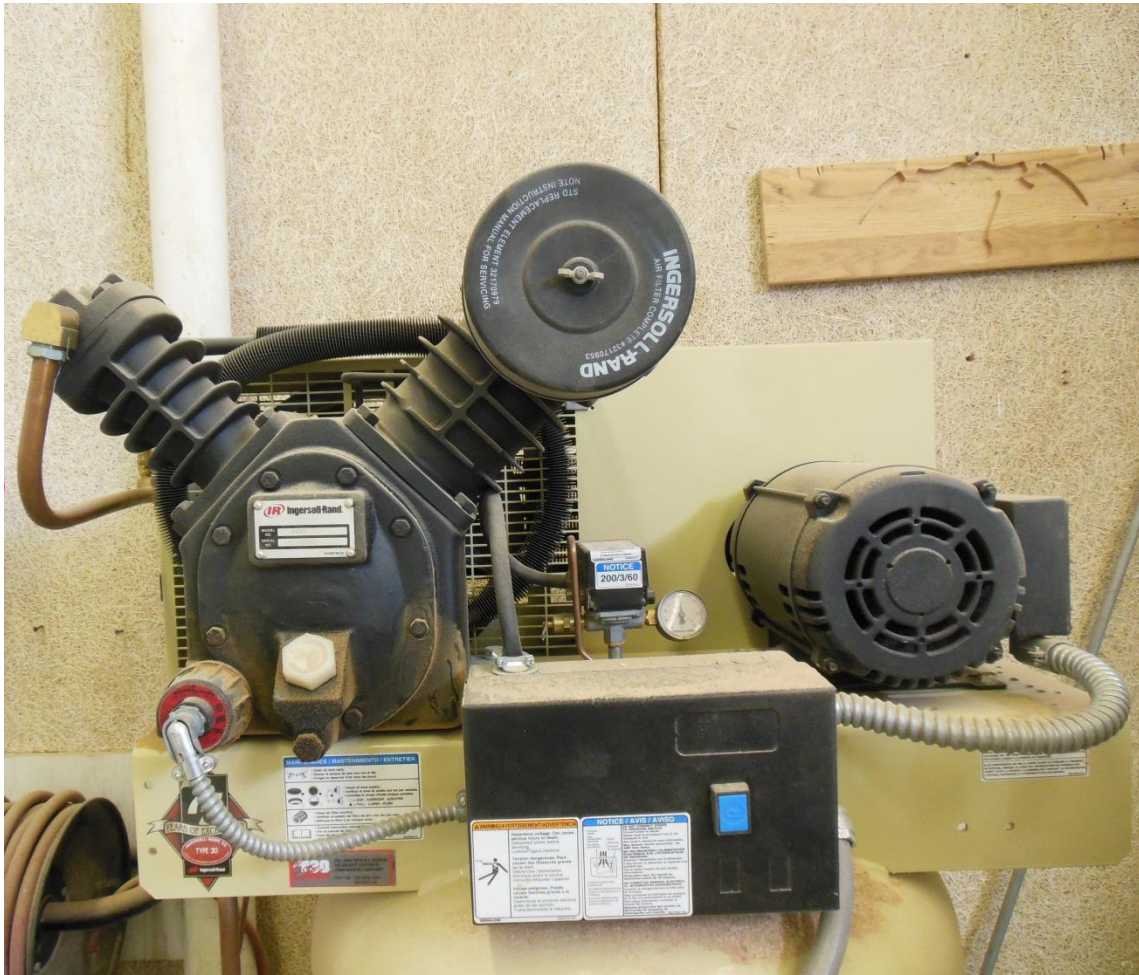
Figure 33 Air compressor unit and filter

The filter on this air delivery system was changed in December 2012, in accordance with the manufacturers recommended time and procedure. Figure 33 shows the air compressor unit and filter system on the Ingersoll-Rand unit.

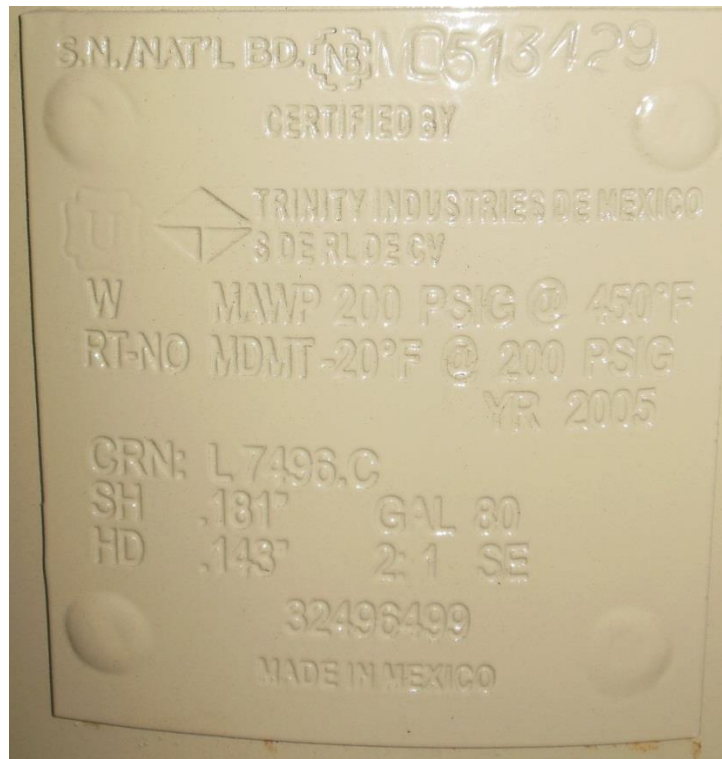
Figure 34 Model details of the air delivery system

Figure 34 provides the model details for the air delivery system. Figure 35 shows the air pressure gauge used to control the flow of air. The gauge was set to the English units of 15 psi, which is 105 kPa using standard conversion formula in the SI system (Cardarelli, 1997).

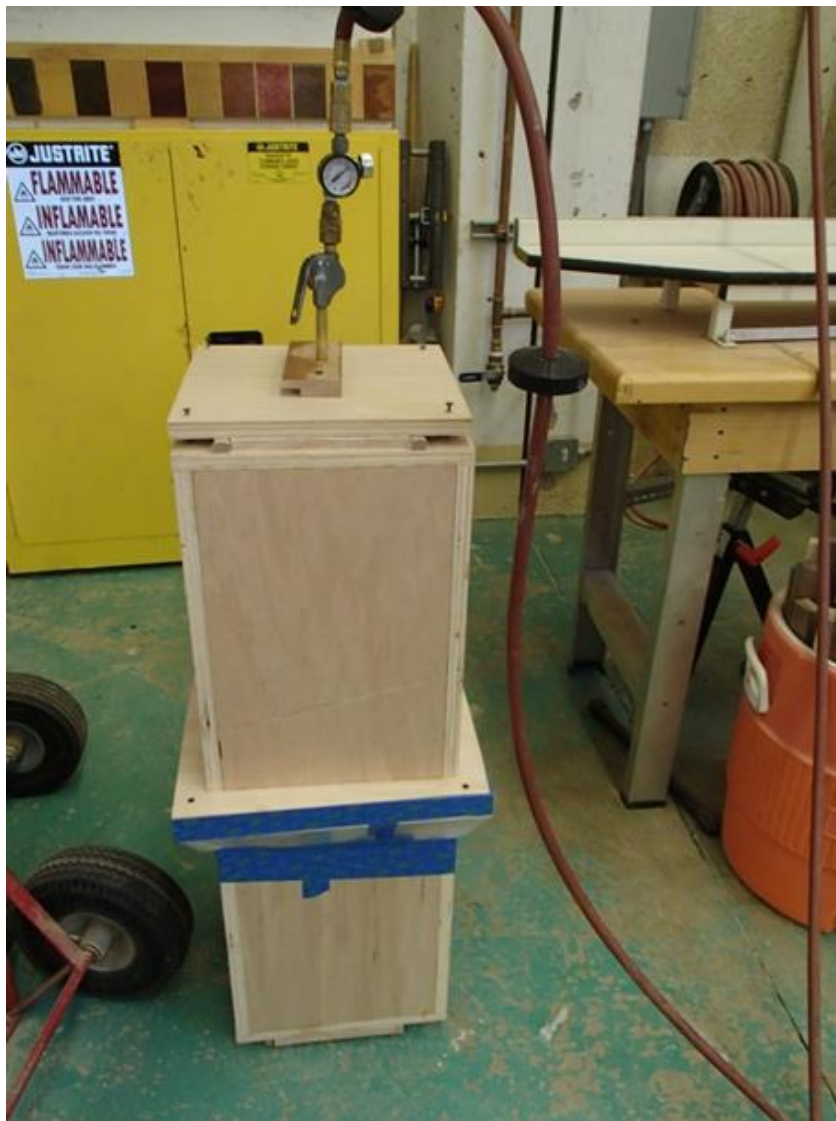
Figure 36 Assembled test unit

The last step was the assembly of the complete unit as shown in Figure 36.

Tests were then run for 18 hours at the 105 kPa pressure.

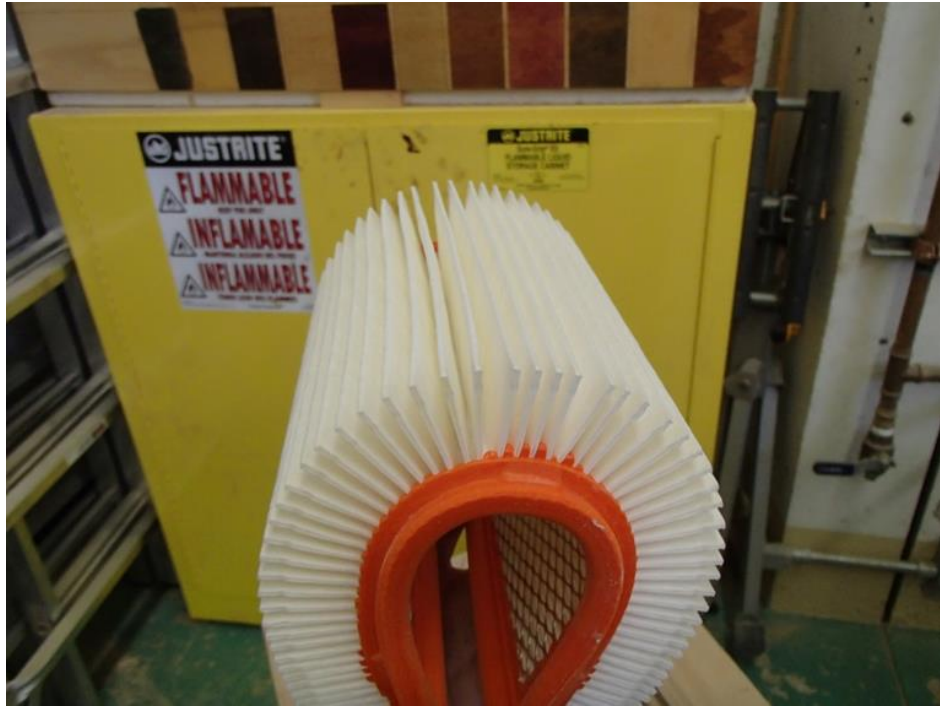
Figure 37 Filter removed after eighteen hours

After the test program was completed, the air filters were removed from the test rig as shown in Figure 37. Figure 38 shows a strip cut from the filter. The strips were bagged, sealed and carefully transported to the TAMU Microscopy Lab.

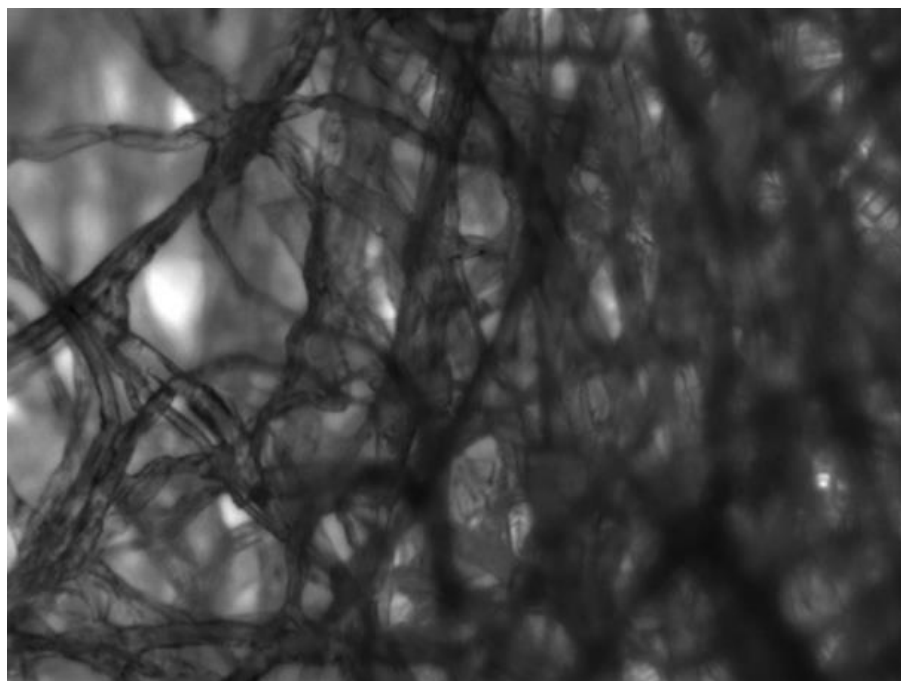
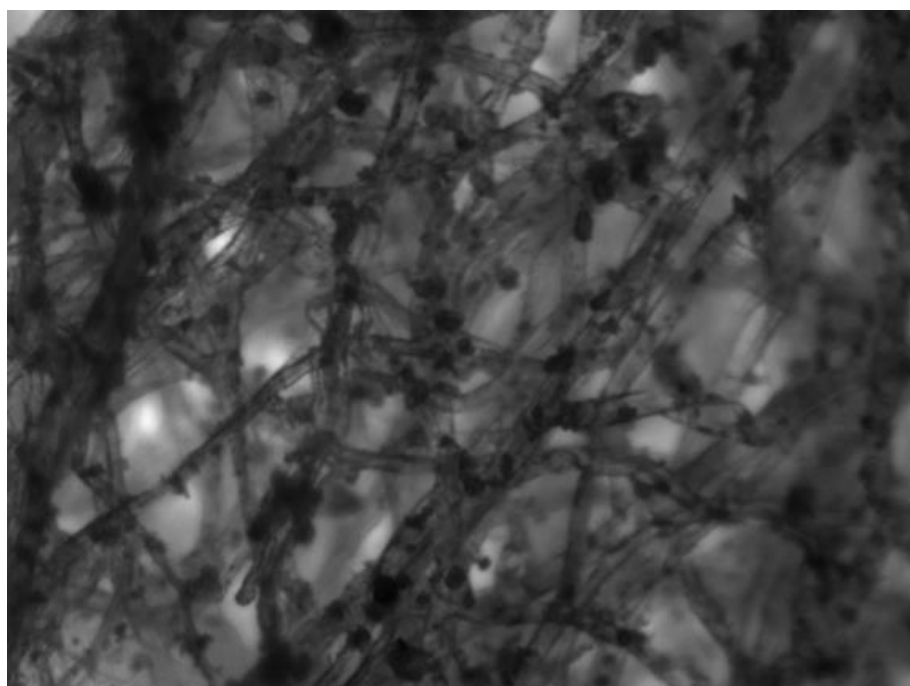
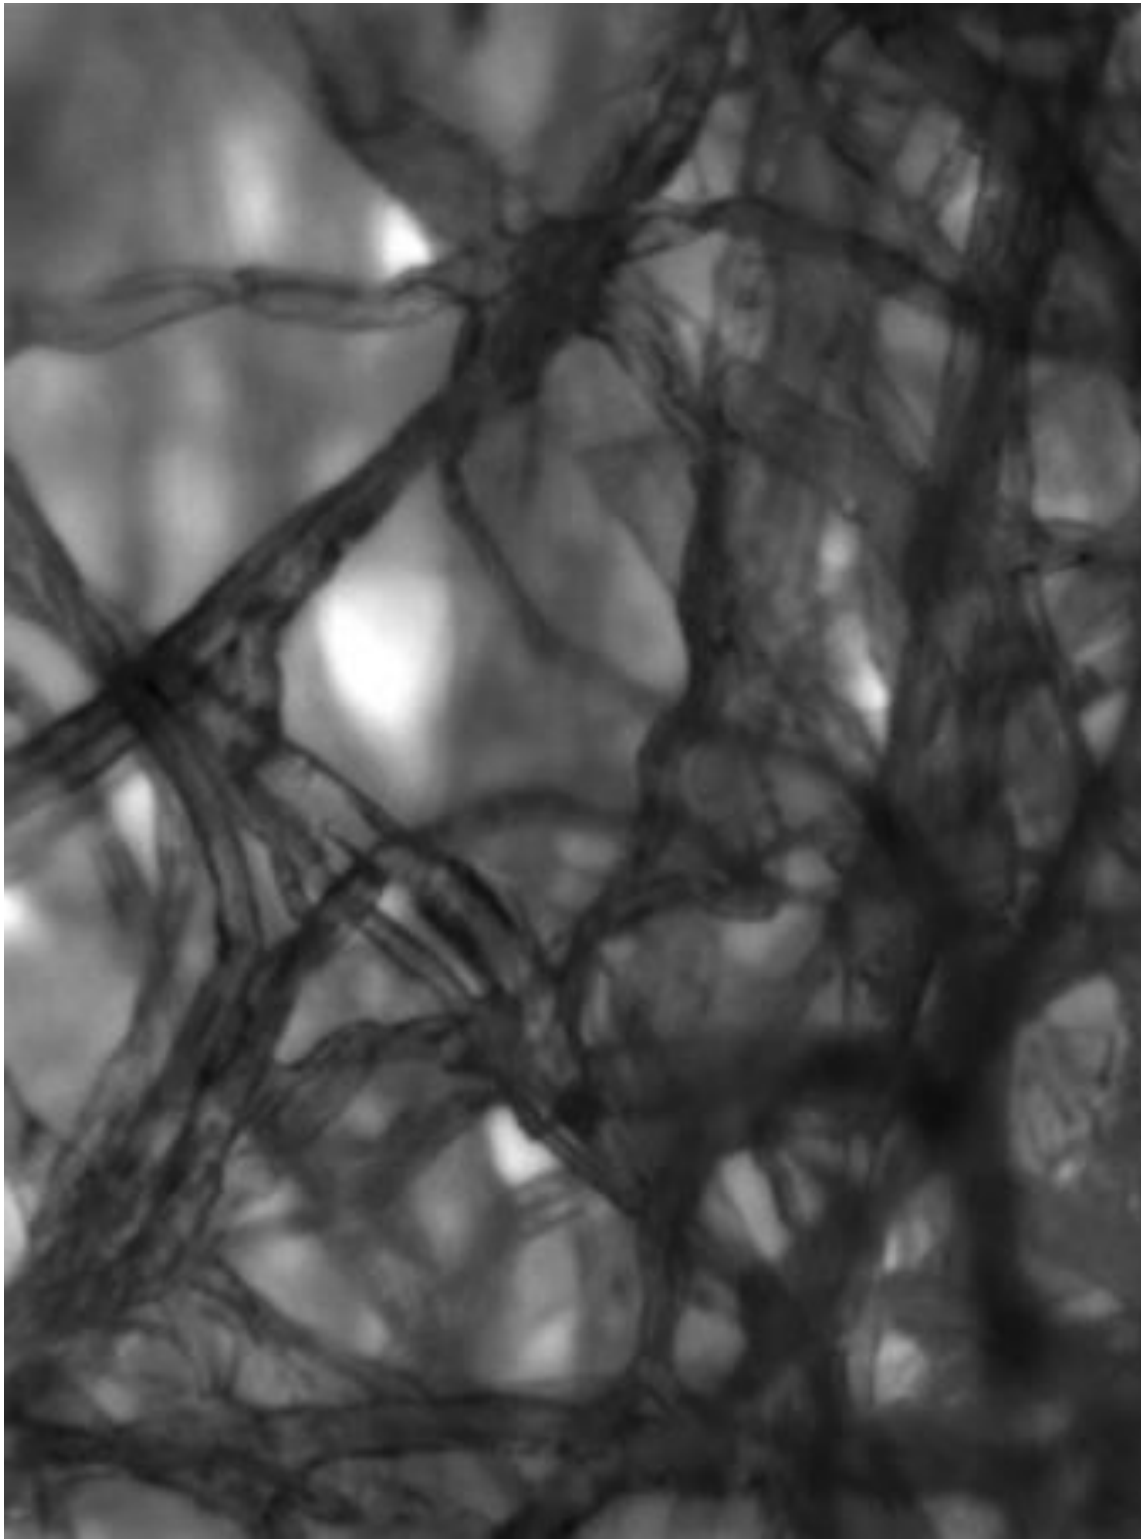
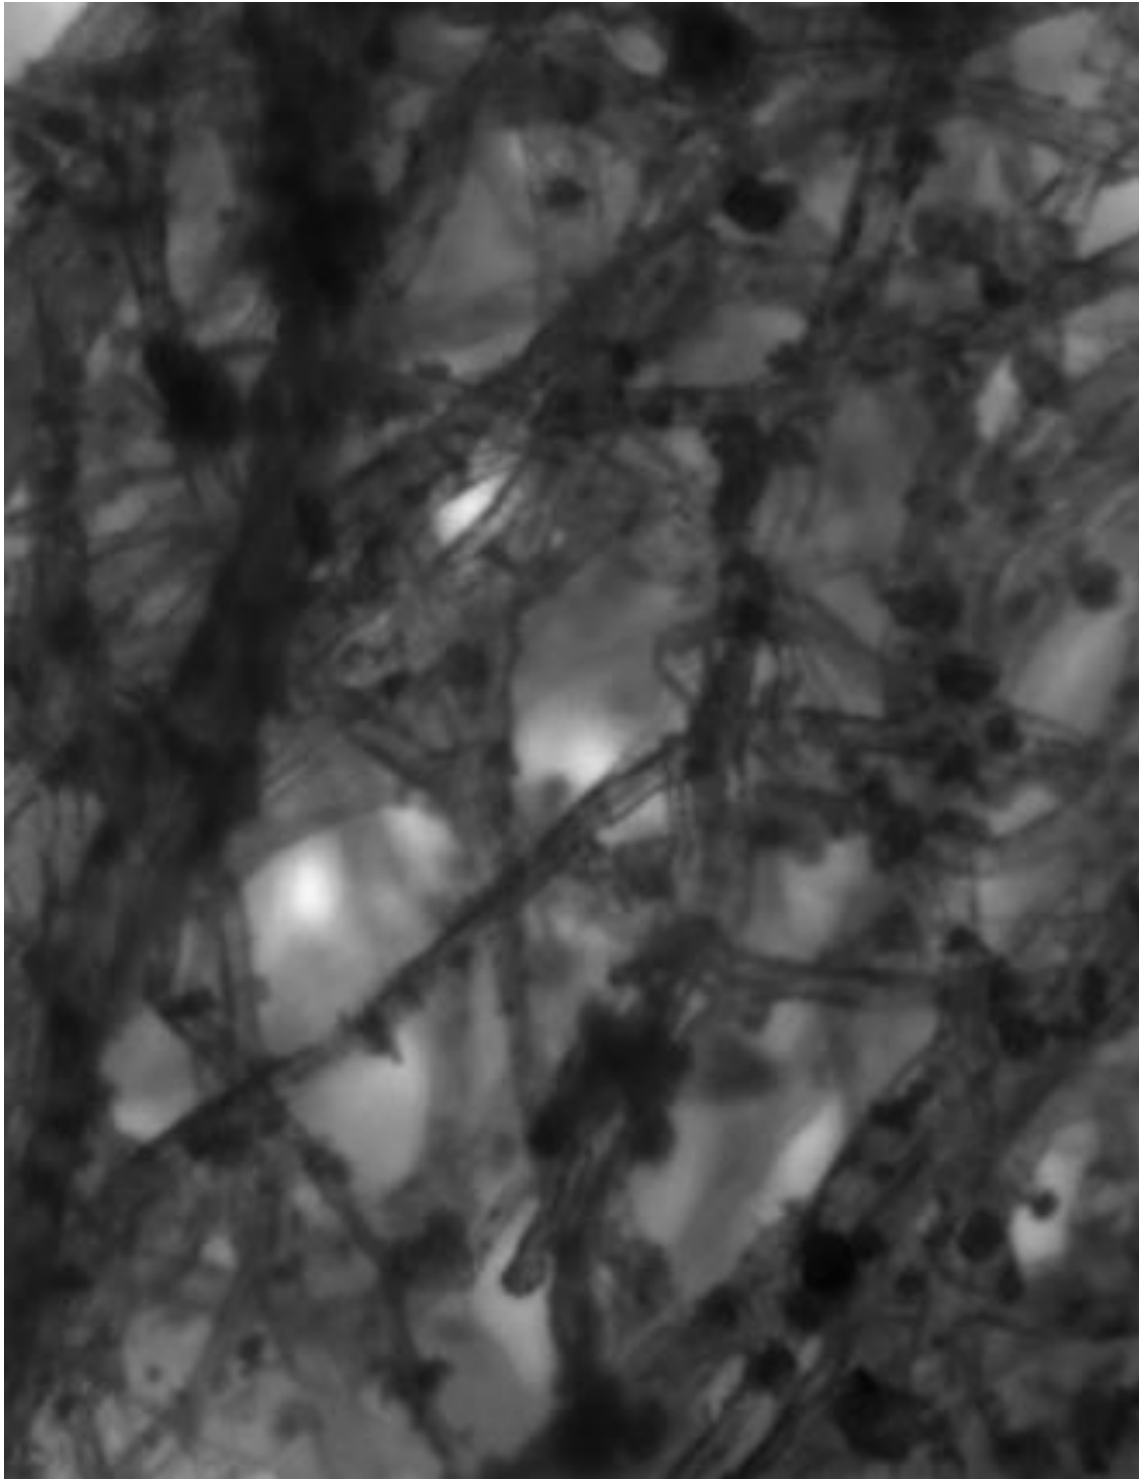
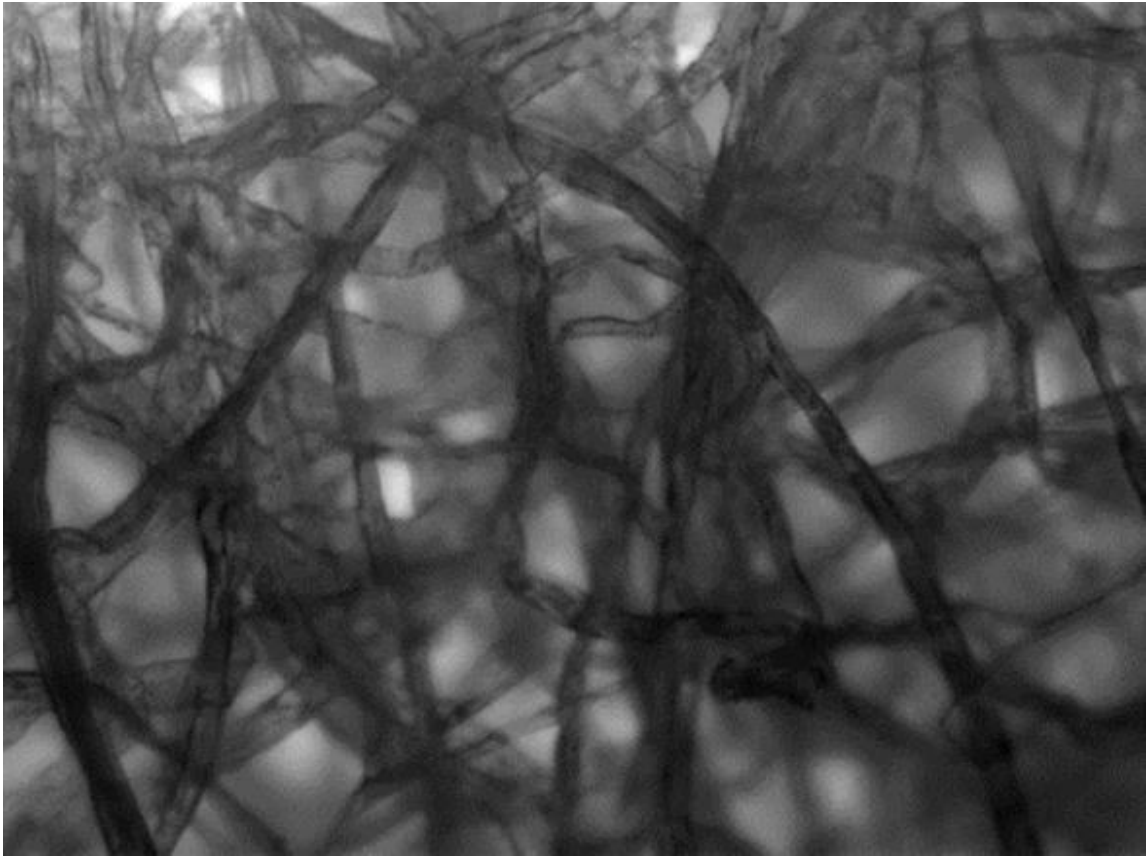
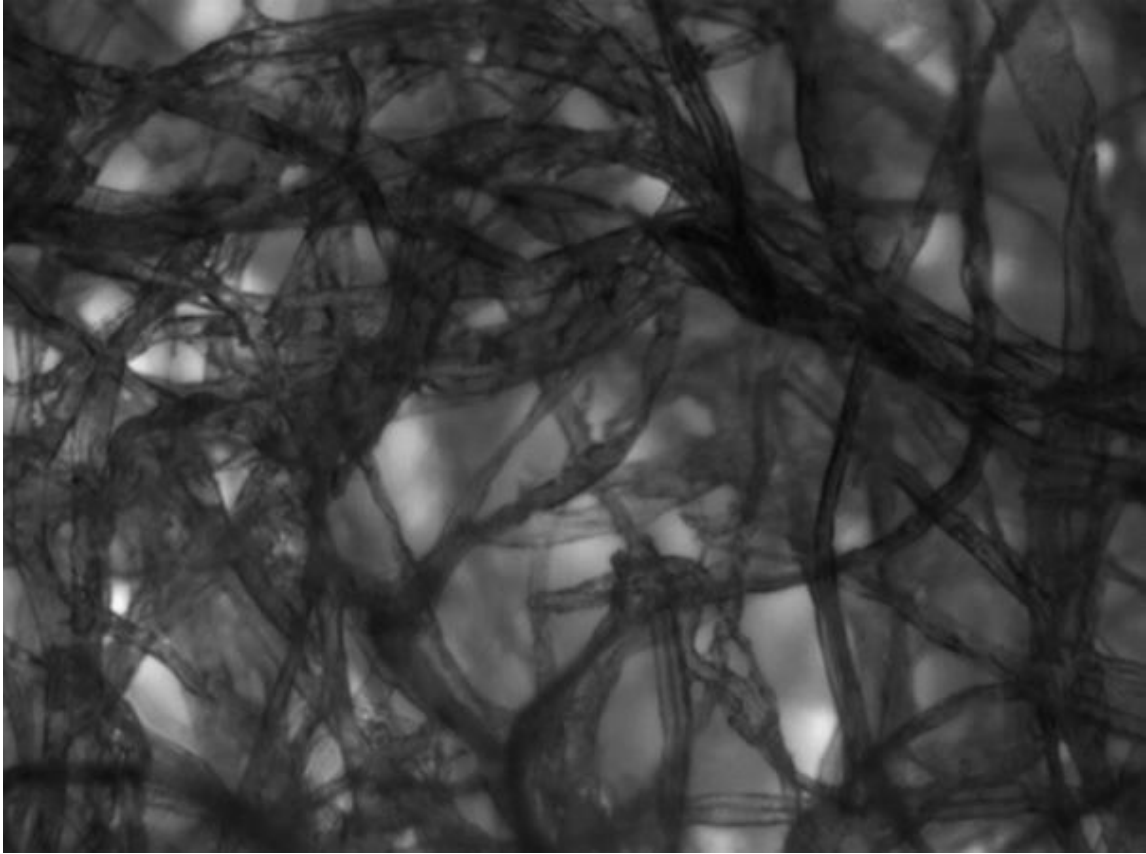
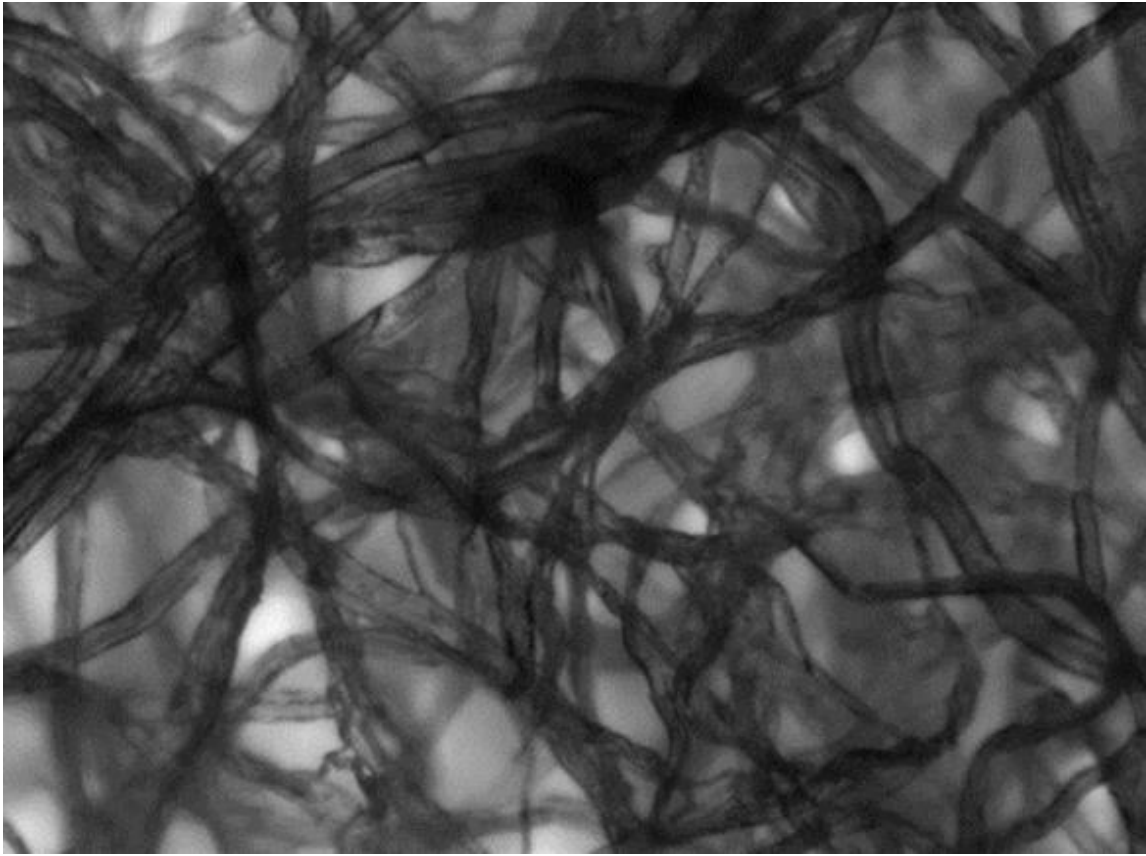
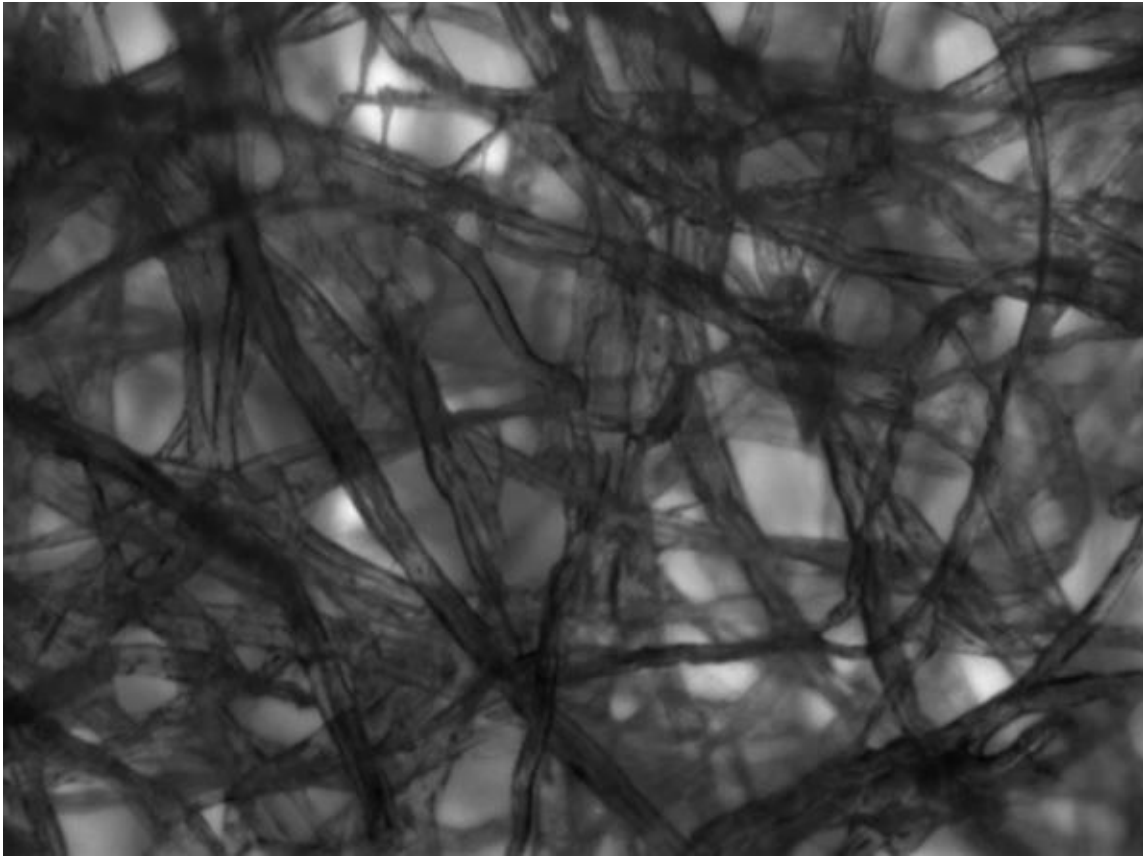
On February 28, 2013, all five samples of the filters from Test One and Test Two, as well as the clean sample from an unused filter, were microscopically observed and photographed at the TAMU Microscopy Lab. The following section shows the photographs taken for each of the samples. The photographs are:

1. Clean Sample
 - a. Figure 39 shows the complete picture of the clean sample
 - b. Figure 40 shows the clean sample contaminated with powder
 - c. Figure 41 shows a section of Figure 39
 - d. Figure 42 shows a section of Figure 40
2. Test One
 - a. Figure 43 shows the input filter on the test system
 - b. Figure 44 shows the output filter on the test system
3. Test Two
 - a. Figure 45 shows the input filter on the test system
 - b. Figure 46 shows the output filter on the test system
