THE CONSERVATION AND ANALYSIS OF SMALL ARTIFACTS FROM THE
SITE OF USS *WESTFIELD*

A Thesis

JESSICA ROSE STIKA

Major Subject: Anthropology

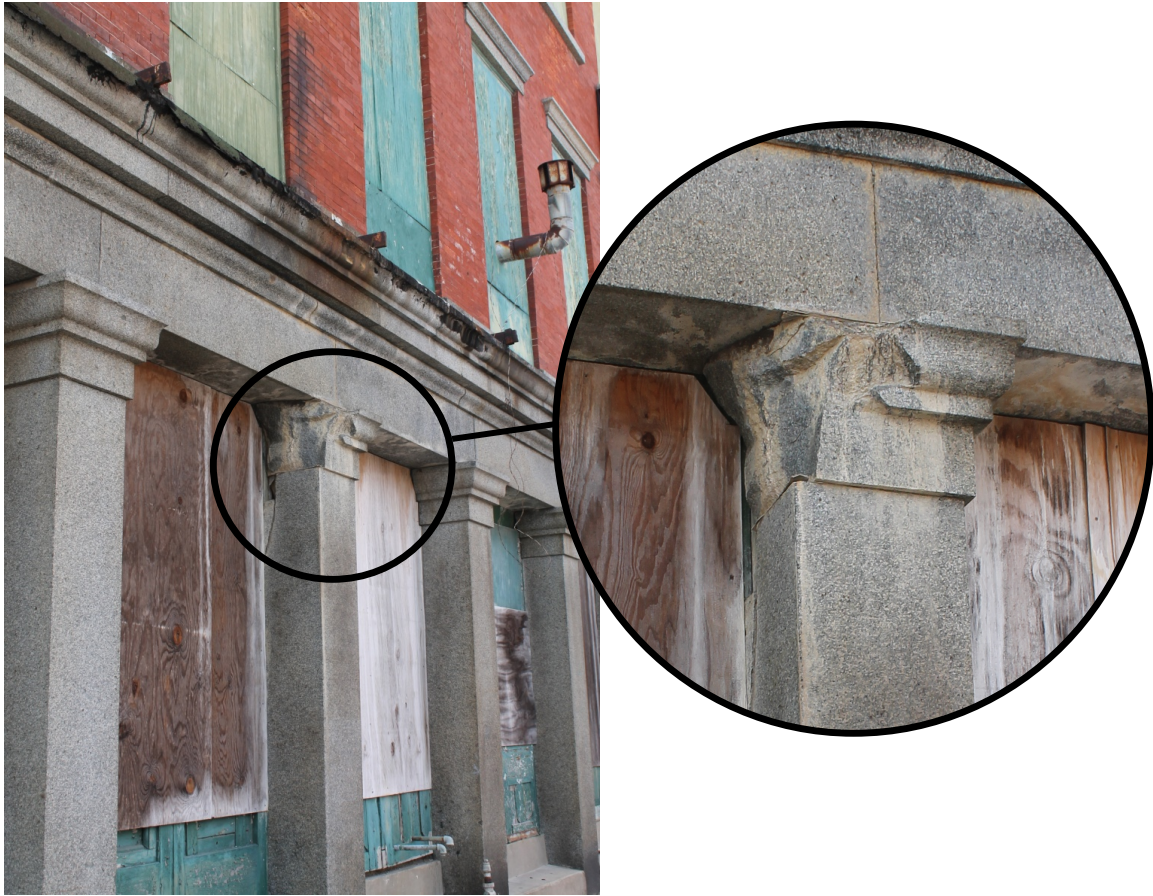
Figure 2.10. Hendley Building, showing damage caused by a shell from USS *Owasco*. Photograph by Jessica R. Stika.

As the sun rose over the island, the Union vessels *Corypheus*, *Owasco*, and *Sachem*, already bombarding the city and causing a significant amount of damage, stepped up their efforts. Damage from one of *Owasco*'s shells can still be seen on the Hendley Building, located along the seafront on The Strand (Figure 2.10). The show of force from the Union ships caused the Confederate troops to retreat to the safety of the surrounding buildings. Magruder felt defeated, but his attitude soon changed when he was informed of the capture of *Harriet Lane* (Cotham 1998:116-122).

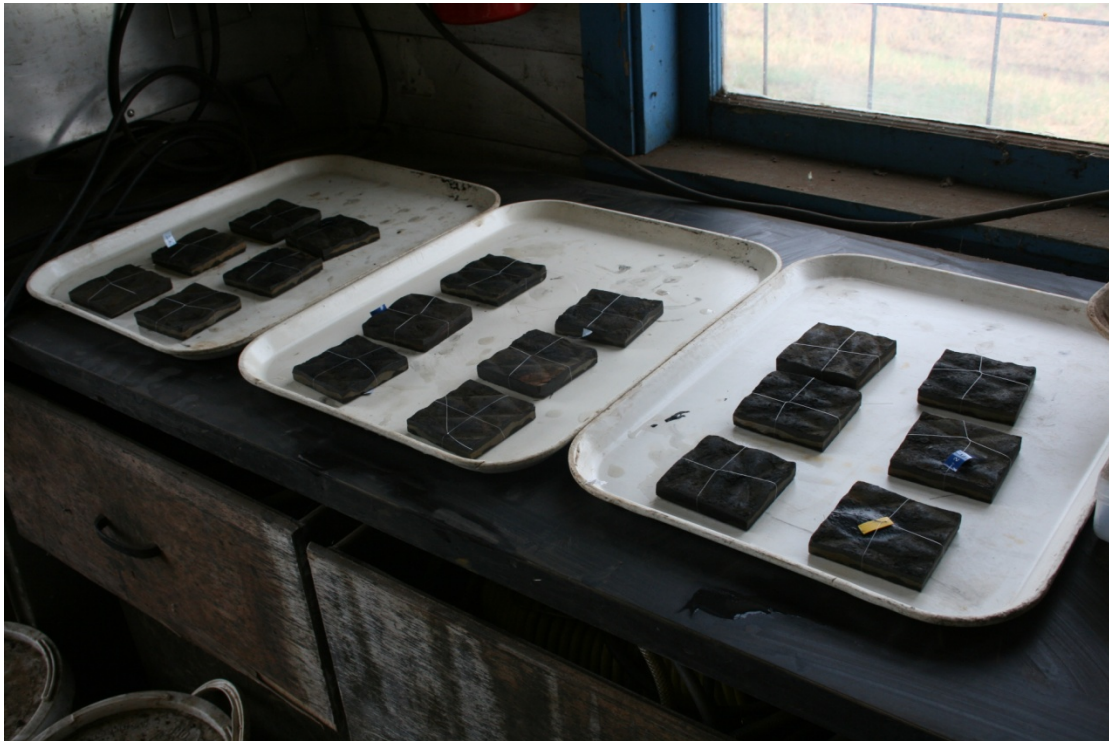
Figure 3.2. Cast iron coupons left to dry after 30 minutes.

A large piece of cast iron diamond-pattern plate was chosen for this experiment because it could be evenly cut into small 3 in. (7.62 cm) coupons using a tile saw. Once these samples were cut, they were weighed and measured, recording the length, width, and thickness. The samples were left to dry as shown in Table 3.1, after which, each sample was photographed on all six sides (shown in Figure 3.1 and 3.2). The control samples were placed into individual sealed containers in a solution of 2% sodium hydroxide. One sample from each test group treated with electrolytic reduction was drilled, as recommended by Dr. Donny Hamilton, so that a screw could be inserted and attached to the inner iron core (Donny Hamilton 2012, pers. comm.). This allowed for the electrical current to be conducted directly to the iron core, bypassing the resistant outer layer of graphite. The other samples treated with electrolytic reduction were attached to the current in the typical manner, which a clip on the surface of the artifact. The chlorides were monitored weekly through the treatment and the sodium hydroxide electrolyte was replaced subjectively, based on the individual chloride readings on each bath, measured with the mercuric nitrate test. The samples treated with alkaline sodium sulfite were placed in separate airtight containers containing 20 g of sodium hydroxide and 126 g of sodium sulfite per 1 L of water. The containers were placed in an oven heated to 60°C (140° F). Following treatment, the samples were again measured, weighed, and photographed. They were boiled to remove the sodium hydroxide and sodium sulfite, and the salts were measured from the boiled water.

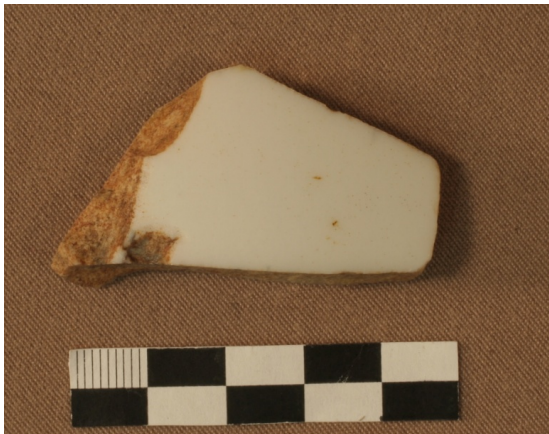
Fig. 4.1.

Small porcelain body sherd. No diagnostic features.

Figure 4.1. Artifact 118-017.

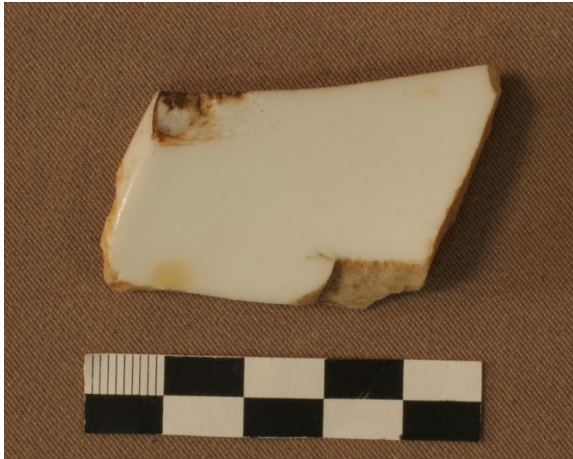
Fig. 4.2.

Small porcelain rim sherd. Small portion of rim preserved. Bend on opposite end where the original object may have sloped downwards to create the concave lower portion of a plate or bowl.

Figure 4.2. Artifact 134-046.

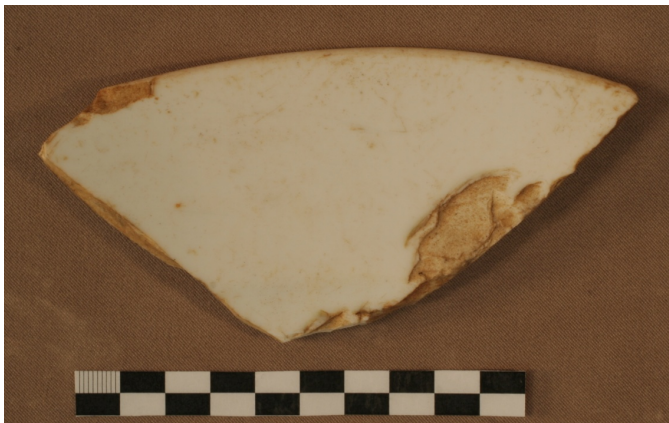
Fig. 4.3.

Ironware rim sherd from plate or platter. Original diameter approximately 12.59 in. (32.00 cm). Scratches along surface. Side opposite rim bends to slope down into concave lower portion of plate.

Figure 4.3. Artifact 120-280.

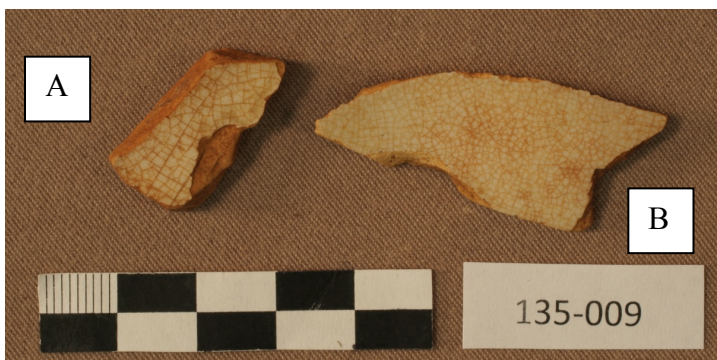
Fig. 4.4

Small whiteware body sherds. No diagnostic features. Significant crazing.

Figure 4.4. Artifact 135-009.

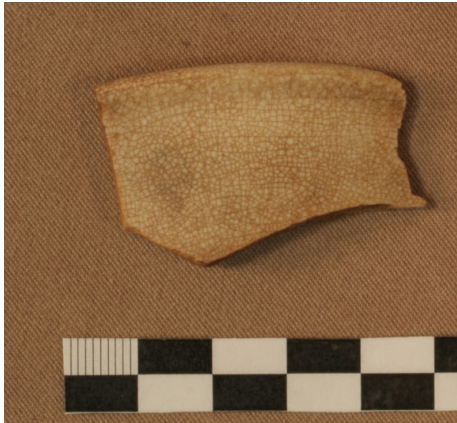
Fig. 4.5.

Small whiteware rim sherd. Portion of rim preserved. Significant crazing.

Figure 4.5. Artifact 140-039.1.

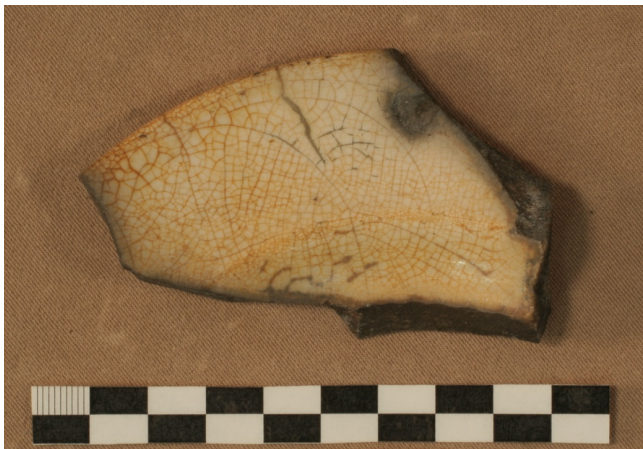
Figure 4.6. Artifact 103-039.1.

Small whiteware rim sherd. Portion of rim preserved. Opposite of rim, the sherd bends to create the concave lower portion of the original plate. Significant crazing observed.

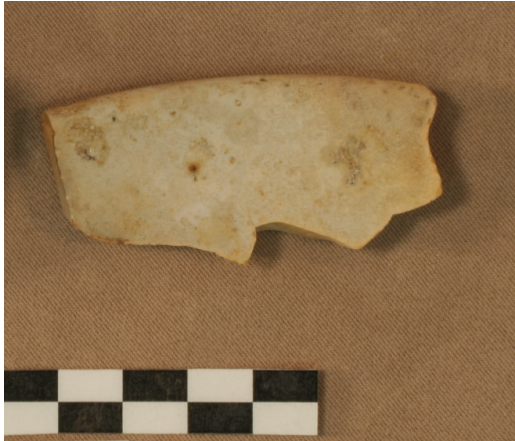
Fig. 4.7.

Small whiteware rim sherd. Portion of rim preserved. Glazing eroded away.

Figure 4.7. Artifact 132-001.7.

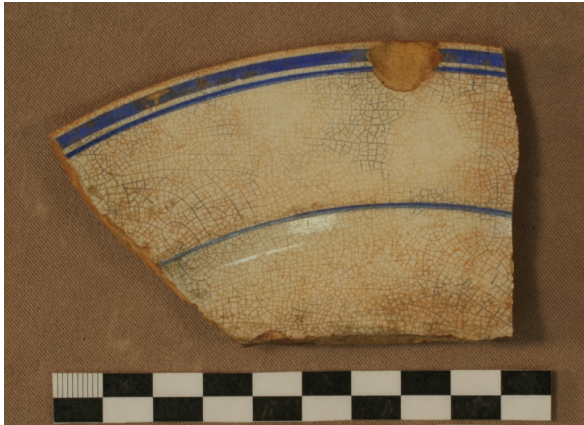
Figure 4.8. Artifact 139-011.

Whiteware rim sherd. Original diameter of plate approximately 9.84 in. (25 cm). Three blue annular lines; two around the edge, one thick and one thin, and one thin line where the sherd bends down into the lower portion of the bowl. Significant crazing observed.

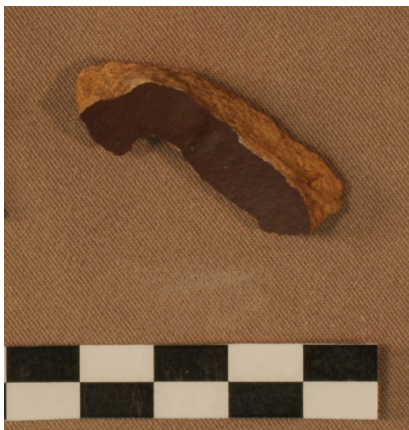
Fig. 4.9.

Small stoneware body sherd. Maroon glaze on both sides. No diagnostic features.

Munsell color grayish brown 5YR 3/2 (Geological Society of America 1991:2).

Figure 4.9. Artifact 140-039.2.

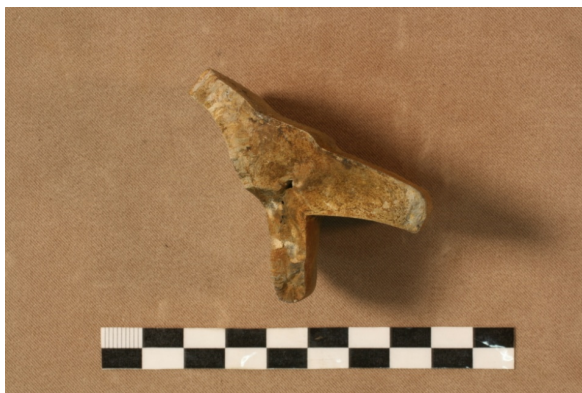
Fig. 4.12.

Small salt-glazed stoneware rim sherd from lid. Glaze present on lower, inner portion of sherd. Rim preserved which would sit on both the outer and inner portion of the pot rim. The heavy lid may have possibly belonged to a large crock pot used for vinegar or pickling (Helen Dewolf 2012, pers. comm.). Munsell color pale yellowish brown 10YR 6/2 (Geological Society of America 1991:2).

Figure 4.12. Artifact 132-001.7.

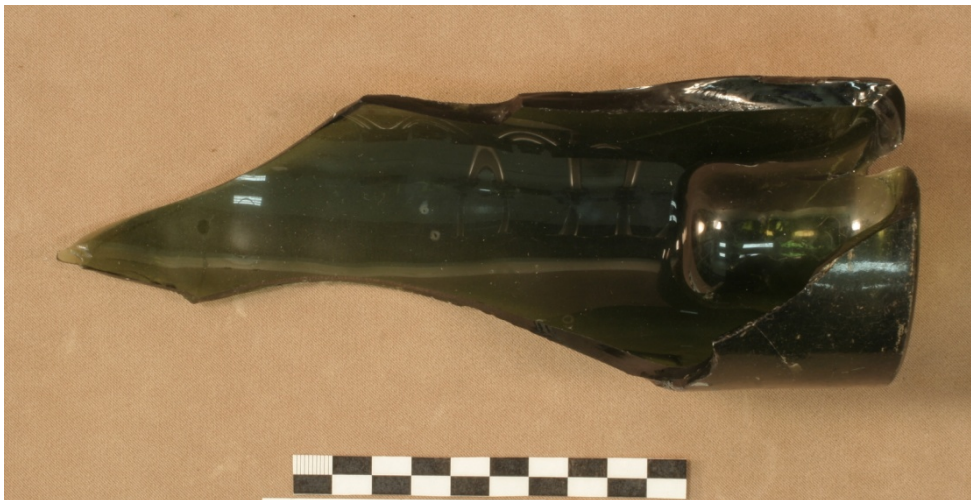
Figure 4.13. Artifact 121-025.

Large dark green glass bottle fragment. Glass is thick and heavy. Missing neck, rim, and most of body. Significant portion of base and kick-up still intact. Outside surface shows horizontal bands or stretch marks that correspond to a smooth, wavy surface on the inside. Outer surface around base exhibits numerous scratch marks. Kick-up is 1.25 in. (3.18 cm) in diameter and has a smooth, concave surface. Walls of the kick-up are almost parallel to bottle walls. Small air bubbles on base, especially on the kick-up.

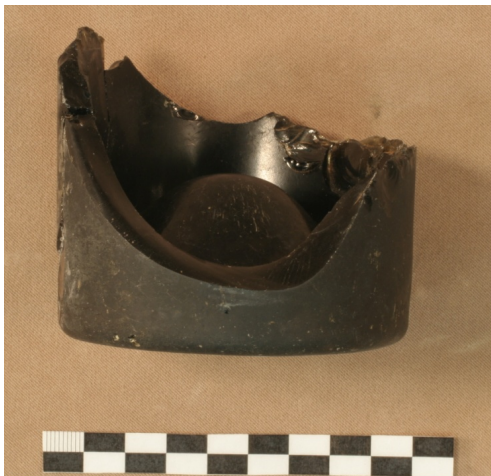
Fig. 4.14.

Very dark green (almost black) bottle base fragment. Glass is thick and heavy. Only base, kick-up, and small portion of walls preserved. Surface shows scratch marks. A few large air bubbles present, in particular, one along the inside junction between the wall and the kick-up. Kick-up has low sloping walls that are almost at 45 degrees from the walls of the bottle. A small, shallow pontil scar is on the outside, convex side of the kick-up. No mold seams present.

Figure 4.14. Artifact 132-396.

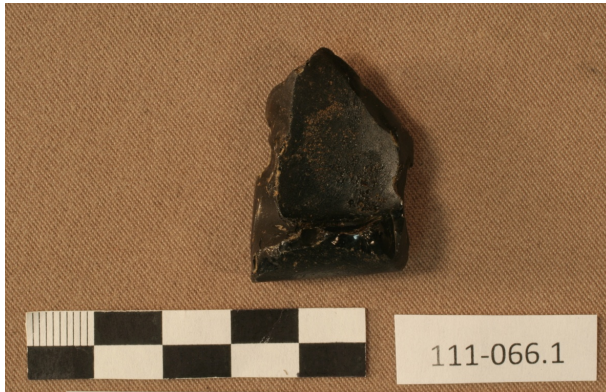
Figure 4.15. Artifact 111-066.1.

Dark green bottle base fragment. Identical color and texture to 132-396, possibly from a similar bottle. Surface is worn and scratched. Original bottle would have had a similar kick-up to 132-396.

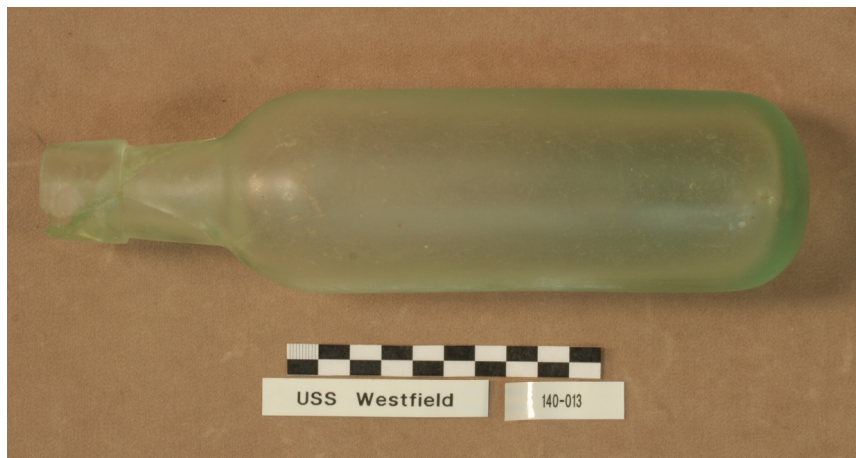
Fig. 4.16.

Soda and mineral water bottles were introduced around 1850. They were made heavier and thicker to prevent explosion and breakage, and fitted with wire fasteners around a heavily collared mouth, to withstand the pressure of the carbonation. The majority of mineral water bottles range from 6-8.5 in. (15.24-21.59 cm) and could hold

anywhere from 8-14 oz. (0.24-0.41 L). They were primarily aquamarine, green, or blue. However, their most diagnostic feature was the smooth or round base, preventing the bottle from being stood upright, an innovation developed in England (Van Rensselaer 1926:39-40; McKearin and Wilson 1978:238-239). This prevented the cork from drying out and shrinking, causing the liquid inside to lose carbonation or evaporate. They were usually produced using a two piece mold; the neck, shoulder, body and entire base was molded, before the thick collar was added by hand. The majority of these soda, or mineral water bottles, were imported from Great Britain, more so than those made in the United States or those made overseas for American companies. Sometimes referred to as ballast bottles, they are thought to have been imported from England as ballast due to their heavy weight. The majority of the round bottom base bottles date from the 1870s to the 1910s, indicating that this example recovered from *Westfield* may be intrusive or deposited on the site during the dredging in the early 20th century. The preservation of the bottle, the only one which is almost complete, would indicate that this may be the case, having been spared from the initial explosion (Lindsey 2012).

Figure 4.16. 140-013.

Light bluish green bottle neck fragment. Identical color and texture to 140-013, possibly from similar bottle with wider base. The angle from the neck to the body is slightly wider than 140-013. Small air bubbles present in glass. No seams visible. Wavy bands on outside surface of neck not present on 140-013.

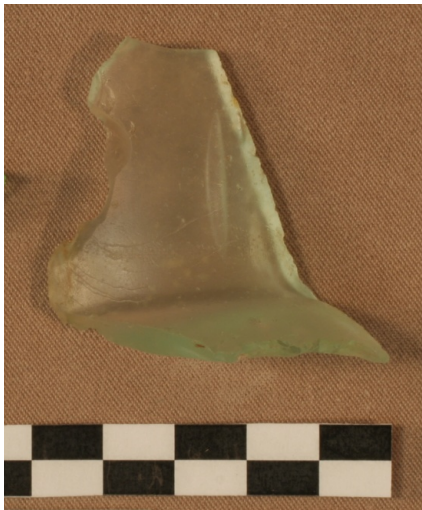
Fig. 4.17.

Figure 4.17. Artifact 134-047.1.

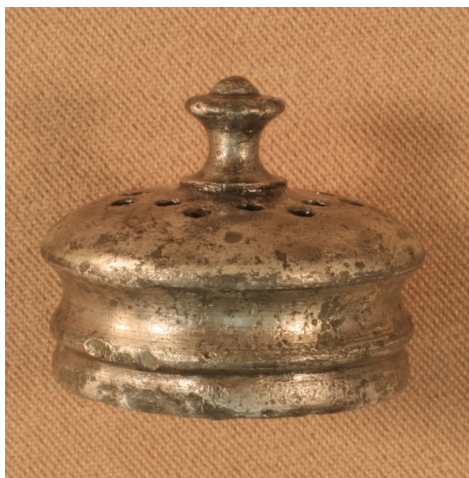
Electroplated silver condiment shaker cap. Small finial at the top surrounded by 14 holes to dispense a condiment, most likely either salt or pepper. The top is rounded around the edges from which the sides descend almost perpendicularly, with a small band designed to fit around the top of the glass bottle below. The inside surfaces are smooth with a spiral pattern on the top. Initial testing with the Bruker XRF revealed that the condiment shaker cap is made from electroplated silver on pewter. High levels of tin, silver, and copper were found, with smaller amounts of antimony and lead. A drawing is shown in Figure 4.20.

Figure 4.18. Artifact 109-010.1. Possible pepper shaker top in progress photos. Side view, bottom view, and top view.

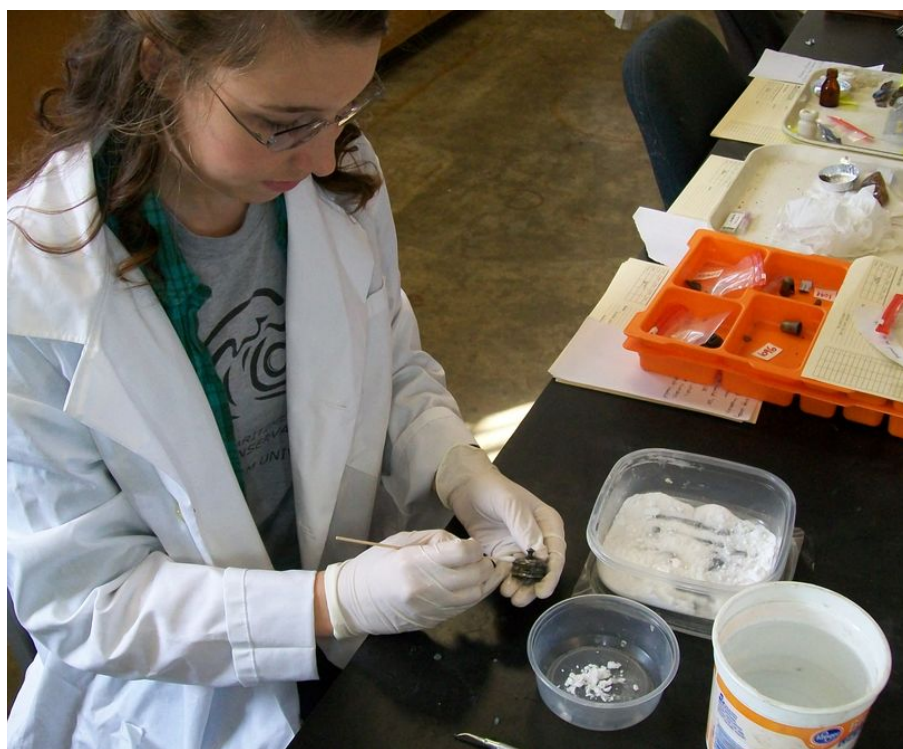
The pepper shaker cap was separated from the bolt, and a significant amount of the concretion was removed using a pneumatic chisel. As the surface of the cap was revealed, the pneumatic chisel was abandoned for small wooden dowels, so the surface would not be scratched (shown in Figure 4.21). After the concretion was completely removed, the pepper shaker cap was placed in baths of 2% sodium sesquicarbonate until the salt content reached a minimum, about 3.5-7 parts per million. After three baths of boiling deionized water, the cap was polished using sodium bicarbonate and a small fiberglass brush. Since the cap base was a cupreous metal, the cap was soaked in a 2% benzotriazole (BTA) and ethanol solution before being coated with Krylon clear finish with 2% BTA added. Following the final coating, the cap was wrapped in a lint free paper towel that had been soaked in 2% BTA and then was sealed in a plastic bag.

Figure 4.21. Cleaning the condiment shaker cap.

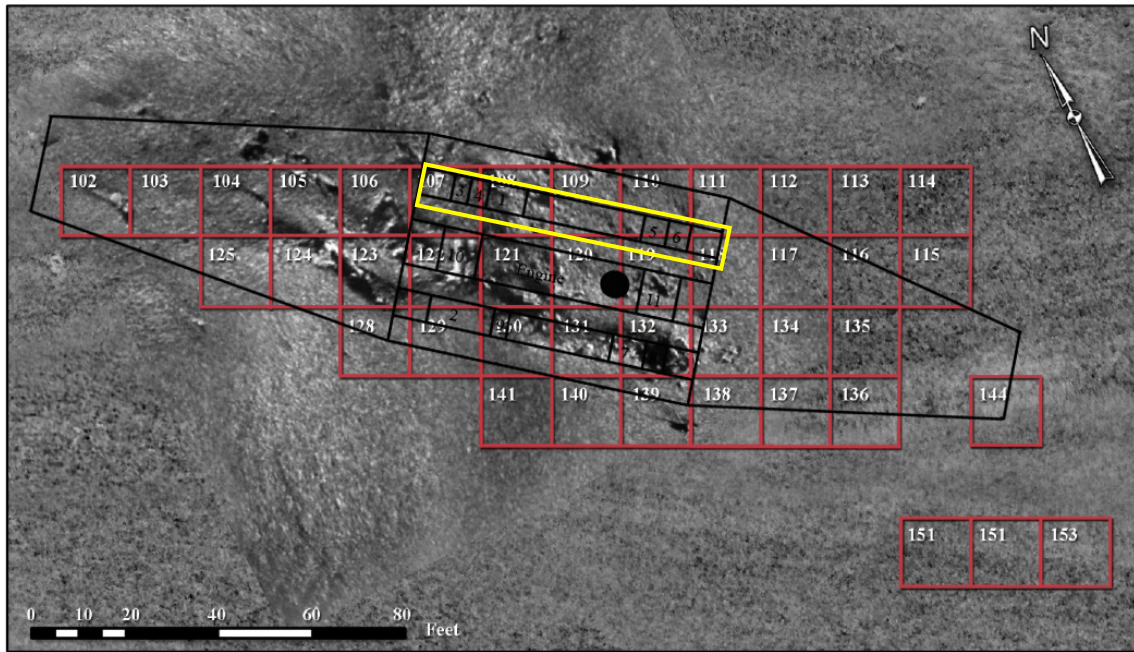
A map of the *Westfield* site is shown below in Figure 4.22, overlaid with the 15 ft. (4.6 m) grid squares in red. An outline of a sketch of USS *Clifton*, sister ship of *Westfield* and very similar in design, is superimposed above the grid squares. The outline has been greatly simplified, stretched, and shifted to fit the length, shape, and possible original position of *Westfield*. Outlined in yellow are the officer's cabins, located on the port side of the ship, directly over square 109. If the room designations of *Clifton* are identical to *Westfield*, *Westfield* sank approximately where the outline is placed over the grid, and erosion and dredging of the site did not move the condiment shaker cap after the sinking, then there is a possibility that this cap came from the officer's table. However, the pepper shaker cap was found concreted to a bolt, which might not be near the cap's original location.

Figure 4.22. Site map of USS *Westfield*. Imposed over the map are a numbered grid and an outline of a sketch of USS *Clifton*. Labels from sketch indicate that row of cabins along the port side, highlighted in yellow, are the officer’s rooms and water closet After Borgens et al. (2010:128,D-6).

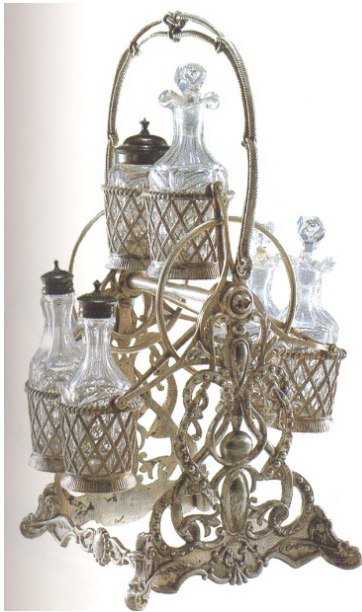
Documentary research may shed more light on the origins of the pepper shaker cap. In Donald Fennimore’s *American Silver and Pewter* (2000:68), the author lists a Victorian electroplated cruet made in 1861 by the Meriden Britannia Company from Meriden, Connecticut. The example shown in Figure 4.23 has three free-swinging baskets which rotate a center axel, allowing the items in each basket to be easily reached. While the set from which the *Westfield* pepper shaker cap may not have been as fanciful as this, the cap does match this set almost identically. The cap most likely came from a glass bottle similar to those shown on the bottom left of Figure 4.23; however, designating the cap as belonging to a pepper shaker is an educated guess. The silver-plated cap could have easily belonged to a salt shaker or another condiment.

Figure 4.23. Victorian electroplated cruet (Fennimore 2000:68).

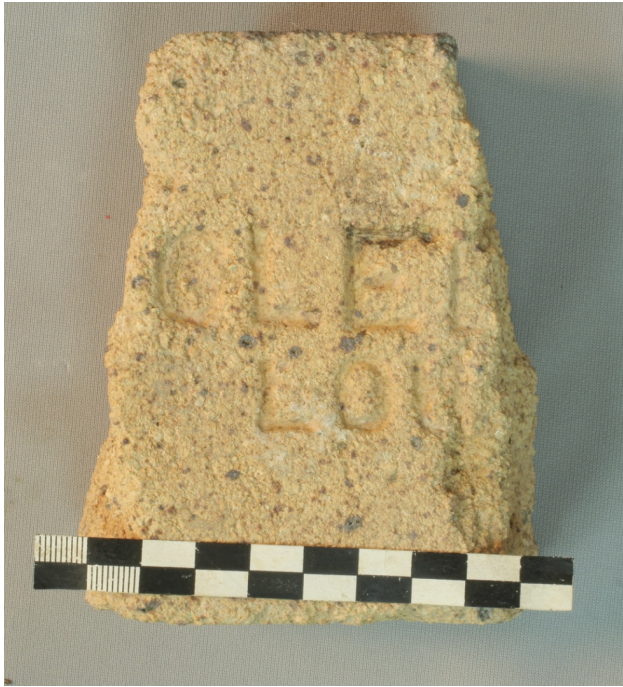
Figure 4.24. Artifact 122-003.

Large brick fragment. Large grained with large inclusions. No mortar, but impressed lettering on obverse side. Letters read “OLE”, followed by what could have been an “N” or “H”. These letters measure 0.75 in. (1.91 cm) tall. Underneath this, the letters are “LON” and measure 0.56 in. (1.43 cm) tall, possibly indicated the word, “LONDON”. Bricks made in London commonly had chalk added to the clay before firing. This chalk prevented shrinkage and cracking and often turned the brick a more yellowish color (Gurcke 1987:12-13). Dark, maroon staining on top of brick. Munsell color pale yellowish orange 10YR 8/6 (Geological Society of America 1991:2).

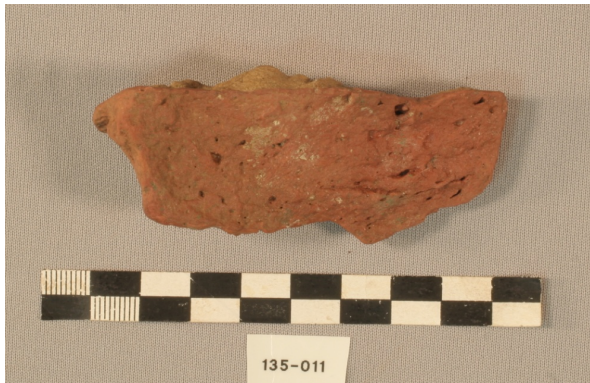
Fig. 4.25.

Small brick fragment. Possible original surface near small bit of mortar, 0.15 in. (0.38 cm thick). Fine grained with small sand grit; small air bubbles that have been compressed in some areas. Munsell colors: brick is moderate red 5R 5/4, mortar is pale yellowish brown 10R 6/2 (Geological Society of America 1991:1).

Figure 4.25. Artifact 135-011.

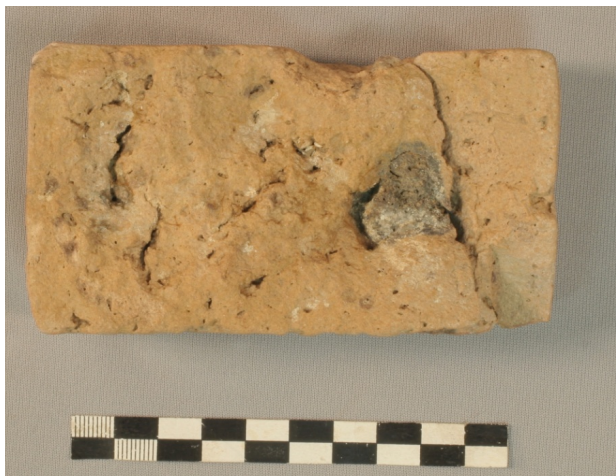
Fig. 4.26.

Almost complete brick in 2 pieces, fine grained with very small grit. No mortar preserved. Small air bubbles on inside of brick. Parallel indentions on one edge of the brick. Munsell color light brown 5YR 6/4 (Geological Society of America 1991:2).

Figure 4.26. Artifact 136-004.

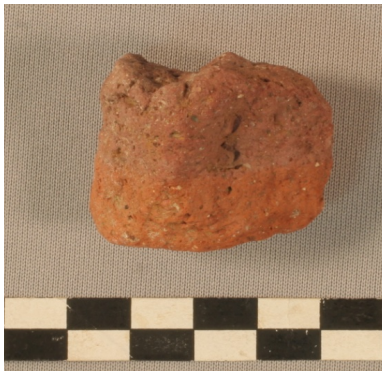
Fig. 4.27.

Fine grained small brick fragment with medium sized inclusions. The fragment has two colors, split halfway down the middle, perhaps due to burial environment. Small air pockets. Munsell colors pale reddish brown 10R 5/4 and moderate reddish orange 10R 6/6 (Geological Society of America 1991:1).

Figure 4.27. Artifact 152-003.

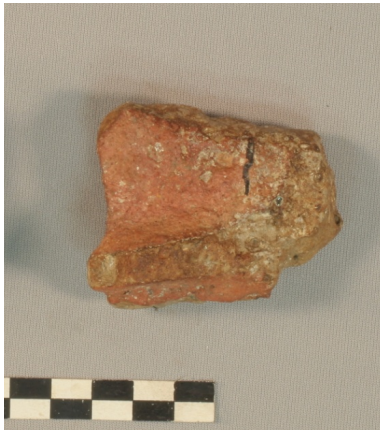
Fig. 4.28.

Small mortar fragment with the surfaces of three bricks present. The bricks were fine-grained with large inclusions. The mortar is fine-grained with few inclusions. The mortar was between two bricks and two layers of bricks. The thickness of the mortar between layers is 0.65 in. (1.64 cm) and between the bricks is 0.31 in. (0.8 cm). The brick is Munsell colors moderate reddish orange 10R 6/6 and the mortar is pale yellowish brown 10YR 6/2 (Geological Society of America 1991:1-2).

Figure 4.28. Artifact 130-033.

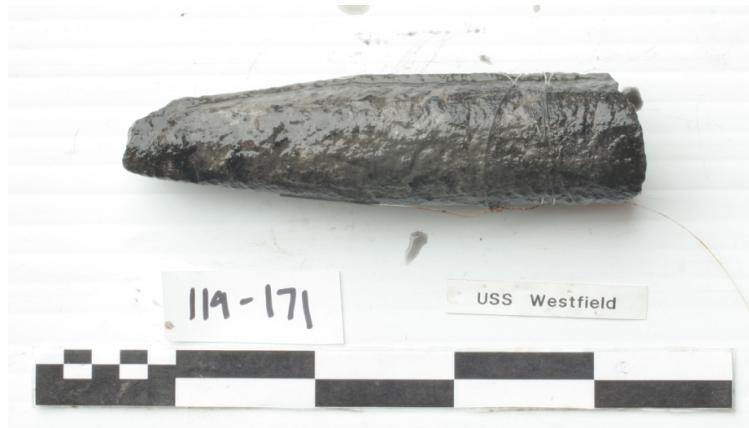
Fig. 4.29.

Lower portion of sash weight. Cylindrical in shape and starts to narrow 2.99 in. (7.60 cm) from the end. Made from a two-piece mold. Two ridges run along the sides opposite of each other, indicating that the mold pieces were not correctly attached when the sash

weight was made. No weight markings were found, as that portion of the weight was not preserved.

Figure 4.29. Artifact 119-171.

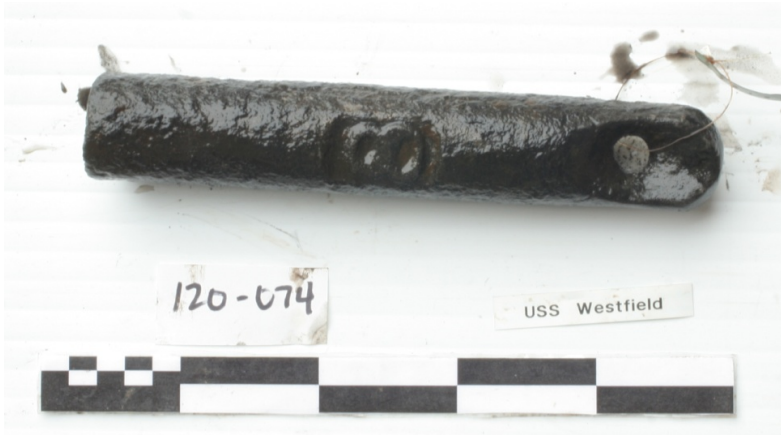
Figure 4.30. Artifact 120-074.

Upper portion of sash weight with hole or opening to allow a rope to be tied around the top. A number “8” is molded into the side, indicating the weight. This sash weight was made from a two-piece mold and shows a small portion of a ridge along one side, indicating the two mold halves were slightly out of alignment.

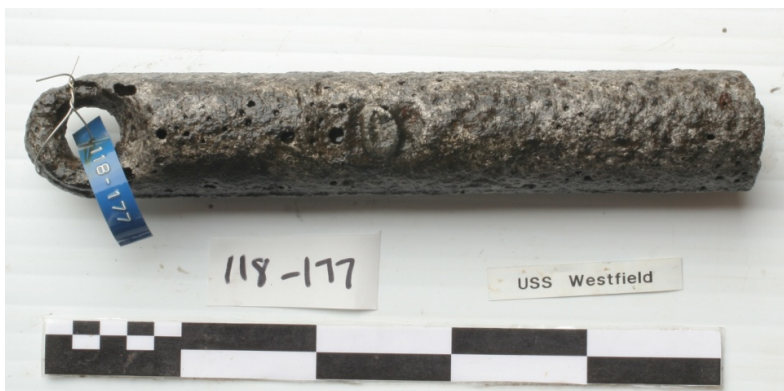
Figure 4.31. Artifact 118-177.

Upper portion of sash weight with hole or opening to allow a rope to be tied around the top. A number “10” is molded into the side, indicating the weight; however the “1” has eroded away. This sash weight was made from a two-piece mold and shows a ridge along one side. Poorly preserved with many pockets in the cast iron.

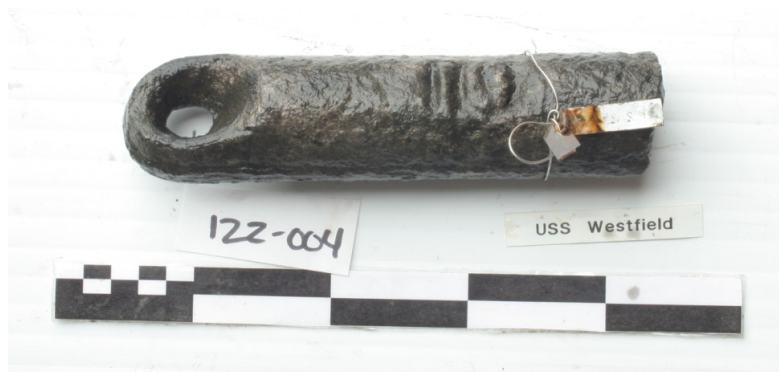
Fig. 4.32.

H./W.:1.52/0.84 in. (3.87/2.13 cm), Weight number H./W.:1.06/0.80 in. (2.68/2.04 cm)

Upper portion of sash weight with hole or opening to allow a rope to be tied around the top. A number “10” is molded into the side, indicating the weight. This sash weight was made from a two-piece mold and shows a small portion of a ridge along one side, indicating the two mold halves were slightly off.

Figure 4.32. Artifact 122-004.

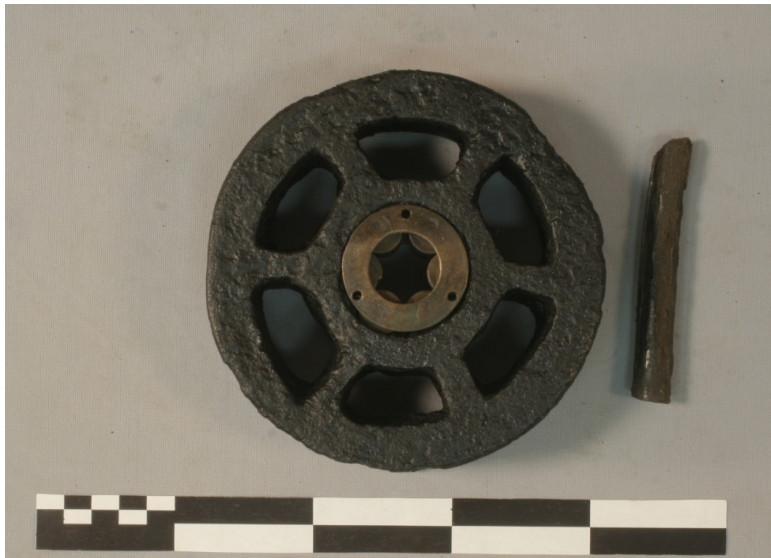
Figure 4.33. Artifact 120-308.

Cast iron sheave with cupreous bearings. Six spokes connect the inner circle to the outer circle. The inner circle shows ridges on the top and bottom to encase the cupreous bearings. The outer surface of the outer circle has a wide indentation to hold the rope or chain. Poor cast iron preservation obscures any sign of wear. Six small cupreous bearings are sandwiched between two circular plates. The plates are held together by two cupreous rectangular rods. The cylinders rotate around small circular protrusions on the two plates. The bearings rotated around a cast iron shaft. The shaft, cast in epoxy, is poorly preserved and signs of wear are not visible.

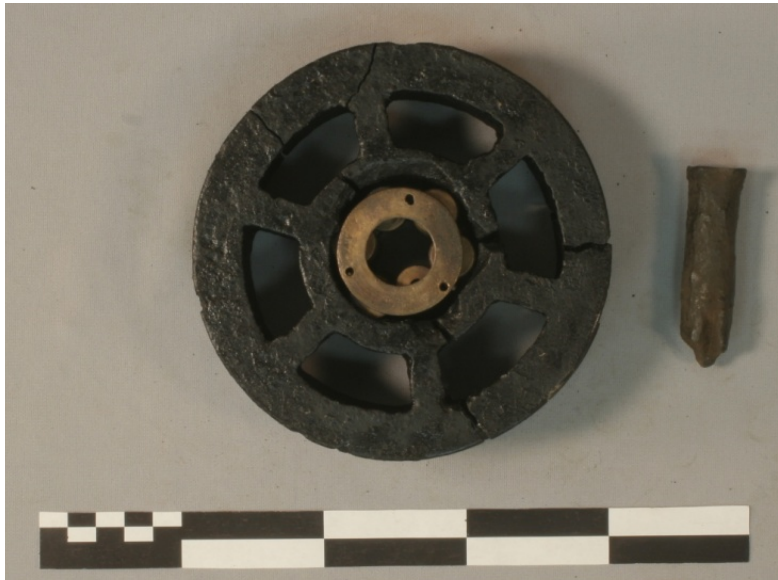
Fig. 4.34.

Cast iron (epoxy) shaft: L.:2.74 in. (6.97 cm), Diam.:0.71 in. (1.79 cm)

Figure 4.34. Artifact 128-016.

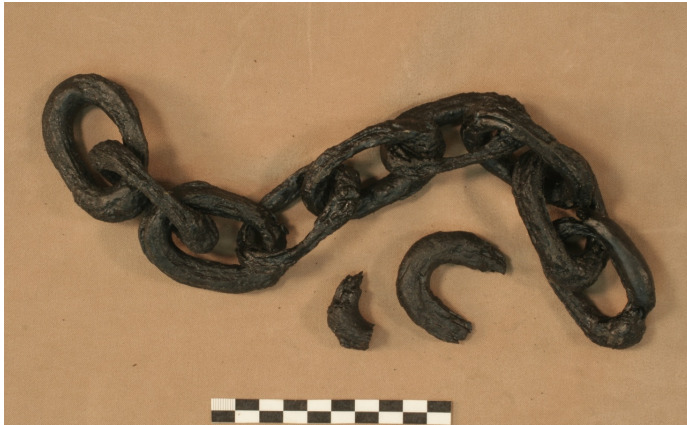
Fig. 4.35.

L.:2.44 in. (6.19 cm), W.:1.52 in. (3.85 cm), Diam.:0.57 in. (1.45 cm)

Nine complete wrought iron chain links and one half link. Poorly preserved.

Figure 4.35. Artifact 102-009.

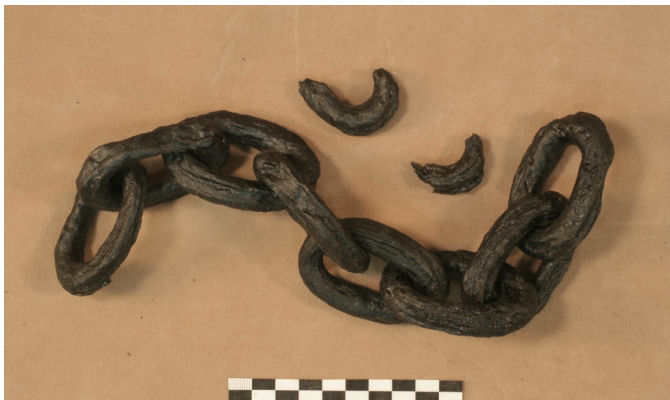
Fig. 4.36.

Chain link: L.:2.60 in. (6.60 cm), W.:1.71 in. (4.34 cm), Diam.:0.53 in. (1.35 cm)

Eight complete wrought iron chain links. Poorly preserved.

Figure 4.36. Artifact 103-067.

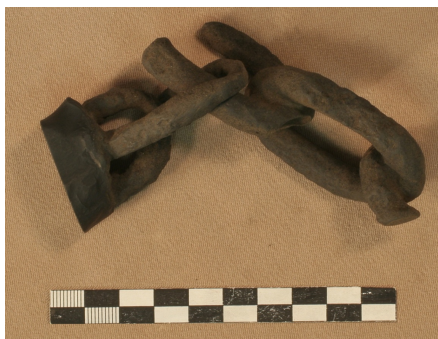
Fig. 4.37.

Chain link: L.:2.28 in. (5.80 cm), W.:1.25 in. (3.17 cm), Diam.:0.37 in. (0.95 cm)

Poorly preserved iron chain (cast epoxy). One link and four partial chain links preserved.

Figure 4.37. Artifact 114-004.

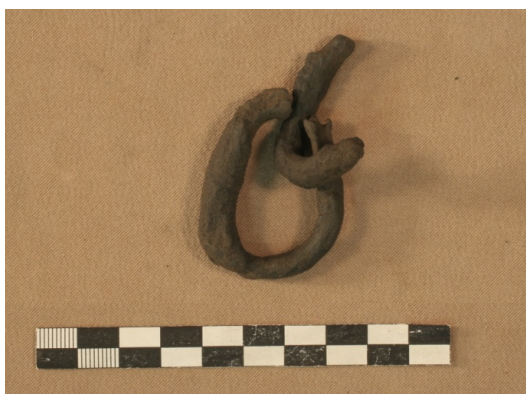
Fig. 4.38.

Chain link: Diam.:0.40 in. (1.02 cm)

Two partial iron (cast epoxy) chain links. Poorly preserved.

Figure 4.38. Artifact 134-086.

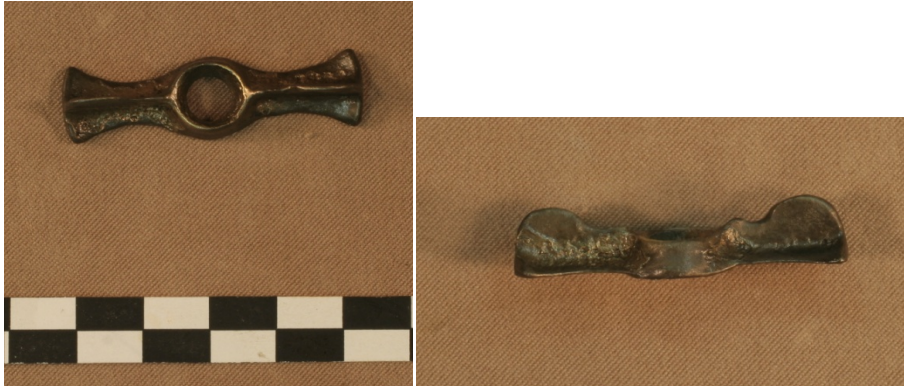
Fig. 4.41.

Cupreous cupboard button. Rotated on cupreous plate to hold a cupboard door shut. Two small wings on either side aided in grasping and turning the button. Each end slightly

concave to fit on top of the plate. The length is an estimate, perhaps slightly less than the diameter of the plate.

Figure 4.41. Artifact 120-284.

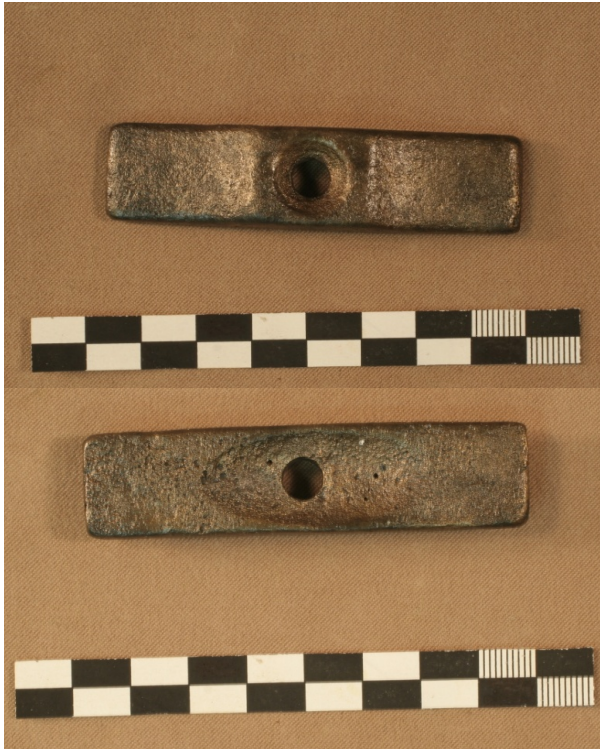
Fig. 4.42.

L:2.94 in. (7.48 cm), W:0.72 in. (1.83 cm), Center hole diameter:0.27 in. (0.68 cm.)

Cupreous cupboard button. Larger than 120-284, this button would have been for a more substantial cabinet latch. The two wings aided in grasping and turning the button on the plate below. The opposite side shows elliptical shallow recess, 1.44 in. (3.66 cm) in length.

Figure 4.42. Artifact 132-128.

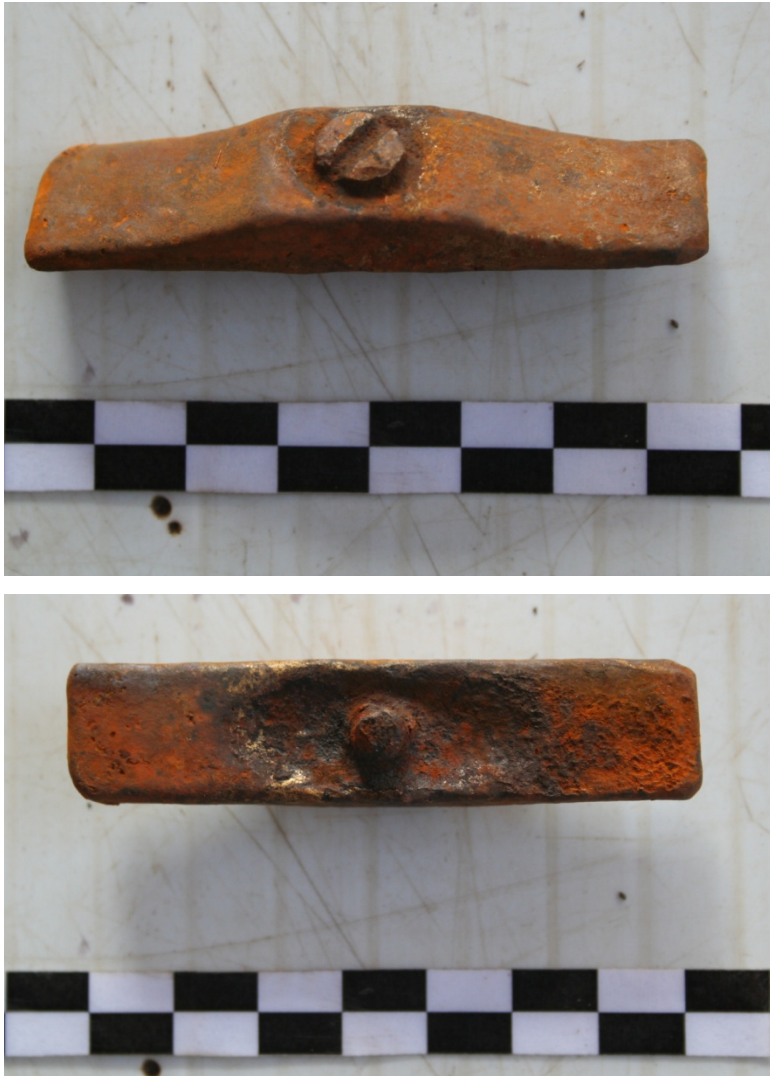
Fig. 4.43.

Screw: L:0.67 in. (1.69 cm), Shaft diam.:0.26 (0.66 cm), Head diam.:0.32 in. (0.81 cm),
Head th.:0.05 in. (0.13 cm)

The two wings aided in grasping and turning the button on the plate below. The original screw that the plate rotated on was preserved. The opposite side shows elliptical shallow recess. Flat head screw through central hole in cupboard button. Not yet conserved at the time of this submission.

Figure 4.43. Artifact 121-078.1.

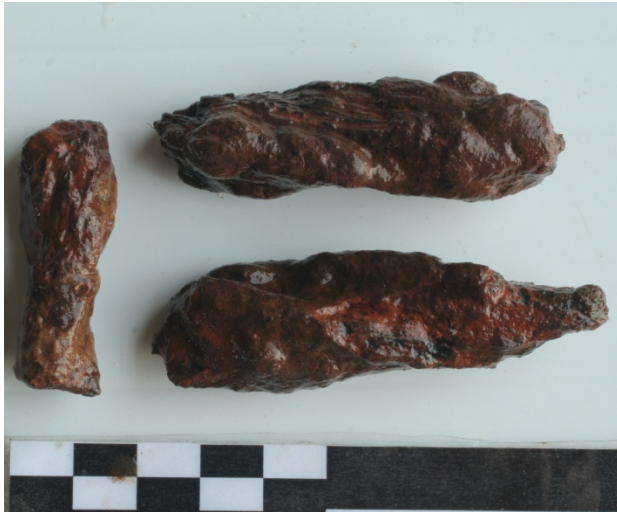
Fig. 4.44.

Remnants of rope preserved in concretions. Did not survive conservation.

Figure 4.44. Artifact 128-043.

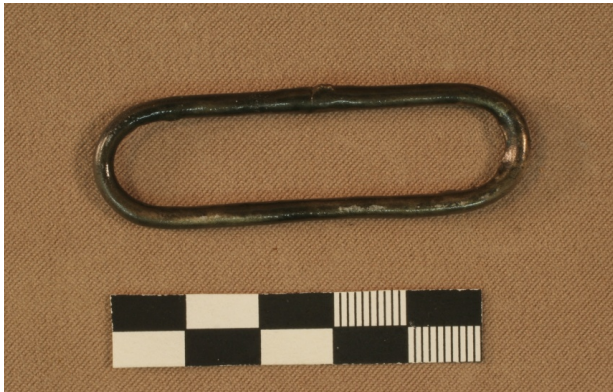
Fig. 4.45.

Cupreous snake belt buckle loop. Associated with snake belt plate (111-064). The midpoint of one long side shows a weld point, and the metal is thicker at that point. In addition, a break point is seen next to the weld point. This is most likely the original

attachment to a small circular loop where the snake buckle would have attached. Another identical loop on the other side of the snake belt plate would have completed the attachment to the belt.

Figure 4.45. Artifact 135-003.

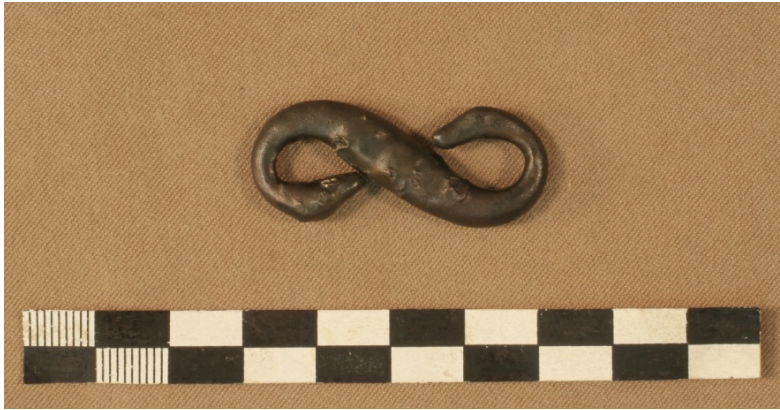
Figure 4.46. Artifact 111-064.

Cupreous snake belt plate. Associated with snake belt plate loop, 135-003. Most likely originally decorated to look like a snake. The head shape is clearly seen in the photograph. A small circular loop would have been linked to both ends and attached to an elliptical loop. The loop would be attached to the belt.

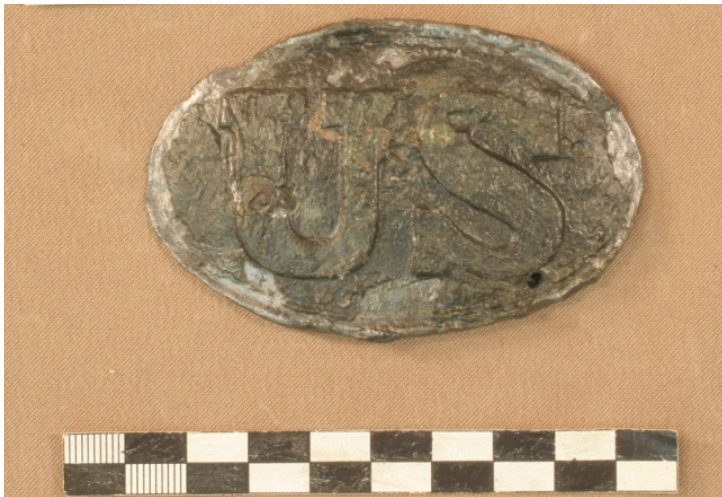
Figure 4.47. Artifact 108-103.

Lead belt plate. Stamped "US" on the front, cupreous mount on reverse, a few tiny spots where stamped brass plate remains.

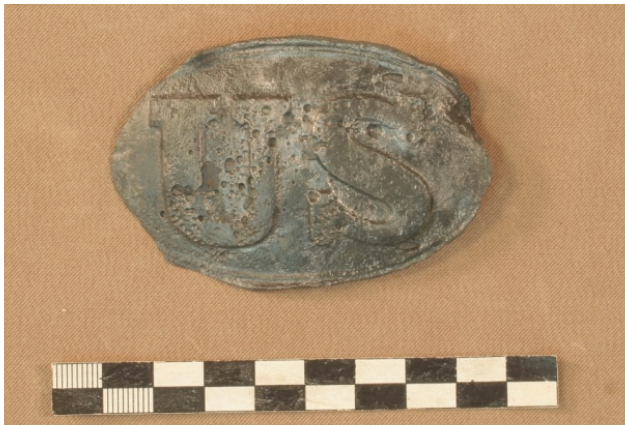
Figure 4.48. Artifact 106-032.

Lead belt plate. Stamped "US" on the front, cupreous mount on reverse.

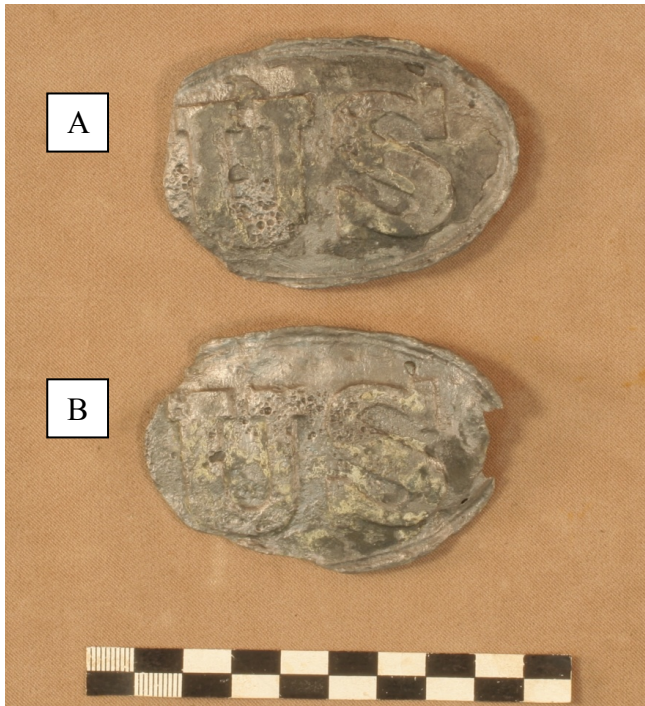
Figure 4.49. Artifact 123-042.

2 Lead belt plates. Stamped "US" on the front, cupreous mount on reverse.

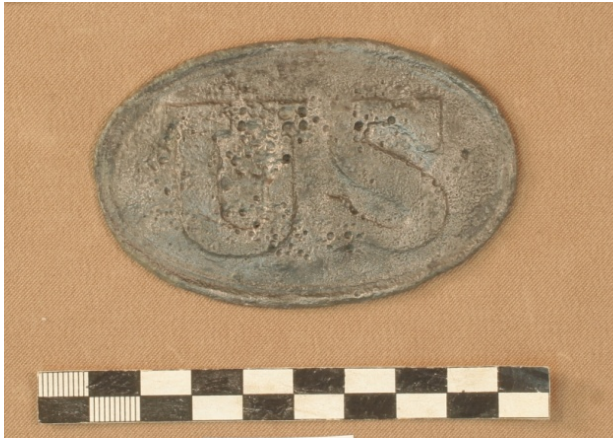
Figure 4.50. Artifact 124-041.

Lead cartridge box plate. Stamped "US" on the front.

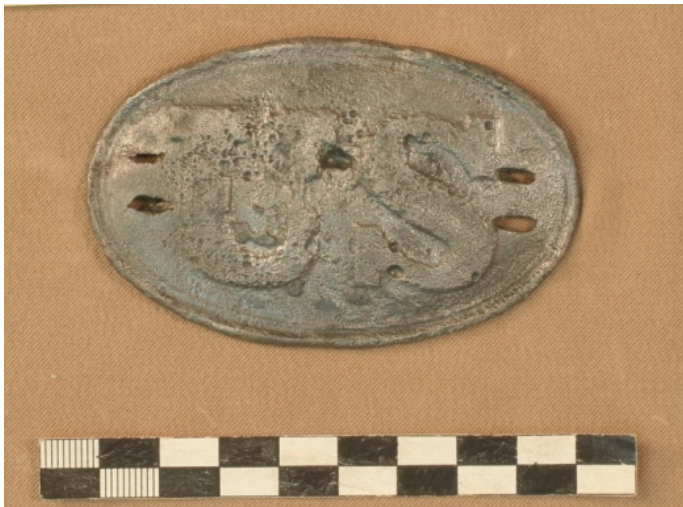
Figure 4.51. Artifact 107-024.

Lead cartridge box plate. Stamped "US" on the front.

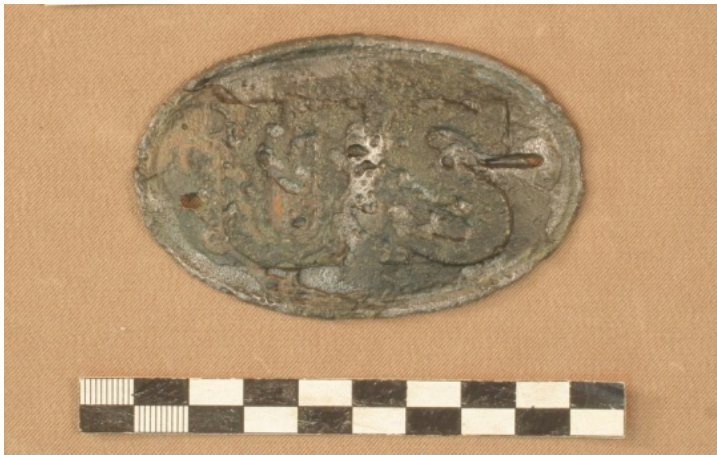
Figure 4.52. Artifact 121-142.

Lead cartridge box plate. Stamped "US" on the front, a bit of the stamped brass plate remains.

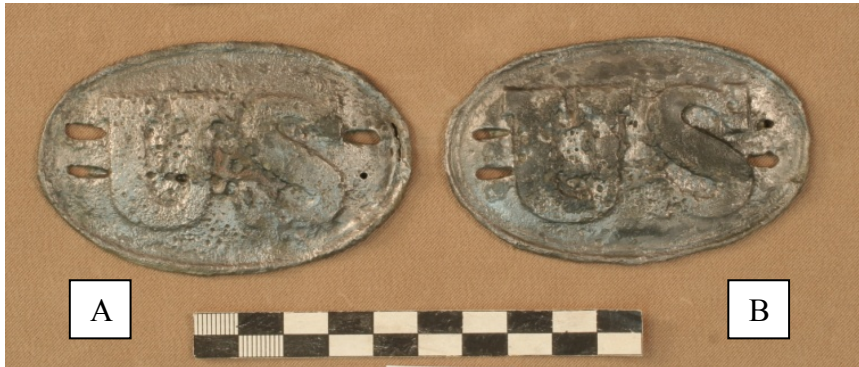
Figure 4.53. Artifact 122-061.

Lead cartridge box plate. Stamped "US" on the front, a little bit of the stamped brass plate remains (mostly on 122-061A).

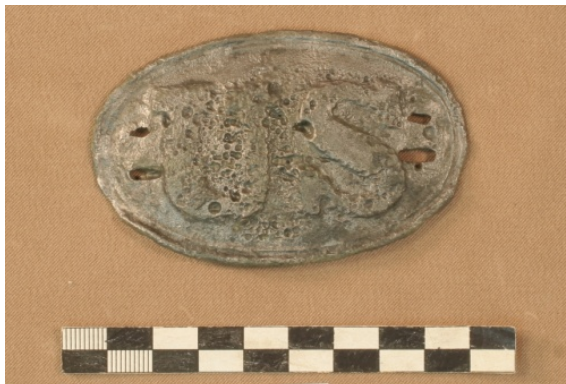
Figure 4.54. Artifact 109-089.

Lead cartridge box plate. Stamped "US" on the front.
