THE CONSERVATION AND ANALYSIS OF SMALL ARTIFACTS FROM THE
SITE OF USS *WESTFIELD*

A Thesis

JESSICA ROSE STIKA

Major Subject: Anthropology

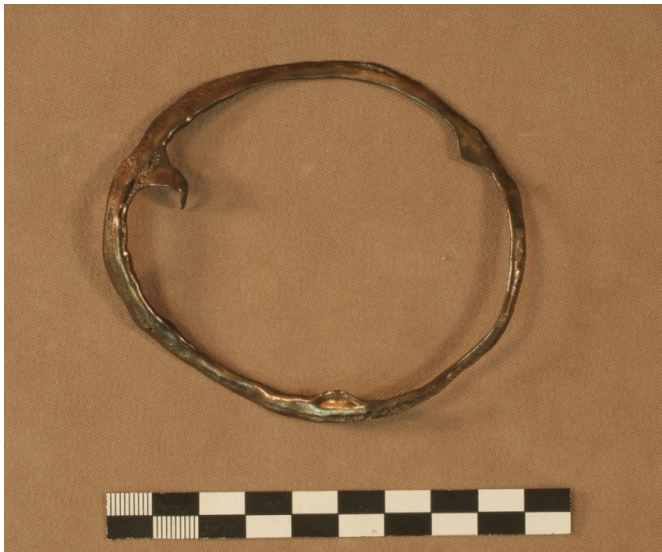
Figure 4.55. Artifact 123-041.

Cupreous belt plate. Most likely originally had decorative insert belt plate. Small tabs still preserved along edges to hold decoration. Bent and poorly preserved.

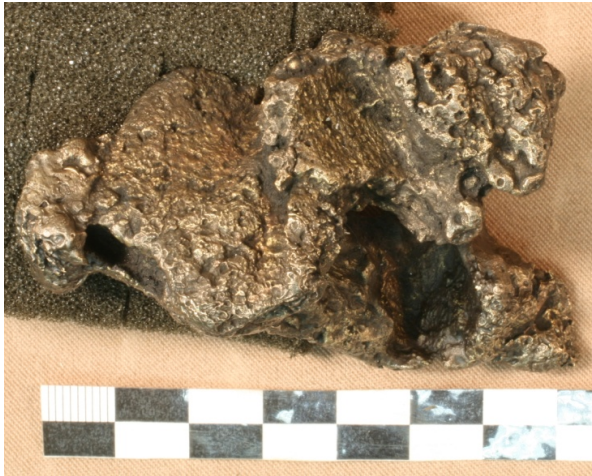
Figure 4.56. Artifact 133-181.

Fabric impression preserved in corrosion products on surface of amorphous cupreous object.

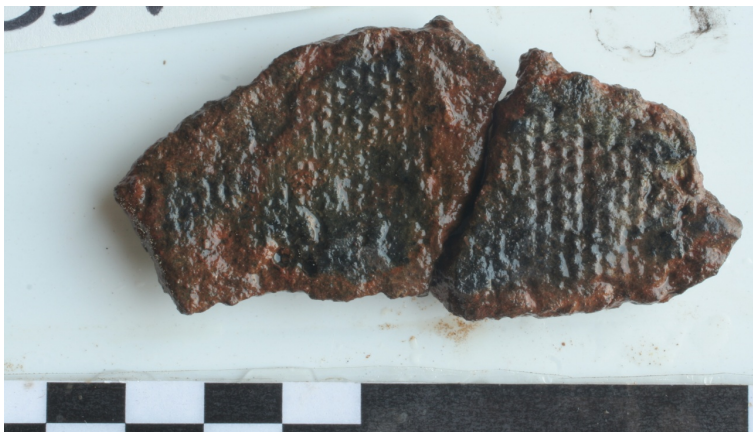
Figure 4.57. Artifact 133-123.

Fabric impression preserved in concretion. The fibers appear to be the same size or larger than 133-181.

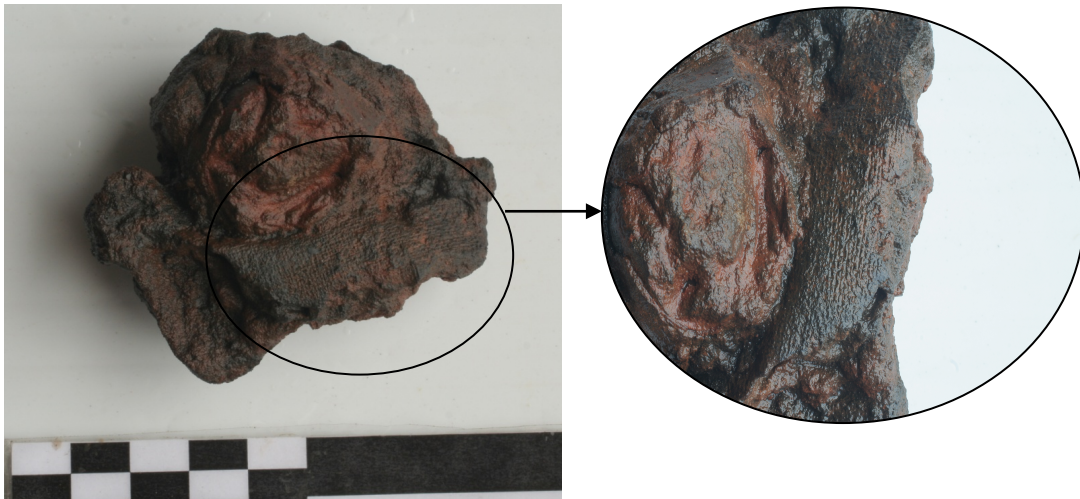
Figure 4.58. Artifact 103-039.

Fabric impression preserved in concretion. Smallest fiber of the three examples selected. Impression indicates that original fabric pieces folded over, possibly wrapped around the ceramic piece that is associated with this artifact.

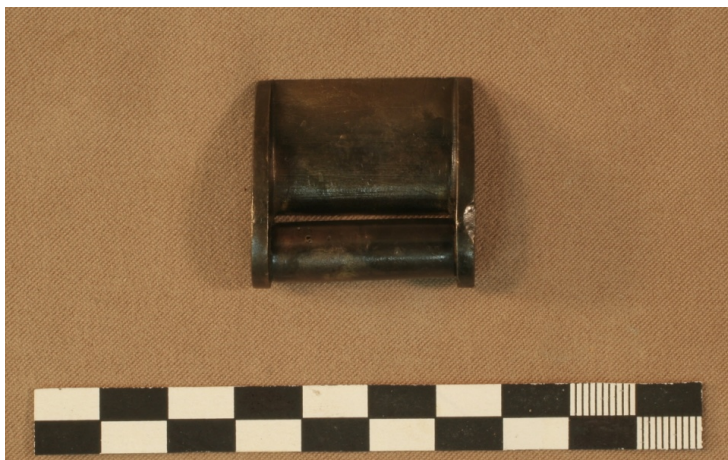
Figure 4.59. Artifact 133-111.

Cupreous clasp. Wear marks on inside of clasp. The marks are regular, straight, and parallel with the cylinder. Irregular scratch makes on both sides. Two small holes on

either side of clasp filled with cupreous material. The cylinder is hollow with wear marks on outside at either end.

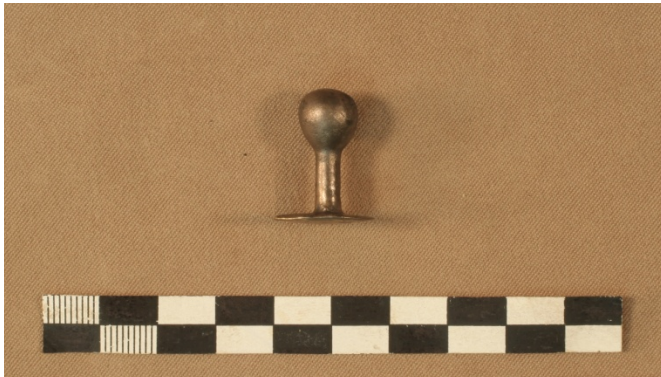
Figure 4.61. Artifact 111-065.

Cupreous stud or button for leather pack.

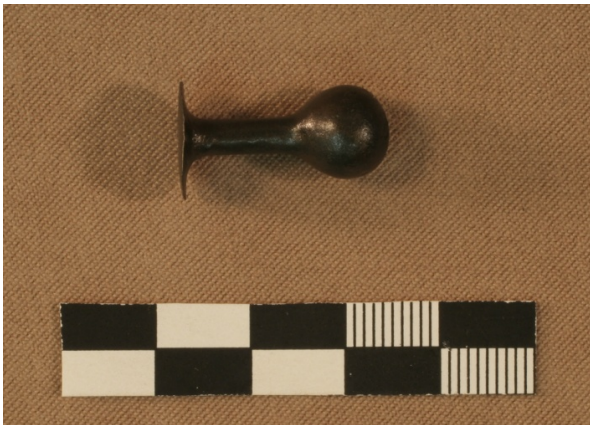
Figure 4.62. Artifact 131-096.

L:0.86 in. (2.19 cm), Diameter of base:0.47 in. (1.20 cm), Th. of base:0.06 in. (0.14 cm),
Shaft diam.:0.15 in. (0.37 cm); Top sphere L:0.41 in. (1.04 cm), W:0.38 in. (0.97 cm)
Cupreous stud or button for leather pack.

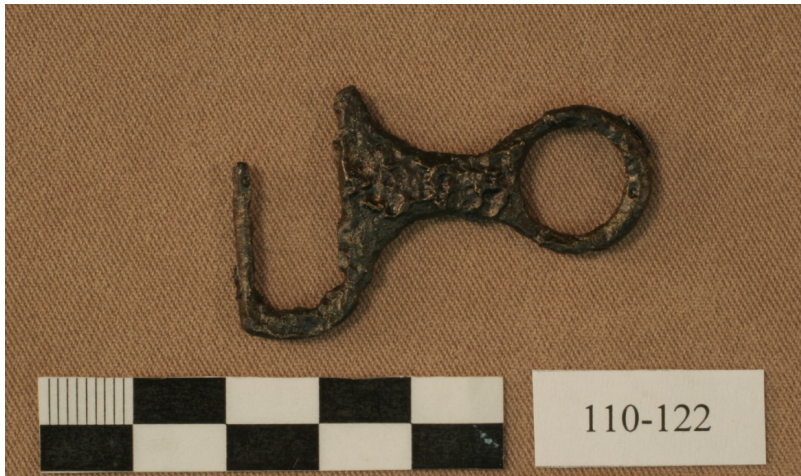
Figure 4.63. Artifact 110-122.

Cupreous strap clasp. Rectangular opening for strap opposite an eye. A small hook
would have been inserted through the eye to connect the strap to another item. Highly
eroded.

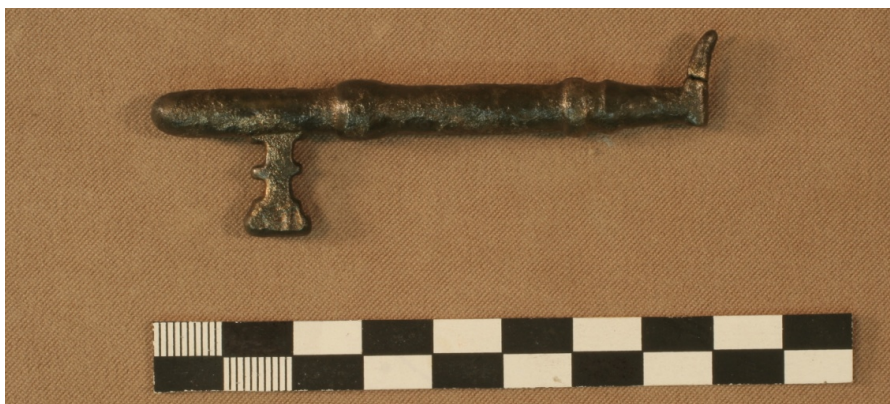
Figure 4.64. Artifact 120-295

Cupreous key. Missing portion of ring. Three bands around the shaft, 0.10 in. (0.26 cm) hole at handle towards bottom of shaft.

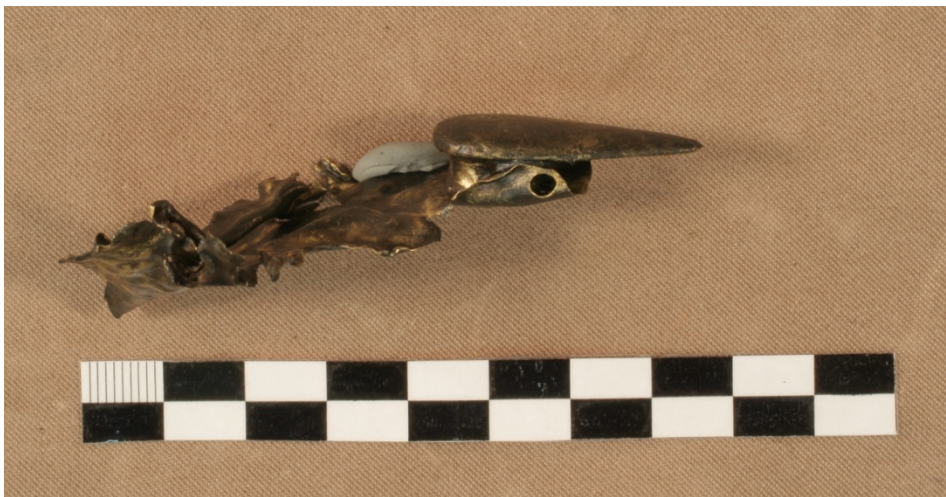
Figure 4.65. Artifact 108-067.

Cupreous bayonet scabbard hook used to clip the bayonet scabbard to the frog that suspended the scabbard from the belt. Attached to cupreous plate which wrapped around the top of the leather bayonet scabbard. Two holes in plate for fasteners.

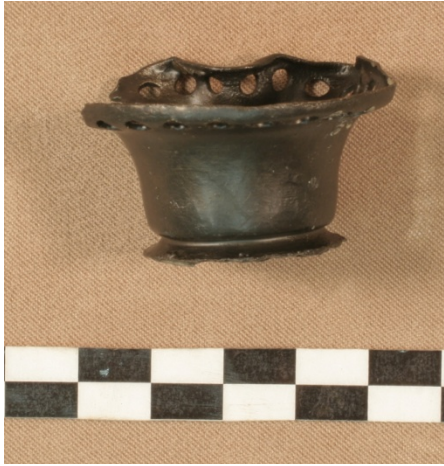
Figure 4.66. Artifact 110-54.1

Cupreous oil lamp piece. Circles unevenly spaced around circumference, 0.02-0.13 in. (0.05-0.33 cm) apart holes are uniform in size, 0.12 in. (0.30 cm) in diameter. These are most likely made from a punch by hand. The lip around the top circumference would have held the glass in place. The lower portion is formed to fit onto the base of the lamp. The oil lamp piece shows damage and wear on both the top and bottom.

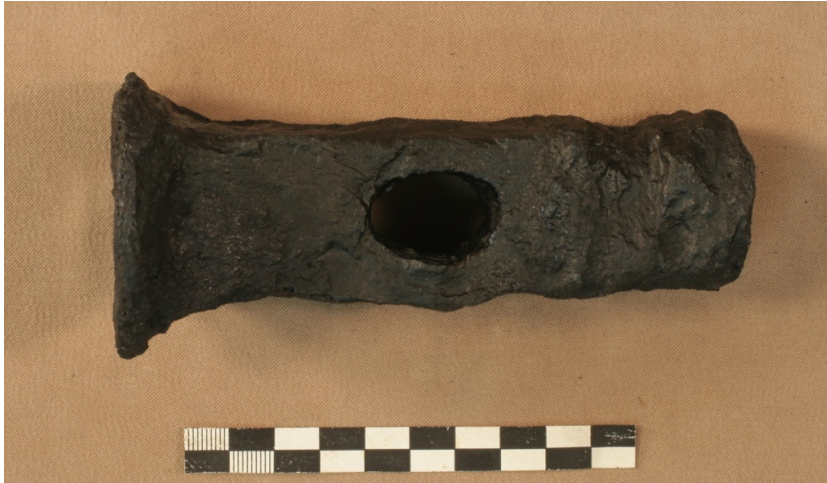
Figure 4.67. Artifact 132-385.

The U.S. Navy issued a variety of hammers issued to navy ships, including chipping hammers, hand hammers, riveting hammers, and assorted copper hammers (United

States Navy Department 1865:26). The type of this particular example is difficult to identify due to the hammer's poor preservation.

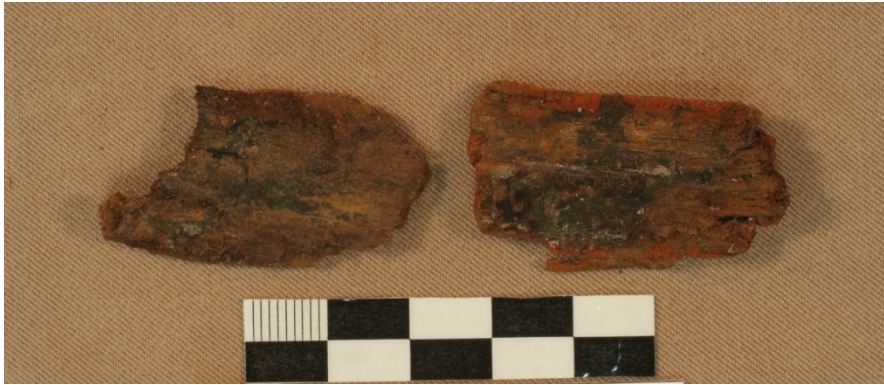
Figure 4.68. Artifact 132-385A.

Two wood fragments from hammer head. Fragmented on inside, side towards the middle of the original handle, and smooth on the outside, where the wood sat against the iron.

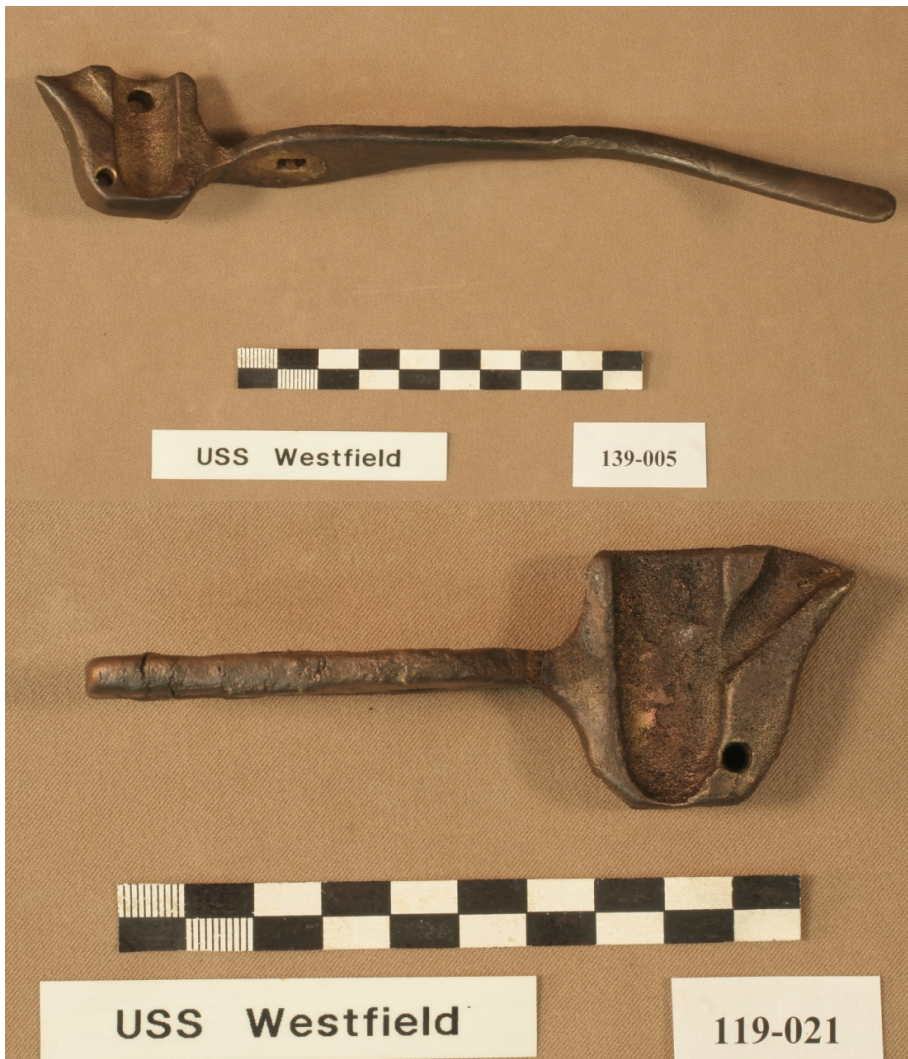
Figure 4.69. Artifacts 139-005 and 119-021.

Cupreous bullet mold with complete handle on one half of mold (139-005) that splays outward and downward from the mold at a length of 6.19 in. (15.73 cm). The handle is missing for the other half (119-021). The two halves join together just behind the mold where the handle is much wider. The piece with a missing handle (119-021) may have sat on top of 139-005. 119-021 has a circle hole with a diameter of 0.33 inches (.84 cm) at the attachment point. The other half, 139-005, may have been placed under the first piece and has a square attachment hole with a length of 0.28 in. (0.70 cm). The mold cavity matches up well on both sides with a maximum length of 1.22 in. and a maximum width of 0.61 in. (3.1 cm and 1.54 cm, respectively). There is a small spout where the metal was originally poured. At the top of the spout, the diameter is 0.47 in. (1.2 cm) which narrows to 0.30 in. (0.77 cm). A small hole, diameter 0.24 in. (0.61 cm), on the upper portion of the mold on the complete handled half (139-005) either marks a fill line for the mold or indicates another piece was attached, at 1.00 in. (2.54 cm) from bottom of the mold. Another hole is below the spout and in front of the “U” shaped mold cavity. Another piece would have likely gone here, so that both halves could lock together on the other side of the mold. The lower half (139-005) shows evidence of a washer with a

diameter of 0.65 in. (1.66 cm) fitted to the bottom face at the attachment between the two halves, while the other half (119-021) shows evidence for a similar washer with a diameter of 0.57 in. (1.46 cm) on the top of the attachment point. Due to their similar size, the two mold halves likely belonged to the same bullet mold or to an identical mold.

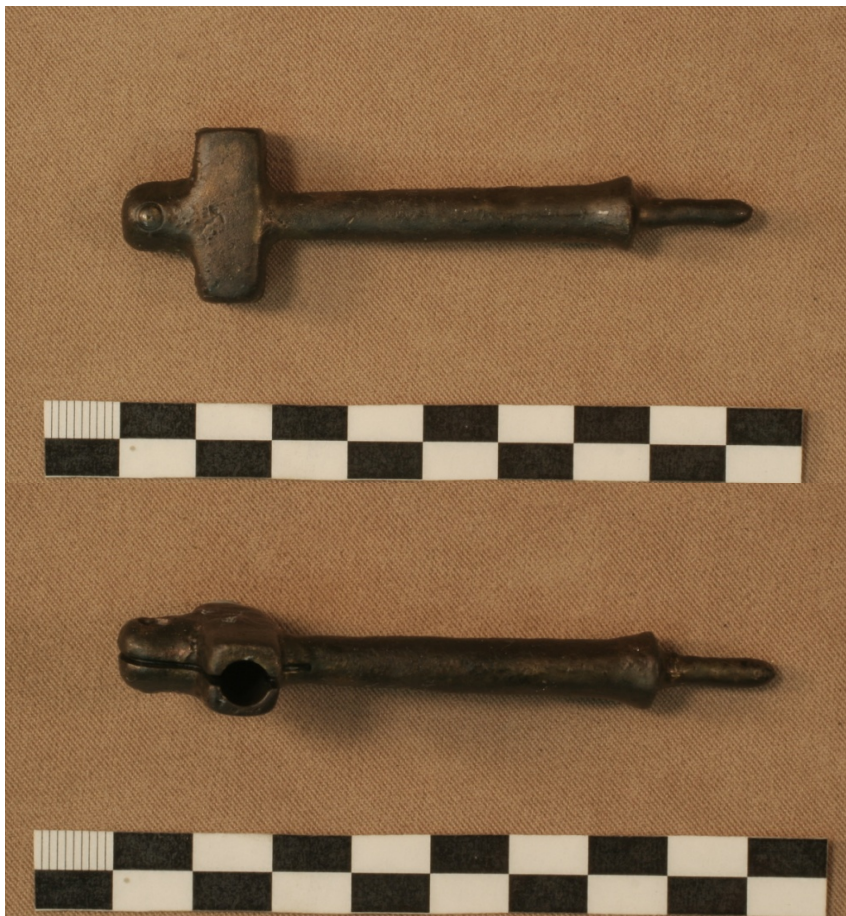
Figure 4.70. Artifact 118-023.

Cupreous unidentified cross-shaped tool. Base has extension to fit into a handle, possibly of wood. Opposite this, a 0.03 in. (0.06 cm) slit originally held another thin object. The object would have been held in place by a small screw at the top of this unidentified tool and supported by the two arms or extensions. The slit extends 0.89 in. (2.25 cm) from the top of the tool. The two arms or extensions are hollowed out in the shape of a cylinder with a diameter of 0.21 in. (0.53 cm).

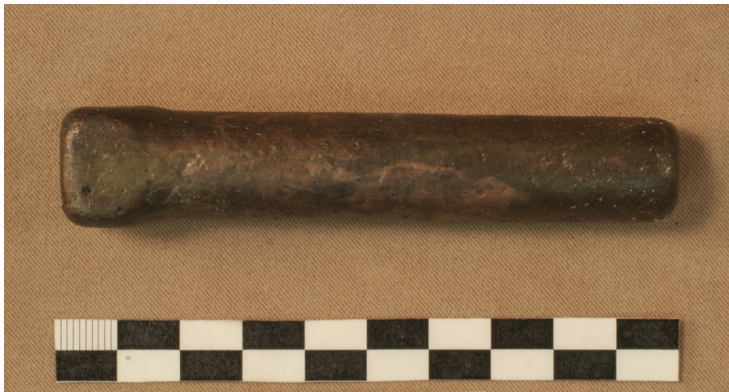
Figure 4.71. Artifact 133-130.

Unidentified cupreous object or tool. Square head with cylindrical shaft. Small indentations visible on bottom, possibly from use or from erosion.

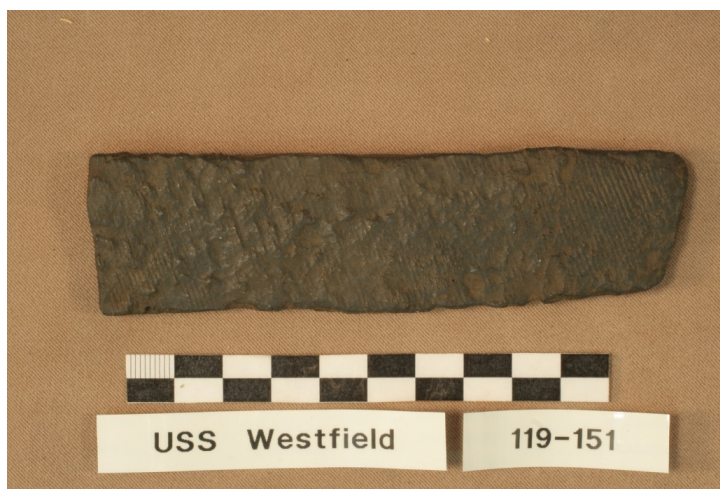
Figure 4.72. Artifact 119-151.

Fragment of iron single-pointed flat file. Point opposite the tang or spike preserved. Teeth 0.04 in. (0.10 cm) apart on faces and edges. Angled, double-cut teeth across both faces. On the original cast, the double-cut teeth are preserved. These are shown in photographs of the cast below (Figure 4.73). These are not as evident on the painted epoxy cast (Figure 4.72). Teeth along the edges and point are perpendicular to the surface. Poorly preserved. Original iron not preserved, only the epoxy cast of the concretion mold.

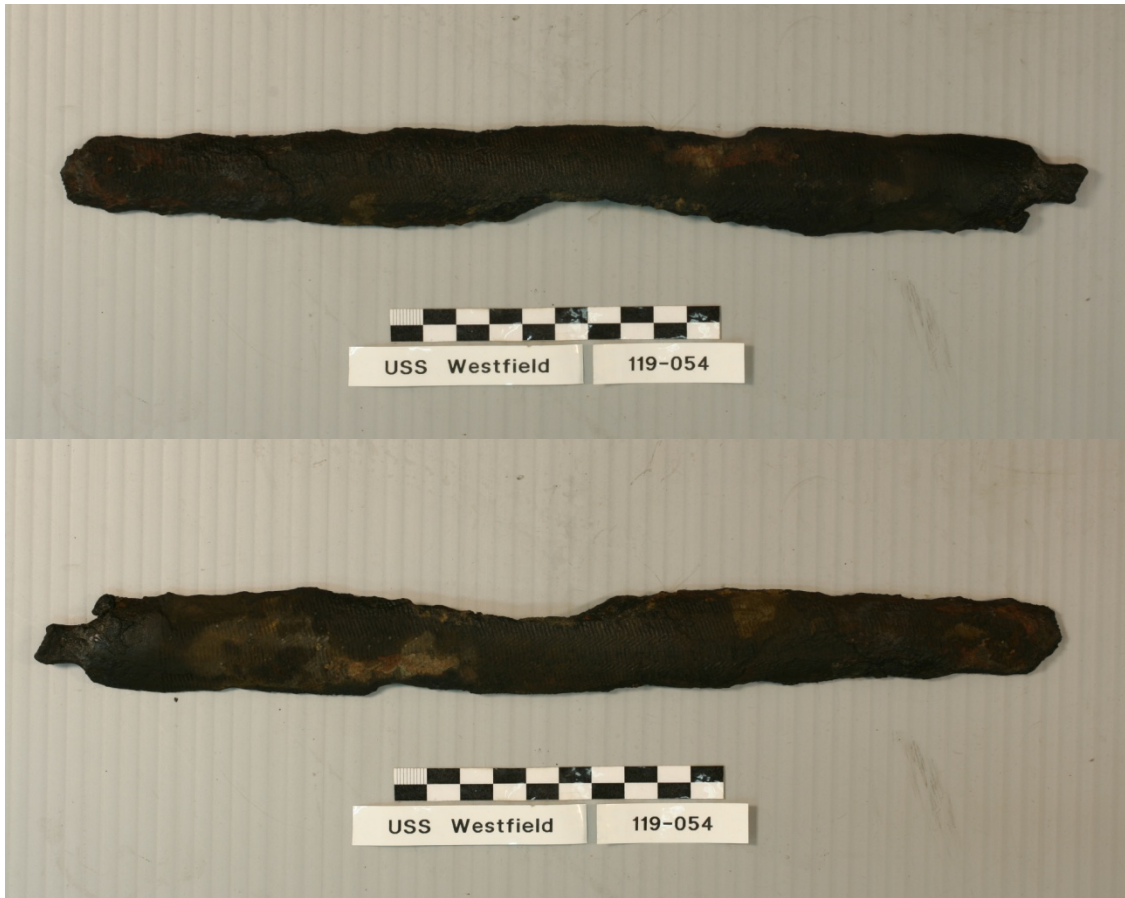
Figure 4.74. Artifact 119-054.

Almost complete half-round file. Preserved from point to the upper portion of tang or spike. Missing the majority of the handle. Teeth 0.05 in. (0.13 cm) apart on faces and edges. Angled, double-cut teeth across flat face and angled, single-cut teeth on rounded face. These are shown in photographs of the original artifact below (Figure 4.72).

Original iron artifact did not survive conservation, this is the epoxy cast.

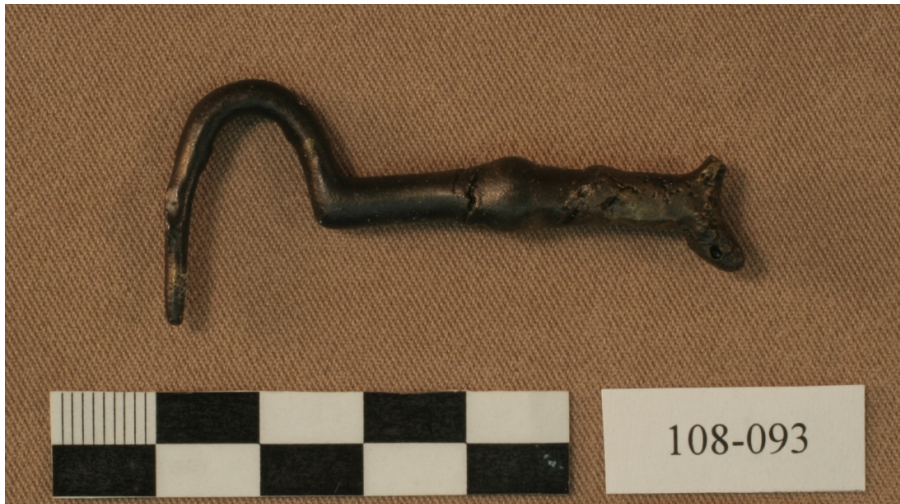
Figure 4.75. Artifact 108-093.

Cupreous latch. Eye opposite of hook not preserved. One large band around the shaft.

Ring end missing.

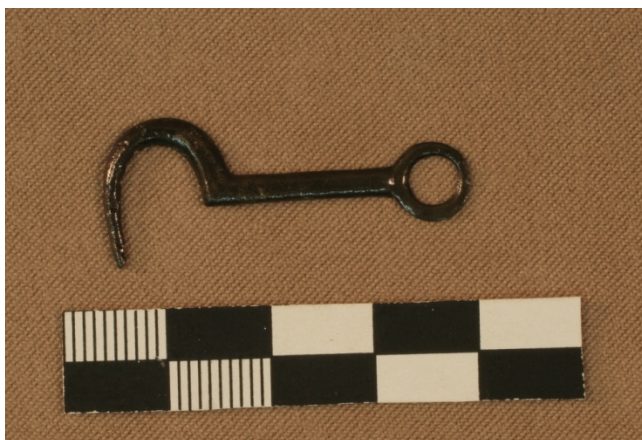
Figure 4.76. Artifact 128-063.

Cupreous hook or latch. Surface flat on one side and concave on the opposite side. Edges not well preserved around the eye. Ring end is badly eroded.

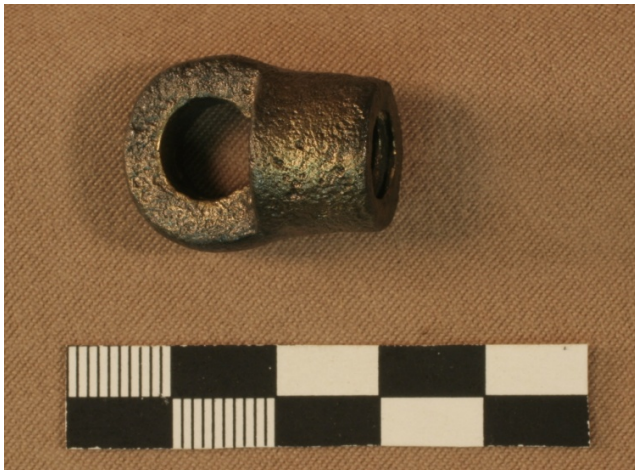
Figure 4.77. Artifact 121-137.

Cupreous loop. Threaded, hollow cylinder with loop attached to top.

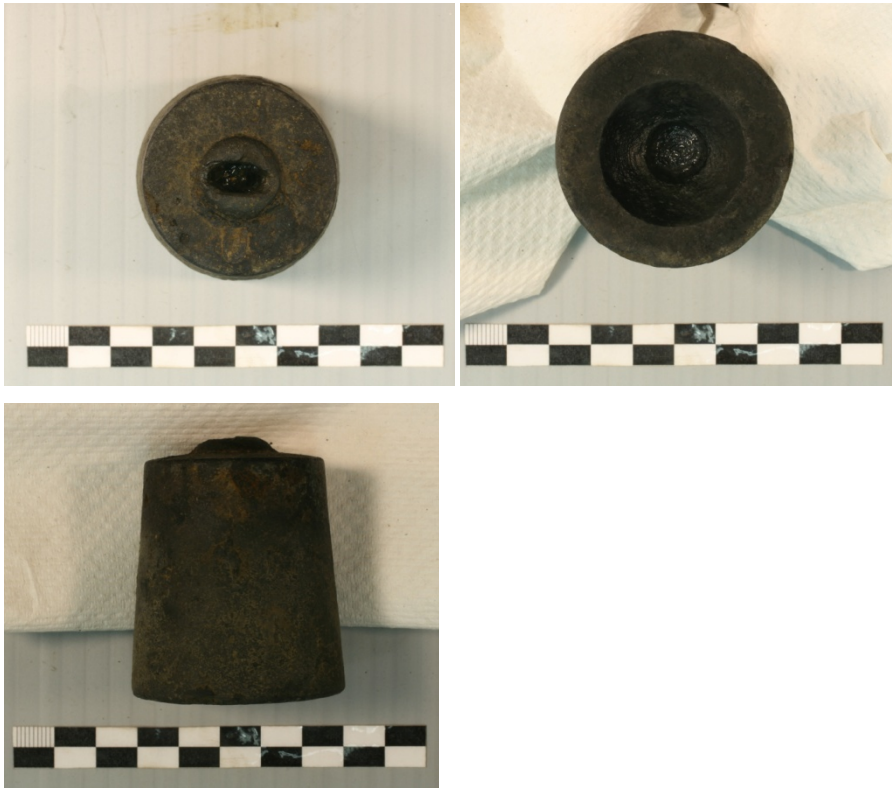
Cylindrical counterpoise weight. Cast iron with lead adjustment in central shaft originating from bottom central depression. Small circle on the top which allowed the weight to be hung. A ring would have been attached to the top for hanging. Bottom has another indented circle which allows the lead inside to be seen. The weight would have hung from a scale, counterbalancing the object was placed on the scale to be weighed. A cross-sectional drawing is shown in Figure 4.79.

Figure 4.78. Artifact 121-084. Top view, bottom view, and side view

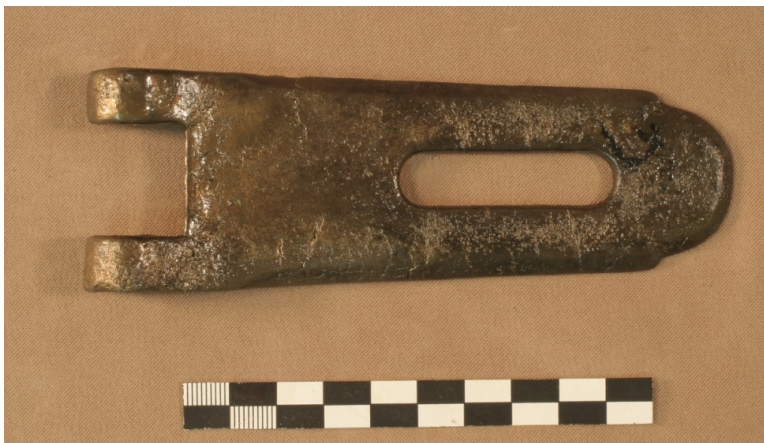
Figure 4.80. Artifact 134-035.

Cupreous hasp for padlock clasp. Two holes on one end. One of these holes is filled with copper, suggesting that the other portion of the hasp was also made of copper. The other end has decorative beveling, flat on one side and concave on the other, and a long ellipse opening to allow for loop to enter and a lock to be attached.

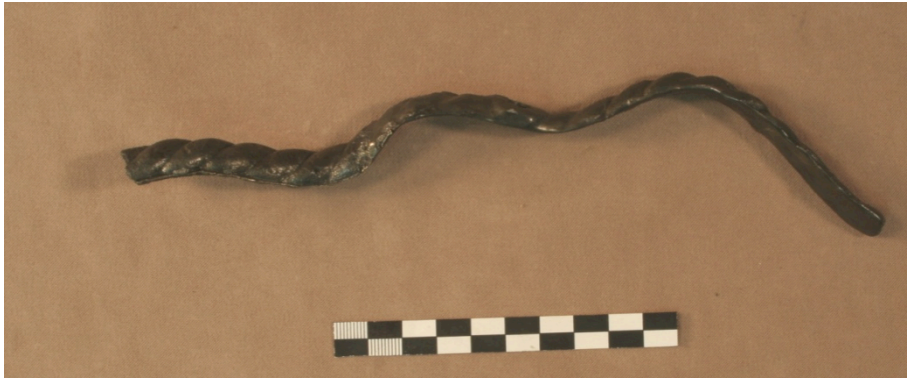
Figure 4.81. Artifact 125-037.

Cupreous plate with rope decoration. Possibly a handle or decorative plate for a handle. “S” shape rope design on outer face. Both ends show break. Small circular hole with oval border in center for handle. Twisted and bent.

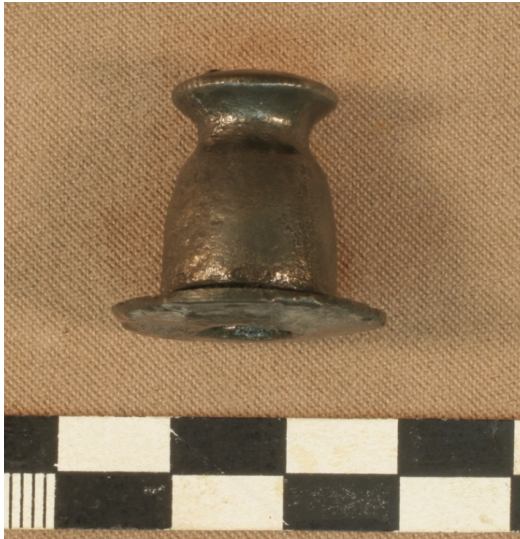
Figure 4.82. Artifact 132-001.02.

Cupreous finial. Composed of two pieces. Lower portion appears to be cylindrical with a circular base, 0.91 in. (2.31 cm) in diameter. Inside of lower portion is hollow, with a diameter of 0.32 in. (0.80 cm). The outer diameter of the cylinder, barely visible below the upper portion, is 0.46 in. (1.18 cm). The upper portion fits over the lower portion and has a maximum diameter at its base of 0.58 in. (1.46 cm). This diameter slowly decreases as the upper portion extends until it forms a convex cross-section with a diameter of 0.37 in. (0.95 cm). The diameter increases to form the top button, diameter 0.56 in. (1.42 cm), which marks the top of the finial. Small, poorly preserved grooves or teeth are evident around the top circumference of the button.

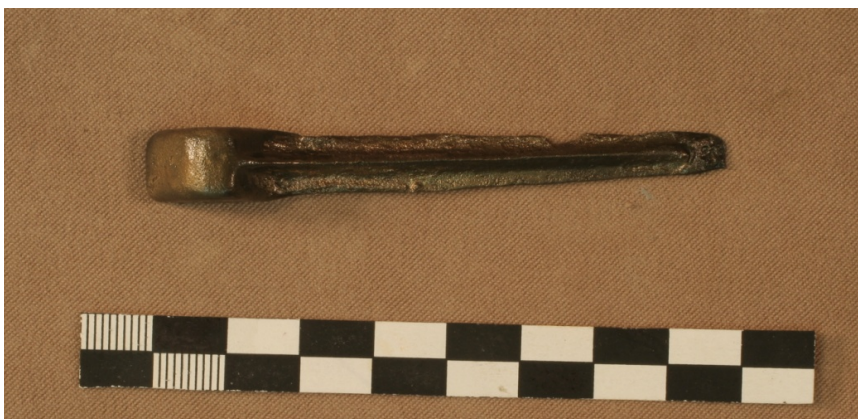
Fig. 4.83.

L:3.08 in. (7.82 cm), W:0.40 in. (1.02 cm)

Unidentified cupreous object.

Figure 4.83. Artifact 125-062.

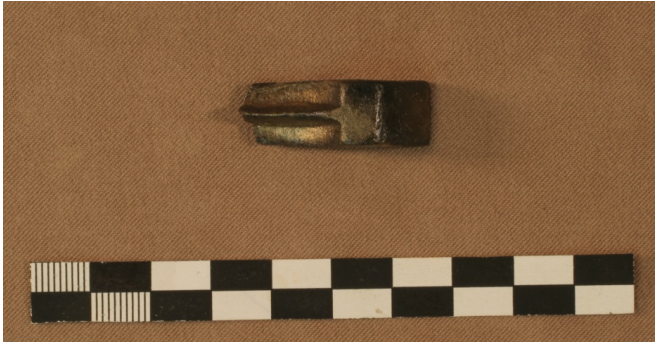
Fig. 4.84.

120-271 Unidentified

L:1.20 in. (3.04 cm), W:0.44 in. (1.11 cm)

Unidentified cupreous object.

Figure 4.84. 120-271.

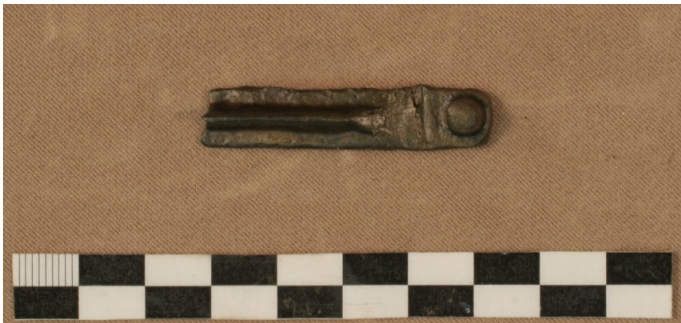
Fig. 4.85.

128-064 Unidentified

L: 0.68 in. (1.73 cm), W: 0.15 in. (0.37 cm), Th.: 0.11 in. (0.28 cm)

Unidentified cupreous object.

Figure 4.85. Artifact 128-064.

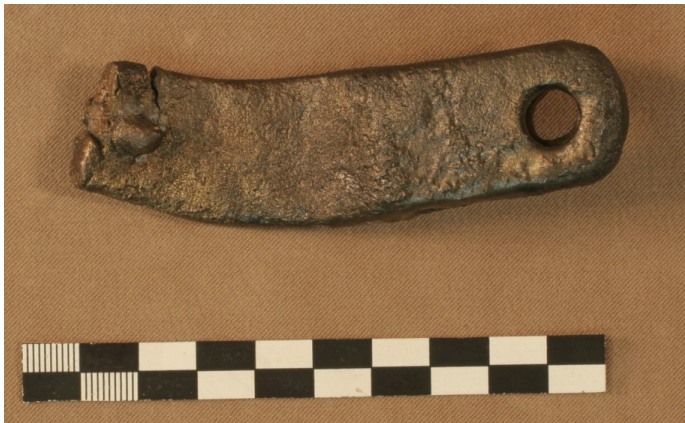
Fig. 4.86.

131-078 Unidentified strap

L:3.69 in. (9.38 cm), L of fork ends:1.51 in. (3.83 cm), Max W:1.03 in. (2.62 cm), Max Th. of strap before fork:0.23 in. (0.59 cm)

Cupreous unidentified forked strap. One hole at the end of the strap. Originally, the two sides would have formed a “U” shape. Small copper shaft through opposite end. Fork sides separated 0.37 in. (0.93 cm), holes at end of forked ends diameter of 0.39 in. (1.0 cm).

Figure 4.86. Artifact 131-078.

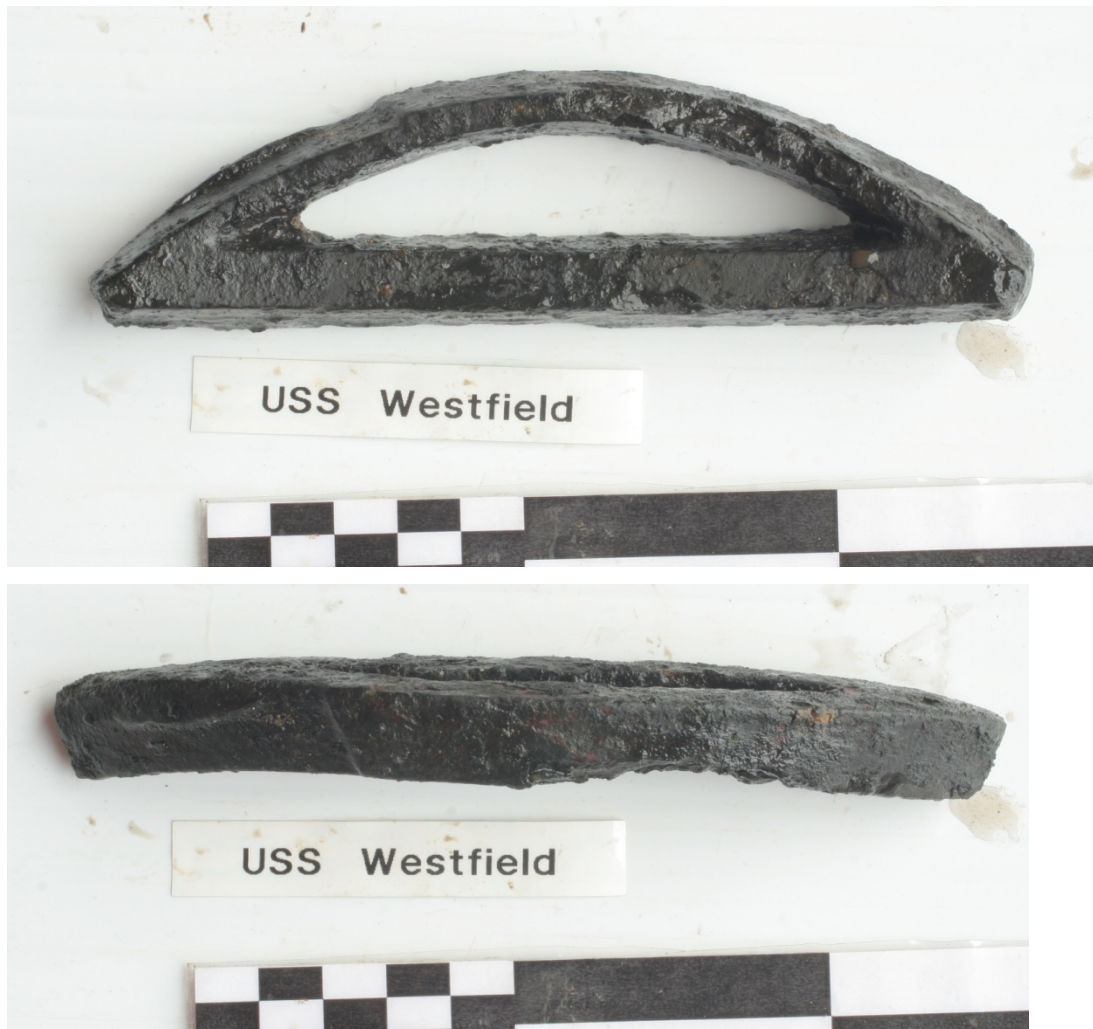
Fig. 4.87.

40 Unidentified Object

L:5.75 in. (14.6 cm), Max. W.:1.61 in. (4.1 cm), Th.:0.59 in. (1.49 cm)

Unidentified cast iron object. Concave and half-circle in shape with a small, possibly purposeful notch on the top left.

Figure 4.87. Artifact 40.
