Monitoring-Based Commissioning *with Advanced EMIS Analysis*

Boban Ratkovich, MEng, PEng, CEM, BESA, LEED AP
President

CES
GROUP

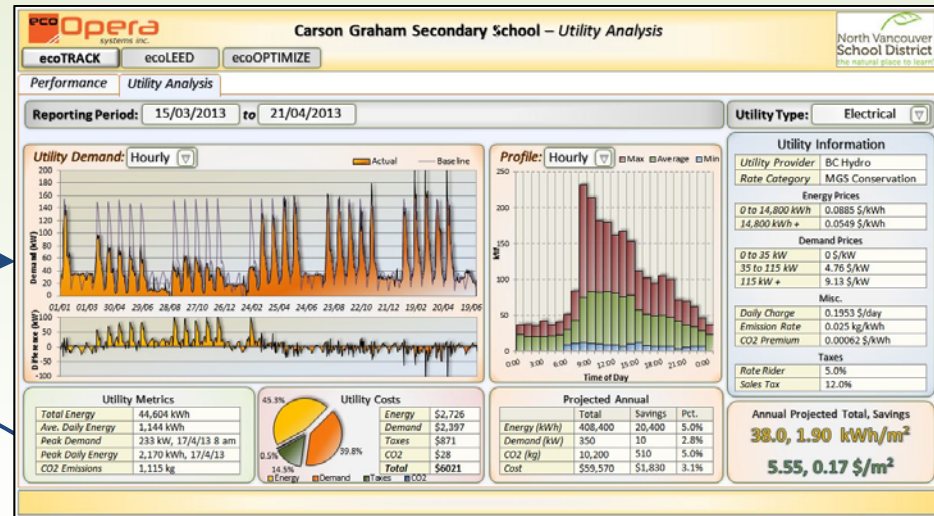
EMIS Engine

EMIS Process

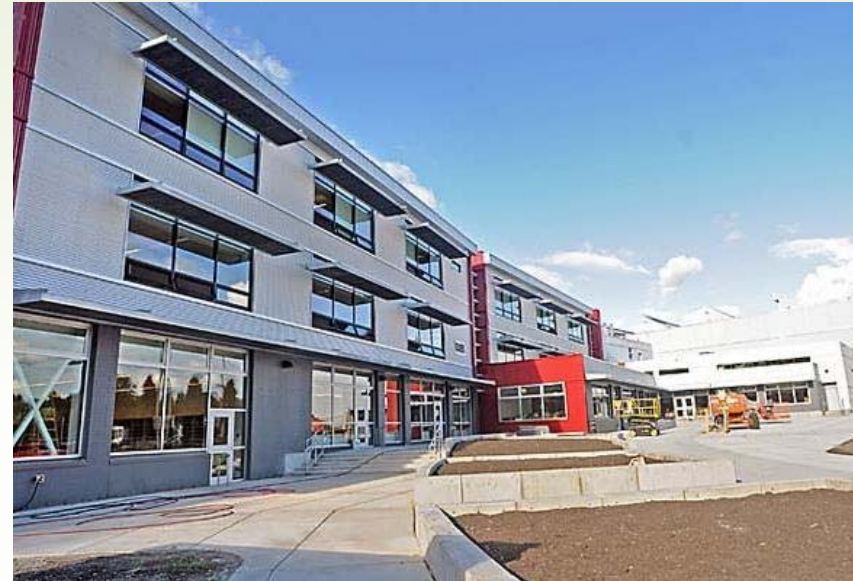
Carson Graham Secondary School

Performance Features

- 9,300 m², targeting LEED Gold
- High performance envelope
- BAS-integrated lighting with occ-sensor and photocell control
- VAV Energy-Recovery-Ventilators with VFDs and occ-sensor enabling
- Reversible ASHPs with condensing boiler backup and VFD pumping

Deficiencies Identified

- Systems over-enabling
- Deficient air system pressure reset
- ASHPs greatly under-utilized
- No HW temperature reset
- VFD pumps at 100% continuously
- Pump false-starting
- MUA continuous operation

Baseline Projected EUI*	102
NRCan Database EUI	180
Proposed Energy Model EUI	82
Reference Energy Model EUI	121
Proposed EUI After MBCx	88
Baseline Annual Utility Cost	\$83,000
Life-Cycle Savings NPV (30 yr)	\$334,000

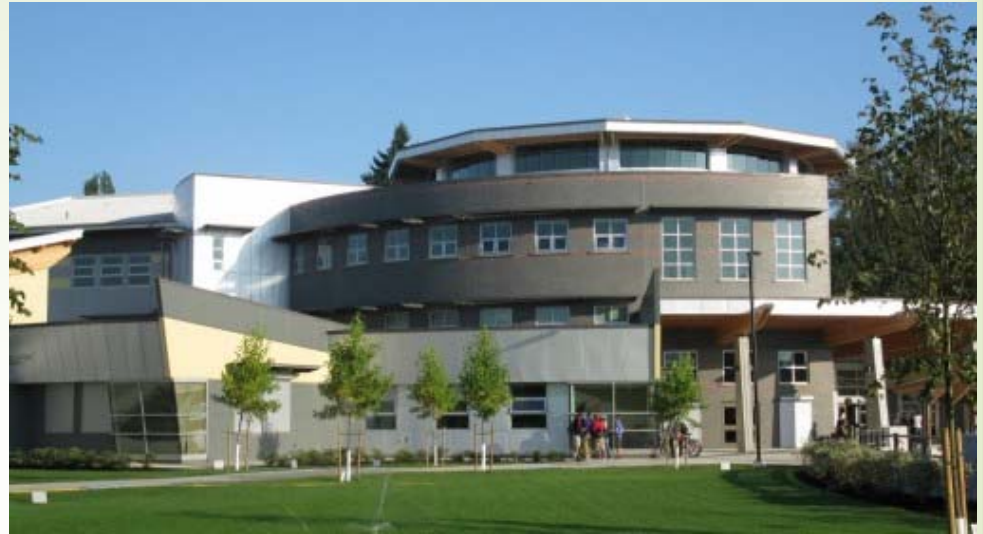
Abbotsford Senior Secondary

Performance Features

- 10,700 m², targeting LEED Gold
- Extensive lighting controls via occ-sensors and photocells
- VAV Energy-Recovery-Ventilators with VFDs and occ-sensor enabling
- WSHPs served by an reservoir with condensing boiler backup
- Distributed water-loop heat-pumps

Deficiencies Identified

- Systems over-enabling
- Deficient hydronic pressure reset
- ASHPs greatly under-utilized
- Deficient SWT reset
- Pumps enabled continuously
- Continuous exhaust fan operation

Baseline Projected EUI*	89
NRCan Database EUI	180
Proposed Model EUI	85
Reference Model EUI	128
Proposed EUI After MBCx	81
Baseline Annual Utility Cost	\$79,000
Life-Cycle Savings (30 year)	\$222,000
