# AN ARCHAEOLOGICAL SURVEY FOR THE LAS PALMAS WASTEWATER COLLECTION SYSTEM IMPROVEMENT PROJECT IN WEST-CENTRAL ZAPATA COUNTY, TEXAS

Antiquities Permit 5581

Brazos Valley Research Associates  
Contract Report Number 235

BVRA Project Number 10-04

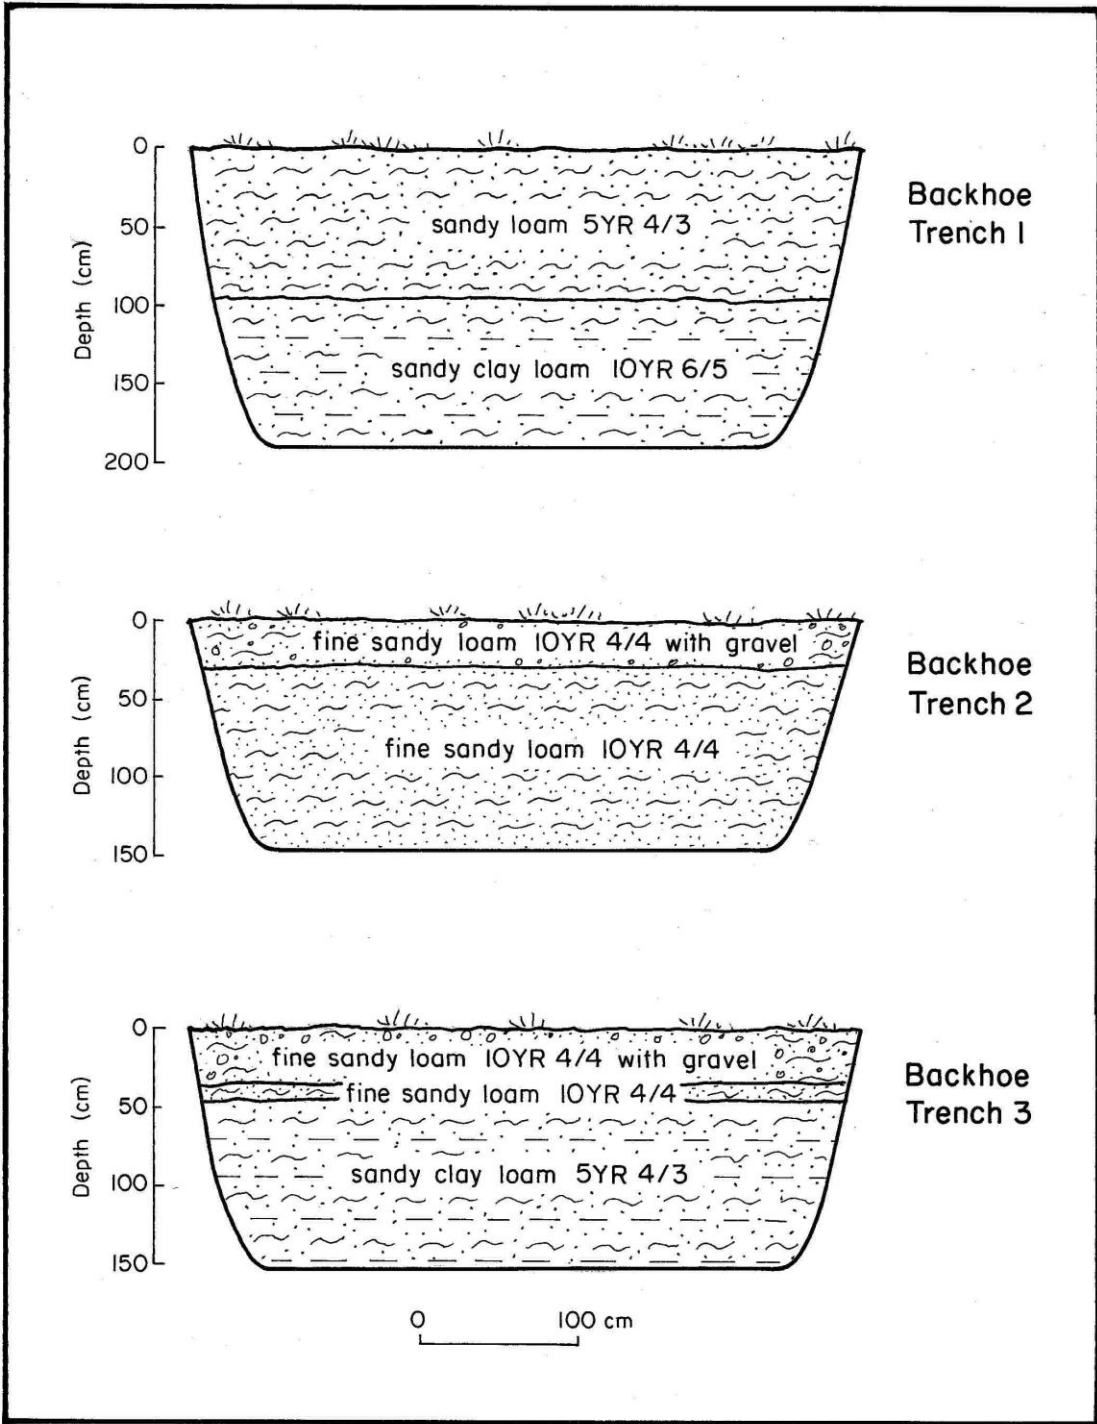
Backhoe Trench Profiles – Trenches 1-3

Area 1 is the footprint of the proposed lift station on private property on the northwest side of Las Palmas Road (Figure 2). After a visual inspection of the surface revealed no evidence of a prehistoric or historic site, Backhoe Trench 1 was excavated. This trench was 14 feet long, 36 inches wide, and 75 inches deep (see Appendix I for profiles of the backhoe trenches). It was dug through sandy loam (5YR 4/3) to a depth of 38 inches and through sandy clay loam (10YR 6/5) from 38 inches to 75 inches. This trench was terminated when the client informed the survey crew that they had reached or surpassed the APE. No cultural materials or features were observed.

Backhoe Trench 3 was dug on the southeast bank of the arroyo just inside the fence within the highway right-of-way. It was 14 feet long, 36 inches wide, and 60 inches deep. The top 18 inches consisted of fine sandy loam (10YR 4/4) with gravels in the first 14 inches and no gravels in the next four inches. The underlying soil was sandy clay loam (5YR 4/3). This trench was terminated when the client informed the survey crew that they had reached or surpassed the APE. No cultural materials or features were observed within either trench. Three percussion flakes were found in the first 12 inches, but their context is not known. They were not collected.
