ATTOYAC BAYOU SURFACE WATER QUALITY MONITORING REPORT

Attoyac Bayou Surface Water Quality Monitoring Report

November 8, 2012

Texas Water Resources Institute Technical Report-457

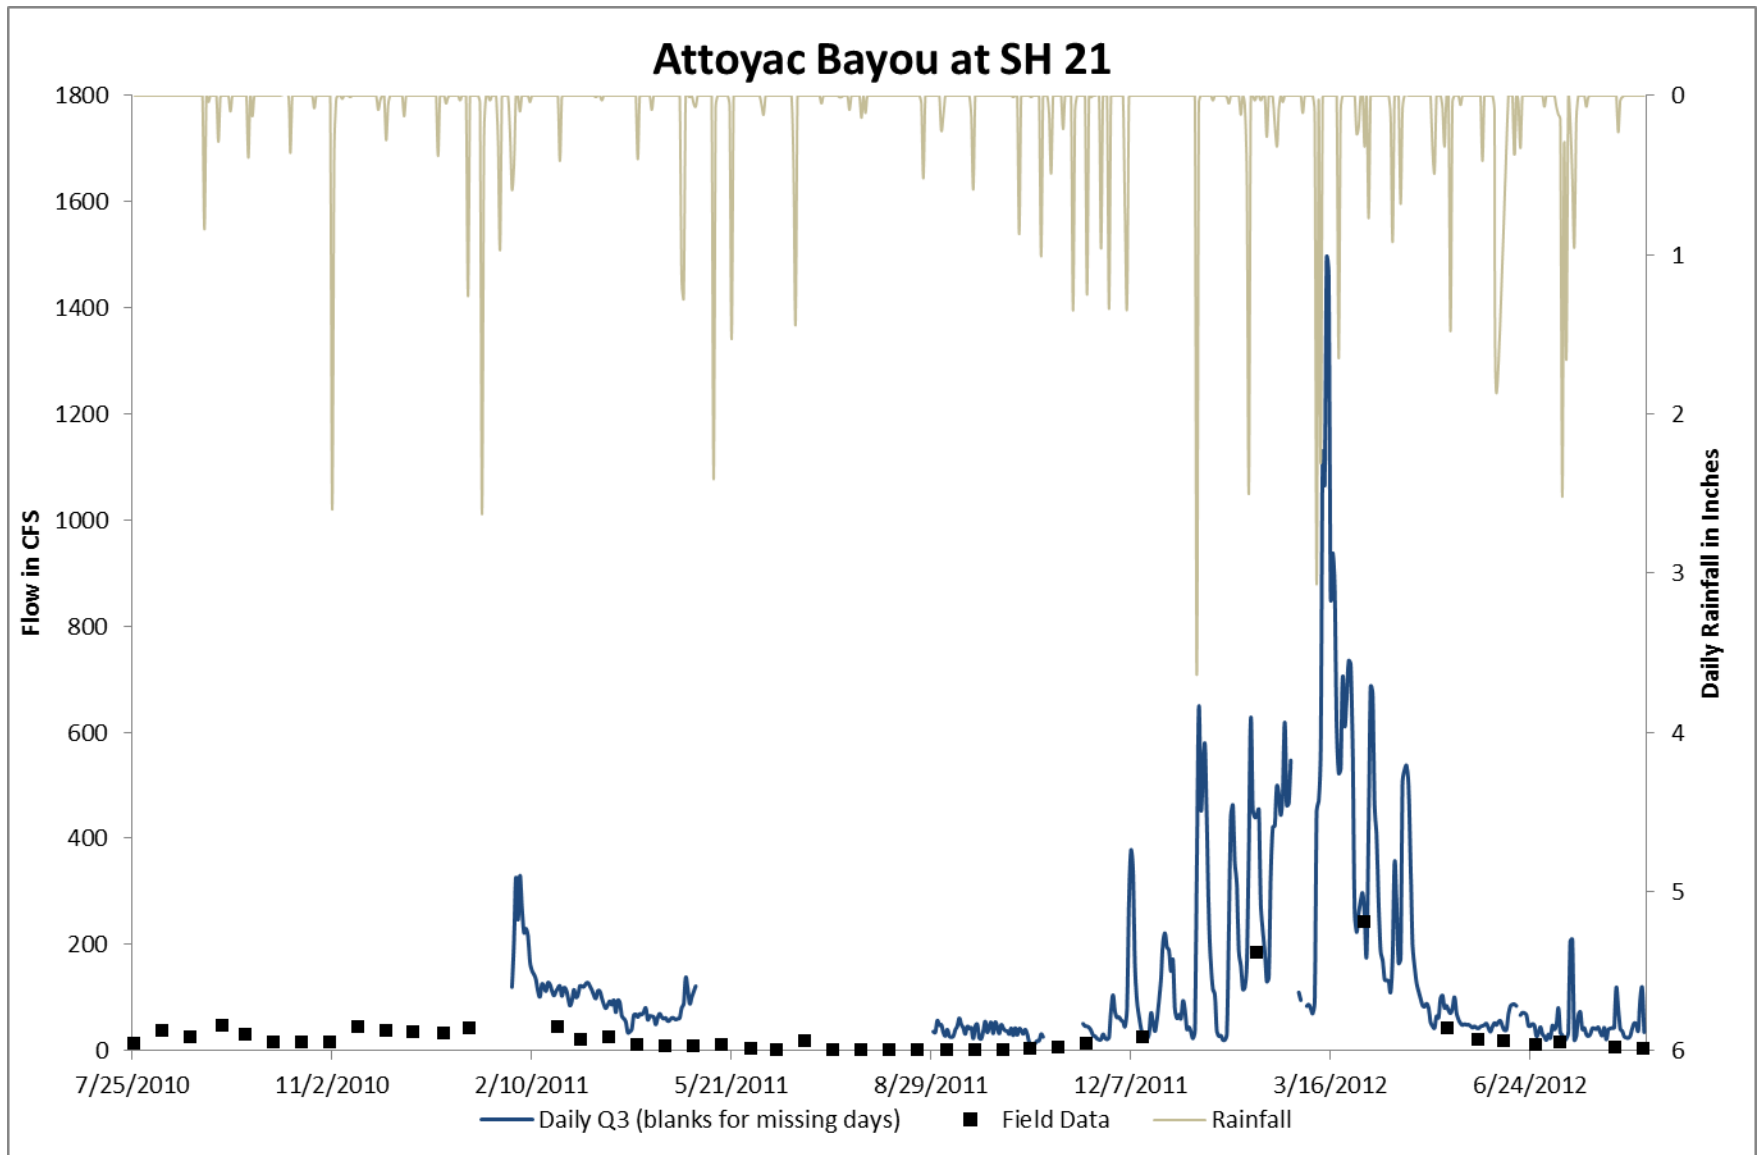
Figure 2. Automated stream flow and precipitation data recorded for the Attoyac Bayou at SH 21

To approximate daily stream flow rates using these data, several methods were evaluated. Initially, a 75th percentile rolling average was calculated but it did not mitigate the intra-day variations observed. Selecting only maximum values was also attempted; however, this method clearly biased flows higher. After calculating daily minimums, maximums, averages and quartiles, the 3rd quartile appeared to provide the most reasonable estimate of daily flow rates at the automated sites. This variability in calculated flow rate stems largely from the recorded velocity since the depth varied only slightly and the stream cross-section used in the calculations remained static. The processed flow records for each site are presented in Figures 2 and 3.

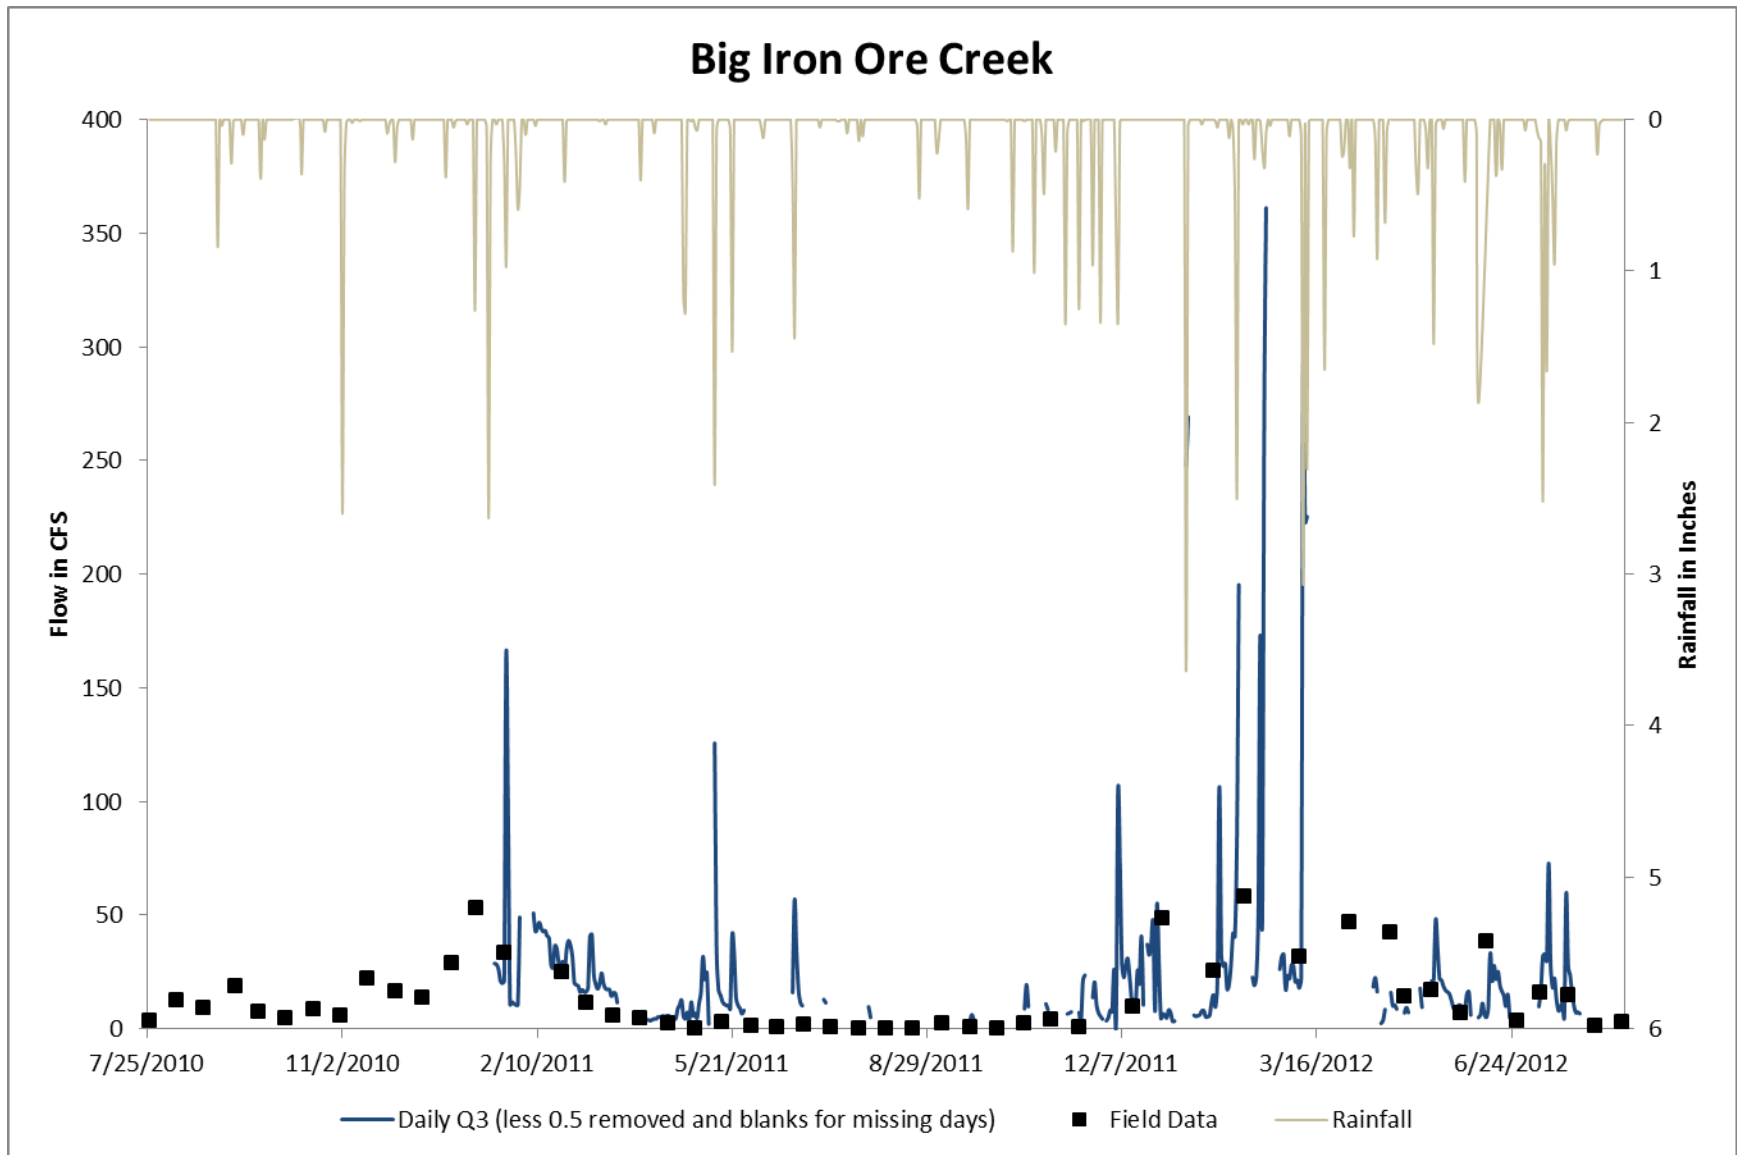
Figure 3. Automated stream flow and precipitation data recorded on Big Iron Ore Creek at FM 354

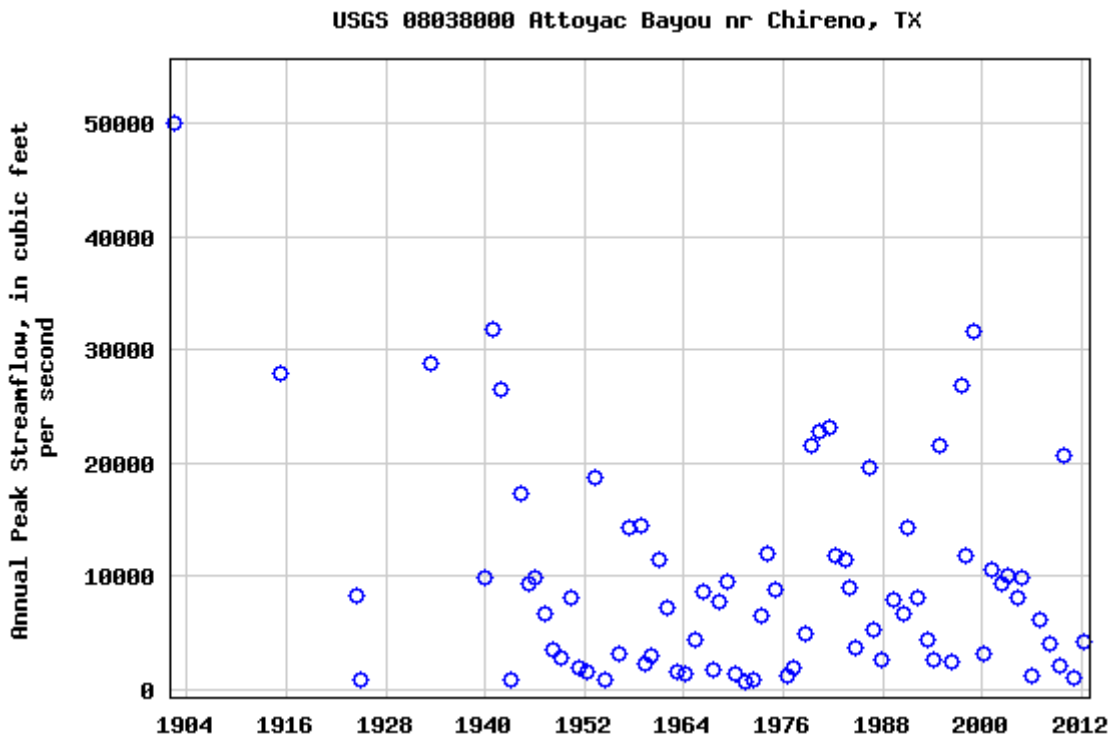
Figure 4. USGS peak discharge recorded on the Attoyac Bayou at SH 21 (Station 10636)

was recorded in 1902. In the last decade, maximum annual peak discharge rates have been around 10,000 cfs on several occasions and above 20,000 cfs in one instance (Figure 4). This illustrates the variable nature of flows in the watershed and reiterates the fact that instantaneous flow measurements only represent a very small amount of actual stream flows.

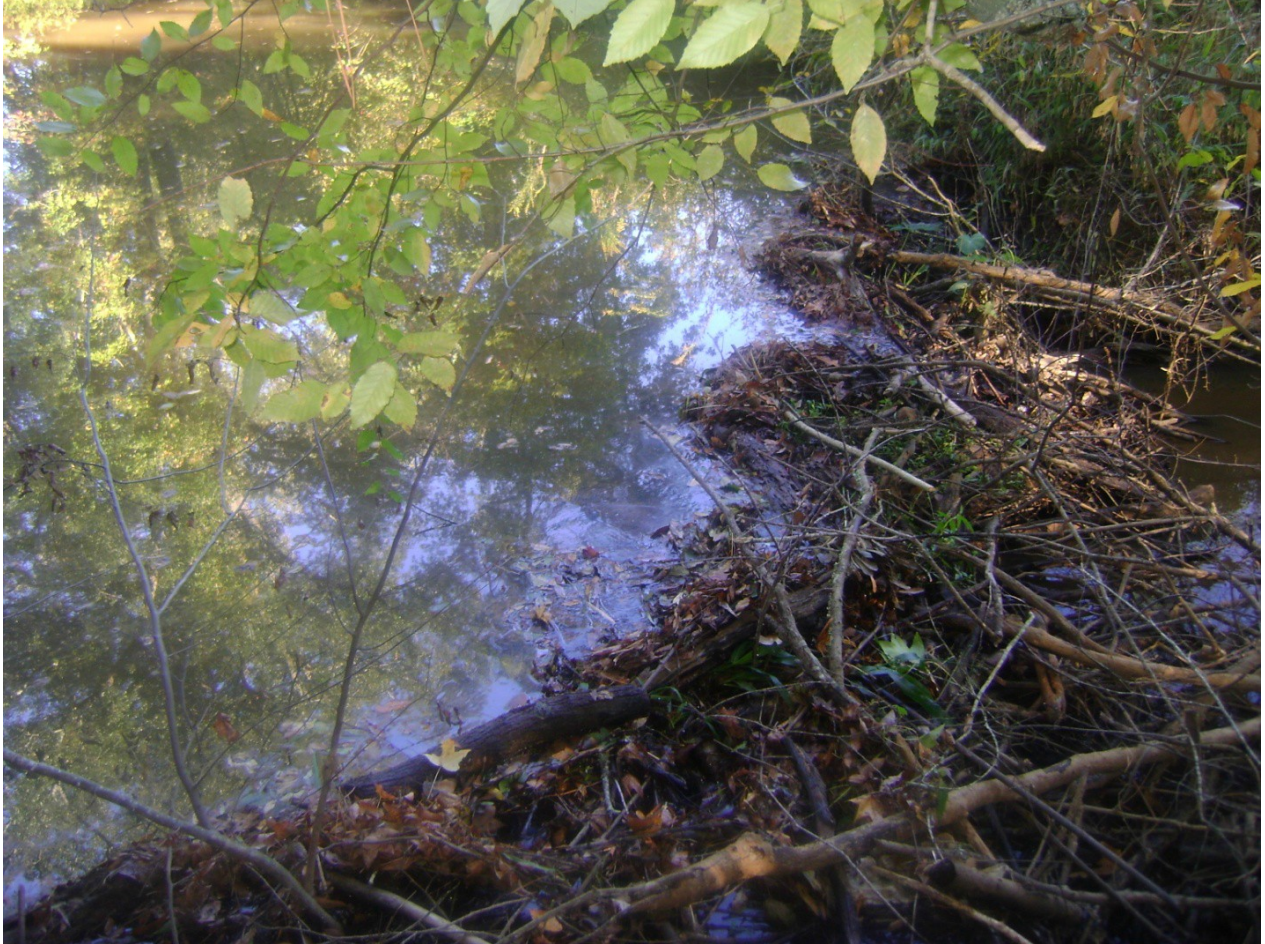
Waffelow Creek at FM 95 (16083), 11/8/2010, beaver dam impeding flow.

Throughout the course of this project, 3 sites experienced natural problems that greatly hindered flow. The monitoring station on Waffelow Creek (16083) was blocked repeatedly by multiple beaver dams upstream and downstream of the site. Attoyac Bayou at US 59 (Station 16076) was also impacted by beavers. The beaver dam at this site became so large that cattle from the surrounding area were able to walk across it. This dam created a large fishing area that people from the local area enjoy visiting. The most upstream sampling site on the Attoyac Bayou at US 84 (Station 20842) also experienced extremely low or no flow during much of the project. Also, the way in which the bridge at this site was constructed formed a small check dam in the channel that formed a pool upstream of the roadway. During monitoring, drought conditions resulted in insufficient water to flow over this artificial barrier.

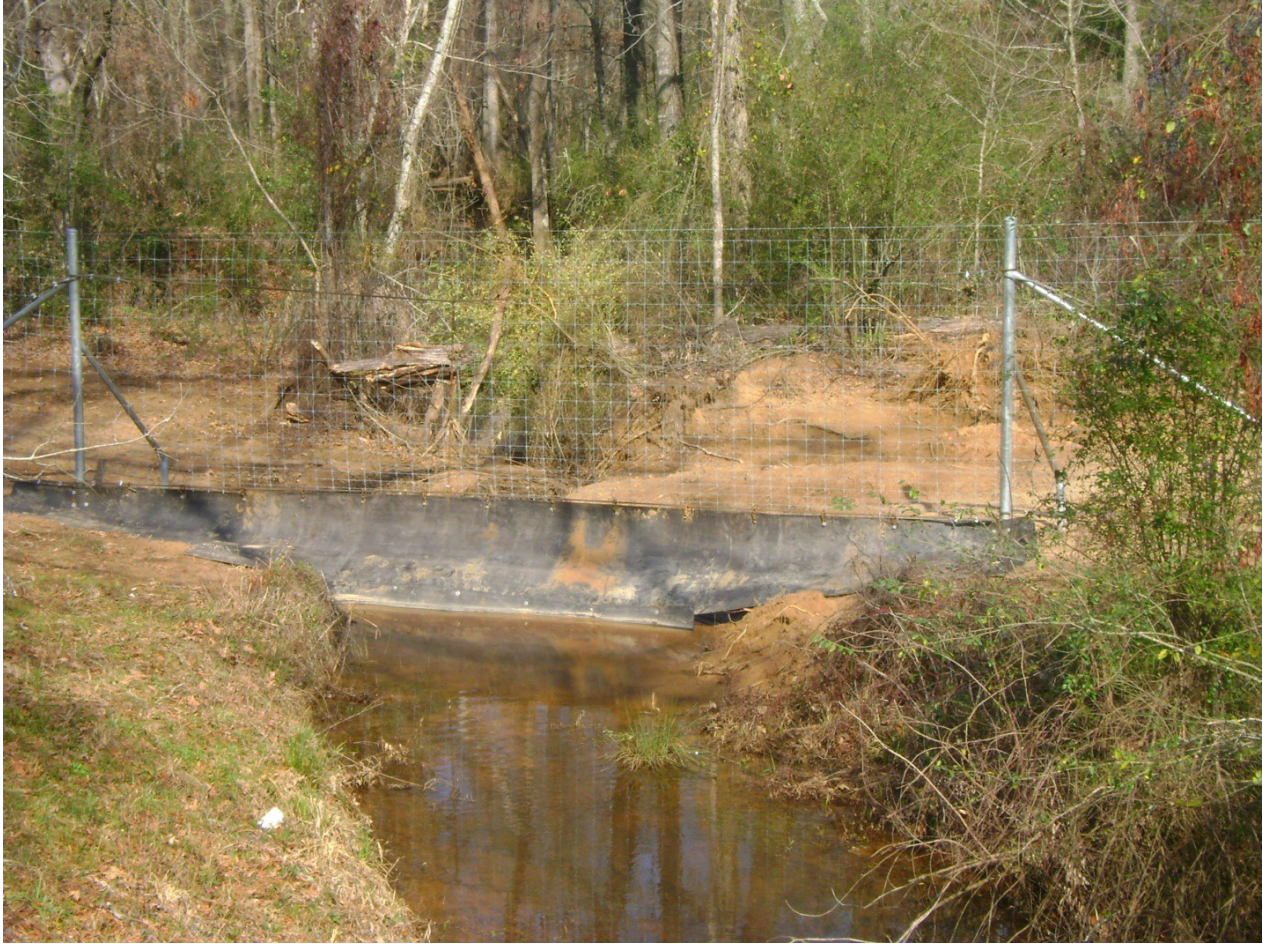
Attoyac Bayou at US 84 (20842), 2/8/2012 addition of silt screen and game fence.

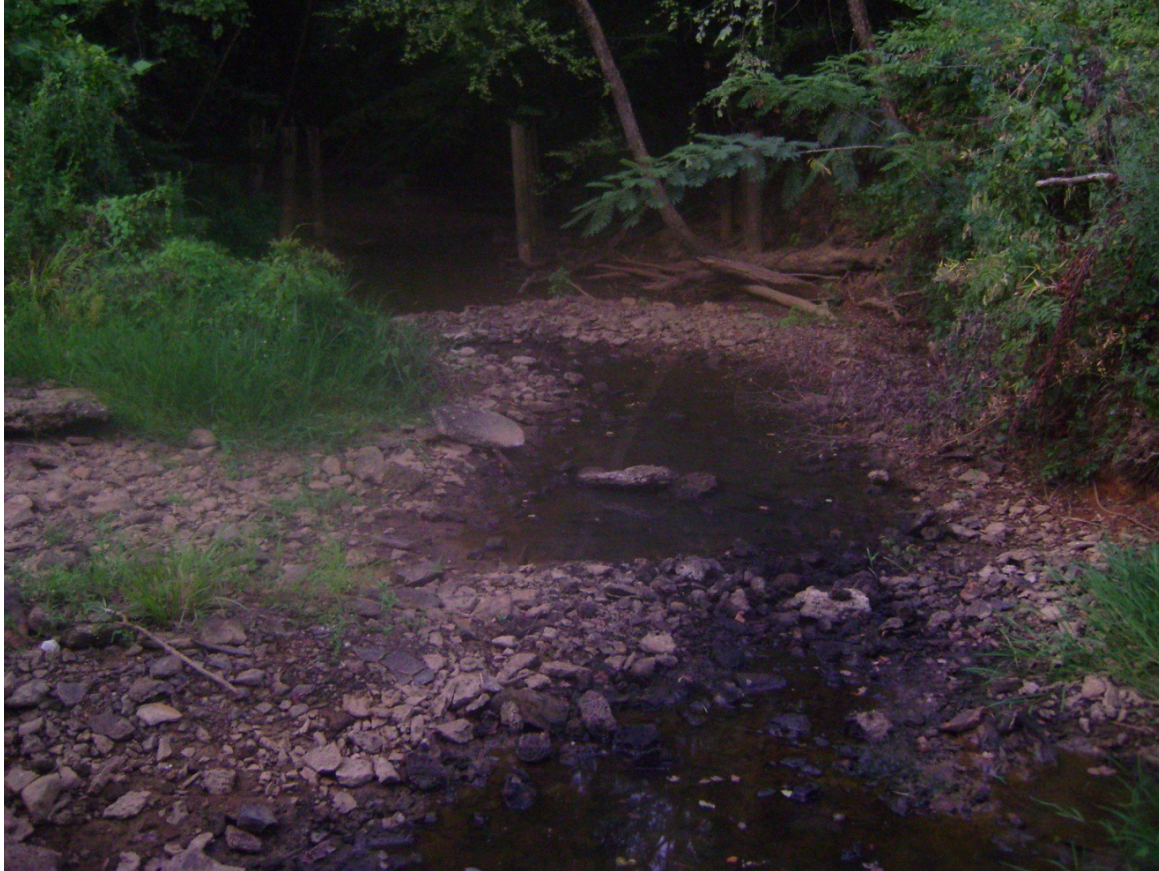
Big Iron Ore Creek (20844) 8/22/2011, during the 2011 drought. The creek had riffles and pools.

These conditions resulted in streams and rivers ceasing to flow, leaving the base flows extremely low to intermittent. The upper portion of the Attoyac Bayou dried up as did the tributaries while the lower part was reduced to about ½ a foot deep. Area lake levels also dropped to near historic low levels. For example, Sam Rayburn Reservoir, which receives water from the Attoyac Bayou, was more than 13.6 below normal pool.

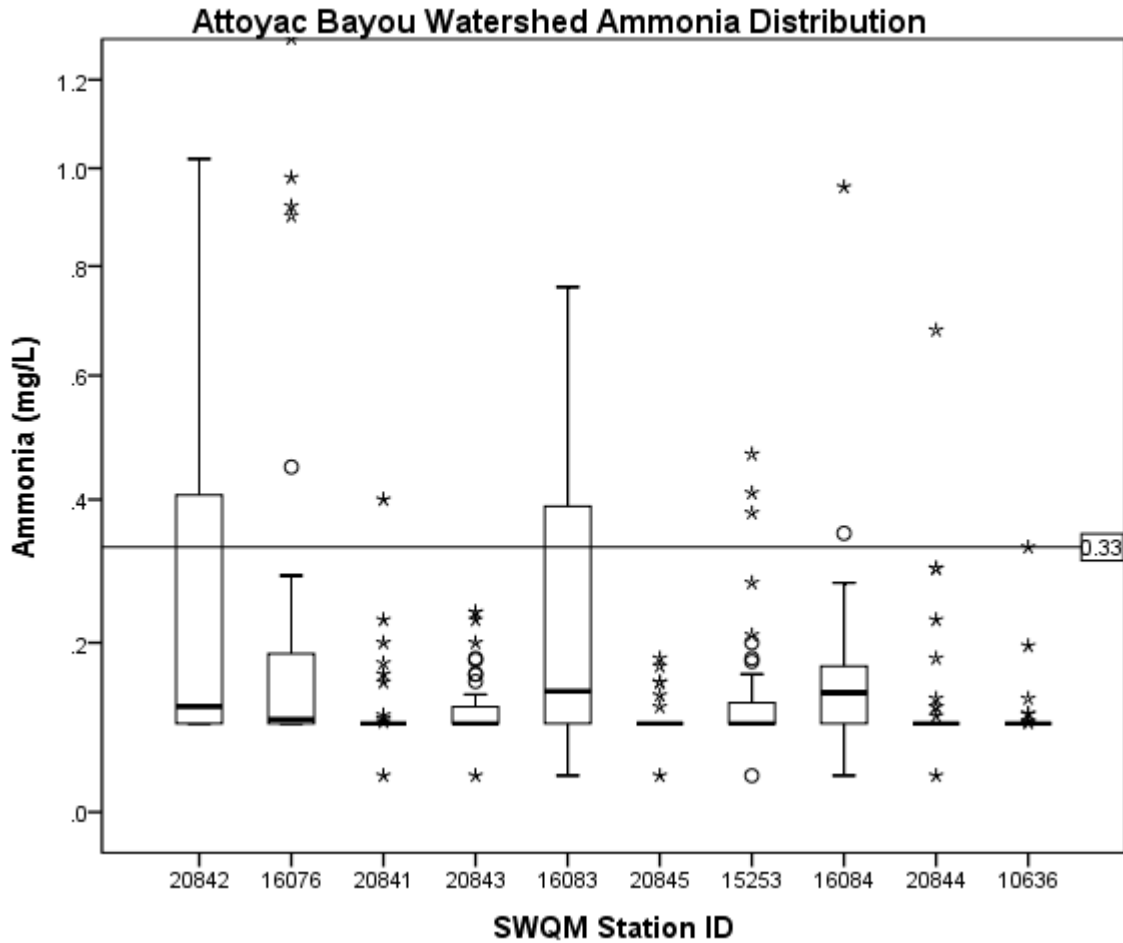
Figure 5. Ammonia-N data summary for the Attoyac Bayou and its tributaries. (Data are presented in an upstream to downstream manner)

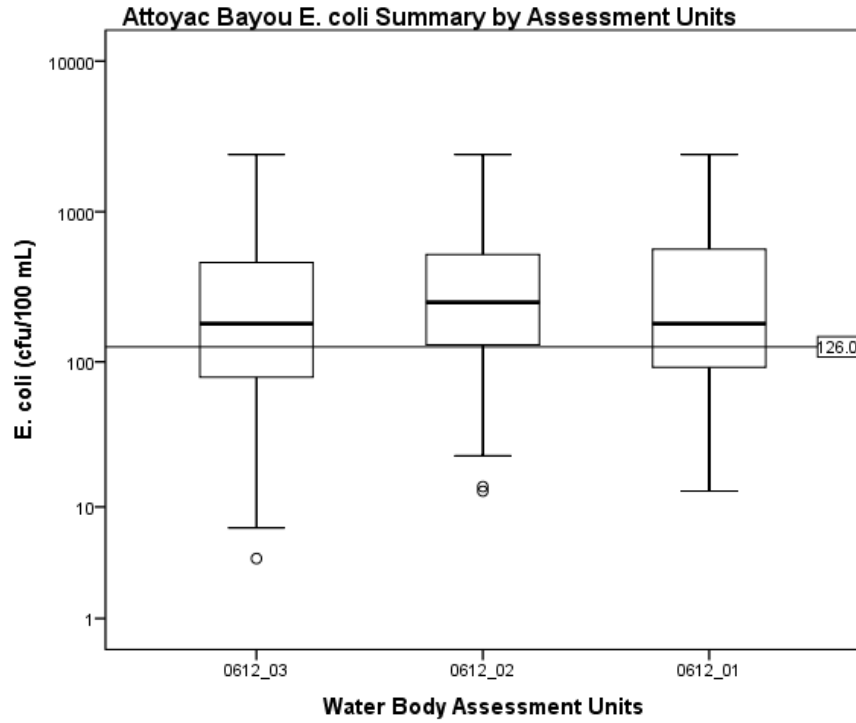
Figure 6. *E. coli* data summary for the Attoyac Bayou by assessment units: upstream to downstream

While there are variations in the dataset as seen in Figures 6 – 8, overall geometric mean values were not significantly different among monitoring sites. A comparative analysis of the geometric means using the non-parametric Kruskal-Wallis test indicated that no significant difference among sites exists ($p = 0.437$; $\alpha = 0.05$).

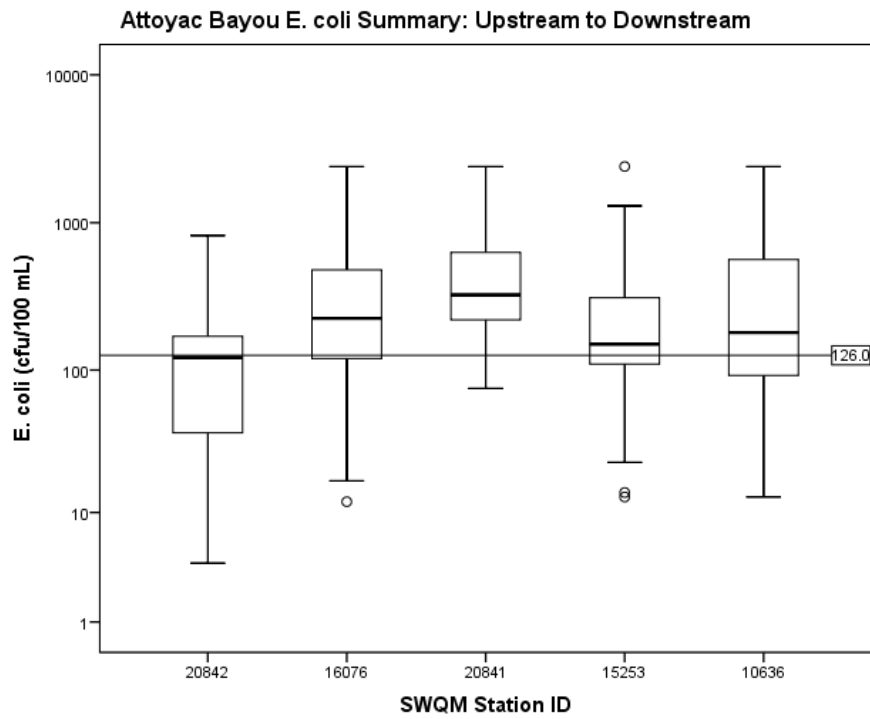
Figure 7. *E. coli* data summary for the Attoyac Bayou by station: upstream to downstream

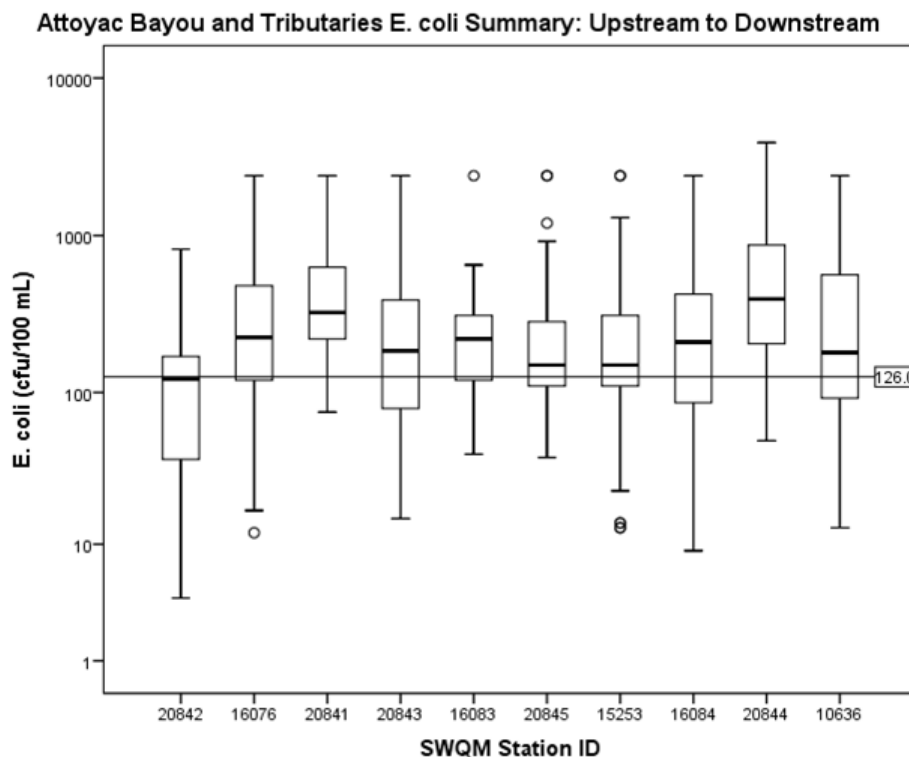
Figure 8. *E. coli* data summary for the Attoyac Bayou and its tributaries by station: upstream to downstream (tributary sites are situated to mimic the relative location that they empty into the Attoyac Bayou)

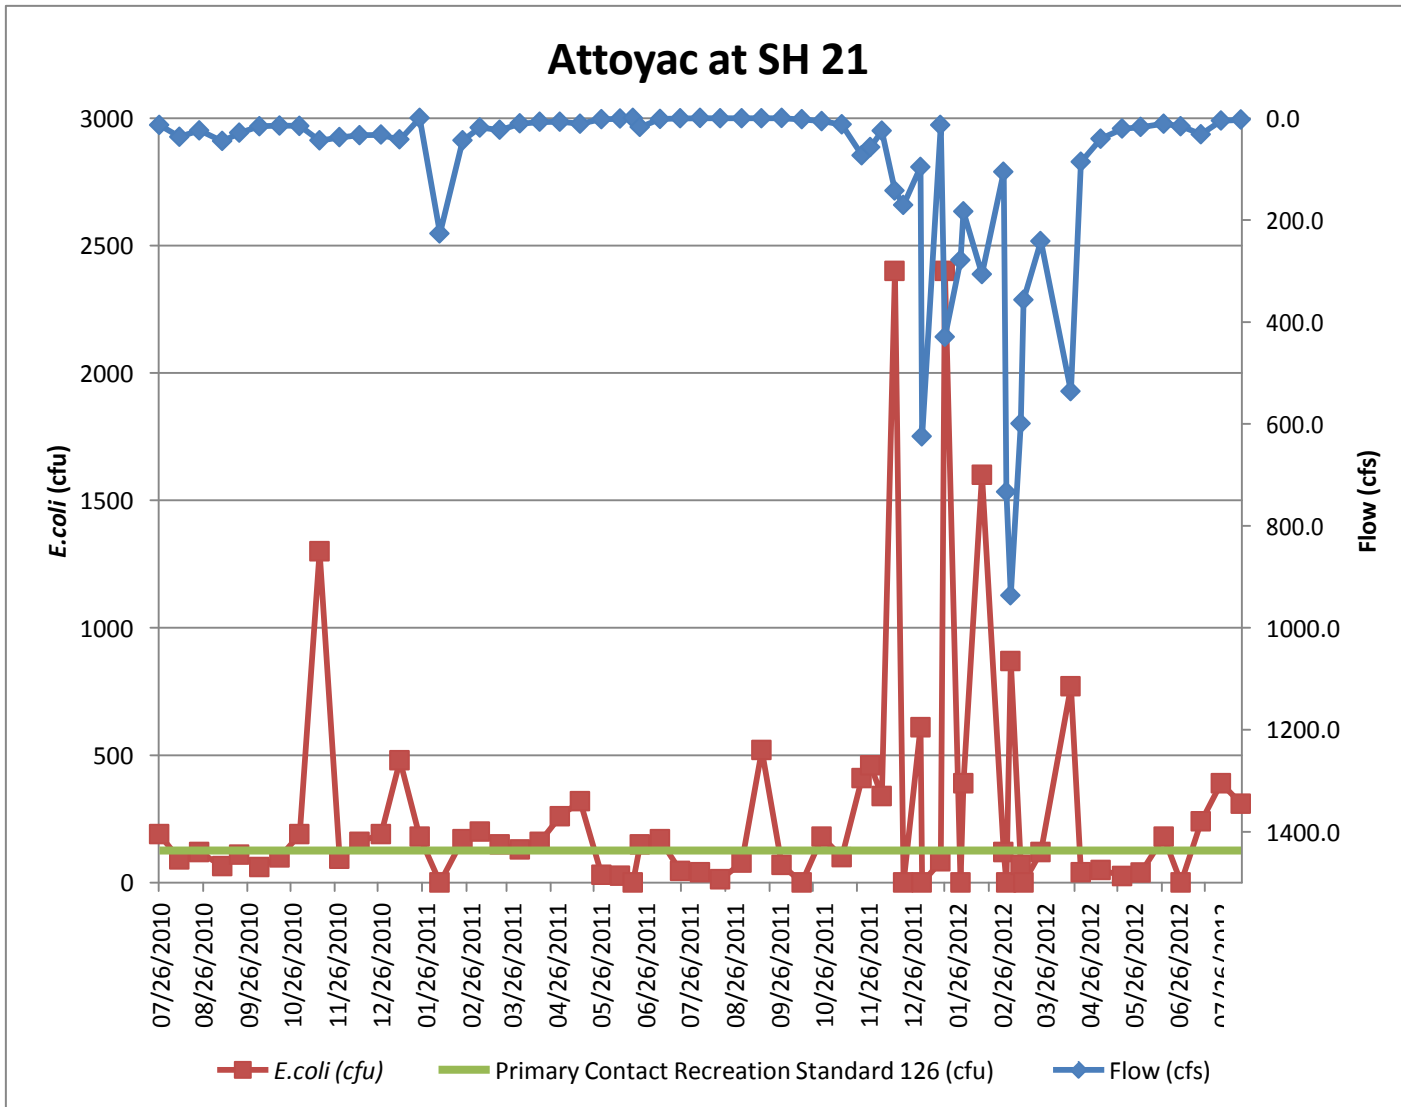
Figure C-1. Attoyac Bayou at State Highway 21 *E. coli* (cfu) vs. flow (cfs), from 7/26/2010 through 8/20/2012, compared to the standard for primary contact recreation 126 cfu. ** *E. coli* values reported as >2400 were entered as 2400.

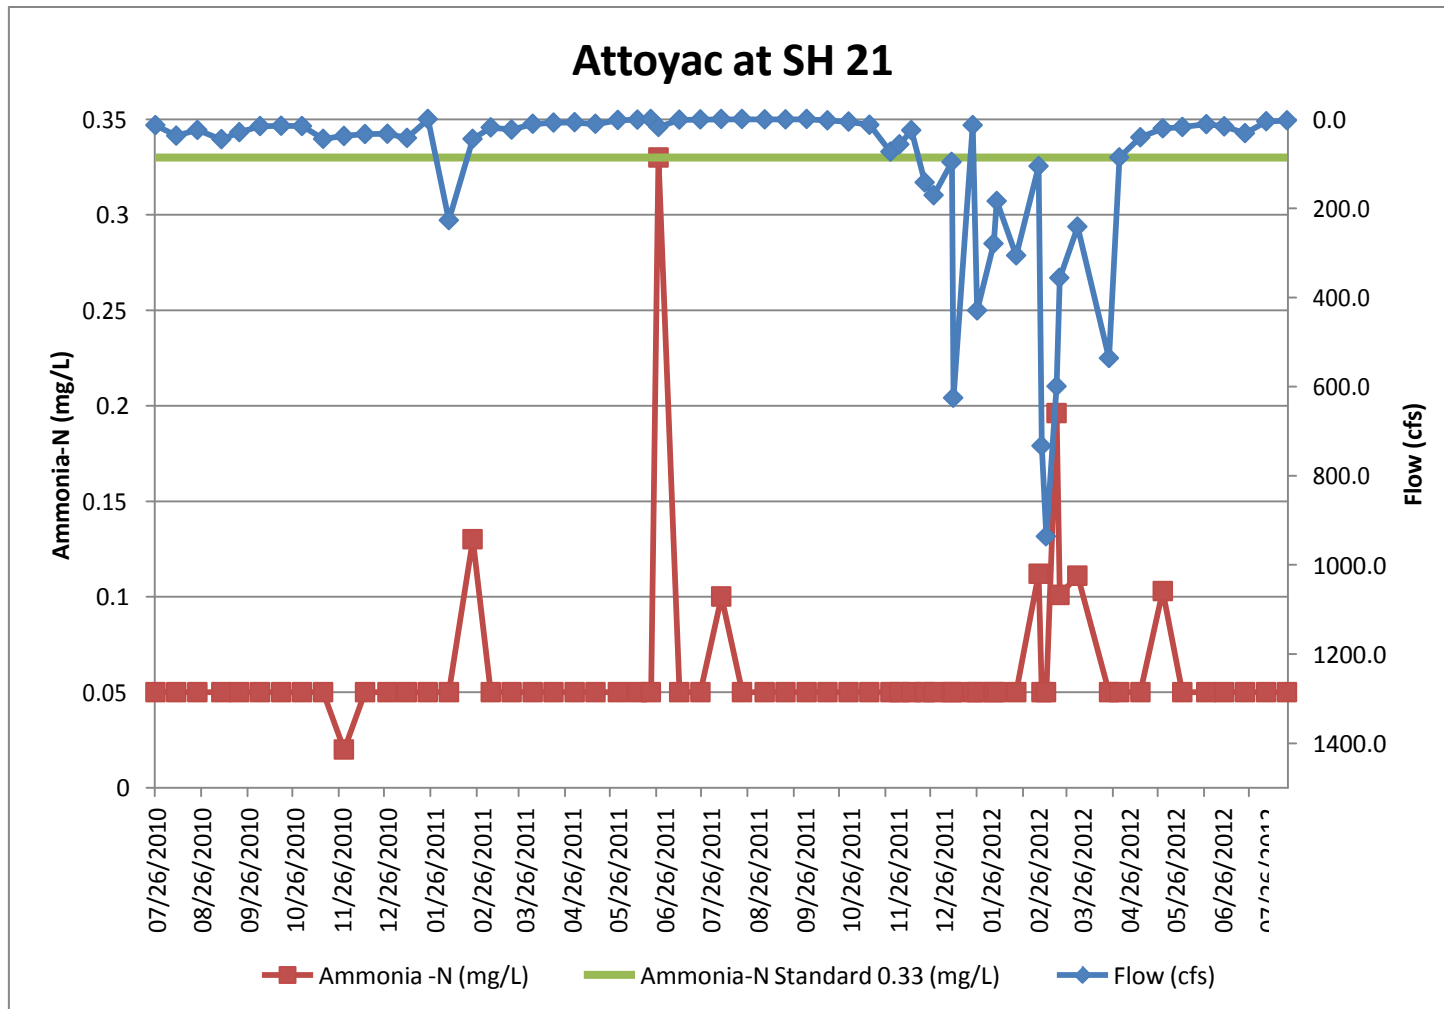
Figure C-2. Attoyac at State Highway 21 ammonia-n (mg/L) vs. flow (cfs) from 7/26/2012 through 8/20/2012, compared to the ammonia screening level of 0.33 mg/L. * Ammonia levels reported at <0.1 were entered as 0.05 mg/L.**

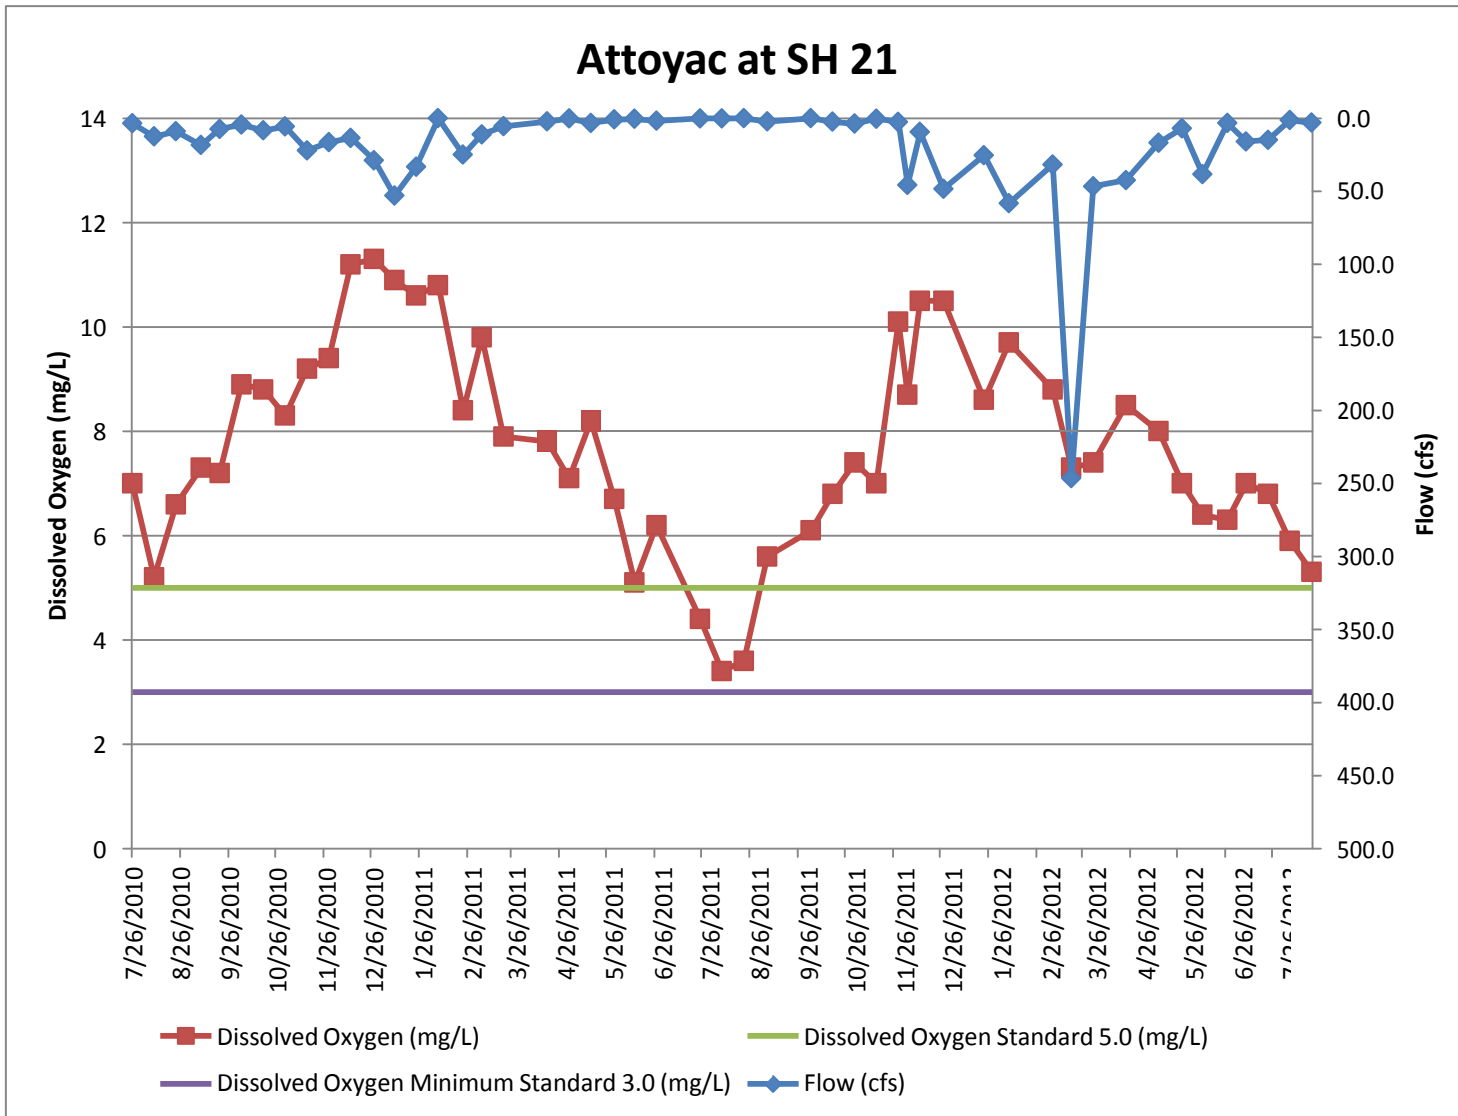
Figure C-3. Attoyac Bayou at State Highway 21 dissolved oxygen (mg/L) vs. flow (cfs) from 7/26/2010 through 8/20/2012, compared to the grab sample screening level of 5.0 mg/L.

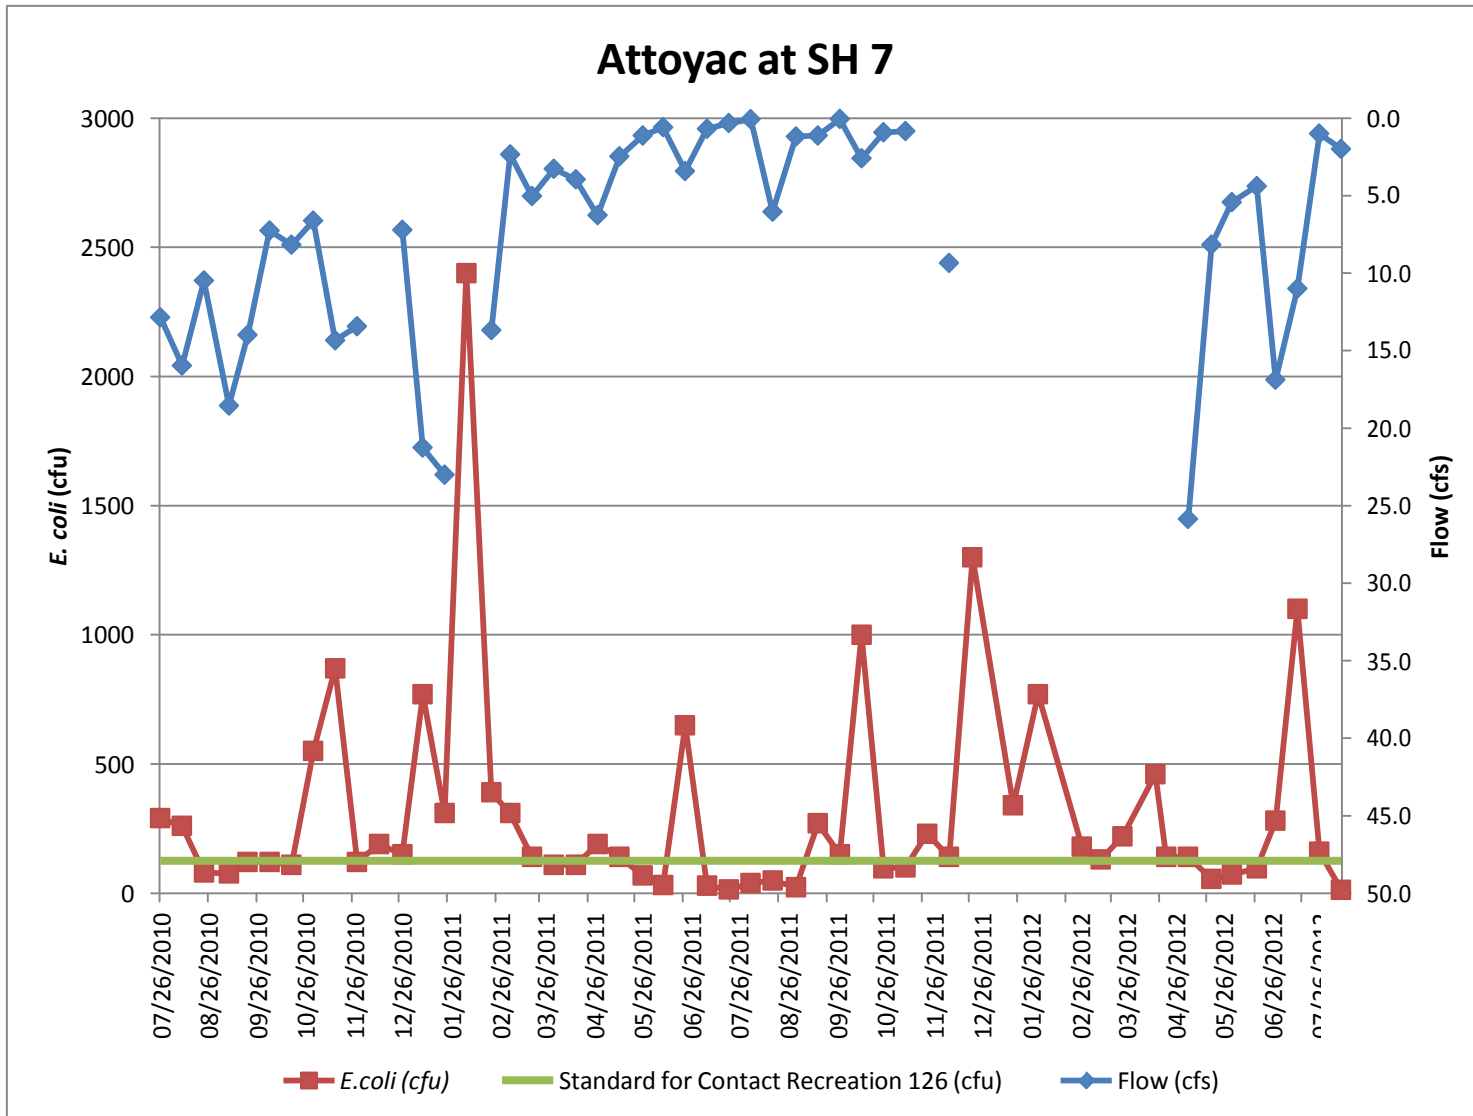
Figure C-4. Attoyac Bayou at State Highway 7 *E. coli* (cfu) vs. flow (cfs) from 7/26/2010 through 8/20/2012, compared to the standard of 126 cfu. * *E. coli* values reported as >2400 were entered as 2400.**

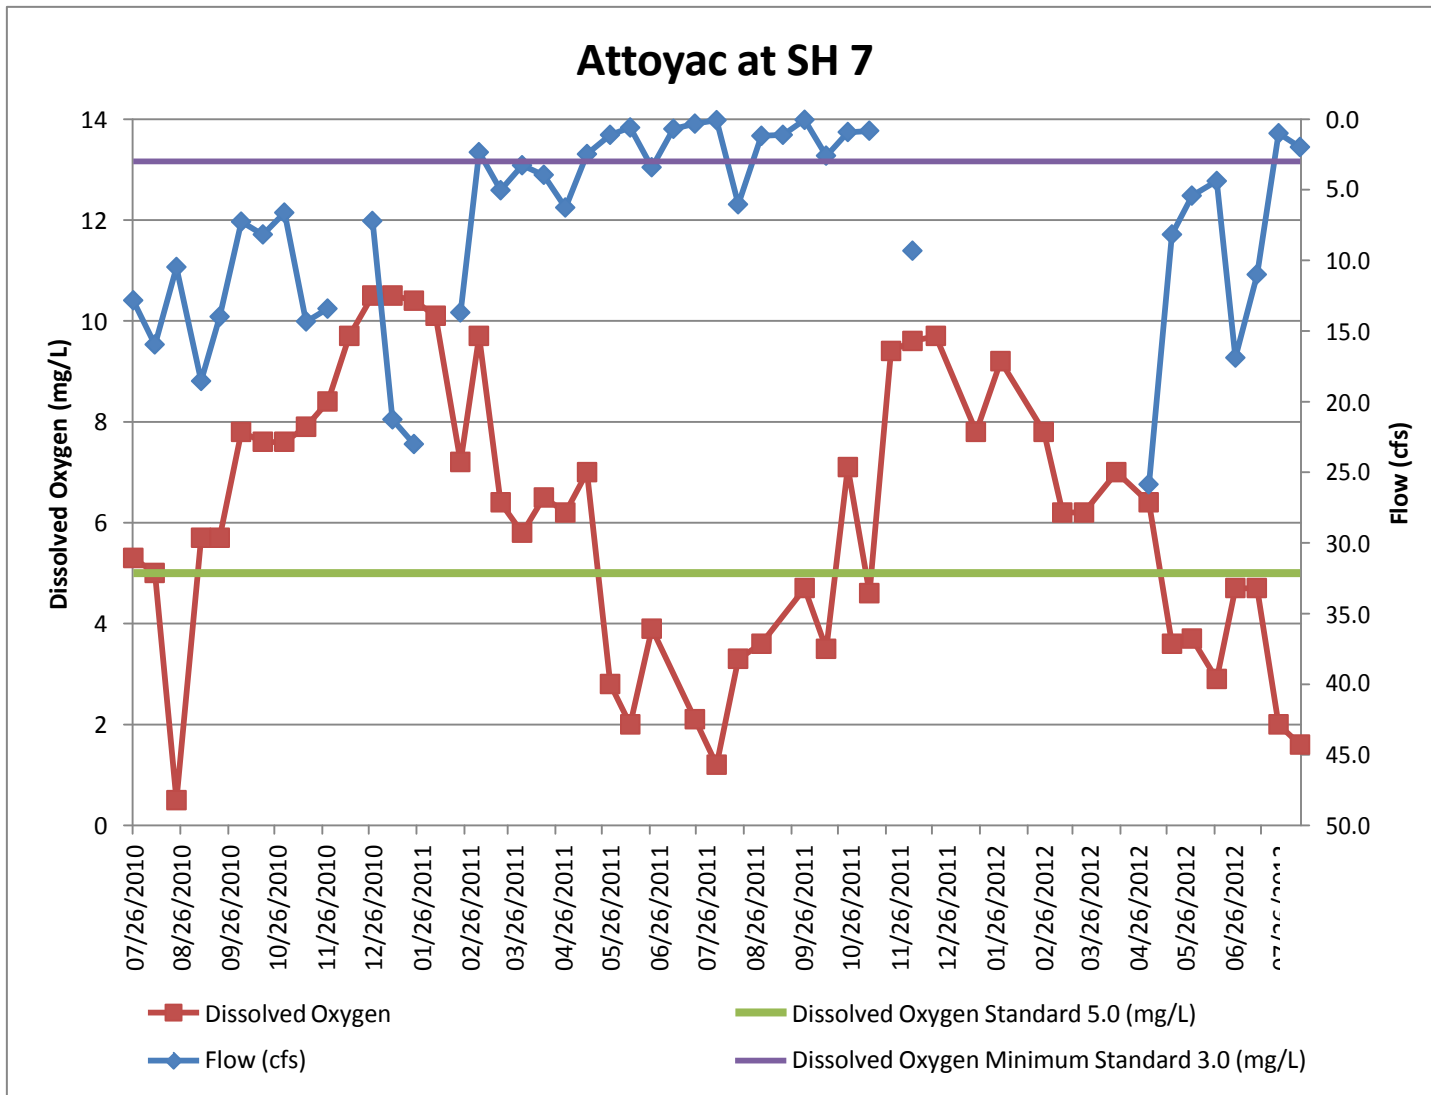
Figure C-6. Attoyac Bayou at State Highway 7 Dissolved Oxygen (mg/L) vs. flow (cfs), from 7/26/2010 through 8/20/2012, compared to the standard of 5.0 mg/L.

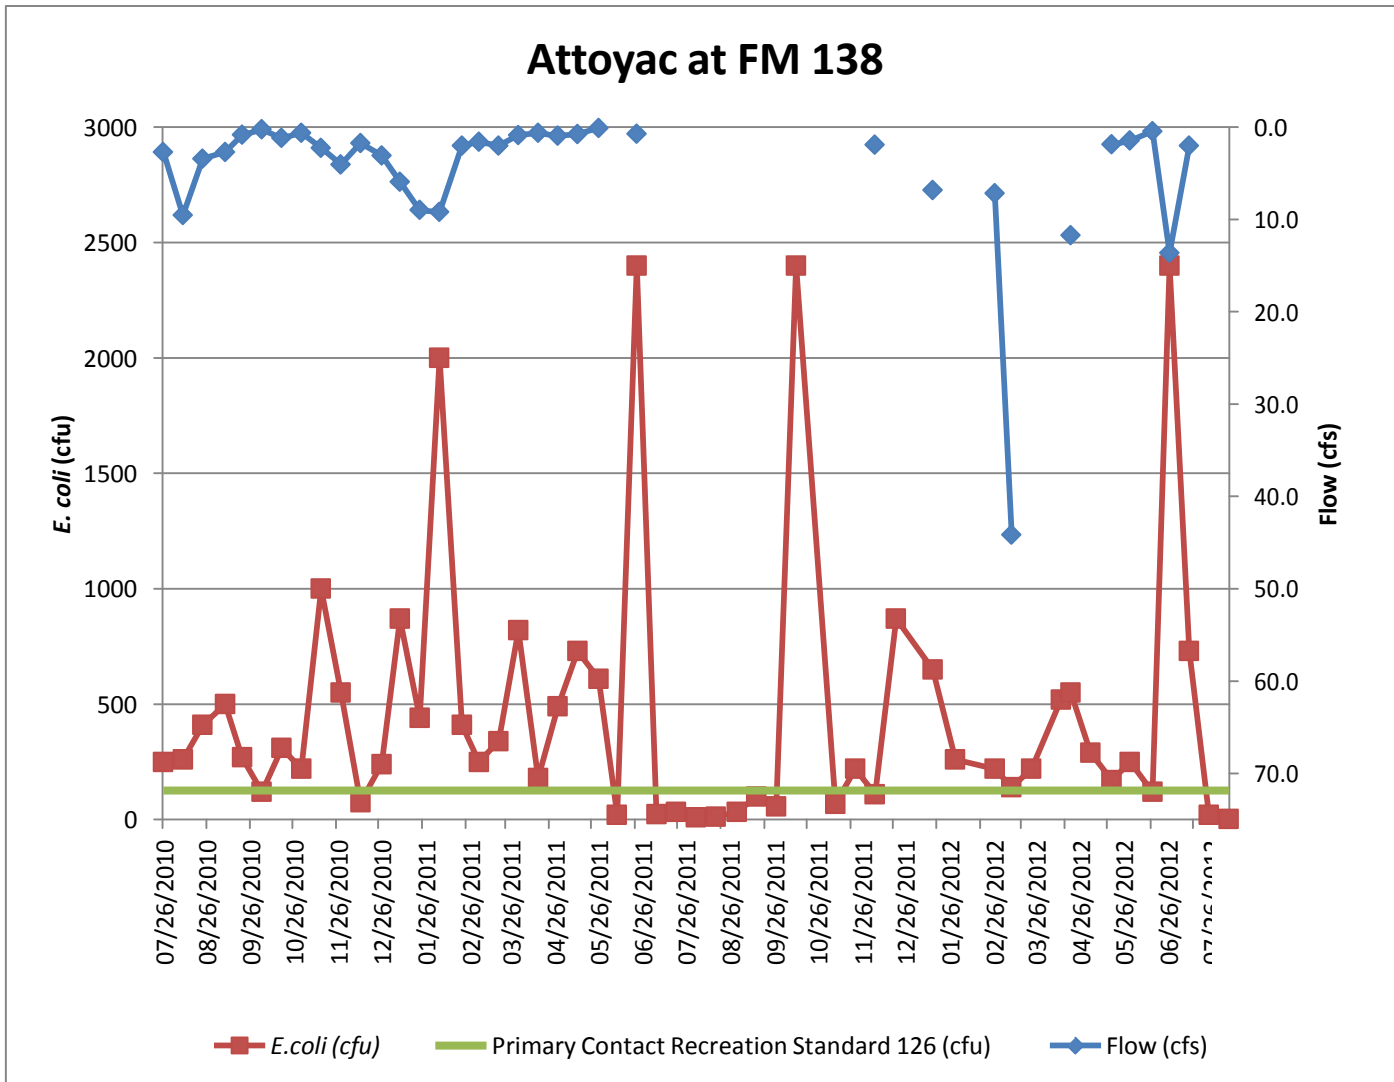
Figure C-7. Attoyac Bayou at FM 138 *E. coli* (cfu) vs. flow (cfs), from 7/26/ through 8/20/2012, compared to the standard of 126 cfu for primary contact recreation. * *E. coli* values reported as >2400 were entered as 2400.**
