ATTOYAC BAYOU SURFACE WATER QUALITY MONITORING REPORT

Attoyac Bayou Surface Water Quality Monitoring Report

November 8, 2012

Texas Water Resources Institute Technical Report-457

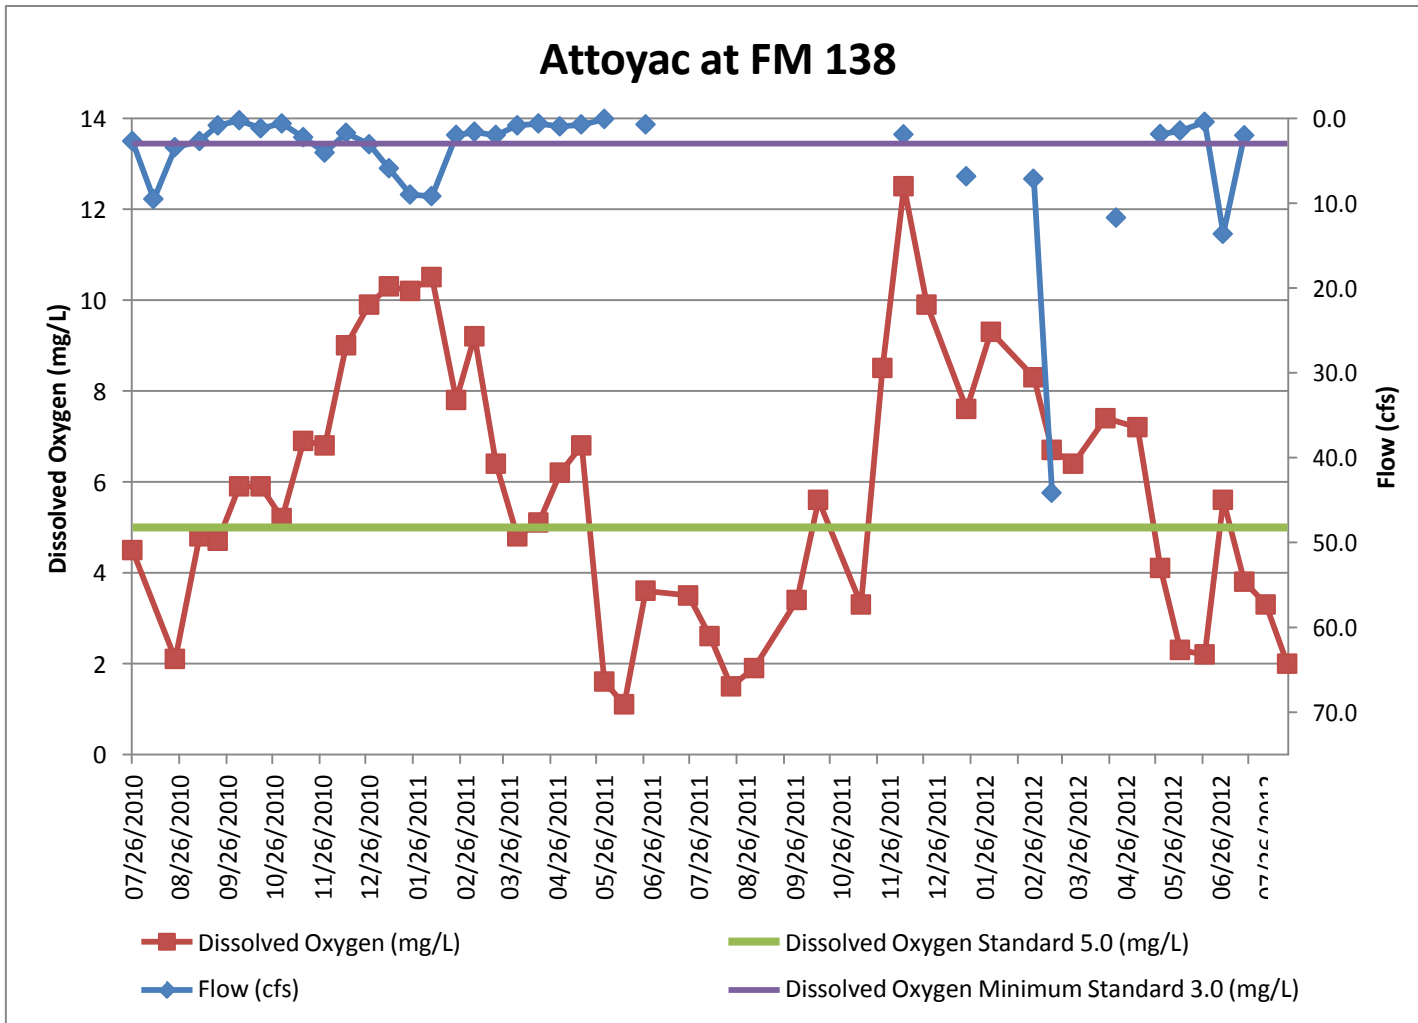
Figure C-9. Attoyac at FM 138 Dissolved Oxygen (mg/L) vs. flow (cfs), from 7/26/2010 through 8/20/2012, compared to the standard of 5.0 mg/L.

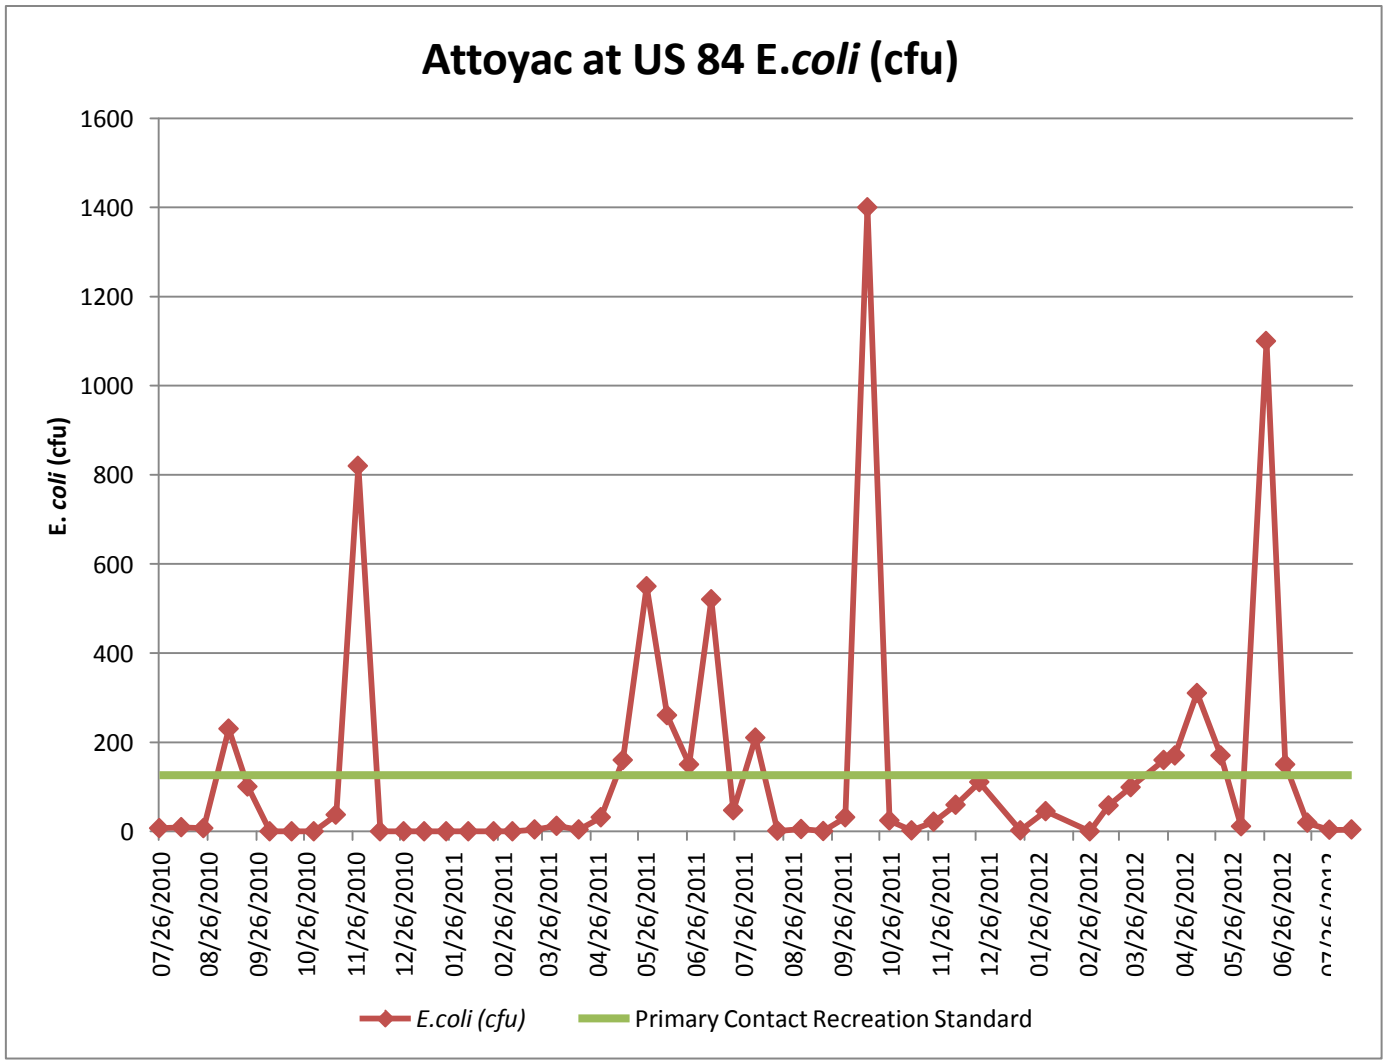
Figure C-13. Attoyac Bayou at US 84 *E. coli* cfu samples from 7/26/2010 through 8/20/2012 compared to the standard for primary contact recreation of 126 cfu. * *E. coli* values reported as >2400 were entered as 2400.**

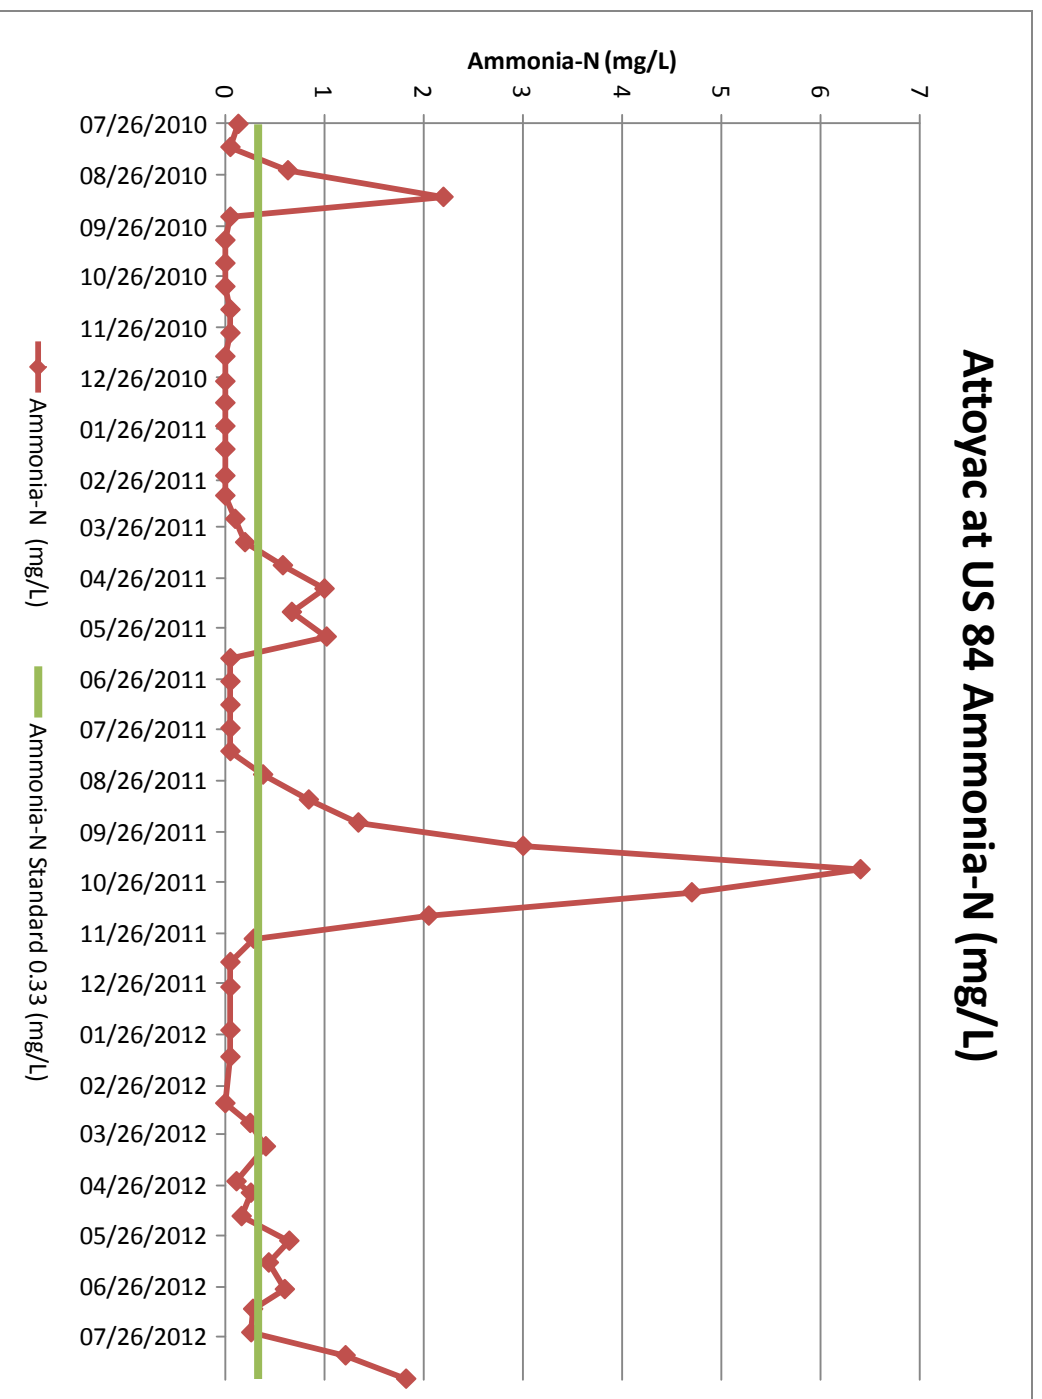
Figure C-14. Attoyac at US 84 Ammonia-A concentrations from 7/26/2010 through 8/20/2010 compared to the standard of 0.1 mg/L. *** Ammonia levels reported at <0.1 were entered as 0.05 mg/L.

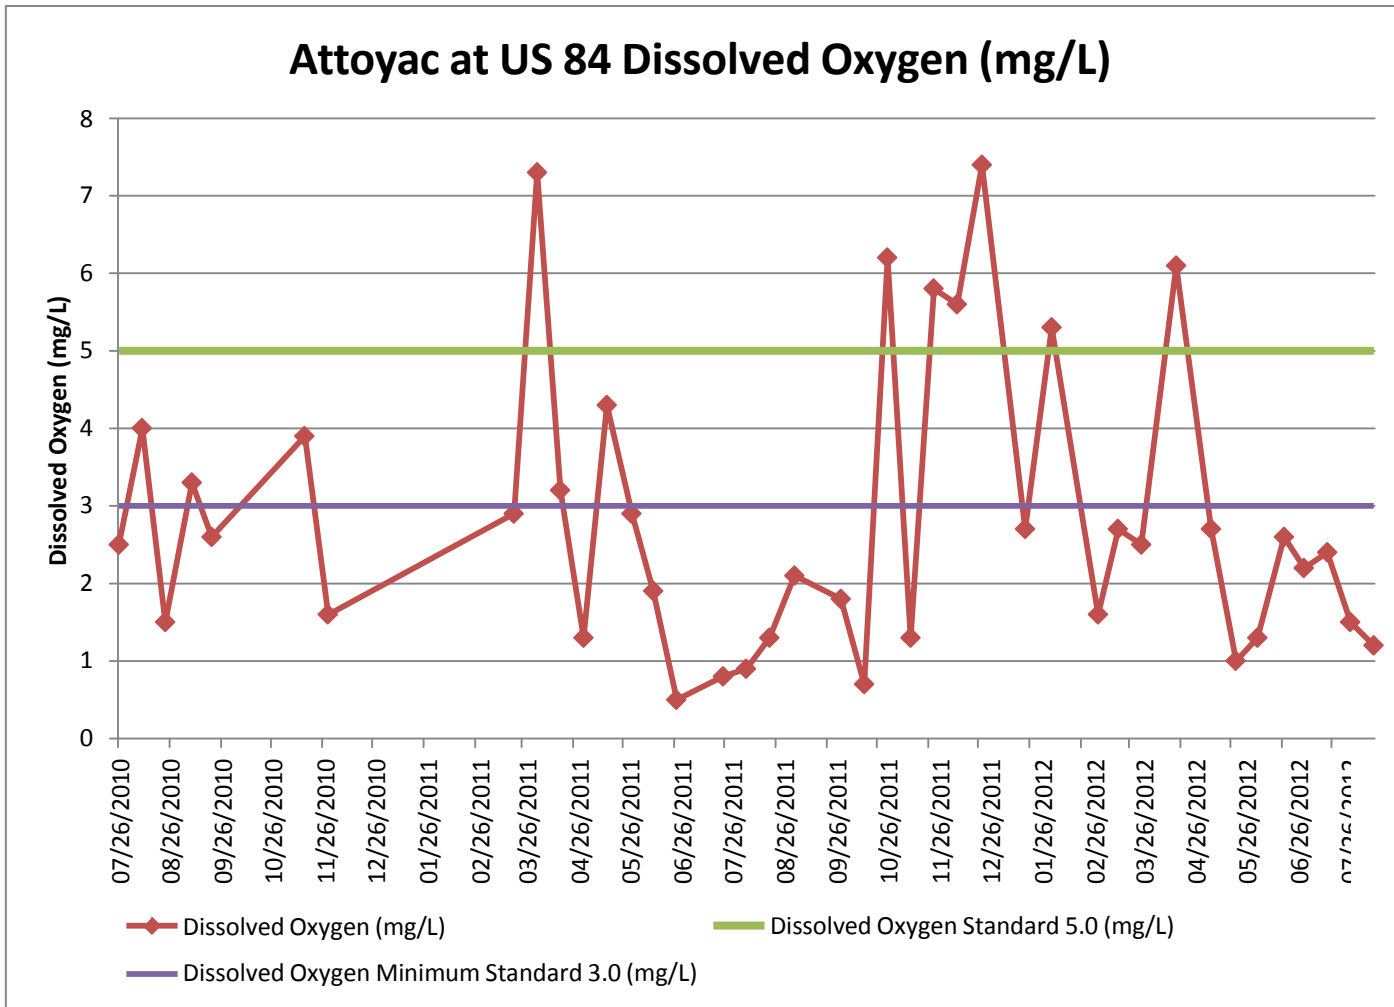
Figure C-15. Attoyac Bayou at US 84 Dissolved Oxygen (mg/L) measurements from 7/26/2010 through 8/20/2012, compared to the grab sample screening level of 5.0 mg/L.

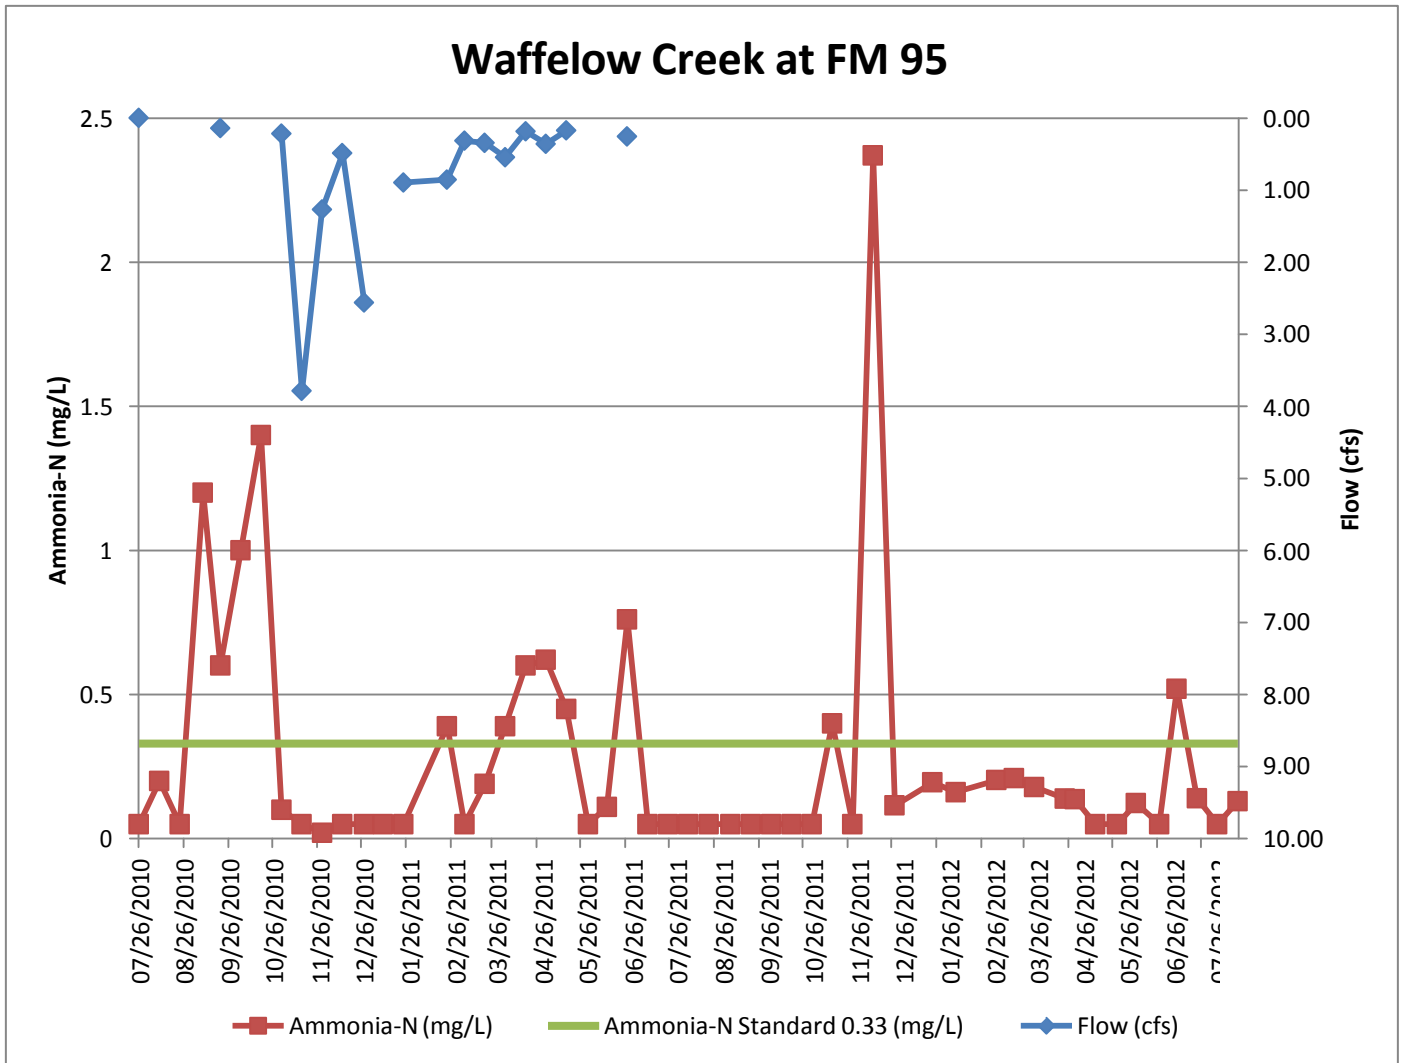
Figure C-17. Waffelow Creek at FM 95 Ammonia-N (mg/L) vs. Flow (cfs), from 7/26/2010 through 8/20/2012, compared to the standard of 0.1 mg/l. ** Ammonia levels reported at <0.1 were entered as 0.05 mg/L.

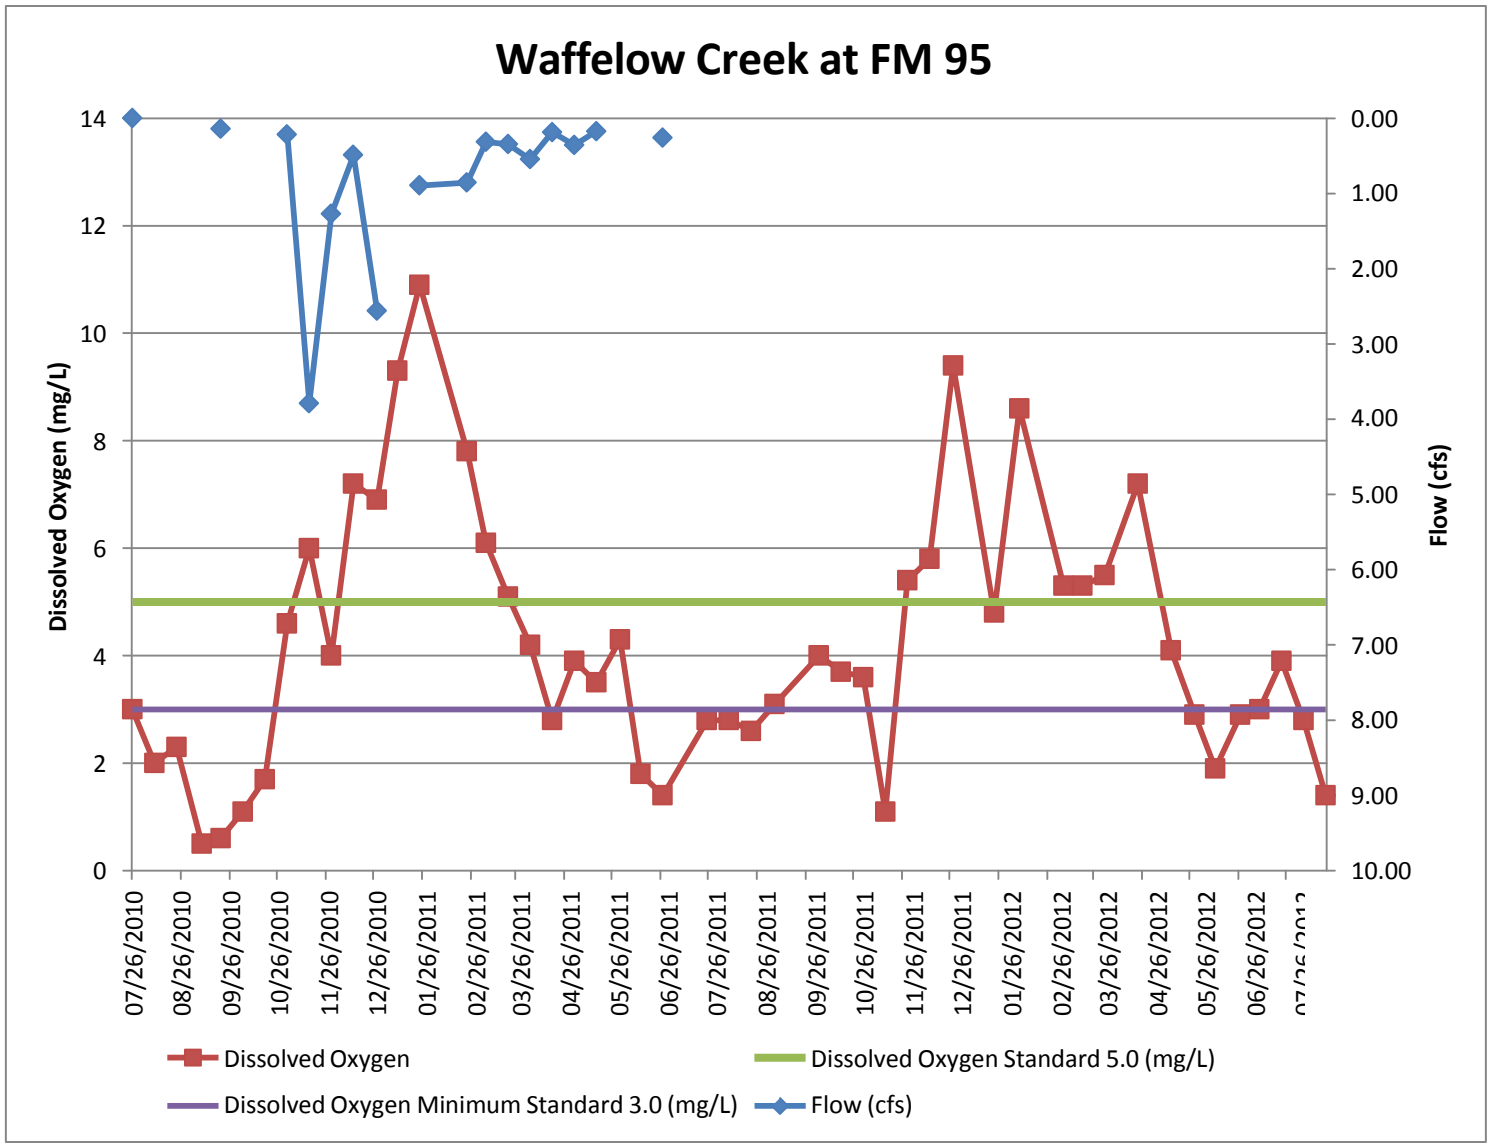
Figure C-18. Waffelow Creek at FM 95 dissolved oxygen (mg/L) vs. flow (cfs), from 7/26/2010 through 8/20/2012 compared to the standard of 5.0 mg/L.

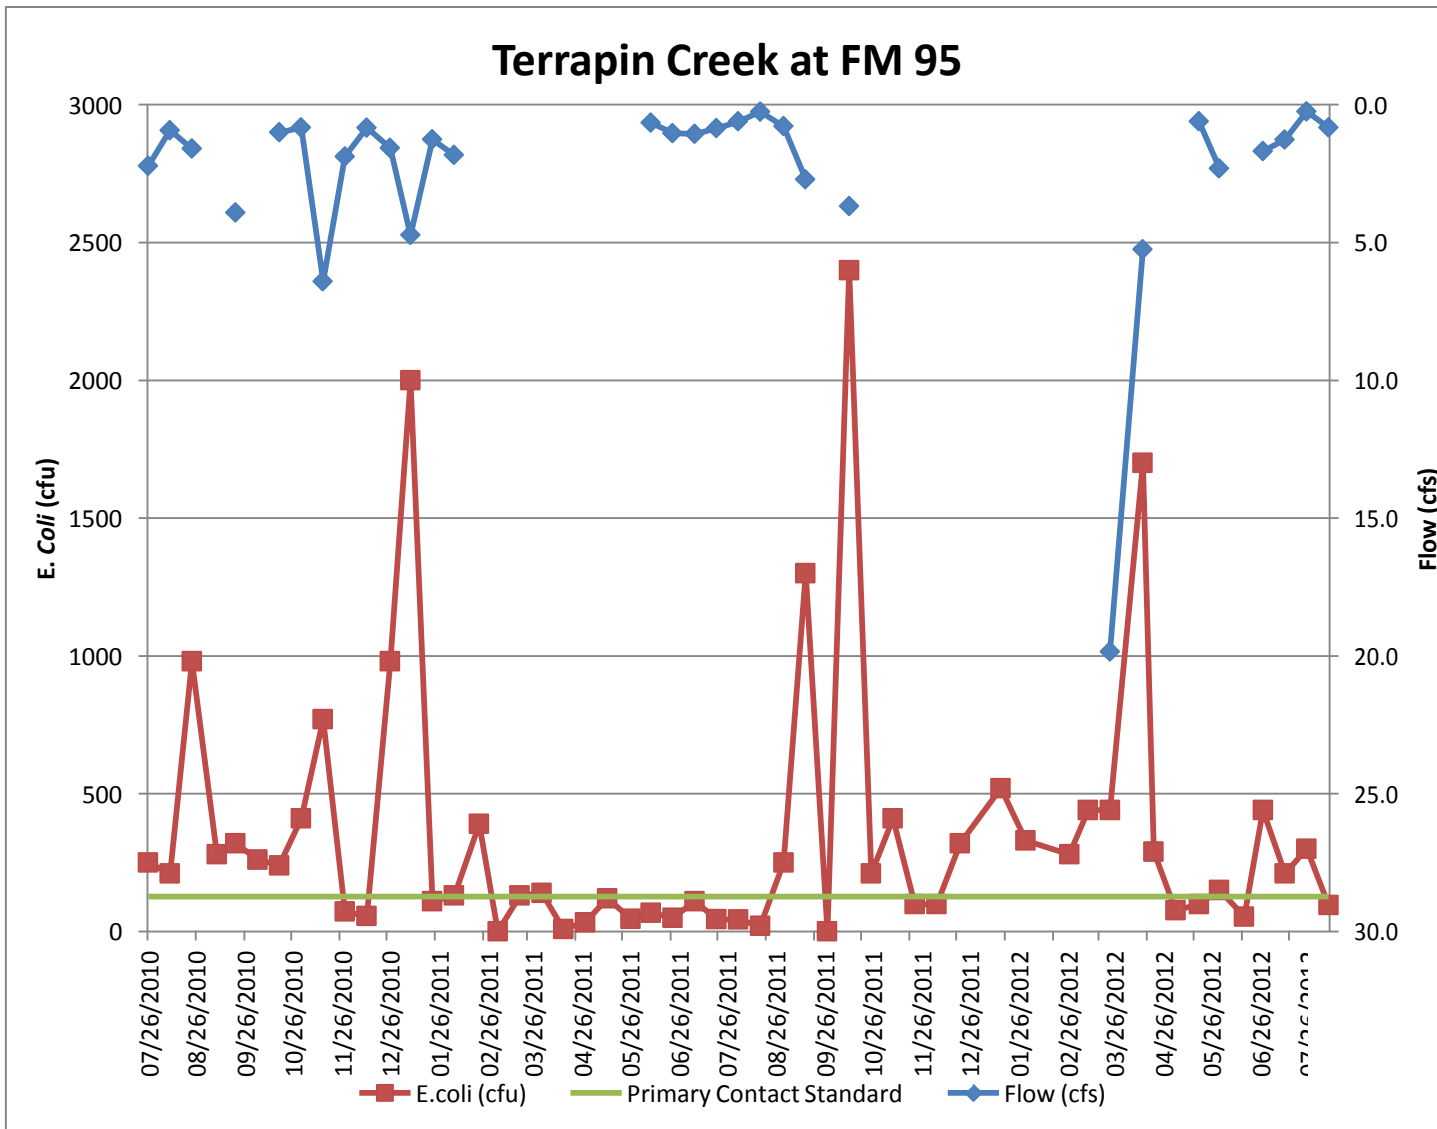
Figure C-19. Terrapin Creek at FM 95 *E. coli* (cfu) vs. flow (cfs), from 7/26/2012 through 8/20/2012, compared to the standard for primary contact recreation 126 cfu. * *E. coli* values reported as >2400 were entered as 2400.**

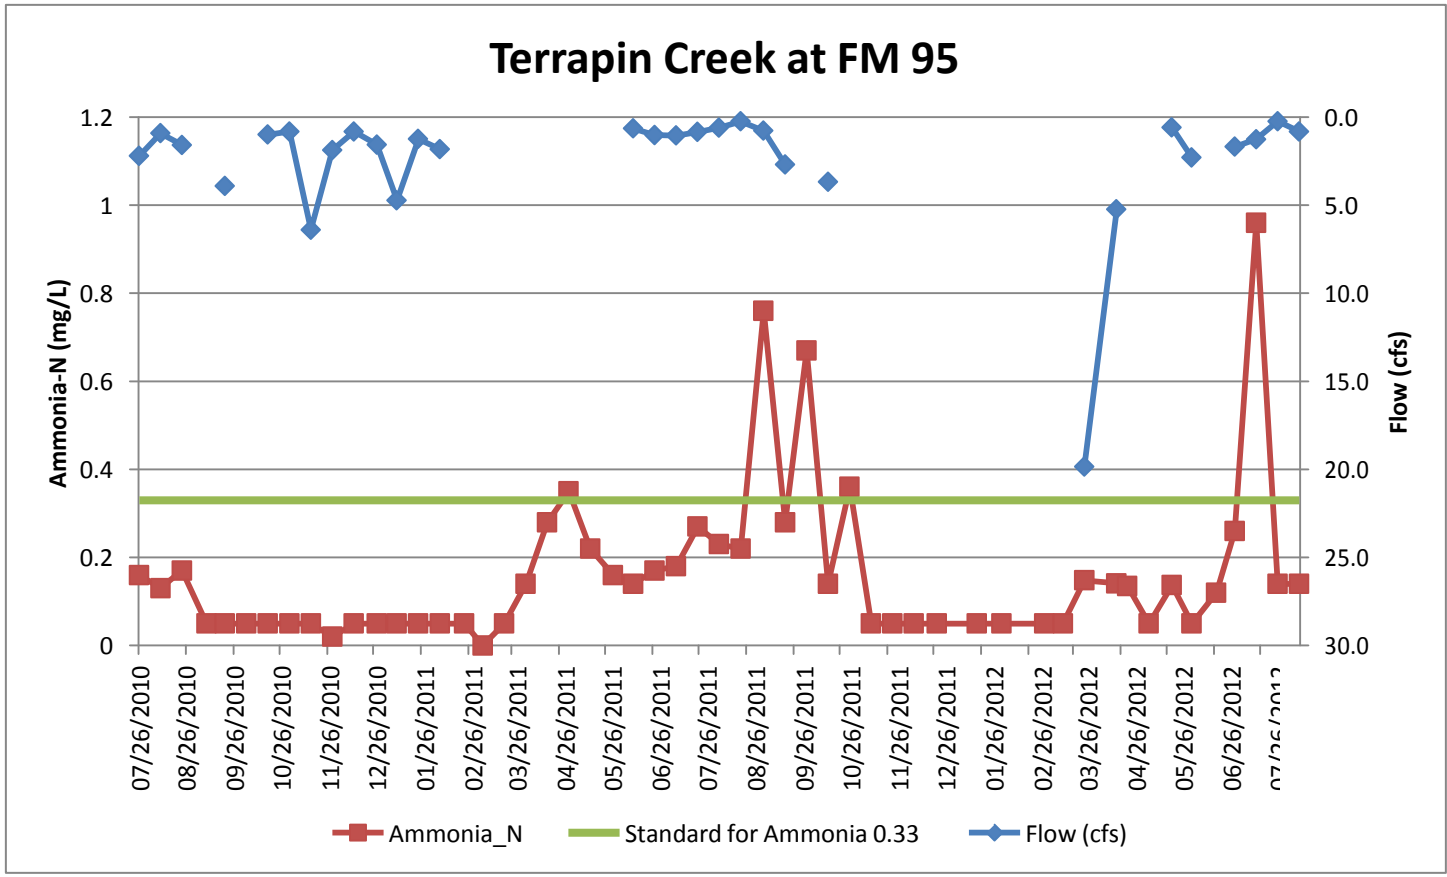
Figure C-20. Terrapin Creek at FM 95 Ammonia-N (mg/L) vs. flow (cfs), from 7/26/2012 through 8/20/2012, compared to the standard of 0.1 mg/L. * Ammonia levels reported at <0.1 were entered as 0.05 mg/L.**

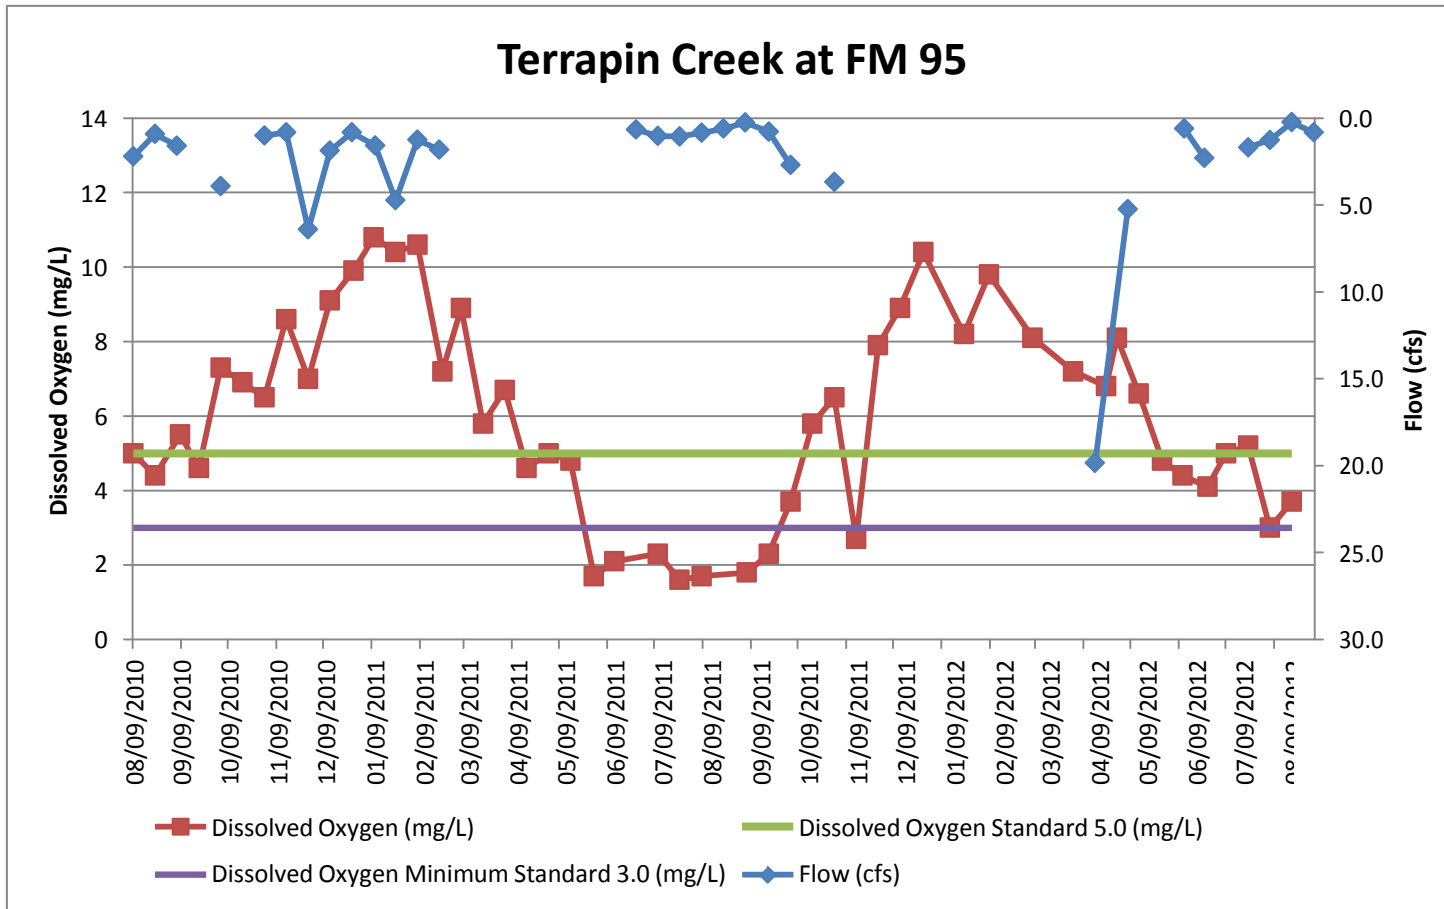
Figure C-21. Terrapin Creek at FM 95 Dissolved oxygen (mg/L) vs. flow (cfs), from 7/26/2012 through 8/20/2012, compared to the standard of 5.0 mg/L.

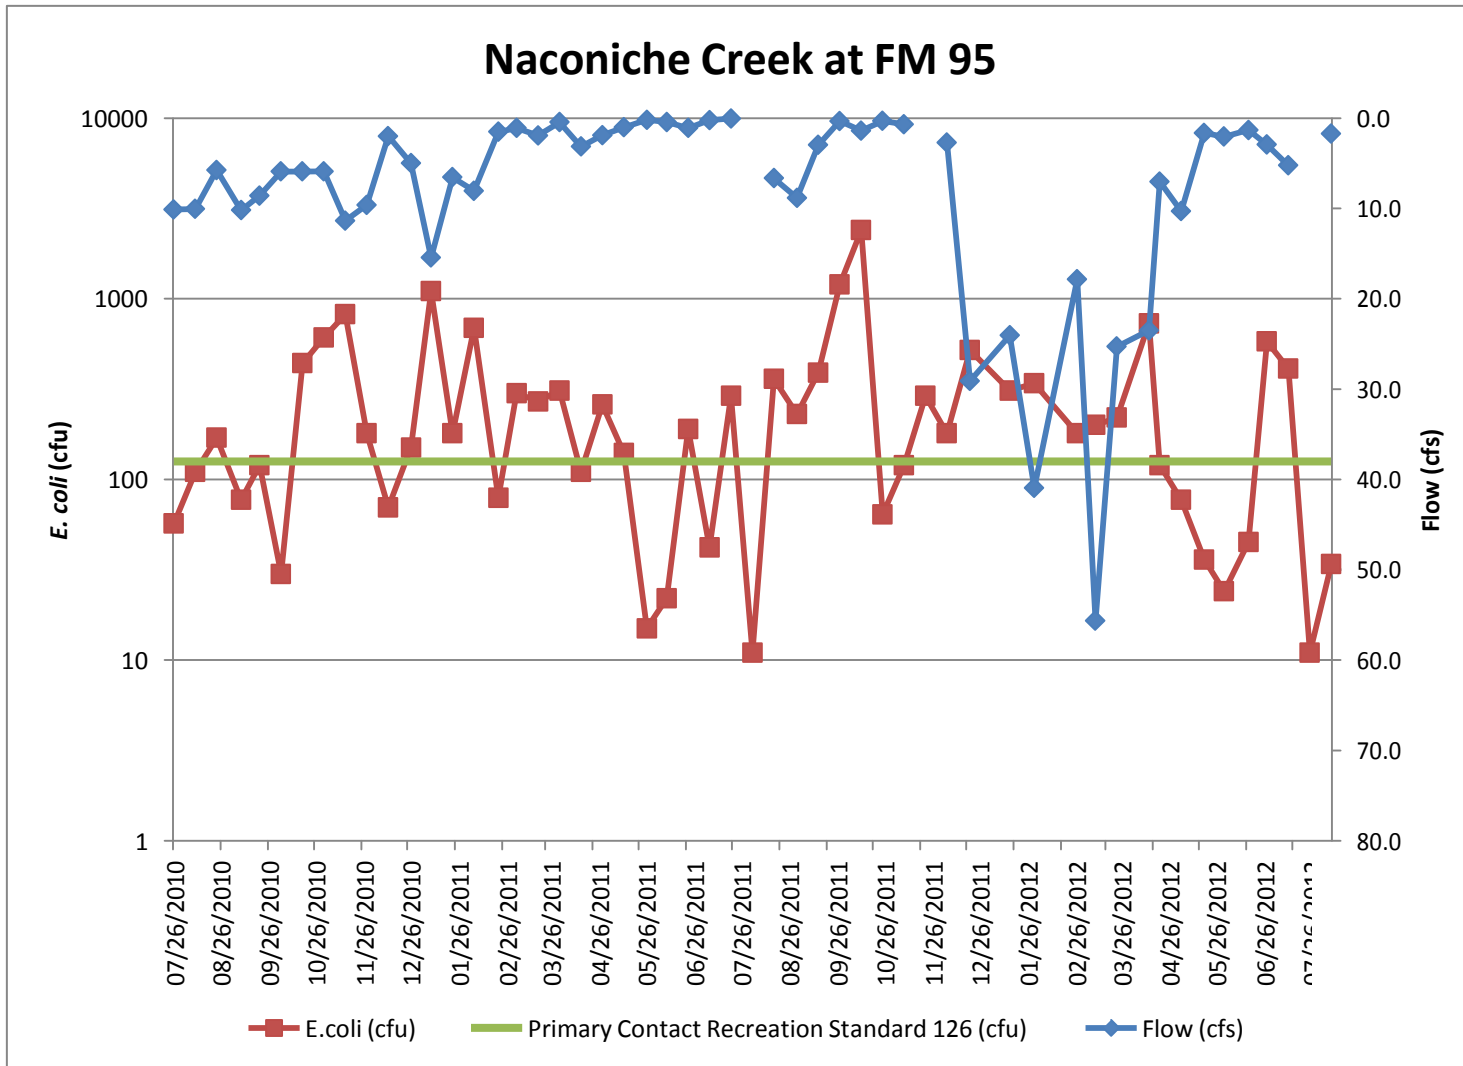
Figure C-22. Naconiche Creek at FM 95 *E. coli* (cfu) vs. flow (cfs), from 7/26/2010 through 8/20/2012, compared to the standard for primary contact recreation 126 cfu. * *E. coli* values reported as >2400 were entered as 2400.**

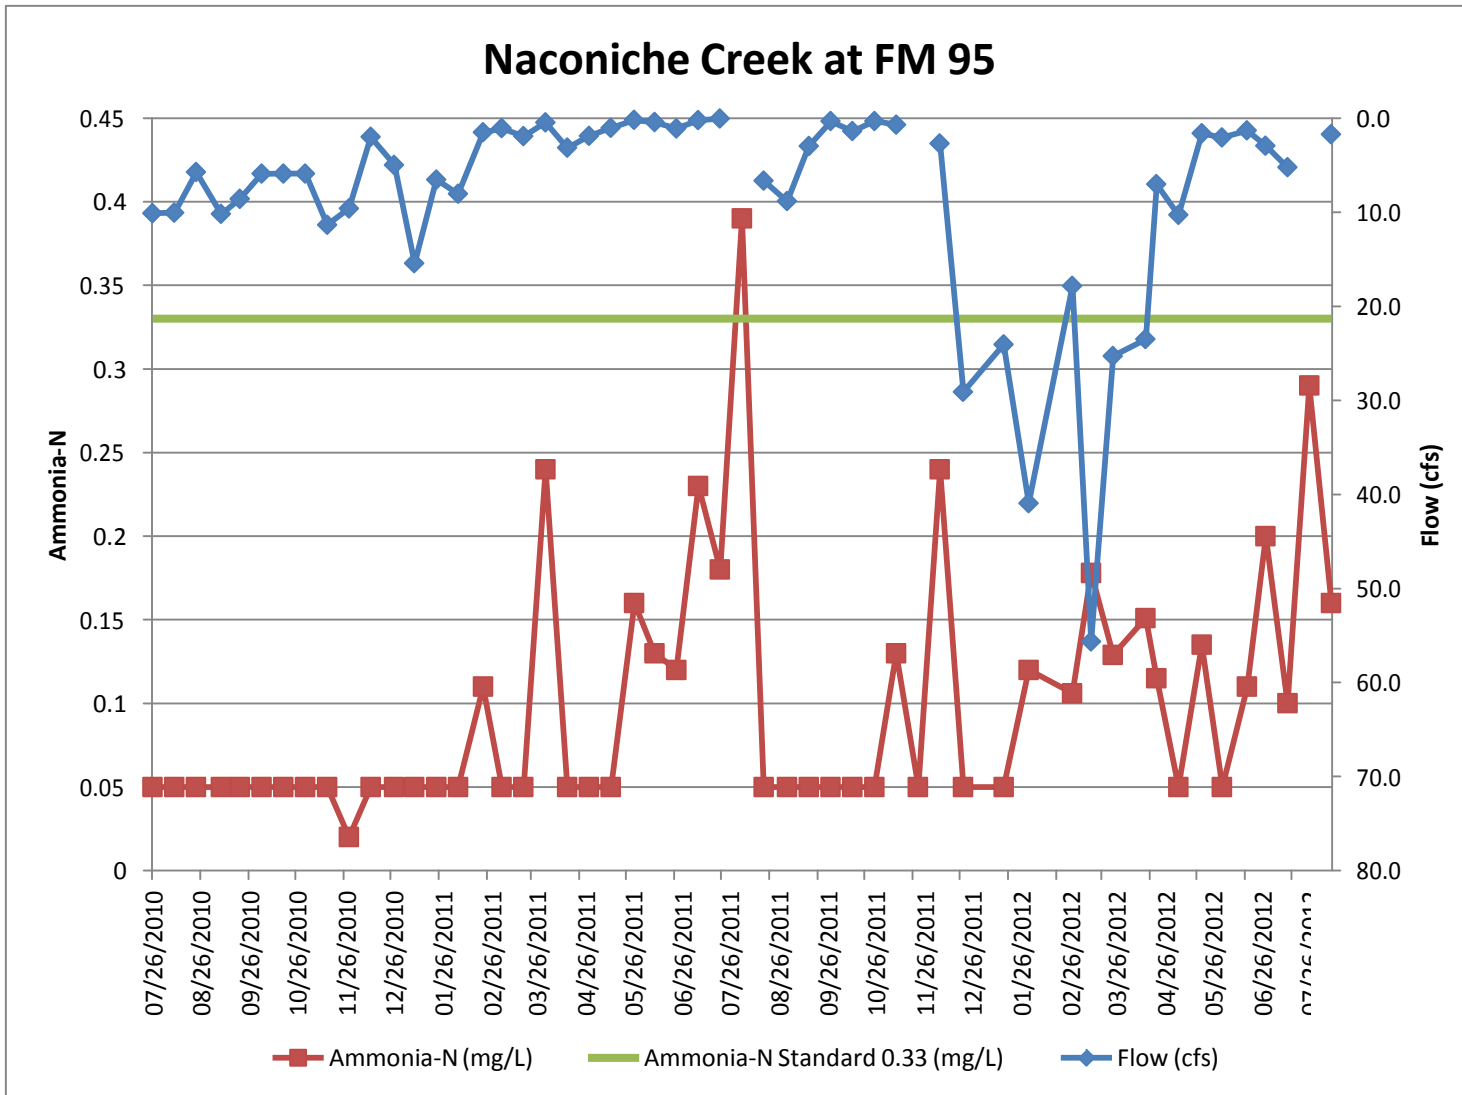
Figure C-23. Naconiche Creek at FM 95 Ammonia-N (mg/L) vs. flow (cfs), from 7/26/2010 through 8/20/2012, compared to the standard of 0.1 mg/L. * Ammonia levels reported at <0.1 were entered as 0.05 mg/L.**

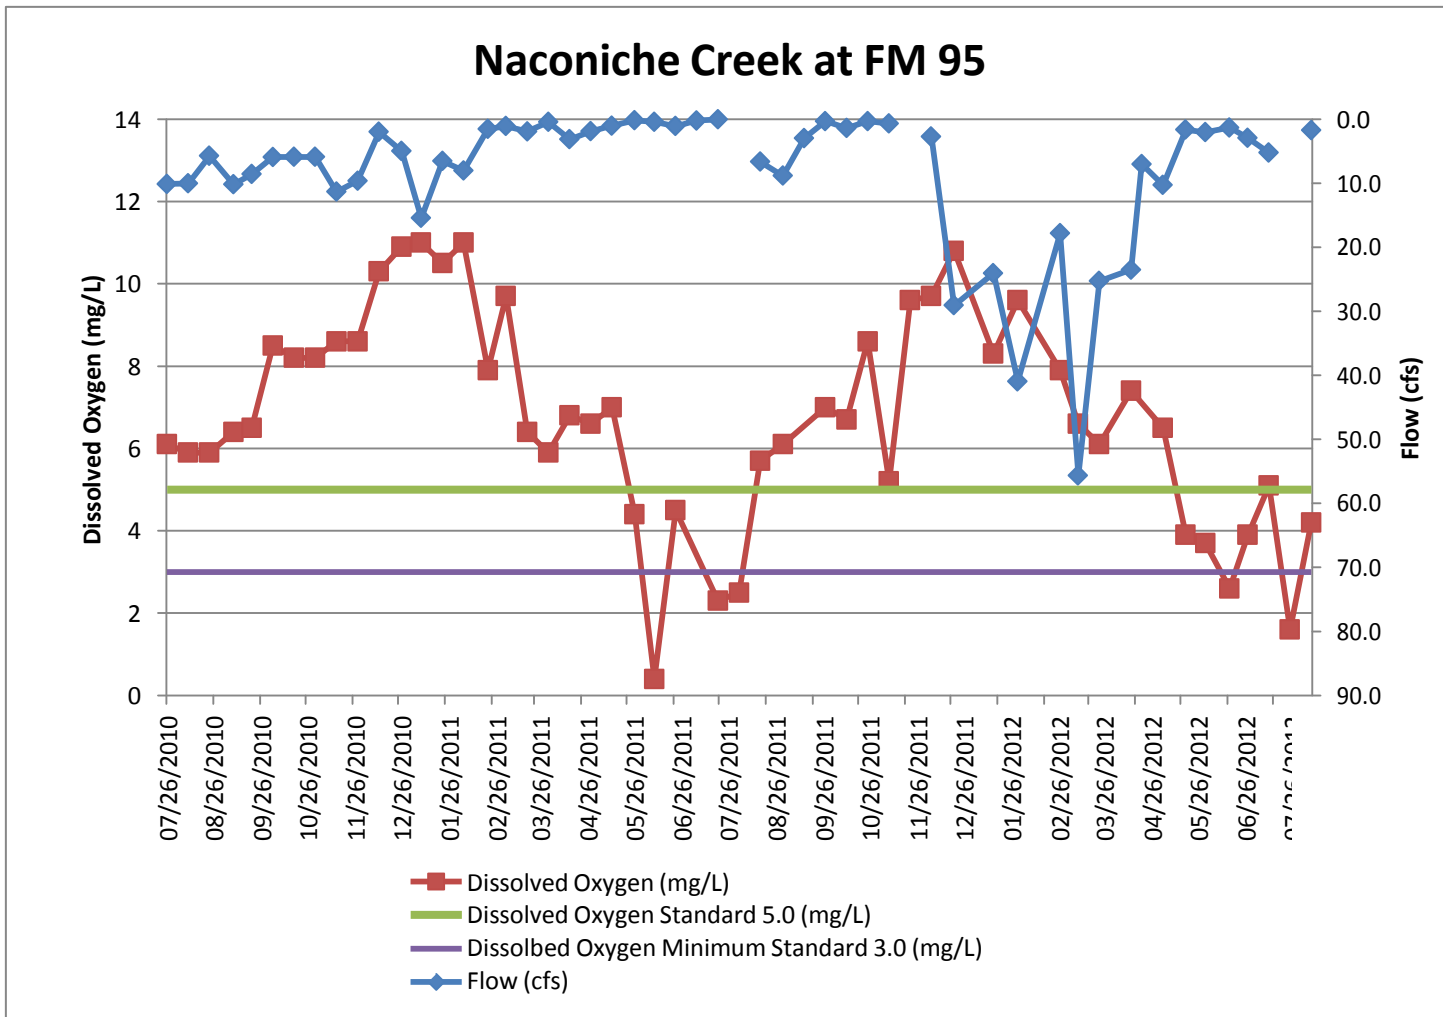
Figure C-24. Naconiche Creek at FM 95 Dissolved oxygen (mg/L) vs. flow (cfs), from 7/26/2010 through 8/20/2012, compared to the standard of 5.0 mg/L.

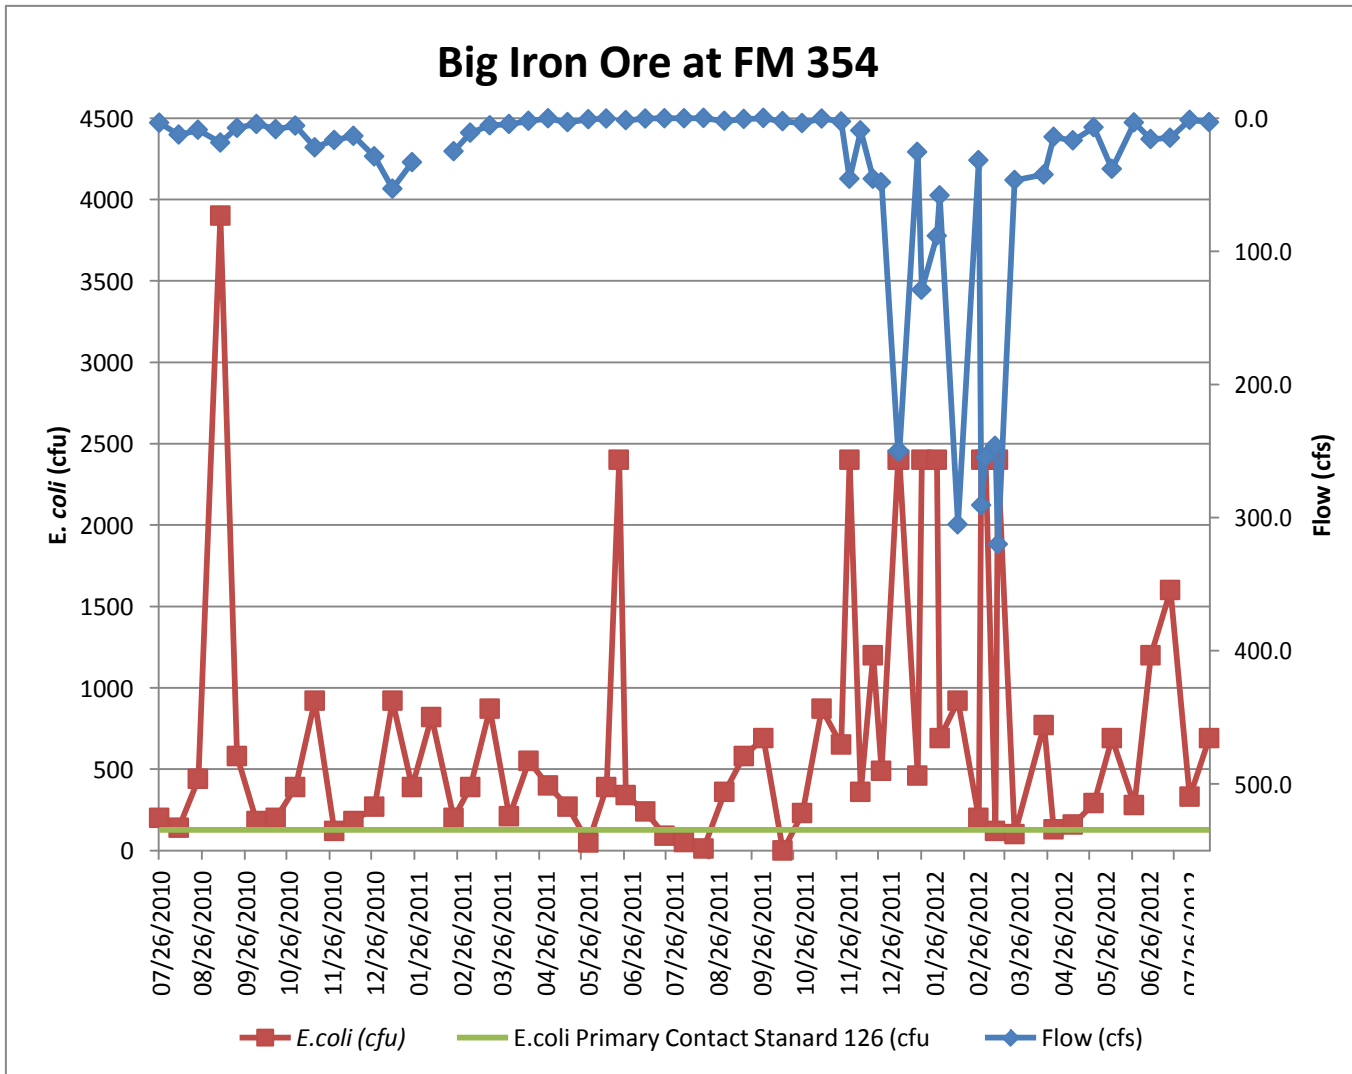
Figure C-25. Big Iron Ore Creek at FM 354 *E. coli* (cfu) vs. flow (cfs) from 7/26/2010 through 8/20/2012, compared to the standard for primary contact recreation 126 cfu. *** *E. coli* values reported as >2400 were entered as 2400.

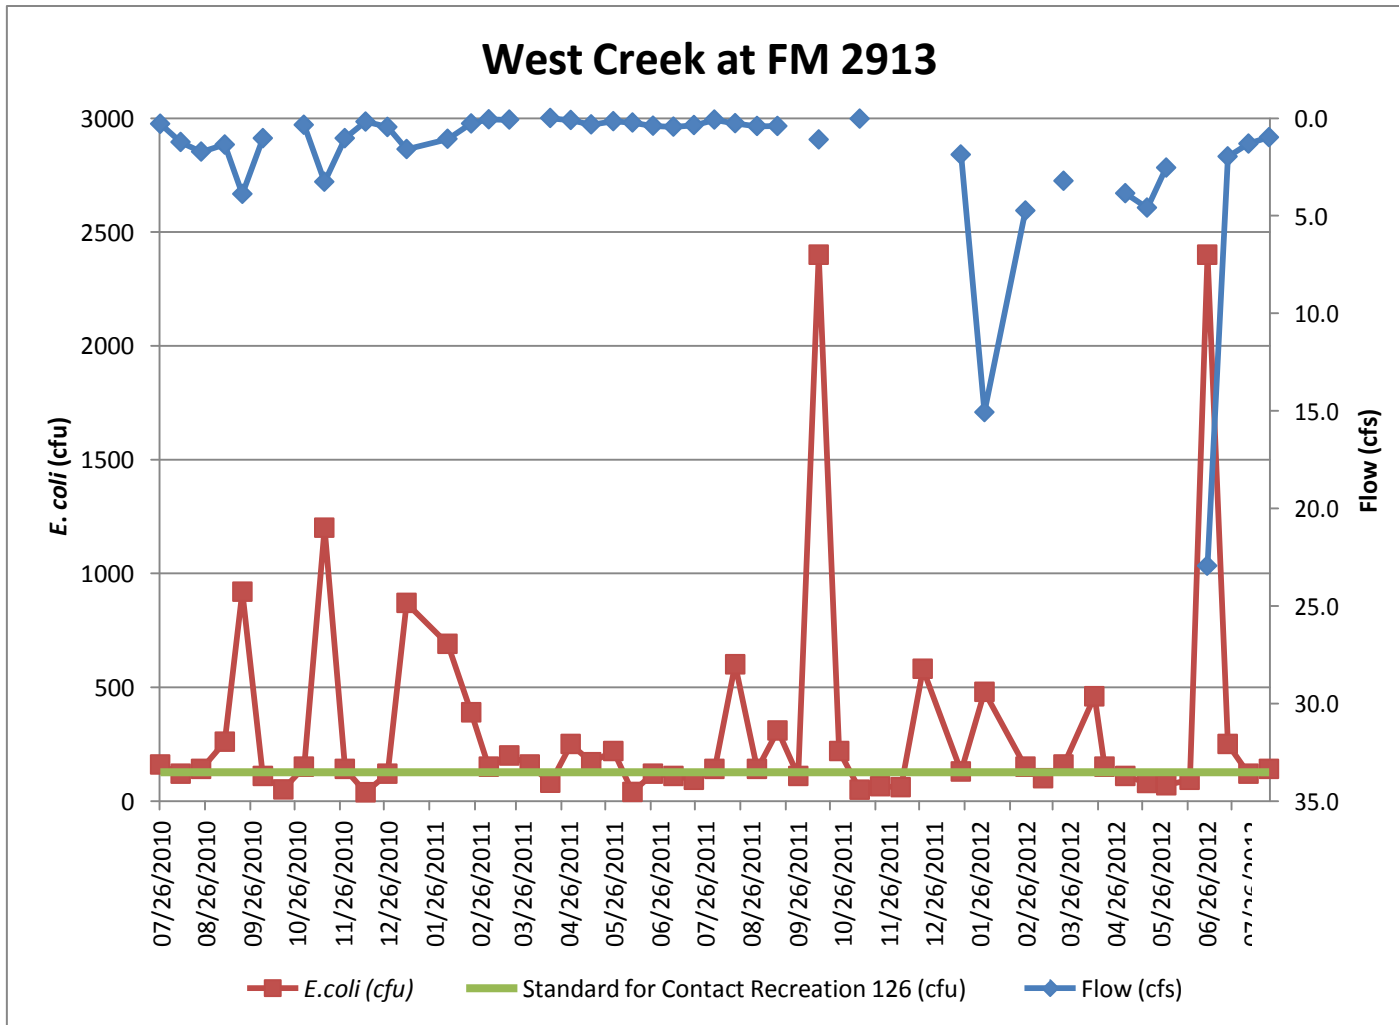
Figure C-28. West Creek at FM 2913 *E. coli* (cfu) vs. flow (cfs), from 7/26/2010 through 8/20/2012, compared to the standard for primary contact recreation 126 cfu. * *E. coli* values reported as >2400 were entered as 2400.**
