A DENROGEOLOGICAL ASSESSMENT OF THE DONALD DUCK
LANDSLIDE COMPLEX, GRAND MESA, COLORADO

A Thesis

December 2016

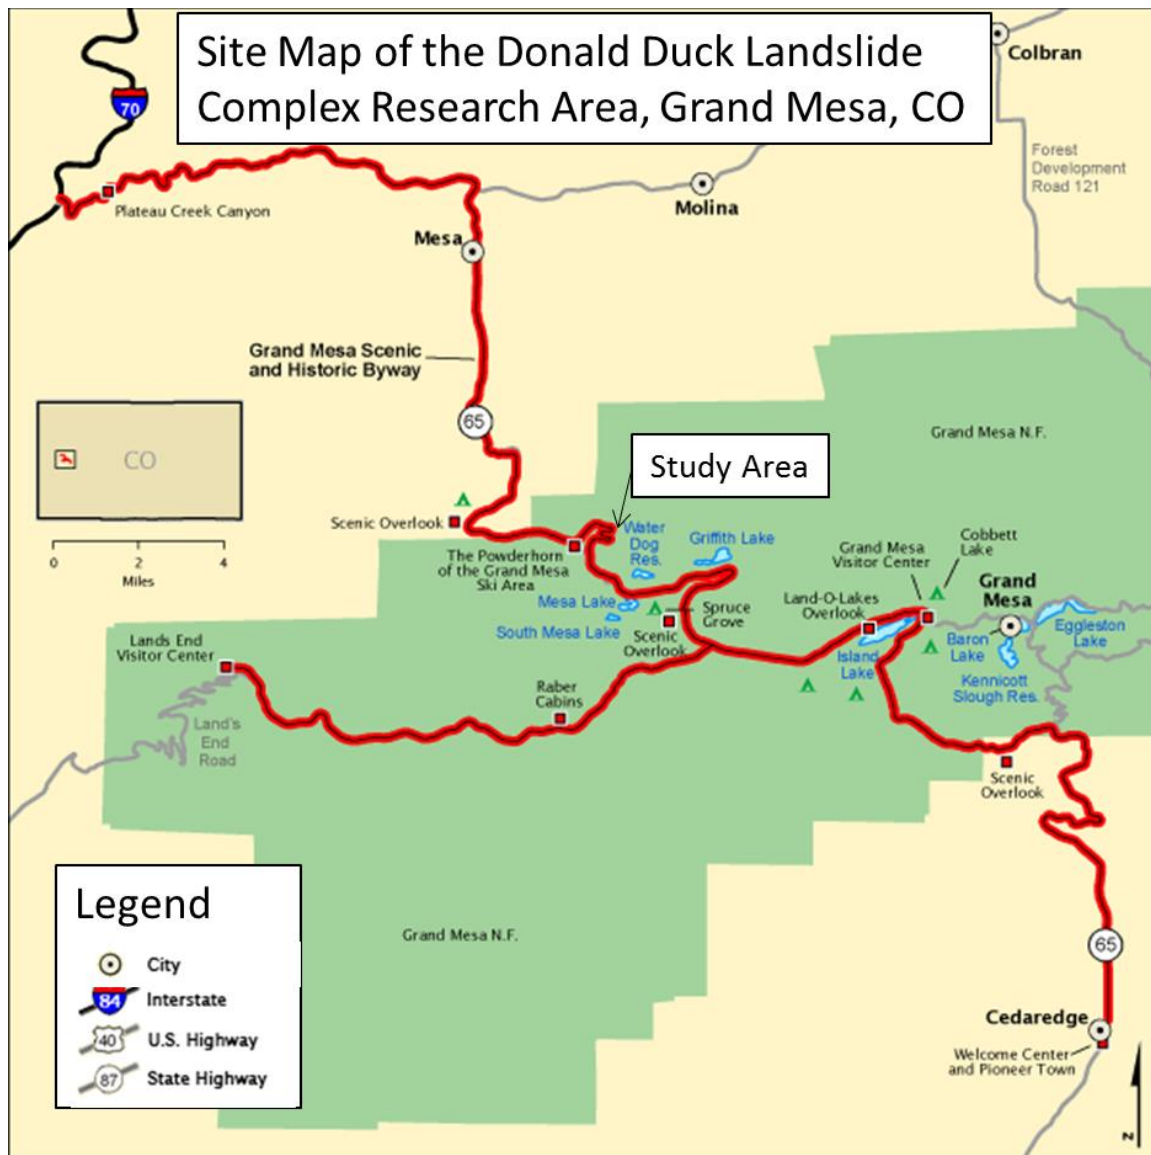
Figure 1. Site map. Location of the Donald Duck Landslide on Grand Mesa, Central West Colorado.

The Donald Duck landslide complex is located on the northern slope of Grand Mesa, Colorado on the east side of State Highway 65 along a prominent switchback between the old Mesa Creek Ski Resort and Mesa Lake (N39°04'17", W108°05'35", N39°04'15", W108°05'30", Figure 1). The elevation at the head of the complex is 2,841m and at the base is 2,813m. The aspect of the complex is northwest and is situated on the edge of a valley that drains to Coon Creek and then to Mesa Creek.

The Donald Duck landslide complex is noticeable from Highway 65 between mile markers 38 and 39 between Mesa Lakes Lodge and Powderhorn Resort (Figure 1). The complex stands in contrast to the surrounding densely forested hillside by a lack of mature trees and a presence of thick cover of native grasses. Aspen is the dominant tree species

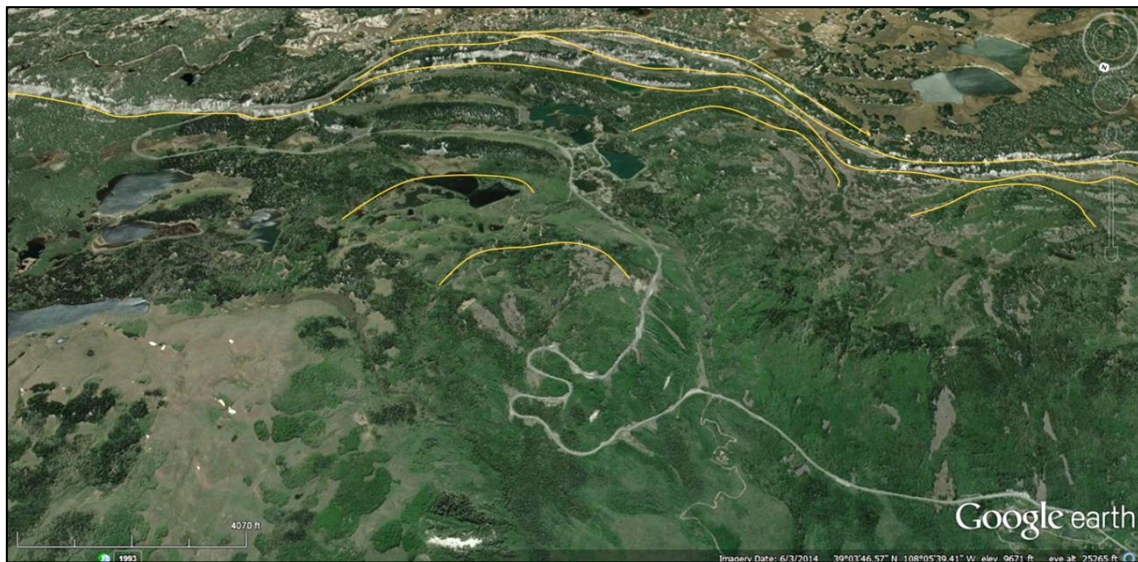
Figure 4. Geomorphology of Grand Mesa. Ancient landslides are evident below the outlined scarps and toreva blocks. Google Earth, June, 2014.

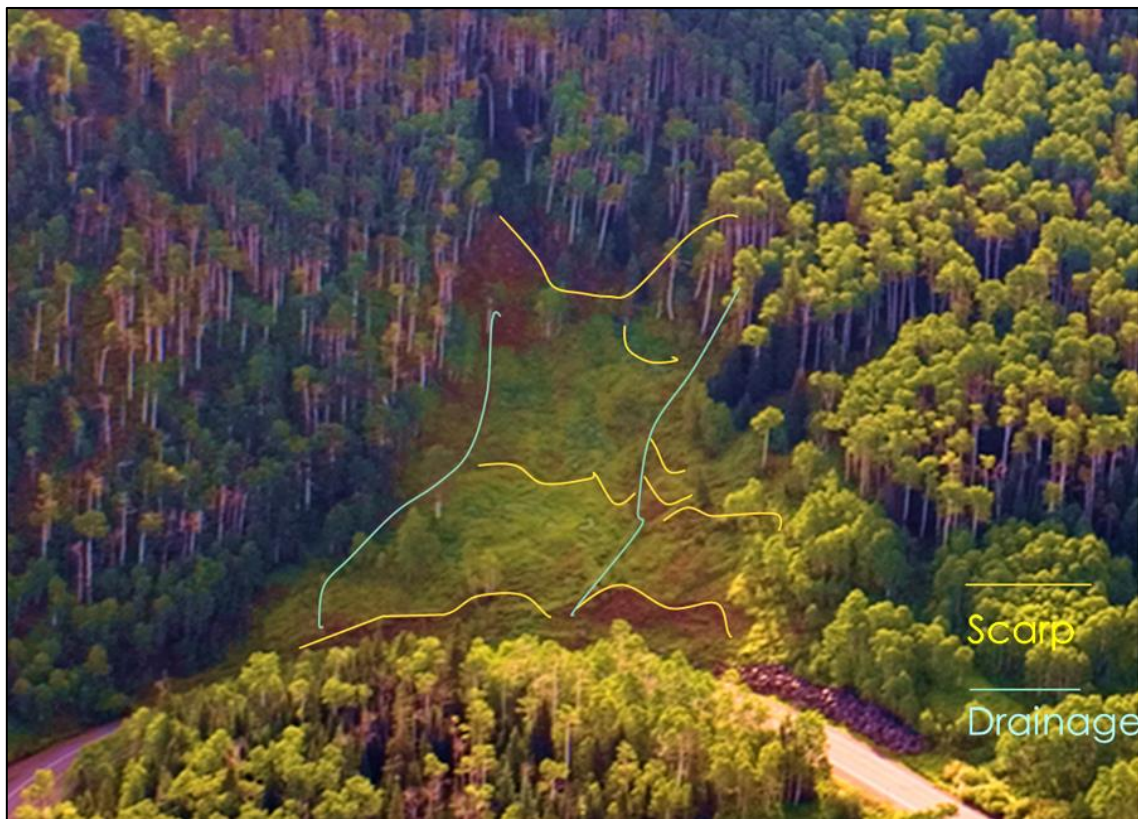
Figure 5. Aerial image of the Donald Duck Landslide Complex. Landslide scarps are drawn as well as modern surface drainage. Aug. 2011.

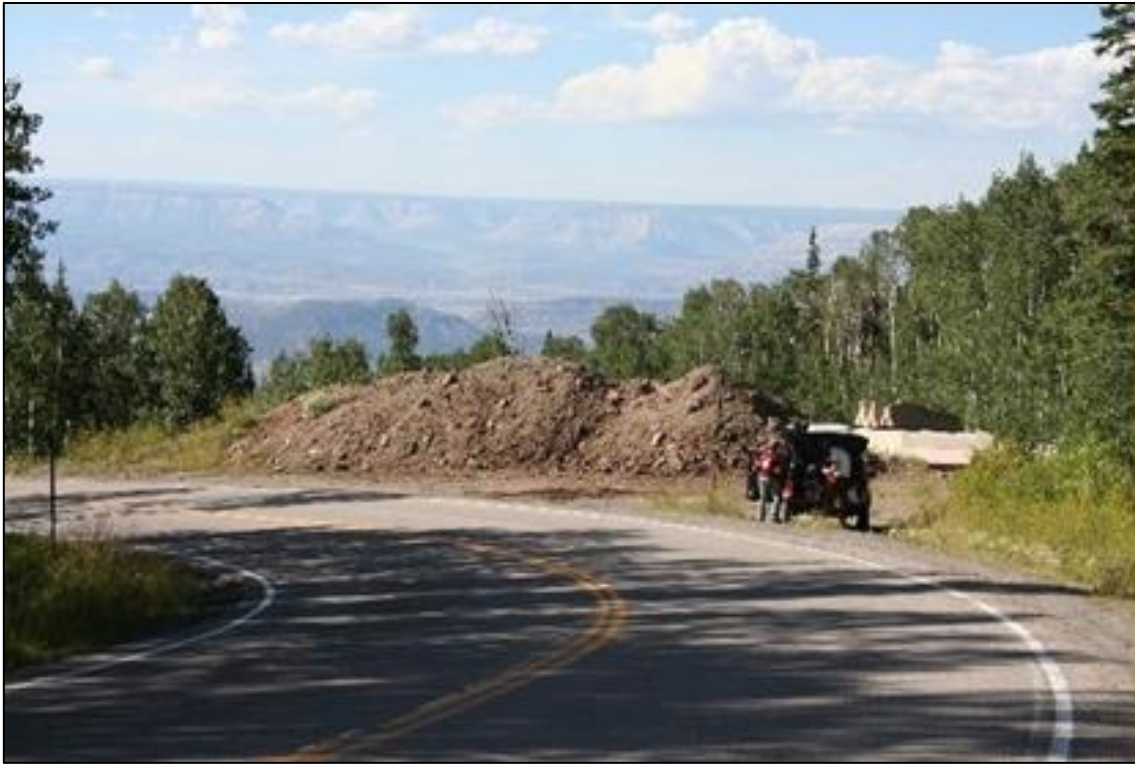
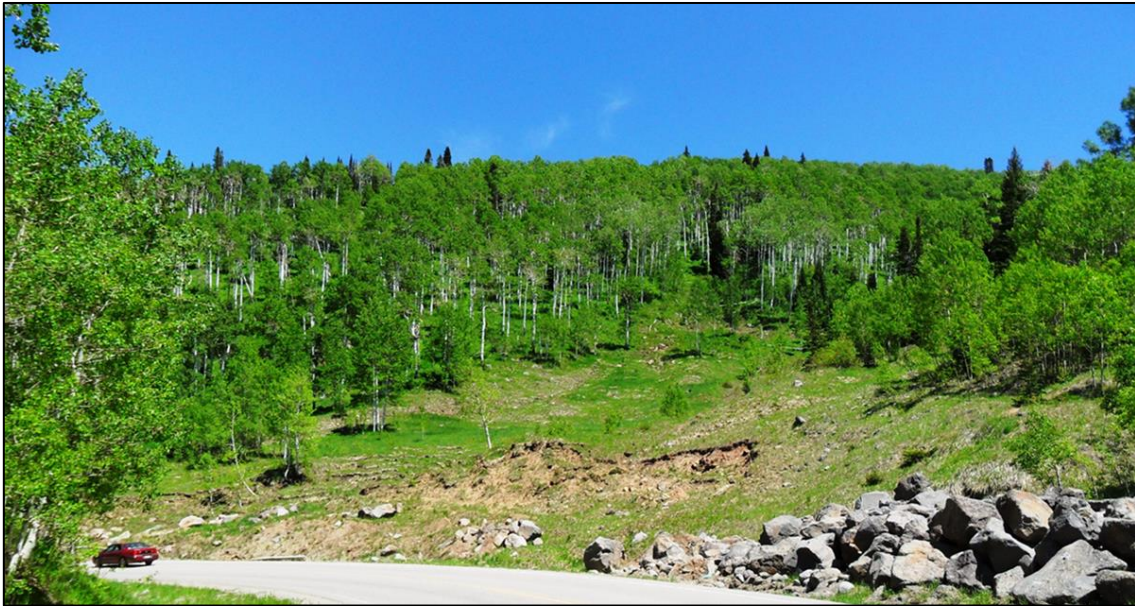
Figure 6. CDOT management of the DDLC. Debris is removed from the road and stockpiled (6a) while concrete barriers and boulder rip-rap are used to stabilize the toe. July 2011.

department in an apparent attempt to weigh down the toe of the slide and potentially stabilize the complex. The stockpile and concrete barriers can be seen in Figures 6a and 6b.

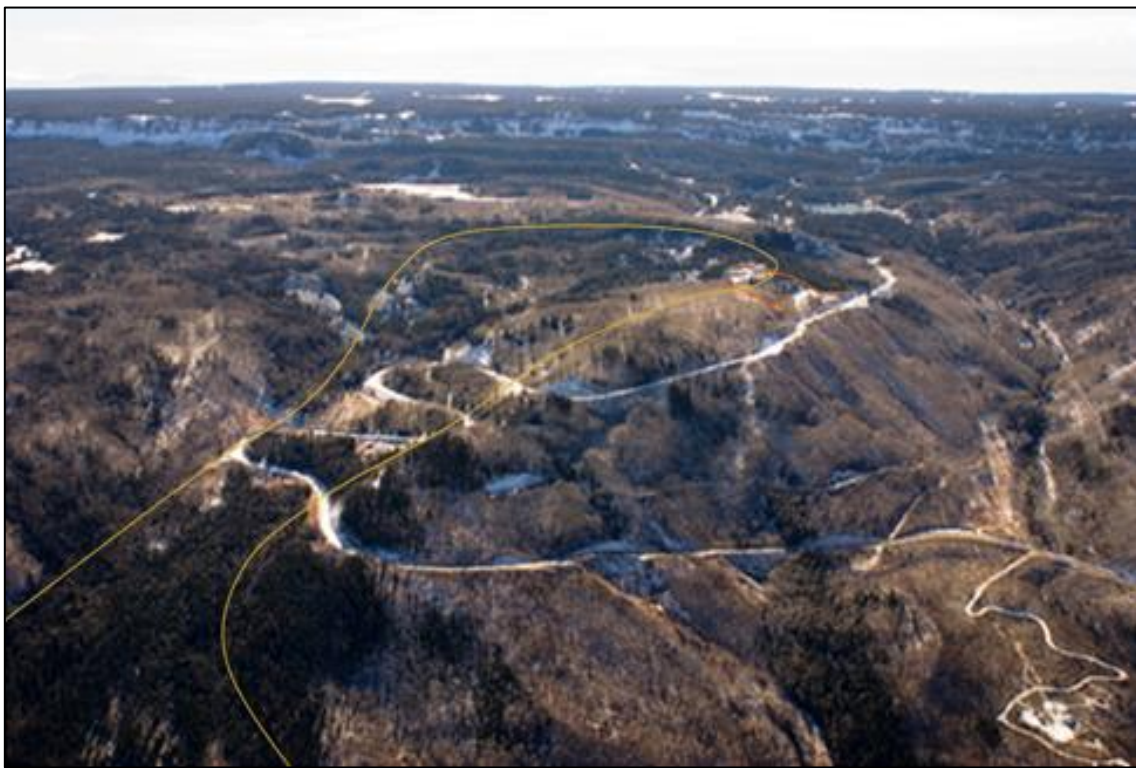
Figure 7. Outline of the ancient landslide. The gold line outlines the ancient landslide. The landslide underlies the entire valley occupied by the SH 65 switchbacks. Google Earth, Jan. 2014.

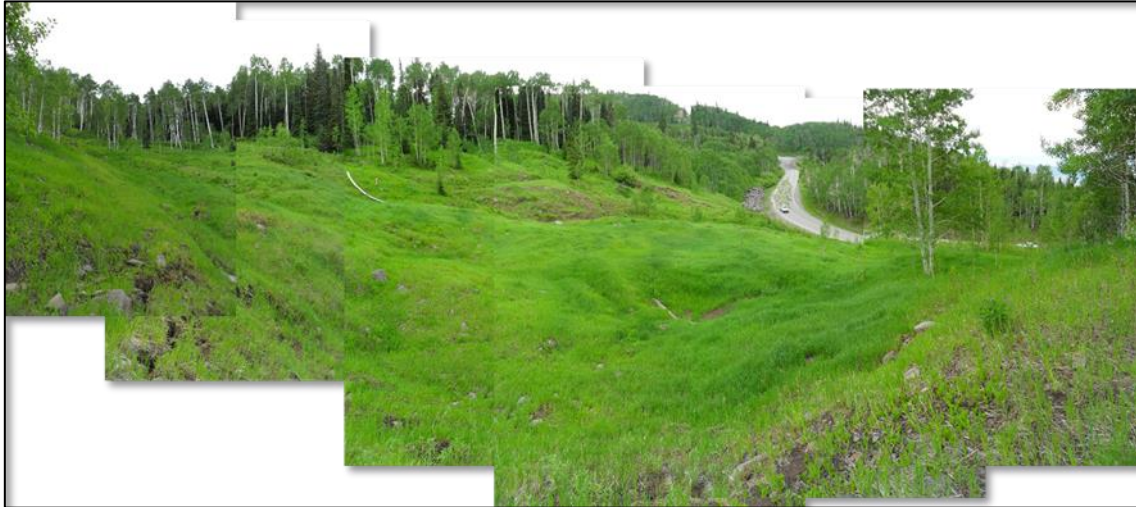
Figure 8. Panoramic view of the DDL from the north flank. The main scarp, body and toe are visible in the near field view. The smaller two contributing slides are in the far field view. Personal photos, June 2011.

in sequence. The complexity of the Donald Duck site is illustrated in Figure 8. The head scarp, three lobes, the main body, neck, toe and tension cracks are visible from a vantage point southwest of the complex along State Highway 65.

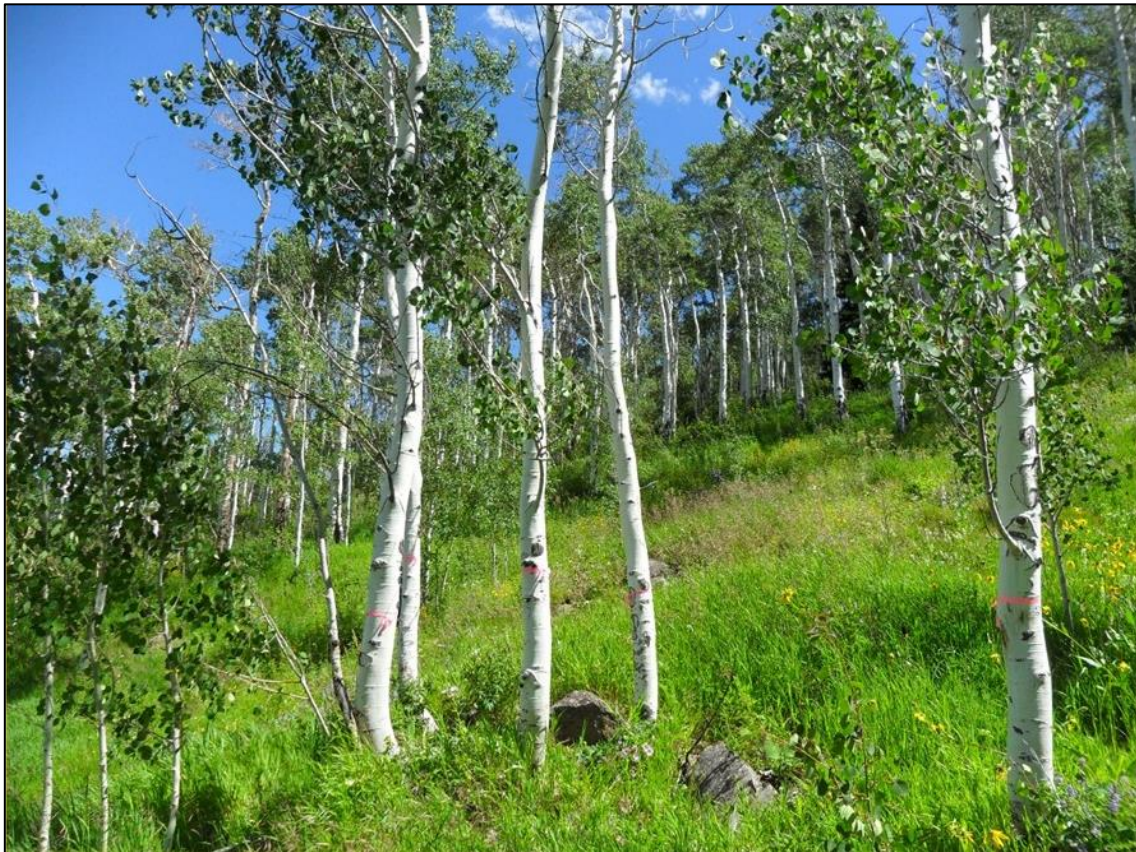
Figure 9. A tree cluster on the DDLC. These five mature trees were each cored then grouped as part of the 'scarp' unit. Personal photo, June 2011.

individually and then grouped in units according to the geomorphic location on the landslide. One such grouping of trees is shown in Figure 9.

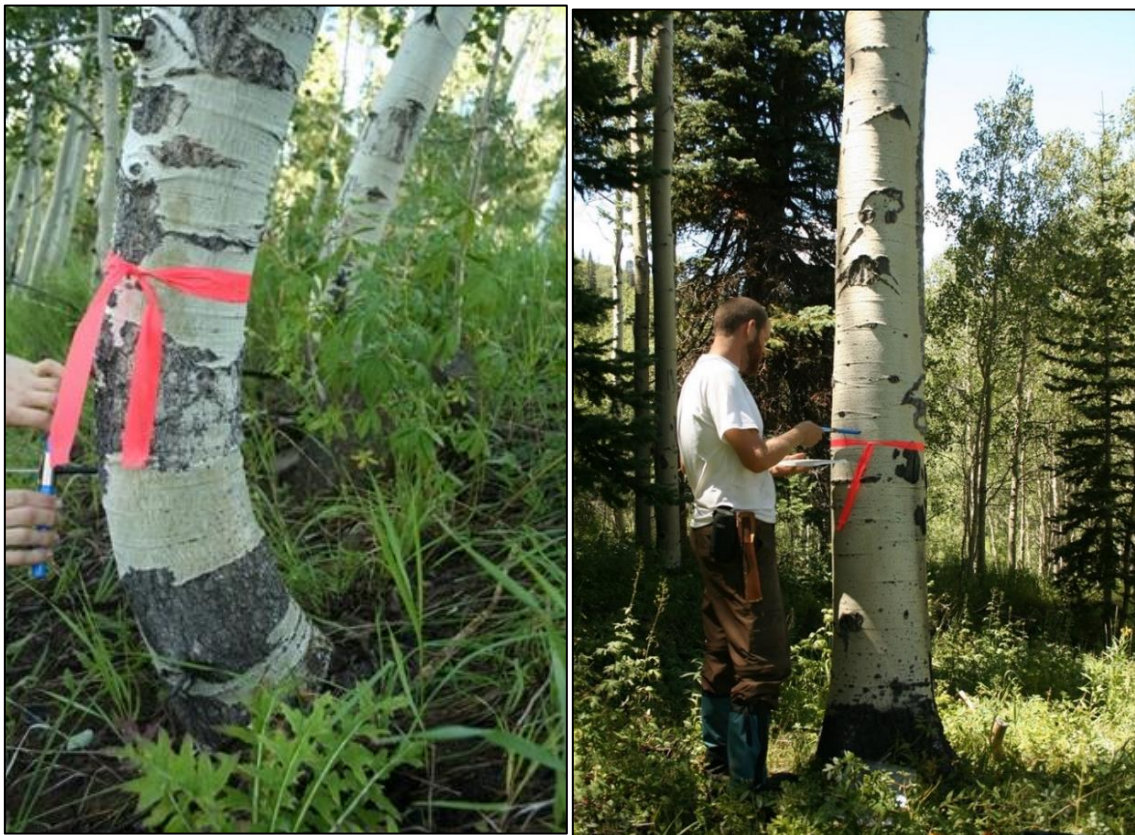
Figure 10. Coring trees. Coring through geotropic growth (10a) of impacted trees and at breast height of age referenced trees (10b). Personal photos, Aug. 2010.

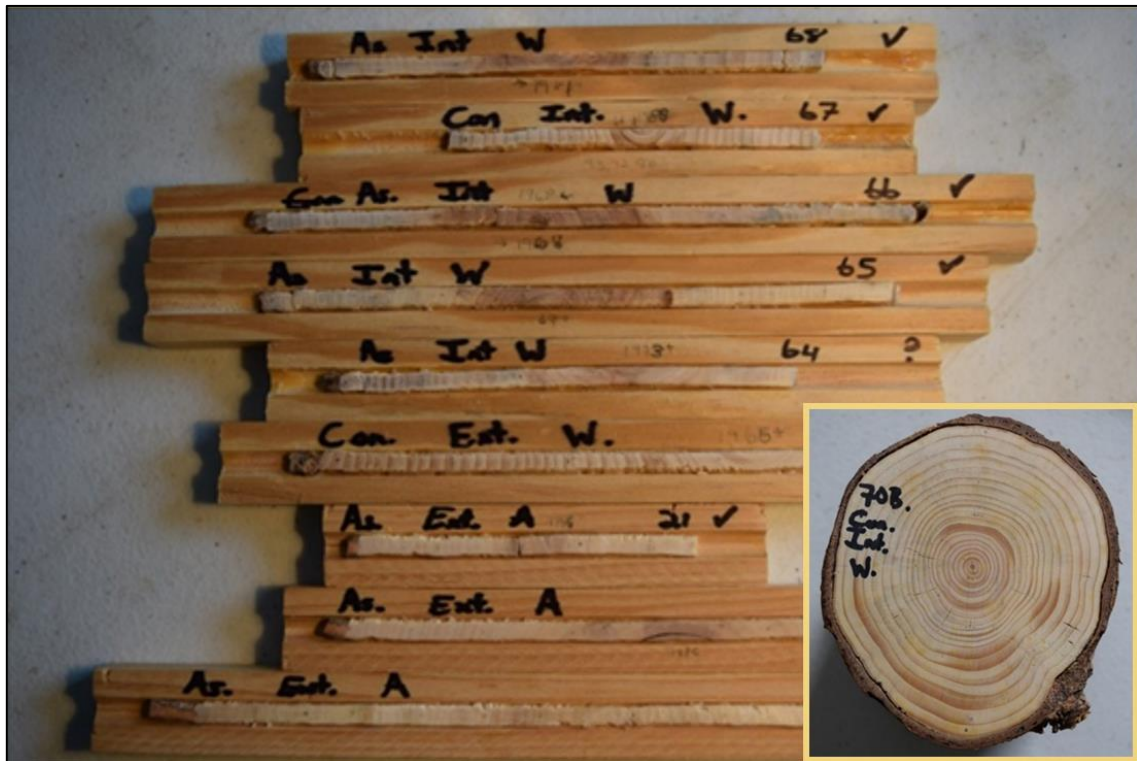
Figure 13. Cores and cookie. Examples of aspen and conifer in core. The conifer cookie demonstrates the complexity of movement at the junction of the three slides. Personal photos, March, 2015.

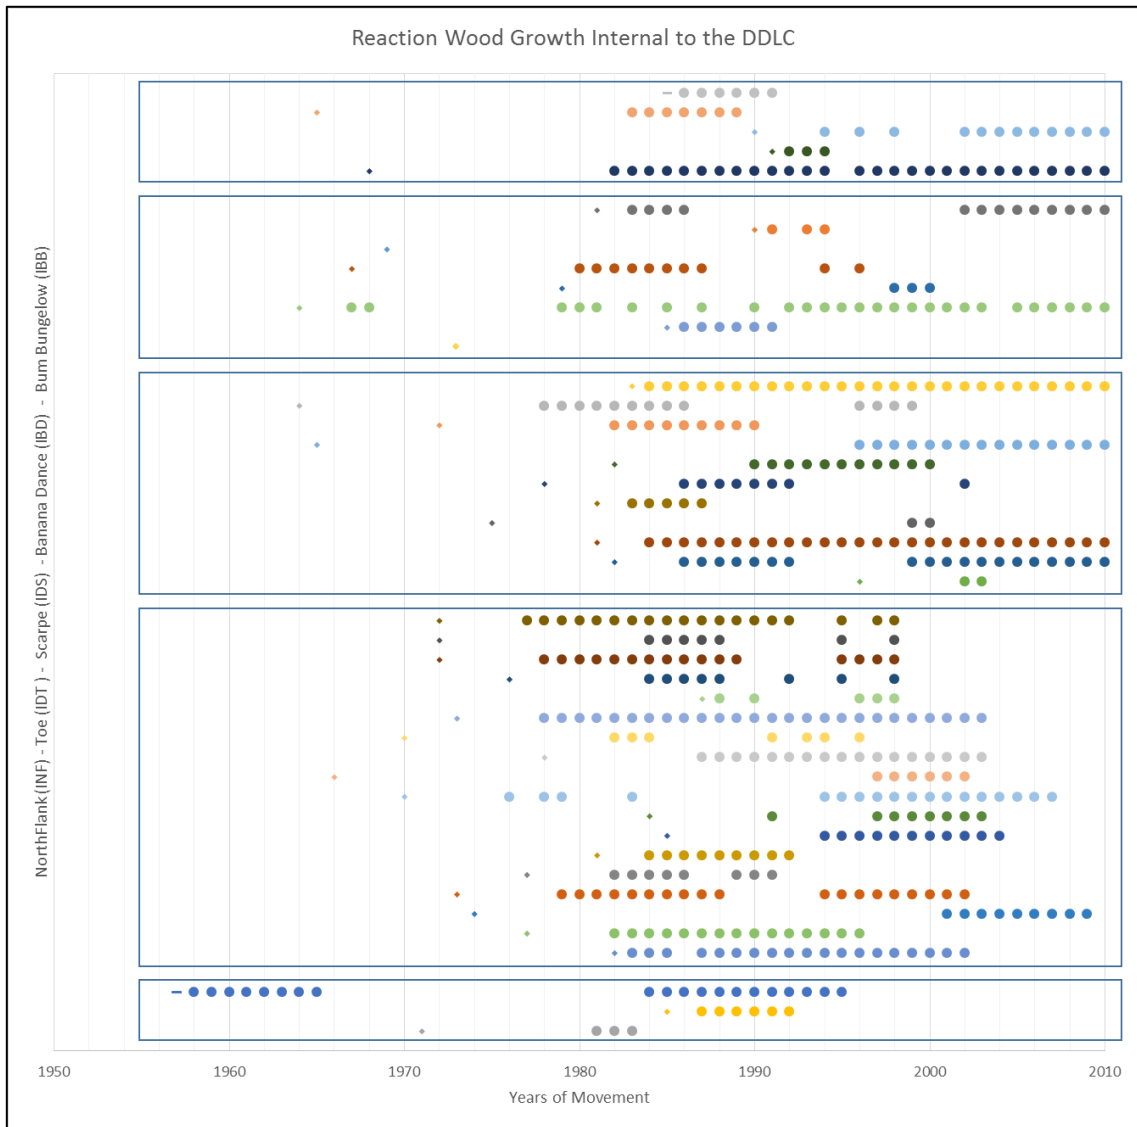
Figure 16. Graph of tree ages and response growth. The groupings are tree clusters as they occur on the complex. (X) indicates the age of the tree, the dots are tree ring years where reaction wood growth was observed in the individual tree within the tree cluster.

In Figure 16, the first response years of landslide movement as recorded in tree-ring cores are plotted by tree groupings. Years of activity that show response in only one of the groupings or directly following the response pattern of movement that follows

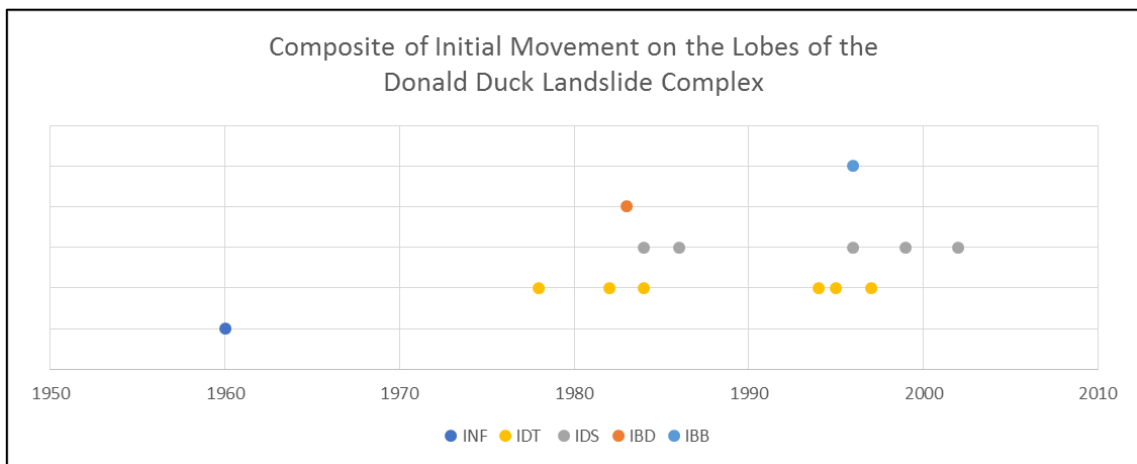
Figure 17. Composite graph of movement as indicated by statistically significant initiating movement as recorded in the reaction wood of the tree rings. The complex will have regained quasi-stability after internally adjusting from the initiating event before it will record the next initiating event.
