**"A FORMIDABLE LOOKING PILE OF IRON BOILERS AND MACHINERY":**

**RECONSTRUCTING THE CIVIL WAR GUNBOAT USS *WESTFIELD***

A Dissertation

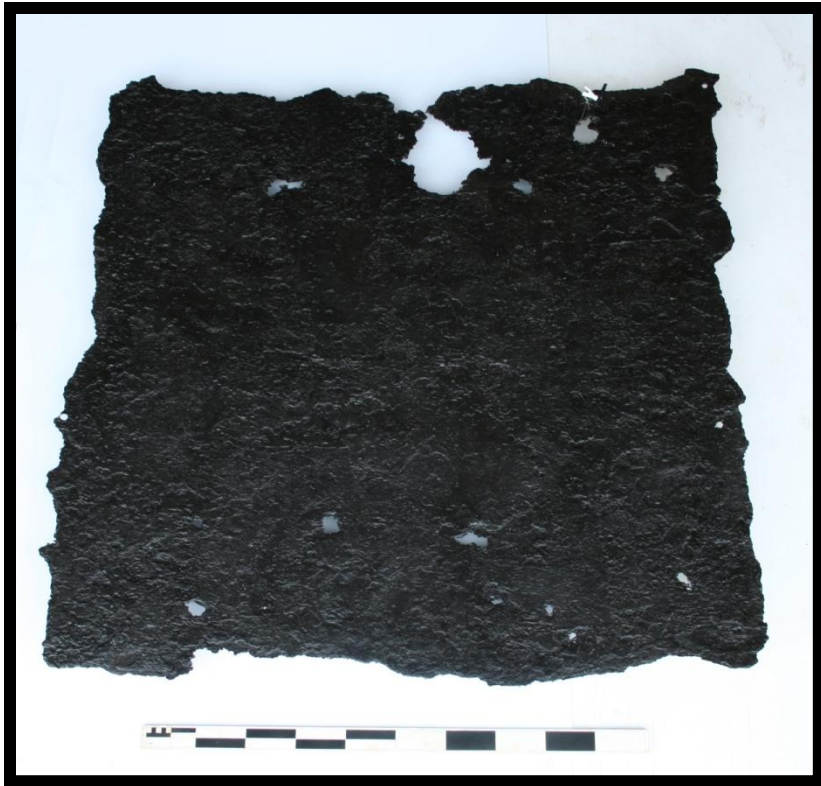
Figure 37. Square armored plate (Artifact 108-001; scale cm./dm.).

Six boilerplates used as armor were recovered relatively intact (Artifacts 102-006, 108-001, 111-001, 111-002, 111-003, and 122-045). Their sizes varied by a few inches due to corrosion along the plates' edges; however, the most intact plate (Artifact 108-001), measured 5 by 5 ft. (1.52 by 1.52 m.), allowing the original standard plate size to be determined (Figure 37). This size is consistent with the size of plates covering the cabin in the Memphis drawing of *Westfield* (Figure 27). Conservators determined that the plates were originally 5/16 in. (7.94 mm.) thick, sufficient only to protect the gun crews from small arms fire and possibly small canister shot.

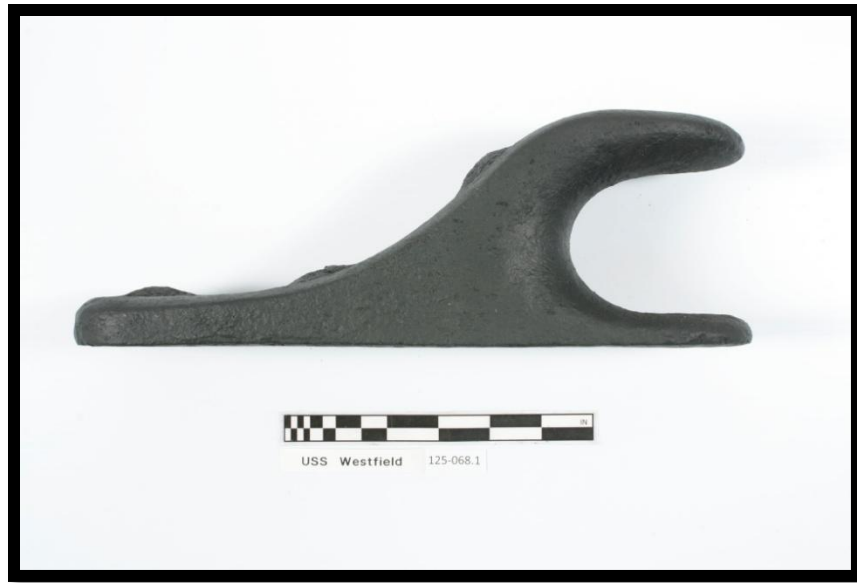
Figure 53. Cast iron rolling chock (Artifact 125-068; scale inches).

A single cast iron rolling chock (Artifact 125-068) was found near the stern area (Figure 53). This artifact was originally secured to the vessel with three bolts. Seen on ships today, rolling chocks were used to guide mooring lines when *Westfield* tied alongside another vessel or docked near land. Since the armored plates likely interfered with mooring lines, the rolling chock may have been mounted on the outer guard. On the lowest part of the bulwarks, the water way timber allowed for scupper holes that provided deck drainage, and ropes and chains that passed through hawse pipes. A lead pipe that was recovered is believed to have been used as a scupper hole (Figure 54). The object is too soft for chain, contains an internal diameter of 2 in. (5.08 cm.), which is likely too small for rope, and does not contain any of the internal wear marks that would be found on a hawse pipe. The pipe measures 14-1/2 to 15 in. (36.8 to 38.1 cm.) along the center, excluding the flanges, consistent with the original bulwark thickness through which the pipe passed. On each end, the metal has been hammered down to create a rim or flange. Along the flanges, small holes indicate that the pipe was secured to the bulwarks with nails.

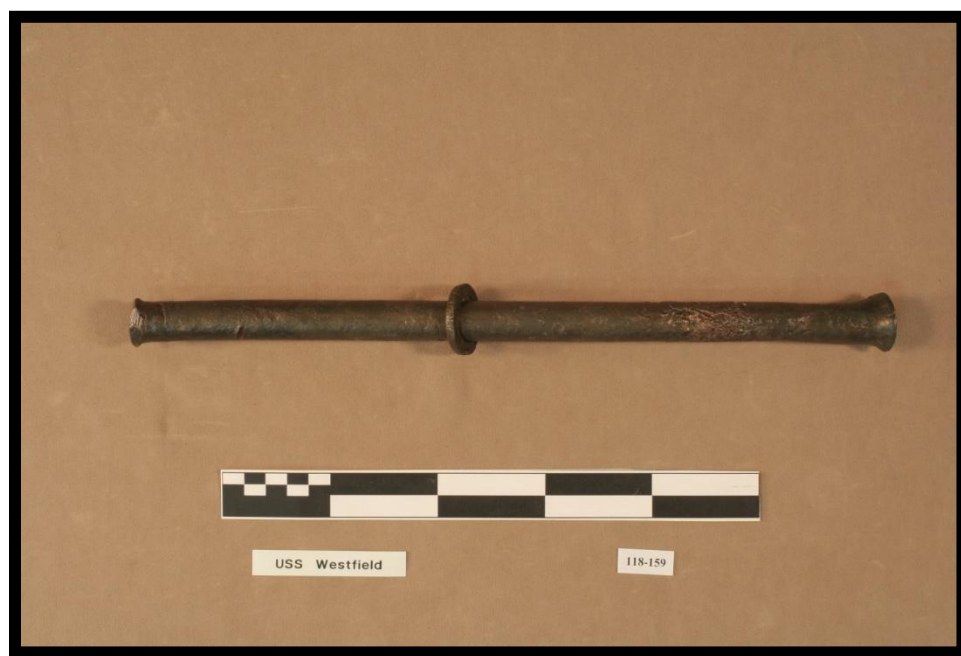
Figure 60. Cupreous through-bolts (Artifact 118-159; scale cm.).

The largest single category in the *Westfield* artifact assemblage is fasteners. Over 1,800 fasteners have been documented and include 1,565 tacks, 143 spikes, 94 bolts, and 18 screws. Though there are many different fastener types, certain examples were purpose-made for specialized uses. This includes small cupreous tacks for attaching sheathing to the hull, cupreous spikes used to nail planks to the frames and deck planks to the deck beams, and cupreous bolts used along the keel and sister keelsons. Cupreous metals are more resistant to corrosion resulting from salt in the marine environment. Thus, fasteners used below the waterline were predominately cupreous. Cupreous metal also prevented a galvanic reaction that would otherwise be created if the copper-alloy hull sheathing was secured with iron tacks. The sheathing tacks from *Westfield* are essentially small cupreous nails ranging from 1 to 1-1/2 in. (2.54 to 3.81 cm.) long, with a large diameter round head of about 1/4 in. (6.35 mm.) diameter (Figure 58). The cupreous spikes had three primary uses: single deck nails, double deck nails, and boat nails. Single deck and double deck nails fastened the deck planks to the deck beams, and boat nails attached planks to frames. Boat nails were of varying lengths, were square at the point, and generally rose-headed (McCarthy 2005:175). Deck nails from the *Westfield* site are typically 6 to 7 in. (15.2 to 17.8 cm.) long with an approximate 3/4 in. (1.90 cm.) square head (Figure 59). There are numerous cupreous through-bolts that are likely from the keel or keelson of *Westfield* (Figure 60). The larger bolts range from 10

to 19 in. (25.4 to 48.3 cm.) in length (some are broken) and have a shaft diameter of approximately 3/4 in. (1.90 cm.). Some examples, like Artifacts 107-035, 108-006, and 120-077, are through-bolts that still retain their clinch ring. The clinch ring is a round washer that was placed at either or both ends of a bolt. The act of hammering the bolt (clinching) caused the bolt head to flatten against the clinch ring and helped secure it in place (McCarthy 2005:181). The clinch rings have a diameter of approximately 1-1/4 in. (3.17 cm.).

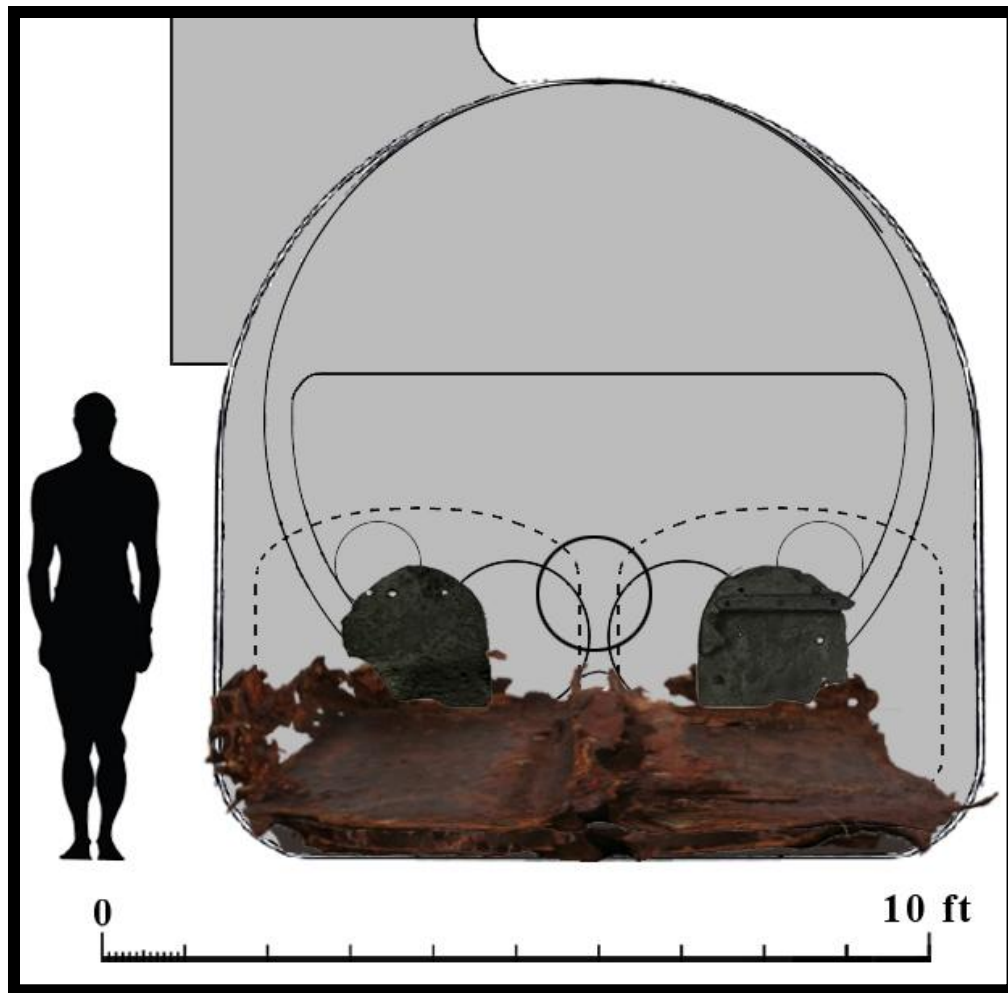
Figure 143. Fire door arrangement on *Westfield*; viewed front to back (by author).
