A REPORT ON
THE COYOTEPE REFUGEE CAMP
IN
MASAYA, NICARAGUA

by
Frederick C. Cuny, PIC
INTERTECT

COYOTEPE REFUGEE CAMP

The Coyotepe Refugee Camp, located 3 kilometres from Masaya, Nicaragua, was built to house refugees from the December 1972 earthquake in Managua.

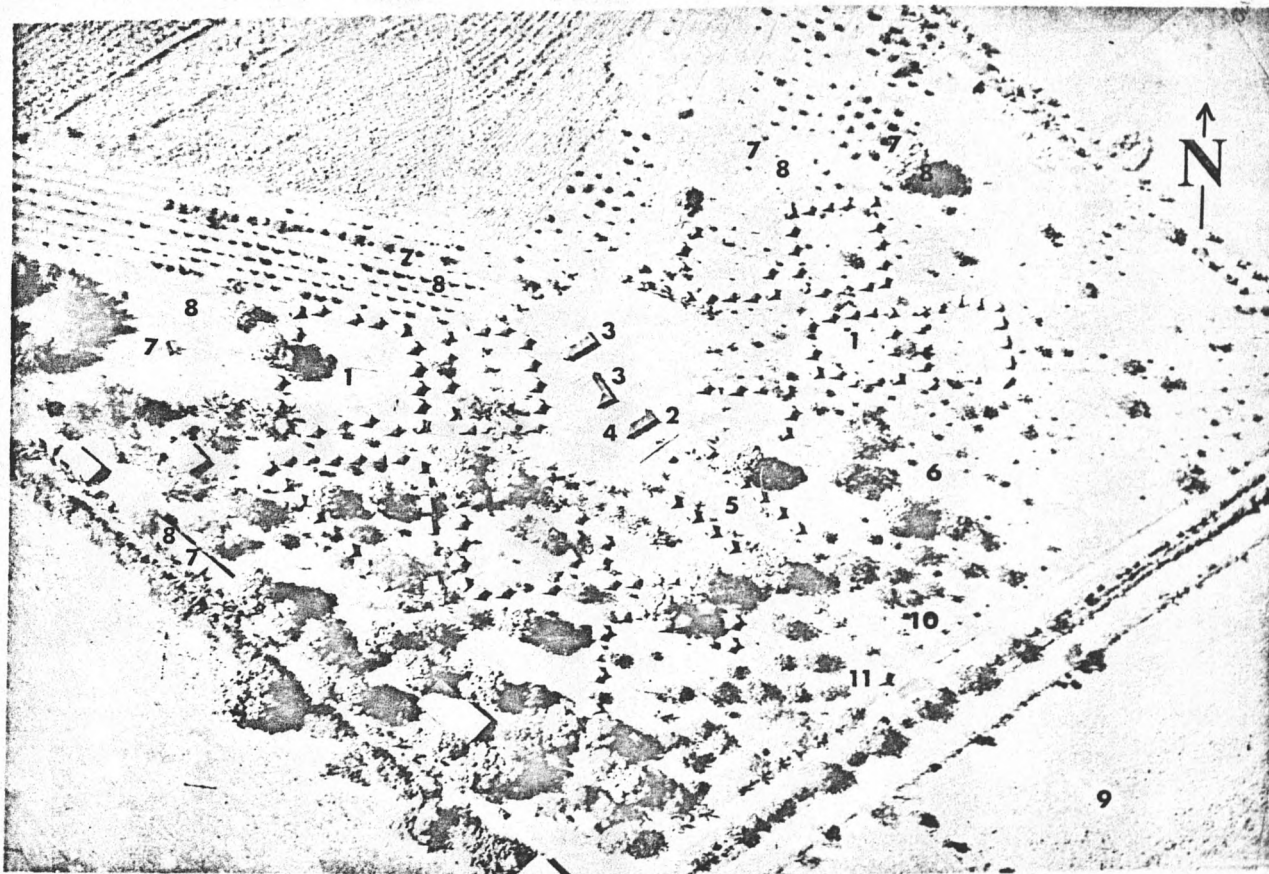
Aerial Photo of Stage I (11 Jan. 1973)

1. Housing Areas (Communities)
2. Administration
3. Clinic
4. Storage
5. Staff Quarters
6. Playground

7. Latrines
8. Showers
9. Heliport
10. Parking
11. Guardhouse
