HIGH SPEED ARRANGEMENT 1 SEALS IN WATER INJECTION SERVICE

ABSTRACT

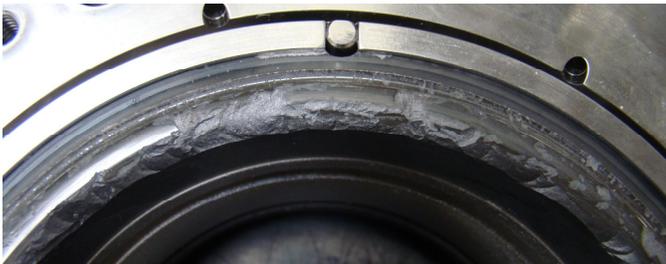
Figure 1: Stationary Face Damage

Multiple seal investigations showed similar failure modes; heavily worn seal faces (Figures 1 & 2) and signs of high vibration on parts with small design clearances. Fixing the issue of face wear and vibrational damage would be difficult enough. However, further investigation into how the pumps were operated revealed that the service was more demanding than originally expected. The pumps go through at least one start cycle per day. They also have a very long roll down period where the seals are operated well under the minimum speed requirement causing face contact. Lastly, the end user reported multiple instances of severe water hammer, some large enough to extrude the pump suction flange gasket.

A root cause analysis (RCA) was completed and identified four shortcomings in the seal design:

- Inadequate flush flow to the seal faces
- Inadequate slow roll capability
- Inadequate start/stop capability
- Excessive vibration damage between parts

The remaining issues identified in the RCA required dynamic seal testing to design and verify. The hard face combination selected for stability could not tolerate face contact with a water process fluid so a face feature was required. The original feature was designed to create lift while running at rated speed while still providing low leakage. Multiple seal failures showed that the faces were seeing hard contact that was wearing away the features and damaging the faces. The multiple start/stop cycles and slow roll operation were identified as the most likely times for face damage since the lift created was dependent on shaft speed. A new face feature design was needed to provide lift over the entire speed range including off-design conditions such as slow roll.

The original face features needed more than 750 RPM for non-contacting operation. The face feature pattern designed for testing produced full non-contacting operation under static pressure. This insures that the faces would not contact under any speed

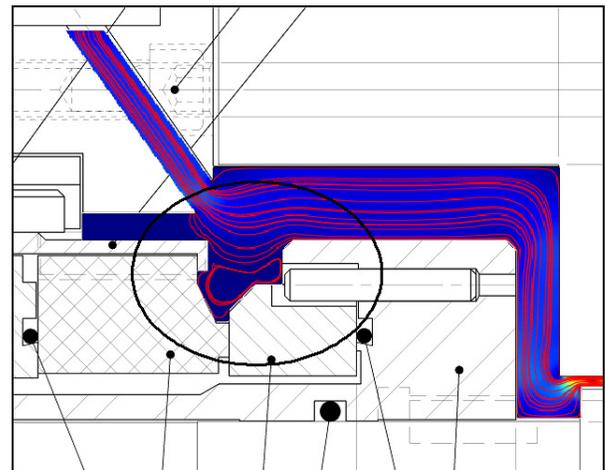
Figure 3: CFD Flush Flow Model

However, high speed can also create a thermal stratification in the seal where warmer fluid gets trapped at the faces due to the lower density. Cooler fluid coming in from the seal flush supply is heavier and is therefore pushed to the outside of the seal chamber by the centrifugal forces. This then prevents cool water from getting to the interface and further heats the water that is already there, which exaggerates the problem.

Computational Flow Dynamics (CFD) were used to analyze the existing flush flow and verify this effect. The high speed of the application was indeed causing a local recirculation at the faces that was not allowing cooler flush fluid to remove sufficient generated heat (Figure 3).

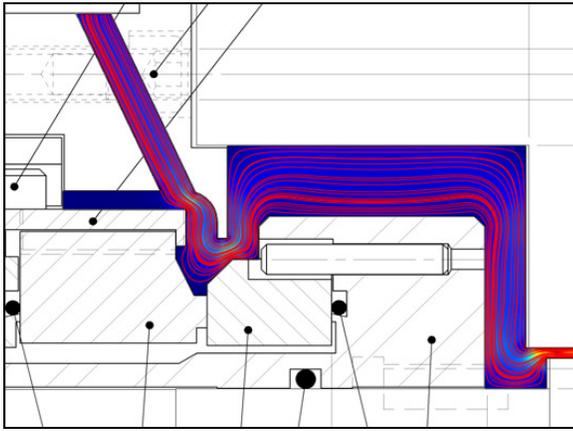
Figure 4: Flush Flow with Baffle Installed

A flush baffle can be used to drive fluid down to the face edge and break up any local recirculation. References of seals in similar high speed applications were used to determine a design for a baffle to direct flush flow to the faces. The baffle was then modeled in CFD and the shape and size were tuned to provide sufficient flush velocity and to break up any internal recirculation (Figure 4).

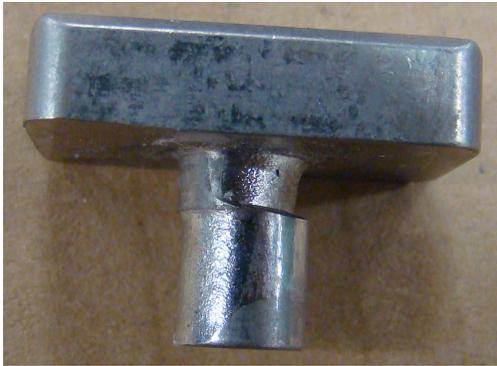
Figure 5: Pin Damage from High Frequency Vibration

Overall equipment vibration levels on the pumps in the field were very low. The damage seen in the seal parts was not coming from the equipment movement but from high-frequency movement between the seal parts. This is a result of the high fluid velocity around the seal and the relatively tight clearances between the parts. Vibration damage was centralized around the stationary face drive features. A T-shaped pin is used to hold two parts together and transfer torque from the stationary face to the seal gland. The combination of vibration and excessive clearance between the pins and the other parts in the assembly caused damage to the pins and the holes they engaged (Figures 5 & 6).

This problem had not resulted in failure but was clearly a sign of problems to come. The allowable movement increased as the pin holes enlarged and ultimately, the assembly would not be driven once the pins sheared. Failure of the drive mechanisms in this service would cause a major seal failure and could even damage the pump if not identified quickly.

The pin holes are typically drilled separately in the two mating parts so clearances were kept loose to allow easy assembly. The holes needed to be drilled in both parts at the same time so that the clearance and tolerance could be reduced without affecting assembly. A match-machining fixture was designed that holds the two parts together along with a dummy spacer to represent the stationary face. The holes could then be made using a high precision reamer bit rather than a standard drill bit. The parts would be marked to indicate their angular position when drilled to speed assembly.

Reducing the clearance between the parts minimized the allowable movement but did not prevent the vibrations from occurring. Absorbing the energy would also help prevent the movement from ever happening. A gasket was placed between the parts to dampen the vibrations and prevent movement (Figure 7). This gasket has no sealing purpose; it is only a vibration control feature.

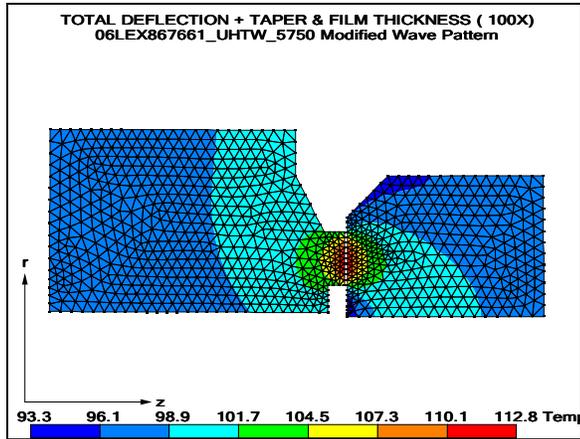
Figure 8: FEA Results for Final Face Design (8400 RPM)

Finite Element Analysis (FEA) was used to optimize the stationary face and to design the face features used to provide load support and film thickness (Figure 8).

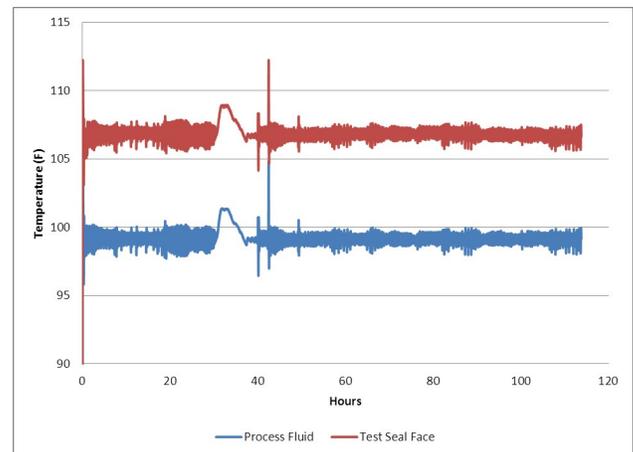
Figure 9: Qualification Test Temperatures

Qualification Testing was performed at rated pump speed and pressure for 100+ hours. This was used to establish and evaluate equilibrium operating conditions, seal leakage, seal face temperatures and face wear rate.

Seal face temperatures were less than 15°F over bulk seal chamber temperature for the entire test protocol (Figures 9, 10, 11 & 12). This is slightly lower than the pre-test FEA predictions and is much lower than predictions for flat faces under the same conditions.

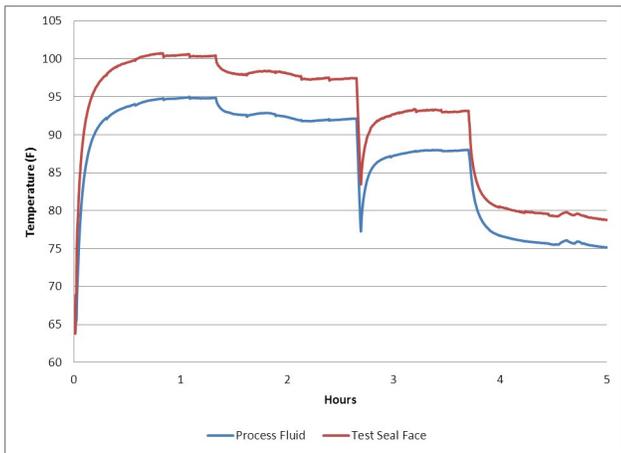
Figure 10: Pressure/Speed Variation Stage Temperatures

Pressure and Speed Variation Testing was performed at four different speeds and four different pressures to evaluate the effects of changing operating conditions (four speeds with four pressure points at each speed).

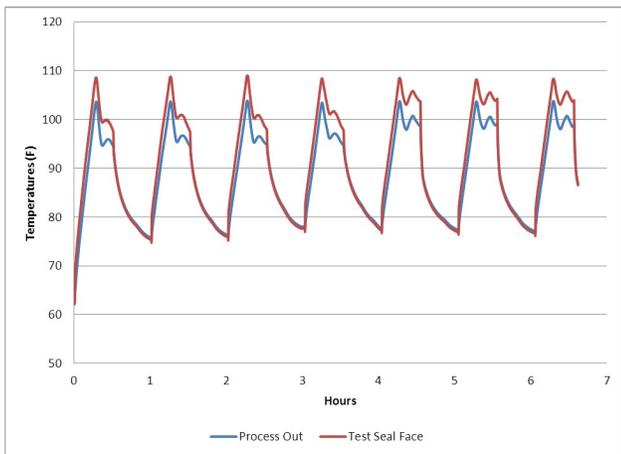
Figure 11: Start/Stop Stage Temperatures

Start/Stop Testing was performed to evaluate the effects on the seal performance from multiple start/stop cycles. A total of 7 cycles would be performed with the seal running for one hour under rated conditions before the stop occurred.

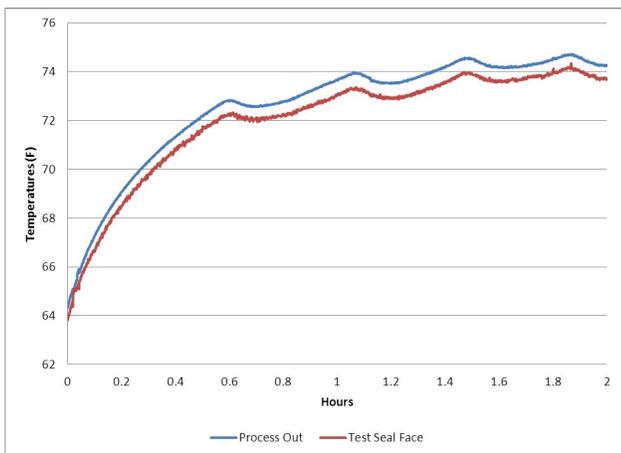
Figure 12: Slow Roll Stage Temperatures

Slow Roll Testing was performed to verify full lift off at low speed. This test would operate at 180 RPM, which is the minimum stable speed for the tester. This stage would be performed at both minimum and maximum rated seal chamber pressures.

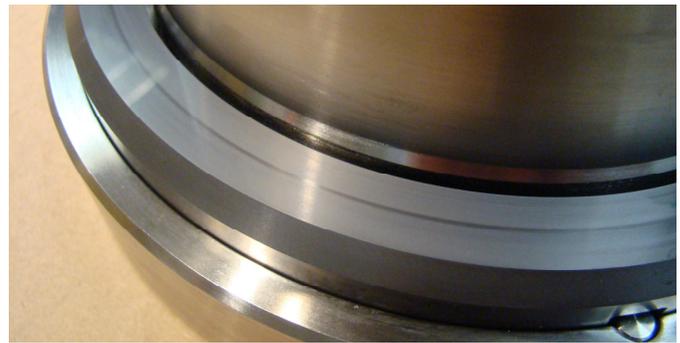
Figure 13: Rotating Face Post Test

The faces were inspected for damage after each stage. No damage was found and the faces were simply wiped with solvent and re-installed for the next test step. A very faint circumferential track is seen on the rotating face (Figure 13).

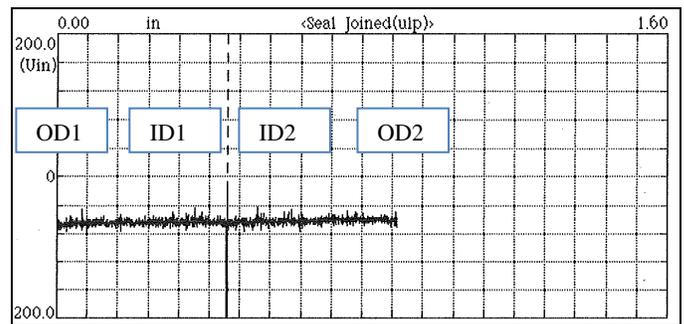
Figure 14: Post-Test Rotating Face Profile

Post-test profile traces show there is no depth to this mark, only a slight polish that changes the surface finish (Figure 14). There were no marks on the stationary face and profile traces showed no signs of contact (Figure 15).

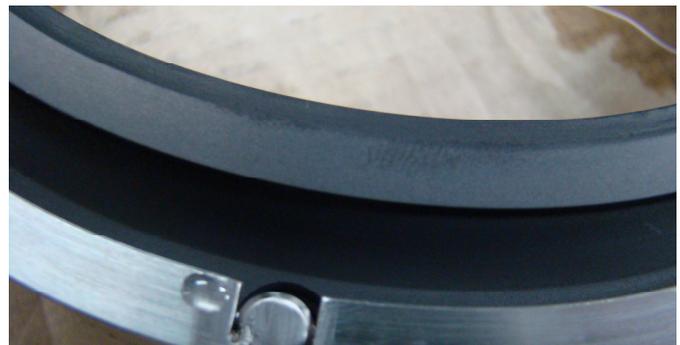
Figure 16: Post-Test Thrust Balance Seal Stationary Face

The carbon face used in the thrust balance seal was also undamaged and was not repaired throughout the entire test program (Figure 16).

The thrust balance seal carbon face produced more erratic leakage under all conditions. This is likely a result of the lower stiffness and thermal conductivity as compared to silicon carbide (Lebeck 1991). The silicon carbide face was chosen for the final design since the leak rate was consistent and there was no face damage. Silicon carbide also provides the highest resistance to water hammer damage since it has a very high compression strength.

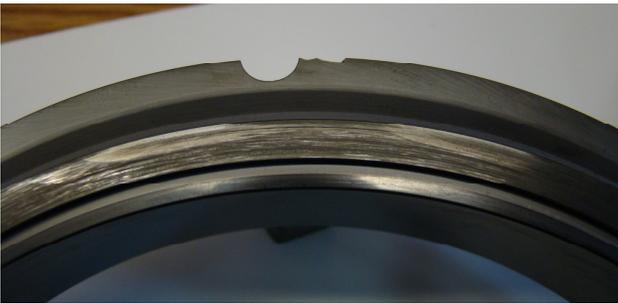
Figure 17: Test Seal Stationary Face After Slow Roll Testing

The slow roll testing was performed again using the original face feature pattern after the entire test plan was complete. This was done to verify that the damage seen on previous failures was a result of insufficient face separation at low speed. The test ran for 20 minutes at 1200 RPM when the seal face temperature rose quickly and a grinding sound was heard from the tester. The faces showed hard contact damage when removed (Figure 17).

The test seal was refurbished and run again under the same conditions. The temperatures spiked and a grinding sound was heard at 700 RPM on the second iteration. The faces showed hard contact damage when removed. This testing verifies that the hard contact at low speeds would occur with the previous face feature design and provides a link to previous failures.

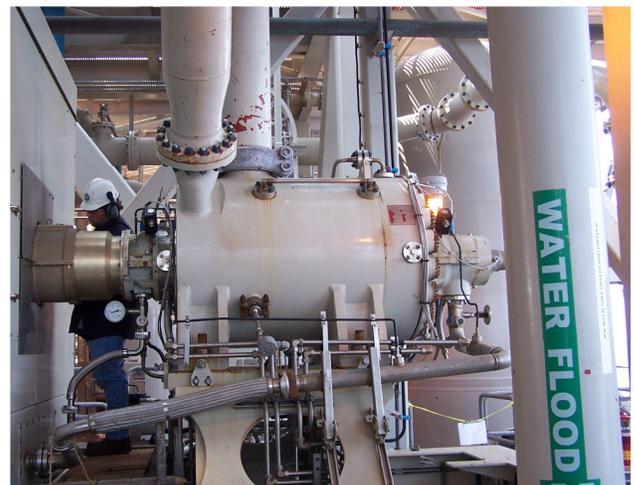
Figure 18: Application 1 Installed Pump

Mean Time Between Failures (MTBF) for the original seal design was three months. Seals using the newly developed design features have not failed since being installed over two years ago. The installed pump can be seen in Figure 18 below.
