## THE EVOLUTION OF SUCCESSFUL ELIMINATION OF ELECTRO-CORROSION IN MECHANICAL SEALS FOR REACTOR- AND BOILER FEED WATER PUMPS HANDLING ULTRA-PURE WATER

### ABSTRACT

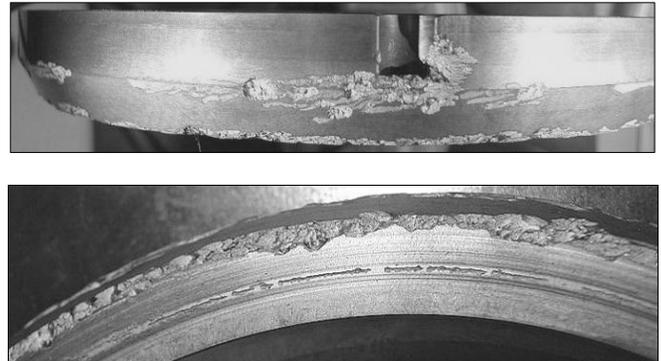
Close examination of parts using Scanning Electron Microscopes (SEM) and Energy Dispersive X-ray (EDX) techniques, revealed that in this corrosion process silicon carbide is transformed into silicon oxide, which sometimes can be found as white coloured comet like trails attached to the edges of the craters. Presence of free oxygen in the chemical composition of the seal face material has become a valuable indicator to prove the presence of electro corrosion. In fact, laboratory testing in ultra-pure water demonstrated that the initial start of electro corrosion damage can be found within only a few hours into the test. Figure 1 shows the formation of electro corrosion on  $\alpha$ -SiC rotating seal face used in a BWR reactor feed pump seal, which operated for 21 months under continuous operation.

Figure 1. Electro corrosion on an  $\alpha$ -SiC rotating seal face, used in an European reactor feed pump seal

In April 2006, the previously mentioned Scandinavian utility returned a decontaminated  $\alpha$ -SiC bi-modal rotating seal face, which had been in continuous operation for about 21 months. Reference is also made to Figures 1 and 2. This particular seal face had operated at a sealing pressure of 2.8 MPa in ultra-pure reactor feed water with an electrical conductivity less than 0.1  $\mu\text{S}/\text{cm}$  at a circumferential speed of 43 m/s for the duration of 15500 hours. This specific rotating seal face material had been recommended by the vendor in 2004, based on close examination of the original used rotating

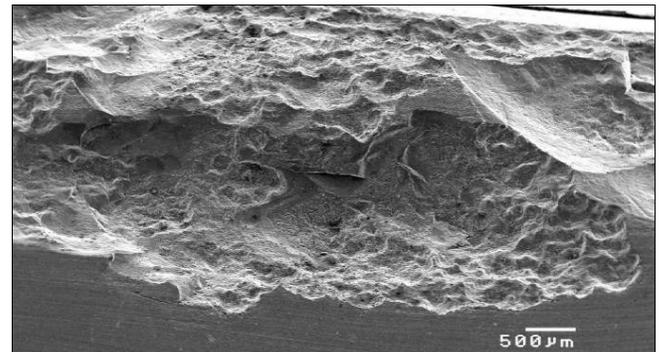
In Figure 2 an image is shown of the same seal face using a SEM with a magnification of 20X. The formation of nuclei is clearly visible with further evidence of actual chipping damage.

Figure 2. Corrosion nuclei with subsequent chipping of the affected areas of a  $\alpha$ -SiC rotating seal face

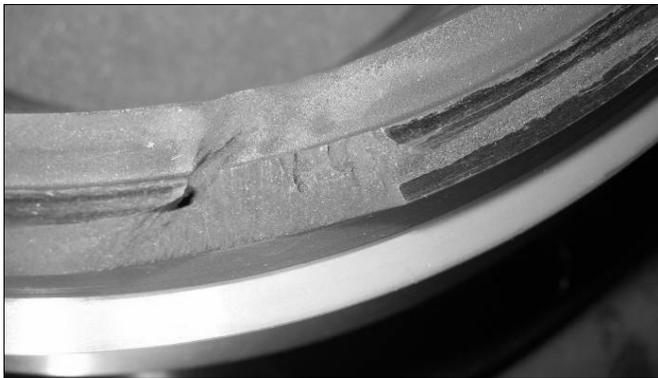
As the relative soft carbon graphite material is structurally weakened by this binder depletion, it leads to breaking out of small carbon graphite particles with a progressive development into formation of uncontrolled radial flow channels across the wear nose of the carbon graphite seal face. Progressive leakage flow of high velocity, degassed feed water increases the risk of material erosion damage. Figure 3 shows an example of a fully developed radial flow channel in a resin impregnated carbon graphite seal face, which was taken out of service at a European BWR power station.

Figure 3. Radial flow channel development carbon seal face

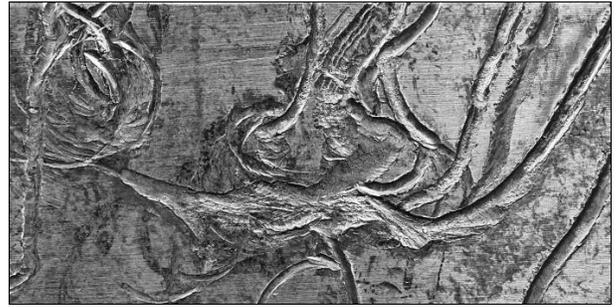
A third indication of electrical activity in high speed feed pumps are damages observed between different pump –and seal metal parts or between a metal and a non-metallic part within the mechanical seal itself. The damages found are typically quite deep, erratic shaped lines and grooves. Figure 4 shows a close up photo of a metal seal face holder used in a fossil feed pump application operating on CWT feed water. While such damage looks severe and parts may need replacement, they seldom lead to unexpected seal failures or problems.

Figure 4. Metal part damage from electrical activity

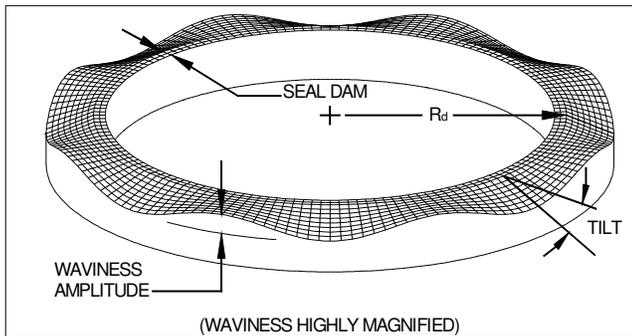
Wavy face technology used in mechanical seals involves the use of one of the two seal faces being equipped with circumferential waviness with radial tilt and seal dam. Circumferential waviness by itself was first explored over forty years ago and was shown to be a source of hydrodynamic lubrication. The addition of radial tilt and a seal dam has also long been established in literature and practiced in a wide range of applications (4). Figure 5 displays a highly magnified graphic of a wavy face geometry.

Figure 5. Wavy face geometry

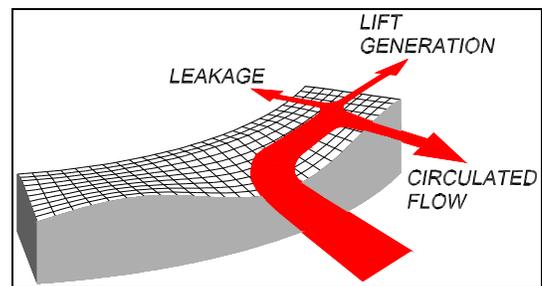
Figure 6 illustrates how the flow of the fluid is distributed inside a single wave feature. Under pressurized and dynamic condition, the fluid enters the (deepest) valley portion of the wave and then undergoes compression toward the wave peak due to rotational movement of the pump shaft transmitted onto the rotating seal face of the mechanical seal. At the wave peak, the fluid pressure is higher than the surrounding fluid, and so a small portion migrates across the seal dam as normal intended seal leakage. Some of the liquid travels across the wave and is ultimately responsible for the lift-off effect resulting in hydrodynamic or full lift-off lubrication. However, the majority of the fluid is circulated back into the seal chamber, which is at a lower fluid pressure. This recirculation effect of the wave profile assists in hindering debris from entering the actual sealing interface. In-house testing and examination of seals in field applications operating in debris laden applications have verified the functionality of this feature.

Figure 6. Fluid distribution inside a single wave

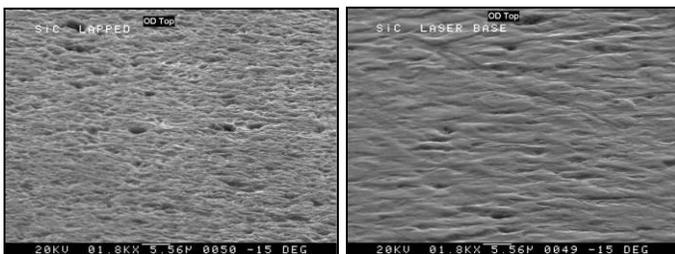
Another crucial step forward made with the use of this new laser surface treatment was a further reduction in the final surface roughness, which reinforces the self-cleaning effect inside the circumferential waviness pattern when dealing with tiny particulates and dirt in the fluid system. Figure 7 shows the difference in surface roughness between a traditional lapped SiC seal face and one that has been treated with the preferential surface treatment laser process. Use of the preferential surface treatment technology was integrated into the R&D program launched to solve the seal face generated EC problem.

Figure 7. (Left) Lapped SiC, (right) laser processed SiC

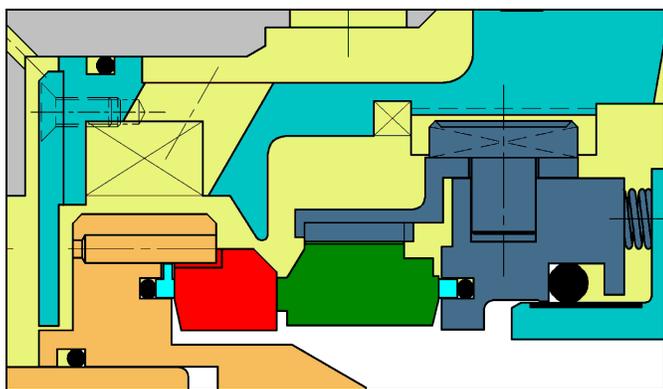
Pump installation was conducted in May 2009 and after 15840 operating hours an opportunity came about, not related to the mechanical seals, to open up the pump and inspect the mechanical seals in the presence of the Jämschalde station personnel. Figure 8 shows this seal design, using hard-soft seal face combination, tested at Jämschalde power station in the period between May 2009 and July 2011. Interesting to note is that this particular feed pump underwent a total of 37 operational transients, going from normal plant operation at full speed to slow roll conditions during stand-by mode.

Figure 8. Mechanical seal using a resilient hard-soft seal face combination with anti-EC technology

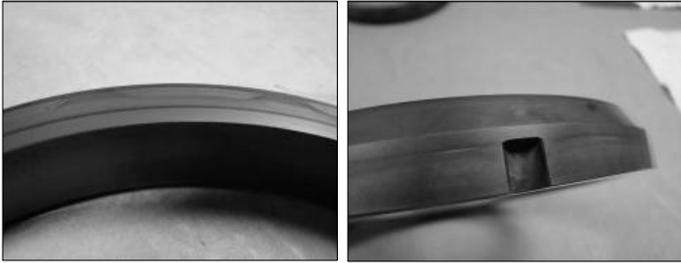
out for a detailed inspection. The inspection revealed that the seal faces were in excellent condition, which confirmed that the combination technology of precision face topography and preferential surface treatment is able to withstand seal face generated EC down to a water purity of  $0.5 \mu\text{S}/\text{cm}$  without sustaining any damage. Figure 9 displays one of the rotating seal faces as found after 7000 hours of operation.

Figure 9. SiC rotating seal face after 7000 hours of operation in  $0.5 \mu\text{S}/\text{cm}$  electrically conductive feed water

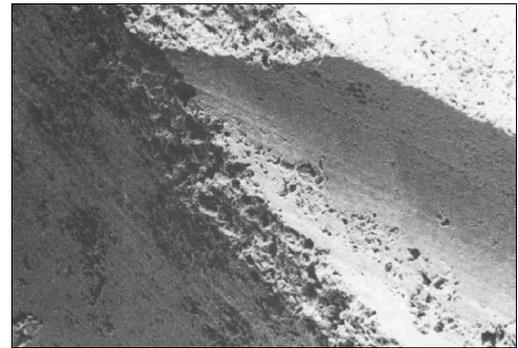
Cavitation may destruct seal face materials in either the sealing gap or on the outer ring surface in contact with the liquid. The latter can be caused by turbulences rotating with the ring. Discontinuous edges like lubricating grooves give rise to local degassing and cavitation. SiC has a weak ability in absorbing energy during deformation by the impact. Material removal is initiated by propagation of cracks at the grain boundaries or at the surface. Most energy is dissipated by crack formation, which leads to more frequent material removal. The absorbed energy to remove a certain volume of material by cracking is much less than when removing the same material through plastic deformation. It is the reason why brittle materials are less resistant to cavitation. Figure 10 shows damage of SiC seal ring in the vicinity of a lubricating groove.

Figure 10. SiC face damage lubricating groove

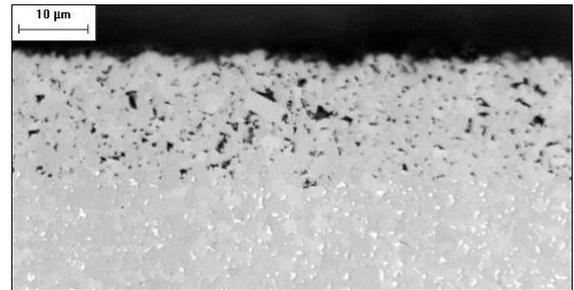
Use of tungsten carbide with nickel based binder has been used in nuclear and fossil feed pump applications for many years. When used in a neutral water applications these materials have demonstrated leaching of the nickel binder located in between the hard tungsten carbide crystals. This leaves behind an abrasive tungsten carbide surface that can damage the counter carbon graphite seal face. Figure 11 shows a close up of a tungsten seal face where the nickel has disappeared leaving behind the tungsten carbide crystals. If left in this state, also the base material would be attacked.

Figure 11. Removal of the white nickel binder in a tungsten carbide seal face, used in neutral water

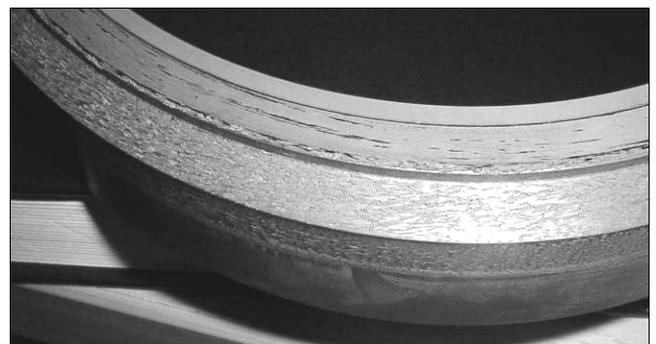
Experiments held to study the oxidization and dissolution of tungsten carbide in water (8) has shown that this material can suffer from ultra-pure water corrosion, as can be seen in Figure 12. Laboratory testing of nickel impregnated tungsten carbide conducted has also revealed the formation of what at first are small radial flow channels. These flow channels can grow from the seal face inner- or outer diameter and then develop into the sealing interface area where they will cause an uncontrolled hydrodynamic lift off effect raising seal leakage. Using a scanning microscope, these flow channels can be visualized and even measured. Actual field experience has shown that significant formation of radial flow channels can develop even after a few months into operation.

Figure 12. Tungsten carbide seal face with severe corrosion damage, fossil feed pump application

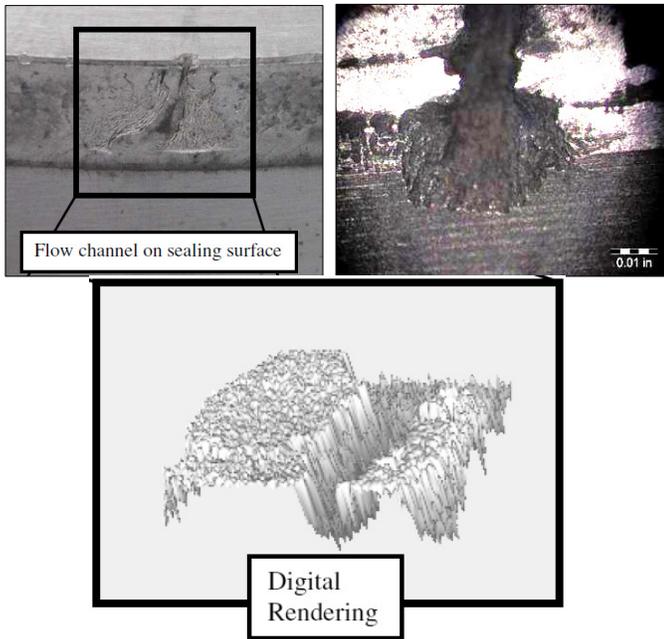
water temperature of 38 °C, sealing pressure of 4.0 MPa and seal's circumferential speed around 48.3 m/s.

Figure 13. Radial flow channel development on the outer diameter of a tungsten carbide rotating seal face

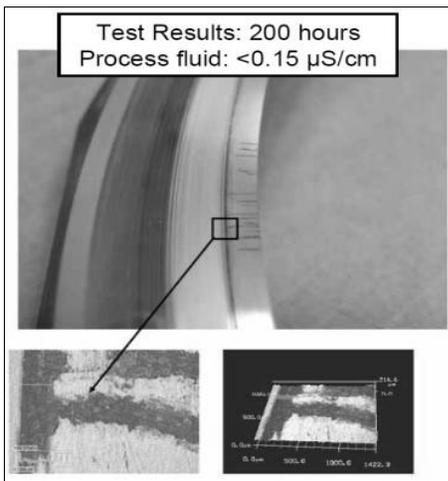
Figure 14 is an image of radial flow channel development on the inner diameter of a tungsten carbide rotating seal face tested in ultra-pure water for 200 hours, whereby severe pitting and erosion type flow channels have been developed. The depth of the flow channels measured in this tested seal face were 0.001” or 0.025 mm deep and these were observed around the entire circumference of the ring. While the radial flow channels were not yet protruding into the wear track of the seal face, in time they could lead to a premature failure of the mechanical seal due to uncontrolled hydrodynamic lift off effects created by these same channels.

Figure 14. Radial flow channel development inner diameter of a tungsten carbide rotating seal face

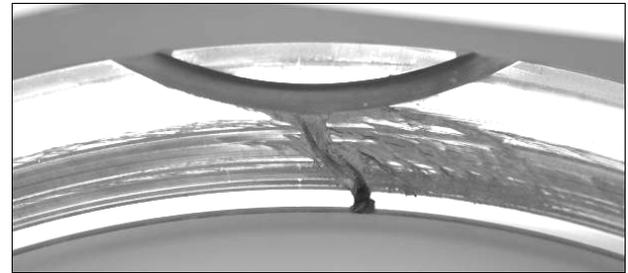
Rotating seal faces made from tungsten carbide, which have been designed using sharp edges, such as the ones used as for lubrication grooves, seem to be particularly prone to this damage mechanism. With reference to the hypothesis that this damage could be the result of an accumulation of high amounts of static electricity stored into the tungsten carbide material, it appears that the presence of sharp edges may promote the accumulation of the static charge, much like the tip of a spark plug, until the limit of material's capacitive energy storage has been reached and the charge is suddenly discharged. Damage as shown in Figure 15 can occur within months of operation and has resulted in unscheduled outages of power stations not being able to maintain system pressure due to high seal leakages.

Figure 15. Developed radial flow channel with erosion in a tungsten carbide rotating seal face using Mayer lubrication groove technology

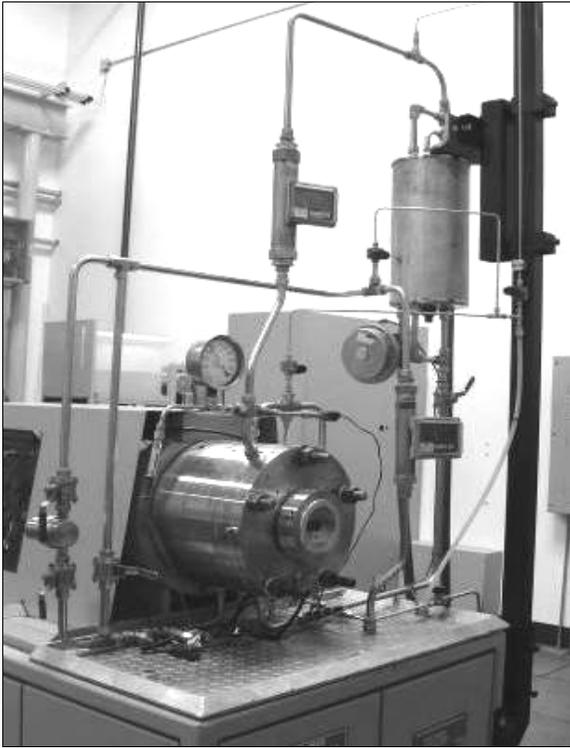
To rule out influences from external electrical sources, the two seal test units used for this experimental testing were designed in such a way that they were electrically isolated from ground, including the interconnecting seal system piping. Using tester hardware made from AISI 316 stainless steel, residual magnetic influences were minimized, which may have affected testing. Figure 16 shows one of two seal test units used for these experiments.

Figure 16. Seal test unit used for EC testing

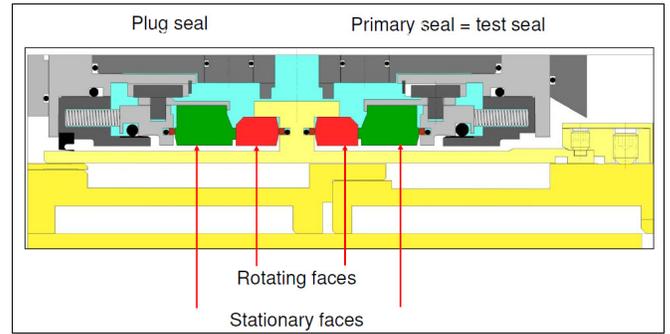
During some tests, a single ceramic rotating seal face was placed in between the plug- and test seal. This separate rotating seal face was installed using electrically insulated materials to ensure it would not be influenced by the plug- or test seals. The purpose of these specific separate spinning seal face tests was to investigate the friction effect between a rotating hard face and the ultra-pure water, without this part being subjected to other types of friction, such as potentially created through asperity contact with a carbon graphite counter face. These single ceramic seal face spin tests proved to be very enlightening as they too revealed formation of EC on the ceramic ring's surface, although the EC effect was less strong compared to EC damage observed in a traditional two seal face system being tested under the same conditions.

Figure 17. Test seal set up

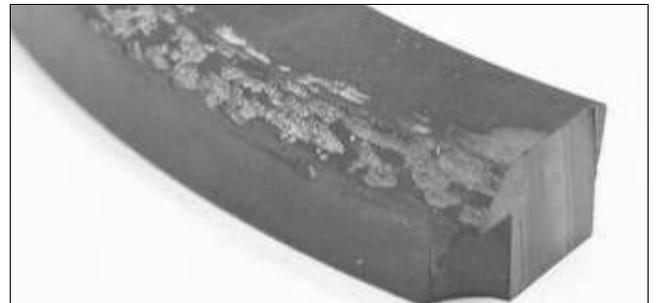
The second step was to verify if the specific rotating seal face damage as observed in actual BWR feed pump seal applications, could be repeated under controlled laboratory conditions. This appeared to be the case. Figure 18 shows a fine grain direct sintered SiC rotating seal face after 12 months of operation in a BWR feed pump. Figure 19 shows the same SiC material but tested for a period of merely 184 hours under the test conditions as previously defined. The damage observed is very similar and demonstrates that the benchmark laboratory test conditions, plus the design of the test unit are comparable to actual field conditions in BWR reactor feed service. BWR reactor feed service being identified as one of the most challenging high speed ultra-pure water applications to be sealed. Interesting to note is that the drive notches which are made in the back of the rotating seal face to drive the ring tend to be susceptible to seal face generated EC damage. Something often observed during the duration of this development program.

Figure 18. Rotating SiC seal face after 12 months in BWR operation

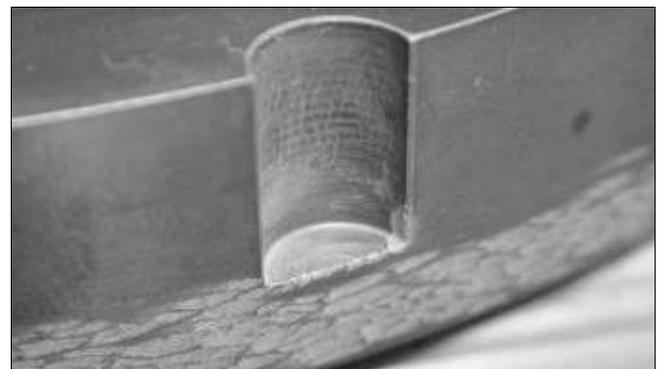
Figure 19. Same SiC seal face material tested 184 hours under benchmark laboratory conditions

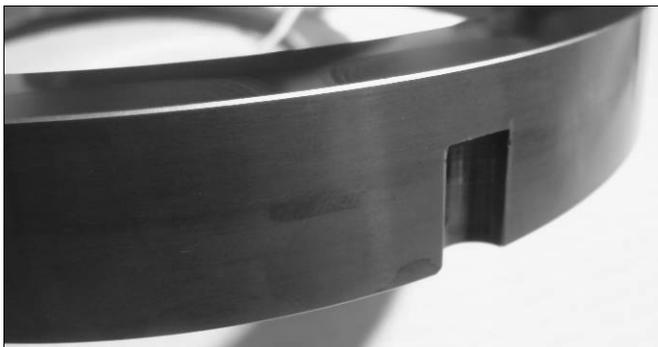
The second test used exactly the same test set up and materials as in the first test, except now the water's electrical conductivity was kept between 20 – 30  $\mu$ S/cm and the seals were tested for 300 hours. Upon inspection, no signs of seal face generated EC were found on either of the 2 rotating SiC seal faces, nor any other type of electrically induced damage was observed. The seal faces looked in pristine condition as can be seen in Figure 21.

Figure 21. Rotating SiC seal face after 168 hours in 20 – 30  $\mu$ S/cm electrically conductive water

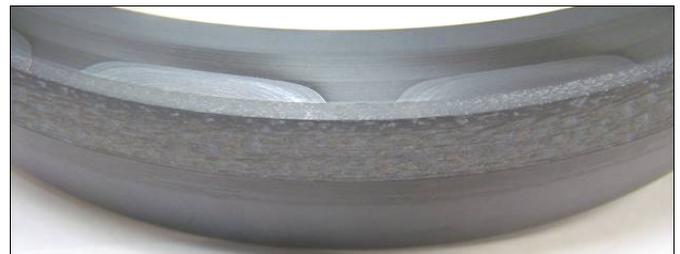
A test was set up using a specific  $\alpha$ -SiC rotating face material specifically recommended by a vendor incorporating the precision face topography and preferential surface treatment technology as field tested versus an iso-statically molded resin carbon graphite stationary seal face. These seal face materials were used for both the plug- and test seal. A test was run for 168 hours under the benchmark conditions and upon inspection of both rotating seal faces, significant seal face generated EC damage was found on the chamfered area of the rings, as can be observed in Figure 22.

Figure 22. Seal face generated EC damage when tested at 48.3 m/s circumferential speed

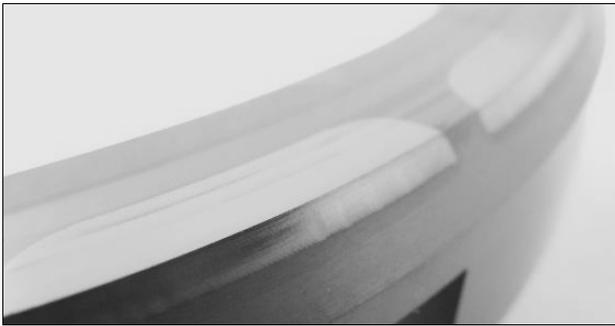
Upon detailed inspection, no seal face generated EC was found on both rotating seal faces tested, nor was there any other electrically induced damage found in the remainder of the hardware. Figures 23 and 24 show one of the  $\alpha$ -SiC rotating seal faces after testing, appearing to be in excellent condition.

Figure 23. Rotating SiC seal face after a 168 hour test at 15.8 m/s circumferential speed

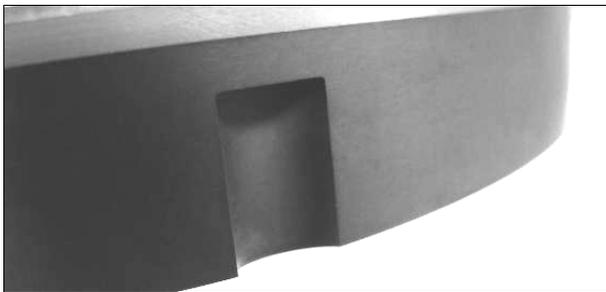
Figure 24. No seal face generated EC damage observed at seal face drive notches

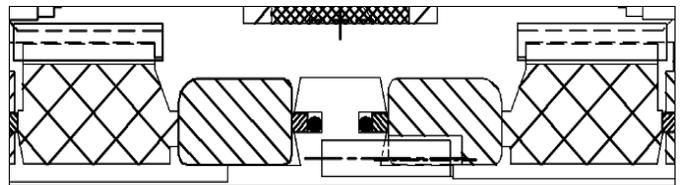
For these tests a rotating seal face design was used with a smooth outer diameter and a fillet instead of a chamfer. The drive notches, usually prone to seal face generated EC, were located at the inner diameter to minimize water turbulence at the outer diameter. The principle of this design is shown in Figure 25. The plug seal used a  $\alpha$ -SiC bi-modal SiC rotating face, whereas the test seal used a fine grain self-sintered SiC. Both these rotating faces ran against the same resin impregnated carbon graphite material, both of which were equipped with a wire to ground.

Figure 25. Fillet design rotating face with internal drive pins

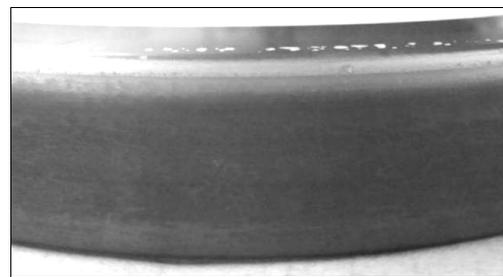
Figure 26 shows the fine grain self-sintered SiC tested for 168 hours under ultra-pure water conditions at 30 °C. Figure 27 shows the same seal face material tested for 168 hours under ultra-pure water conditions at 55 °C.

Figure 26. Fine grain SiC rotating face tested at 30 °C

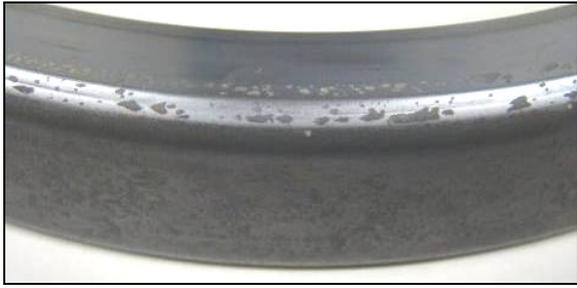
Figure 27. Fine grain SiC rotating face tested at 55 °C

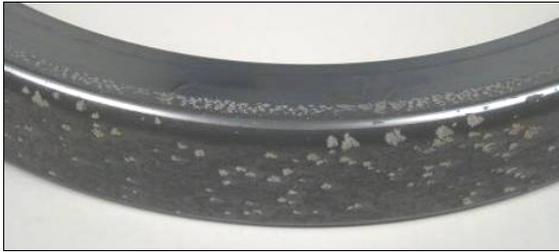
Figure 28 shows the  $\alpha$ -SiC bi-modal SiC tested for 168 hours under ultra-pure water conditions at 30 °C. Figure 29 shows the same seal face material tested for 168 hours under ultra-pure water conditions at 55 °C.

Figure 28.  $\alpha$ -SiC bi-modal SiC rotating face tested at 30 °C

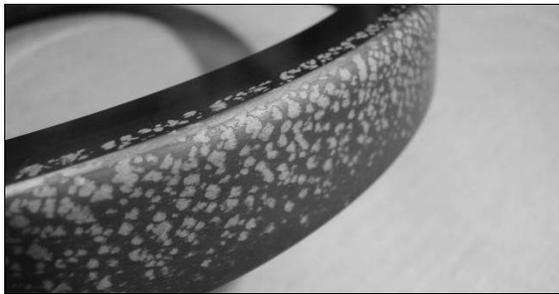
Figure 29.  $\alpha$ -SiC bi-modal SiC rotating face tested at 55 °C

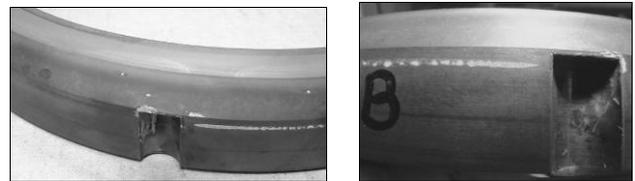
While seal face generated EC was found to be significantly less compared to traditional sealing technology used in boiler feed pump seals, EC concentrations were found around the drive slots of both rotating seal faces. Figure 30 shows the plug seal rotating face on the left and the test seal rotating face on the right. Both show signs of seal face generated EC.

Figure 30. EC at the ring drive slots mainly

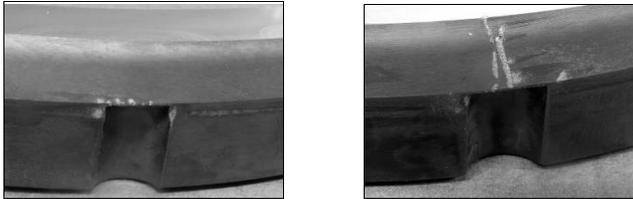
Upon inspection of the rotating seal faces, both from the full electrically isolated set up and the full conductive set up, signs of seal generated EC were detected. For the isolated faces, damage was found at the drive slots, whereas for the conductive seal faces, EC damage was found around the OD and chamfer areas of the rotating seal faces. Figure 31 shows the parts of the electrically isolated seal faces. Figure 32 shows the parts of the full conductive seal faces.

Figure 31. EC damage using full electrically isolated set up

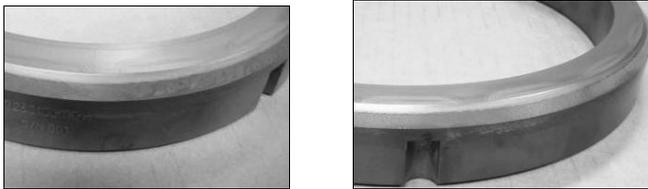
Figure 32. EC damage using full electrically conductive set up

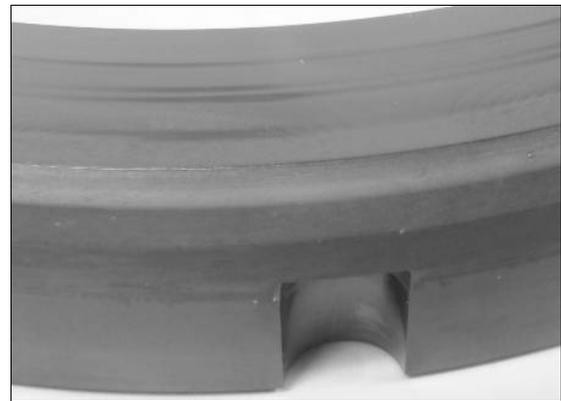
Upon inspection the fine grain self-sintered SiC showed a very good resistance to seal face generated EC, while the  $\alpha$ -SiC bi-modal material of the test seal rotating face showed pitting on the edges of the face and in the wave region of the stationary face. Figure 33 shows the result of the grounded SiC face while Figure 34 shows the EC damage found on the seal face with no grounding wire.

Figure 33. No apparent EC damage on fine grain self-sintered SiC rotating face, operated with a ground wire

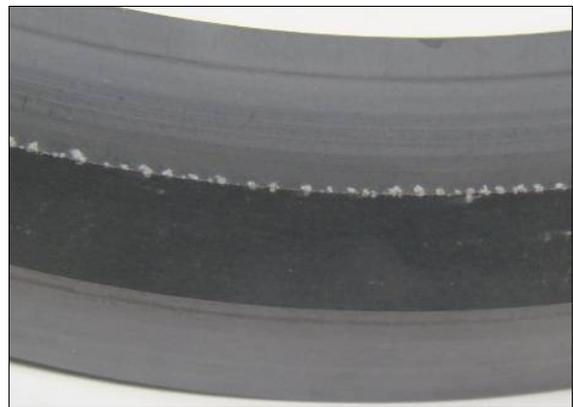
Figure 34. EC damage on  $\alpha$ -SiC bi-modal rotating face edge, operated without a ground wire

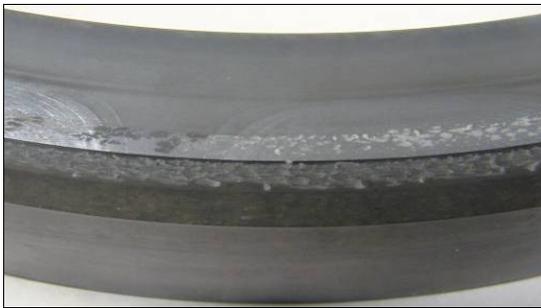
Upon inspection, it became evident that while the fine grain self-sintered SiC had not shown any seal face generated EC in the first test using a ground wire, this time it did show significant EC damage. Also the test seal rotating face, despite connected to a ground wire, displayed a significant amount of EC damage. Figure 35 shows the ungrounded fine grain self-sintered SiC seal face from the plug seal, while Figure 36 shows the  $\alpha$ -SiC bi-modal rotating face from the test seal equipped with a ground wire to its stationary seal face.

Figure 35. EC damage on fine grain self-sintered SiC rotating face, operated without a ground wire

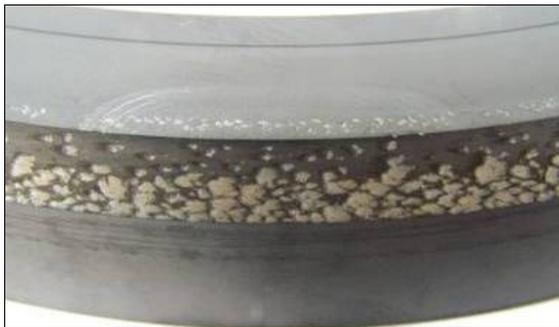
Figure 36. EC damage on  $\alpha$ -SiC bi-modal rotating face, operated with a ground wire

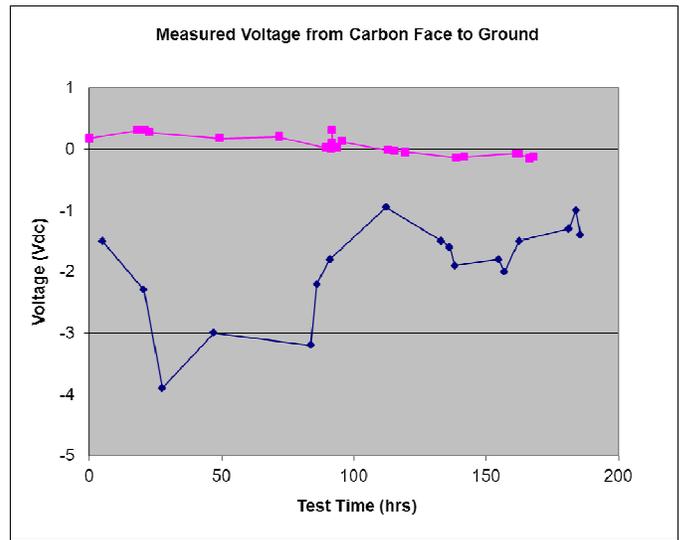
During both tests a series of voltage measurements were conducted from the carbon graphite stationary face to ground. Figure 37 shows the graph made from these shaft voltage measurements. The blue dots are measurement results obtained during the first test and the pink dots are the result from the second test.

Figure 37. Shaft voltage results ground wire tests

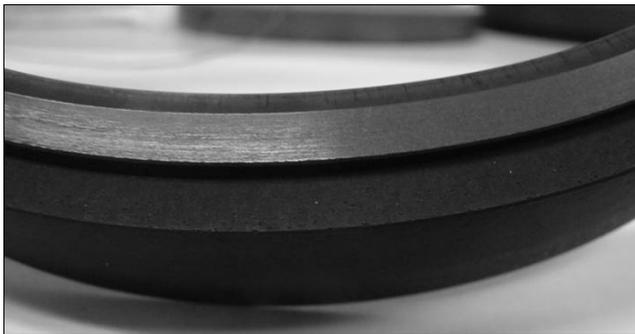
Inspection of the rotating carbon graphite seal face showed a grainy texture of the wear nose towards the outer diameter, which was likely caused by material pull out due to high shear. While the fine grain self-sintered SiC appeared to be in excellent condition, seal face generated EC was found in the middle of the features lasered resembling the deepest part of the valley inside the wavy profile. Figure 38 shows the grainy texture found on the wear nose of the rotating carbon graphite seal face. Figure 39 shows the fine grain self-sintered SiC stationary seal face with EC damage in the middle of the lasered features. The polishing effect of the carbon rotating face can be well observed and EC damage seems to coincide with the outer diameter of the carbon wear nose.

Figure 38. Grainy texture rotating carbon graphite seal face

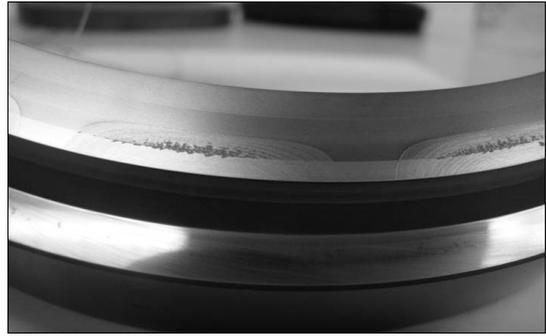
Figure 39. EC damage inside lasered feature of stationary seal face coinciding with wear nose OD of rotating seal face

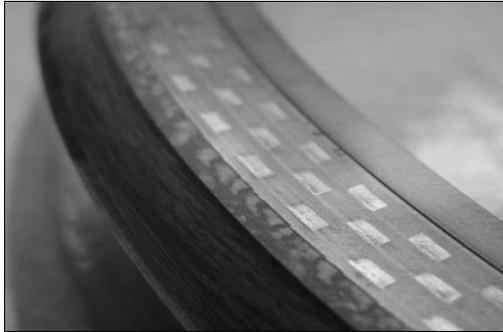
Figure 40 shows the plug seal rotating seal face with signs of EC on the outer, unprotected area of the fine grain self-sintered seal face.

Figure 40. Use of special friction reduction features on a fine grain self-sintered SiC rotating seal face

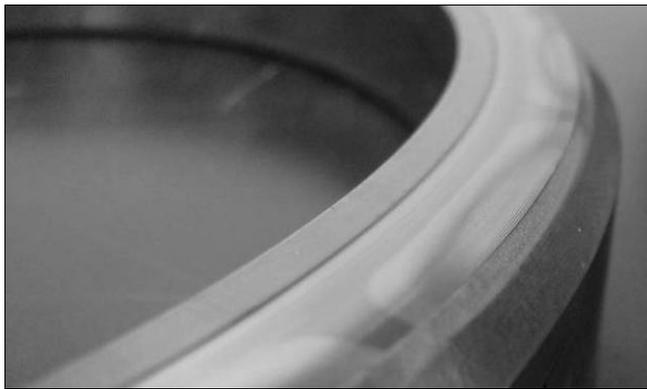
Figure 41 shows the new proprietary seal face material which operated for 397 hours under the ultra-pure water regime without developing any EC damage whatsoever.

Figure 41. Proprietary rotating seal face material using wavy face technology to reduce face friction

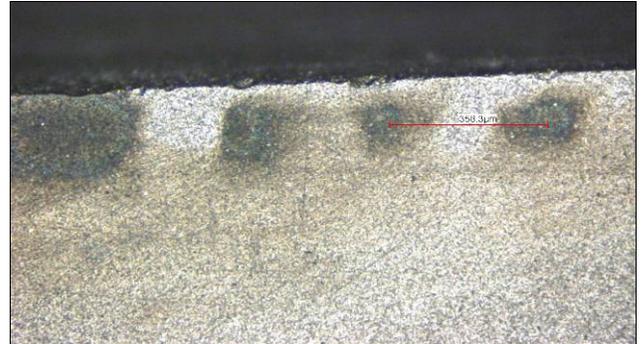
The first test used a  $\alpha$ -SiC material. It was operated for 165 hours under the benchmark ultra-pure water conditions. Upon inspection EC damage was found on the drive notches with circumferential erosion/corrosion damage starting from these drive notches. Damage was also observed on the SiC seal face at the outer diameter boundary where both PTFE rings are situated on both sides of the ring. The damage seen appeared to have some periodicity to it. Figure 42 shows the observed damage found at this specific location.

Figure 42. EC damage SiC face at OD boundary with PTFE clamp ring

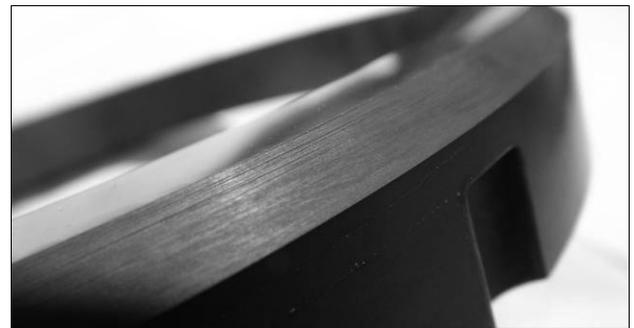
Finally, a third test was conducted. The free rotor material used was a self-sintered SiC was tested designed with a special porosity. The rotor was operated for 168 hours in the ultra-pure water. Upon inspection the rotor displayed some very light EC type markings on the OD, but no measurable wear could be found. Figure 43 shows a picture of this particular rotor tested.

Figure 43. Very light EC markings, no measurable wear
