## TECHNICAL ASSISTANCE TO THE MANUFACTURE, CONSTRUCTION AND ASSEMBLY OIL PIPELINE FLOW PUMPS

This paper reports the experiences acquired through the modifications and improvements implemented in the manufacture, construction and assembly of the oil flow centrifugal pumps. A Brazilian oil pipeline pumping capacity expansion, on Rio Grande do Sul – South Region of Brazil, was conceived aiming at refinery processing increase project from 20,000 m<sup>3</sup>/day to 30,000 m<sup>3</sup>/day, besides changing the product profile from processed product to national high viscosity national oils. Due to this reason, a new pump park and a new intermediate pump station have been erected. Thus, the oil received by a tanker and stored at the first pump park should be sending through a 97 km long and 560 mm diameter oil pipeline. In order to get such oil flow done, 03 new main pumps have been installed at the first pump park, one of them being a stand-by one, and other 03 pumps at second pump park, one of them being also a stand-by.

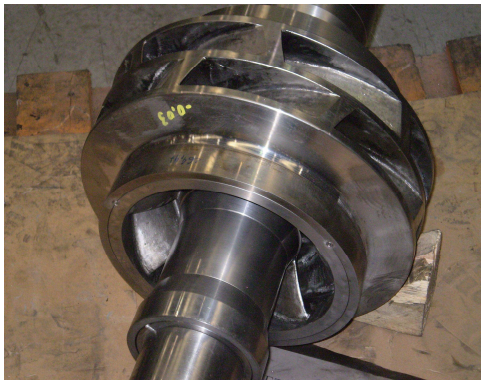
Figure 4: Impeller detail

The replacement of the impellers originally melted in sand mold for components melted in ceramic molds aimed at eliminating the maximum of dimensional deviations (of approximately 20%) in the impeller fluid exit areas. A greater dimensional uniformity in this region provides a better radial distribution of pressure and, consequently, a greater rotor hydraulic balance.
