CASE STUDY: BEARING FROSTING AND THE UNIQUE OCCURRENCE ON A GEARED CENTRIFUGAL COMPRESSOR

ED CZECHOWSKI
CHRIS NAPOLEON
MIKE TURSKY

FS-ELLIOTT
NAPOLEON ENGINEERING
FS-ELLIOTT

42nd Turbomachinery
29th Pump SYMPOSIUM

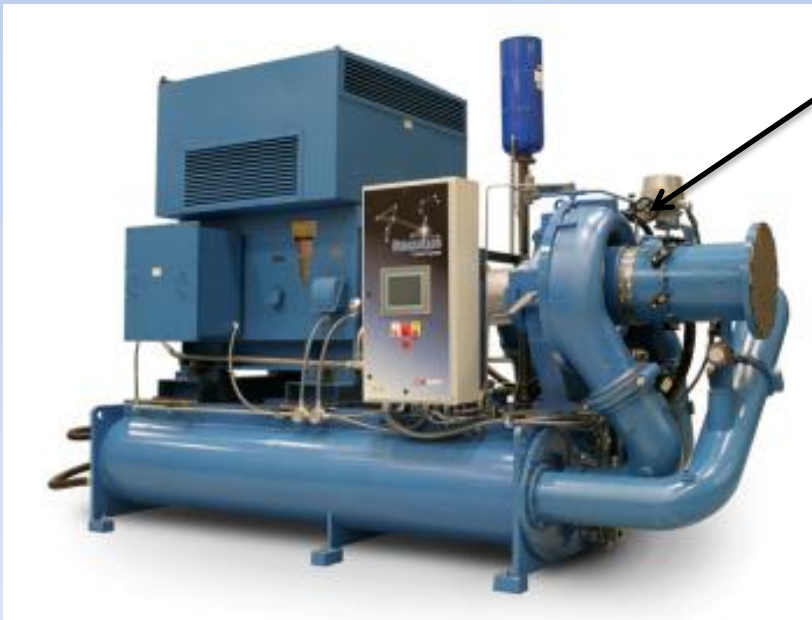
Static electricity on steam exit side bearings

- Manufacturing processes – part holders, lathes
- Magnetic base inspection indicators
- Gear box Machining processes
- Magnetic Particle inspection
- Space heater failure
- Welding on frame
- Motor feed and drains
- Group III oils

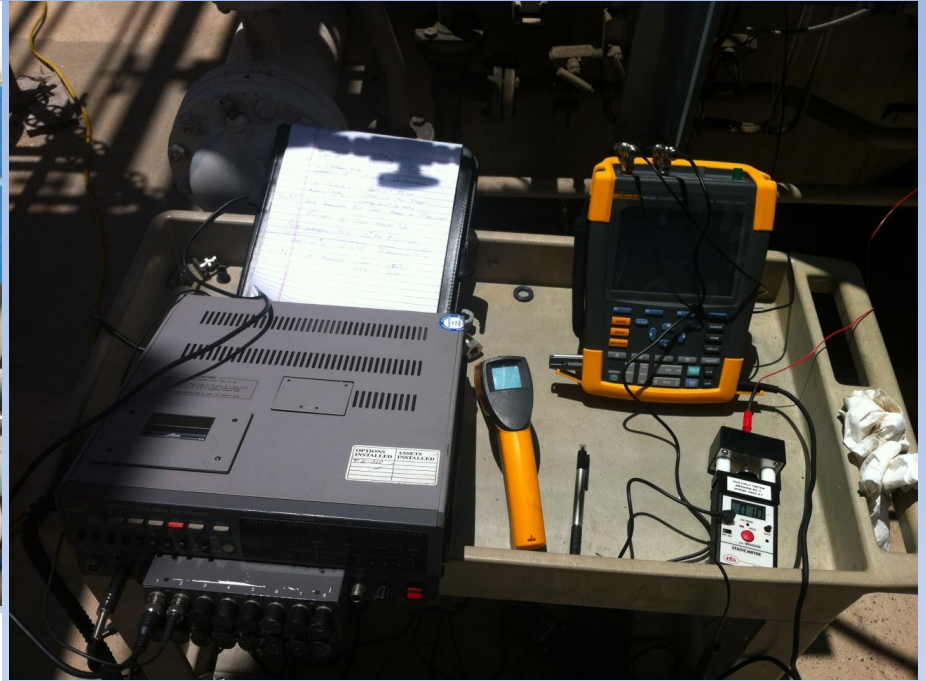
Carbon fiber shaft probe and portable oscilloscope

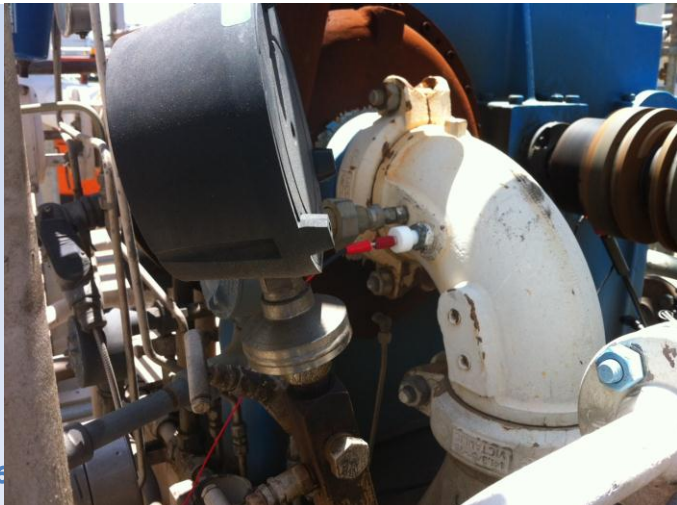
Electro-static charge detector with a charge plate adapter for use with a pipe probe

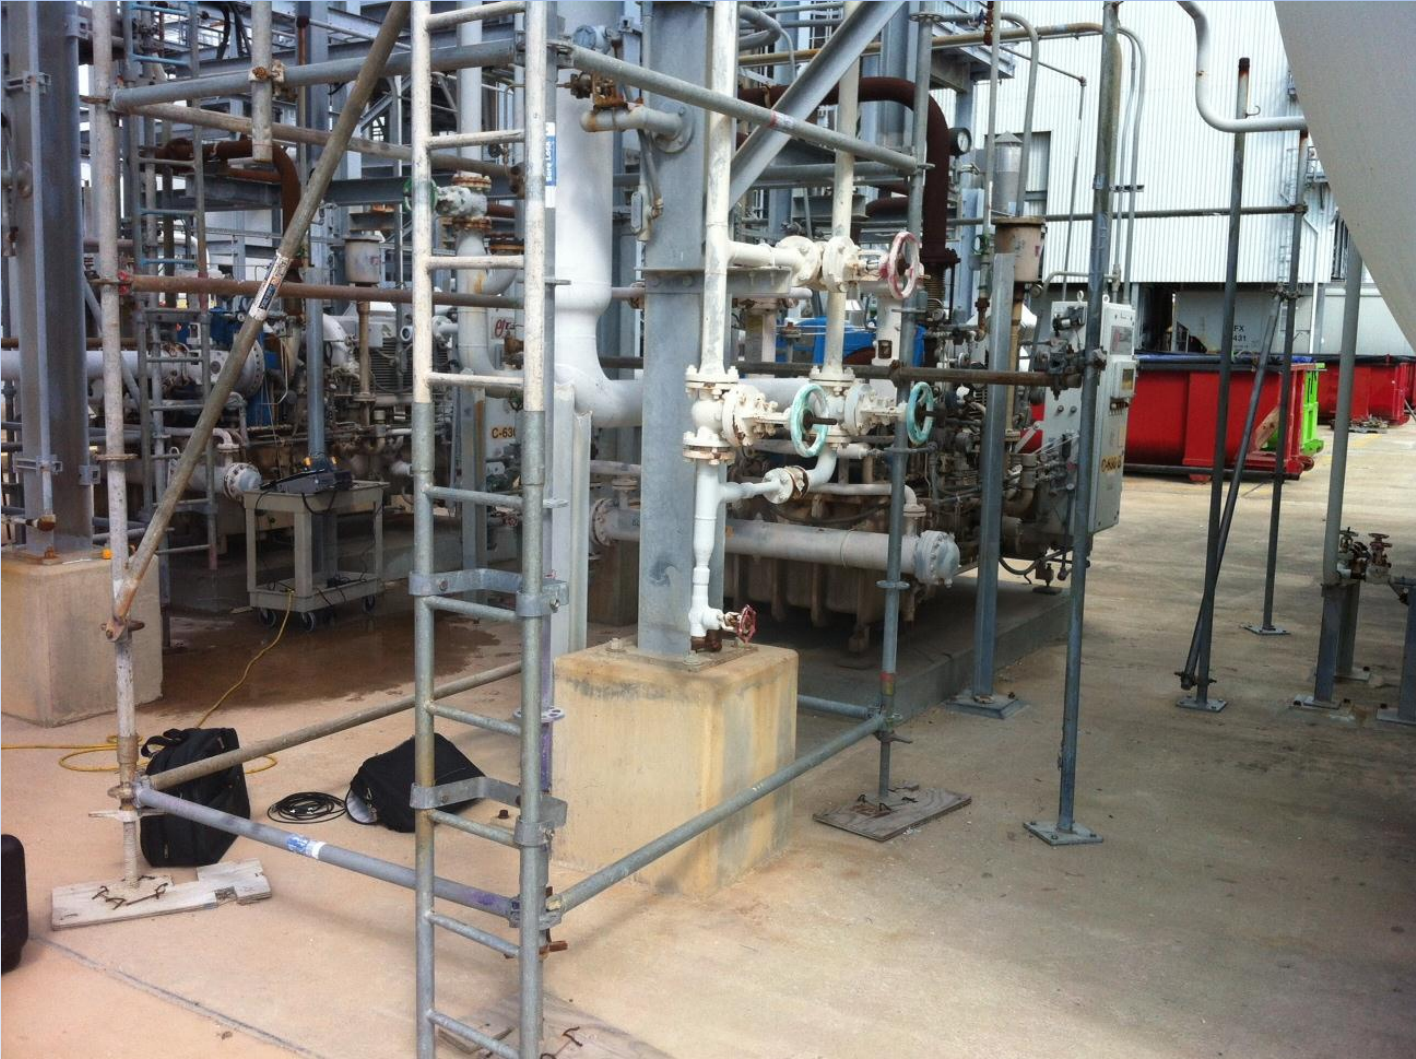
Case Study Example – two compressors one with a bull gear shaft grounding ring and one without.

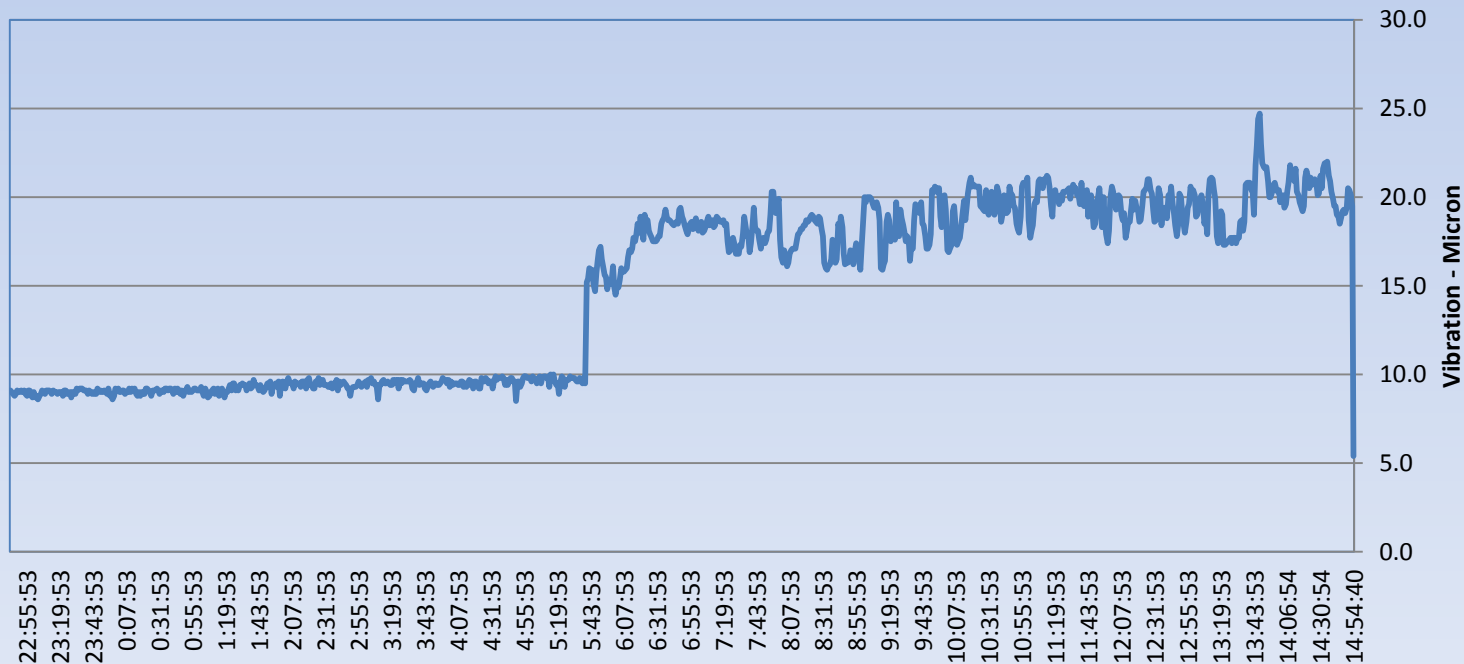
Initial Data from one of the Failed Units

- The compressors in this case study all experienced alarm and trip levels of vibration before being shut down for bearing replacement. One unit exhibited a sudden shift in vibration just hours after start up...an oversize pinion bore caused by bearing frosting ended up being the problem.

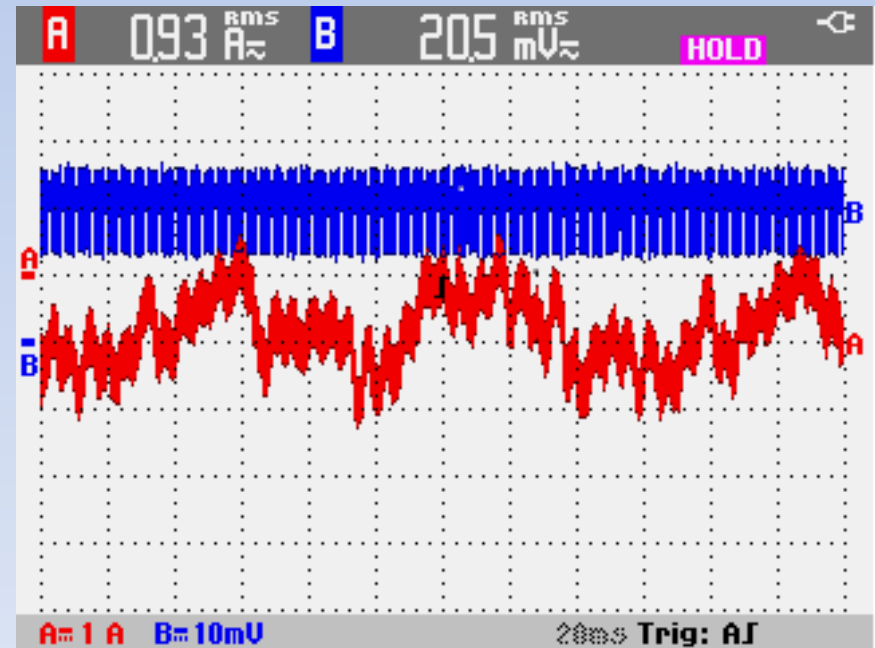
Unit	Shaft Voltage	Shaft Current	Static Charge	Comments
W/ Ground ring	31 mV rms	26 mA rms	170 - 515 V	Static decayed over time
W/O GR	1.029 V rms	.93- 1.02 A rms	50 – 360 V	Cycled every eight minutes

Unit w/o ground ring

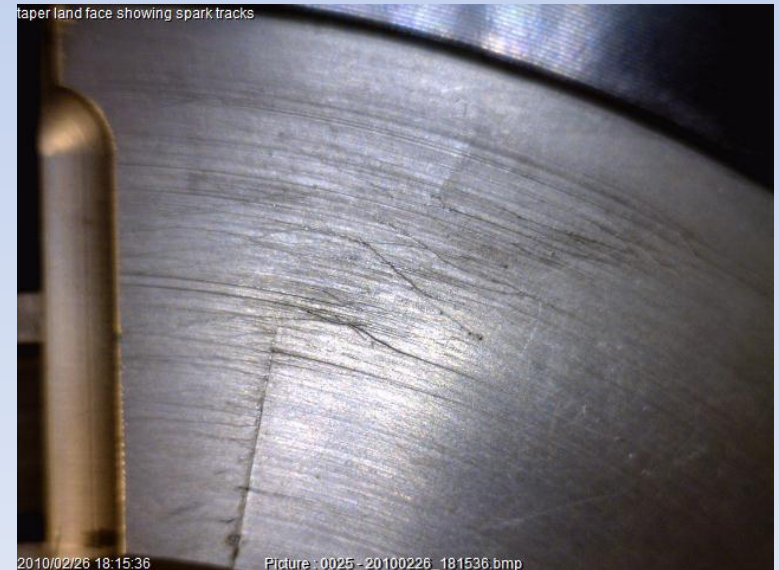
Typical Sleeve and Thrust Bearing Damage

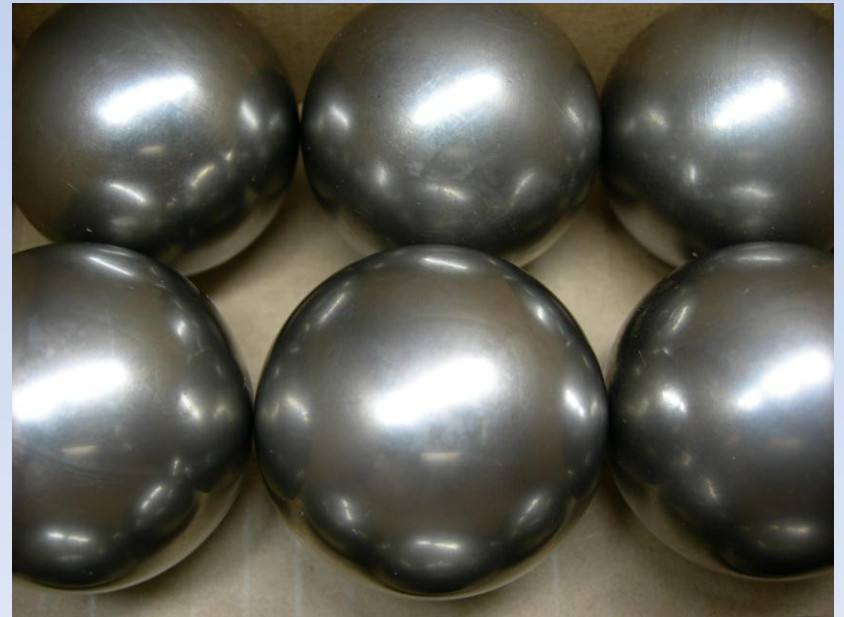
Rolling Element Bearing Damage

- Micro-cratering – damage surface appears dull, characterized by molten pit marks

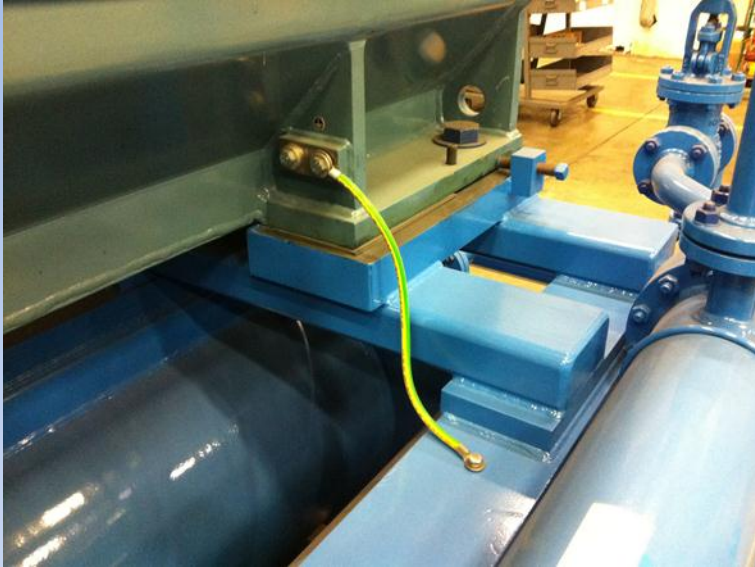
Grounding Strap on Motor.

- Drive motor with insulated rear bearing - \$\$
- Insulated drive coupling - \$\$
- Insulated forced feed lube and drains - \$
- Grounding straps on drive motor - \$
- Bull gear shaft grounding brushes - \$
- No welding stickers - \$
- Degaussing processes added - \$\$\$
- Material changes to bearings i.e. ceramic or ceramic coatings - \$\$\$
- Oil additives could be used to make the oil more conductive \$\$

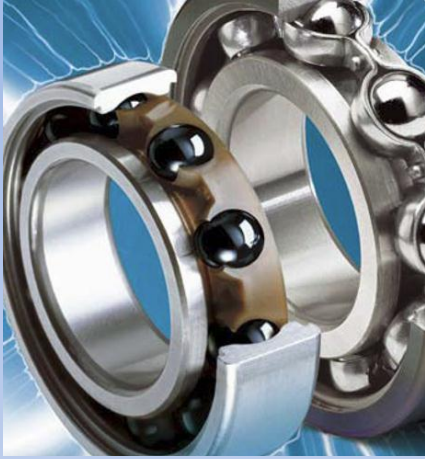
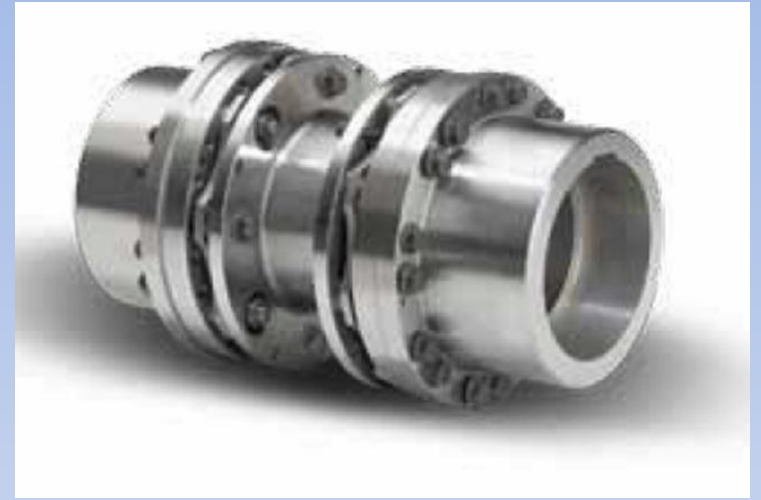
Insulated Drive Couplings

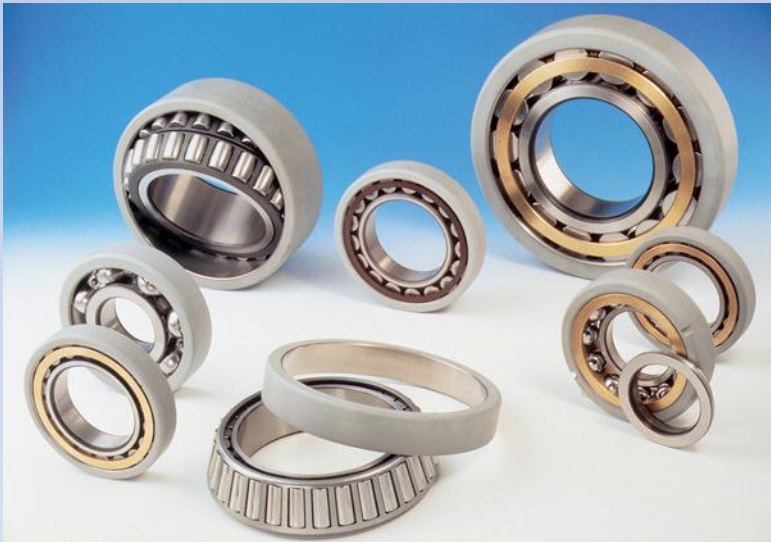
Insulated Bearings for Drive Motors

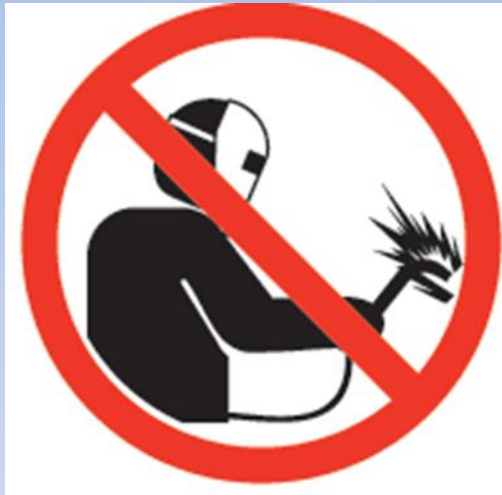
Place “No Welding”
Stickers on
Compressor
Equipment.

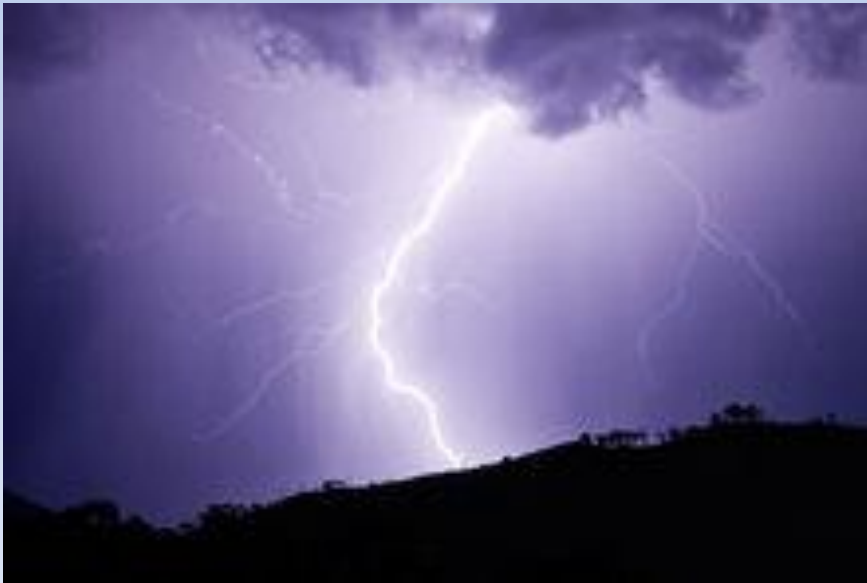
In this case we found that bull gear shaft stray currents were the major contributor to frosted bearings. However, static charges found at plastics plants showed a slow build up in charge potential followed by an immediate discharge leading us to believe that high speed pinions become electrified and that these charges also contribute to bearing damage.

According to (Paschen's Law) electrostatic discharges can occur as low as 380 V.
