**ELECTRIC DRIVEN CENTRIFUGAL COMPRESSOR – SUPER SYNCHRONOUS VIBRATIONS OF THE HIGH SPEED
SHAFT LINE: OBSERVATIONS, ASSESSMENT AND RESOLUTION**

ABSTRACT

An unacceptable vibratory behavior was encountered in 2012 during the full load string test of an electric driven centrifugal compressor. The vibrations were observed on the high speed part of the shaft line and both compressor and gearbox exhibited vibratory levels higher than 50 microns peak to peak on the second harmonic (H2) of the rotational speed. The centrifugal compressor is driven via a variable speed electrical motor through a gearbox. The main characteristics of the shaft line are the following:

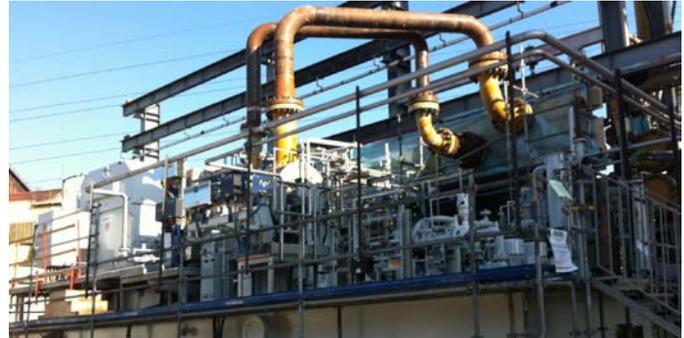
Figure 4: HP1 gas compressor package on the test facility, Le Creusot, France

All compressor packages were string-tested at GE O&G Thermodyn facilities in Le Creusot, France in the dedicated outdoors open area.
