Case Study – Load Dependent Critical Speed

39th Turbomachinery Symposium
October 7, 2010

Problem Statement

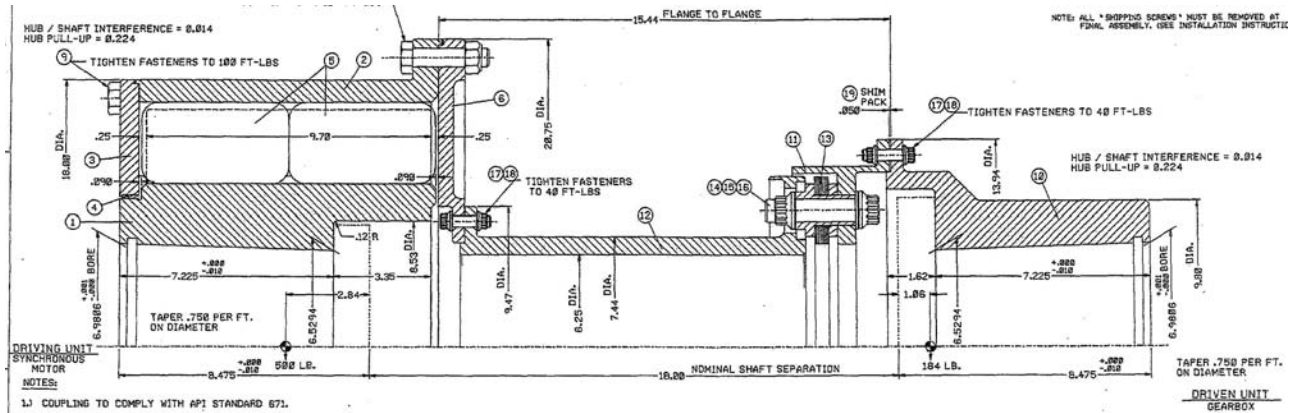
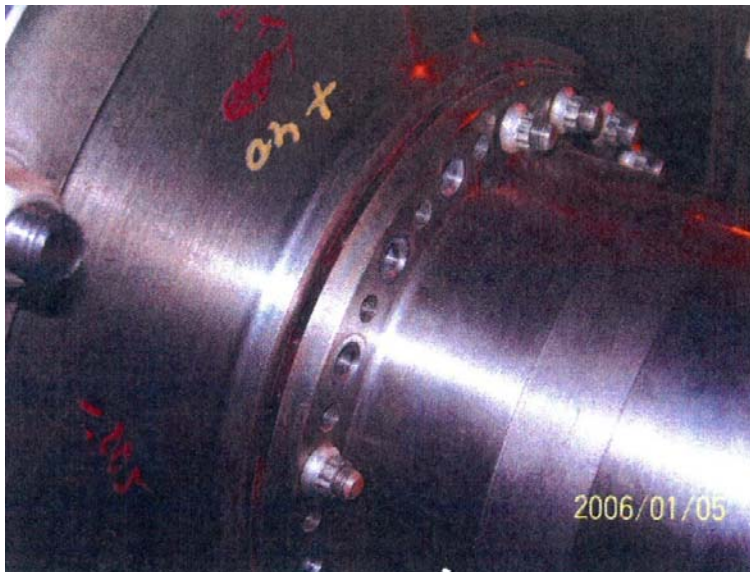
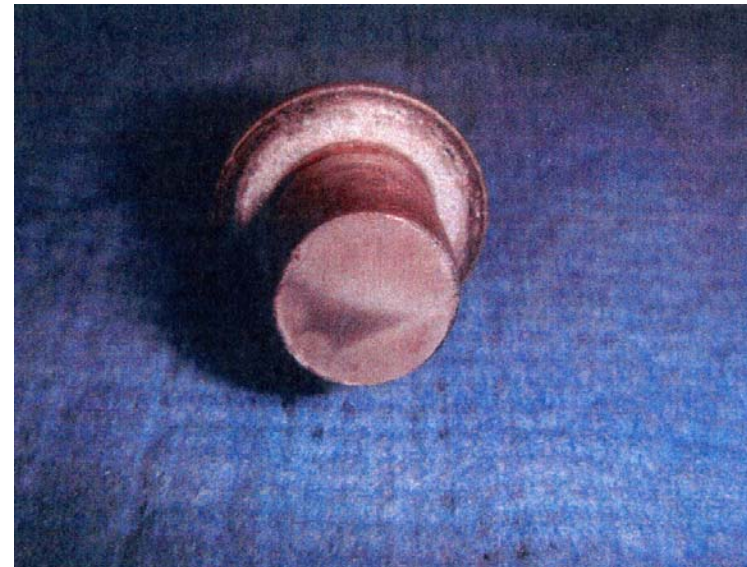
Low Speed Coupling With Elastomer Inserts

- Coupling bolts sheared; most likely cause improper restart.
- Gearbox refurbishment requested.

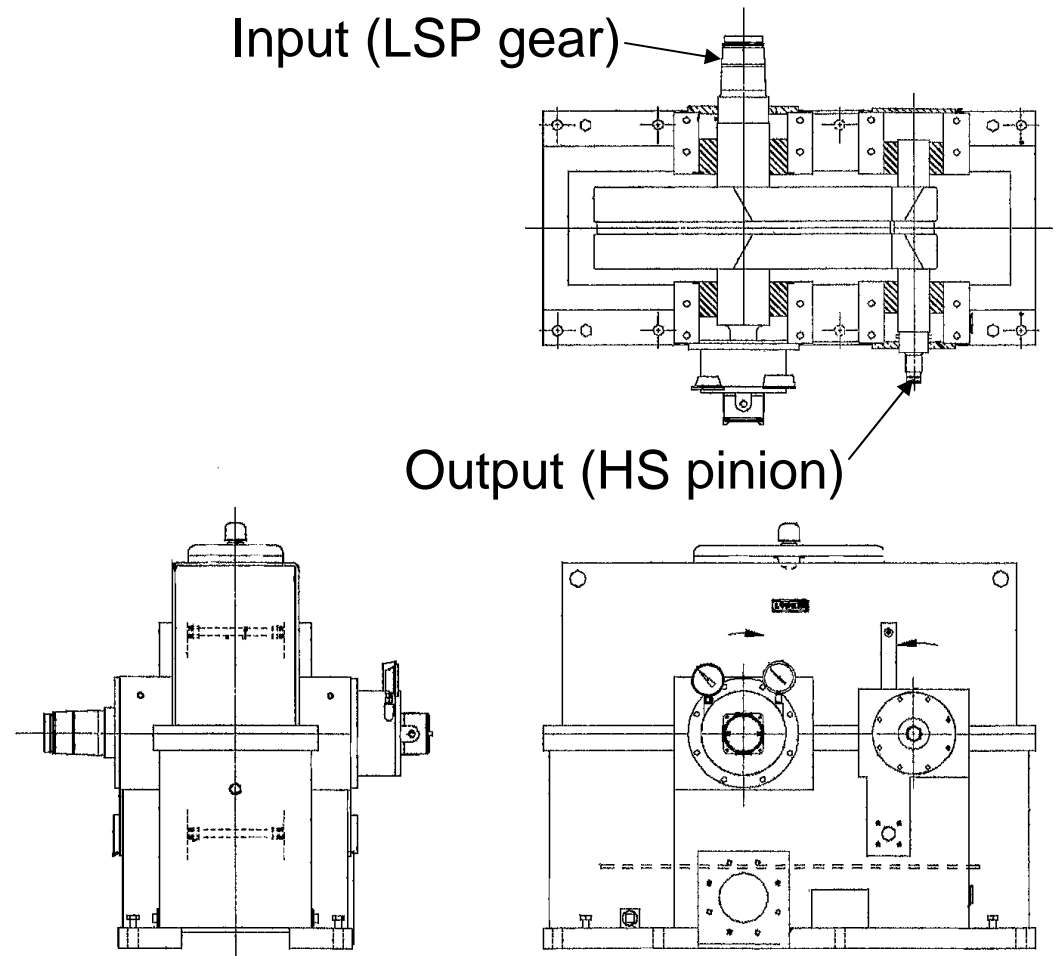
Gearbox Description

- Single stage, 8.1:1 ratio speed increaser
- Shaft center distance 24 inches (610 mm)
- Double helical gearing
- Fabricated steel casing
- Tilting pad HS pinion radial bearings

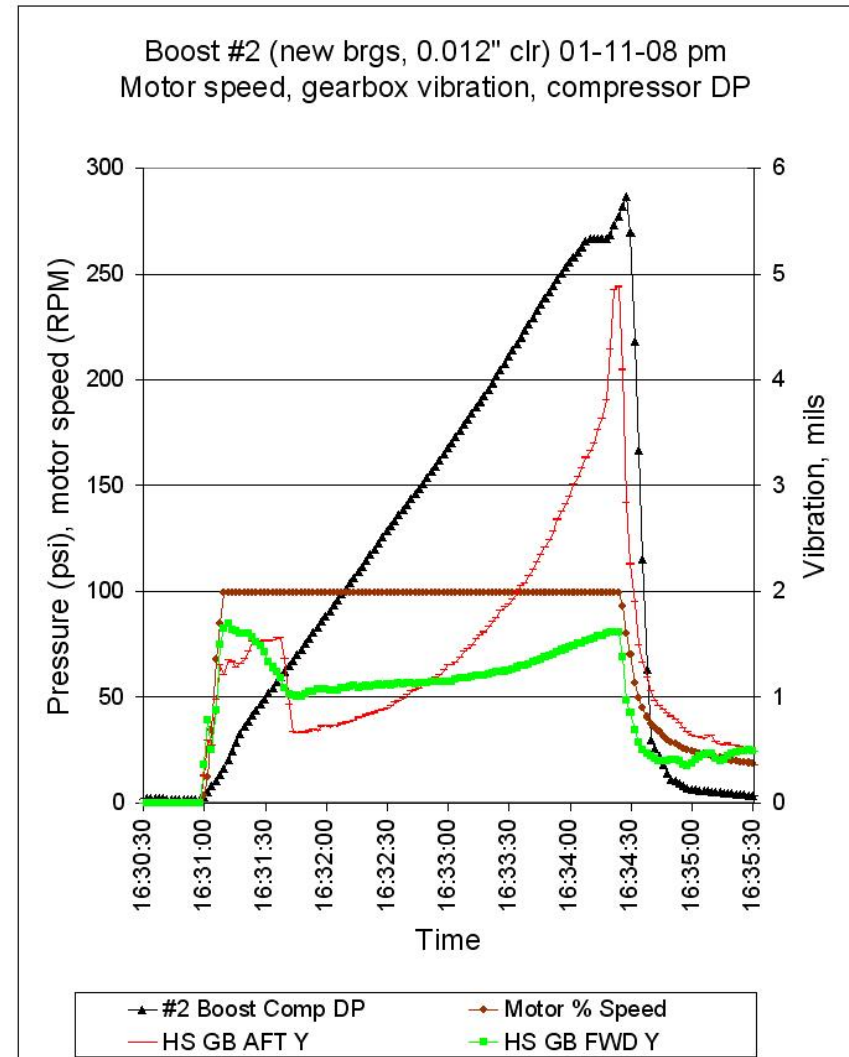
Vibration After Gearbox Refurbishment

- Could get up to speed (initially, no load).
- HS pinion vibration increased with compressor discharge pressure.
- Tripped on HS pinion shaft radial displacement before reaching full load.
- Parallel solution process:
 - Review original design.
 - Simulate analytically.
 - Implement changes in gearbox.

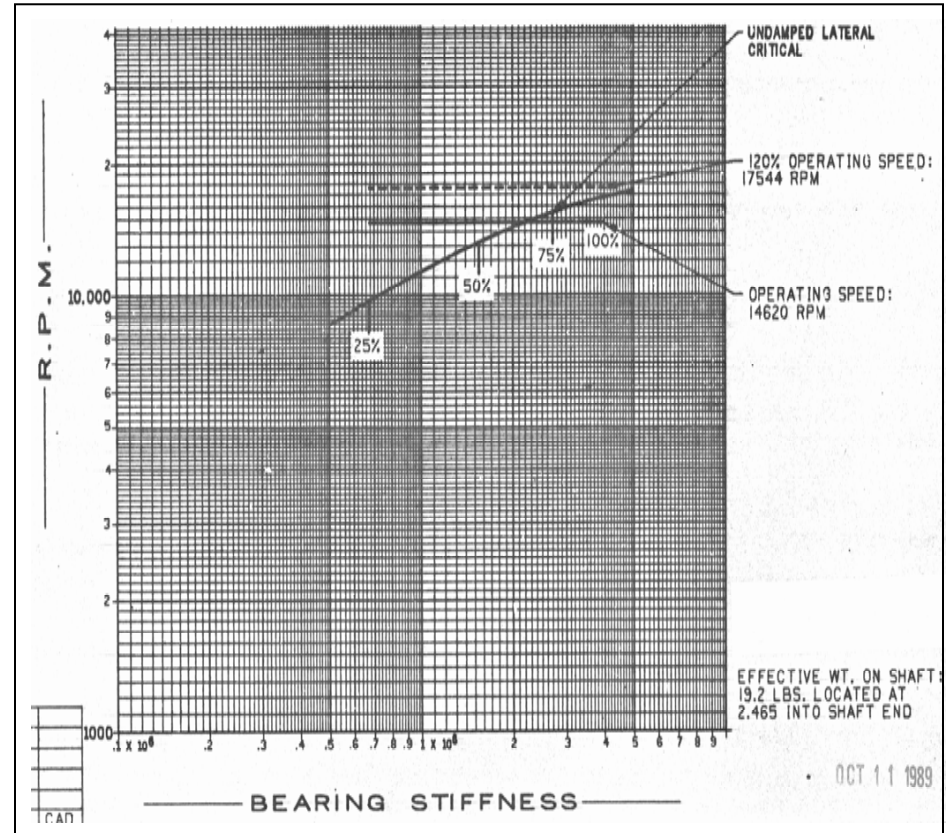
Review of Original Design and Operation

- Condition existed in original design:
 - Calculated natural freq. below running speed at low load.
 - Above running speed at full load.
- Operating data showed pinion vibration problem before refurbishment.
- Amplitude before refurb lower than after refurb; reasons not fully understood.

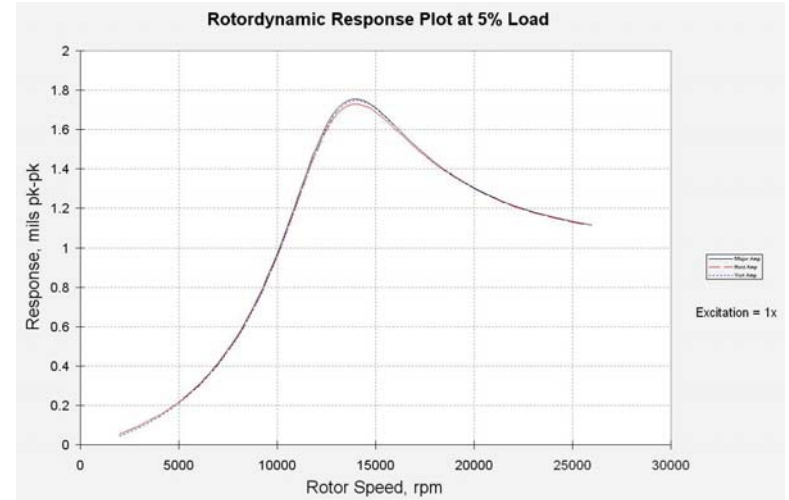
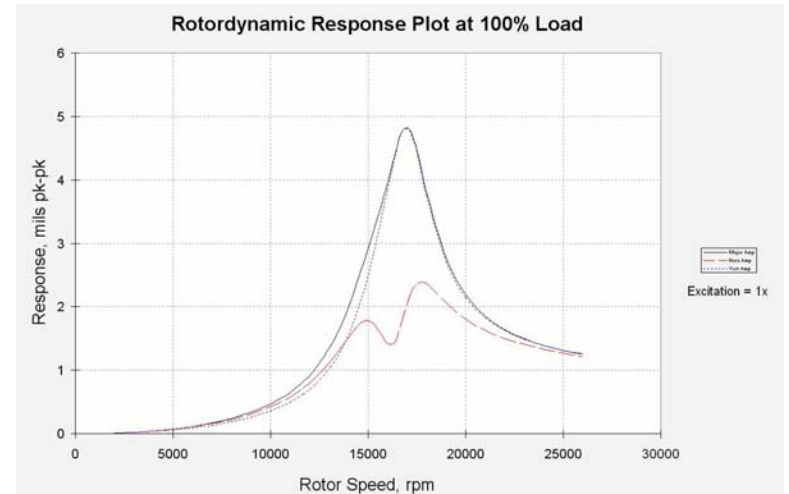
Effect of Load on HS Pinion Bearings

- Gear mesh force proportional to torque
 - Mesh is main bearing load.
 - Low torque = soft bearings.
 - High torque = stiff bearings.
- Operating speed 14620 RPM.
- Calculated critical speed changes with load
 - 13800 RPM at low load.
 - 17100 RPM at full load.
- As machine is loaded critical speed moves from below to above operating speed.

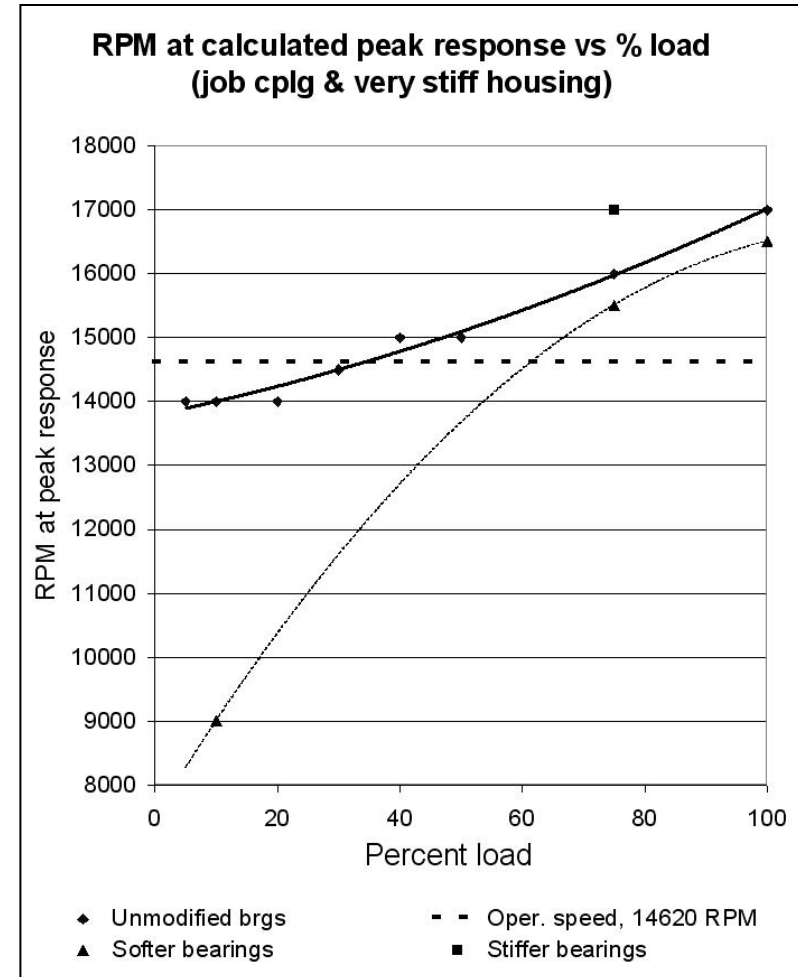
Evaluated Load and Bearing Clearance

- Possibly other system issues, but focus was on gearbox.
- Changed bearing clearance
 - Relatively quick and easy to do (removable pad seats).
 - Affected bearing stiffness at low to medium load.
- Machine still tripped; during loading with medium & loose bearings; at motor start with tight bearings (higher stiffness).
- Field & analytical results were generally consistent.
- Changing bearing clearance was not the solution.

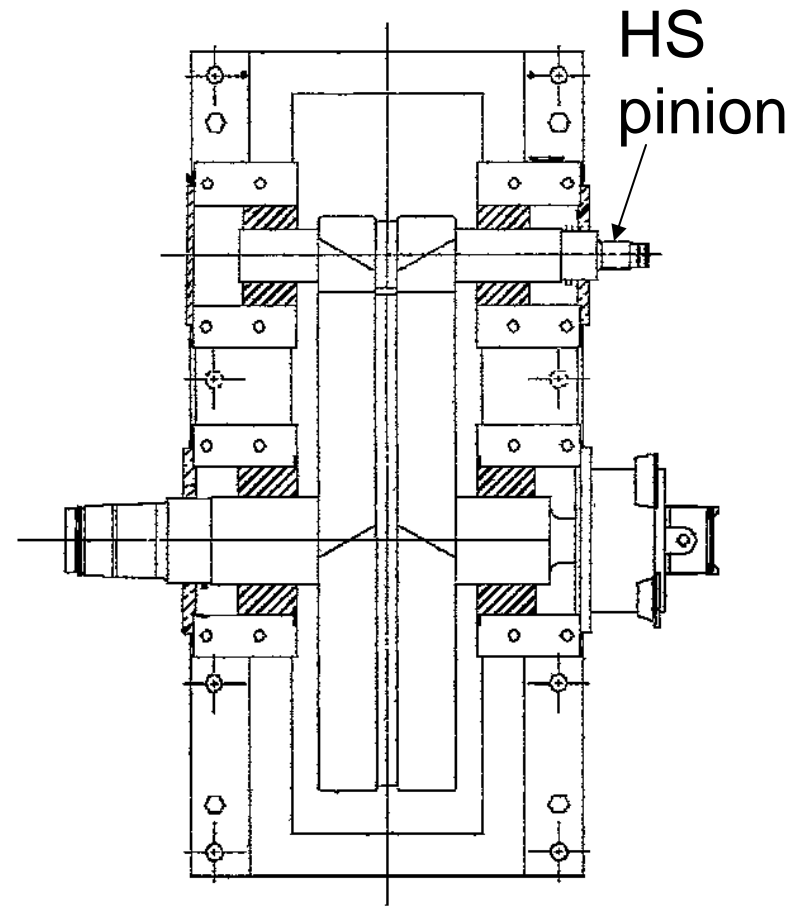
Reviewed Rotor-Bearing Layout

- Substantial change was needed
- HS coupling half CG location was relatively far from the drive end bearing.
- Moving the drive end bearing toward the shaft end should make a significant improvement in the rotor-bearing system behavior. For example, the critical speed should move up in frequency.
- Oil supply passages in gear housing could not be moved without machining housing – not a good option.

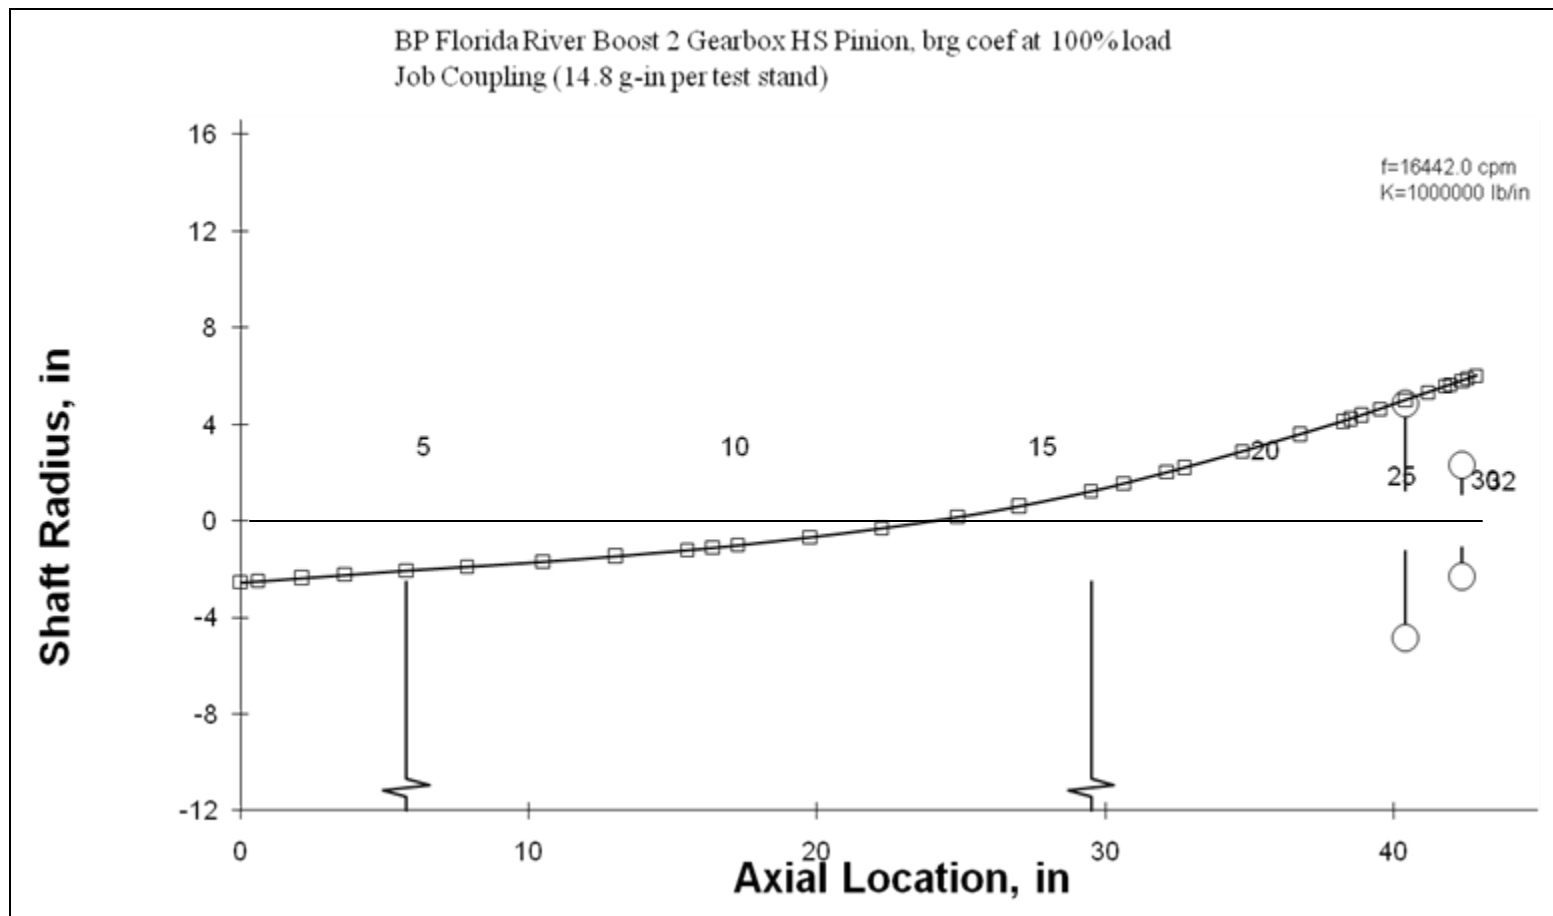
Undamped Mode Shape

- Overhung coupling weight at shaft end has strong effect.
- Moving drive end bearing closer to shaft end is beneficial.

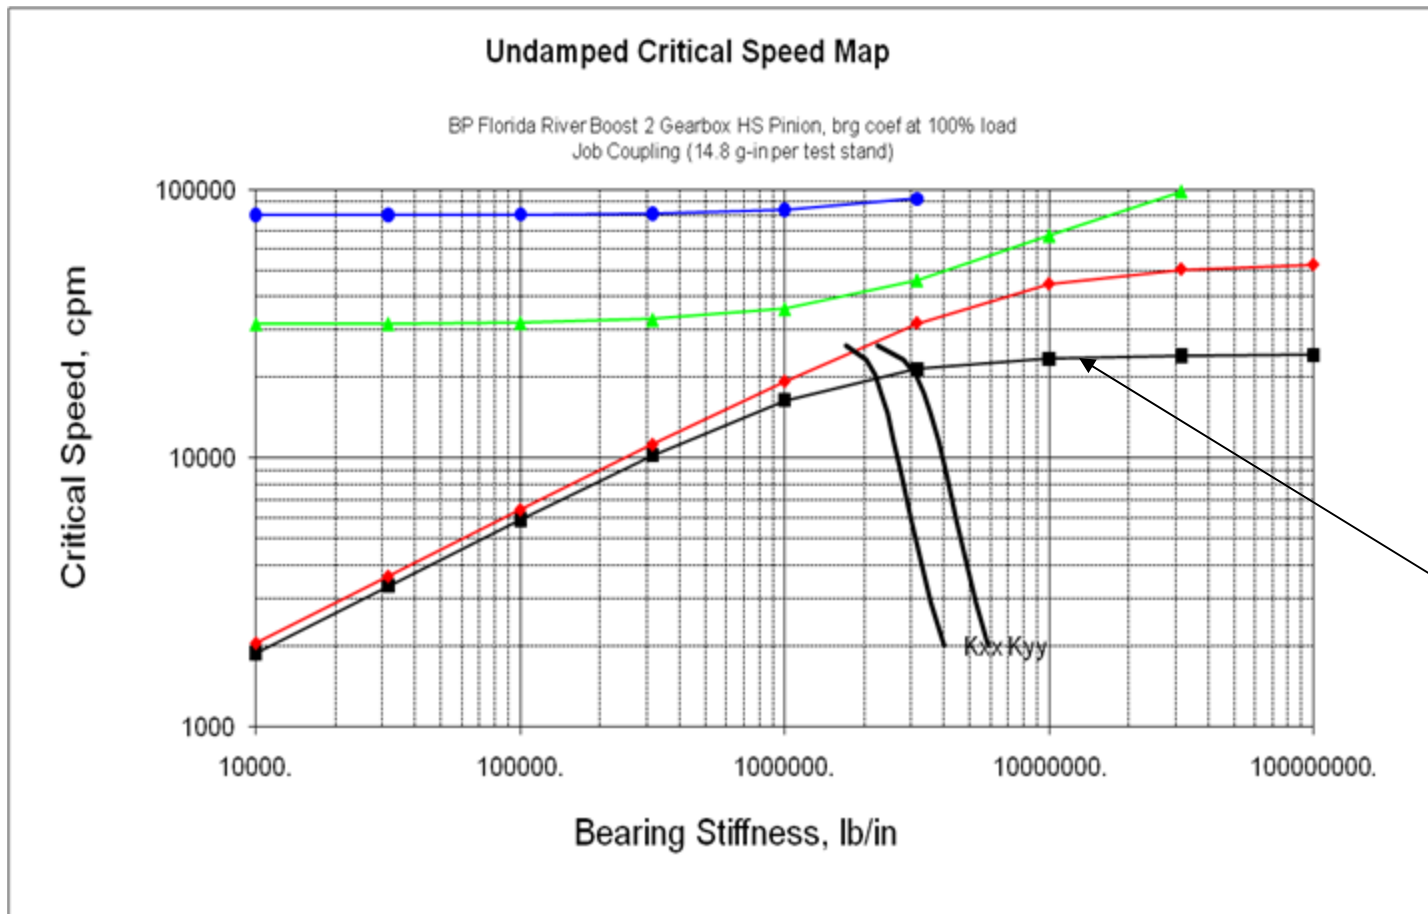
Critical Speed Map

Undamped critical speeds are higher with bearing moved nearer to overhung weight at shaft end

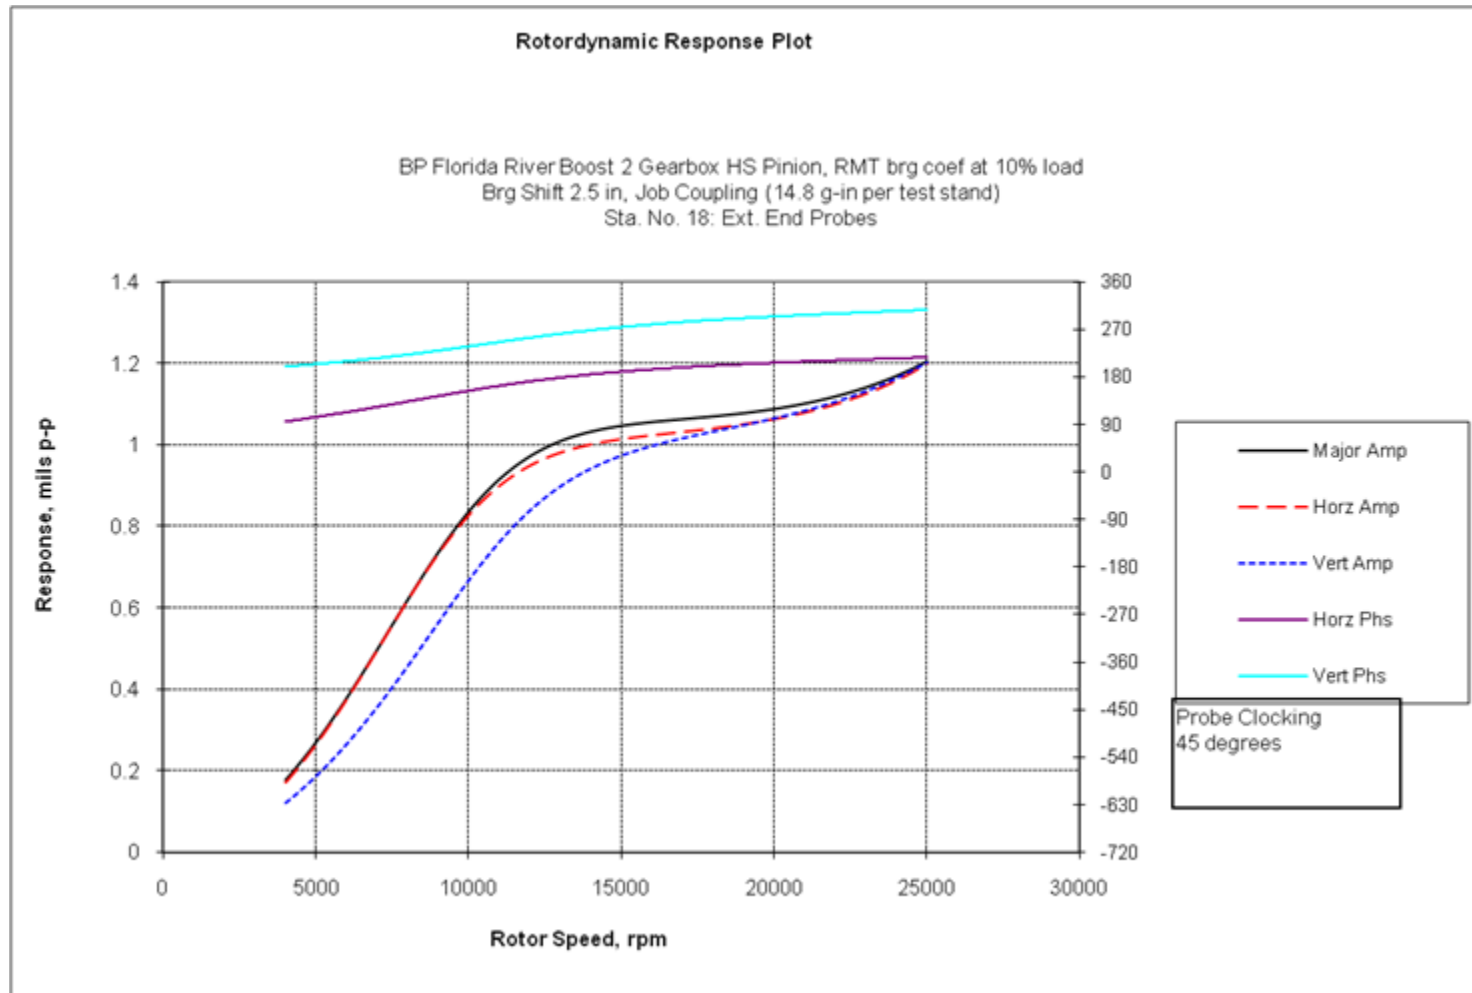
Predicted Effect of Moving Pinion Bearing – Low Load

Natural frequency still low at low load – but now well damped.

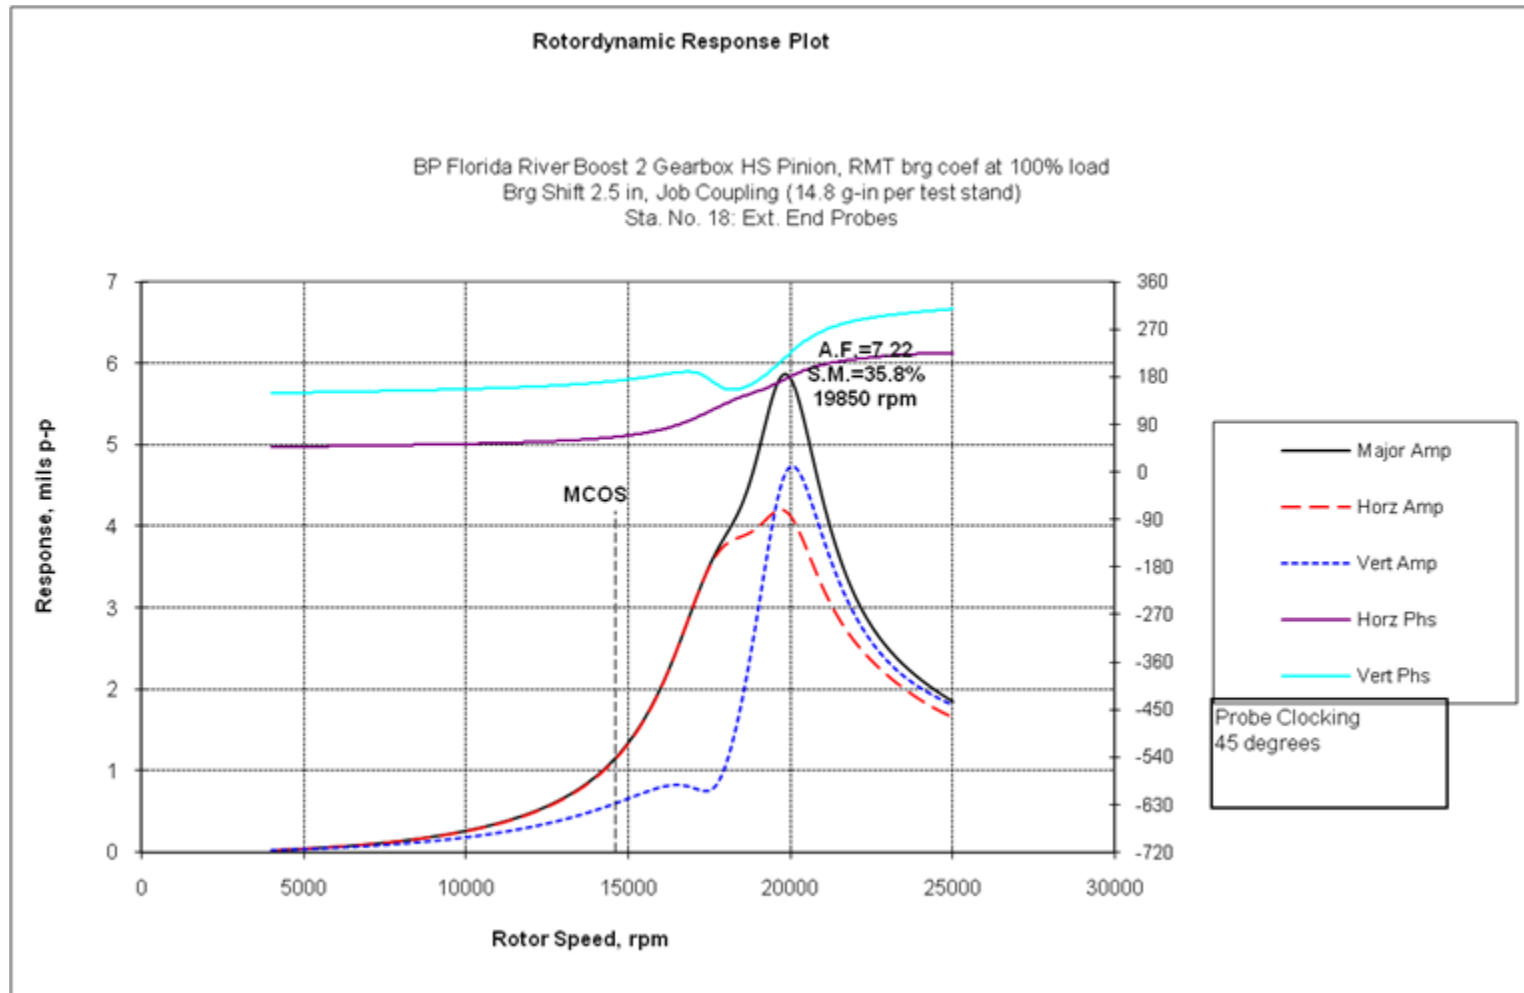
Predicted Effect of Moving Pinion Bearing – Full Load

Critical speed moved up at full load, 17100 to 19850 CPM.

- No problem during startup, about 0.001” (0.025 mm) shaft radial displacement was worst HS pinion vibration observed.
- Pinion running about 0.0003-0.0004” (0.008-0.010 mm) at load.
- Gearbox robust enough to resist possible alignment or compressor problems.
- The machine now runs better than it did before the refurbishment.
- Good performance in more than two years operation since fix.
