SELECTION OF MATERIALS AND MATERIAL RELATED PROCESSES FOR FCC POWER RECOVERY TURBINES

Elliott Company

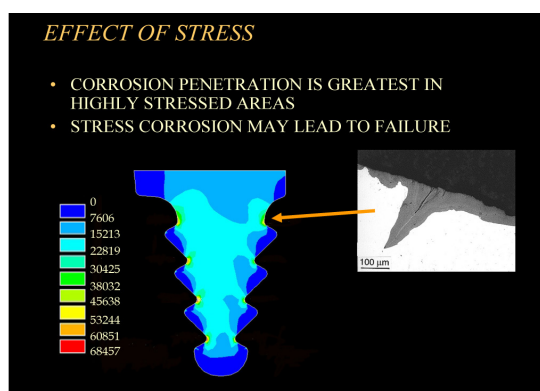
Figure 3. Showing Location of Highest Stress at Root of Blade.

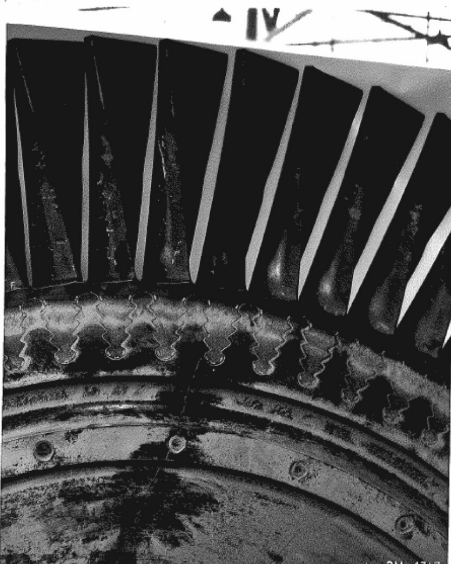
Figure 5. Failed A286 Disk.

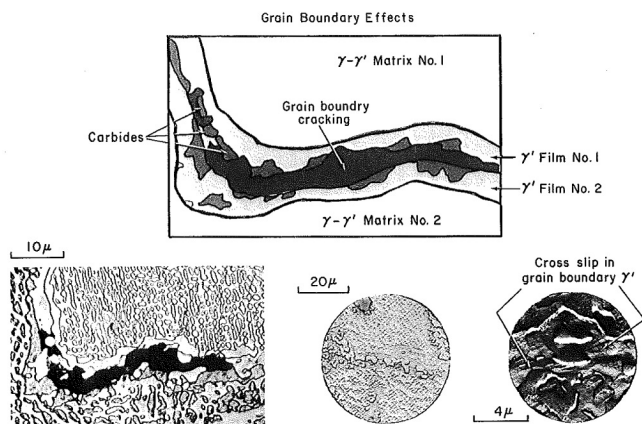
Figure 10. Flow and Fracture Behavior in the Grain Boundary of Waspaloy. (Courtesy Simms and Hagel, 1972)

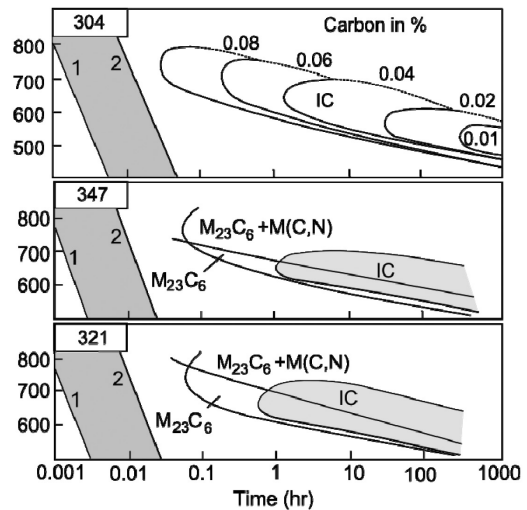
Figure 13. Influence of Structure and Alloying Additions on $M_{23}C_6$ Precipitation and Intergranular Corrosion Attack.

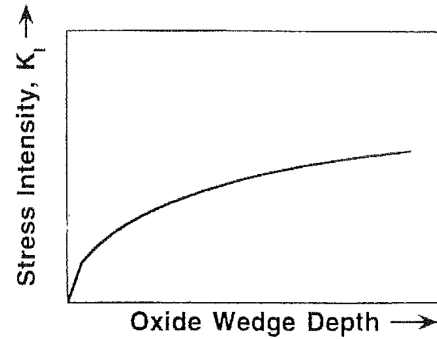
Figure 26. Stress Intensity Profile, as a Function of Oxide Wedge Depth Penetration into the Blade Root Substrate.

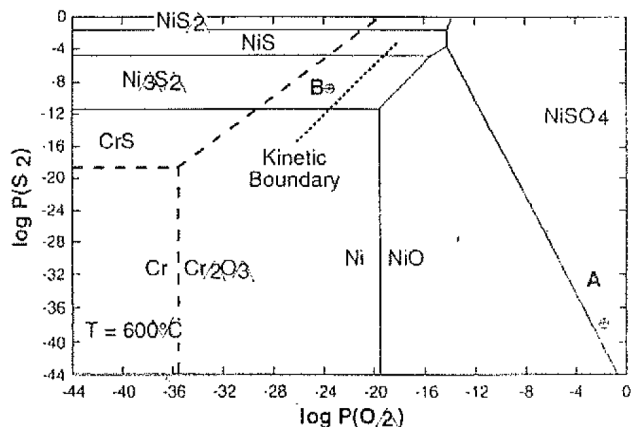
Figure 28. Superimposed Thermodynamic Stability Diagrams for the Ni, Cr, S, and O Systems at 1112°F (600°C). Point A Corresponds to an "Oxidizing" Environment Typical of Fully Combusted Flue Gases. Point B Corresponds to a "Sulfidizing" Environment Typical of Partially Combusted Flue Gases.

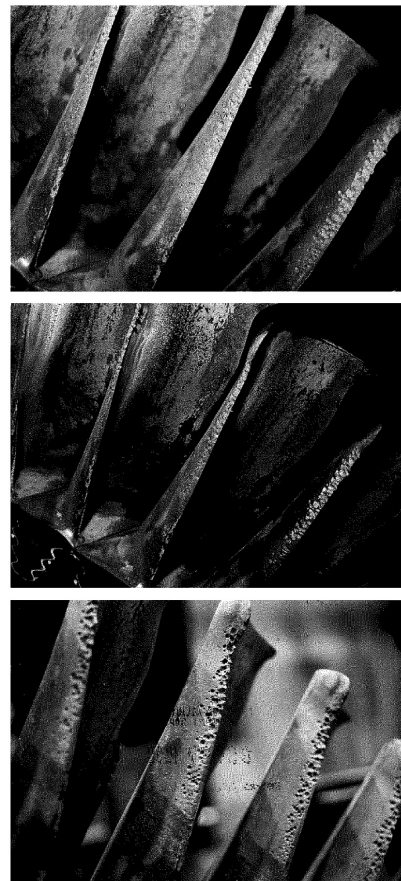
Figure 31. Primary Erosion of Rotating Blades (A).

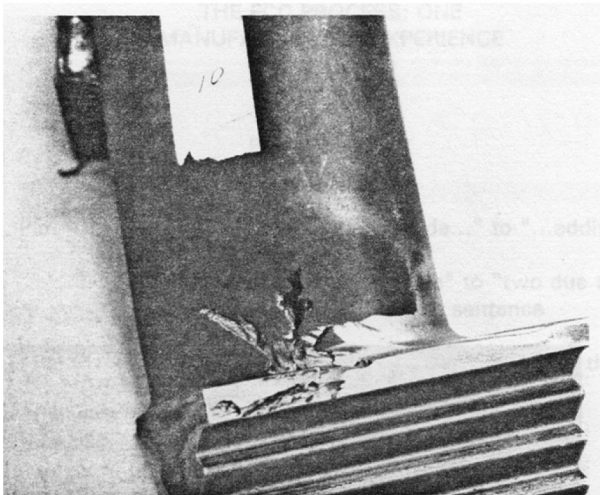
Figure 33. Secondary Erosion of Waspaloy Rotating Blades (A).

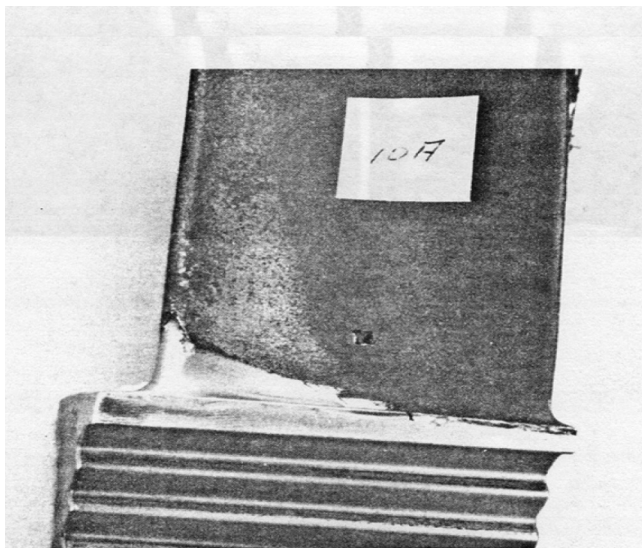
Figure 34. Secondary Erosion of Waspaloy Rotating Blades (B).

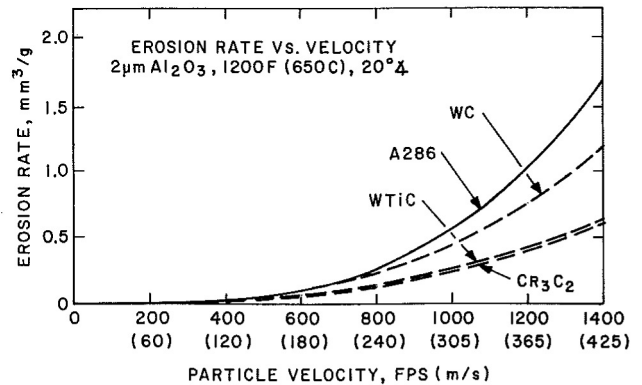
Figure 35. Solid Particle Erosion of Various Coating Materials.

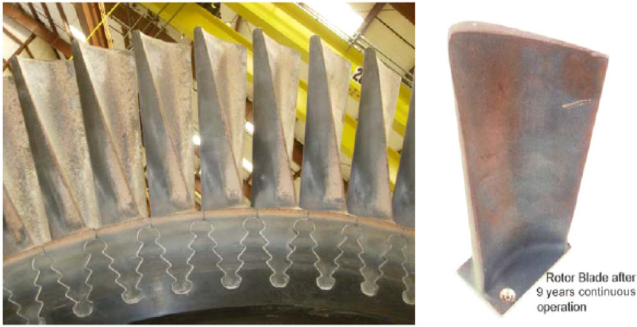
By streamlining the gas flow between the stator blades and rotating blades, secondary erosion is eliminated (Figure 36).

Figure 36. Rotating Waspaloy Blades after Nine Years Continuous Service.

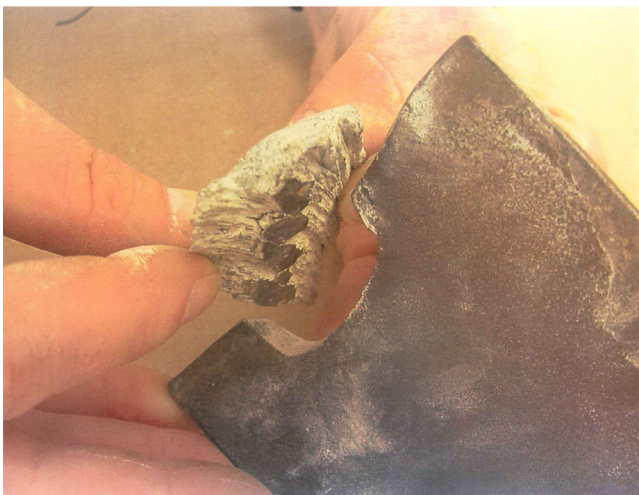
Figure 38. Rub Tip Cracking on Rotating Waspaloy Blade Leading to Material Removal.

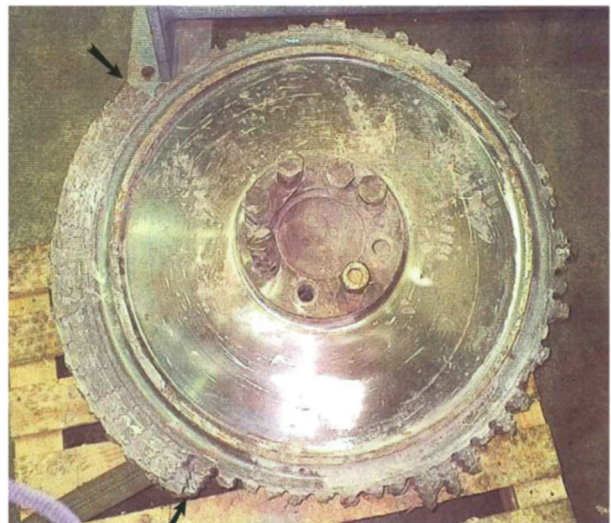
Figure 40. Photograph of Failed First Stage Disk. Arrows Indicate Area Where Disk Tenons Remained Attached.

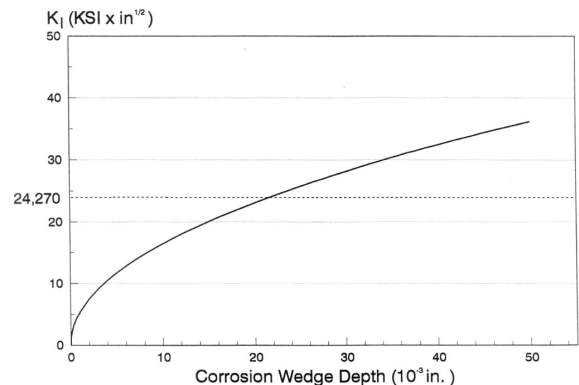
Figure 51. Stress Intensity Versus Corrosion Wedge Depth for Fourth Root Landing of Disk.

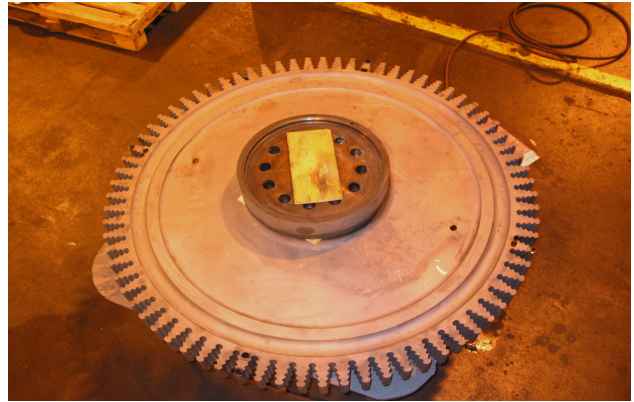
Figure 52. Picture on the Inlet Face of the Expander Disk.

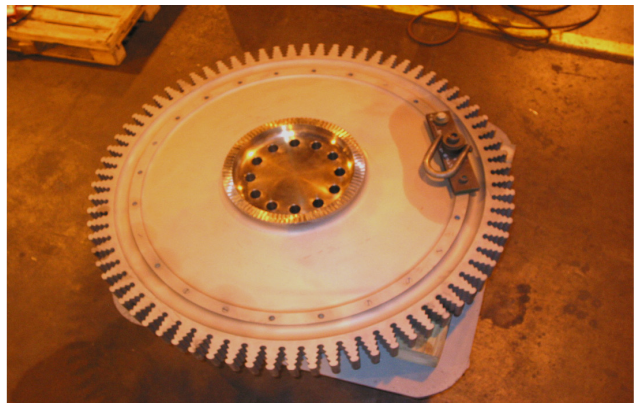
Figure 53. Picture of the Exhaust Face of the Disk.

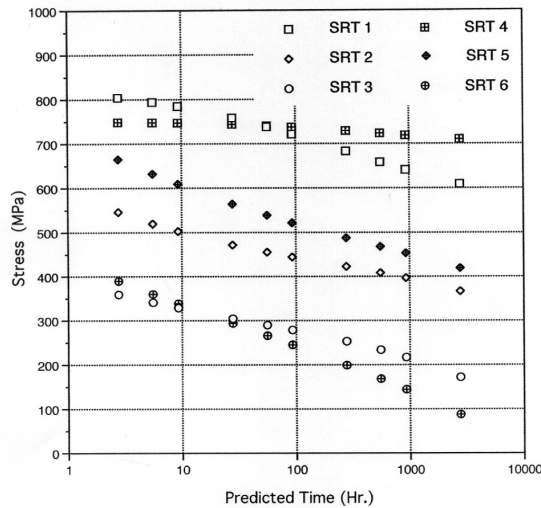
Figure 70. Stress Versus Predicted Time for 1 Percent Creep Comparison Between Service Condition Blade and Reheat Treated Blade.

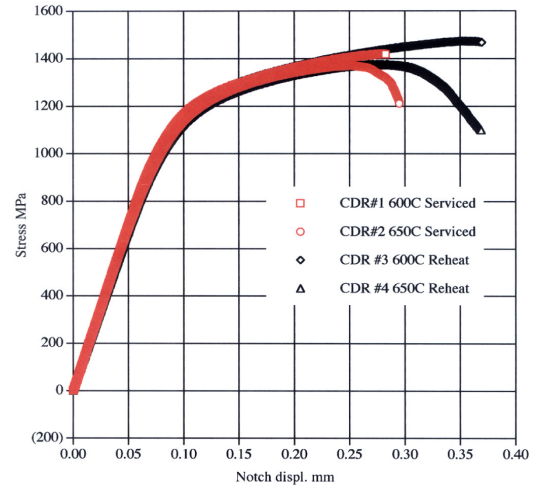
Figure 72. CDR Results at 1112°F and 1202°F (600°C and 650°C) for Service Condition Blade and Reheat Treated Blade.
