Application of Corrosion Resistant / Antifoulant Coating on Latter – Stage Steam Turbine Blades

38th Turbomachinery Symposium

Derrick Bauer
Elliott Company

David Tadeu Silveira Morais
Petrobras

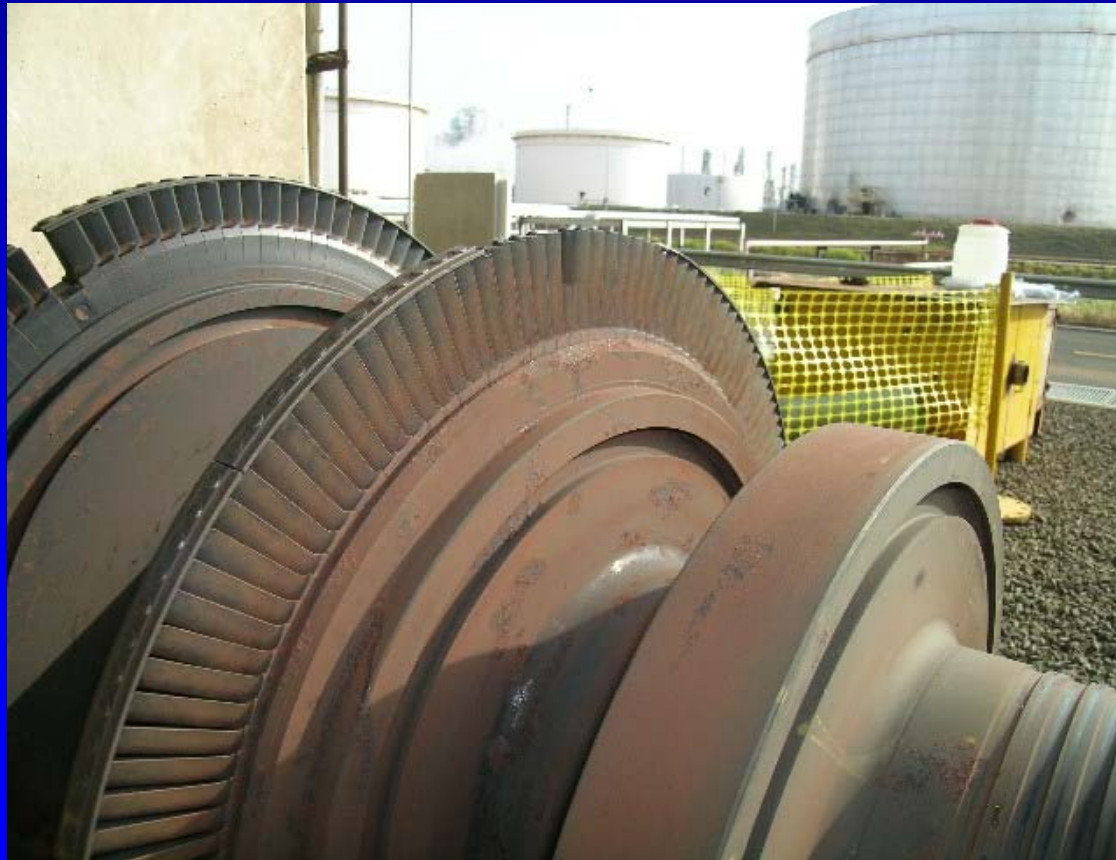
Fractured 2nd Stage Blades

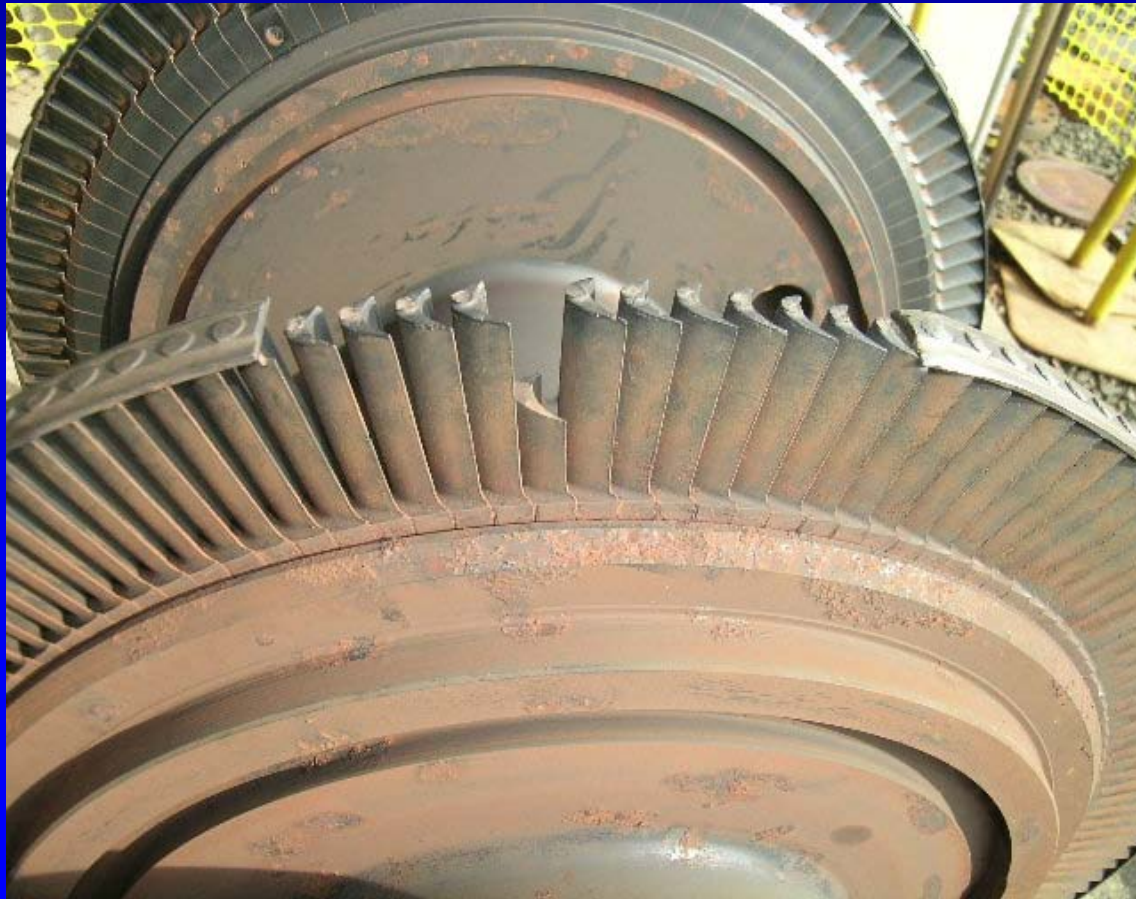
Fractured 2nd Stage Blades

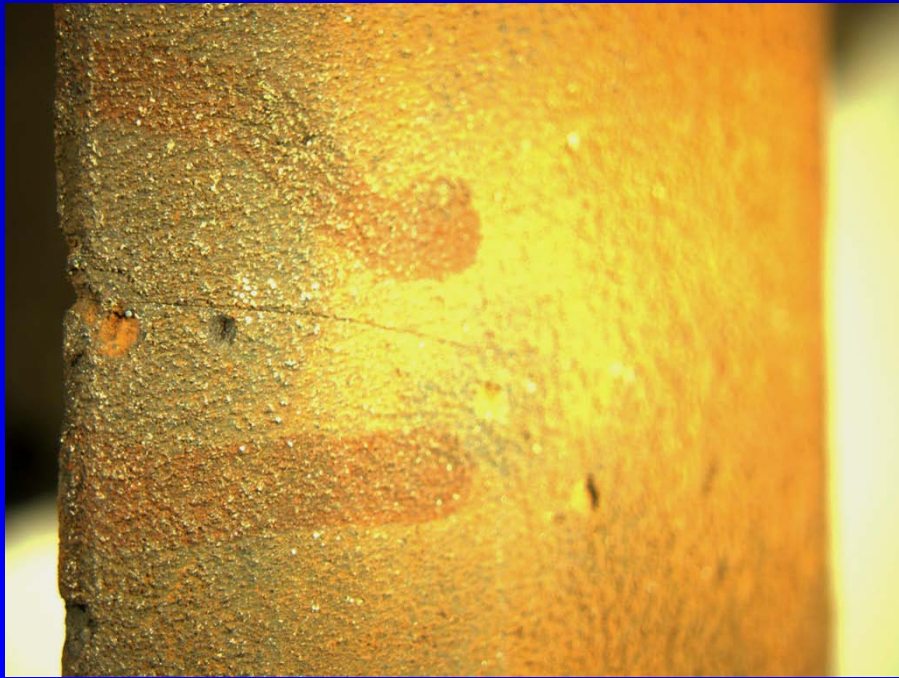
Fatigue Cracking
Initiating from
Corrosion Pit
On Blade #86

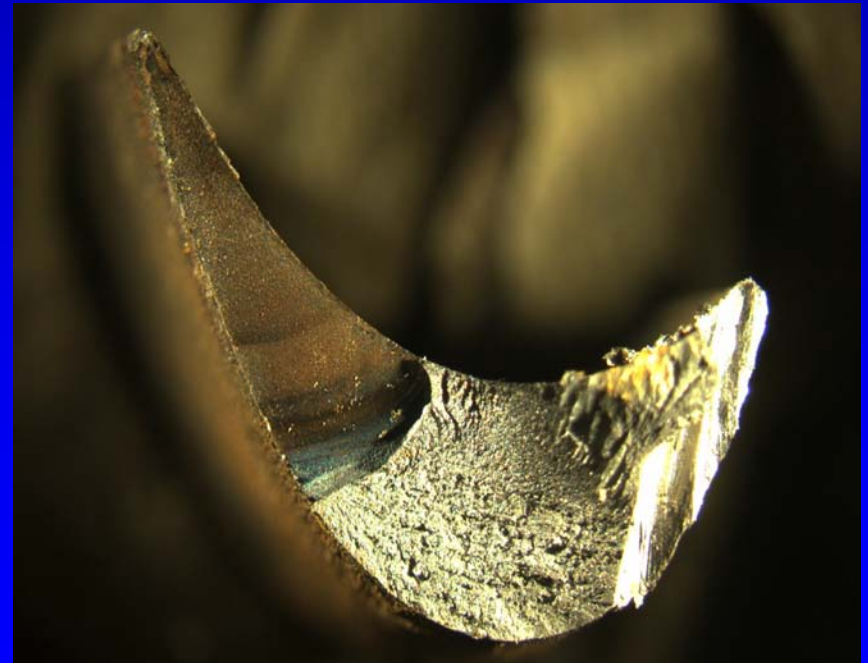
Exposed Fracture Surface
On Blade #86

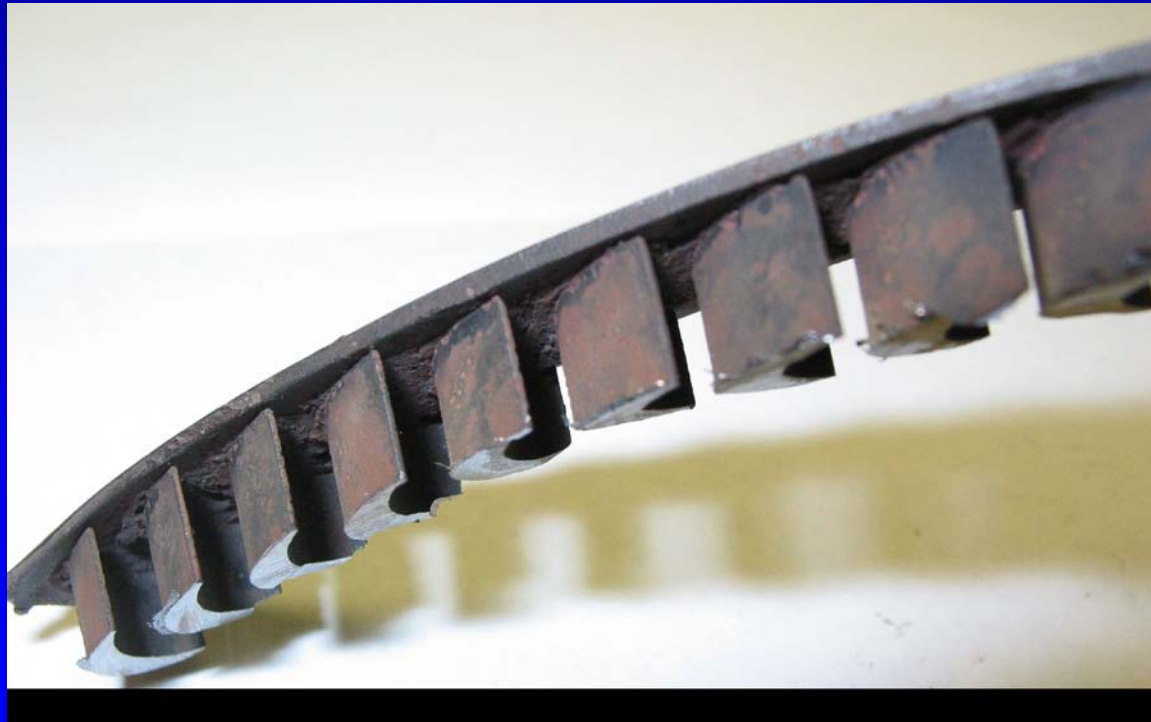
Deposit Buildup on Blade Airfoils

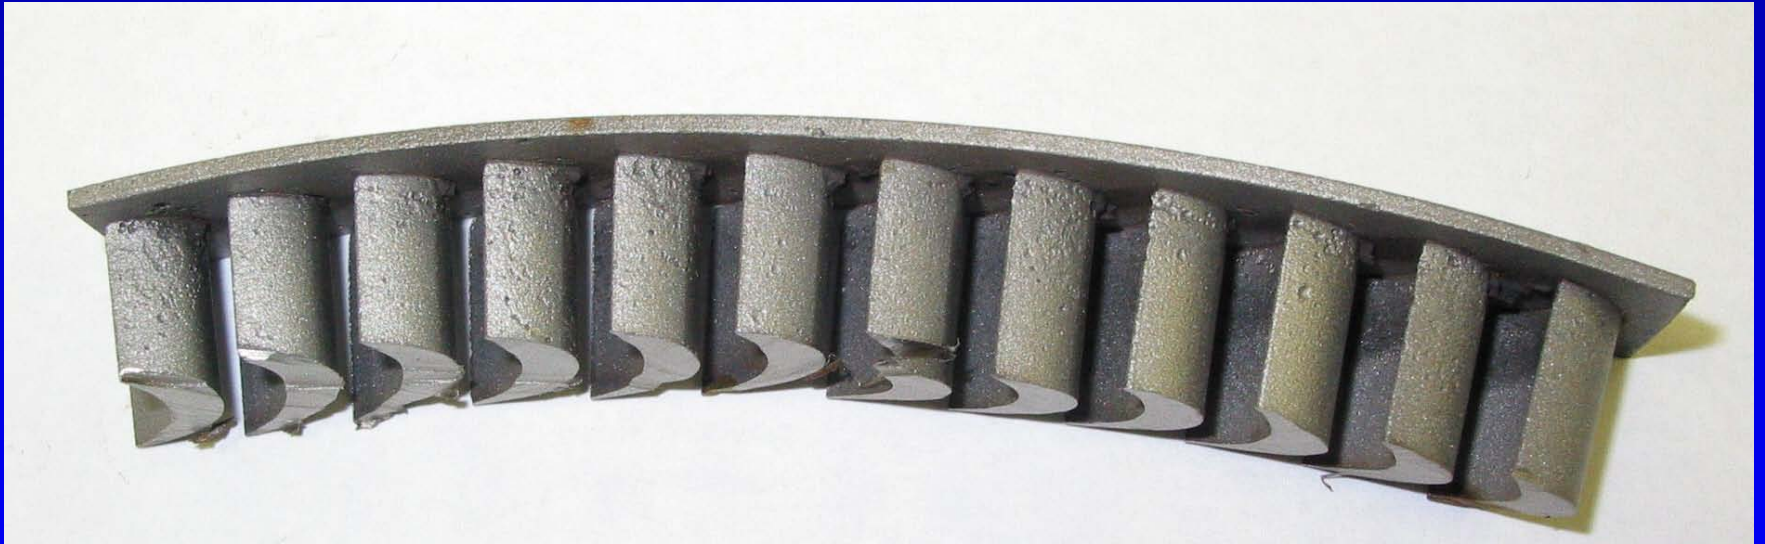
Pitting Corrosion Beneath Deposit

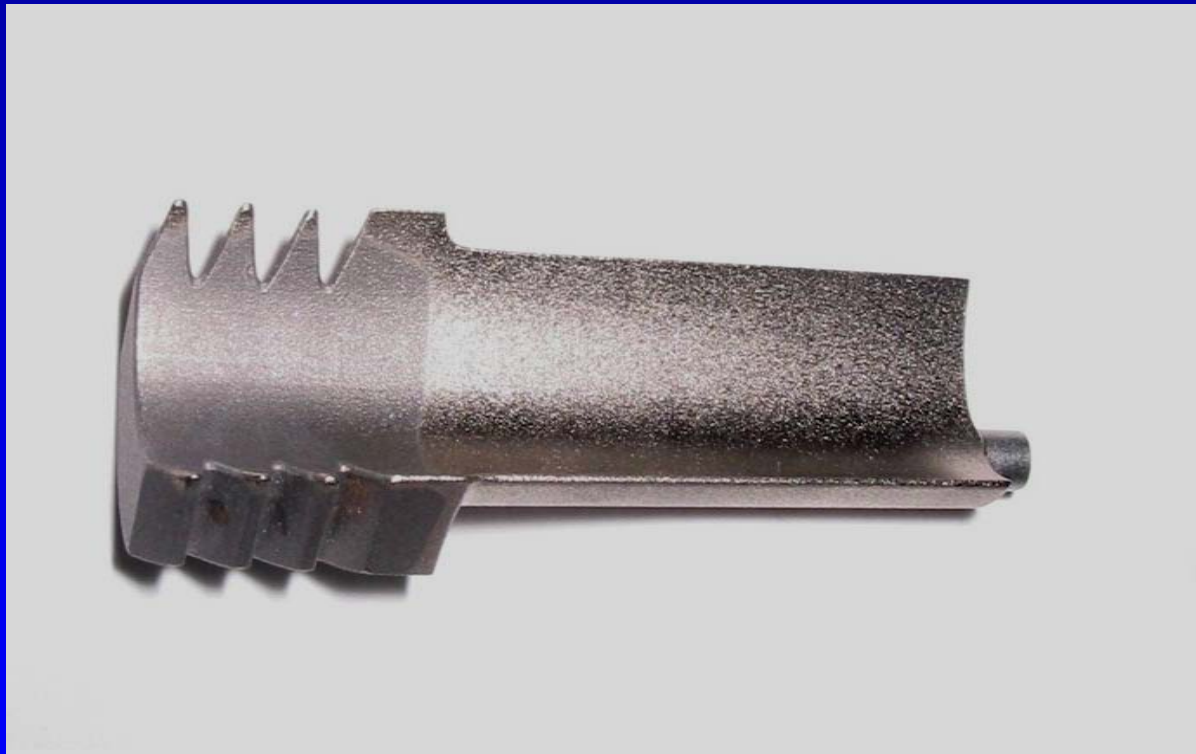
Picture of Coated Blade

- ◆ Applied coating to second stage blades
 - Hard, 3-part coating which is chemically bonded to the blade
 - **Top coat is an amorphous nickel**
 - Provides significant improvement in foulant release ability, minimizing the amount of buildup
 - Provides excellent corrosion protection
 - No reduction in fatigue properties of base metal
 - Durable coating, only removed by extensive liquid impingement

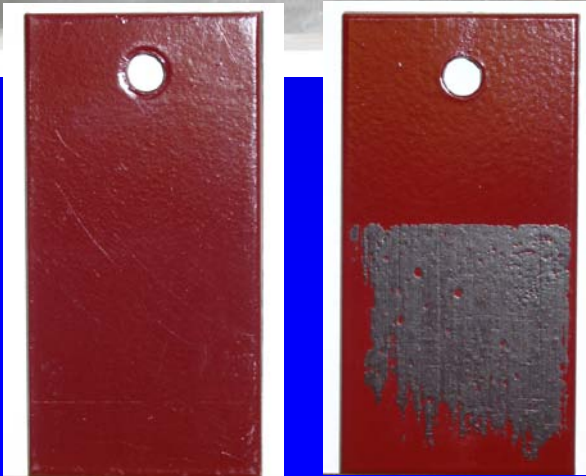
Foulant Release Testing Device

50 ml	CORN OIL
2 g	CARBON BLACK
0.4 g	CABOSIL
10 g	IRON OXIDE

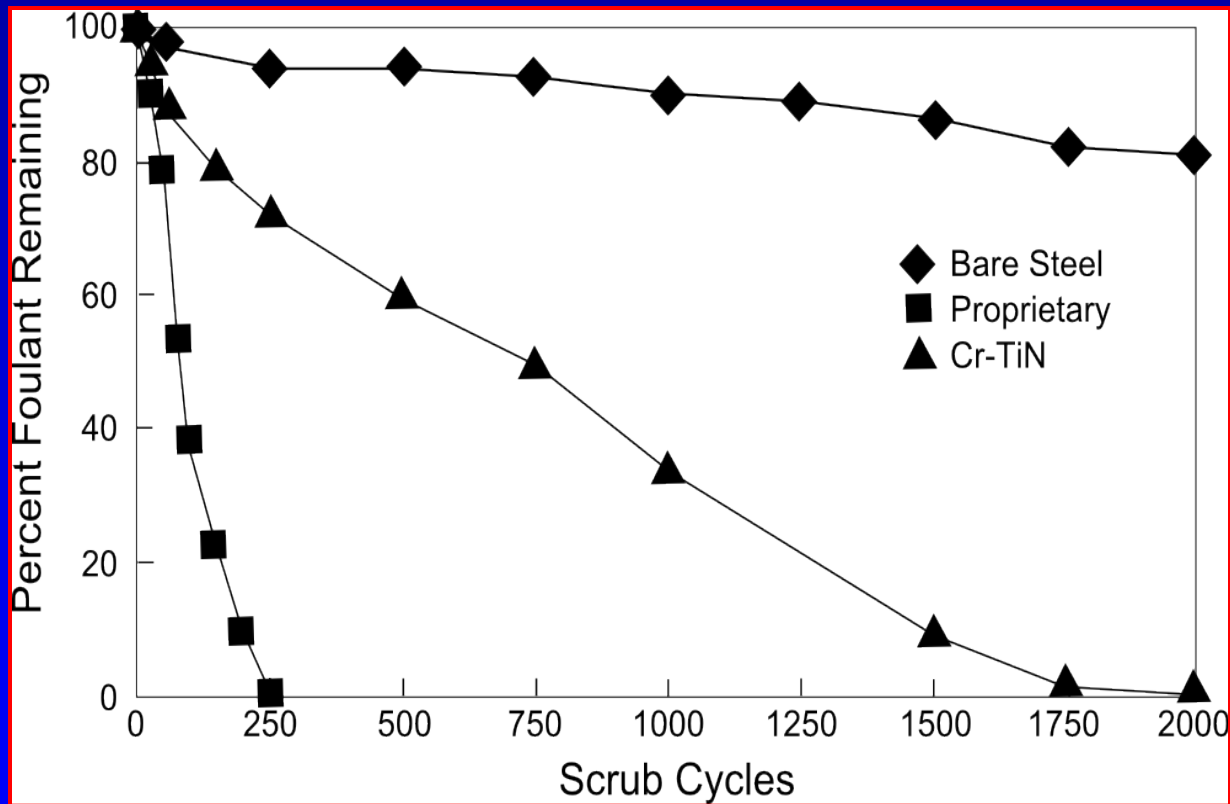
Foulant Release Testing of Anti-Fouling Coatings

Comparison of Foulant Release Performance of Bare Steel Against Proprietary Coating and Cr-TiN Coated Samples
