INVESTIGATION OF CORROSION FATIGUE PHENOMENA IN TRANSIENT ZONE AND PREVENTIVE COATING AND BLADE DESIGN AGAINST FOULING AND CORROSIVE ENVIRONMENT FOR MECHANICAL DRIVE TURBINES

Mitsubishi Heavy Industries, Ltd.

ABSTRACT

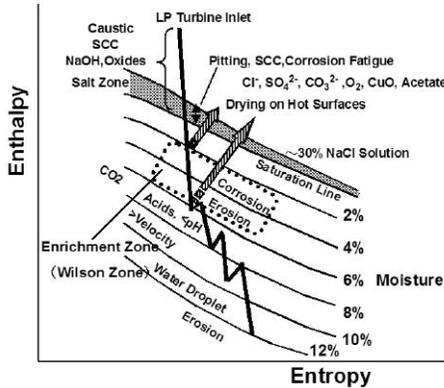
In the physical process of the low pressure stages of a steam turbine expanding from the superheated zone to the saturated zone, possible causes of mechanical damage are shown in Figure 1. On dry and wet areas around the saturation line, we tend to observe stress corrosion cracking (SCC) caused by high concentrated NaOH, pitting, corrosion fatigue related to NaCl enrichment in the special zone (Wilson zone) in which dry and wet conditions continuously occur in the moisture range of 2 percent to 6 percent, and heavy drain erosion in high moisture zones of over 12 percent. As shown in Figure 2, a fatigue endurance limit for 13Cr stainless steel under NaCl distilled water decreases drastically, and in this Wilson zone particular attention has to be paid to blade design, while considering the critical importance of controlling impurities in steam for actual continuous operation. It is necessary to understand the corrosive environment in actual operation to evaluate fatigue life. However, it is very difficult to expect concentration level changes of corrosive chemicals under conditions of rapid expansion in complicated high velocity flow fields. In this sense, it is important to evaluate mechanical integrity with a combination of detailed static and dynamic stress analysis and operation experience.

Figure 1. Turbine Expansion Line and Typical Damage.

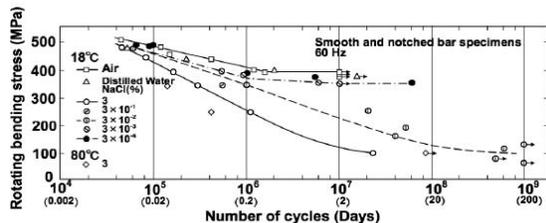
Figure 2. Decrease of Fatigue Endurance Limit for 13Cr Stainless Steel under NaCl Distilled Water.

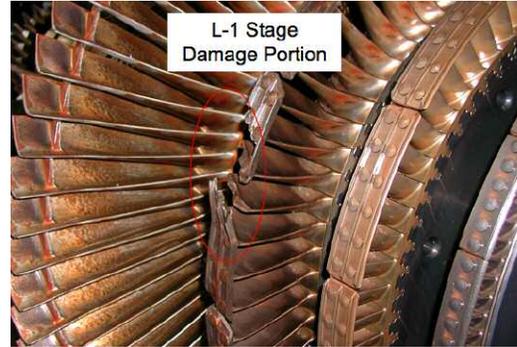
Figure 3 shows a typical failure of blades in the low pressure section (tenon and finitely grouped type of L-1 stage) (Naumann, 1982). The tenon and shroud plate have failed. Detailed conditions of the fracture surface and crack propagation direction (arrows) are shown in Figure 4. This is conformed cracking initiated on the internal side of the tenon, and this failure is high cycle fatigue (HCF) according to the observed fine spacing striation (Hiroshi, *Fractography*).

Figure 3. Typical Blade Damage of LP Section.

The results of static stress and dynamic stress analysis for the actual failed blade shown in Figure 3 are shown in Figures 6, 7, and 8. The tenon has the maximum peak static stress at its outside, which is a different location from the actual crack initiation point. However, the location of crack initiation has a minimum safety margin and this margin has to be evaluated according to both static and dynamic stress on a Goodman diagram. To analyze the dynamic vibration stress, a 3D solid model is made for one group of blades, including the rotor disk to take into account the couple modes of the blades and disk as one vibration system. The natural frequency for each mode is calculated and plotted on a Campbell diagram as shown in Figure 7.

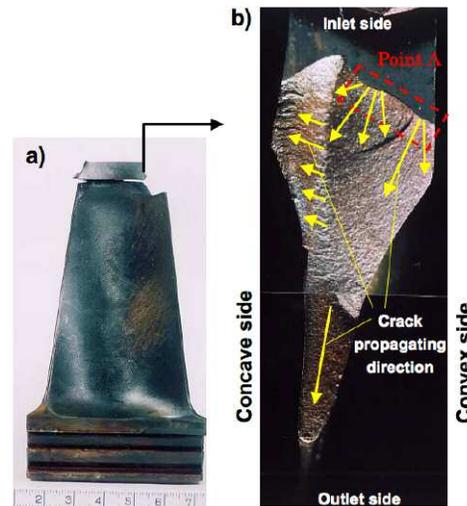
Figure 4. Crack Propagation on Fracture Surface.

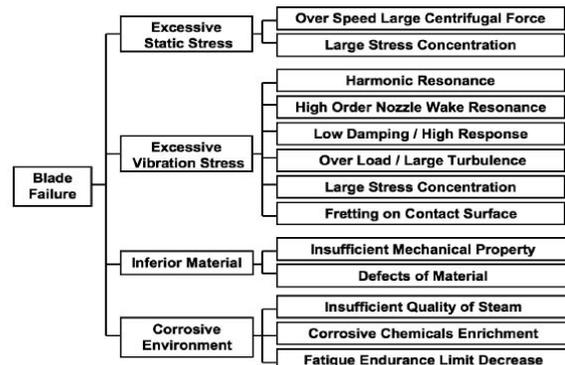
Detailed fracture and stress analyses of the actual blade are carried out by root cause analysis, which is shown in Figure 5. Key factors involved in this failure could include excessive static and dynamic external forces, and a decrease in the fatigue endurance limit in a corrosive environment. It is also important to evaluate resonance stress in the variable speed range in such a corrosive environment.

Figure 5. Root Cause Analysis for Blade Damage.

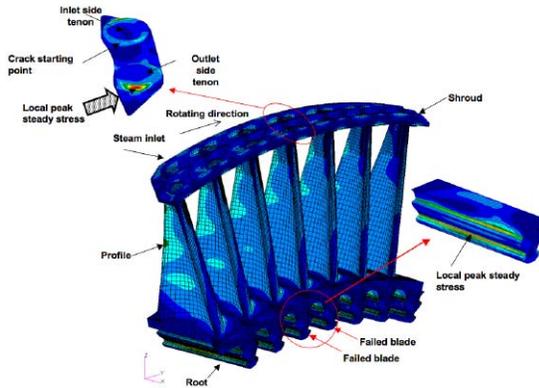
Figure 6. Static Stress Analysis Result.

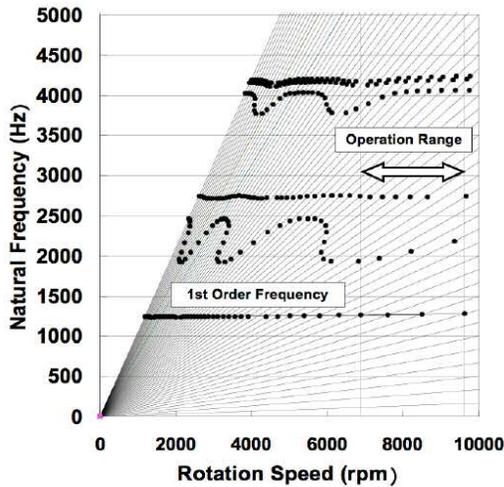
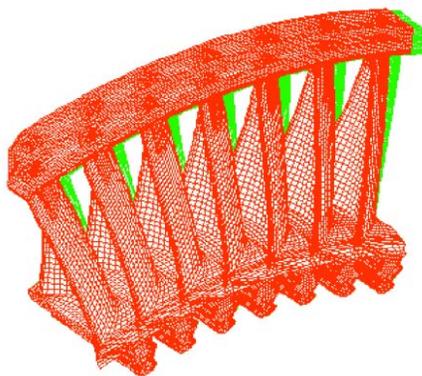
1st Order Vibration Mode

Figure 7. Campbell Diagram and Operation Range.

The resonance points are identified in the operation speed range and analyzed to determine the vibration response of the excitation force at resonance point (Wagner and Griffin, 1996). In case of finitely grouped blades, the vibration stress becomes largest at resonance with lowest frequency harmonic tangential in-phase mode. The excitation force is given on the blade profile calculated from pressure distribution of a steady computational fluid dynamics (CFD) analysis and stimulus of fluctuation level per steady level and harmonic number. The vibration response is calculated in relation to system damping. The vibration stress profile (contour) is shown in Figure 8, and the maximum peak vibration stress is observed on the inside of the tenon and stress concentration point of corner radius, which is the same as the actual crack initiation point.

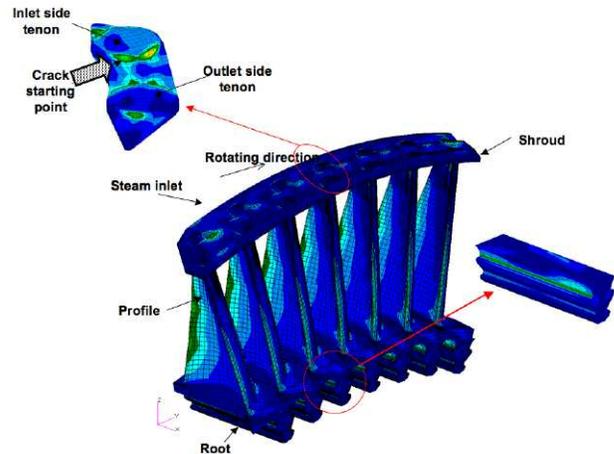
Figure 8. Vibration Stress Analysis Result for First Mode.

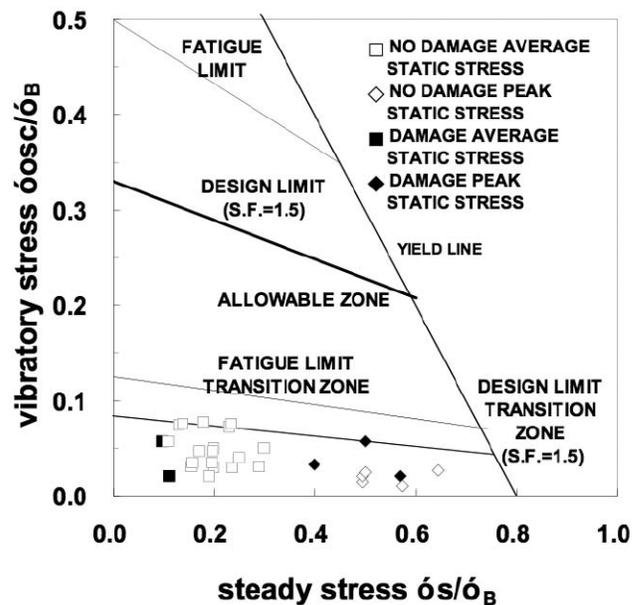
The same standard blades have been applied to over 80 turbines, which have all been in long-term operation. Among them, three turbines have the same blade damage. The static stress and vibration stress for each turbine is plotted on the Goodman diagram shown in Figure 9, comparing the allowable fatigue limit corresponding to a wet and dry transient Wilson zone (Ebara, et al., 1982). Considering the fact that vibration stress is very small and lower than this limit, and this blade damage happened after long-term operation, it is expected that the blade damage is caused by a corrosive environment related to unsuitable water and steam quality control.

Figure 9. Design Experience on Goodman Diagram.

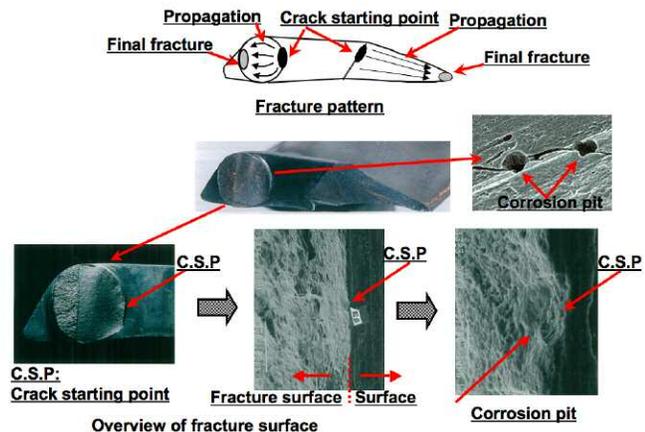
As a result of the fracture surface analysis shown in Figure 10, the typical corrosion pits of about 20 micrometers in diameter are observed around the fatigue crack starting point. Though corrosion fatigue includes environmental factors, it is difficult to quantitatively estimate the actual operating condition affecting the fatigue limit, and there are a lot of other unclear factors. A basic mechanism of corrosion fatigue is explained in Figure 11 (Ebara, 1982; Katayama, et al., 1977). This corrosion fatigue phenomenon is affected by certain types of chemical materials and their concentration levels, and it is thought that concentration cell effect and selective passive film formation cause material embrittlement.

Figure 10. Corrosion Pits on Fracture Surface.

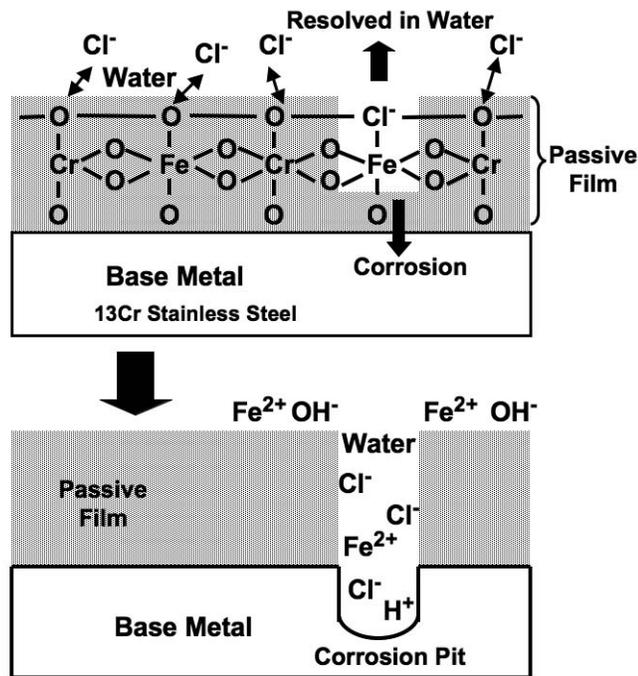
Figure 11. Mechanism of Corrosion Pit Generation.

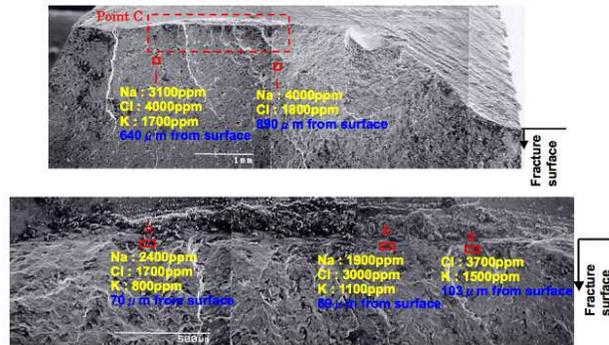
deposits on the fracture surface is carried out. As indicated in Figure 12, the concentration of Na and Cl are at a maximum of 4000 ppm and that of K is 1700 ppm; these levels are relatively high.

Figure 12. Corrosive Chemicals Concentration of Deposits on Fracture Surface.

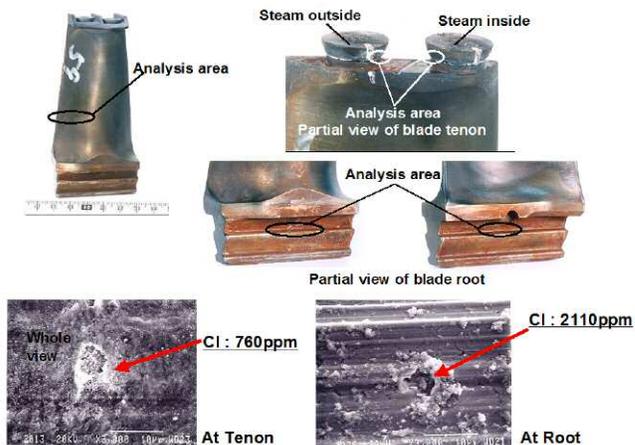
In addition, the same corrosion pits are observed on the tenon, blade profile, and root of sound blades of the same stage and turbine as shown in Figure 13. Inside these pits, 2000 ppm Cl is detected. For further investigation, the numbers of corrosion pits are counted on the blades for each stage from the high-pressure section to the low-pressure section in the flow path to compare the corrosion environment level reiteratively. The profile of the measured pit count number in the flow path is shown in Figure 14.

Figure 13. Corrosion Pits on Sound Blade and Corrosive Chemicals Concentration Inside of Pits.

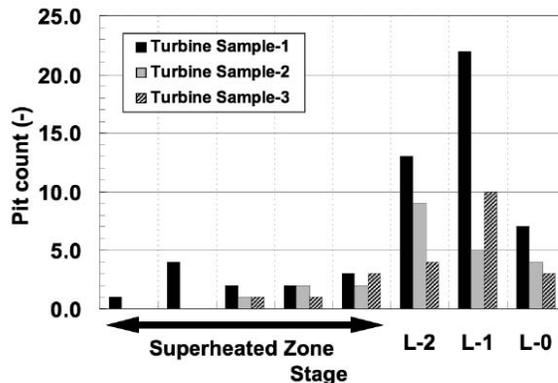
Figure 14. Corrosion Pit Number of Each Stage and Profile.

According to this profile, the frequency of corrosion pits occurrence in the three stages (L-2, L-1, L-0: last stage) of the low-pressure section located in the wet zone is high. This is

especially the case for the L-1 stage located in the wet/dry transient enrichment zone, which has the highest frequency of corrosion pit occurrence. The profile of the measured concentration of corrosive chemicals that is sampled from the blade surface for each stage is shown in Figure 15. According to this profile and the Cl concentration of the L-1 stage, which is extremely high at around 40,000 ppm (Ebara, et al., 1978), it is considered that the corrosive chemical enrichment in the wet/dry transient zone and the corrosive environment have a strong relationship with blade corrosion fatigue damage. The threshold of the Cl deposit concentration level for determination that is a cause of general fatigue or corrosion fatigue is around 1000 ppm.

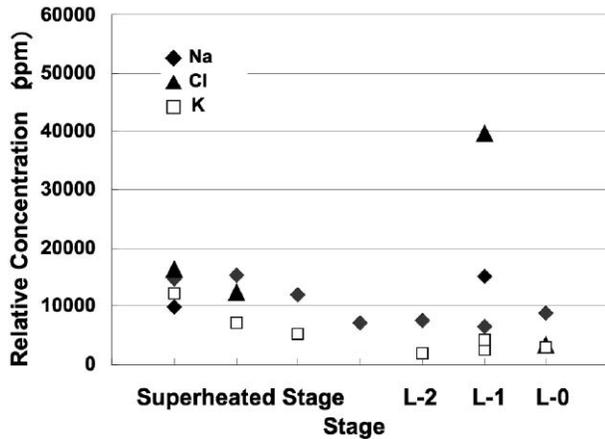
Figure 15. Corrosive Chemicals Concentration Profile of Deposits.

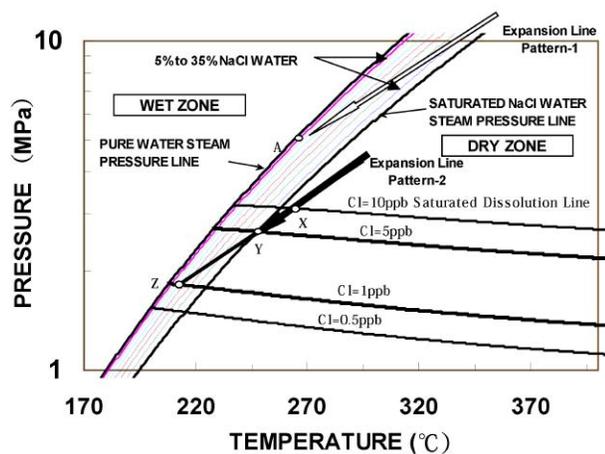
The separation and deposit, liquid, or solid phases and concentration level of corrosive chemicals on the nozzle and blade profile in each stage are determined by steam temperature and pressure on the turbine designed expansion line and concentration of impurities in steam, which is related to water/steam quality control. The analysis results of Cl concentration in steam expansion and deposit/dissolved condition are shown in Figure 16. This analysis is based on steady chemical equivalent conditions (Steltz, et al., 1983) by varying pressure, temperature, and Cl saturated concentration, and focusing on the NaCl supersaturation line in the high concentration zone.

Figure 16. Cl Concentration in Steam Expansion and Deposit/Dissolved Condition.

In Figure 16, two different expansion lines are described as arrows “pattern-1” and “pattern-2.” Where Cl concentration reaches 10 ppb for pattern-1, steam expands in the region of high pressure and temperature over the Cl saturation line. Even if the steam

condition expands to point-A, the NaCl phase is still gas in the dry zone, and the blade surface is not exposed to high concentrations of corrosive elements in wet conditions.

On the contrary, in the case of 5 ppb, if steam expands in the temperature and pressure of the Cl saturation zone and goes to supersaturation point-Y, water with 30 percent NaCl, an extremely high concentration, occurs and the blade surface is exposed to a severely corrosive condition. According to these analysis results, even if the Cl concentration is extremely low, such as 1 ppb to 5 ppb in steam, a severely corrosive environment can still appear around the blades (Bischoff and Pitzer, 1989).

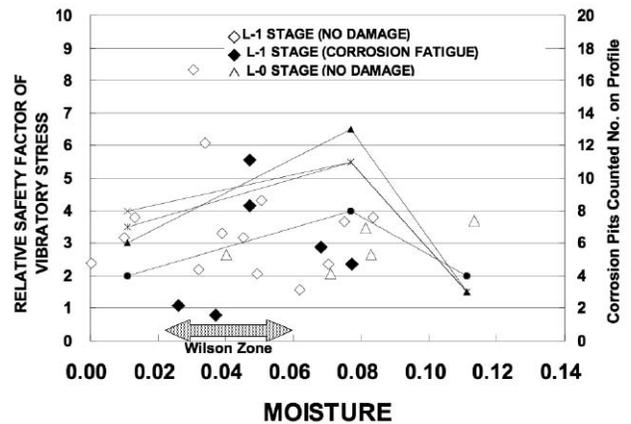
The L-1 stage blade damage is related to the enrichment and concentration level in the wet/dry transient zone, and the vibration stress level. To verify this relationship for damaged and undamaged blades, the relative safety factor of vibration stress based on the allowable limit in the transient zone and measured number of corrosion pits are plotted per each designed stage moisture level as shown in Figure 17. From this result, it is clear that, even if the relative safety factor is sufficient, corrosion fatigue damage occurred in the enrichment zone. Furthermore, it is confirmed that the number of corrosion pits is maximum in the enrichment zone, in the same fashion as the profile of the relative safety factor of vibration stress.

Figure 17. Relation of Wilson Enrichment Zone, Actual Moisture, and Fatigue Strength Safety Factor.

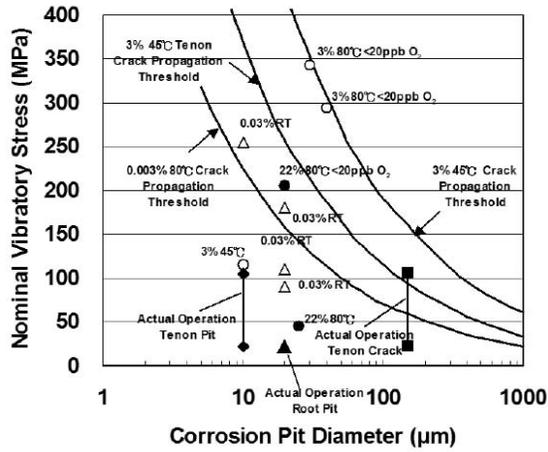
The authors studied the question of whether only a corrosive environment contributes to initial crack generation and crack propagation or the corrosion pit itself contributes by stress concentration as a general fatigue phenomenon. Fatigue tests were conducted in a corrosion environment by changing the concentration of NaCl to 0.03 percent, 3 percent and 22 percent, respectively (Allmon, et al., 1983). The relationship between vibration stress of fatigue test conditions and the observed corrosion pit diameter is plotted on Figure 18. In this figure, the vibration stress range is based on a calculation of the threshold of stress intensity factor (Maday, et al., 1989), and thus the limit of crack start propagation, as well as the vibration stress measured from detail fracture surface analysis for actual damaged blades, are plotted.

Figure 18. Relation of Corrosion Pit Size and Vibration Stress in Comparison with Crack Propagation Limit Line.

According to these results, if a corrosion pit of over 100 micrometers diameter has a vibration stress of less than 100 MPa, there is a possibility of crack propagation. Under a severe corrosive condition of 22 percent NaCl concentration, together with a small amount of oxygen, even if a low vibration stress acts on the blade, small corrosion pits of 20 micrometers are observed and finally fatigue failure occurred. Based on the fact that the blade actually failed under low vibration stress and several corrosion pits were observed, it can be concluded that a corrosive environment heavily contributes to initial crack generation, but crack propagation and corrosion pitting themselves do not seem to contribute to stress concentration.

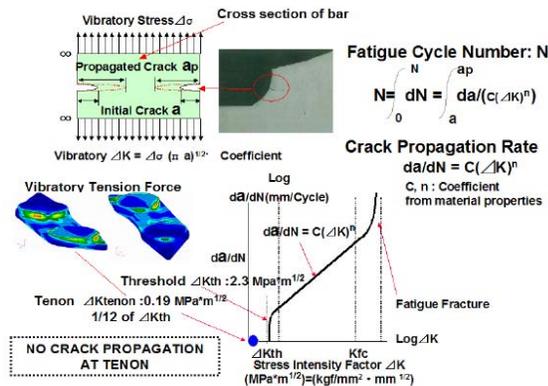
Conventional blades have a tenon, and after tenon caulking from plastic forming, microwrinkle occurs. It is suspected that this microwrinkle contributes to crack propagation as a stress concentration or stress raiser in certain conditions. In Figure 19, the stress intensity factor calculated from the actual observed wrinkle depth and acting vibration stress is compared to the threshold of stress intensity factor. This figure tells us that if a large excitation force over 10 times that calculated acts on a blade, there is a possibility of crack propagation from microwrinkles in tenon caulking.

Figure 19. Tenon Caulking Stress Raiser and Crack Propagation Limit.

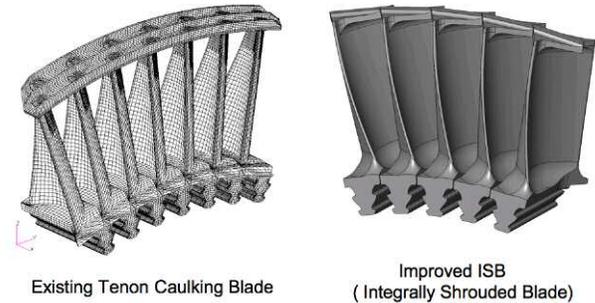
Having reached this conclusion, as shown in Figure 20, the integral shroud blade (ISB) (Ebara, et al., 1990) was developed by applying the blade profile and shroud in one piece without a tenon.

Figure 20. Improved ISB for Corrosion Fatigue Strength.

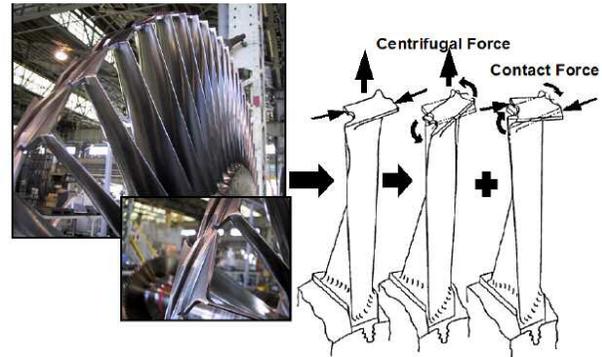
These blades are thus infinitely grouped with a twist back torque mechanism as shown in Figure 21 in order to eliminate lowest frequency tangential load in phase mode and increase natural frequency. For this improved ISB, a stress analysis has been completed and sufficient improvement of safety factor confirmed (Katayama, et al., 1977). Furthermore, this ISB has been applied on actual turbines and successfully operated.

Figure 21. Mechanism of ISB Twist Back Infinite Coupled.

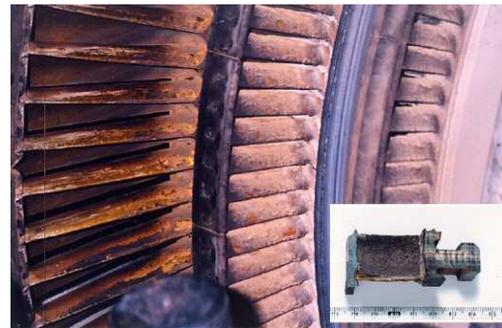
During steam turbine continuous long-term operation, steam contaminants, such as silicate and sodium, deposit on the internals as solids. This occurs under certain operating conditions related to steam pressure and temperature for each of the stages. These contaminants foul the surfaces of nozzles and blades and gradually build up during steam turbine operation. Figure 22 shows the fouling condition after seven years of continuous operation.

Figure 22. Deposit Condition of LP Section.

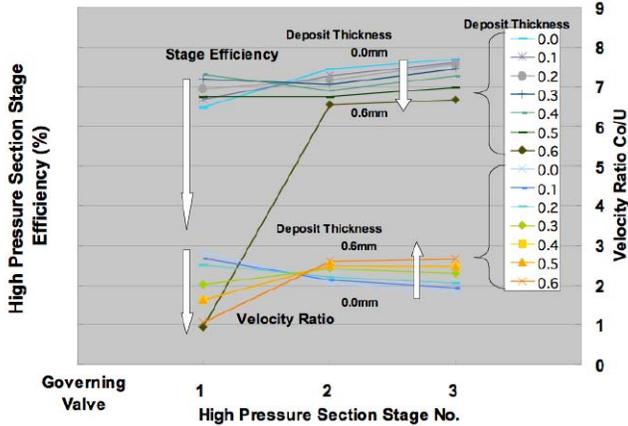
The composition and characteristics of the fouling materials are different along the steam path from the high-pressure stages to the low-pressure side. Under these fouling conditions, the pressure profiles across the nozzles, blades, and throat areas increase. These profiles in turn result in the deterioration of turbine performance, and it will continue to do so over time if left unattended. The authors have calculated the relationship between after stage pressure increase and efficiency change (loss) due to the fouling

Overall efficiency change and after stage pressure change depend on what stage has deposits and its fouling thickness.

Figure 23. Blade Design, Efficiency Affected by Fouling in Each Stage.

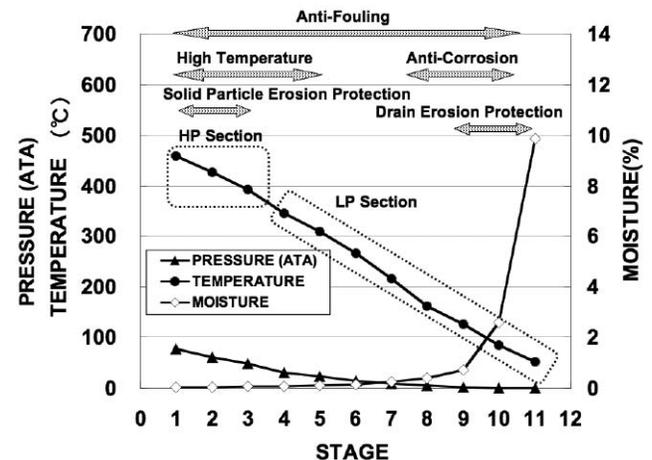
In order to prevent both steam turbine performance deterioration and blade strength margin decrease during long-term operation, a new surface treatment is necessary to meet requirements of solid particle erosion prevention, anti-fouling, anti-corrosion, and drain erosion protection corresponding to steam temperature and pressure for each stage as shown in Figure 24. In this study, the requirements are defined as shown for the low pressure section of steam temperature, which is lower than 662°F (350°C), as follows:

- 1) Prevention or relaxation of fouling on nozzle and blade profiles,
- 2) Improvement of washing efficiency during online washing,
- 3) Prevention of decrease in corrosion fatigue strength,
- 4) Anti-drain erosion performance in the same way as base materials.

Figure 24. Turbine Internal Condition and Coating Required Function.

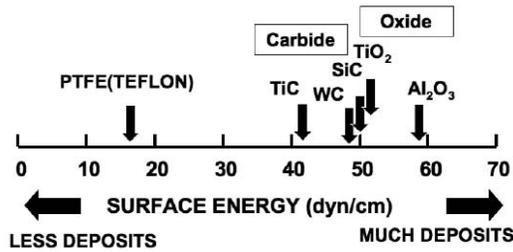
One of the main factors affecting fouling on the blade profile surface is the material surface energy. As shown in Figure 25, polytetrafluoroethylene (PTFE) has a lower surface energy than other types of ceramics and this is therefore suitable for prevention of fouling. However, PTFE own strength is low and it is necessary to improve coating performance with a hybrid for actual application.

Figure 25. Several Types of Ceramics and Surface Energy Level.

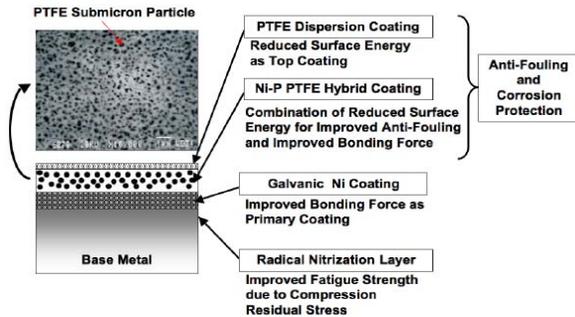
In order to realize a new suitable and multifunction coating considering the bonding strength between the anti-fouling coating layer and base metal, anti-erosion (prevention of layer separation), and anti-corrosion, a new coating has been developed. This coating concept is shown in Figure 26.

Figure 26. Basic Concept of Developed Coating.

Compression stress is produced in the surface of the base metal with a radial nitriding surface treatment. Furthermore, a galvanic Ni coating layer is formed to improve bonding condition and coherency. A Ni-P PTFE hybrid coating is formed to realize the combination of reduced surface energy for improved anti-fouling and bonding force. Finally, a top PTFE dispersion coating is formed to further reduce surface energy.

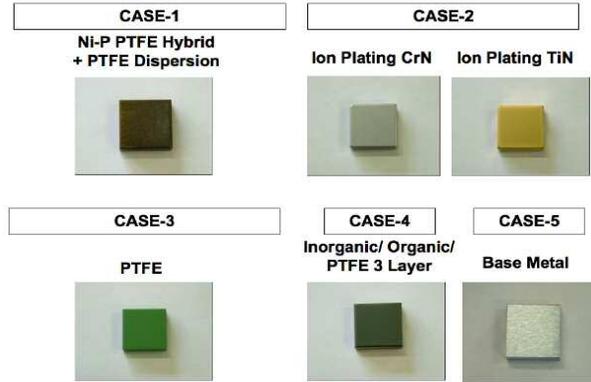
Figure 27. Overview of Coating Test Pieces.

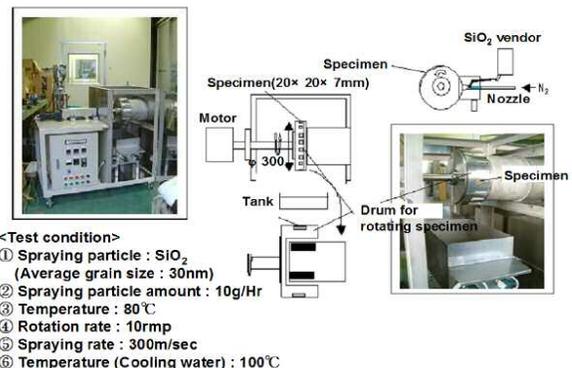
An anti-fouling test set up for simulating fouling conditions so that deposits will form on the material surface has been designed and manufactured according to the theory of cohesion and adhesion engineering of microfine particles. For the basic fouling test procedure, fine particle material, diameter, and particle collision velocity were adjusted the same as actual conditions, and the amount of particle concentration was increased for acceleration of fouling conditions. Figure 28 shows the anti-fouling test set up and Table 5 shows the test conditions. The rotating drum is heated up to 932°F (500°C) and silica fine particles are sprayed over the test pieces at a velocity of 300 m/sec. The ease of fouling is evaluated relatively by measuring the weight increase of deposit on the test piece surface during a 200-hour test period. Figure 29 shows the surface deposit condition during this 200 hours of spraying each test piece. An anti-fouling index (difficulty to deposit) is defined as the ratio of deposit weight based on SUS 410J1 base metal. The relationship between this anti-fouling index and surface roughness for each test piece is shown in Figure 30.

Figure 28. Anti-Fouling Test Set-Up.

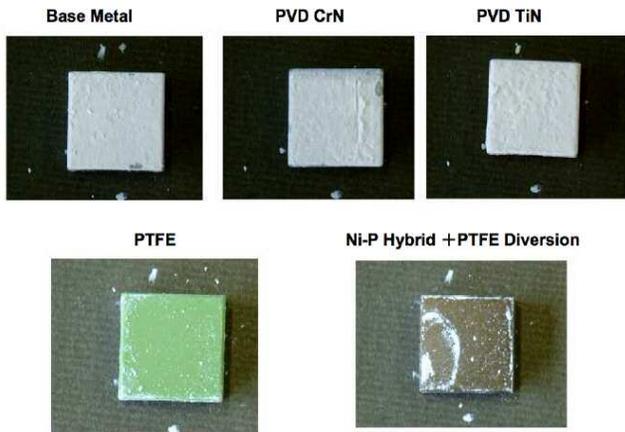
Figure 29. Surface Deposit Condition after 200 Hrs Spray.

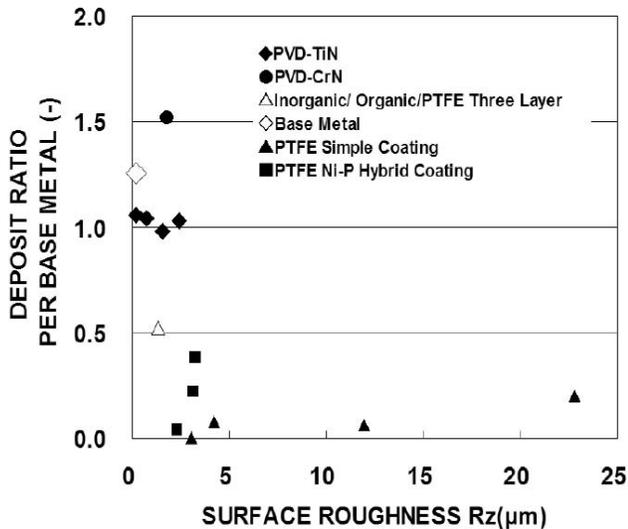
Figure 30. Surface Roughness and Deposits Ratio.

According to this result, PTFE Ni-P hybrid coating has almost the same anti-fouling characteristics as PTFE coating. The change in the anti-fouling index for PTFE Ni-P hybrid coating, when changing the occupation ratio for PTFE dispersion in the top coating is shown in Figure 31. With a 20 percent occupation ratio of PTFE dispersion and practical surface roughness, the anti-fouling index can be decreased to 1/5 of the base material. Furthermore, this coating performance is twice as effective as the conventional spray paint coating usually applied for a compressor.

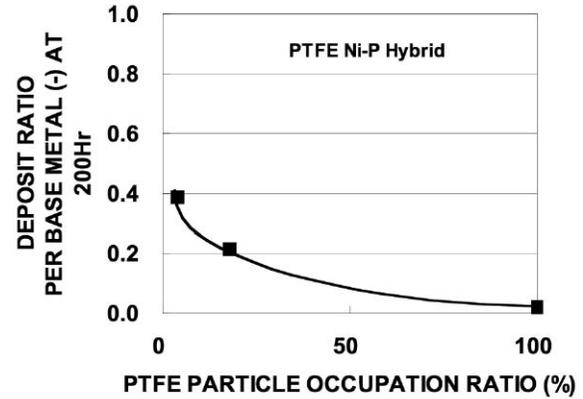
Figure 31. PTFE Occupation Ratio and Deposit Ratio.

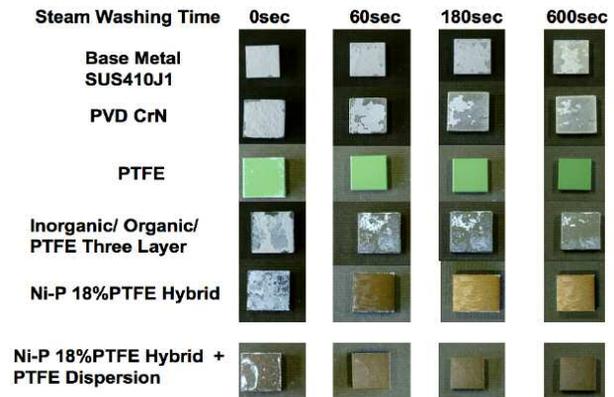
An evaluation procedure for the simulation of actual washing has been developed by applying steam injection to test pieces with deposits after a 200-hour fouling simulation test period. The washing efficiency is evaluated quantitatively by the weight of removed silica deposit and qualitatively by an overview of the washed surface. Figure 32 shows an overview of surface deposit conditions during washing and Figure 33 shows SiO₂ deposit removal mass during washing. The SiO₂ deposit removal time is listed in Table 6.

Figure 32. Surface Deposit Condition During Washing.

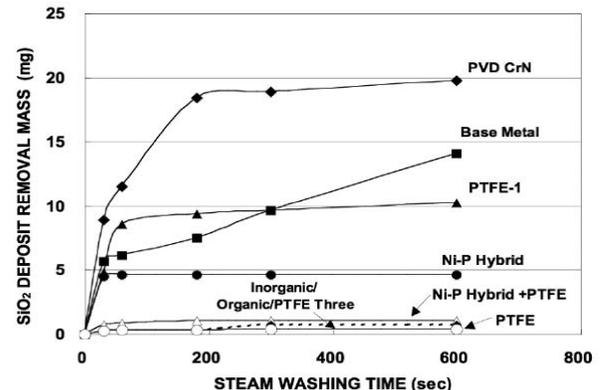
Figure 33. SiO₂ Deposit Removal Mass During Washing.

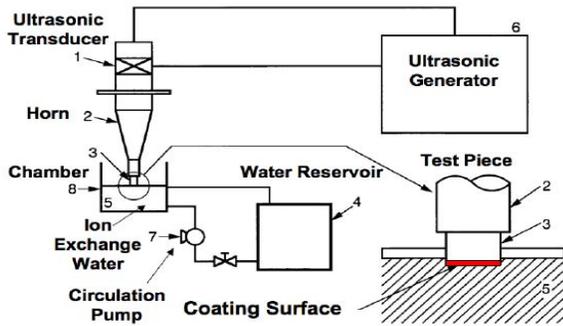
An anti-erosion evaluation test was conducted in accordance with ASTM G32-77 (Saga, et al., 2005) using the cavitation erosion accelerated test set-up shown in Figure 34. The results of this test are shown in Figure 35. The wear mass reduction of the Ni-P PTFE hybrid coating is much smaller than that of the PTFE single coating and larger than that of the base metal at the beginning of the test. However, this wear mass reduction is expected to saturate to a level smaller than that of the base metal at the end of the test.

Figure 34. Cavitations Erosion Accelerated Test Set-Up.

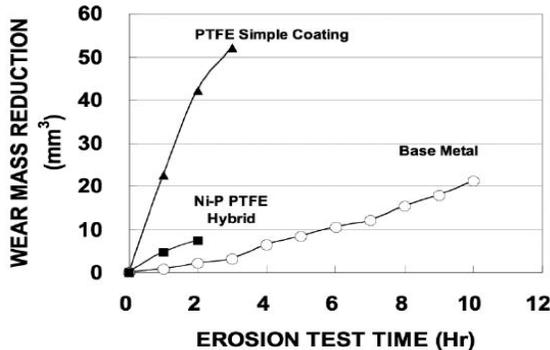
Figure 35. Accelerated Erosion Test Results.

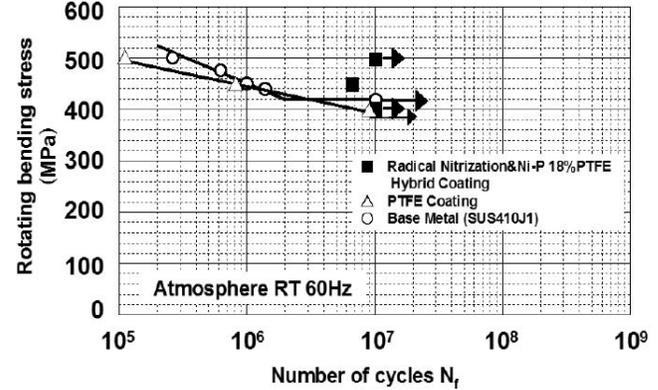
A rotary bending fatigue test was conducted for the PTFE single coating and the radical nitriding Ni-P hybrid coating under normal atmospheric conditions and very severe corrosive conditions, with 3 percent NaCl distilled water. The test results are shown in Figure 36 and Figure 37, respectively. Under normal atmospheric conditions, the fatigue endurance limit for both of the PTFE single coating and

the radical nitriding Ni-P hybrid coating is 400 MPa at 1×10⁷ cycles, almost the same as base metal SUS410J1 applied for blades and nozzles.

Figure 36. Fatigue Test Result at Atmosphere.

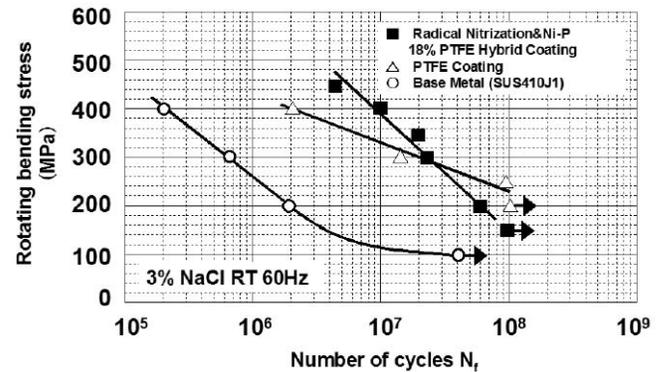
Figure 37. Corrosion Fatigue Test Result.

However, with 3 percent NaCl distilled water, the fatigue failure rotating bending stress decreased to 200 MPa at 1×10⁸ cycles for the PTFE single coating, 100 MPa at 4×10⁷ cycles for the base metal, and 150 MPa at 1×10⁸ cycles for the radical nitriding Ni-P hybrid coating. This is twice the corrosion fatigue resistance than the base metal. It is thought that the reason why the corrosion fatigue resistance is improved with both coatings is because the coating layer is very fine with fewer defects (such as pin holes), and that they contribute to the effect of environment interception. In addition, in the low cycle fatigue (LCF) region of high stress, the corrosion fatigue resistance of these coatings has improved, which means that the layer itself has a high level of toughness and high bonding strength with the base metal.

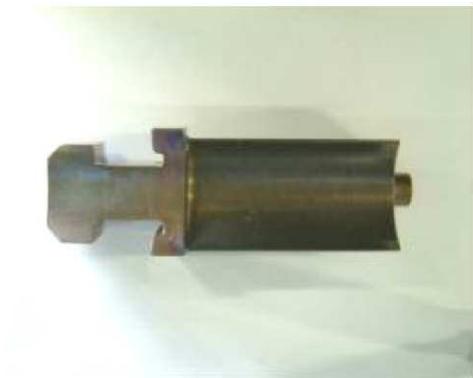
Ni-P 18%PTFE Hybrid

Following the results of this study and the evaluation tests as explained above, the PTFE Ni-P hybrid coating was applied to the actual blade as shown in Figure 38. Additional improvement measures for prevention of steam turbine efficiency deterioration were applied to an actual steam turbine as shown in Figure 39 and listed below. ISB (Sasaki, et al., 2002) was applied for all stages (impulse and reaction types) to increase overall efficiency and prevention of corrosion fatigue in the dry/wet transient zone. For inlet first stage nozzles, boronizing coating was applied to prevent solid particle erosion and last-1 and last stage blade surfaces were treated with TiN ion plating and PTA (plasma transfer arc welding), respectively, to prevent drain erosion. In addition, wide pitch nozzles were applied for all stages to increase stage efficiency and to minimize after stage pressure due to fouling.

Figure 38. Coated Actual Blade.

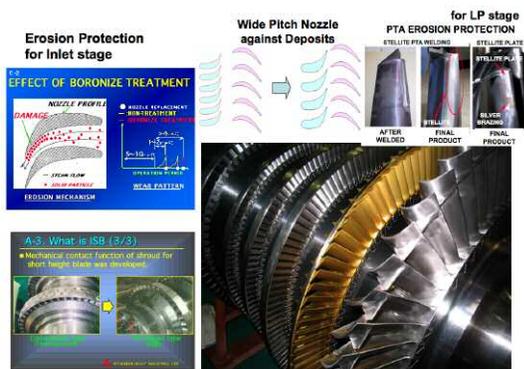
Figure 39. Improvement of Blade Integrity, Coating Application of Actual Blades, and Additional Improvement for Anti-efficiency Deterioration.

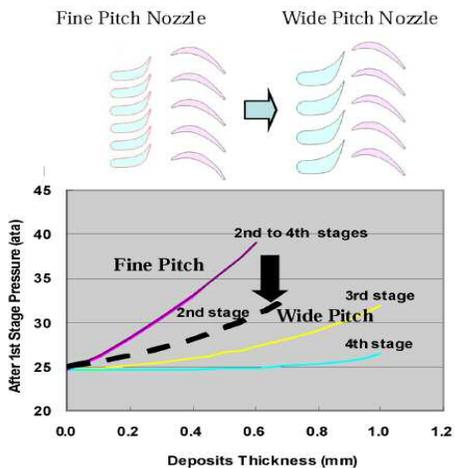
In Figure 40, the difference in after stage pressure increase due to deposits on the nozzle profile is explained by comparing a fine pitch nozzle and wide pitch nozzle. If deposit thickness increase rate (mm/year) is the same, the nozzle area reduction rate of wide pitch nozzles can be decreased by half because of the smaller number of nozzles or smaller profile surface area than the fine pitch nozzle. After-stage pressure increase is proportional to steam flow and this turbine can have more margin for operating time reaching the pressure limitation under fouling conditions, while maintaining the required power and extending operation time. Furthermore, if online washing is executed periodically, the operating time can be extended more by performance recovery.

Figure 40. Wide Pitch Nozzle to Minimize Pressure Increase Due to Fouling.

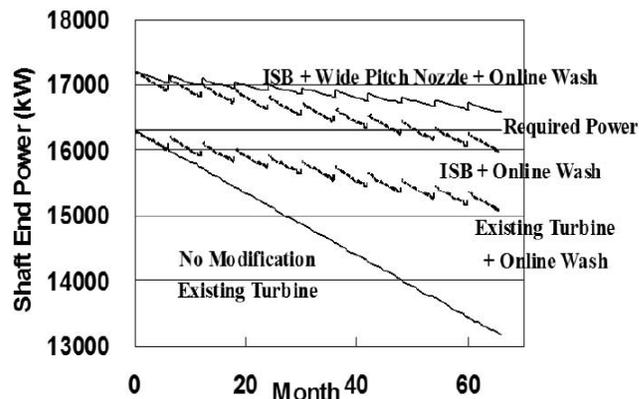
Figure 41 explains the advantage of each improvement and their combination. In this case study, the power recovery ratio after online washing is assumed to be 80 percent and the power decrease rate due to after-stage pressure increase caused by fouling is half of a fine pitch nozzle when using a wide pitch nozzle application.

Figure 41. Advantage for Combination of Wide Pitch, All ISB, and Online Washing.

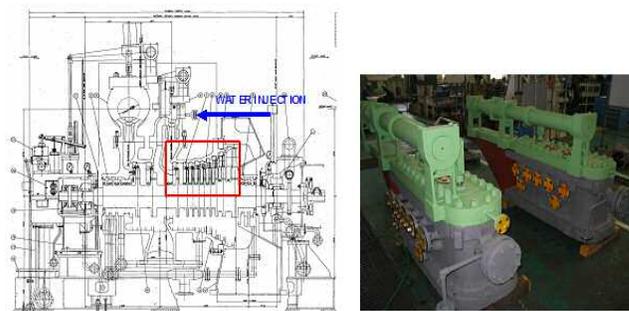
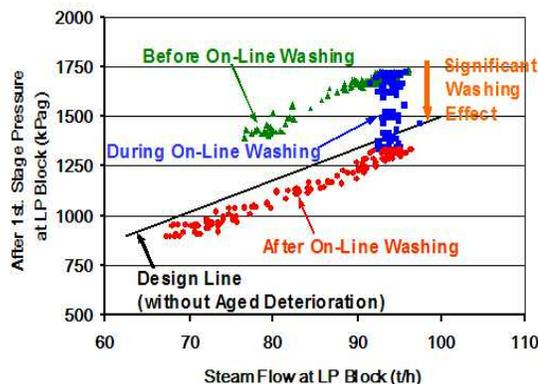
This new online wash technology has been applied for over 20 turbines and typical successful results onsite are shown in Figure 42 (Hata, 2007a, 2007b). In this case, an anti-fouling coating such as an Ni-P PTFE hybrid multilayer coating is not applied. However, it has been confirmed that the turbine performance recovers after online washing to the original clean condition. If this newly developed coating and other improvements, including online washing and wide pitch nozzles as explained above, are applied systematically, the turbine integrity and performance can be maintained to the same as the original during long-term operation over eight years (Hata, et al., 2007a, 2007b, 2007c, 2007d; Hata, 2001).

Figure 42. Successful Online Washing at Site.
