Effect of the Off-line Wash system for Gas Turbines Ruston TB5000 in high polluted conditions

CASE STUDY

Texas A&M University's 36th Turbomachinery Symposium

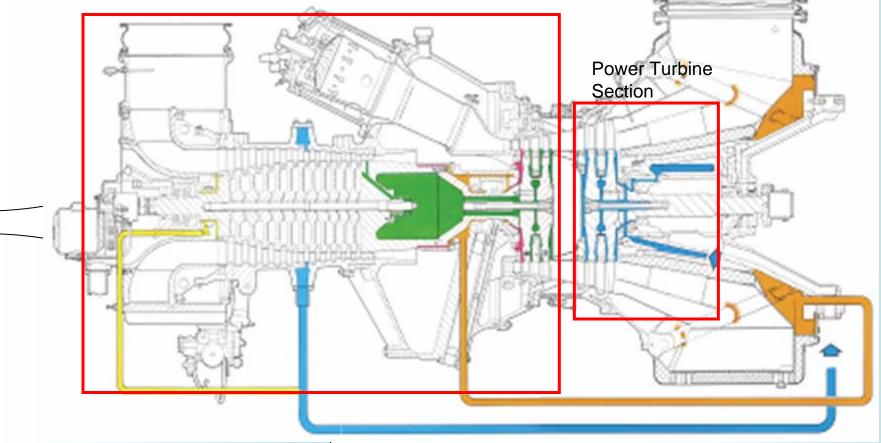
Transversal section schematic for the Ruston TB5000. EGT Lincoln, Uk.

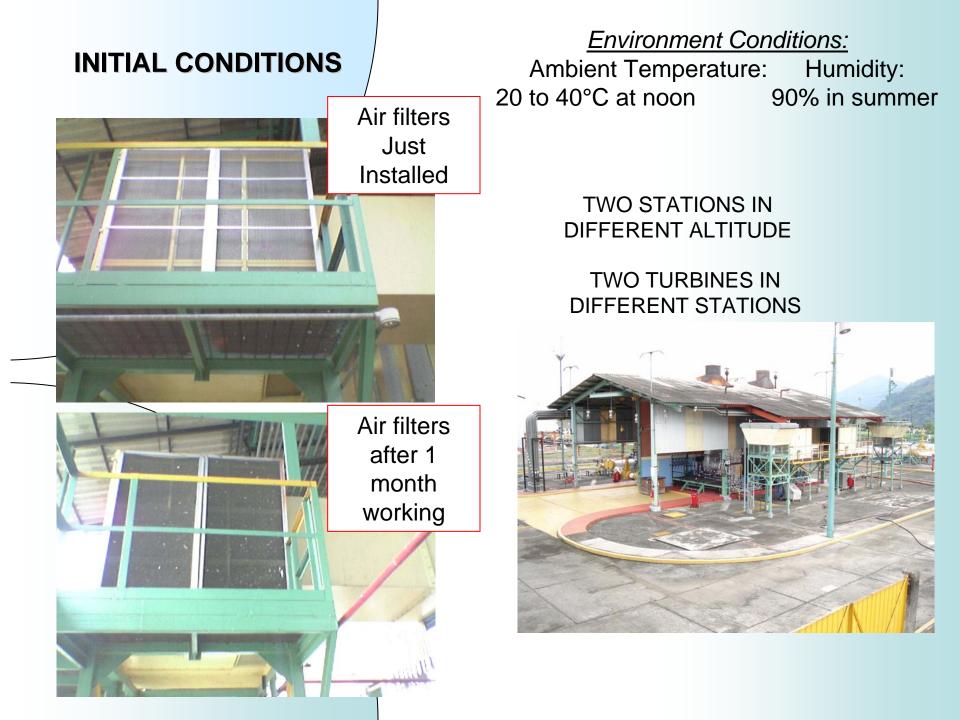
INITIAL CONDITIONS

Operation Conditions Turbine 1 LPG Pump Station:

Date: 28/12/06	Qty	Units
Operation Hours:	110119	h
Operation Temperature:	417	°C
Pressure Compressor Discharge (PCD):	52.3	Psi
% of Gas Generador speed:	89	%
Station's Discharge Pressure:	48.6	kg/cm ²
Station's Discharge Flow:	11648	BPH

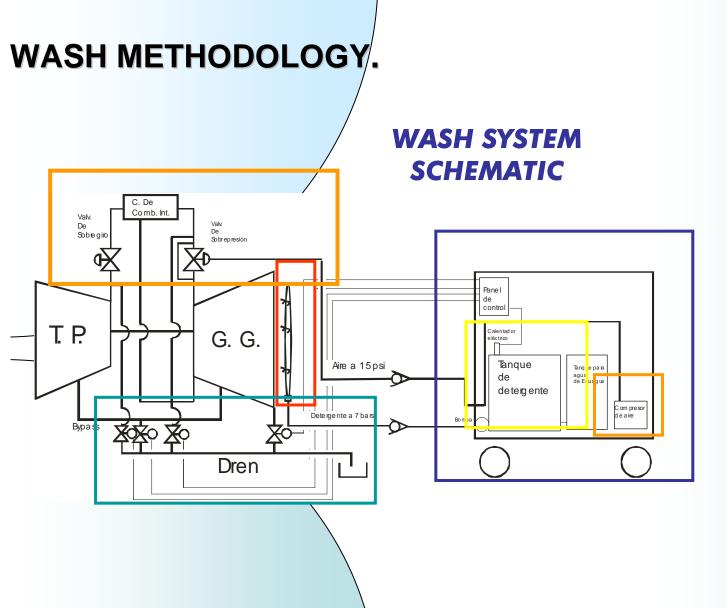
Wash Cart Nozzles System Drain System

Surge Valve's Hatching System

Detergent and water tanks

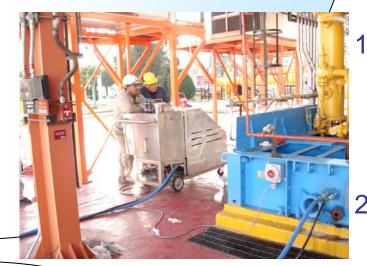
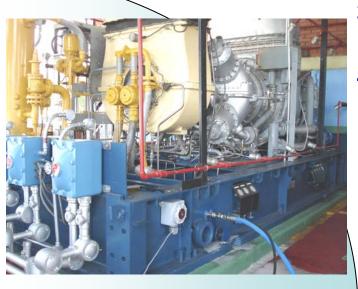
WASH METHODOLOGY.

- Wash Session. Crank the compressor rotor and inject detergent mixture (4 parts of demineralized water per 1 part of detergent) for 1 min because its starting motors may be damaged for a longer period.
- 2. <u>Suck time</u>. Let the detergent for 20 min for react with the dirt and fouling deposited on the blades and internals surfaces.
- 3. <u>Rinse Session</u>. Crank the compressor again for 1.5 min for rinse the first wash session,
- 4. <u>Repeat</u>. If the drain liquid is dark it required to inject more detergent mixture, and repeat the three first steps until the drain becomes clearer.

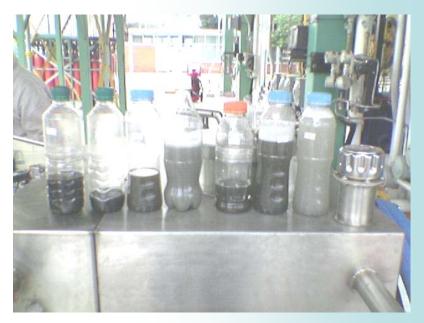
Turbine 1's Liquid drain

$\eta_0 = 48.6 \ [kg/cm^2] / 392.5 \ [^{\circ}C] = 0.1238 \ kg/cm^{2\circ}C$

24.4°C less to reach the same discharge/pressure

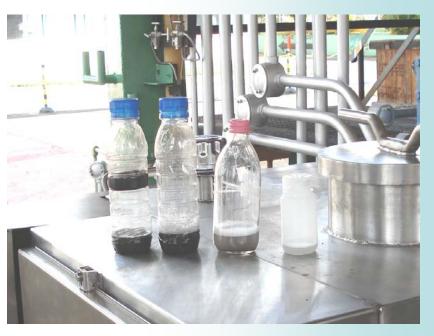
Turbine 2's Liquid drain

$\eta_0 = 50 \ [kg/cm^2] / 395 \ [^{\circ}C] = 0.1266 \ kg/cm^{2\circ}C$

34°C less to reach the same discharge pressure

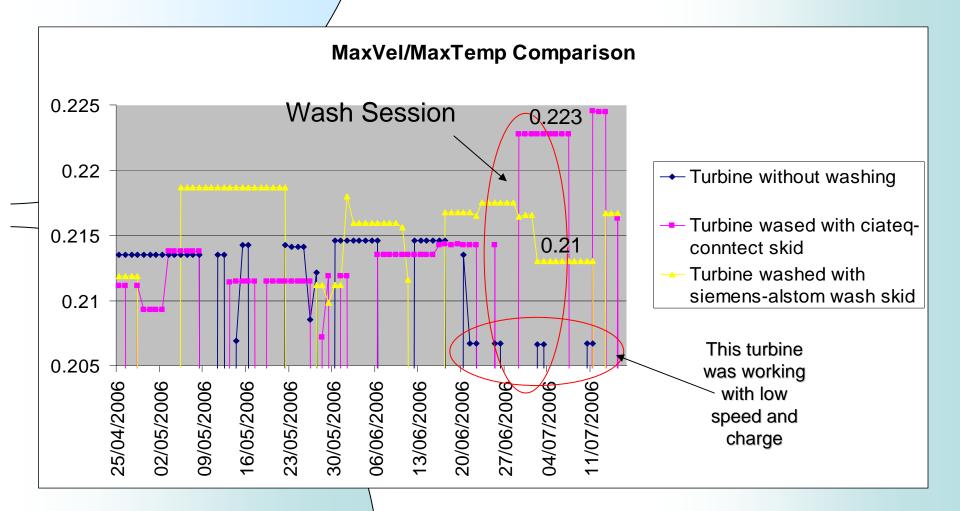
The operation tendency comparison with another turbine which has not been washed is plotted as seen in the image below:

/ Temperature decreasing with alstom-siemens wash system: From 460°C to 440°C = 20°C less

Temperature decreasing with ciateq-conntect wash system: From 429°C to 395°C = 34°C less
