GT2007-28351

## TURBINE INLET ICE RELATED FAILURES AND PREDICTING INLET ICE FORMATION

David M. Maas  
El Paso Corporation

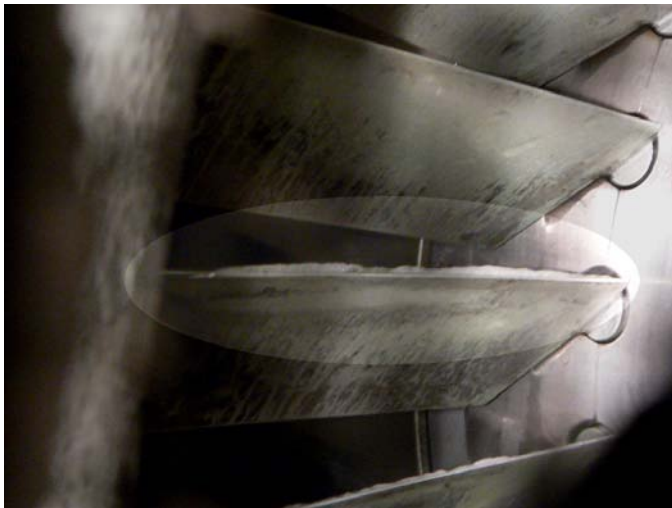
Figure 1. Proof of IGV Ice Formation

On November 23, 2004 foggy conditions with ambient temperatures at or below freezing were present at Seligman station. The Mars unit was shut down and this photo was taken of the inlet guide vanes (IGV) with a hand held camera from an inlet duct access panel. This photo confirmed the suspected ice formation.

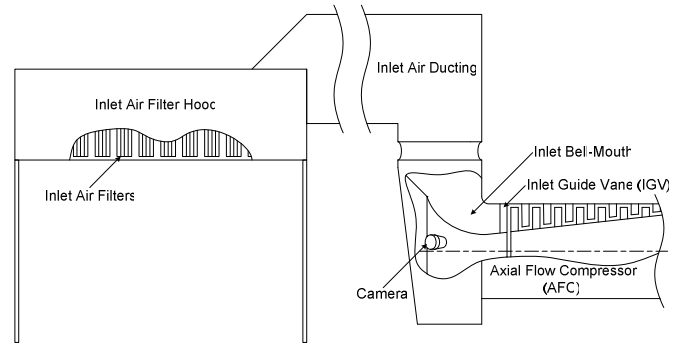
Figure 2. Inlet filter ducting, AFC Cross-Section, and Camera Placement

To further understand the formation of IGV ice, a camera was installed in the inlet duct work of the Seligman Mars and was set up to continuously record images of the IGVs while the turbine was running (see Fig 2). This camera successfully captured multiple icing events during the 2005/2006 winter. By analyzing these images with the trended ambient temperature and RH, the alarm and trip criteria can be more precisely defined. Also, the temperature depression at the inlet guide vanes can be calculated and compared to the established theory.

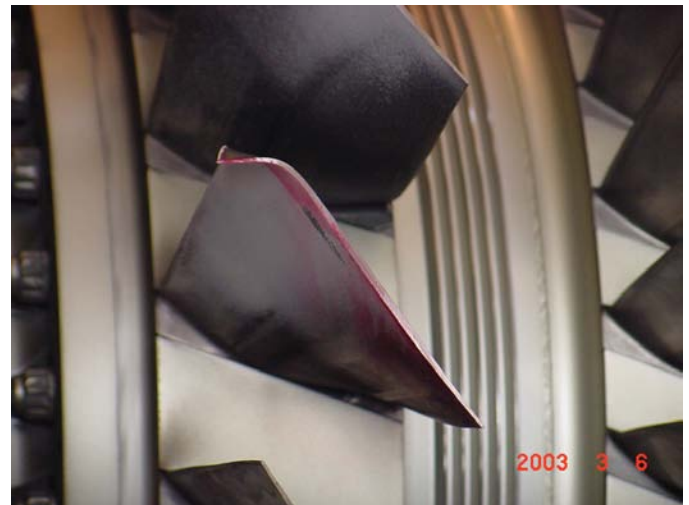
Figure 3. Bent First Stage AFC Blade

A high pitched noise was noted coming from the axial flow compressor (AFC) or gas producer (GP) of the Mars unit by the Cross Functional Technician responsible for Seligman Station the day after a winter storm on March 2<sup>nd</sup>. The situation was discussed with mechanical Services-North, and the unit was shut down. The initial bore scope inspection showed a bent first stage AFC blade. With the help of Solar technicians, one half of the AFC case was removed and four of the first stage blades were replaced (see Fig 3). The total cost was \$11,907.20 not including loss of throughput. [3]

Upon inspecting the inlet ducting, some leaks were discovered. The initial conclusion was rain/sleet from the previous day's storm was sucked through these leaks and puddled in the bottom of the inlet ducting. At some point during the winter

weather, ambient conditions were cold enough for this water to freeze into large sheets that could break off and be sucked into the turbine inlet. This could have bent the first stage AFC blades.

A second similar theory was rain/sleet had been sucked through the inlet leaks and was collecting and freezing on the bell-mouth trash screen. The trash screen is wire mesh with half inch opening locked in the turbine bell-mouth. The trash screen would be several degrees cooler than the ambient air due to the inlet temperature depression. Under the right conditions the water leaking into the inlet ducting would freeze on contact with the screen. Over time the ice would build up and then large pieces could break off and be sucked into the first stage of the turbine and this could have bent the first stage AFC blades.

Both of these theories are examples of precipitation icing. [4] After this failure, all inlet air duct leaks were repaired.

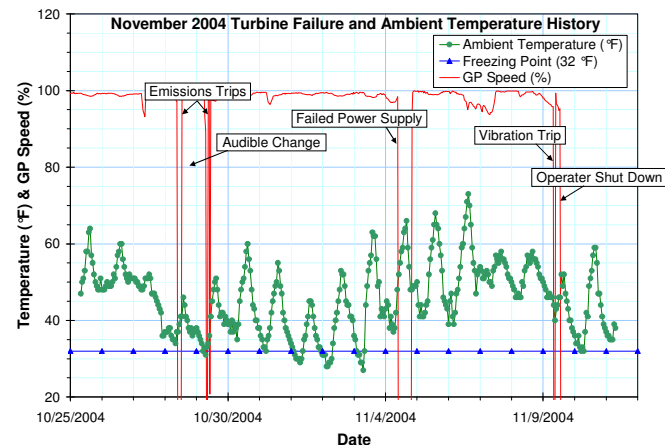
Figure 4. November 2004 Temperature History

On November 9<sup>th</sup>, 2004 the Seligman Mars turbine tripped off line on high vibration. On an attempted restart the unit sounded very poor and was immediately shut down. Previously on October 28<sup>th</sup>, 2004 an audible change was noted in the turbine, but was not severe enough to warrant action. Again, this change in the turbine operating sound occurred after a heavy snow storm.

On clear days and nights the ambient temperature has a large daily swing. High humidity and precipitation is indicated when there is a very small diurnal temperature variation. As the temperatures approach freezing, the rain will change to sleet or snow, as was the case on the 27<sup>th</sup> and 28<sup>th</sup> of October. The failure and ambient history can be seen in Fig. 4.

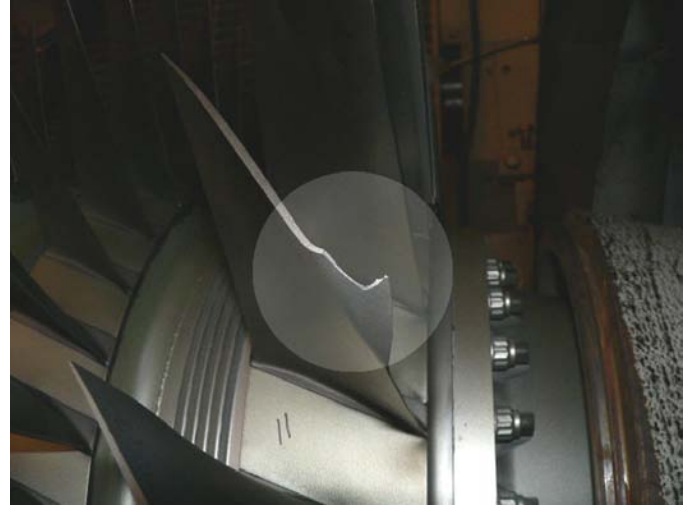
Figure 5. Broken First Stage AFC Blade Tip

On November 19<sup>th</sup>, 2004 the Solar Mars 100 AFC was torn down with the help of Solar technicians. This time, damage from possible ice ingestion was severe; one of the first stage AFC blade tips had broken off and gone through the turbine (see Fig 5). This damaged multiple blades and stators in successive stages in the AFC.

It is suspected that ice ingestion caused a bent AFC blade tip or tips and the resultant change in the turbine operating sound on October 28<sup>th</sup>. The turbine then continued to run until one of the bent blade tips fatigue failed and went through the AFC. The result was a \$191,320.95 repair bill not including loss of throughput.

This second failure was puzzling since the inlet filter and ducting had been well sealed less than two years earlier and it didn't seem possible for liquid water to make its way to the turbine inlet. Nonetheless ice still appeared to be the likely cause of the damage.

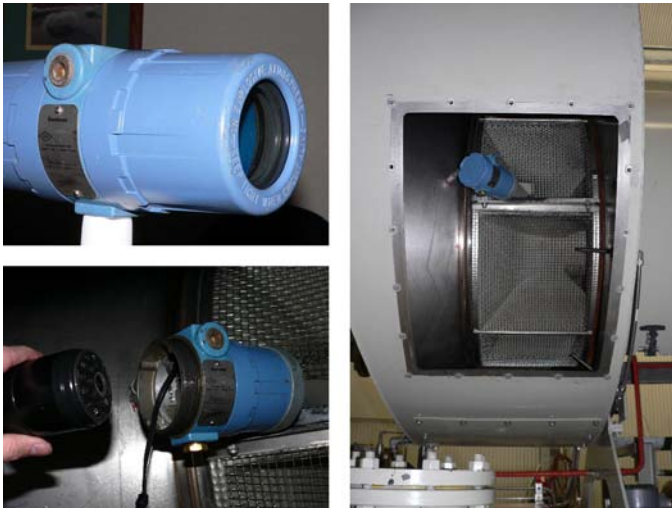
**Figure 6. Window Faced Rosemount Housing, Camera, and Camera Mounting**

Class I Division 2 housing. A window faced Rosemount transmitter housing accepted the camera nicely and is already Class I Division 2 certified. To minimize fogging on the inside of the housing window, a few packages of silica gel were placed inside.

The Camera was placed inside of the bell housing on the inlet air ducting approximately 2 ½ feet from the leading edge of the first stage set of variable pitch inlet guide vane stators. There was one necessary consideration for this installation, the camera needed to be outside of the trash screen located in the center of the bell housing. During the first test run of the camera, the glare of the light emitted from the camera's LEDs on the screen was so intense that the inlet guide vanes were not visible. The decision was made to cut a small hole in the trash screen approximately the size of the window on the Rosemount housing. This provided a well lit, glare free view of the inlet guide vanes.

The inlet Camera and its housing will cause some degree of inlet flow distortion and turbulence. There was no modeling or calculations done to determine the degree of flow disruption or its effect on the turbine AFC blades. The decision was made to keep the camera on the outside of the trash screen with the thought that it would be “far enough” from the turbine inlet. The bearing vibration monitors were monitored when the turbine was started for the first time with the camera in place. There was no noticeable change in the vibration signal pre and post camera installation. Additionally, the Seligman Mars 100 has 6000 plus hours of run time with the camera in place without incident. So it has since been concluded that the Camera induced inlet flow distortion and turbulence did not detrimentally affect the turbine AFC Blades.

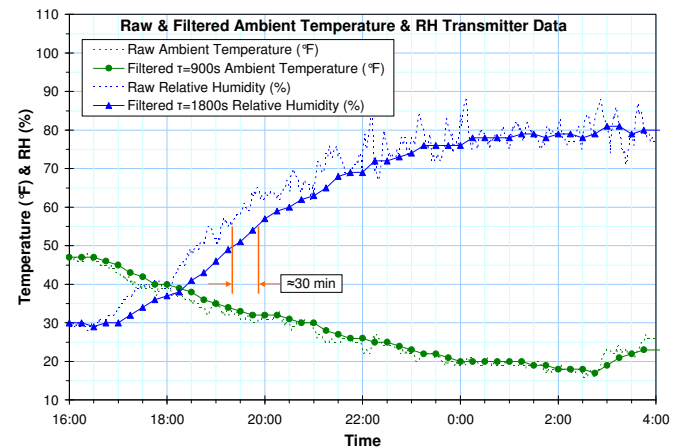
**Figure 7. Raw & Filtered Ambient Temperature & RH Transmitter Data**

The ambient air temperature and relative humidity signals that are driven to the PLC by the ambient temperature and RH transmitter had a lot of natural fluctuation. This fluctuation

would have caused the turbine to trip unnecessarily when the data reached the alarm and trip set points. These set points are as follows: Alarm at 36.5°F (2.5°C) and RH at 90%, Trip at 35.5°F (1.9°C) and below with RH being at 95% and above. To alleviate these unnecessary trips, a first order digital filter was added to the logic to allow for sudden and short changes in the relative humidity and ambient temperature (which happens frequently at the Seligman location) without tripping the turbine. The ambient air temperature signal filter uses a 15 minute (900 second) time constant and the RH signal uses a 30 (1800 second) minute time constant. Refer to Fig. 7. The filtered signals were logged for the 2005/2006 winter. The raw signals were added to logger for the 2006/2007 winter.

The point of this Laplacian treatment shows that when the logged filtered RH is increasing approximately linearly, the un-filtered value can be approximated by time shifting the filtered values back by  $\tau$  or 30 minutes. This algorithm can be applied to roughly recover the unfiltered or actual relative humidity during periods of increasing or decreasing RH. The time shift between the un-filtered and filtered data can be seen in Fig. 7.

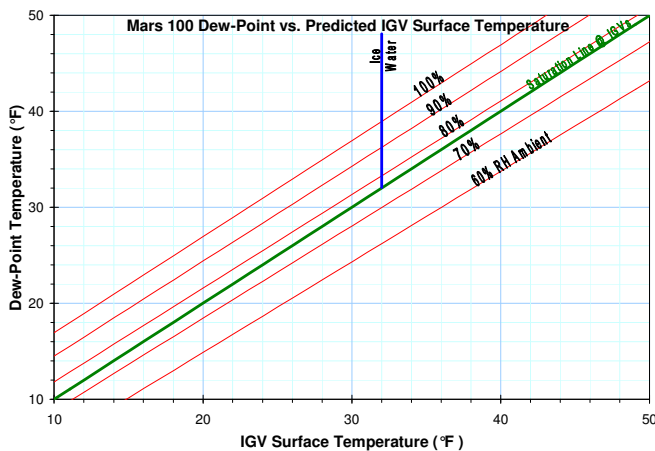
Figure 8. Dew-Point vs. Predicted IGV Surface Temperature

Using the predicted IGV surface temperature depression of 6.9°F (3.8°C) from section 4.2 the dew-point temperature at the IGVs can be calculated across a range of ambient temperatures and relative humidity.

Notice that when the ambient RH has reached 74 to 76%, the saturation temperature has been reached at the IGVs. This is a result of the predicted  $\Delta T$  of 6.9°F (3.8°C). Ice is predicted to form on the inlet guide vanes at ambient temperatures below 38.9°F (32+6.9°F) (3.8°C) and RH above 74 to 76%. The reason for the RH range is the constant RH lines are not exactly parallel with the saturation line (see Fig. 8).

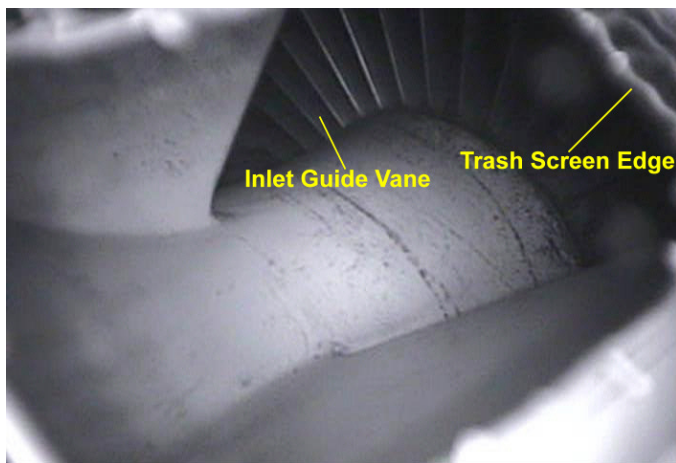
Figure 9. Base Photo of IGVs with No Ice

The turbine inlet camera images, weather radar images, ambient temperature values, and RH values were logged continuously during the 2005/2006 winter. There were 25 separate icing events recorded during this period. Images of ice first forming on the IGVs, images when peak RH occurred, and any others of particular significance were saved for each of the 25 separate icing events. The beginning of an icing event was determined by comparing a base image with no ice to one when ice just begins to form. Notice the ice first starting to form on the IGV in Fig. 10 compared to the base photo Fig. 9.

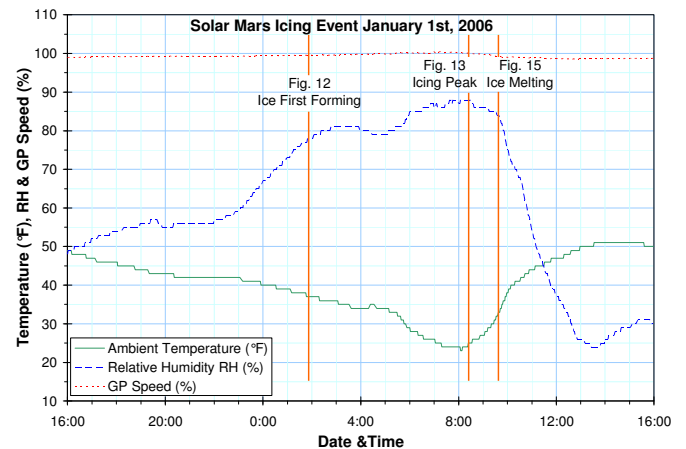
Figure 11. Icing Event 01/01/2006 Temperature & RH Trend

Notice in Fig. 11 how quickly the ambient temperature rises. If you look at Fig. 15, only about an hour after the peak icing conditions were reached, you can see how quickly the ice is melting. Also note the jagged edges of the ice on the IGVs indicating pieces had broken off and been sucked through the AFC. Figure 11 shows the ambient temperature at 32°F and RH at 84% but changing rapidly. It must be remembered that both these values are influenced by a first order filter so the true ambient temperature is greater the 32°F (0°C) and the true RH is less than 84%.

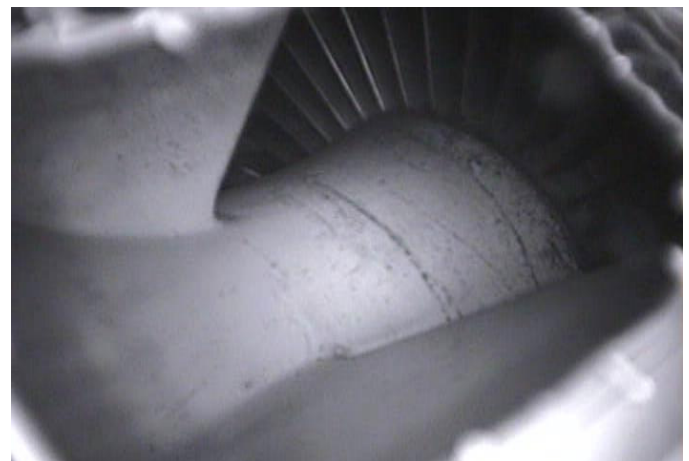
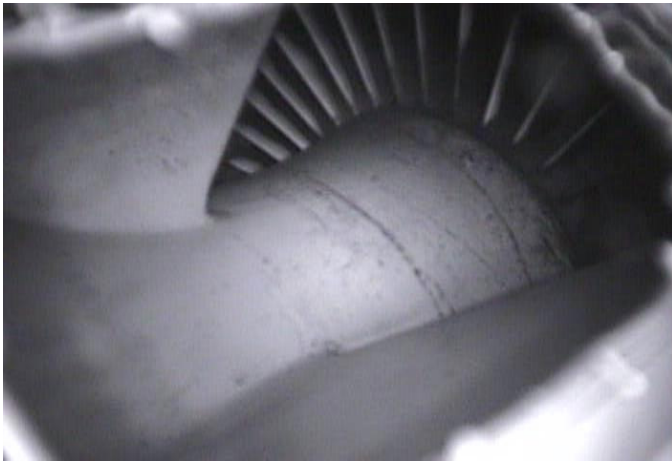
Figure 12. Ice First Forming 01/01/2006 01:51 @ 37°F (2.8°C) & 78% RH

**Figure 13. Icing Peak 01/01/2006 08:23 @ 24°F (-4.4°C) & 88% RH**

The weather radar map for this icing event shows clear conditions over Seligman Station, therefore precipitation being sucked through filters or leaks in the inlet duct work is not the source of the moisture. The IGV ice in Figures 12 & 13 is most evident when comparing them to the ice free base Fig. 9.

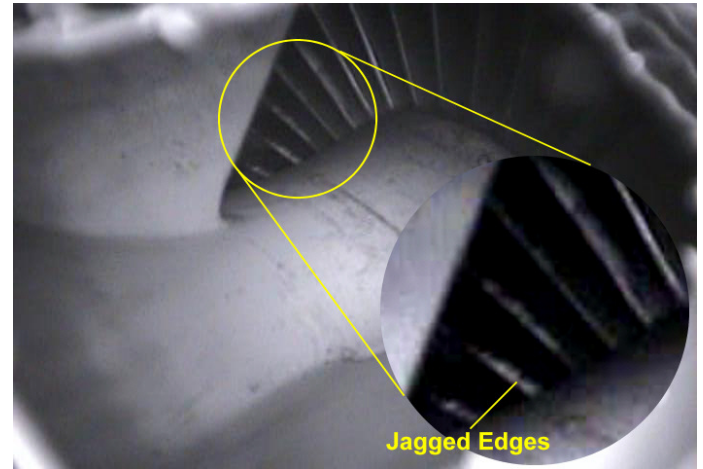
**Figure 15. Ice Melting 01/01/2006 09:38 @ 32°F (0°C) & 84% RH**

The inlet camera captured images of ice forming on the inlet guide vanes during cold clear nights. This can be seen in the sample data set in section 5.1. The weather conditions were clear and precipitation free as shown on the weather radar map in Fig. 14. Thus, this set of data is the result of condensate icing and not precipitate icing. In fact, the majority of the ice events captured by the inlet camera were on cold clear nights. Additionally, when the ambient conditions warmed and the IGV ice started to melt, the photos show IGV ice with jagged edges showing the condensate ice was thick enough to break off in chunks and enter the AFC. (see Fig. 15)

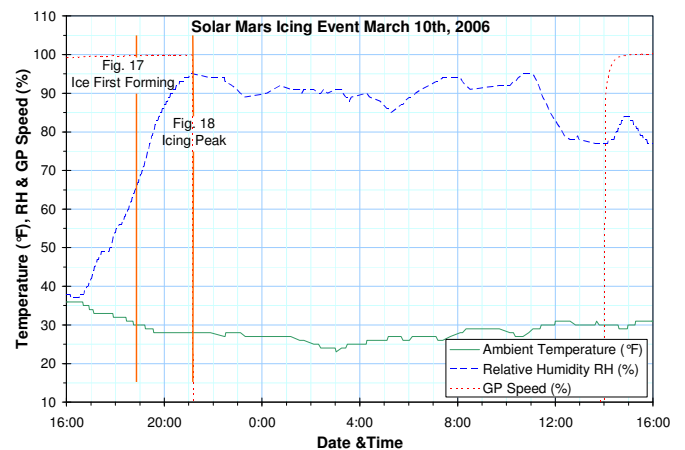
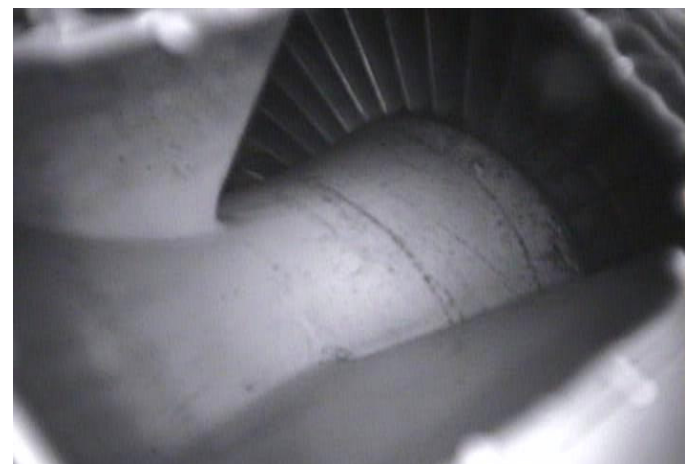
**Figure 16. Icing Event 03/10/2006 Temperature & RH Trend**

**Figure 17. Ice First Forming 03/10/2006 18:44 @ 30°F (-1.1°C) & 64% RH**

The weather radar for this icing event shows a winter storm over Seligman Station. The ambient conditions reached the trip criteria of above 95% RH and below 35.5°F air temperature. The unit was shut down to prevent any ice ingestion damage.

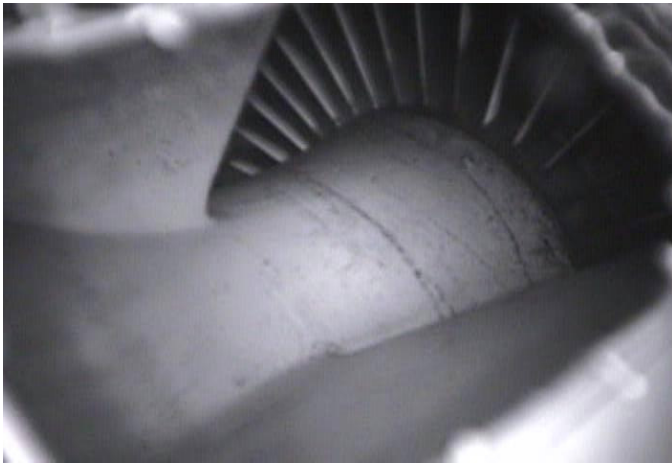
**Figure 18. Icing Peak 03/10/2006 21:08 @ 28°F (-2.2°C) & 95% RH**

Images captured during a winter storm do not show any liquid or frozen water up stream of the IGVs. (see Section 5.2) Primarily I would expect to see ice collecting on the edges of the trash screen visible in Fig. 18 if liquid water was making its way into the inlet ducting, but I do not. This supports the conclusion that icing during a winter storm is also condensate ice and not caused by water being drawn through the inlet filter or leaky inlet ducting (precipitate ice). IGV ice which formed under rain, sleet or snowing conditions shows the same jagged edges when the ice melts with rapidly warming ambient temperatures at the end of the storm. The difference between a winter storm icing event and cold clear night icing event, is the duration and the higher relative humidity. Both of these conditions could cause thicker ice formation and thus larger pieces when they break off.

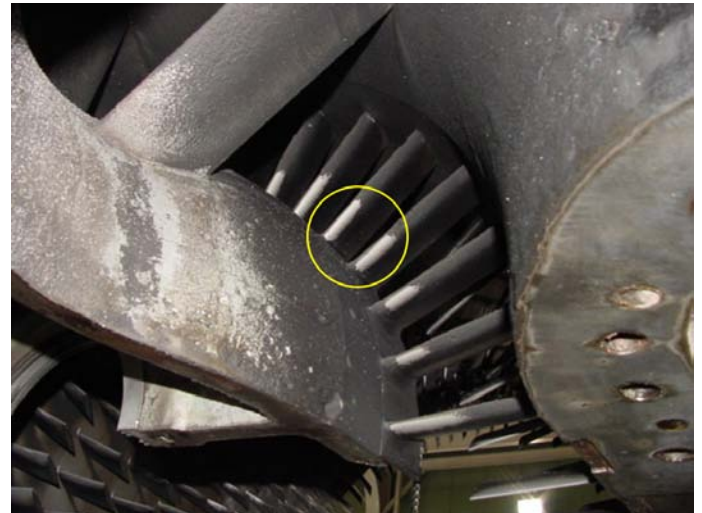
**Figure 20. GE Frame 3 Turbine Inlet Guide Vanes at Seligman Station 03/16/2006**

The General Electric (GE) Frame 3 turbine at Seligman station was down for maintenance on 03/16/2006. The photo in Figure 20 was taken at this time. March 16<sup>th</sup> was only 6 days after a major storm had caused multiple icing events on the Mars unit only 100 yards away from the GE. In theory, the clean spots on the leading edge of the IGVs could be from ice formation and its subsequent melting, cleaning off the dirt. The IGVs were cleaned in March before the turbine was reassembled.

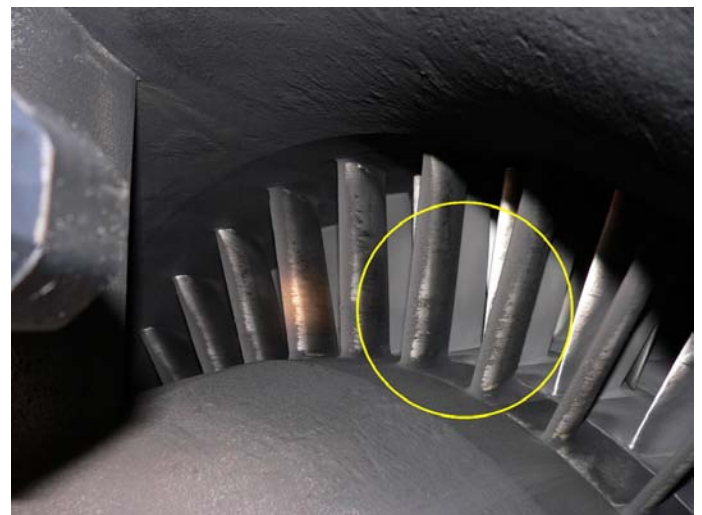
**Figure 21. GE Frame 3 Turbine Inlet Guide Vanes at Seligman Station 08/30/2006**

Figure 21 shows the IGVs at the end of August in 2006 after a summer with no icing conditions present. In this image, the leading edges of the IGVs are dirty, in theory because no ice has formed and melted to keep them clean. This supports the theory that inlet guide vane ice also forms on the GE at Seligman station and likely any turbine in climates where the ambient temperature approaches freezing.

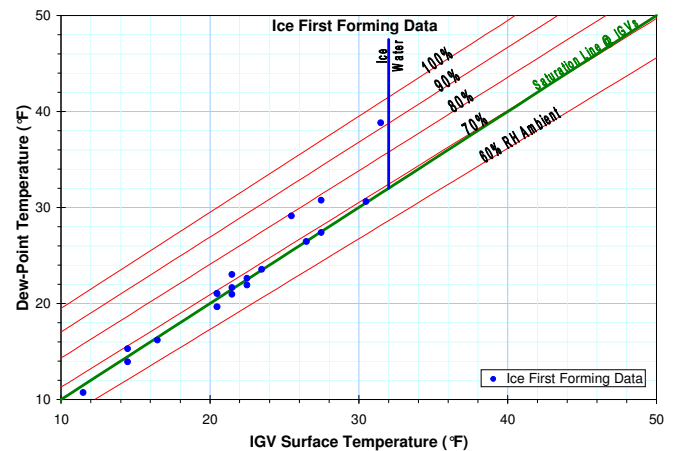
Figure 22. Ice First Forming Data

The moment of first ice formation was estimated from the captured images during each icing event. The time stamp was then used to retrieve the associated ambient temperature and RH from the trended data. Since the RH data was filtered with a digital first order filter, the RH values had to be corrected per the algorithm described in section 4.6. The dew-point for each pair of ambient temperature and corrected RH values was calculated and this represented the temperature of the IGVs at that moment. The difference, with respect to the ambient temperature, was the IGV temperature depression, at that moment. The average IGV temperature depression was measured to be 9.5°F (5.3°C).

The ice first forming dew-point versus IGV surface temperature data has been plotted in Fig. 22. They cluster around the saturation line when the IGV temperature is below freezing or 41.5°F (5.3°C) ambient and the ice/water (freezing) line when IGV temperature is above 32°F (0°C). The data points should fall exactly on the saturation and freezing line but don't due to the error in determining the exact moment of ice formation from the inlet camera image stream and the error in correcting the filtered RH data.

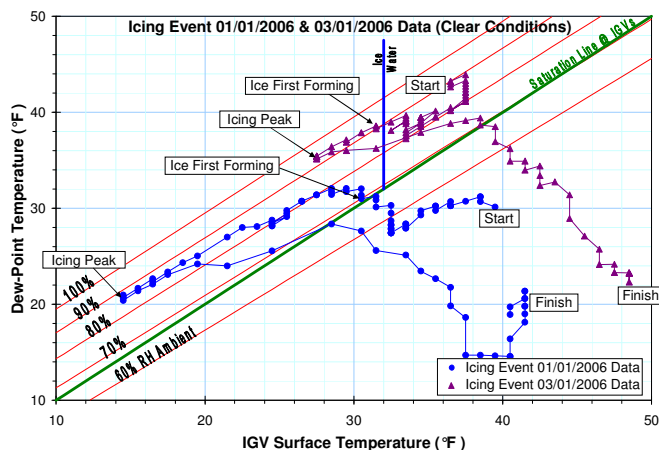
**Figure 23. Icing Event 01/01/2006 & 03/01/2006 Plot (Clear Conditions)**

An individual icing event can be shown on the same dew-point versus IGV surface temperature plot (see Fig. 23).

The changing ambient conditions create a track that starts in a non icing region of the plot and approaches the saturation or freezing line as the ambient temperature drops at night. IGV ice forms as the track crosses the saturation line below the freezing point or crosses the freezing line above the saturation line. On clear cold nights with RH above 67 to 69%, the icing peak is reached just before sunrise after which the ambient temperatures climb rapidly and the data tracks back into non-icing regions. At this point, the ice collected on the IGVs either sublimates or melts away. Figure 15 shows the IGV ice from the January 1<sup>st</sup> 2006 event, melting, breaking into pieces and being sucked into the AFC.

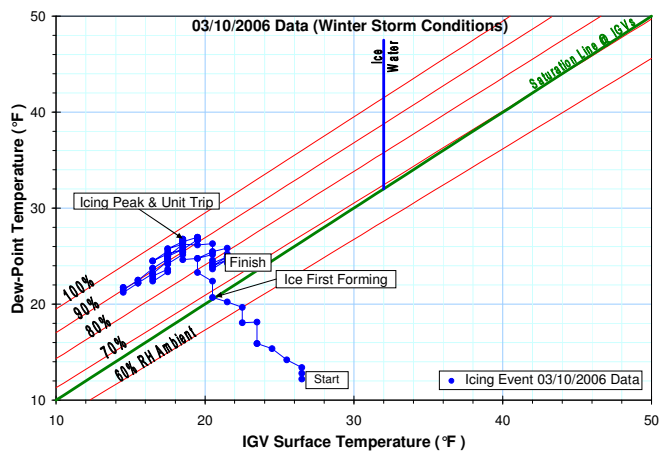
**Figure 24. Icing Event 03/10/2006 Plot (Winter Storm Conditions)**

In Fig. 24 is data from a winter storm event and again the changing ambient conditions create track. As the winter storm approaches, the track crosses the saturation line just as ice begins to form on the IGVs. The unit trips off line about an hour later when the ambient RH reached the trip point of 95%. The winter storm keeps the track on the left side of the saturation line for the remainder of the next day with RH in the mid 90's.

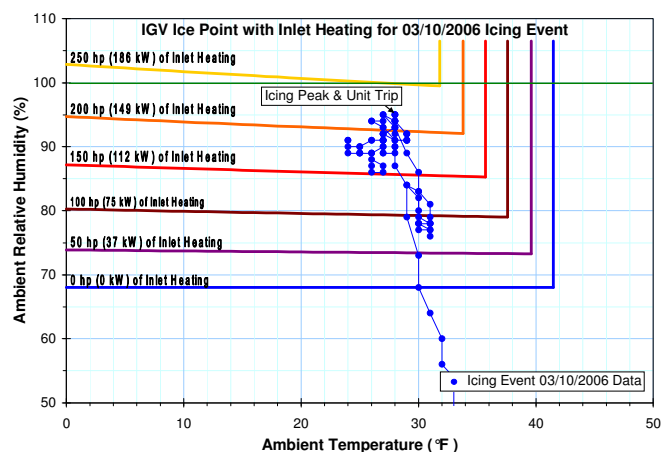
**Figure 25. IGV Ice Point with Inlet Air Heating for 03/10/2006**

Heating the inlet air reduces its relative humidity and increases the maximum ambient (before the air is heated) RH that is required for ice to form on the IGVs. Heating the inlet air stream will also lower the minimum temperature for icing to occur. Using the Mars 100 as an example, the theory developed in section 4 and the IGV temperature depression measured as described in section 6, can be used to calculate how adding heat to the inlet air flow will change the icing criteria. Starting with an inlet volumetric flow rate of 71400 cfm ( $33.6 \text{ m}^3/\text{s}$ ) the icing criteria for different quantities of inlet heat can be calculated.

The blue, zero, inlet heat line in Fig. 25, is the measured icing criteria of above 68% RH and ambient temperatures below  $41.5^\circ\text{F}$  ( $5.3^\circ\text{F}$ ) without inlet heating. The successive lines above this represent different amounts of heat added to the inlet air flow. The energy added to the inlet air is cast in the units of horse power to give a sense of scale with respect to a 11,400 hp (8,500 kW) site rated turbine. It should also be noted that the 250 hp (186 kW) line just crosses the 100% RH level. This implies that adding a little more than 250 hp (186 kW) worth of heat will guarantee ice free operation of the turbine. Once the inlet air is heated to the point the water

The icing event that tripped the Mars 100 offline on March 10<sup>th</sup> is also displayed on the IGV ice point plot with inlet heating (see Fig. 25). The ambient conditions track shows about 225 hp (168 kW) of inlet heating would have kept ice from forming on the IGVs for the March 10<sup>th</sup> winter storm.

These are merely a sample of the many ways to achieve inlet air heating. All systems will affect turbine performance by simulating a warmer day. Any system that uses energy from within the gas firing cycle or dilutes the available oxygen at the turbine inlet will have an additional impact on the performance. Exhaust gas recirculation will likely effect turbine wear, maintenance intervals, and emissions. Any system considered for a Mars 100 will have to meet the energy demands given in Figure 25.

Heating the inlet air will extend the range of ambient conditions a turbine can run without IGV icing and is quantified in Figure 25. Adding little over 250 hp (186 kW) of heat to the inlet air will guarantee ice free operation.
