**EXPERIMENTAL INVESTIGATION OF CYCLIC
VIBRATION MORTON EFFECT IN THE BEARINGS OF
A DOUBLE OVERHUNG COMPRESSOR**

TAMU Turbomachinery Symposium
September 21-24, 2004

by Jim McGinley & Bill Marscher
Mechanical Solutions, Inc., Parsippany NJ
&
Brian Illis
BOC Gases, Murray Hill NJ

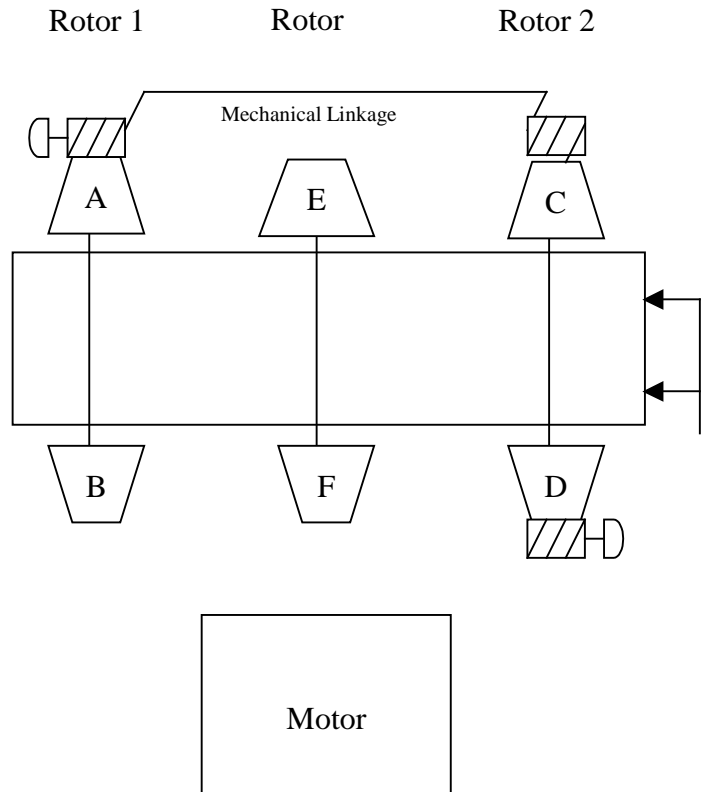
Installation and Compressor Description

Service	Stage	Bearing	Rotor	Speed RPM
CP53 Nitrogen	1	A	1	29,150
	2	B		
	3	C	2	28,210
CP14 Dry Air	1	D	3	23,635
	2	E		
	3	F

Service	Stage (Brg Pos)	Inlet Press Psia	Inlet Temp °F	Power KW
CP53 Nitrogen	3 Stage (C)	330	95	660
CP14 Dry Air	1 Stage (D)	280	95	1200

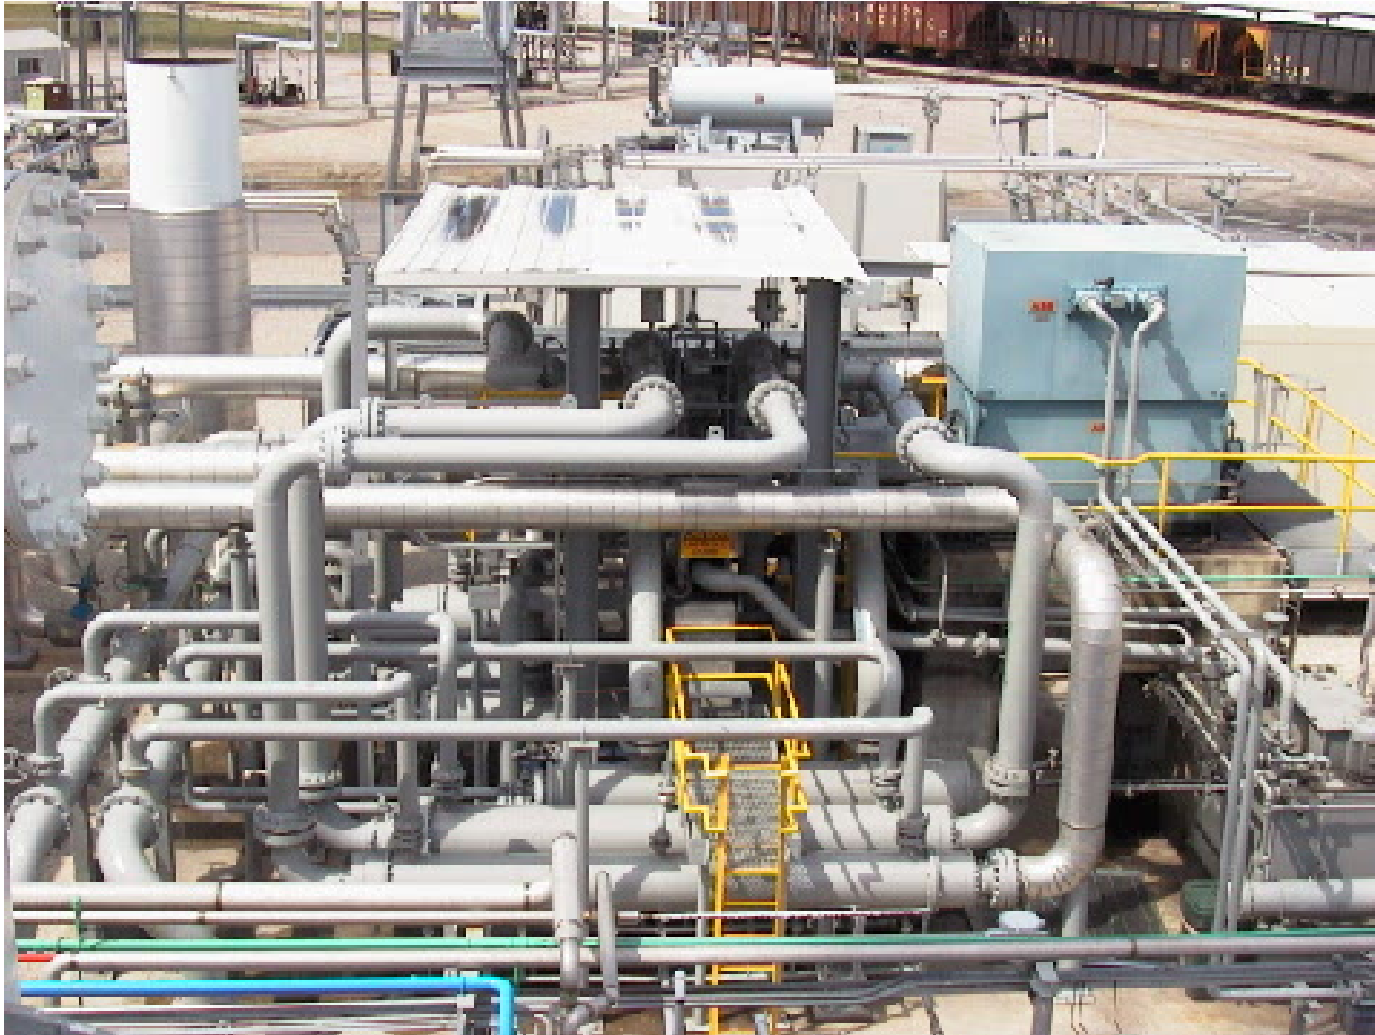
Overhead View of Integrally Geared Compressor

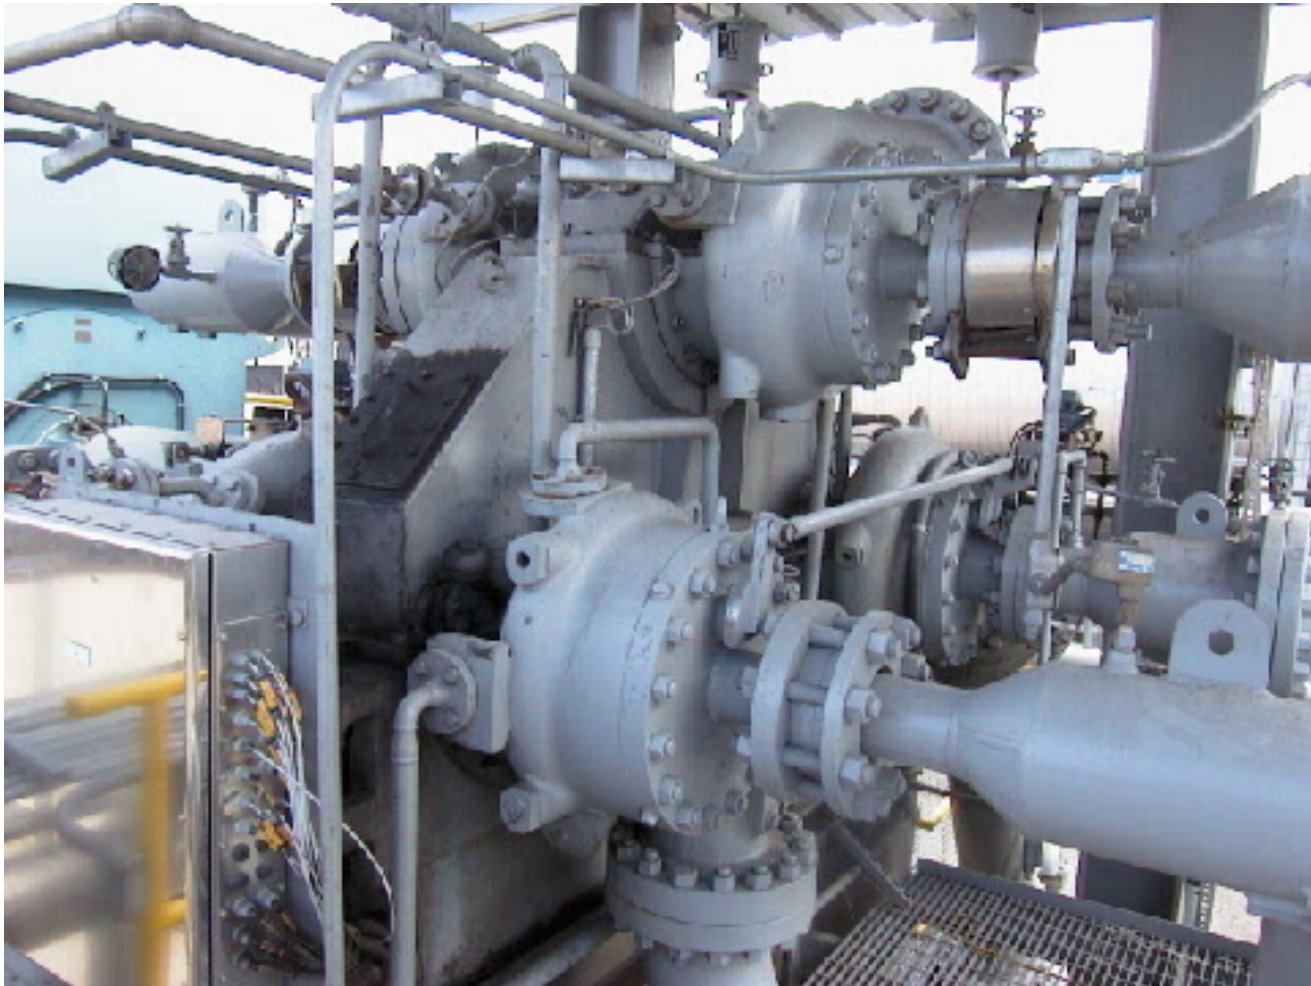
Side View of Gear Box

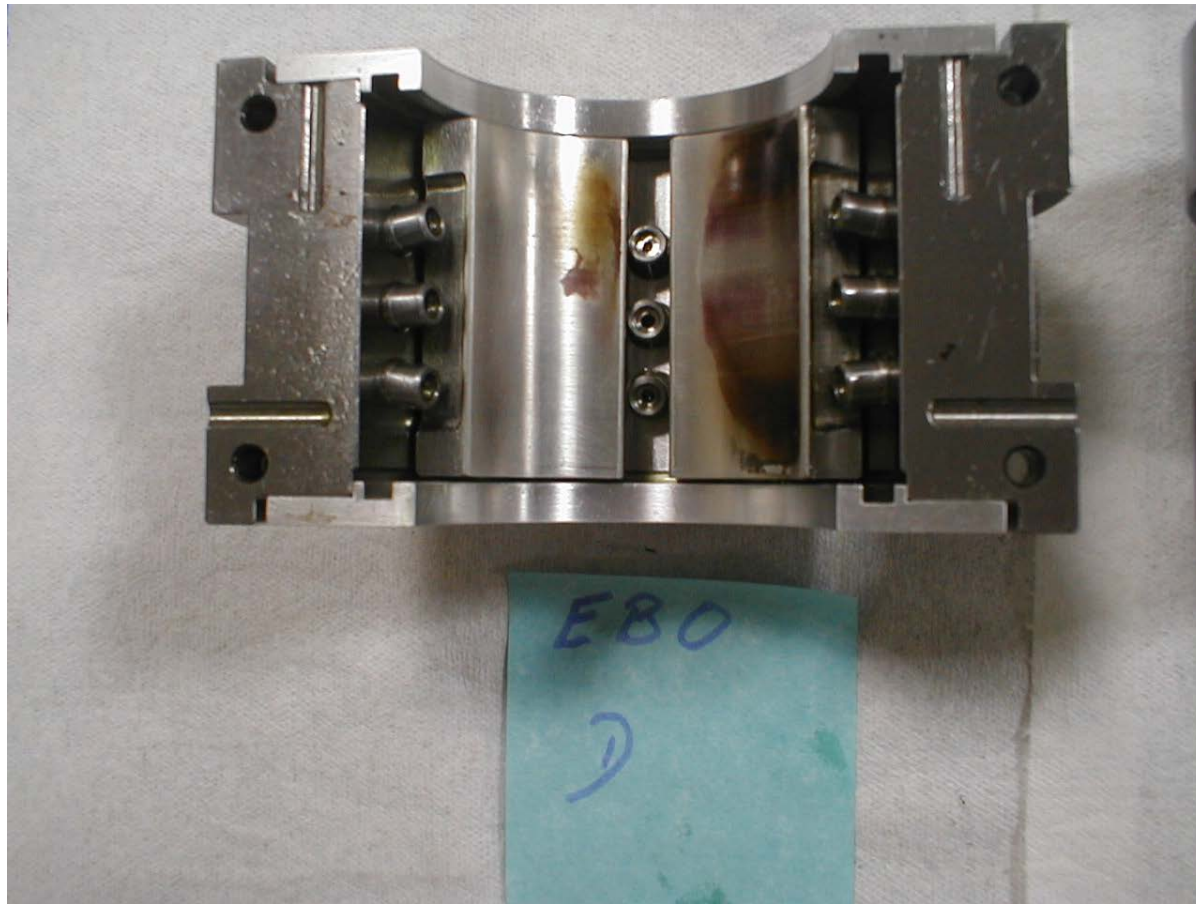
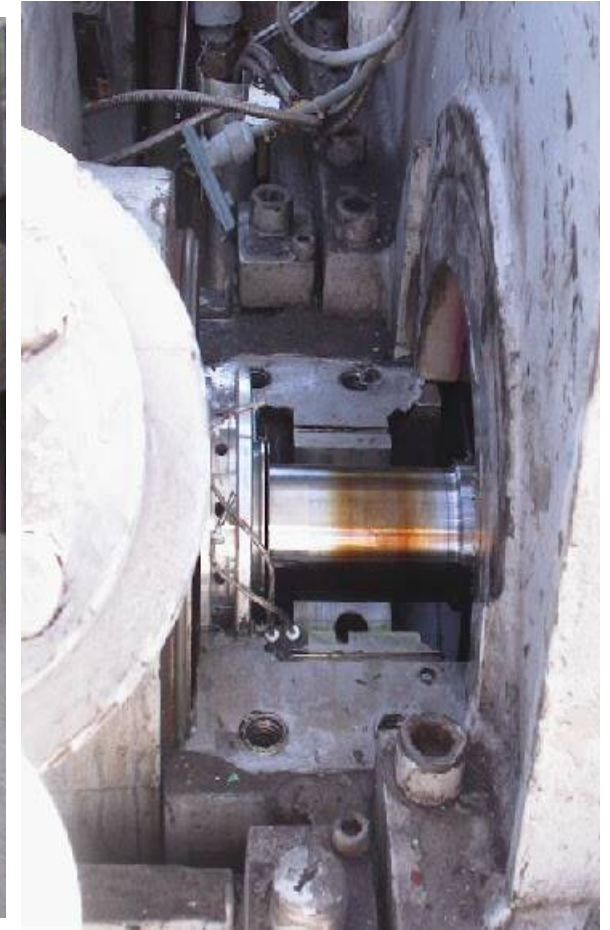
Bearing Style (from a Similar Application)

- Inlet oil temperature increase was effective in solving the problem, as was anticipated.
- A bearing design less prone to development of local hot spots would also have been an effective solution.

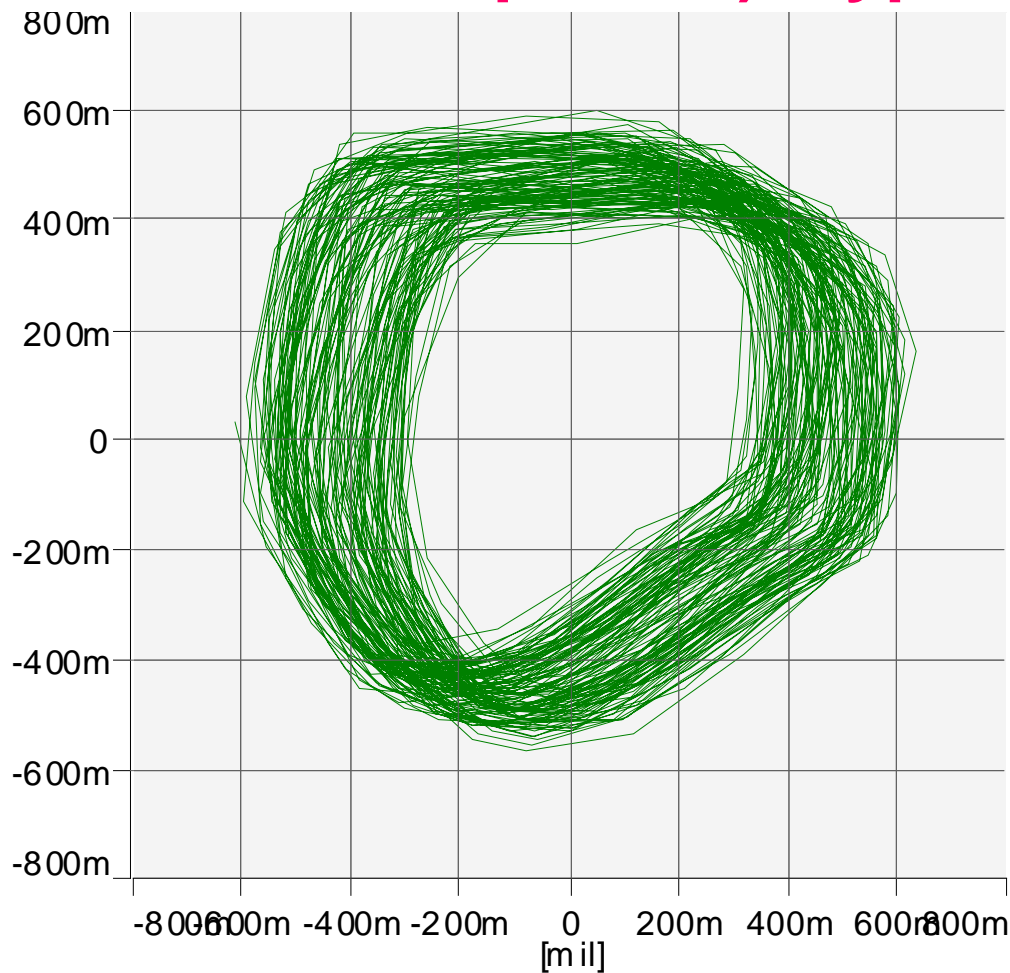
Left Bearing Orbit (Near Peak Amplitude), Typical

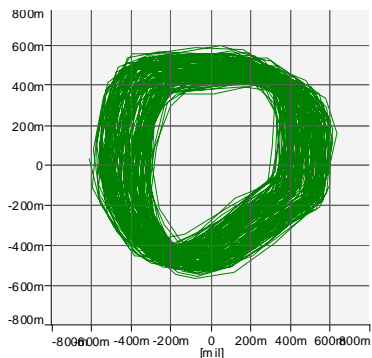
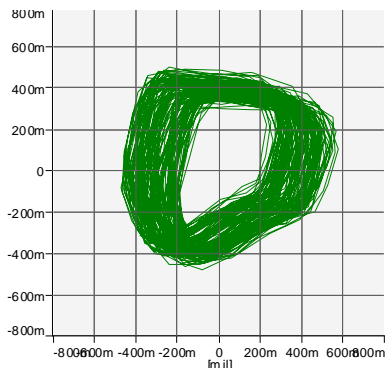
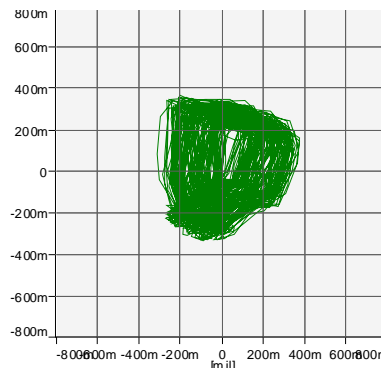
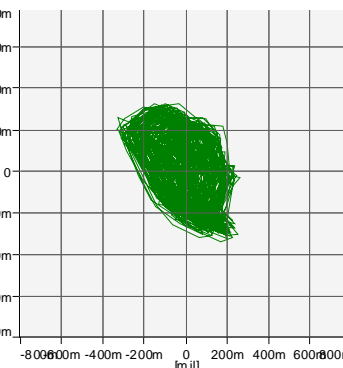
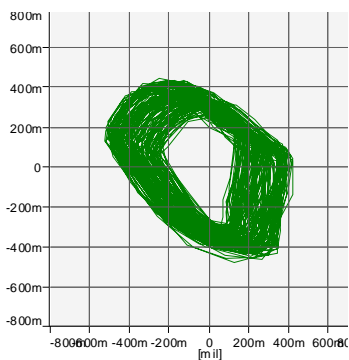
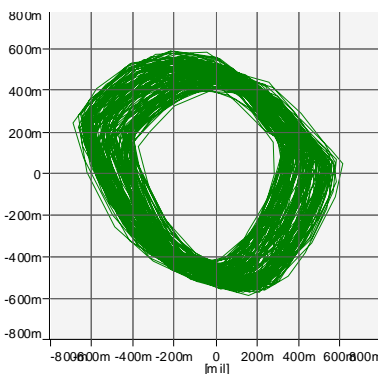
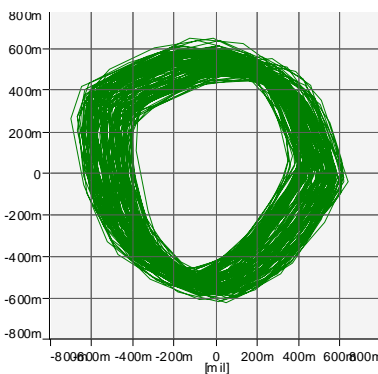
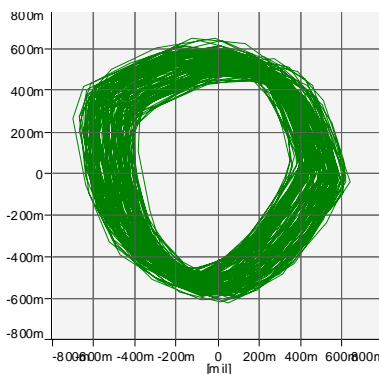
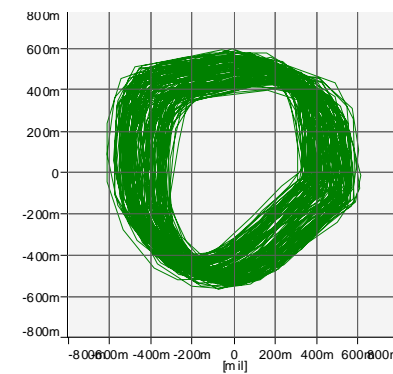
Left Bearing Orbit at Various Moments into Test

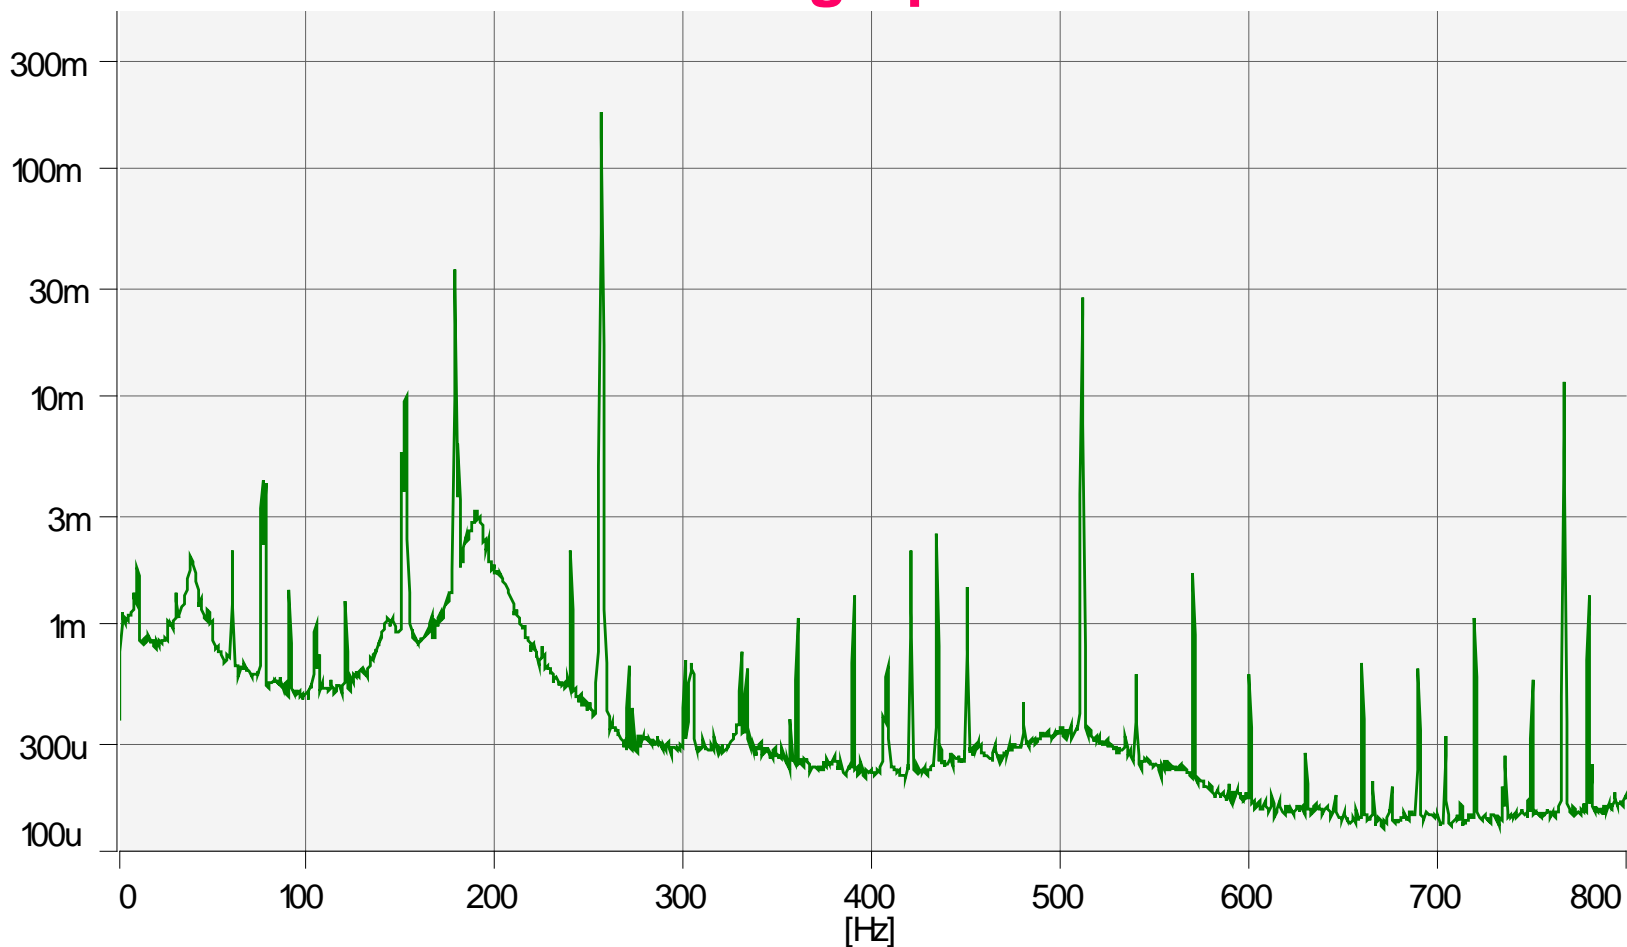
Vibration Spectrum of Left Bearing Proximity Probe (100 Linear Averages)

NOTE: Running Speed is 255 Hz.

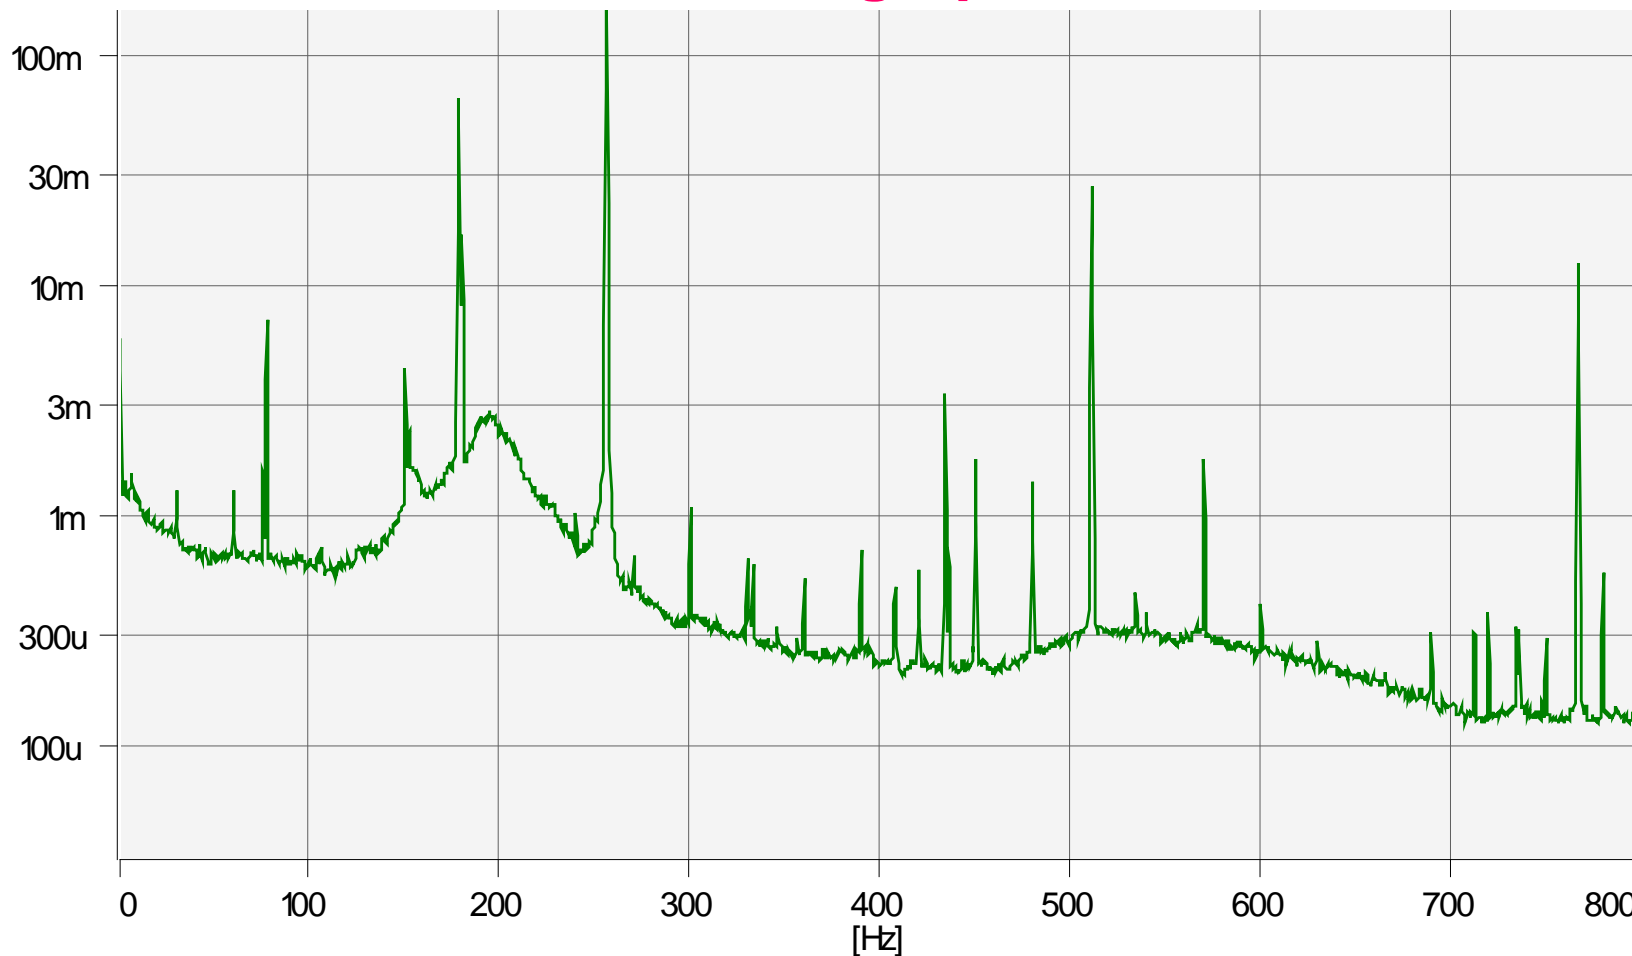
Vibration Spectrum of Right Bearing Proximity Probe (100 Linear Averages)

NOTE: Running Speed is 255Hz.

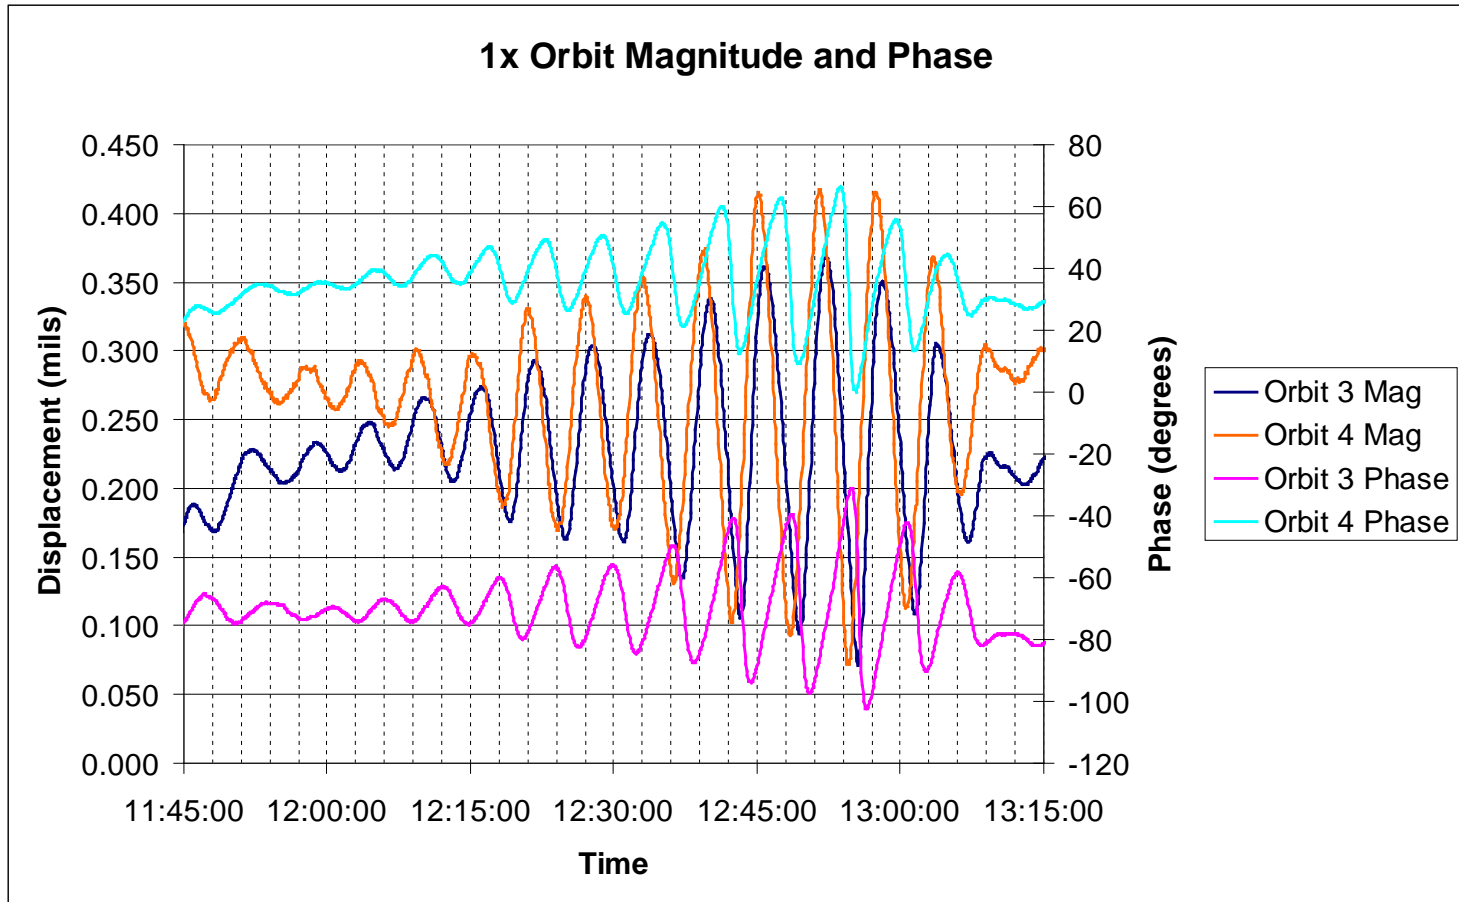
Synchronous Vibration Levels of Bearings vs. Time (Hour:Min:Sec)

- The problem consisted of a slowly cycling amplitude of 1x vibration.
- The envelope of vibration of the rotor was observed to cycle to excessive levels according to a consistent period of about 6 minutes.
- The left stage versus right stage ends cycled roughly 60 degrees out of phase with each other.
- There was no evidence of unstable subsynchronous or resonant 1x vibration.
- The problem only occurred when oil inlet temperature was below a threshold level of 125F.

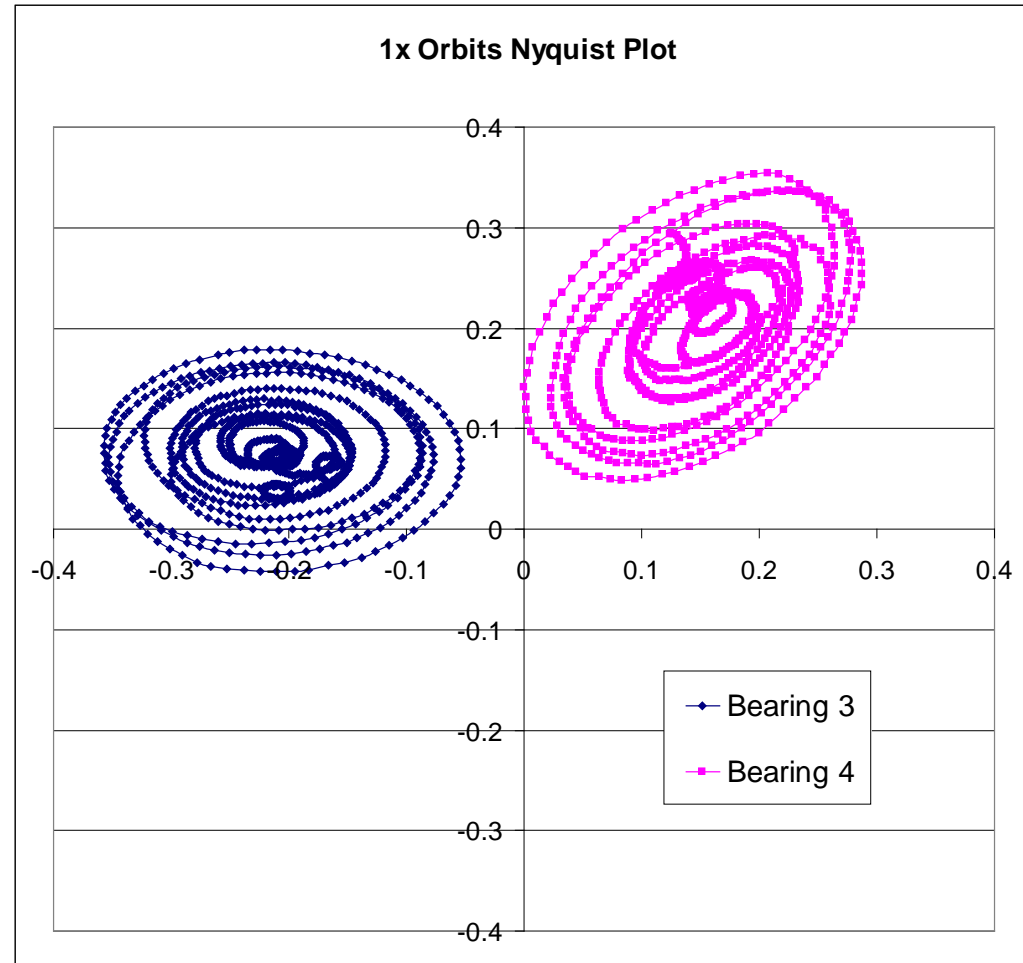
- These are **polar plots** of **amplitude** (vector length from graph center) and **phase angle** (angle the vector makes with the x-axis).
- As time progresses, if imbalance is changing, the tip of the vector plots out as an arc.
- If the imbalance change is cyclic, the vector tip plots as an ellipse or circle.

Nyquist Plots of Orbit Size & Phase for Left (“Bearing 3”) and Right (“Bearing 4”) Orbits

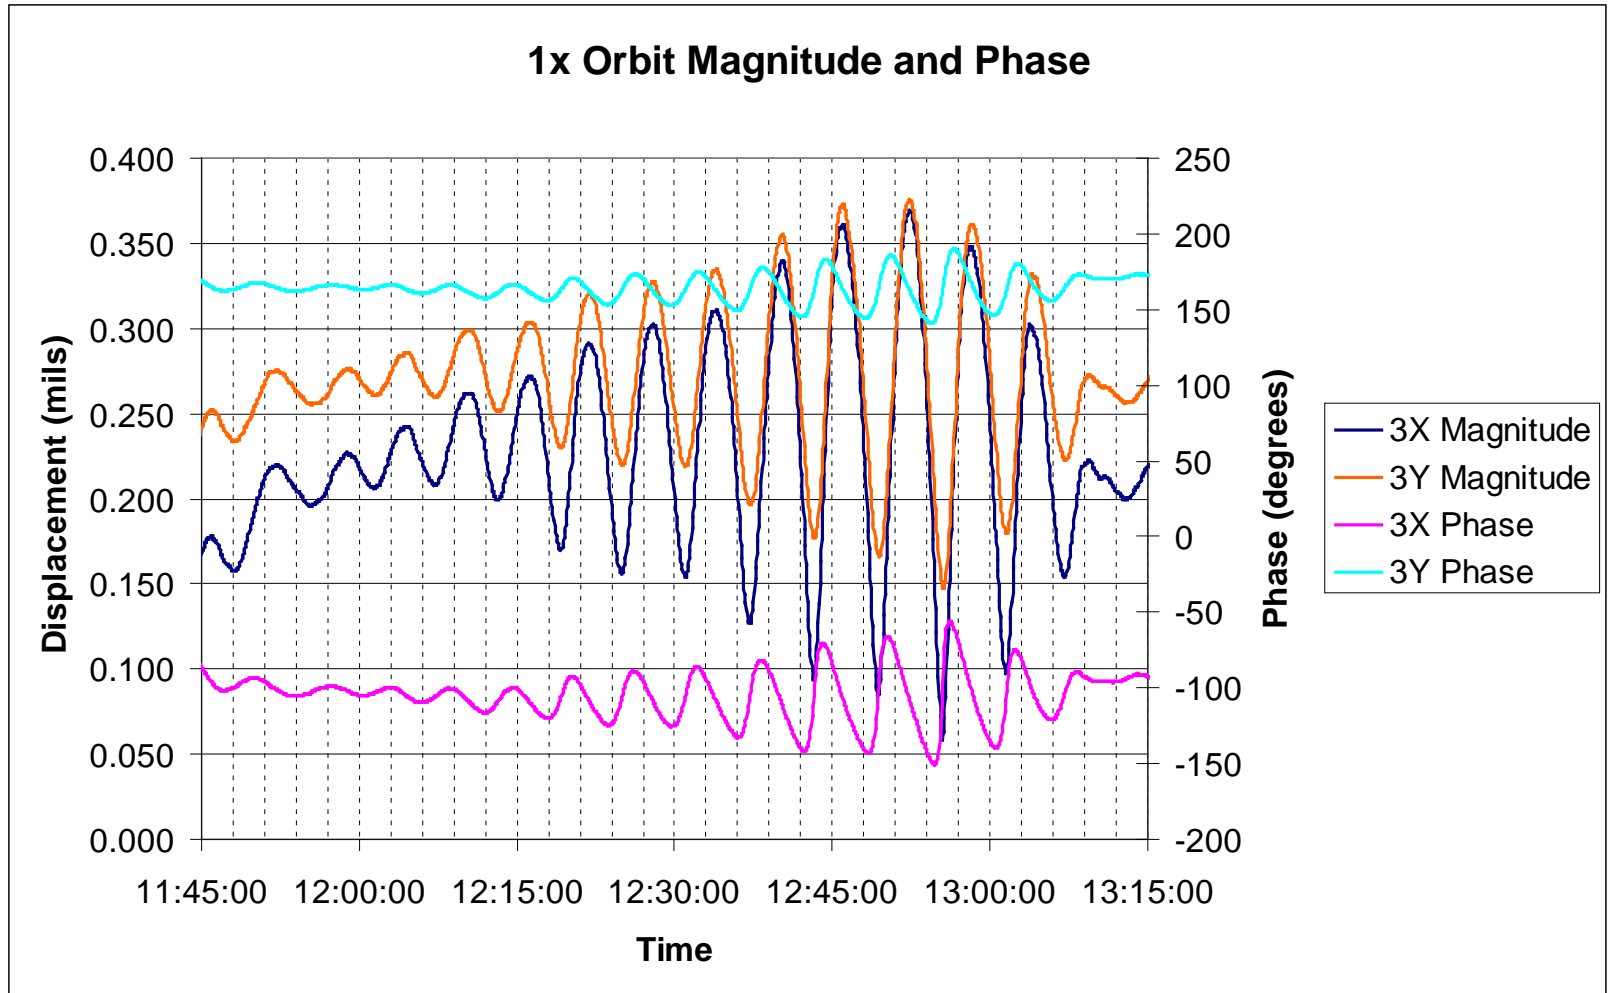
Synchronous Vibration Levels of Probes 3X and 3Y During Testing

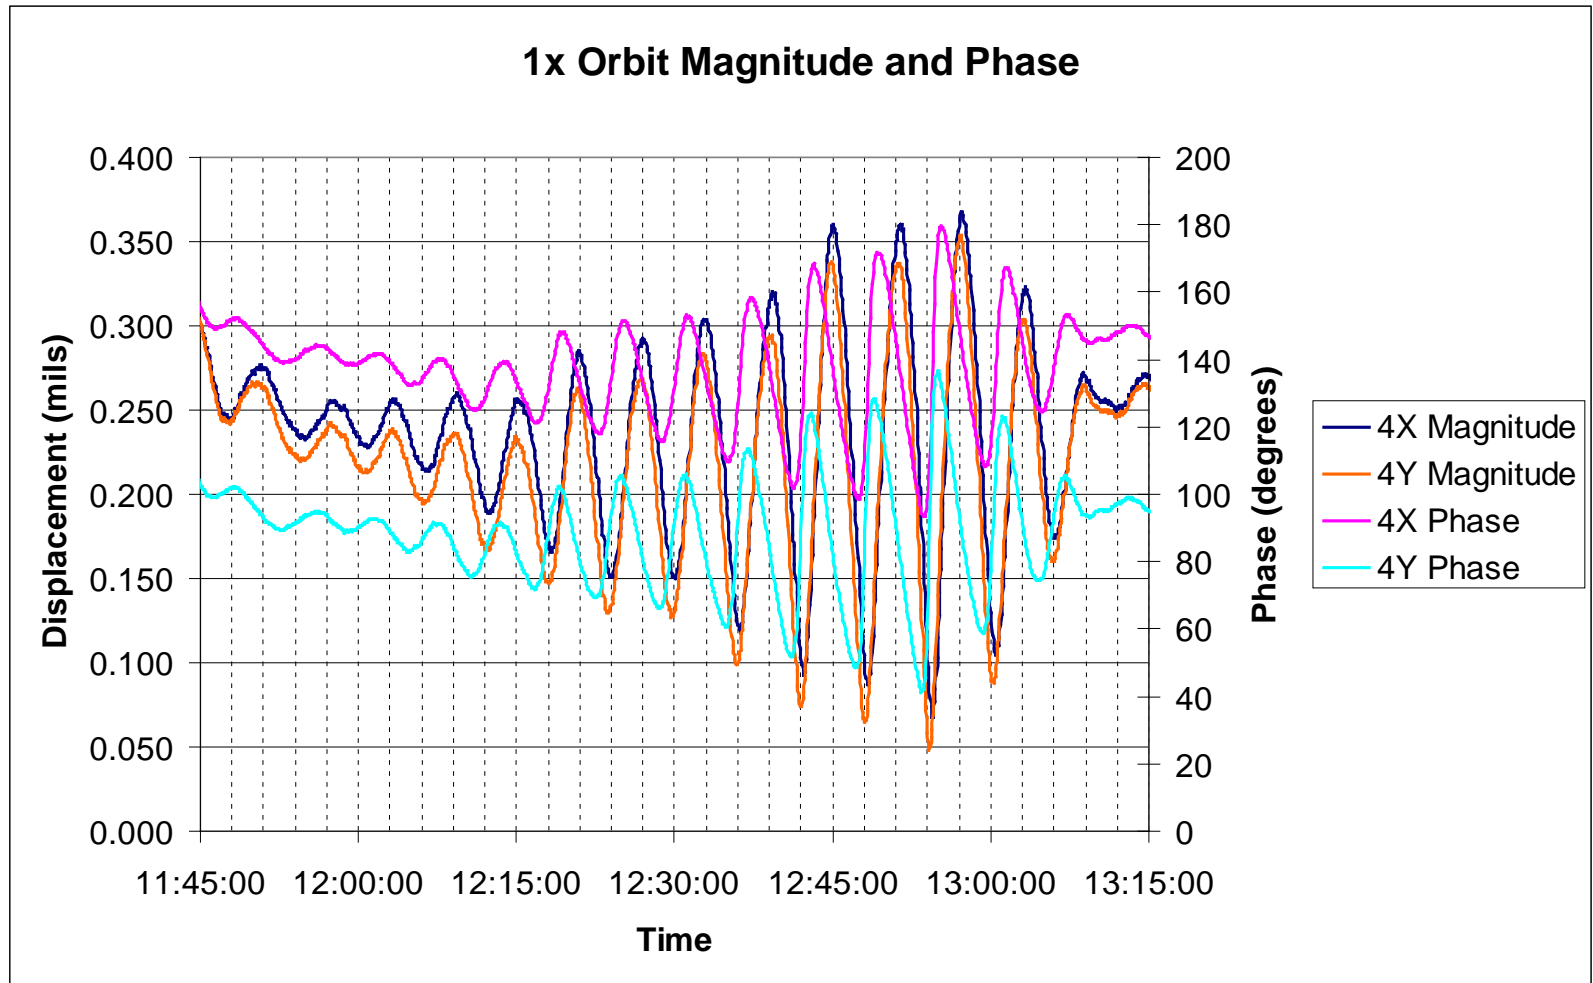
Synchronous Vibration Levels of Probes 4X and 4Y During Testing

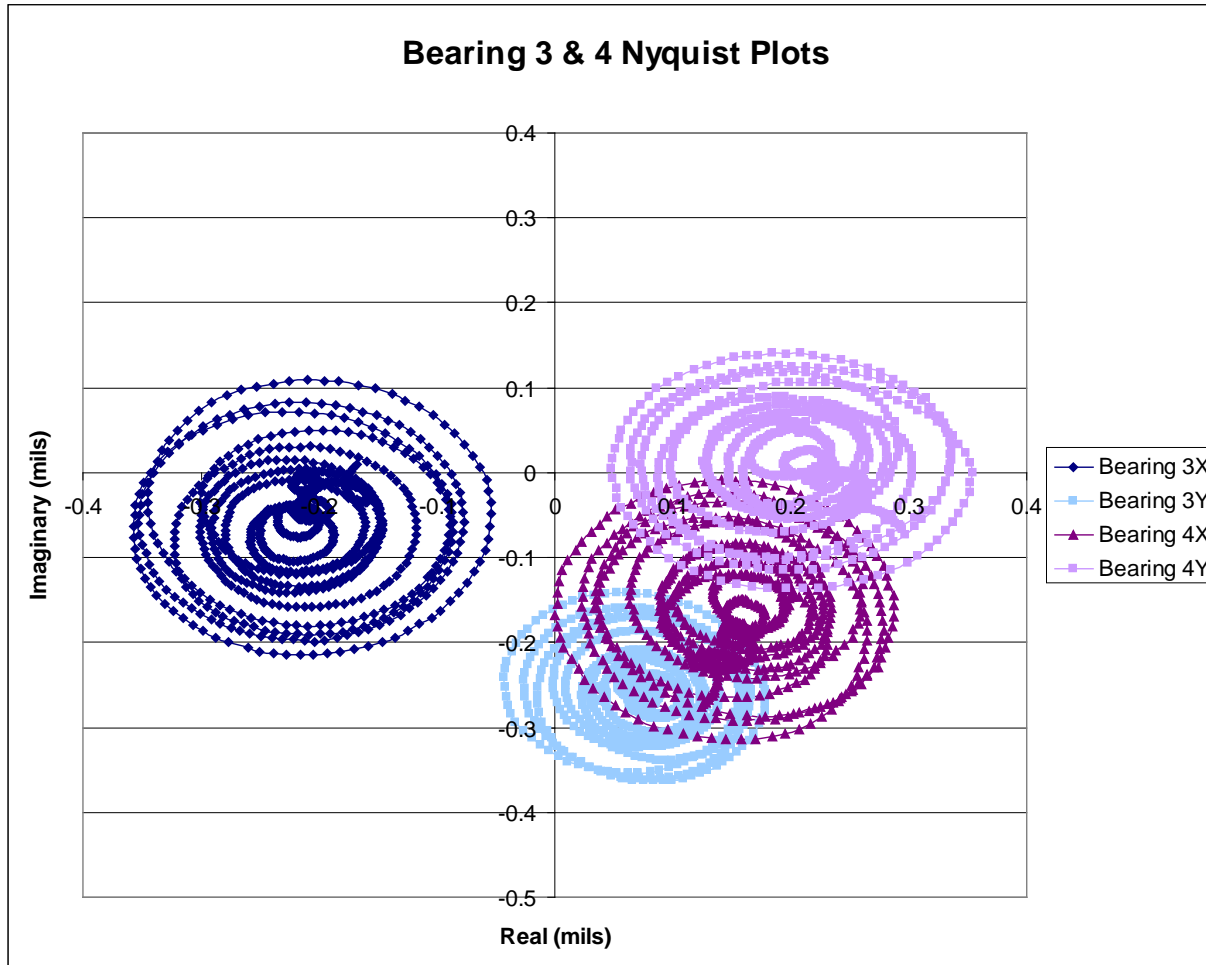
Nyquist Plots of Probes 3X, 3Y, 4X, and 4Y During Testing

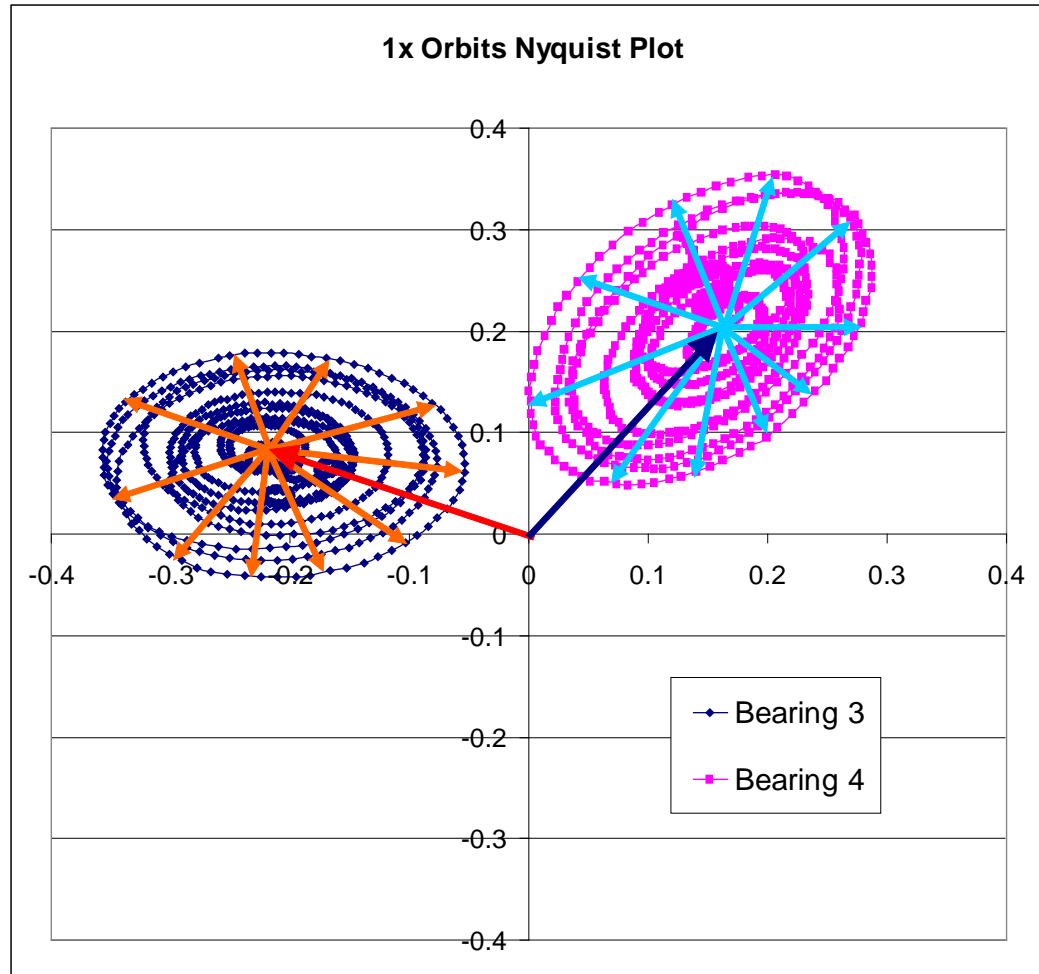
Nyquist Plots of Orbits with Residual Mechanical Imbalance & Cyclic Thermal Imbalance Vectors Overlaid

- In this case, slow oscillation occurred, in a manner that was not in phase end-to-end. Newkirk Effect (rotor rubbing, heating, wearing, cooling, and thereby reversing imbalance location on a cyclic basis) could possibly explain this, but if so the rotor would have been expected to quickly wear itself out, and this did not occur.
- “Morton Effect” is a form of imbalance or bow which changes its magnitude and phasing on a cyclic basis. Depending on the phasing of the thermal unbalance and the original residual mechanical unbalance of the two ends, a cyclic vibration pattern similar to the test data presented becomes possible.
- The circular relationship of cyclic vibration amplitude with phase change at each end is best explained by Morton Effect.

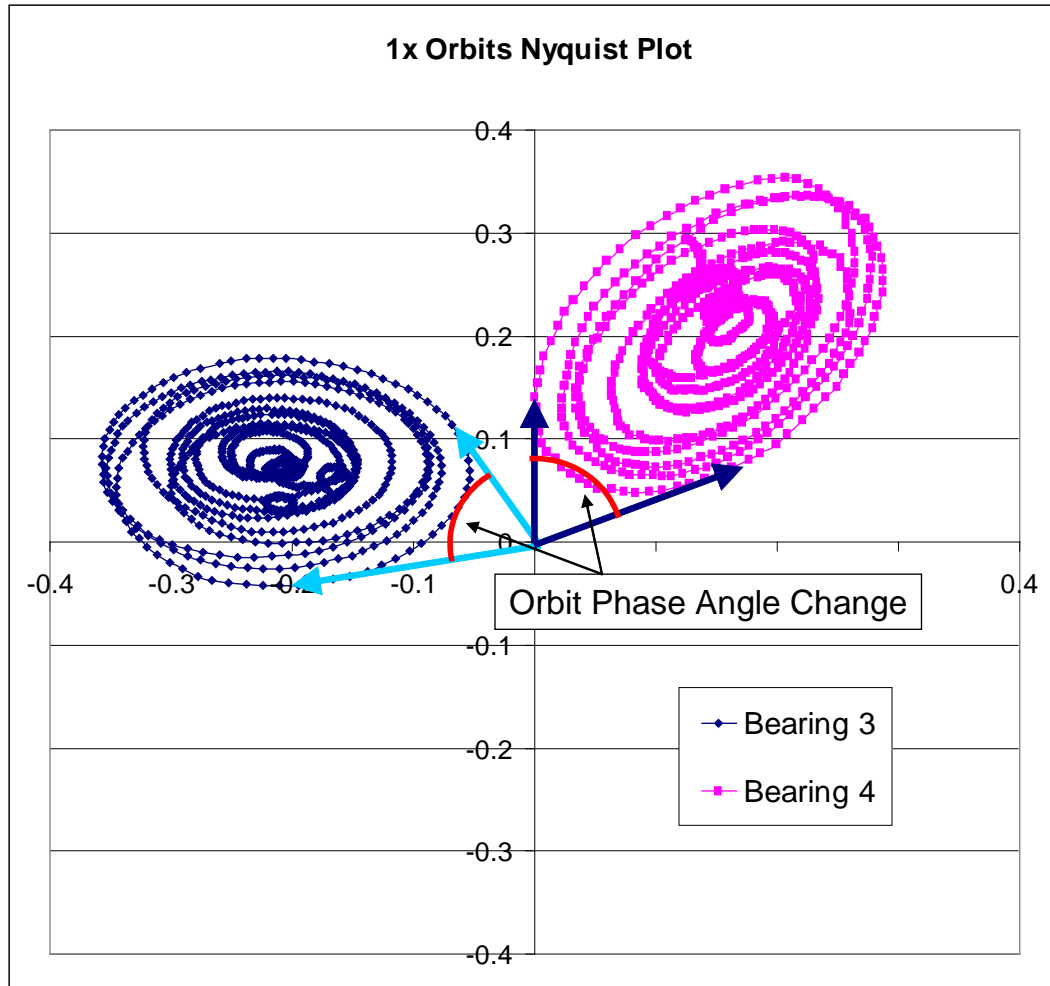
Nyquist Plots of Orbits 3 and 4 with Net Imbalance Force Vectors Overlaid

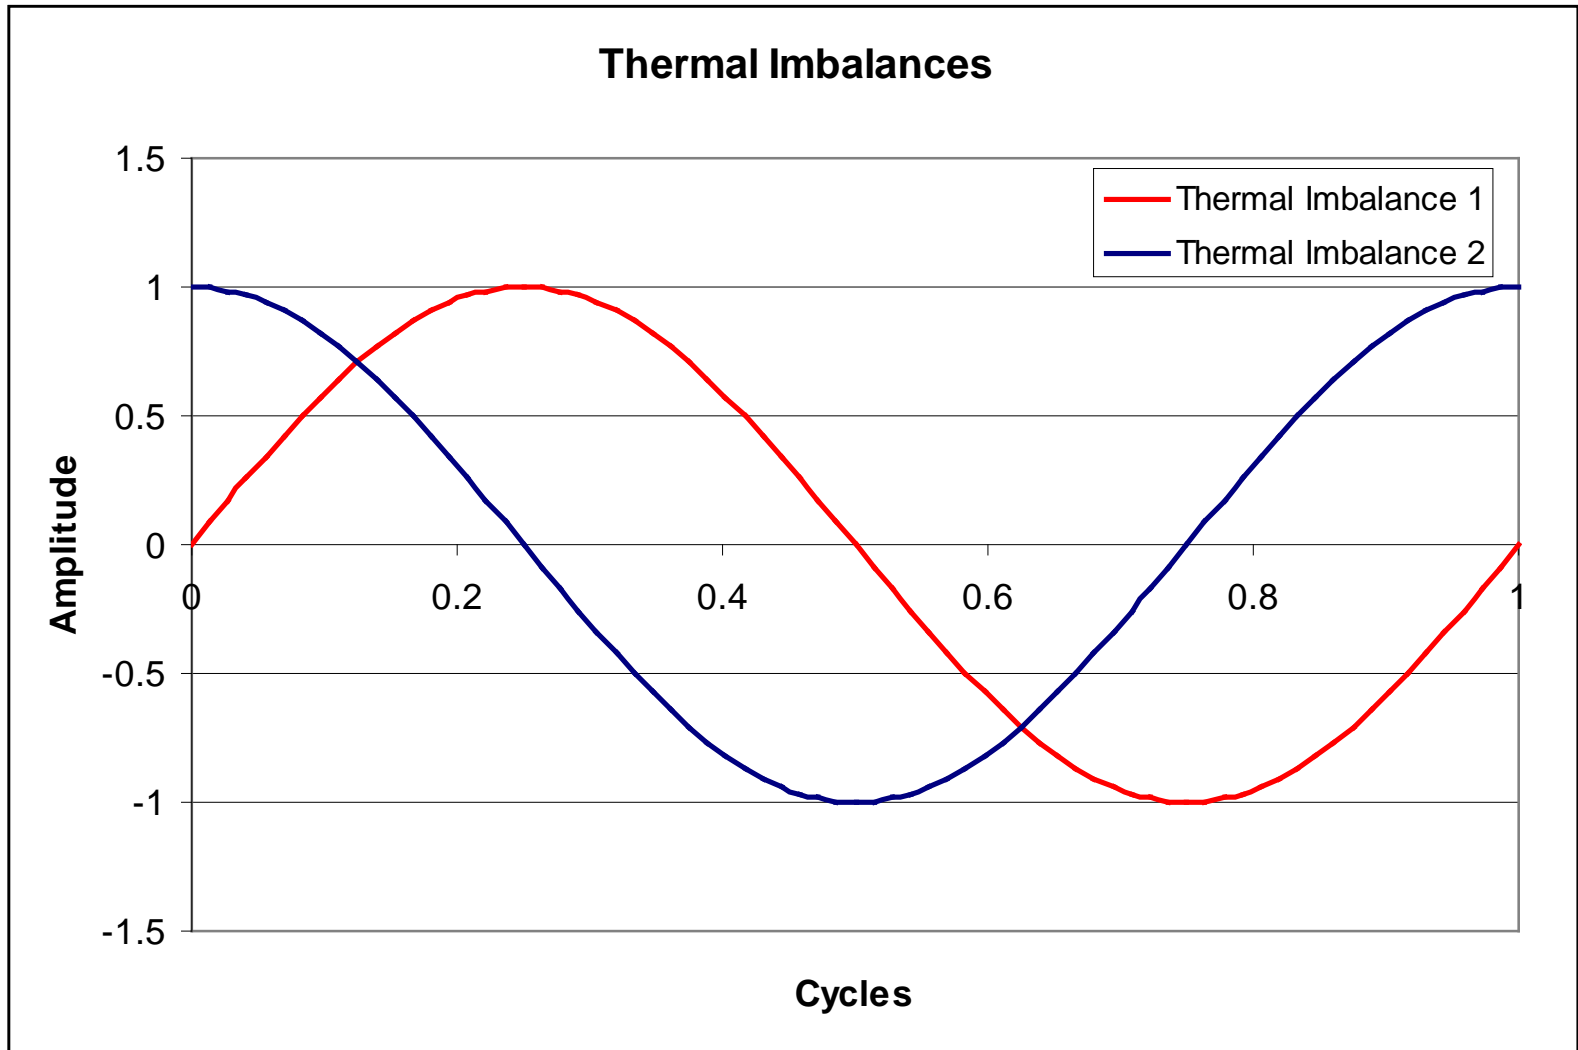
Example Thermal Imbalances

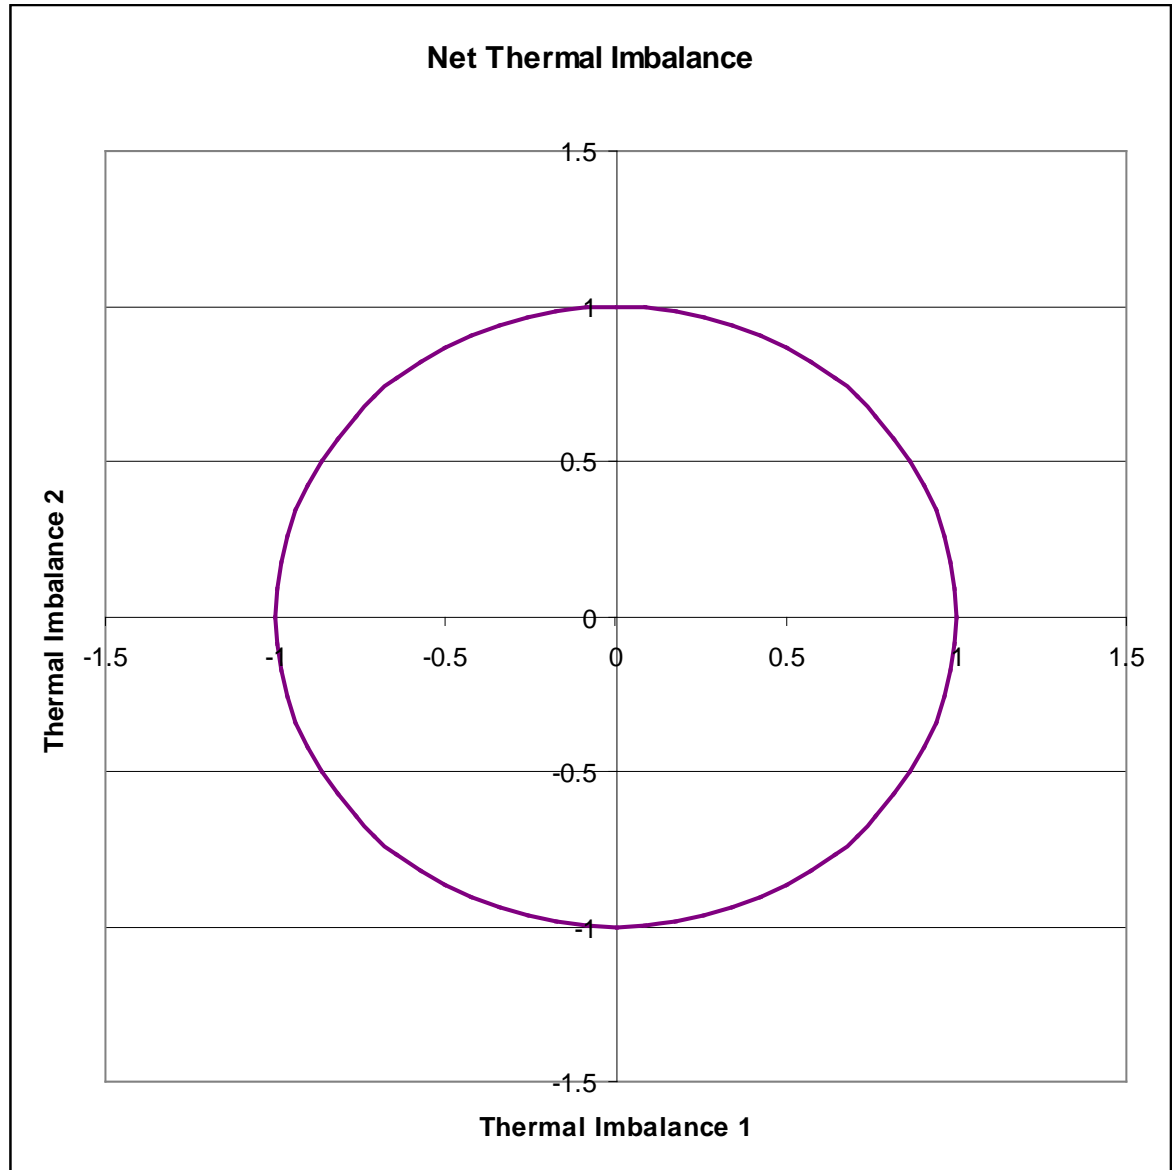
Net Thermal Imbalance From Addition of Example Thermal Imbalances
