**EXPERIMENTAL INVESTIGATION OF CYCLIC
VIBRATION MORTON EFFECT IN THE BEARINGS OF
A DOUBLE OVERHUNG COMPRESSOR**

TAMU Turbomachinery Symposium
September 21-24, 2004

by Jim McGinley & Bill Marscher
Mechanical Solutions, Inc., Parsippany NJ
&
Brian Illis
BOC Gases, Murray Hill NJ

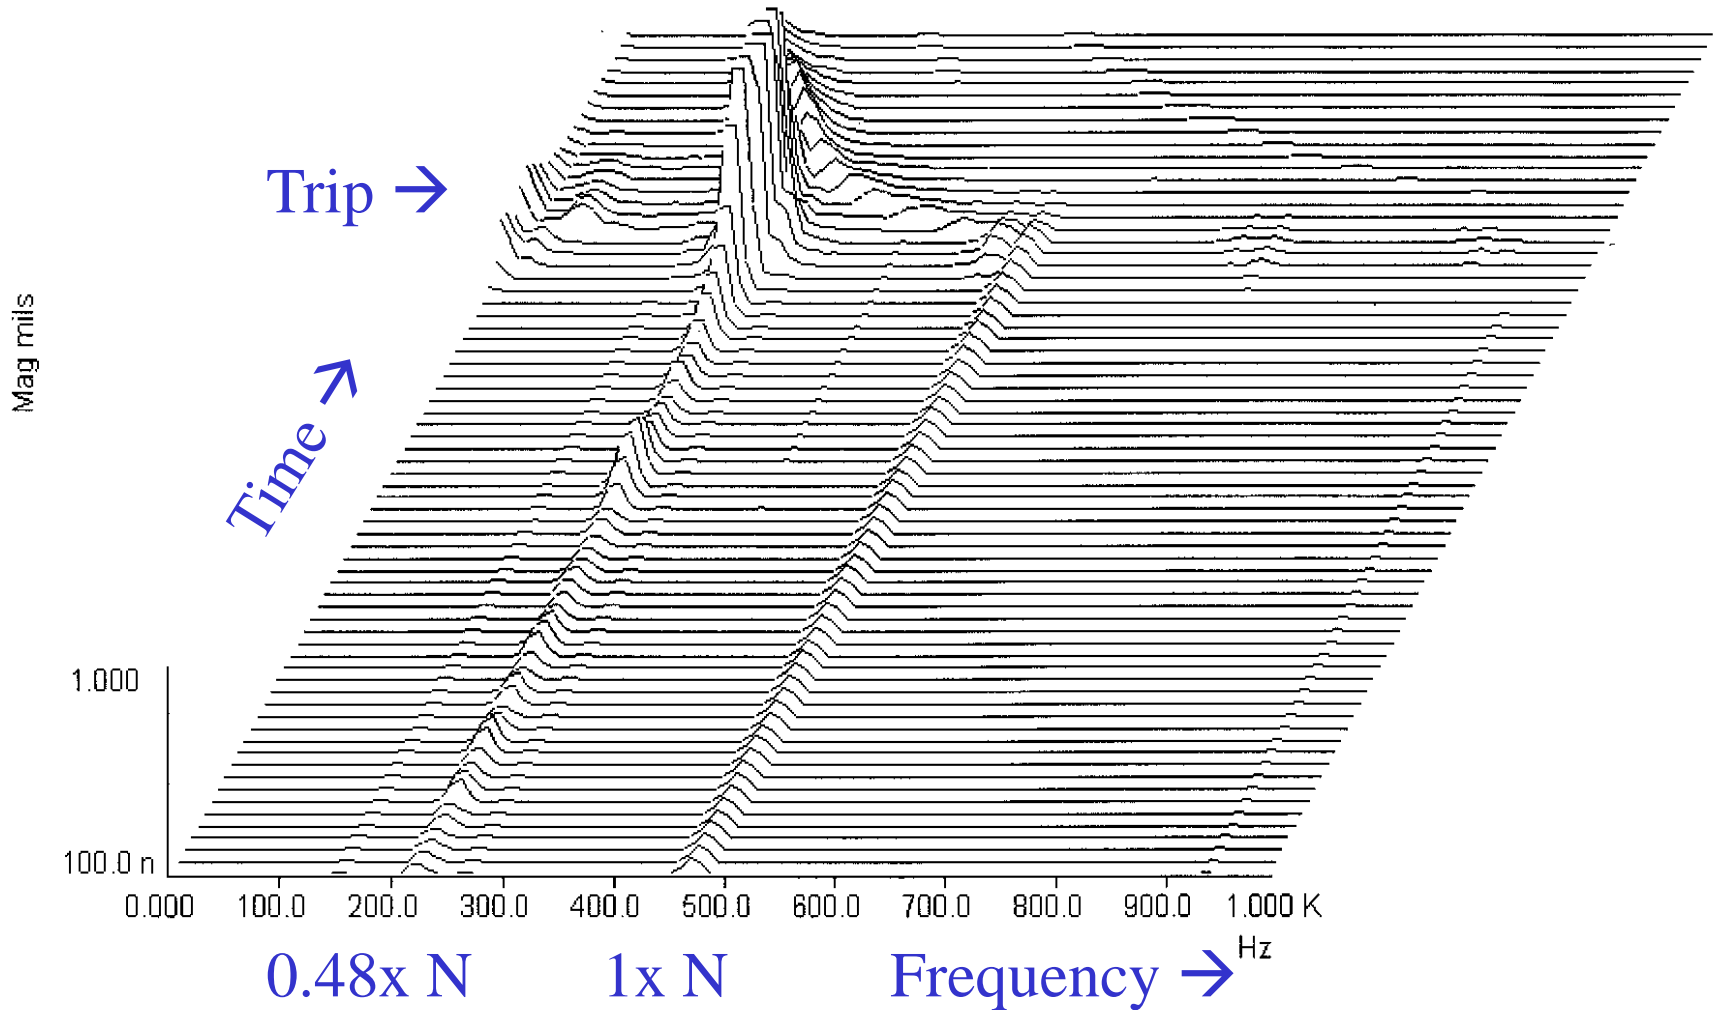
- If the problem was insufficient bearing stiffness, then a large 1x (synchronous) orbit would result, as was observed. Such low stiffness could represent a flaw in bearing design or manufacture, for example by the clearance being too large. Typically, this would not lead to rotor vibration amplitude cycling, however.
- In the case of resonant 1x vibration, typically a “skirt” occurs at the bottom of the 1x vibration narrowband peak, and such a skirt was not present.
- In the case of a rotordynamic instability, the vibration frequency would typically be in the range of 43% to 48% of running speed, which was not the case.

Typical Rotordynamic Instability
