Air Compressor Site Performance Testing: Apparent Simplicity & Practical Complexity

ABSTRACT - CASE STUDY 06

The performance of a steam turbine driven air compressor deteriorated by 35% over a span of four months. This Case Study elaborates on the identification, analysis and restoration of performance.

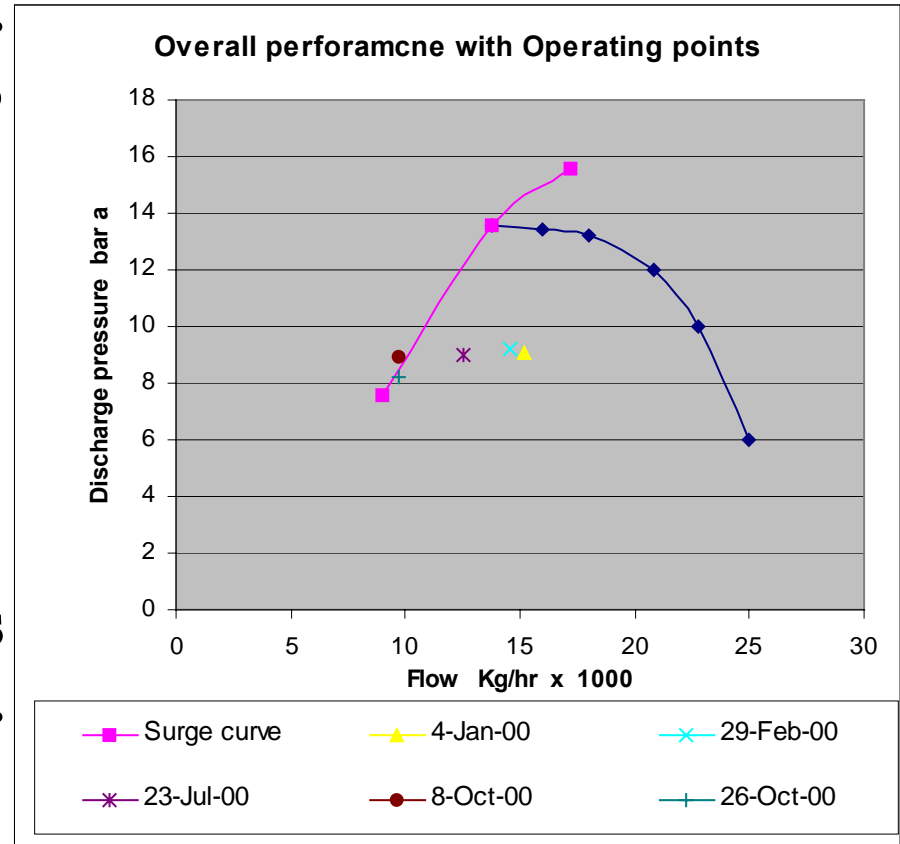
- Compared to design spec. there was 35 % to 40 % deficiency in mass flow.
- Mass flow and discharge pressure were corrected for operating speed and air inlet conditions.
- Couple of operating points were on the surge curve. No real surging occurred.

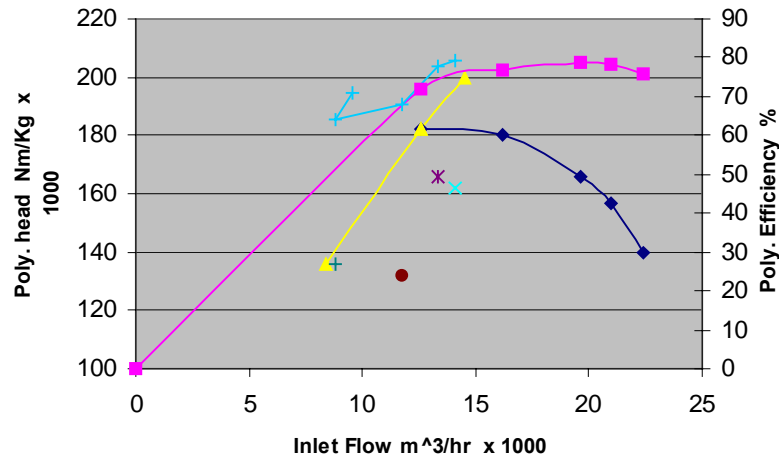
First Stage Design with actual operating points

Poly. η Matched the Design ($\Delta\eta$ 0.7%) on Both Stages

◆ Polytropic head $\text{Nm/Kg} \times 1000$
 ✕ 4-Jan-00
 ● 23-Jul-00
 ■ Polytropic efficiency %
 + Actual Poly. Efficiency %
 ▲ Surge curve
 ✕ 29-Feb-00
 + 8-Oct-00
 ○ 26-Oct-00

Performance testing at site indicated operating points almost on the design surge curve. The difference between the design polytropic efficiency and the polytropic efficiency calculated from data collected during operation at comparable operating points for the first and second casings were marginal, 0.3 to 0.7 percent.

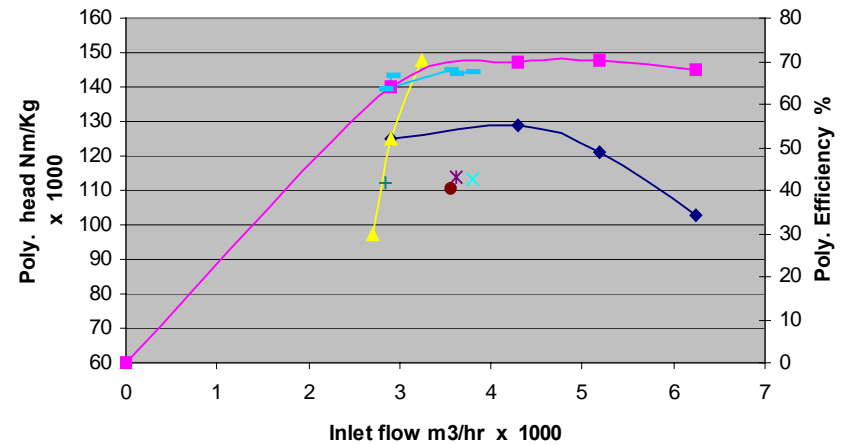
Second Stage Design with Actual operating points

◆ Polytropic head $\text{Nm/Kg} \times 1000$
 ✕ 4-Jan-00
 ● 23-Jul-00
 ■ Polytropic efficiency %
 + Actual Poly. Efficiency %
 ▲ Surge curve
 ✕ 29-Feb-00
 + 8-Oct-00
 ○ 26-Oct-00

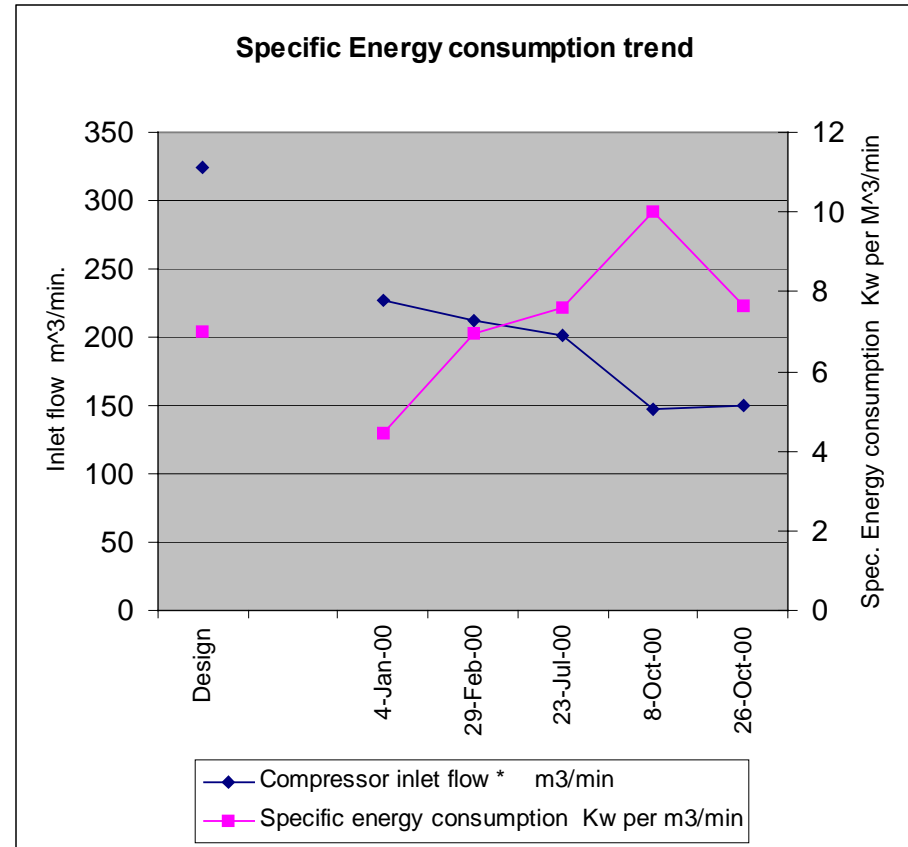
• **Specific energy
{Kw/(m³/min)}**
**consumption showed
increasing trend
from January 2000.**

• **Compressor inlet
and discharge
conditions – NO
significant change.**

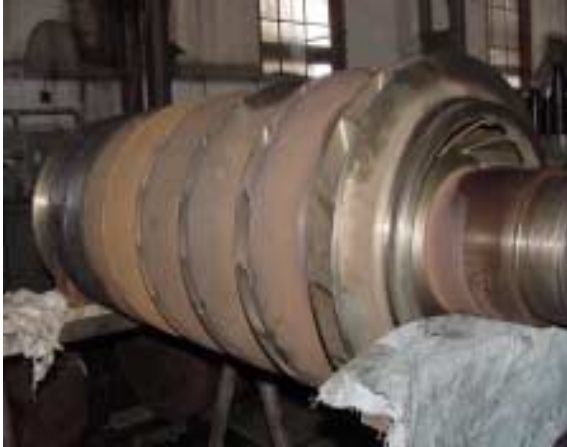
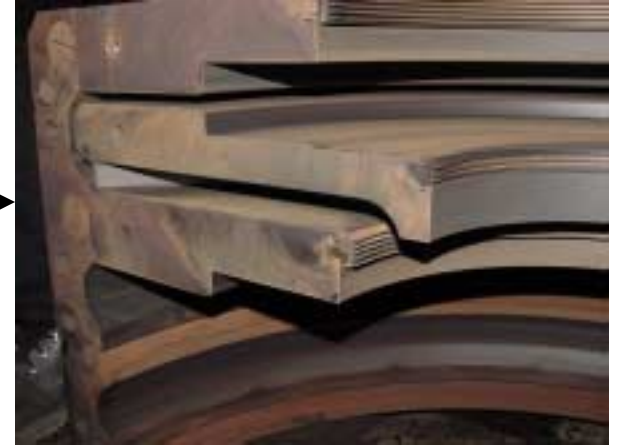
← **Clean
Rotor**

**Clean
Casing** →

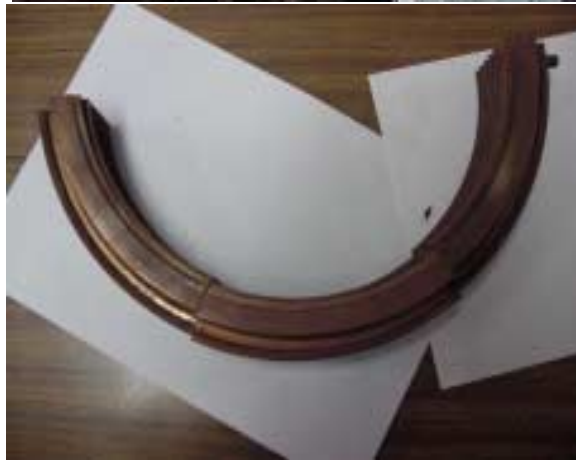
**Dislocated
Balancing Drum**

← **Laby Segment**

- **Balancing drum laby clearance 0.56 mm. Design spec. 0.30 mm. – 2 X the design level – leakage calculation 4.4 % of design mass flow.**
- **Inlet section venturi, silencer inlet and outlet, piping from silencer to compressor inlet.**
- **Inlet silencer – 3 mm mesh strainer welded to the outlet flange and to the internal element.**

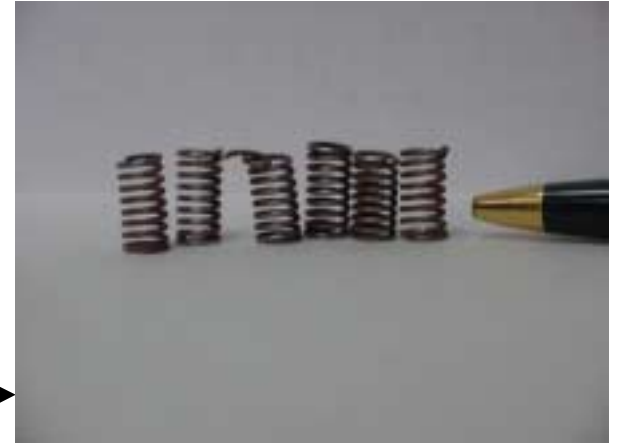
**Damaged Laby
Spring** →

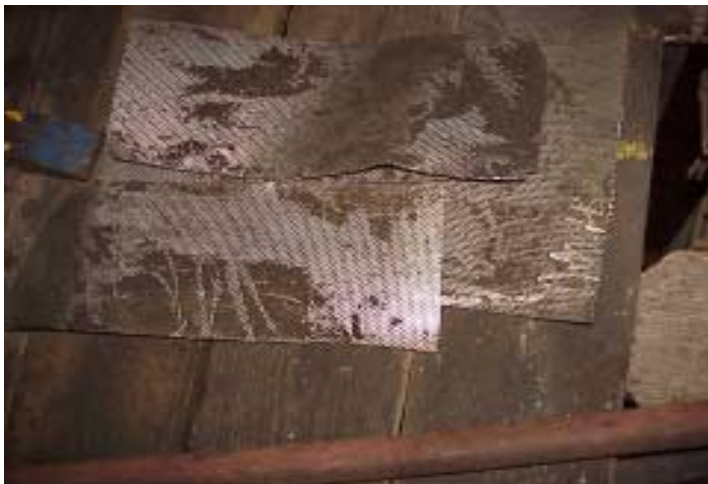
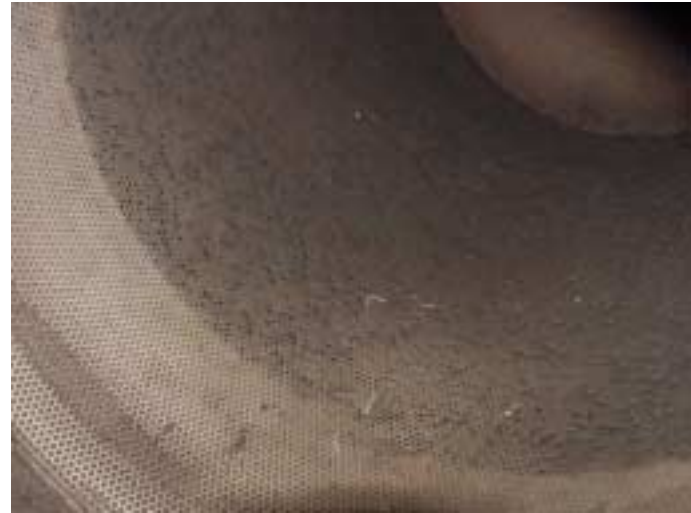
- **Strainer at inlet silencer – plugged severely.**
- **Strainer was welded to the internal element of the silencer.**

- **No pressure indication downstream of the silencer.**

- **3 mm strainer could not be removed.**
- **Large segments were cut and removed and stiffeners were welded.**
- **10 mm removable conical bolt-catcher with ear was installed downstream of the Silencer.**
- **Pressure indicator was provided upstream of the compressor inlet.**
