# ONLINE TECHNIQUES TO MITIGATE THE RISKS THAT LIMIT EXPANDER RELIABILITY

**Ben Carbonetto**

**GE Oil & Gas, CONMEC**

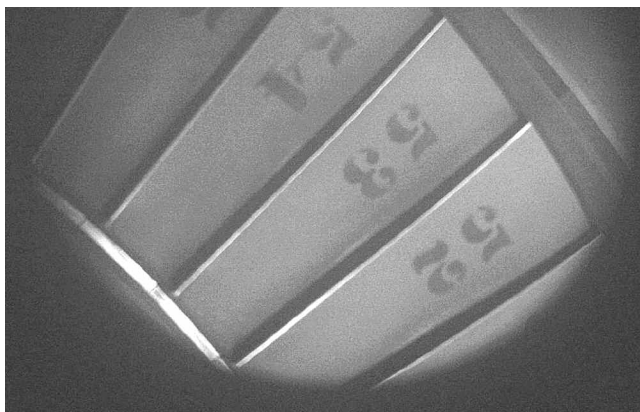
Figure 4. Online Photograph Showing Normal Operation.

The deposits within the expander affect the operation in various ways. A catalyst deposit may form on the shroud of the rotor blades. The tip clearance is reduced and a tip rub may occur. Figure 4 illustrates an expander operating under normal conditions. The reduction in tip clearance can be seen in Figure 5. During the tip rub, heat generated due to friction may increase the blade metal temperature in excess of 2000°F (1100°C). The localized heat can cause damage to the base material of the rotor blade. For example in Waspaloy<sup>®</sup>, these temperatures will cause grain growth and a reduction in mechanical strength and often leads to blade tip cracking and partial airfoil losses (Figure 6). The use of higher temperature alloys, such as Inconel<sup>®</sup> 738, is less affected by the temperatures experienced during a blade tip rub. No changes in microstructure have been seen with the use of Inconel<sup>®</sup> 738, reducing the potential for blade tip cracking and partial airfoil loss.

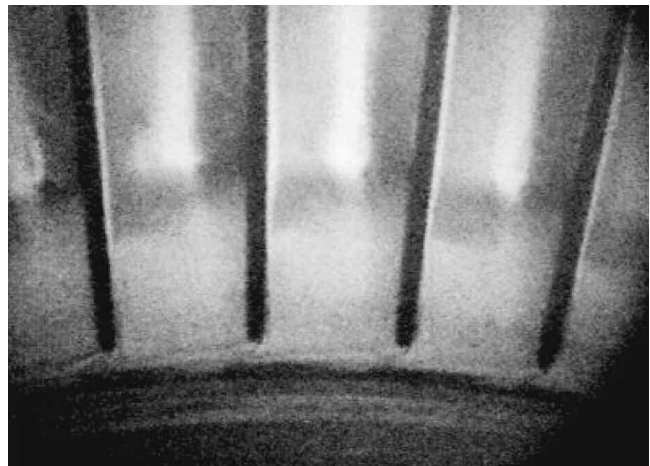
Figure 11. Online Photograph Showing Deposit Formation at Base of Rotor Blade.

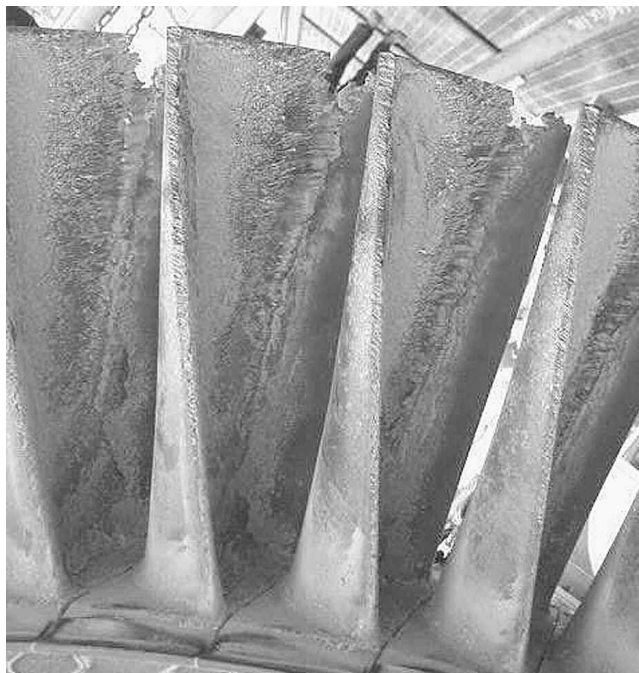
Figure 15. Rotor Blade Primary Erosion.

The same catalyst, which has a tendency to form a deposit, can cause erosion. Caution must be used when reviewing erosion damage, since some erosion can be caused by steam. Erosion can be classified as primary or secondary. Primary erosion is caused by larger (> 5 microns) catalyst particles impacting the surface and removing material. Typical primary erosion on a rotor blade can be seen in Figure 15. Some rotor blades experience secondary erosion at the hub of the airfoil. Secondary erosion occurs when smaller catalyst particles, and sometimes steam, get caught in areas of the flow path where low axial velocities exist. A region of flow recirculation develops, and the entrained catalyst and/or wet steam will start to erode the base material. Due to the complex aerodynamics, multistage expanders are more susceptible to secondary erosion than single stage expanders.

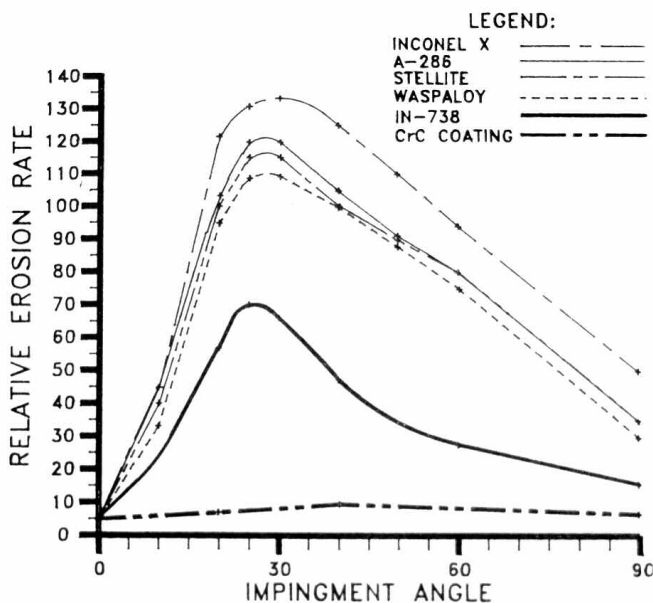
Figure 16. Effect of Base Material and Coating Selection on Erosion Rate at Various Angles of Impact.

Solutions to erosion problems can only be found when the entire FCC unit is reviewed. Although the expander design can be a significant contributor to erosion, the effectiveness of upstream equipment such as the TSS and/or the regenerator cyclones impact erosion significantly. The expander design can be improved to decrease erosion. Aerodynamic tools such as computational fluid dynamics (CFD) have enabled designers to fully understand the particle dynamics, as well as the aerodynamics. After understanding the root cause, aerodynamic changes can be made to significantly improve the erosion life of the flow path components, such as the rotor blades, by using the tools and techniques described in Carbonetto and Hoch (1999). Material and coating selections also have a significant impact on erosion. Figure 16 illustrates the effect of base material and coating selection on the erosion rate of the material at various particle impingement angles. As seen in the graph, coatings provide up to 10 times more erosion resistance than the base materials. Base material selection is still critical because the coatings are limited in thickness, typically 0.006 to 0.008 inch (0.15 to 0.20 mm).

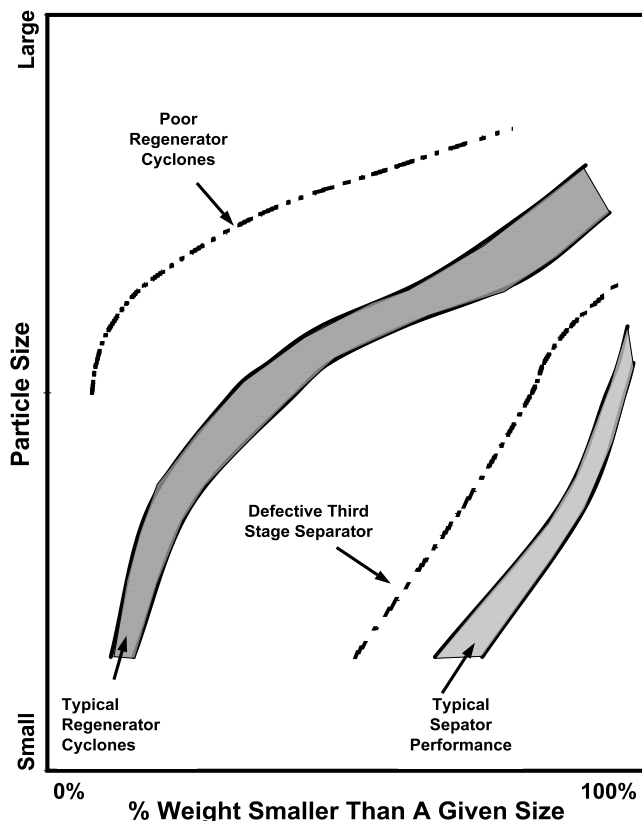
Figure 20. FCC Separator Performance.

To determine the effectiveness of the separation system, the particle size distribution from both the inlet and outlet of the third stage separator are plotted on a performance chart (Figure 20). The x axis is the weight percentage of the sample for a given particle size. The y axis is the corresponding particle size. Reference lines are shown to qualify the test results to industry experience. The gray band to the left is the typical regenerator cyclone performance, third stage separator inlet sample. If the results are above and to the left of this band, the regenerator cyclones may be damaged. Similarly for the third stage separator outlet sample, expander inlet, the gray band to the bottom right of the chart is typical separator performance. Results above and to the left of this area highlight a potential problem with the third stage separator or a blocked underflow line (if equipped). A blocked underflow line can be detected by a reduction in line temperature. Often test results correlating to the defective third stage separator will result in excessive erosion in the expander flow path.
